*NIST Special Publication 862*

# 1994 Northridge Earthquake Performance of Structures, Lifelines, and Fire Protection Systems

*Diana Todd, Nicholas Carino, Riley M. Chung, H. S. Lew, Andrew W. Taylor,  
William D. Walton, James D. Cooper, and Roland Nimis*

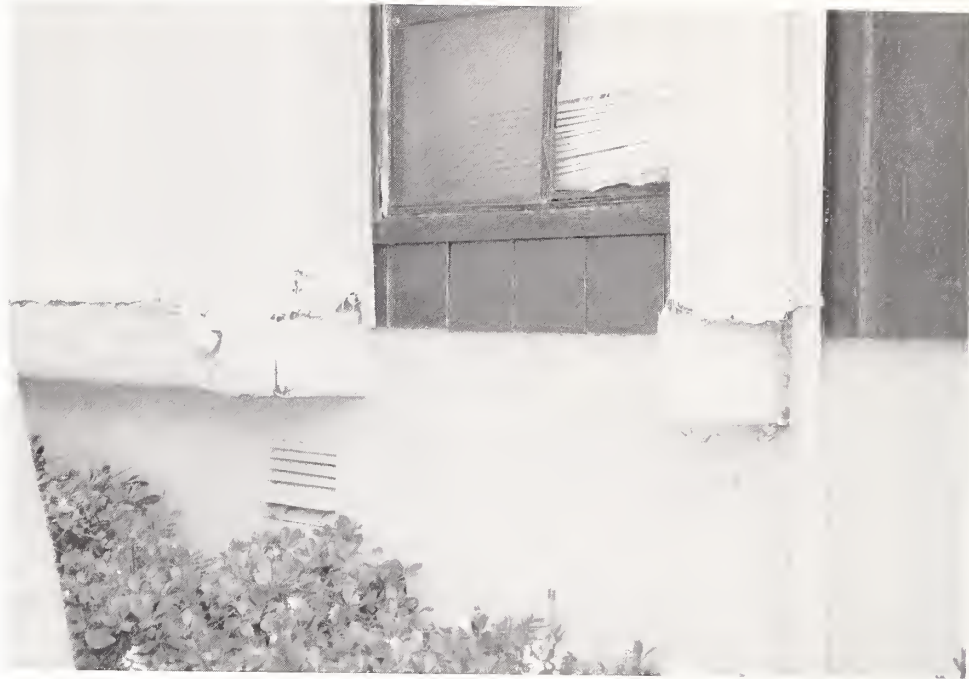
Figure 3.8. Horizontal cracks at the interface of the foundation wall (usually concrete) and the first story (typically wood-framed with stucco facade) were often seen in damaged low-rise apartment buildings.

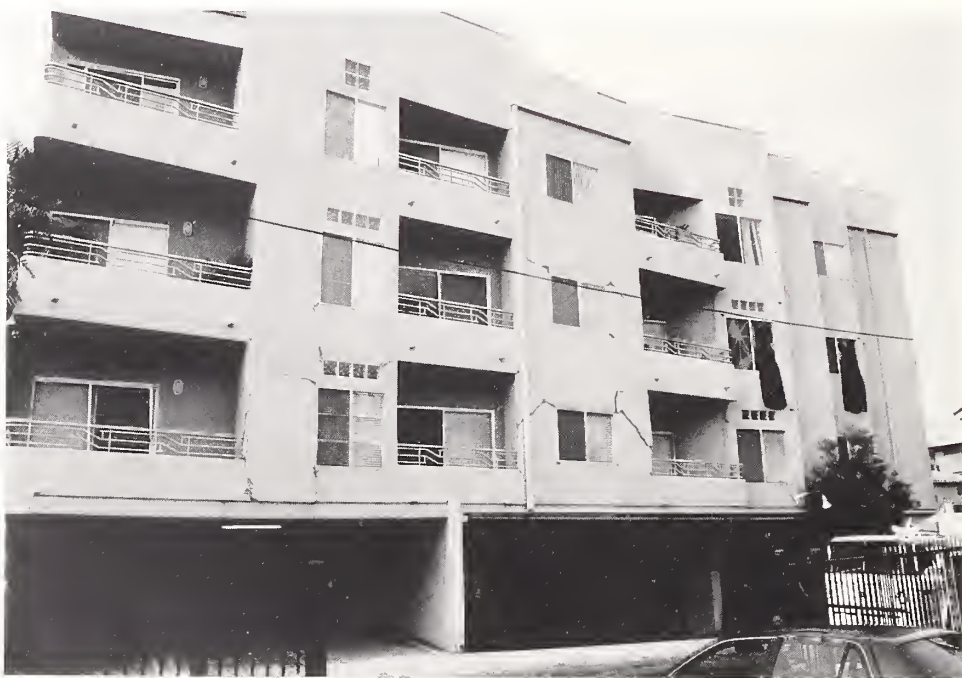
Figure 3.9. Typical damage in to low-rise apartment buildings included diagonal cracks in the stucco facade at the corners of windows and other openings.

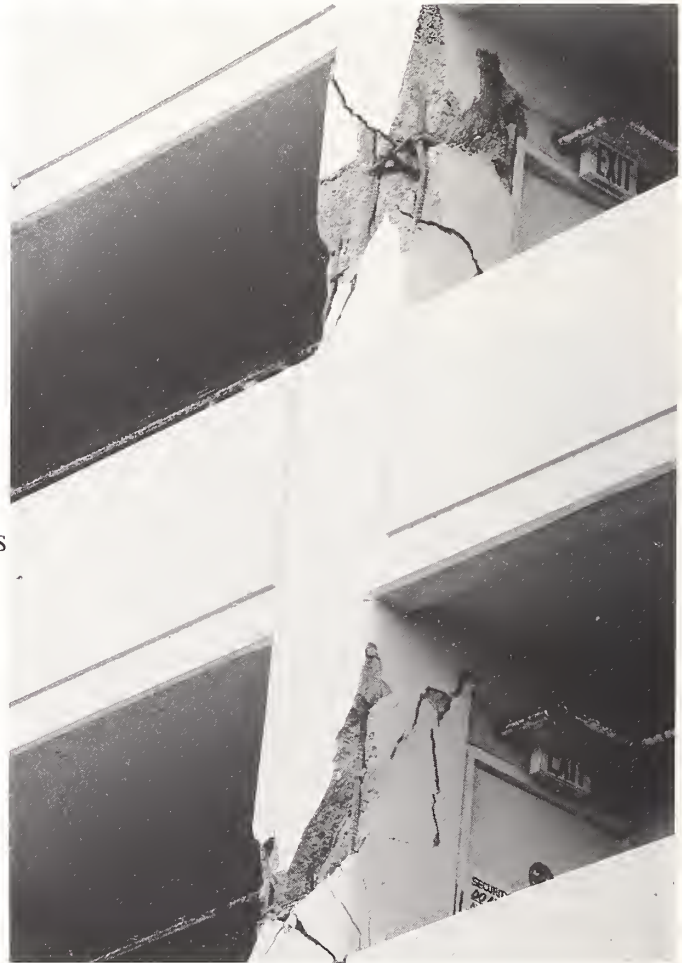
Figure 3.15. A closer view of the failed columns at the back of Champagne Towers shows minimal transverse reinforcement.

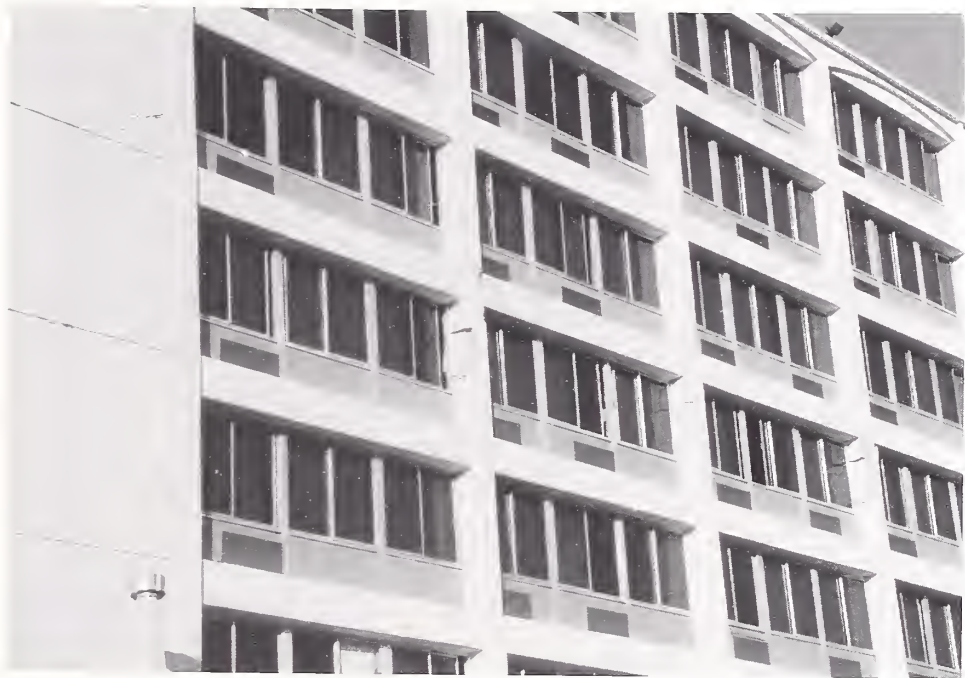
Figure 3.16. The bottom two stories of the concrete frame Holiday Inn in Van Nuys were damaged in the 1971 San Fernando quake and subsequently repaired. In the 1994 Northridge quake, damage was concentrated at the top of the fourth floor columns.

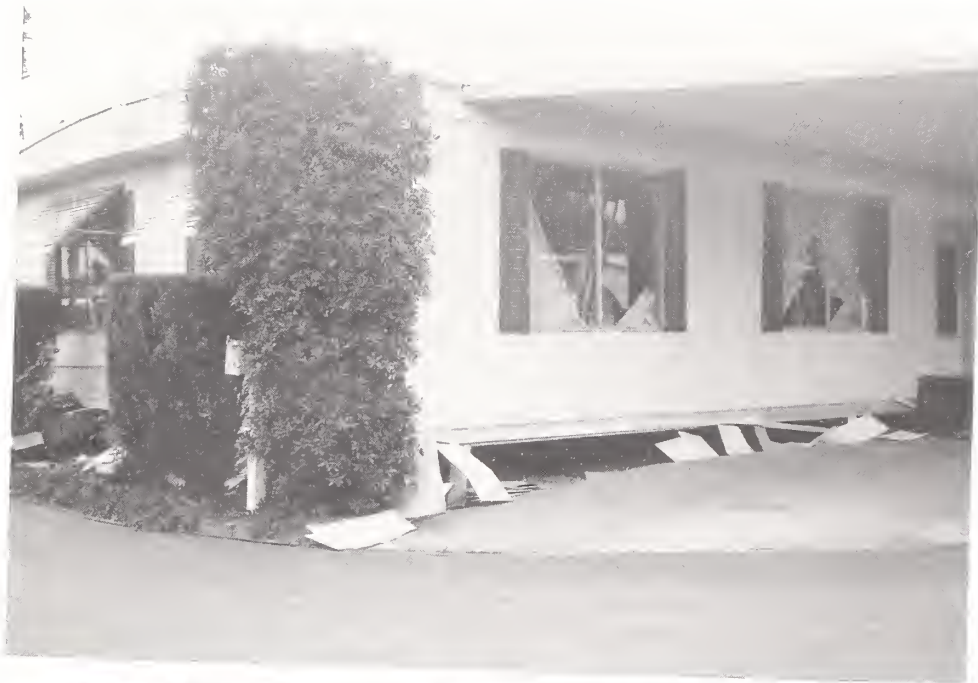
Figure 3.19. Damage to manufactured homes caused by collapsed supports was common.

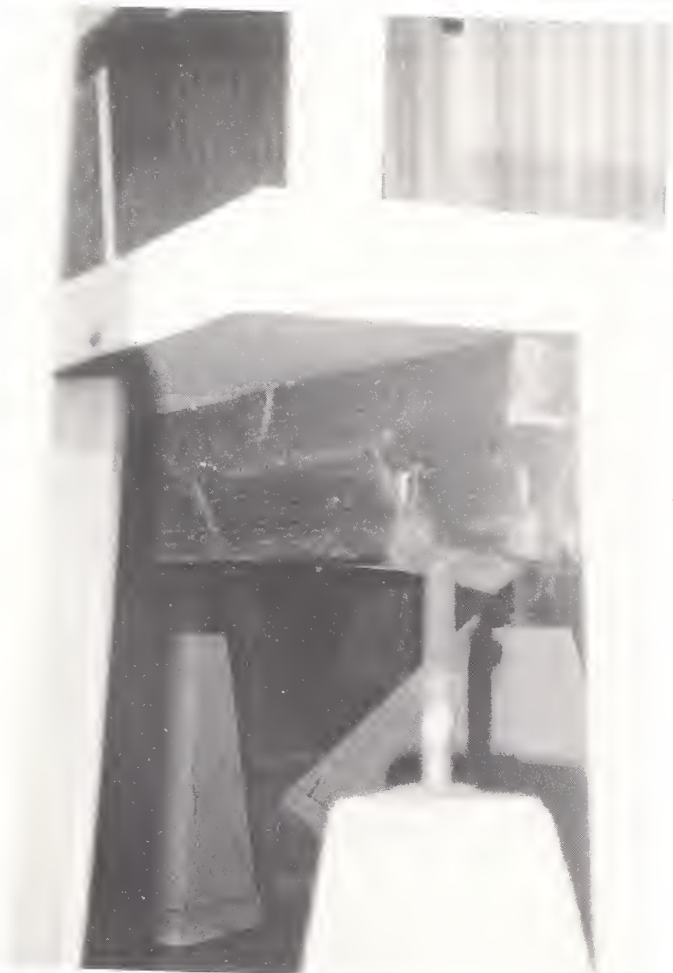
Figure 3.20. Small concrete base supports are a common foundation system used to support manufactured housing. This type of system provided little resistance to lateral forces.

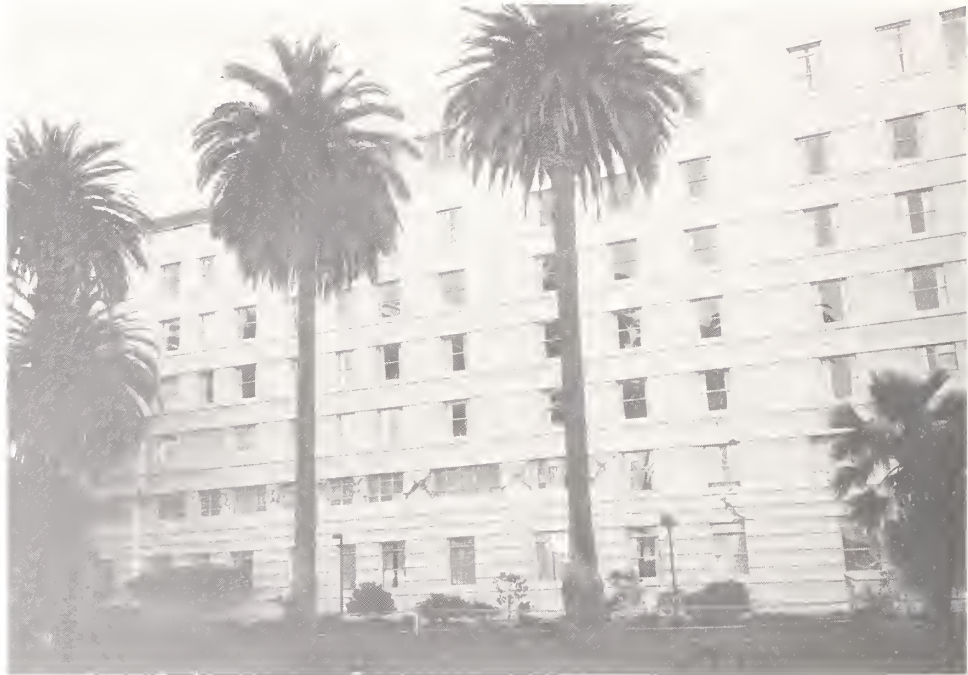
Figure 3.23. The seven-story northwest wing of St. John's hospital in Santa Monica experienced severe X-cracking in the piers between the second story windows.

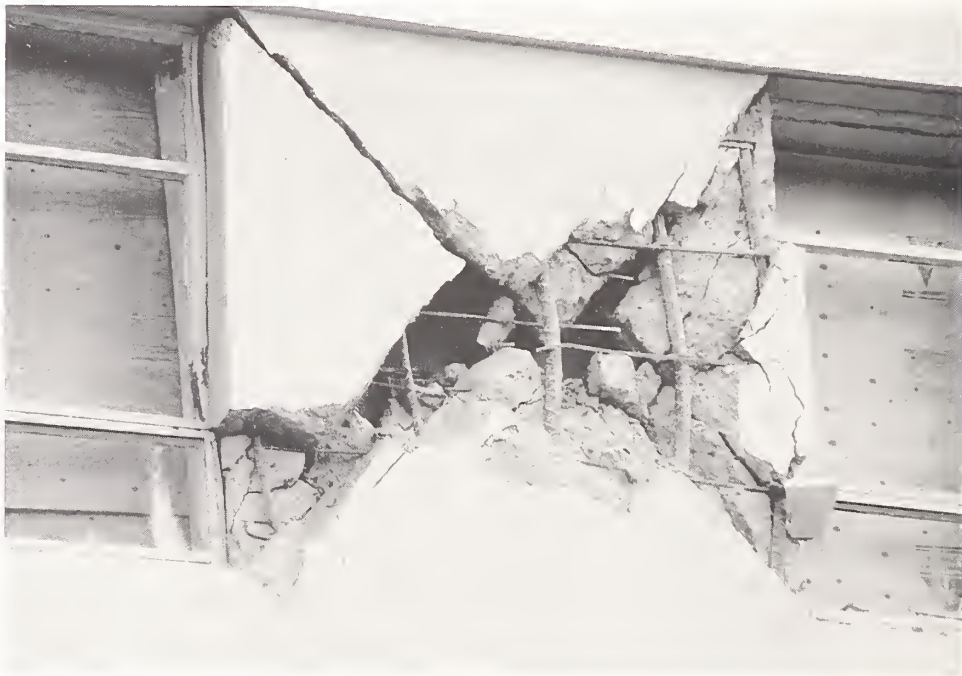
Figure 3.24. The transverse reinforcement in the St. John's hospital window piers was spaced at about 150-200 mm on center with 90° hooks at the ends, typical for construction of its age (about 50 years old).

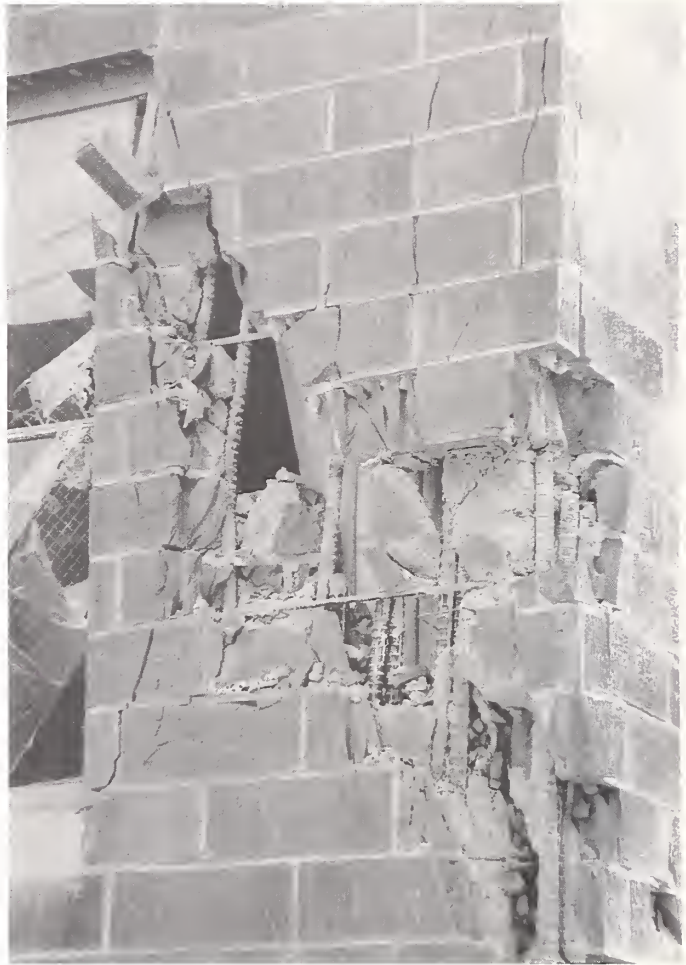
Figure 3.28. Two faces of the Berkley Convalescent Hospital had wing walls separating balconies. The ends of these wing walls spalled at the lower stories.

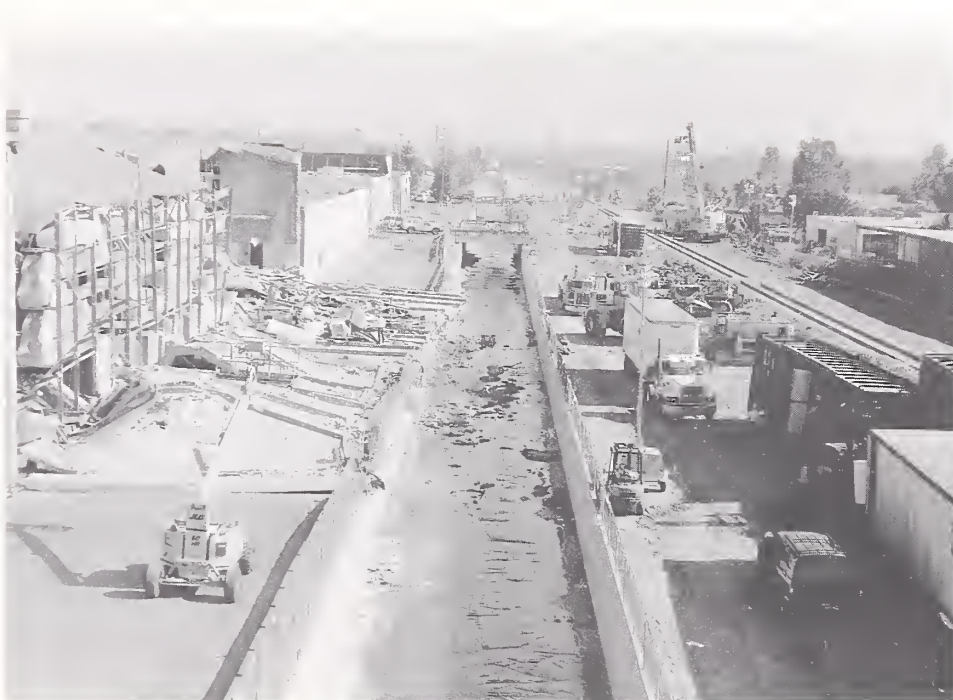
Figure 3.33. The south wall of the concrete tilt-up Levitz furniture store/warehouse south of the Northridge Fashion Center fell away from the building into the alley and stream channel. The damaged roof was being supported by the racks of furniture. On the south side of the stream channel a freight train derailed during the earthquake. That clean-up effort was still underway three days after the quake.

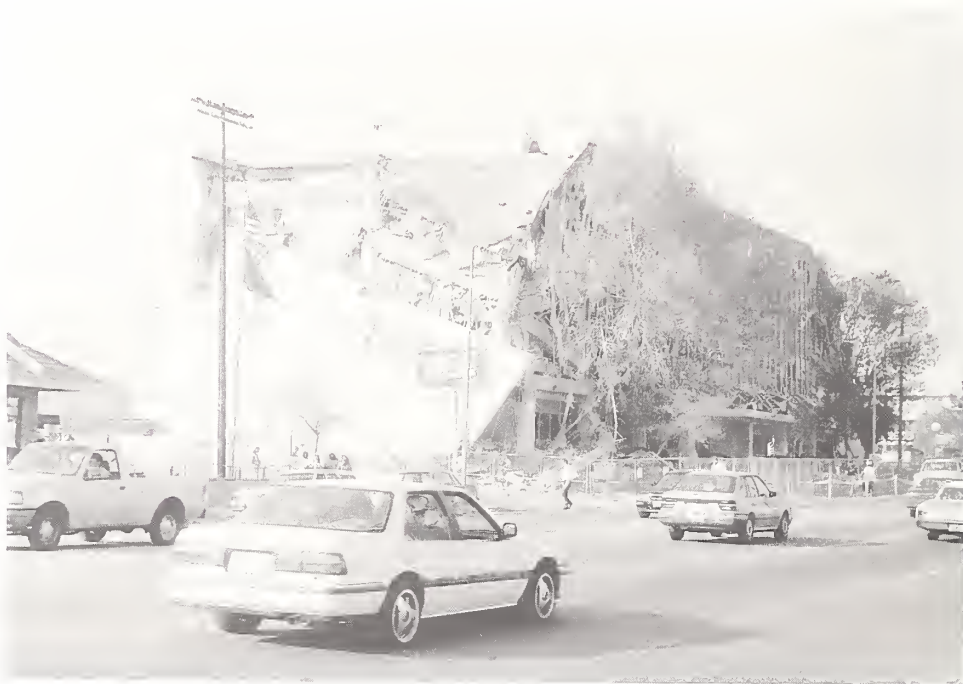
Figure 3.42. Both end walls of the Kaiser Permanente building slid, partially intact, to the ground. The south wall is pictured here. Both ends of the building suffered damage to the concrete frame at all story levels, while the middle half of the building, except for the second story, remained intact.

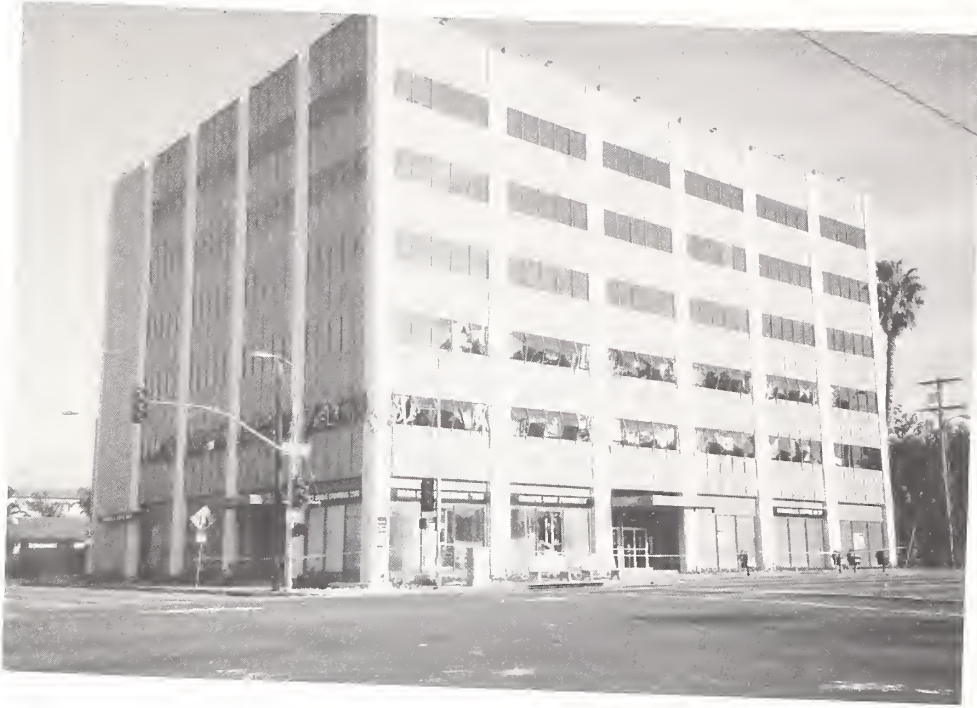
Figure 3.45. The six-story L-shaped concrete-frame Barrington Building on Olympic Boulevard in West Los Angeles lost its vertical-load carrying capacity at the second story.

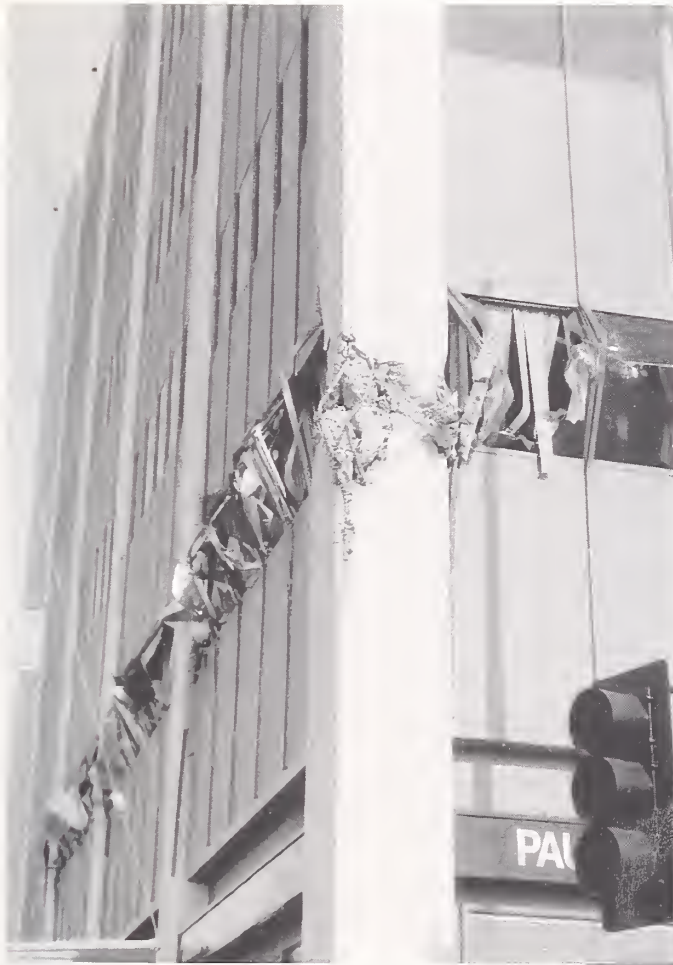
Figure 3.47. The cracking in the concrete columns at the second story was so extensive that the vertical-load carrying capacity of the building was affected. The building settled 50-100 mm at the second story, as these bulging window frames attest. The worst damage was at the southeast corner, the outside corner of the L-shape, pictured here. The building, which developed a slight list, was demolished within days of the quake.

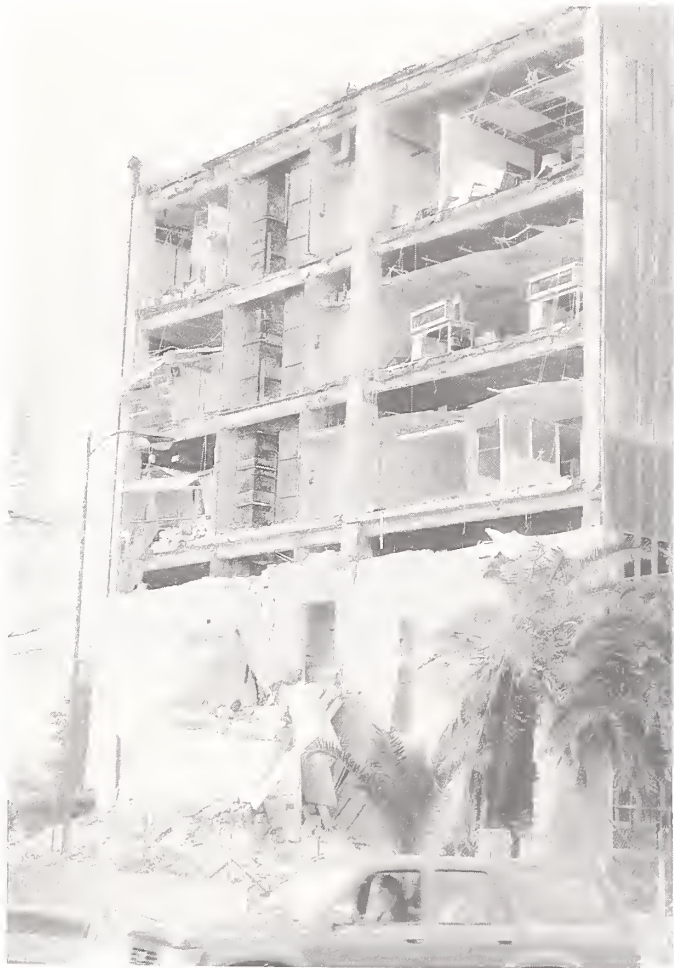
Figure 3.49. The east end wall and stair tower of a five-story apparently steel-framed office building on Sherman Way in Reseda collapsed. The enclosing masonry wall became detached from the structure and slid to the ground, with the upper stories remaining intact. The doorway opening in the wall, shown here resting at about the second story level, originally provided access from the top story to the stair tower.

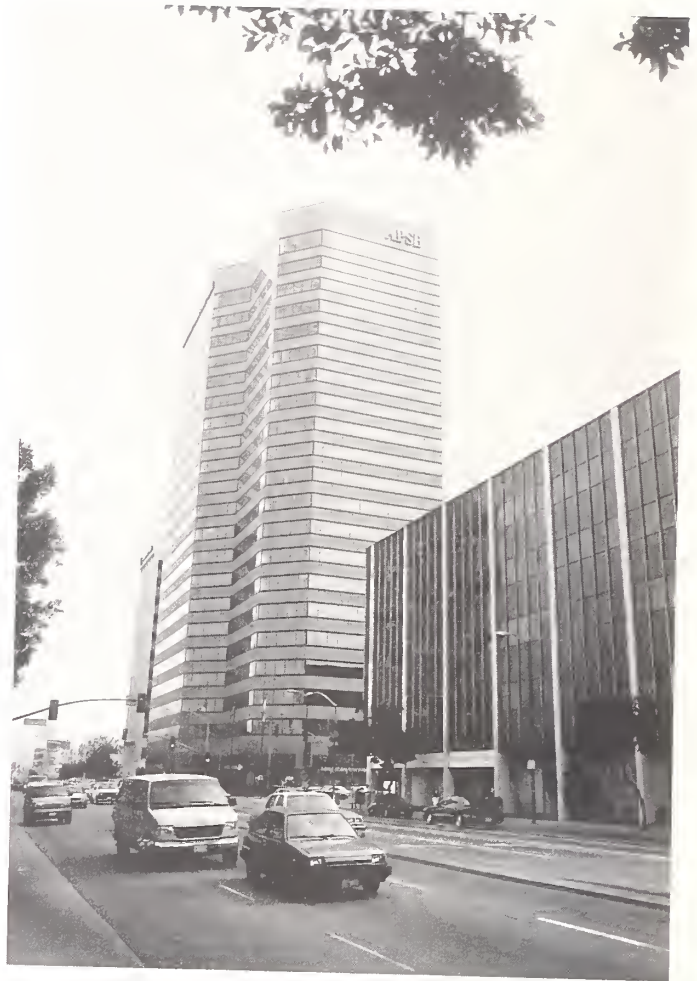
Figure 3.58. The reinforced masonry facade of this steel-framed building in Sherman Oaks was badly damaged.

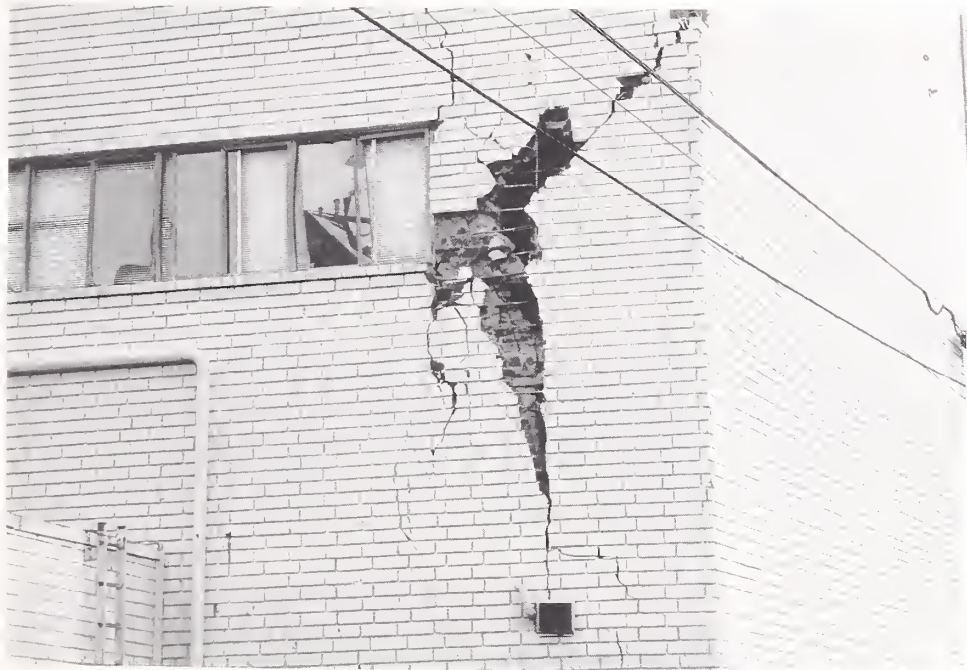
Figure 3.59. A close-up view of the damage shows the pattern of reinforcing used in the masonry facade.

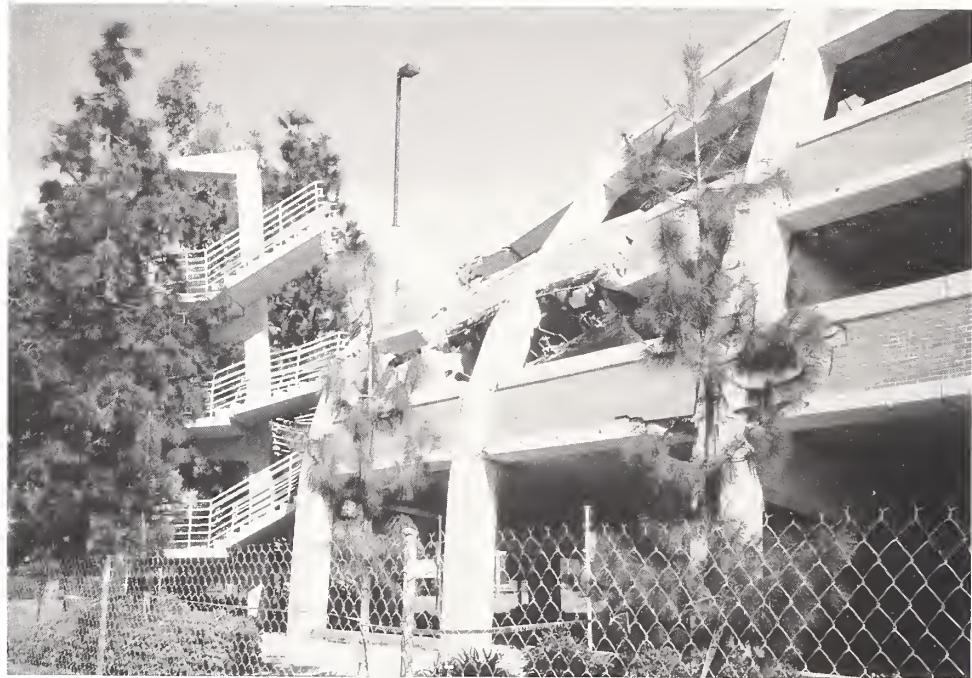
Figure 3.60. The three-year old four-level parking garage at the Northridge campus of California State University partially collapsed in the earthquake. The collapse apparently started at the interior, causing the exterior frame to be pulled in to the middle of the structure. Precast concrete "trees" were connected to form a moment-resisting frame at the exterior of the structure.

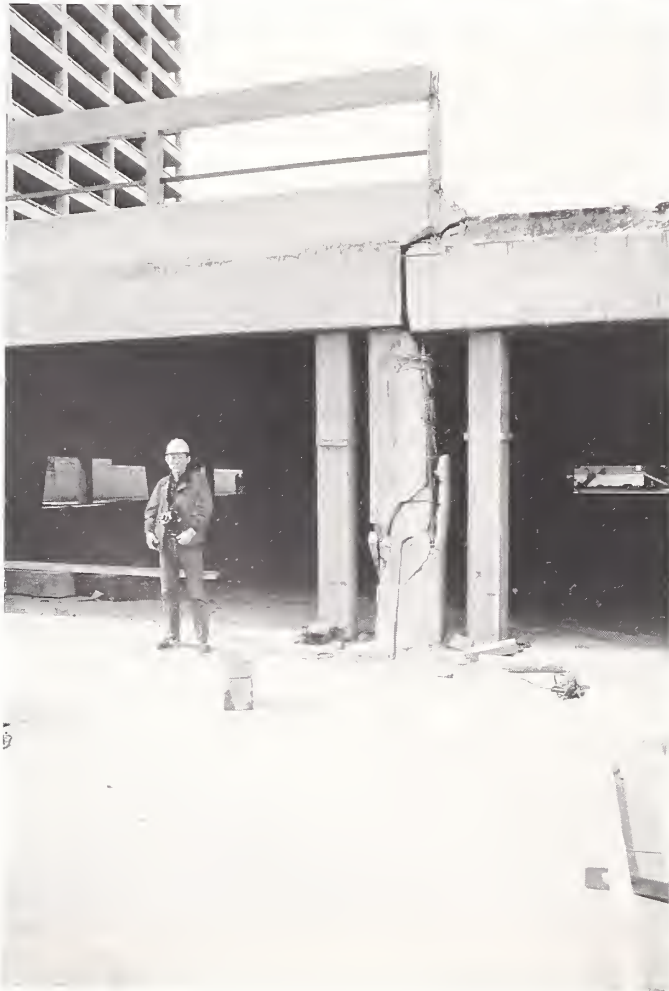
Figure 3.65. The exterior columns of the Trans World Bank parking garage, which had not been strengthened, were badly damaged.

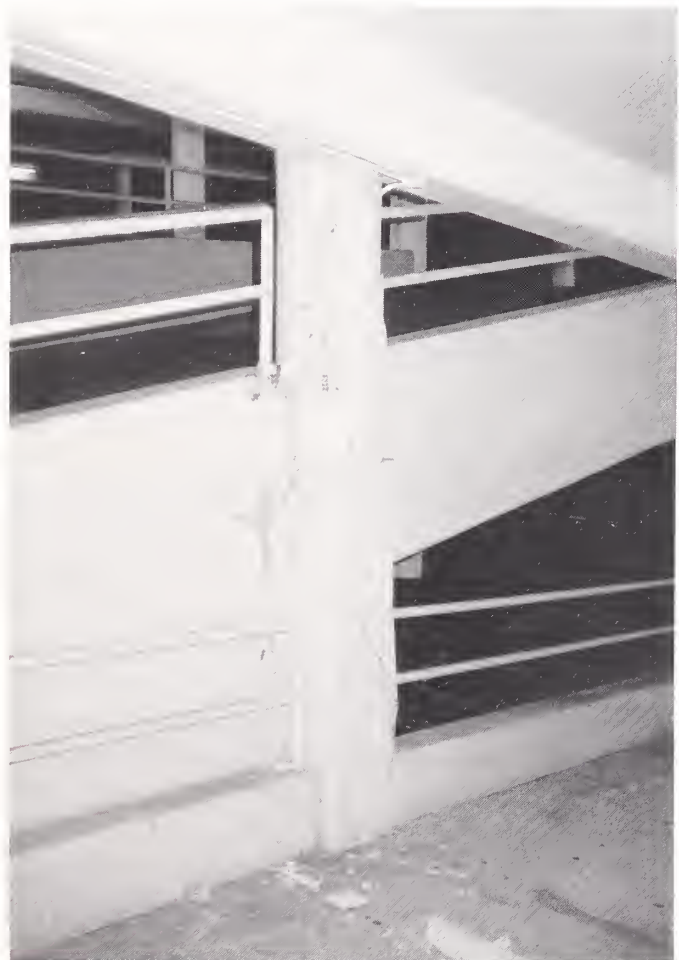
Figure 3.67. In parking garages, ramps can cause unintentionally shortened columns, which are vulnerable to damage, as shown here.

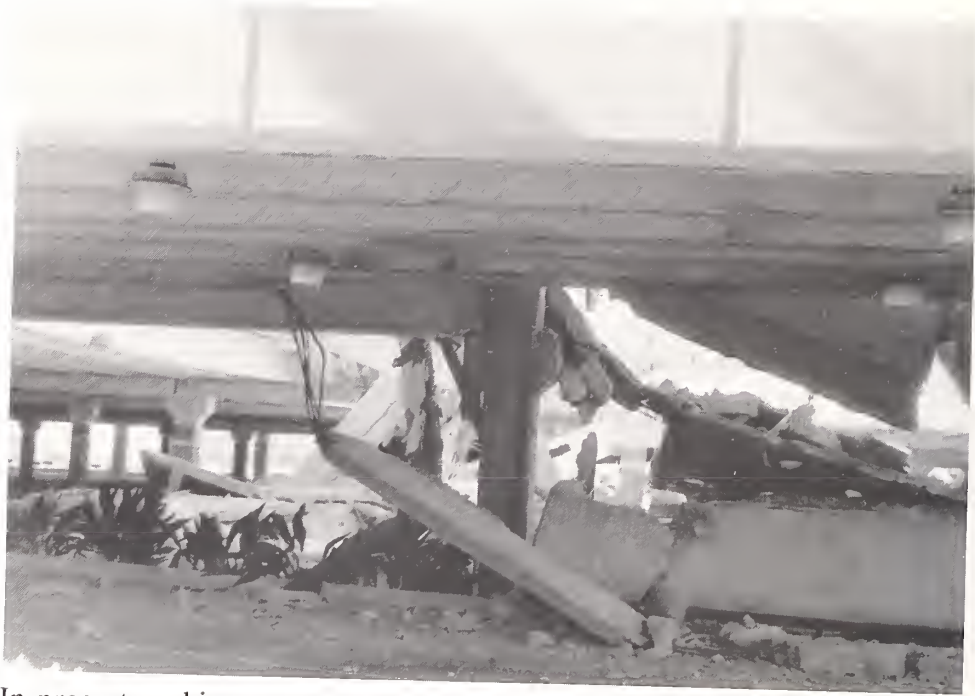
Figure 3.68. In precast parking garages, the support of the double-tees that comprise the floors is a vulnerable link in the system. This garage, at the north end of the Northridge Fashion Center, illustrates a common failure: the double-tees pulled off their supports, leaving the supporting elements essentially intact.

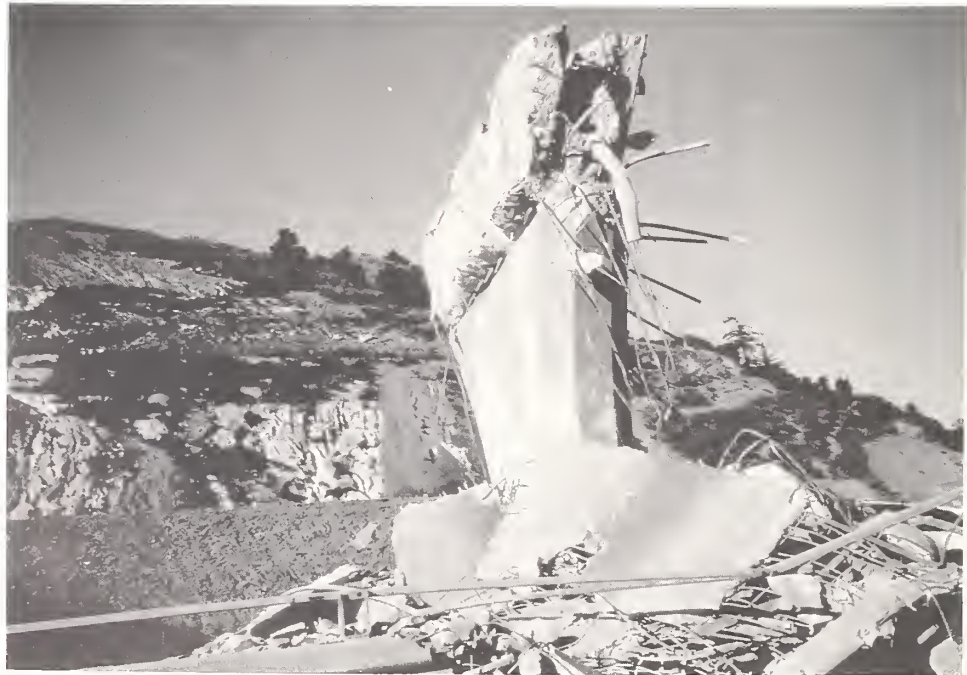
Figure 4.12. Damage at Pier 3 of the SR14/I5 Separation and Overhead, Ramp C, looking to the west (Photo courtesy of EERC).

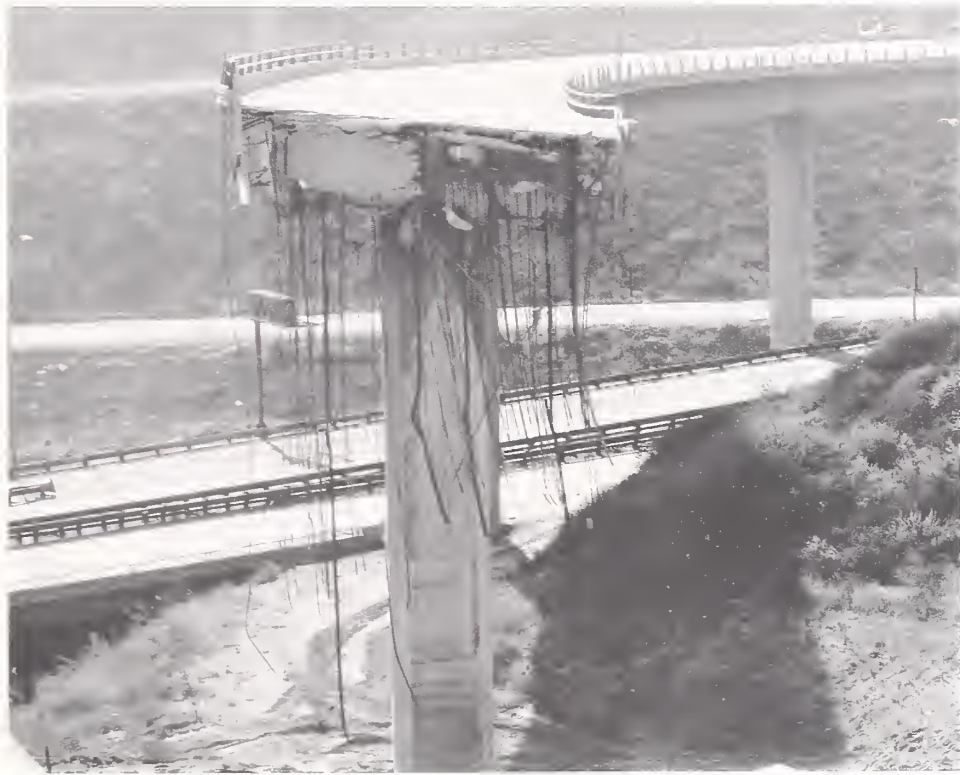
Figure 4.15. View of the flexural failure at Pier 3 of the SR14/I5 North Connector Overcrossing, looking to the south.

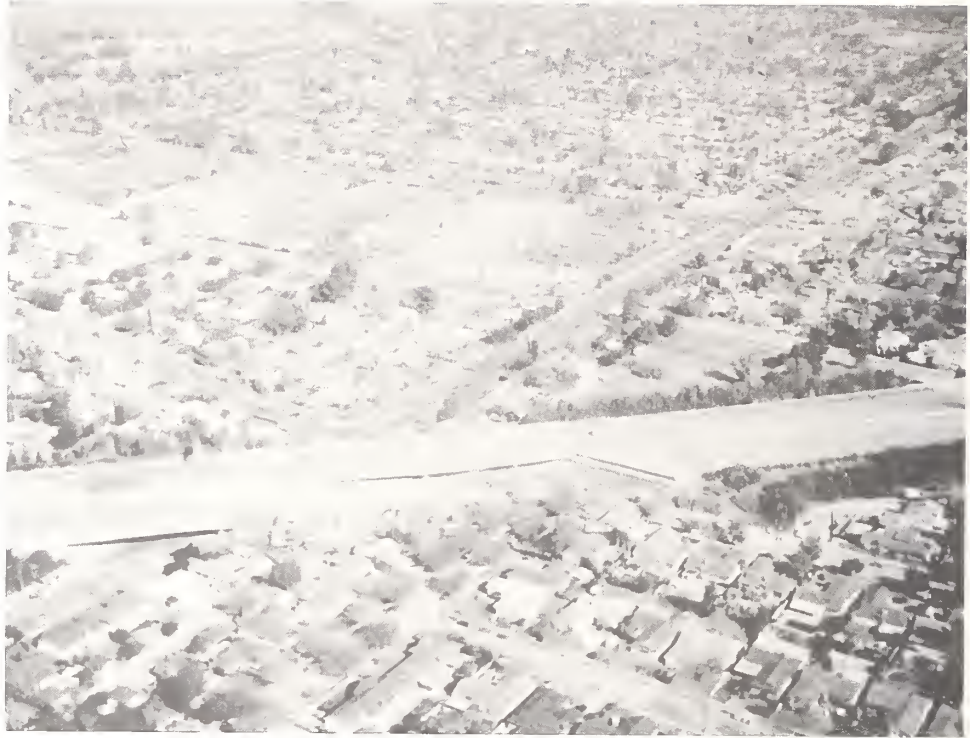
Figure 4.19. Aerial view of the SR118 Mission-Gothic Undercrossing, looking to the north showing collapsed eastbound bridge (Photo courtesy of FHWA).

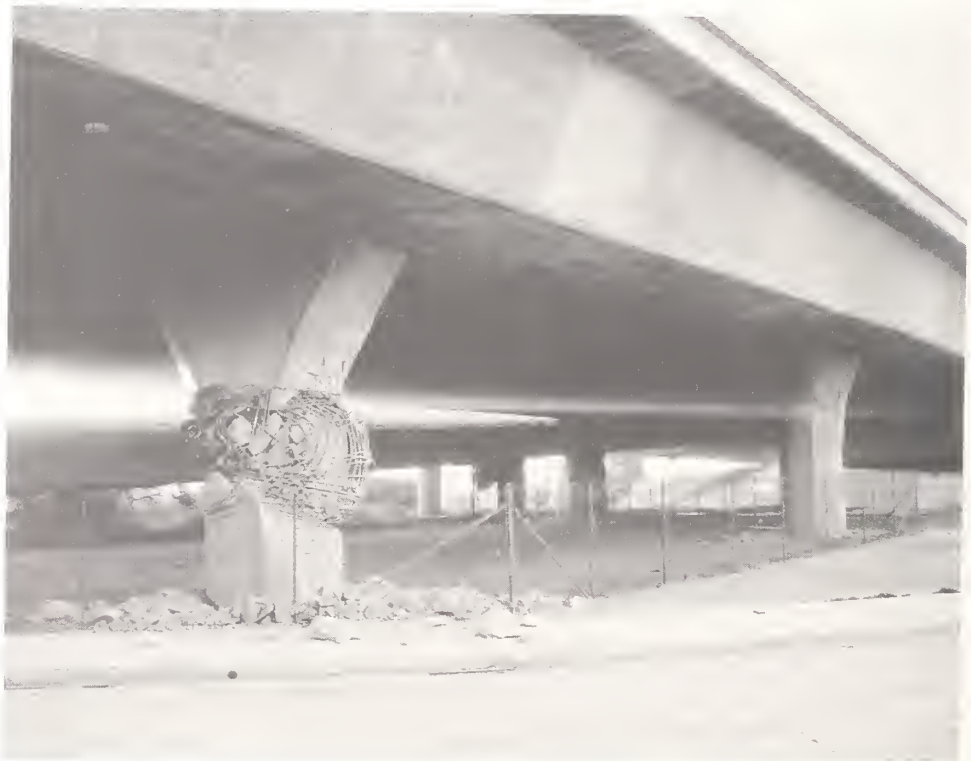
Figure 4.20. Damage to piers of the SR118 Mission-Gothic Undercrossing, looking to the northwest at the north face of the westbound bridge, Bents 3 (foreground) and 2.

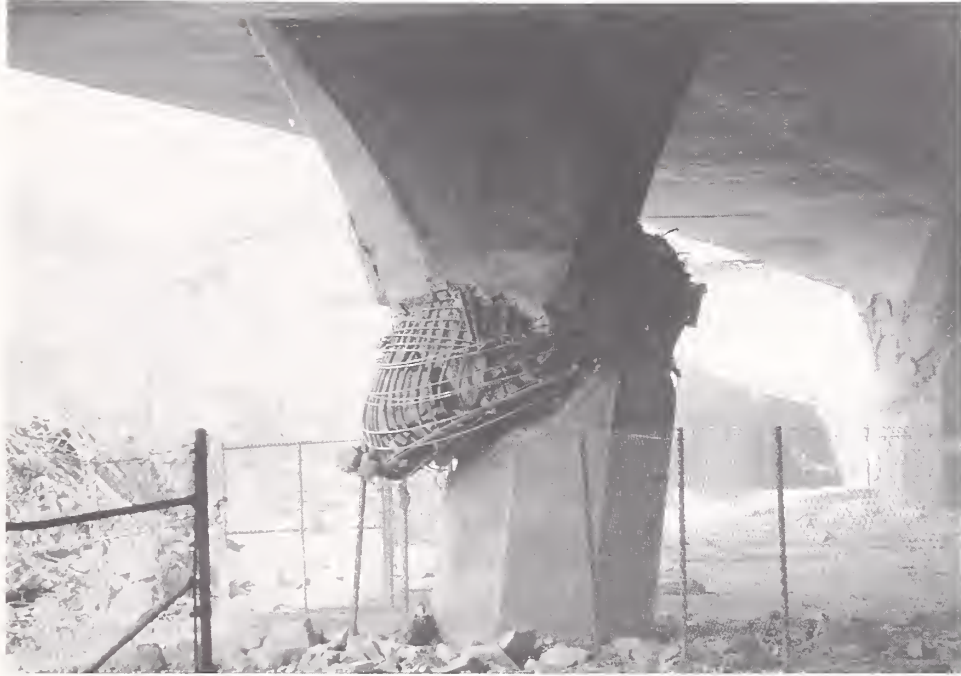
Figure 4.21. Damage to a pier of the SR118 Mission-Gothic Undercrossing, looking to the northwest at the southernmost pier of Bent 3 of the westbound bridge.

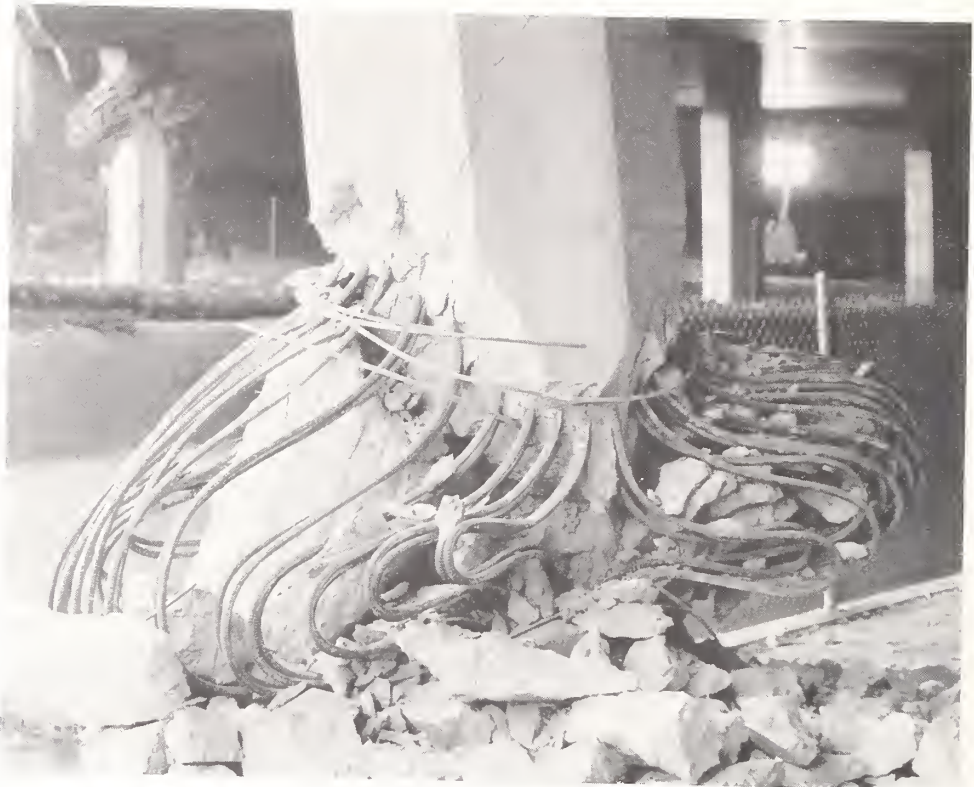
Figure 4.27. Damage to pier 3S-1 of State Route 118 at Bull Creek Canyon Channel, looking to the northwest.

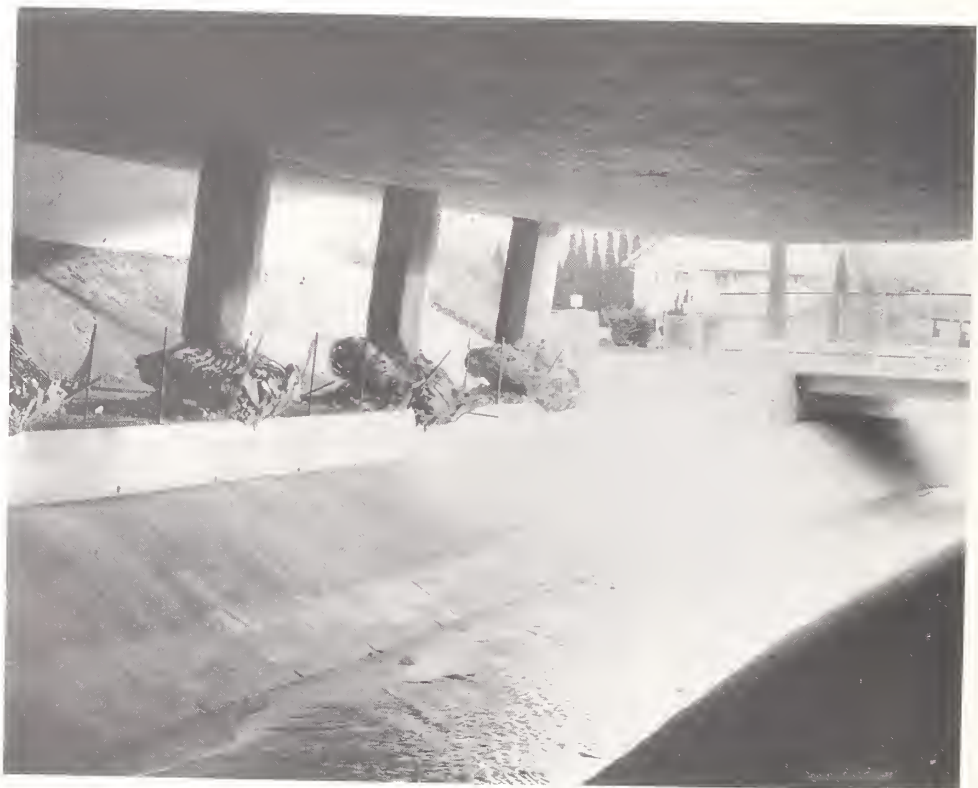
Figure 4.28. Damage to piers of Bent 3S of State Route 118 at Bull Creek Canyon Channel, looking to the southeast.

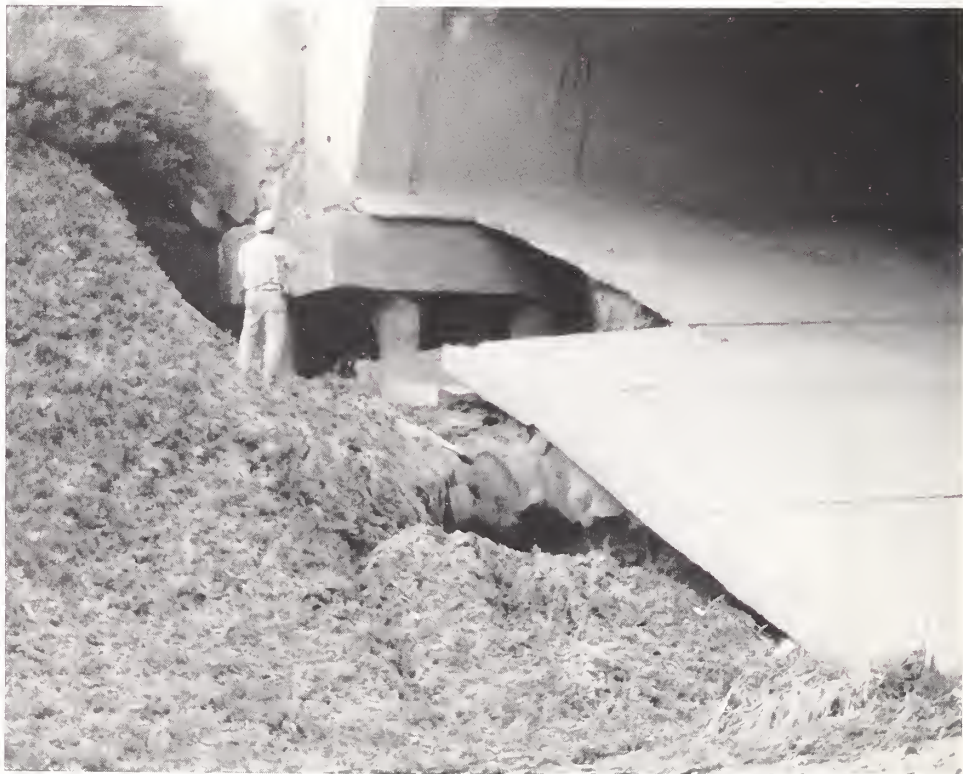
Figure 4.32. SR118 Balboa Avenue Overcrossing, view of the washout on the east side of the south abutment, caused by a ruptured water main.

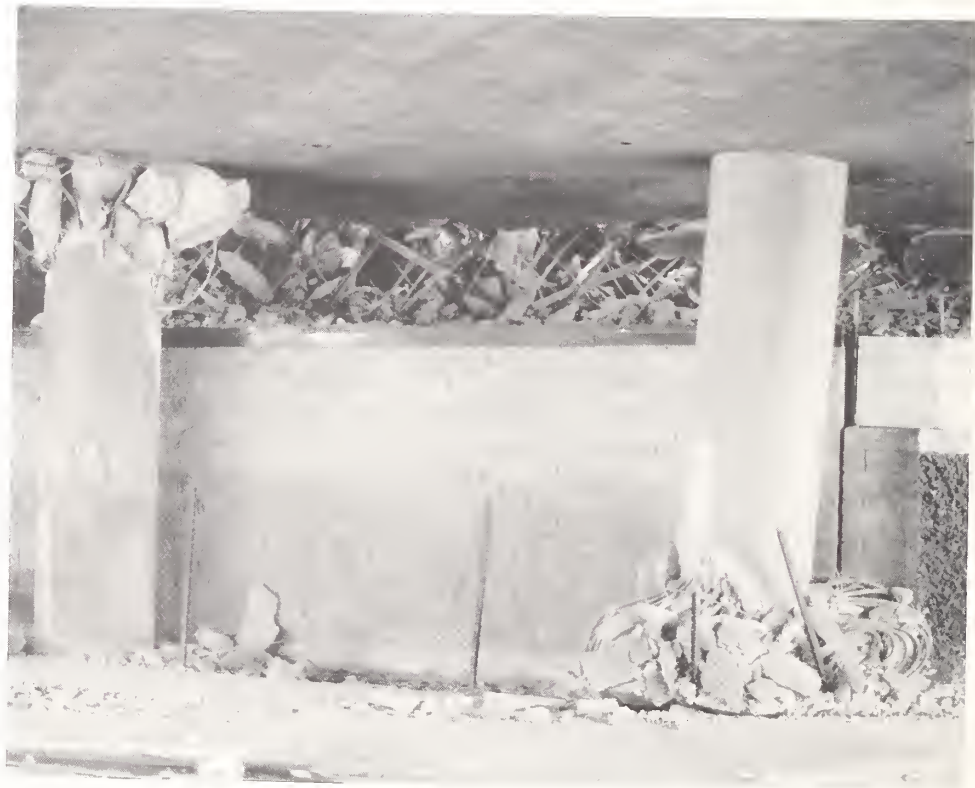
Figure 4.39. Failed piers in Bent 7 supporting westbound lane of I10 at Venice Blvd.

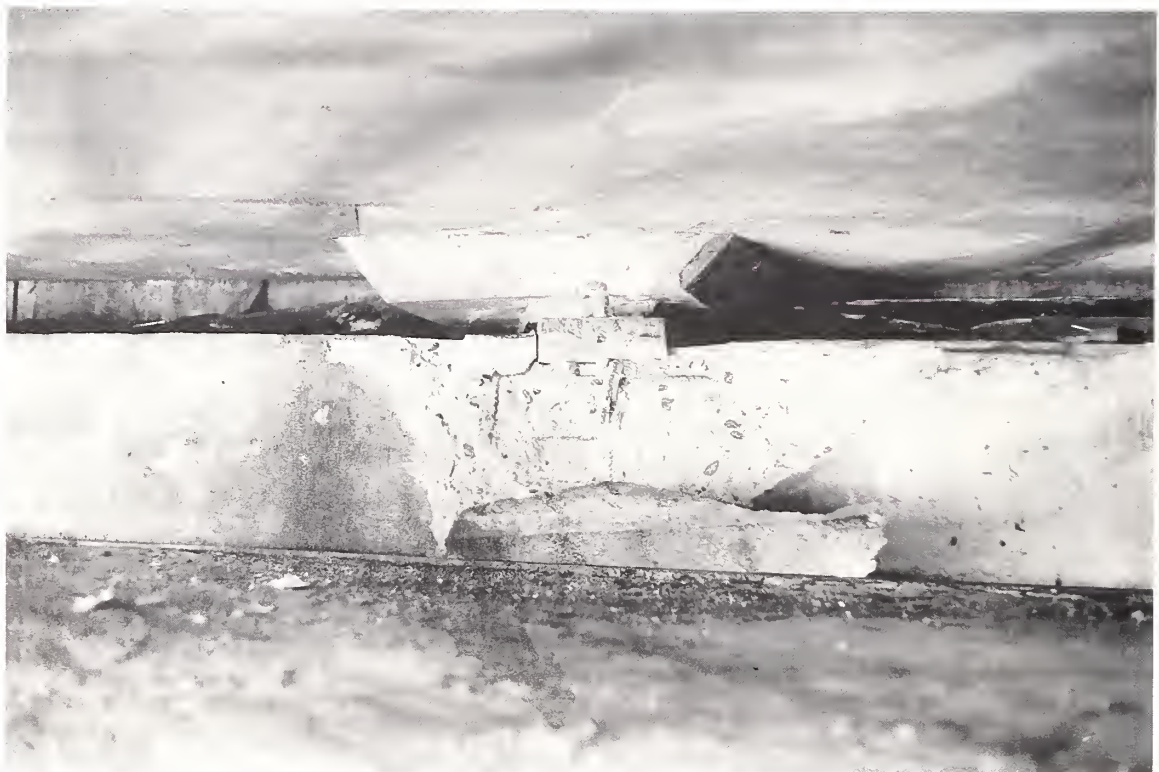
Figure 4.48. Abutment damage at sliding-type bearing.

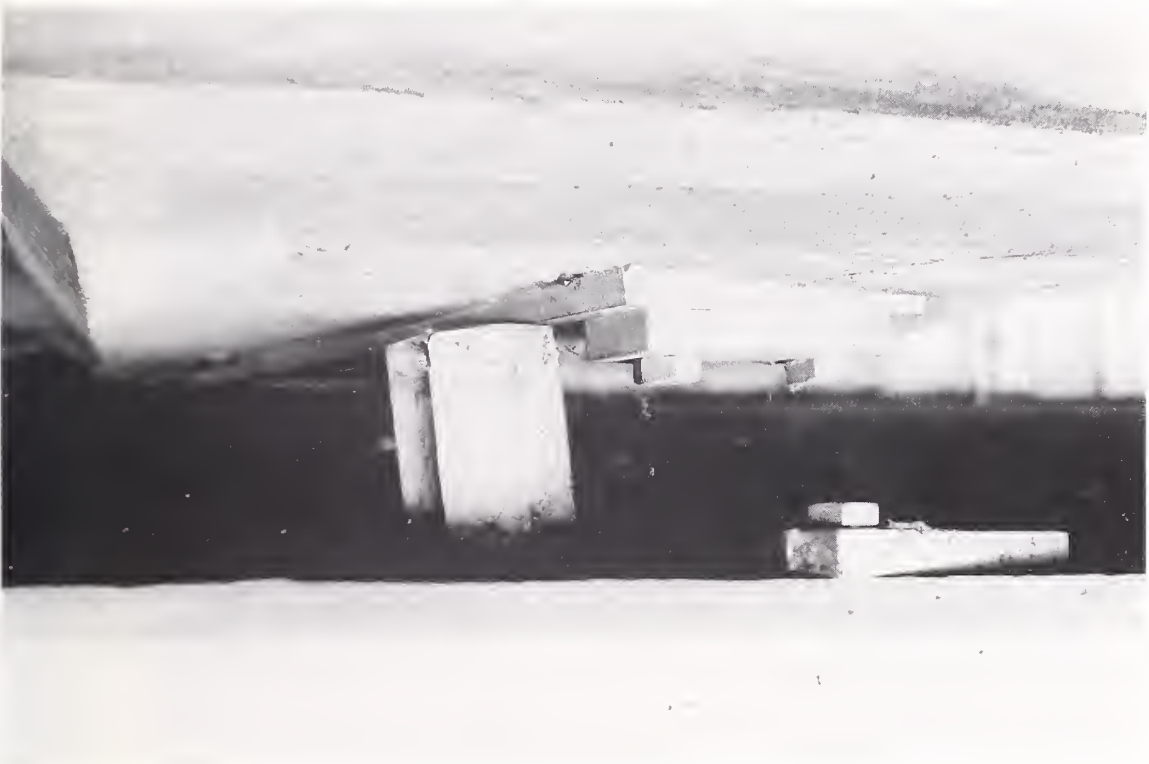
Figure 4.49. Displaced bearing block in rocker-type bearing.
