*NIST Special Publication 862*

# 1994 Northridge Earthquake Performance of Structures, Lifelines, and Fire Protection Systems

*Diana Todd, Nicholas Carino, Riley M. Chung, H. S. Lew, Andrew W. Taylor,  
William D. Walton, James D. Cooper, and Roland Nimis*

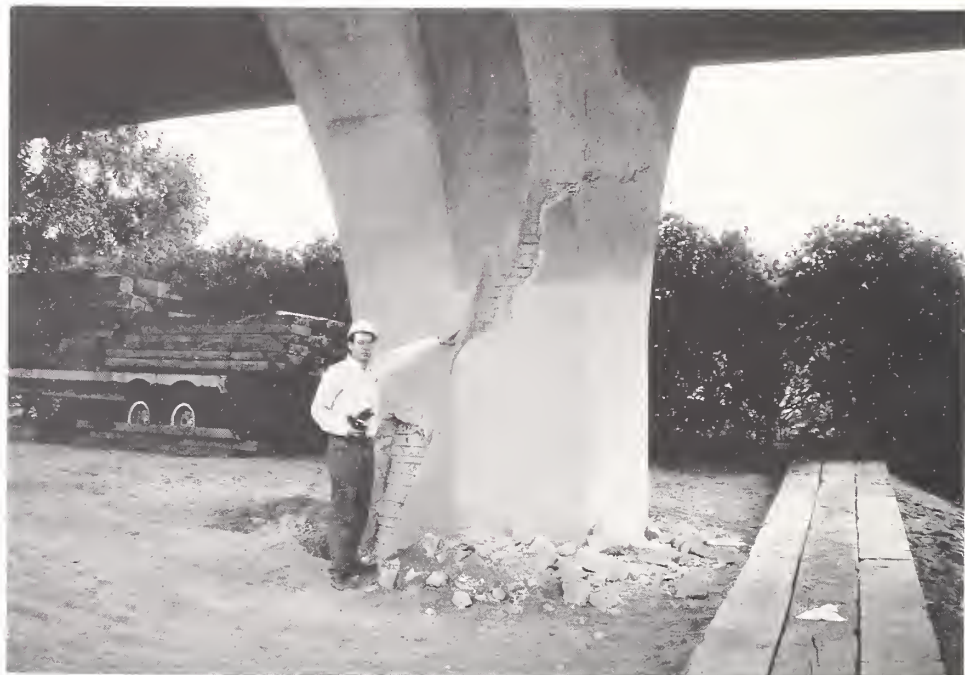
Figure 4.51. View of the westernmost pier at the Interstate 5, State Route 118, Southwest Connector, looking to the southeast. Loose cover concrete has been removed by Caltrans.

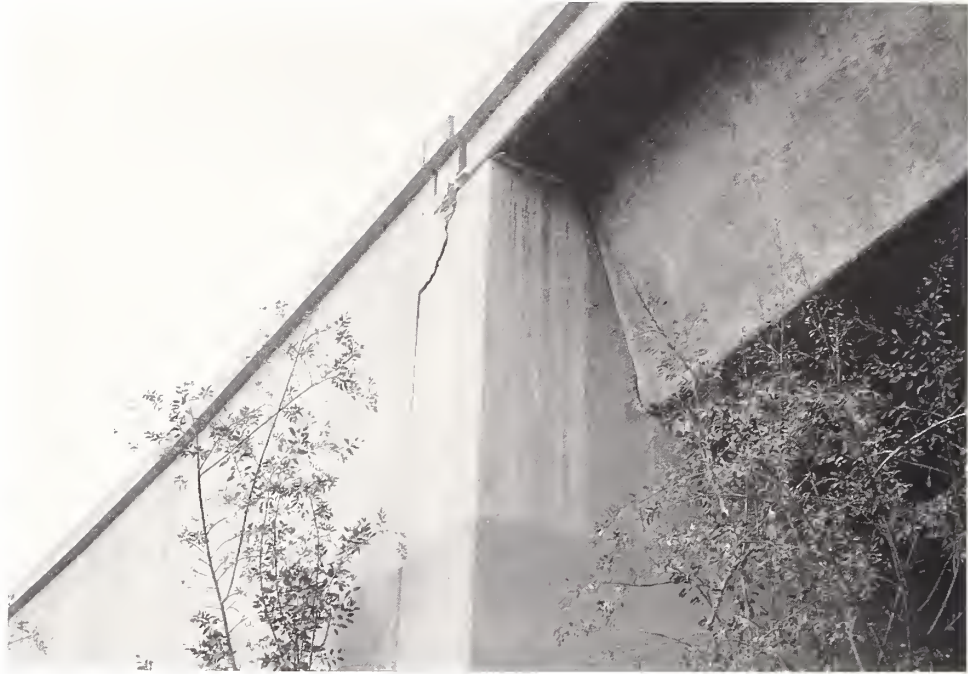
Figure 4.57. Close-up of abutment wall cracking at the east end of the ramp connecting eastbound SR118 with northbound I210.

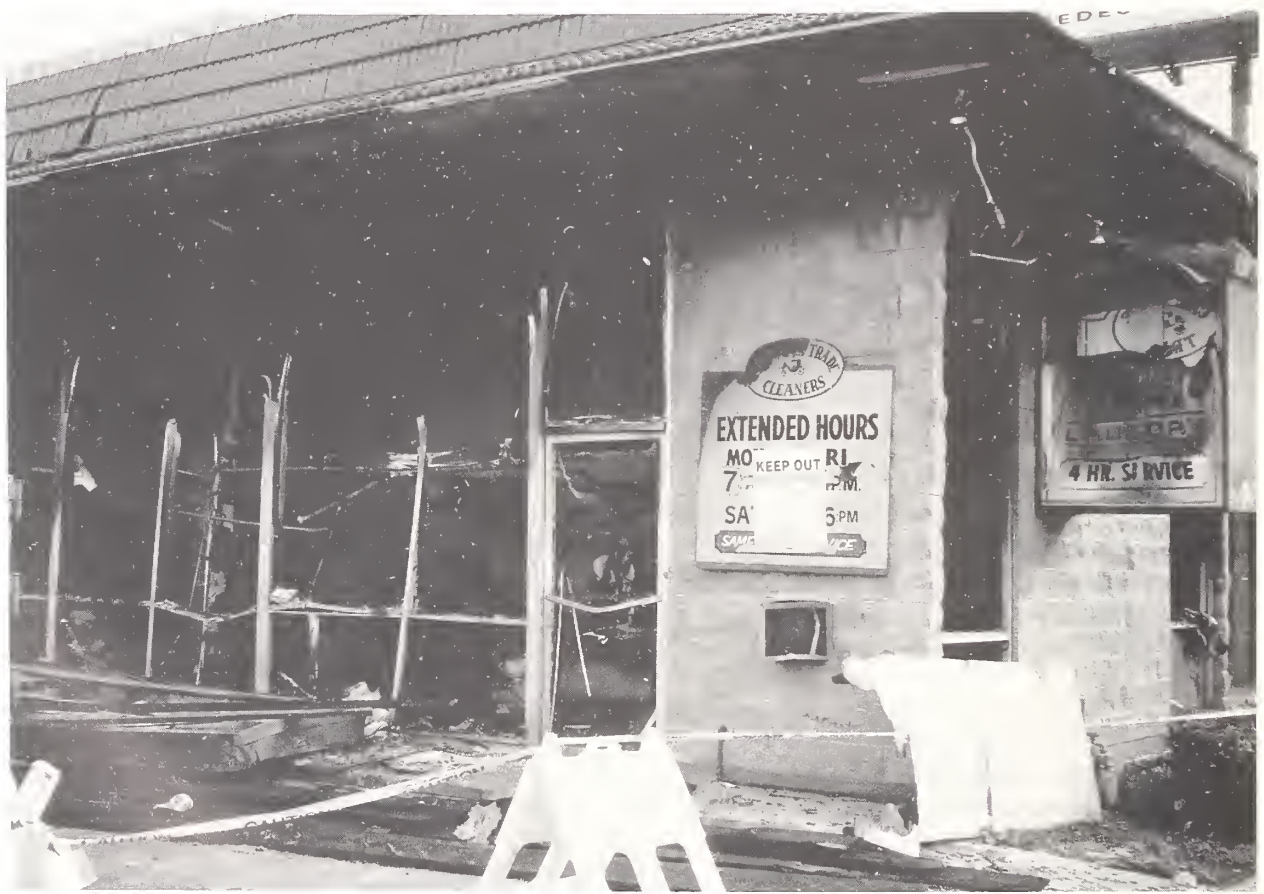
Figure 6.1. Fire damage in a single story commercial building.

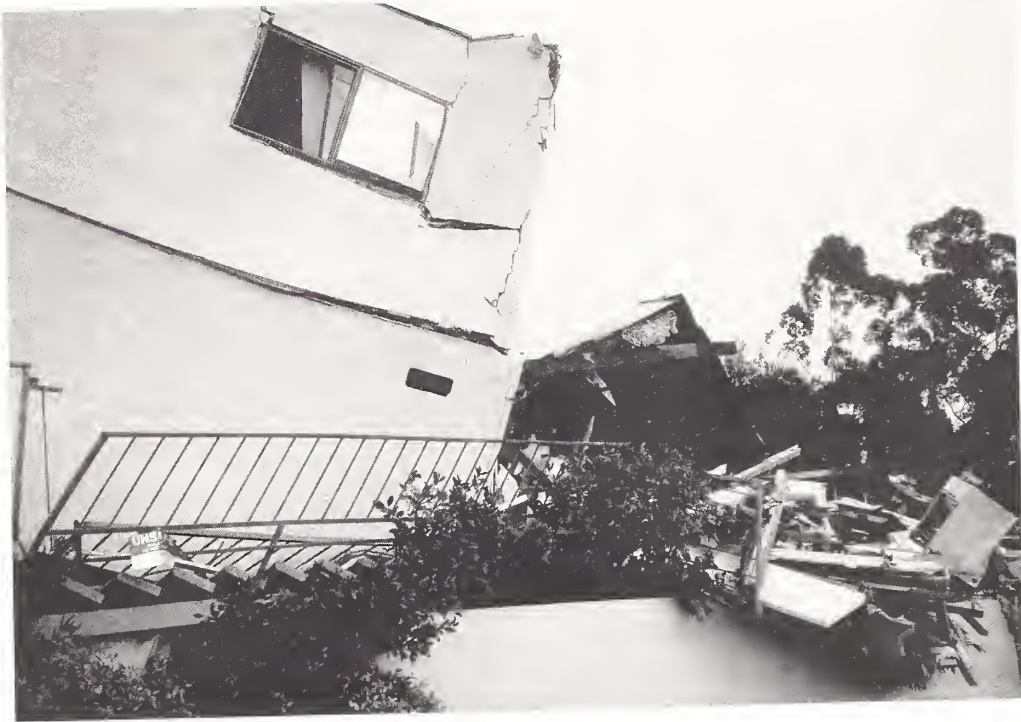
Figure 6.4. Partially collapsed apartment building with fire damage in the rear.

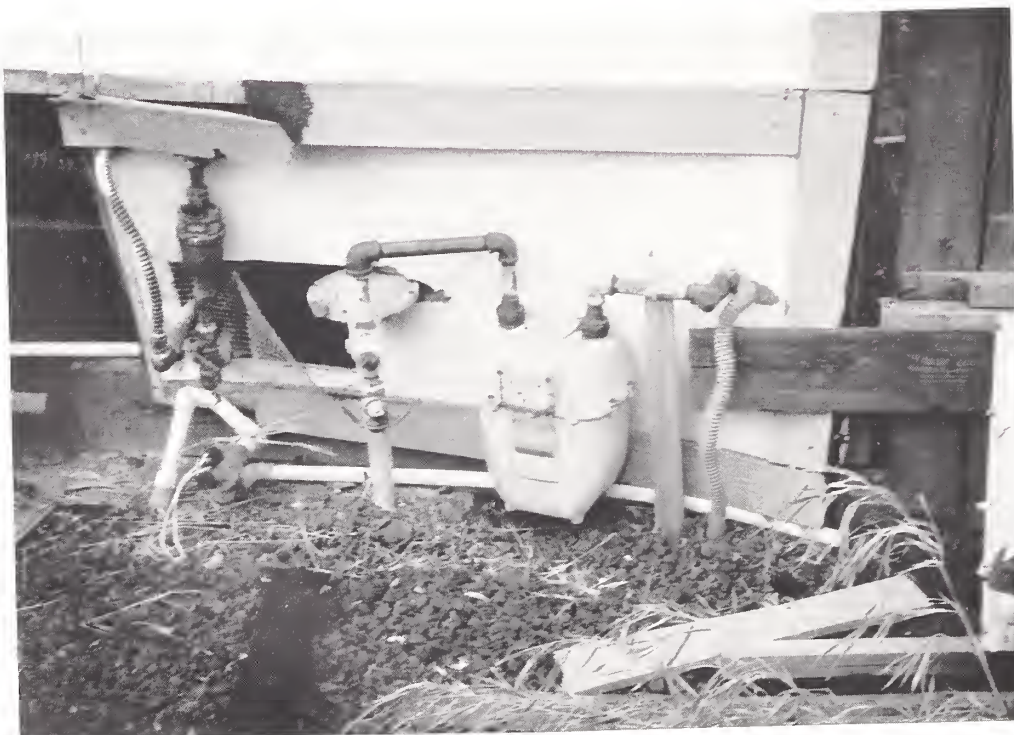
Figure 6.5. Damaged gas service in a manufactured housing development.

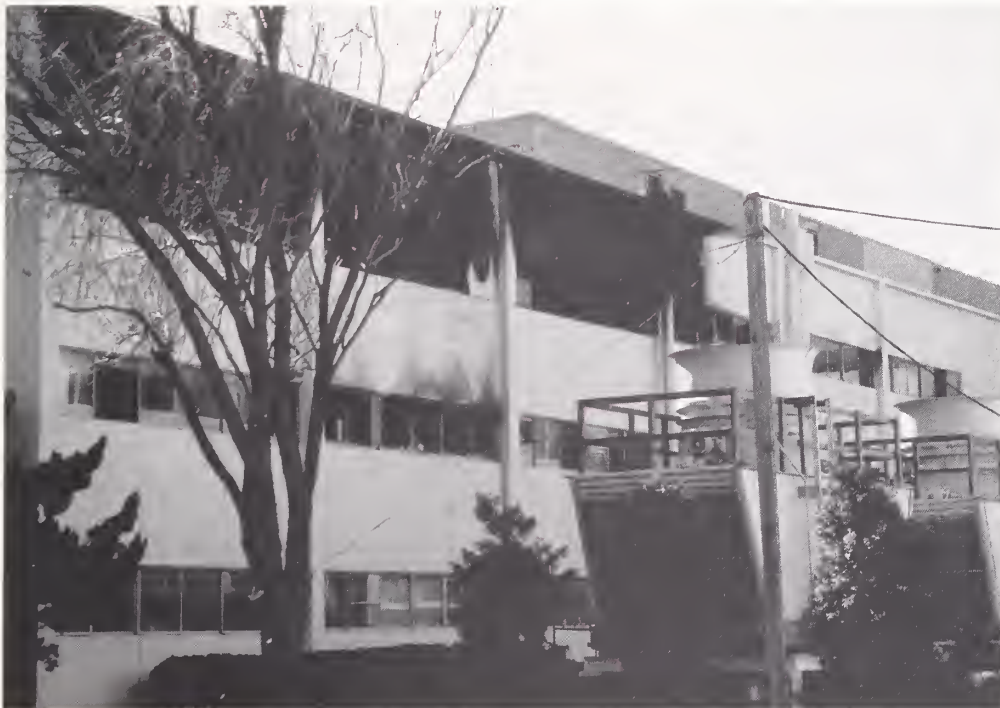
Figure 6.7. University science building damaged by fire.
