# **Pilot Demonstration of Lead Based Paint Hazard Elimination Methods**

Report on Field Study No. 2

T. H. Boone, T. R. Ray, W. G. Street

December 1973

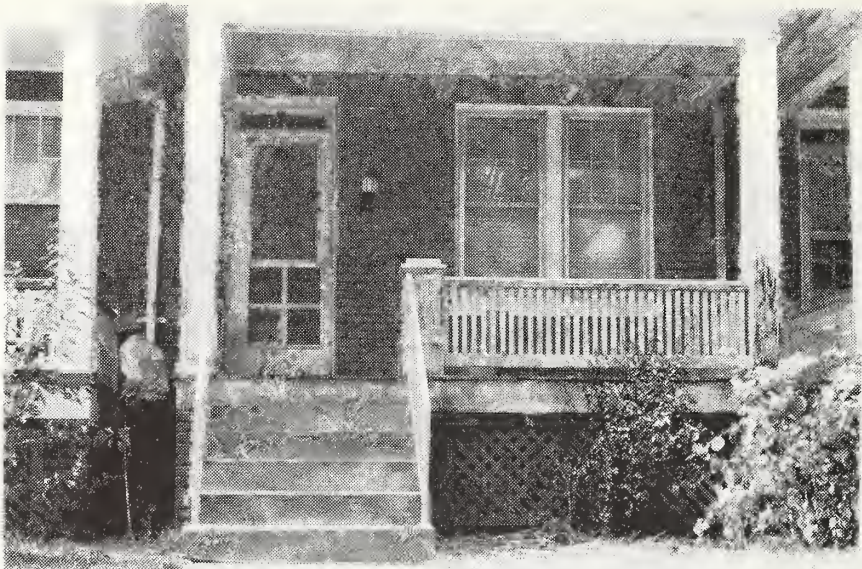
Figure 1. Front porch of pilot demonstration dwelling unit at the start of the paint removal process.

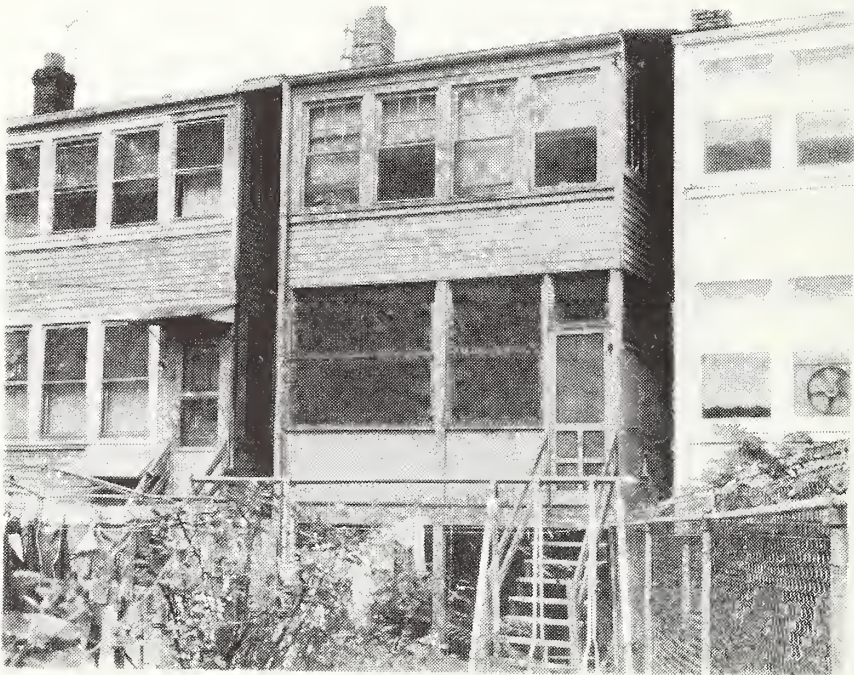
Figure 2. Back screened porch, enclosed second floor porch and basement area way of pilot demonstration dwelling unit before removal of paint.

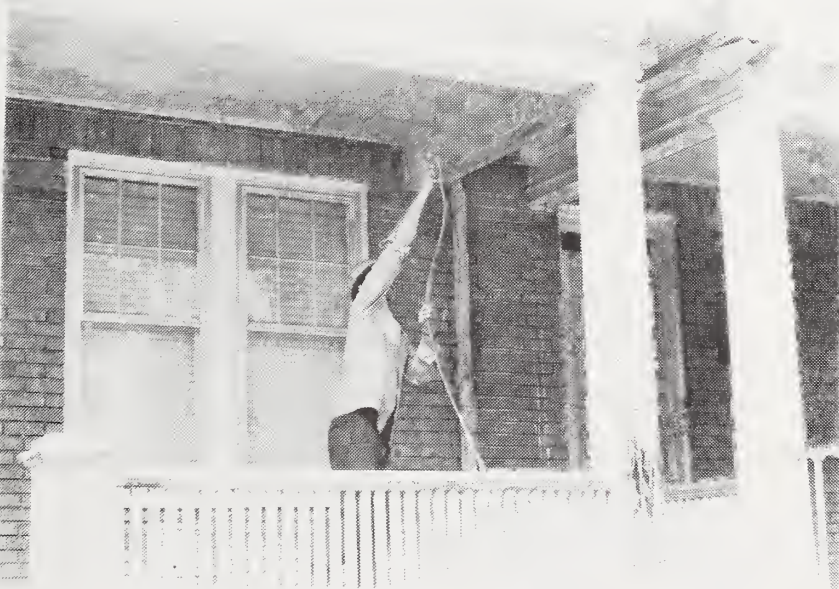
Figure 4. Application of paint remover on painted wood surfaces with spray equipment.

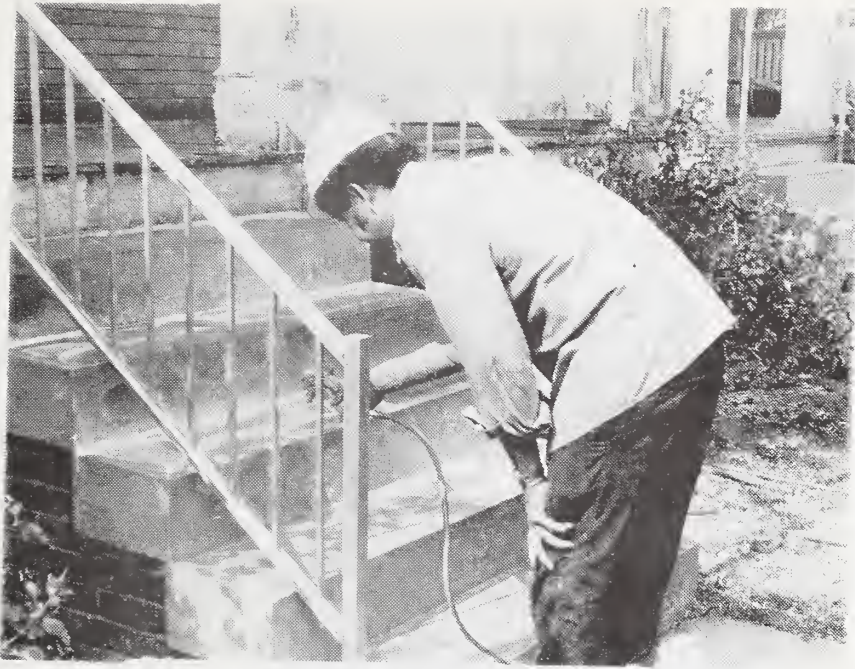
Figure 5. Application of paint remover on painted concrete stairs with spray equipment.

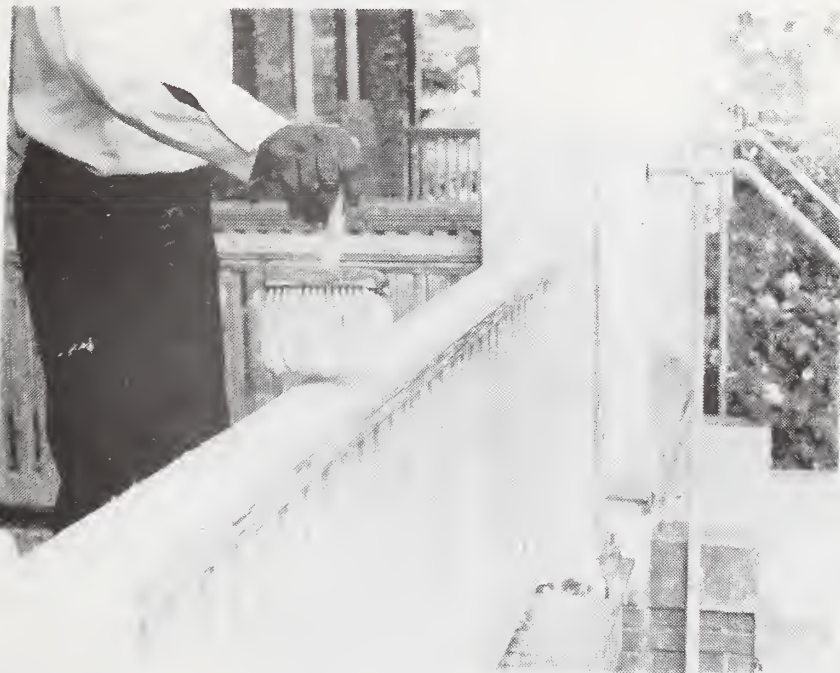
Figure 6. Application of paint remover on painted wood railing by brush.

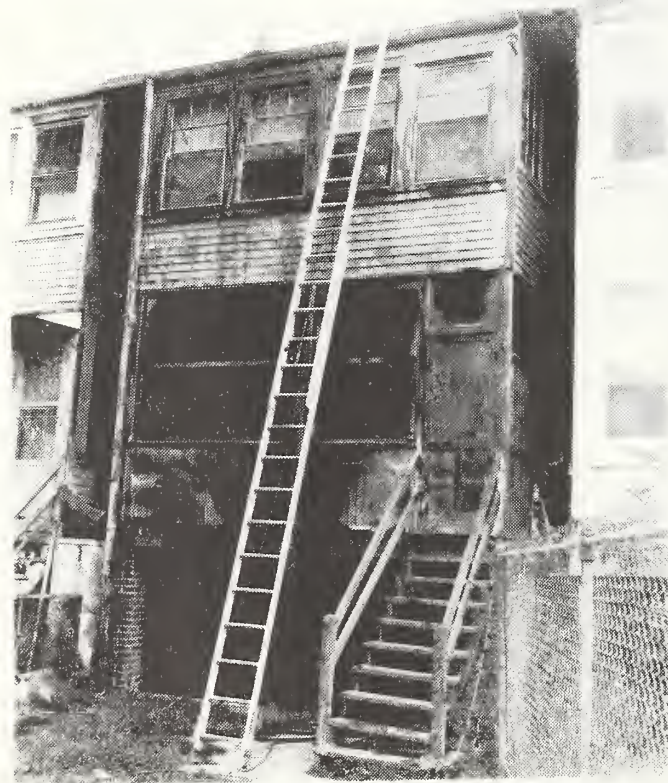
Figure 8. Appearance of paint on wood siding and trim on first floor and basement areas and on metal siding below second floor windows after 30 minutes dwell time of paint remover.

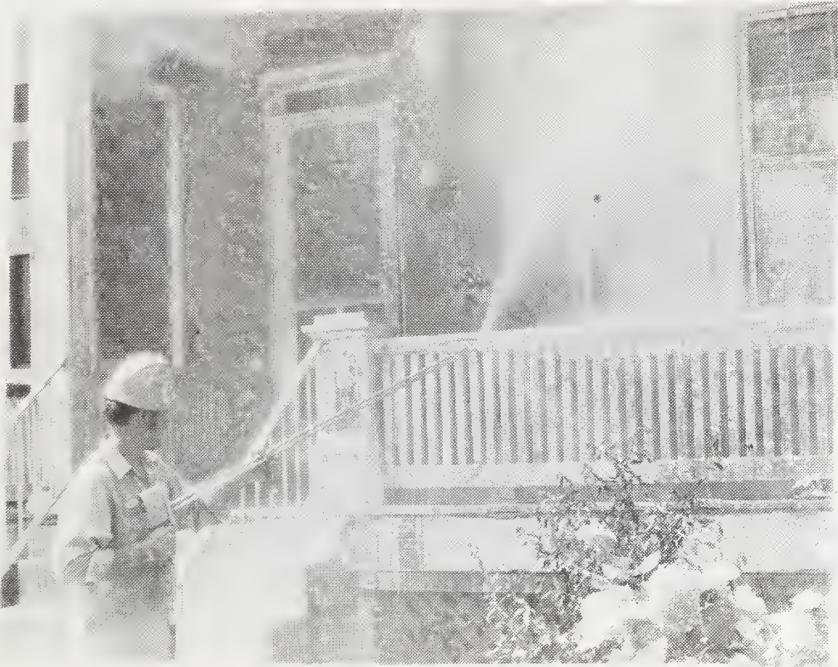
Figure 9. Flushing off old paint with high pressure water spray after treatment with paint remover.

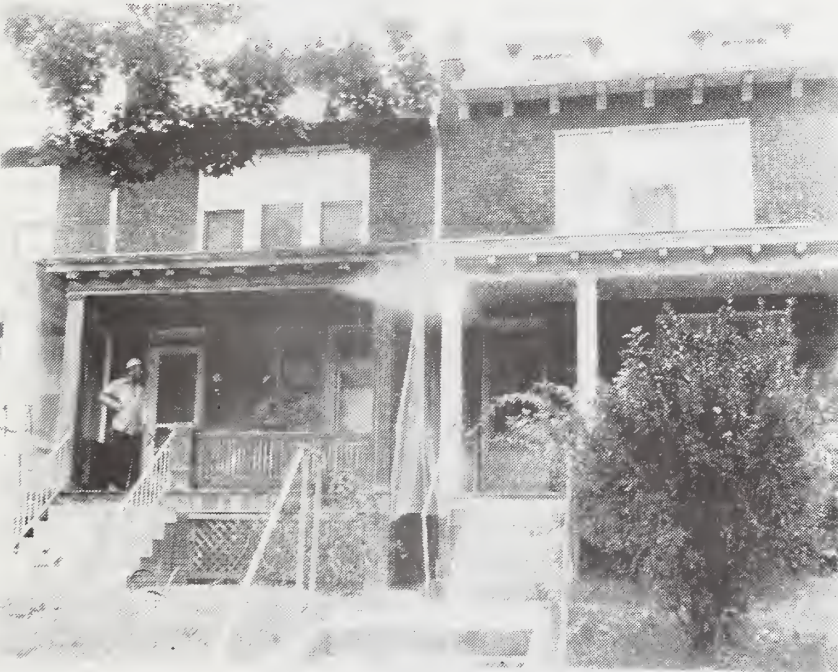
Figure 10. Flushing off old paint with high pressure water spray after treatment with paint remover. Note water overspray onto adjoining porch.

1. Before the contractor used protective plastic coverings, slight breezes caused blow-over of the paint remover spray causing softening and damage to painted surfaces of adjoining property (see figure 10).

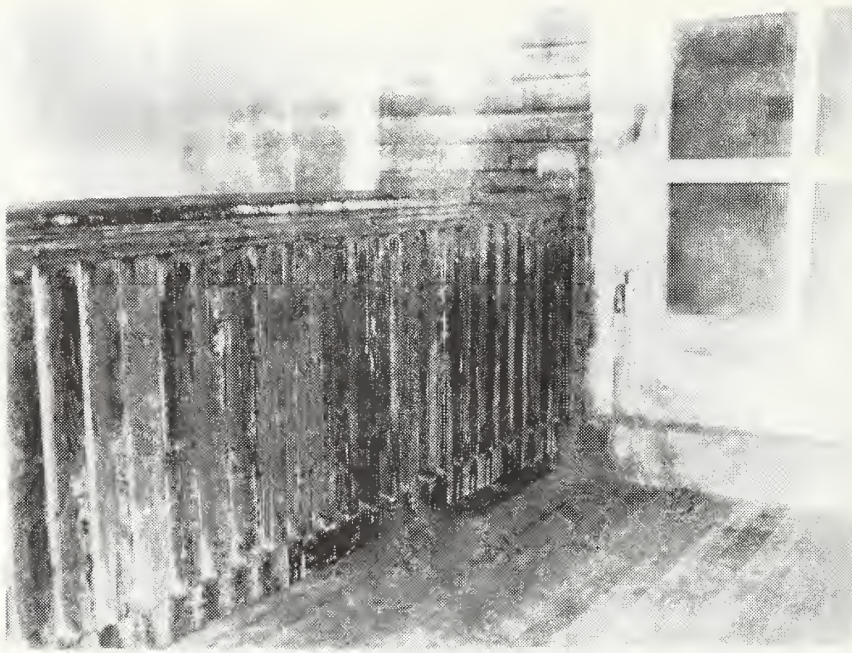
Figure 11. Porch rails after application of three coats of paint remover and water spray flush. Hand scraping was necessary to completely remove paint from the base of railings.

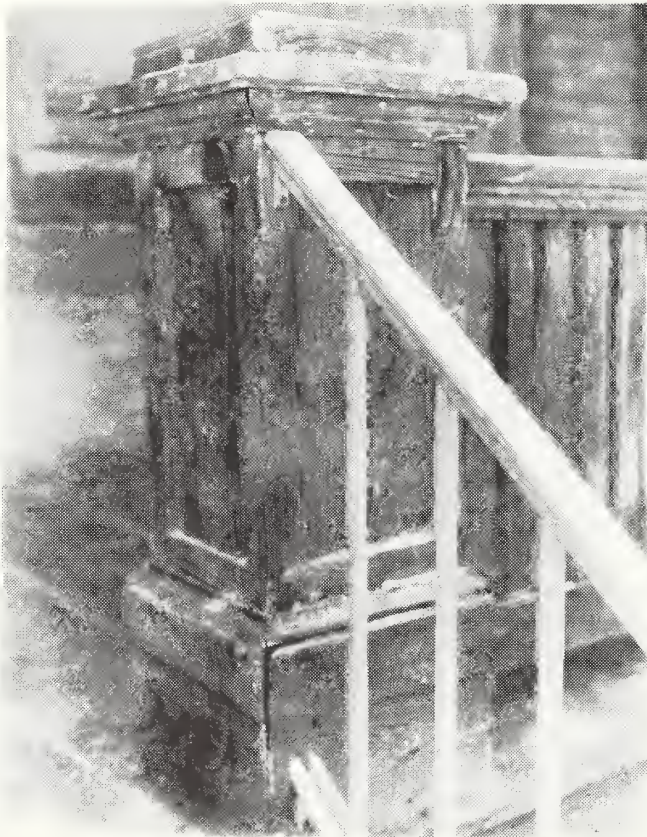
Figure 12. Porch post during water flush operation. Note warpage of post base caused by water soakage during paint removal.

4. Because there were multiple layers of old paint on most wood surfaces, it was necessary to repeat the remover application followed by water rinsing 3 or 4 times. This procedure caused warpage, swelling, buckling, and splintering of some wood surfaces. Sanding, recaulking, renailing and in some areas additional coats of paint were required to make the final appearance acceptable as shown in figures 14, 15, 16, and 17.

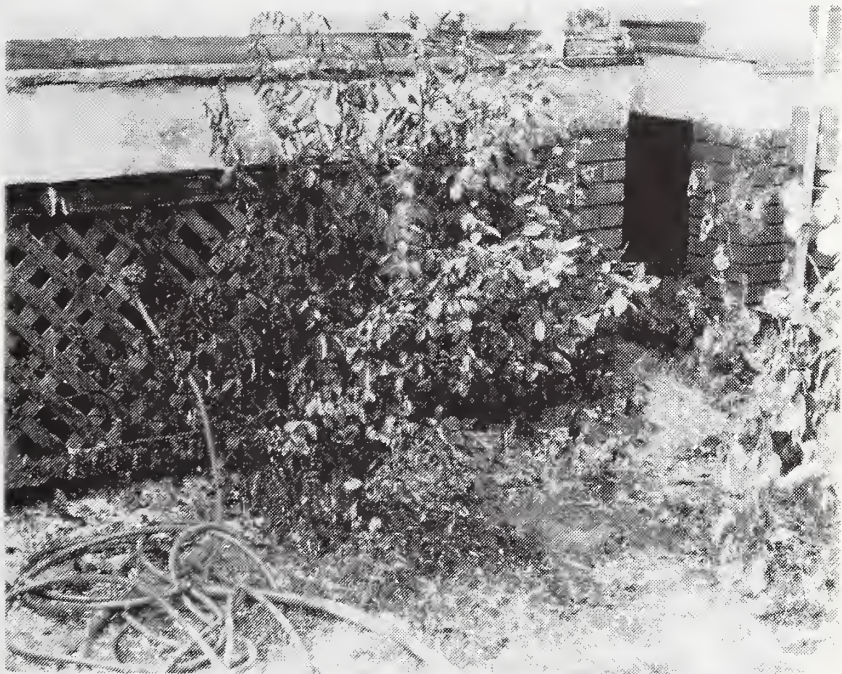
2. The contractor failed to pick up water rinse which contained old lead paint particles and paint remover chemicals. This contaminated water was allowed to soak into the back and front yards, run off into the gutter and, under certain circumstances, splash onto adjoining property or yards (see figures 13 and 14).

**Figure 13. Liquid residue which caused damage to grass and bushes.**

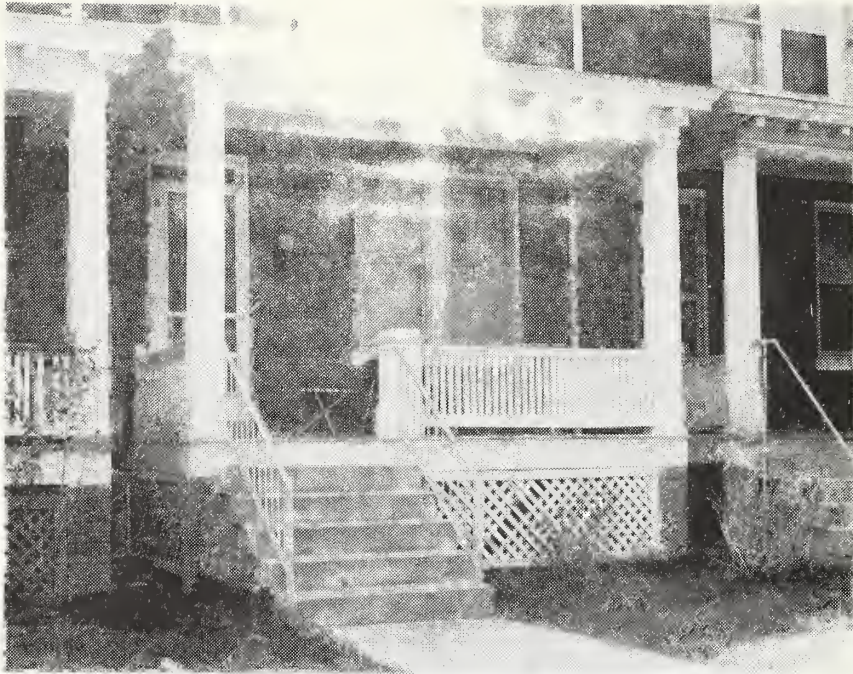
Figure 14. Front porch of pilot demonstration after removal of old paint and repainting. Note loss of foliage on bushes. The damaged grass sod was removed and replaced with new sod.

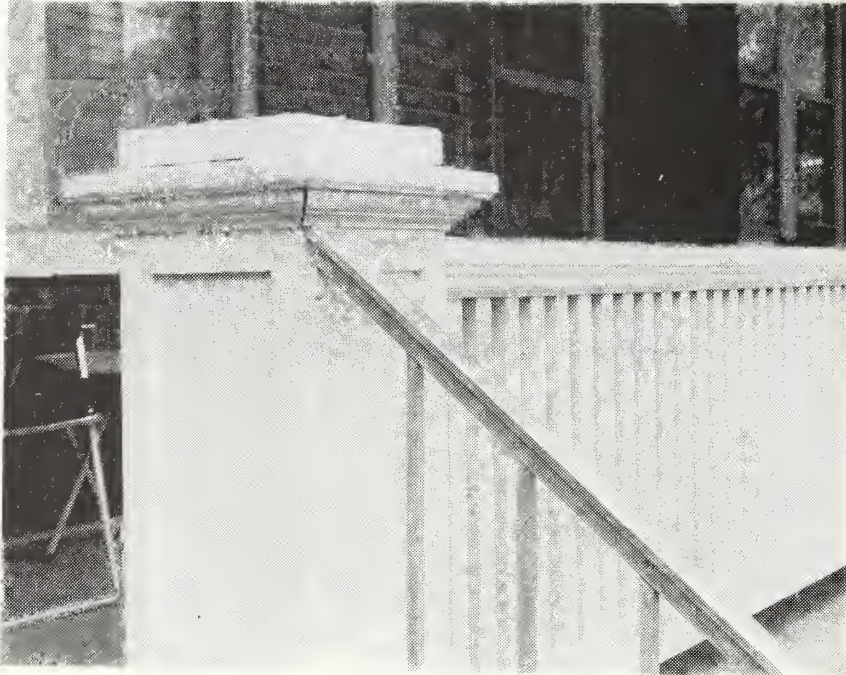
Figure 15. Front porch post and railing after removal of old paint and repainting.

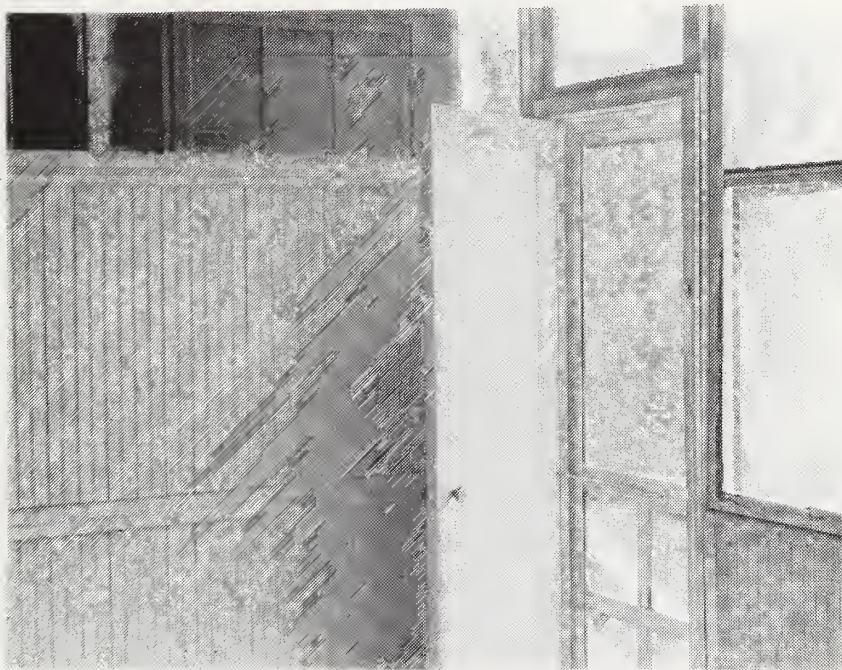
Figure 17. Interior view of wall and door of screened porch after removal of old paint and repainting.
