REPORT OF THE CIVIL AERONAUTICS BOARD

Of the investigation of an accident involving civil aircraft of the United States NC 17315 which occurred near Robertson, Missouri, on January 23, 1944.

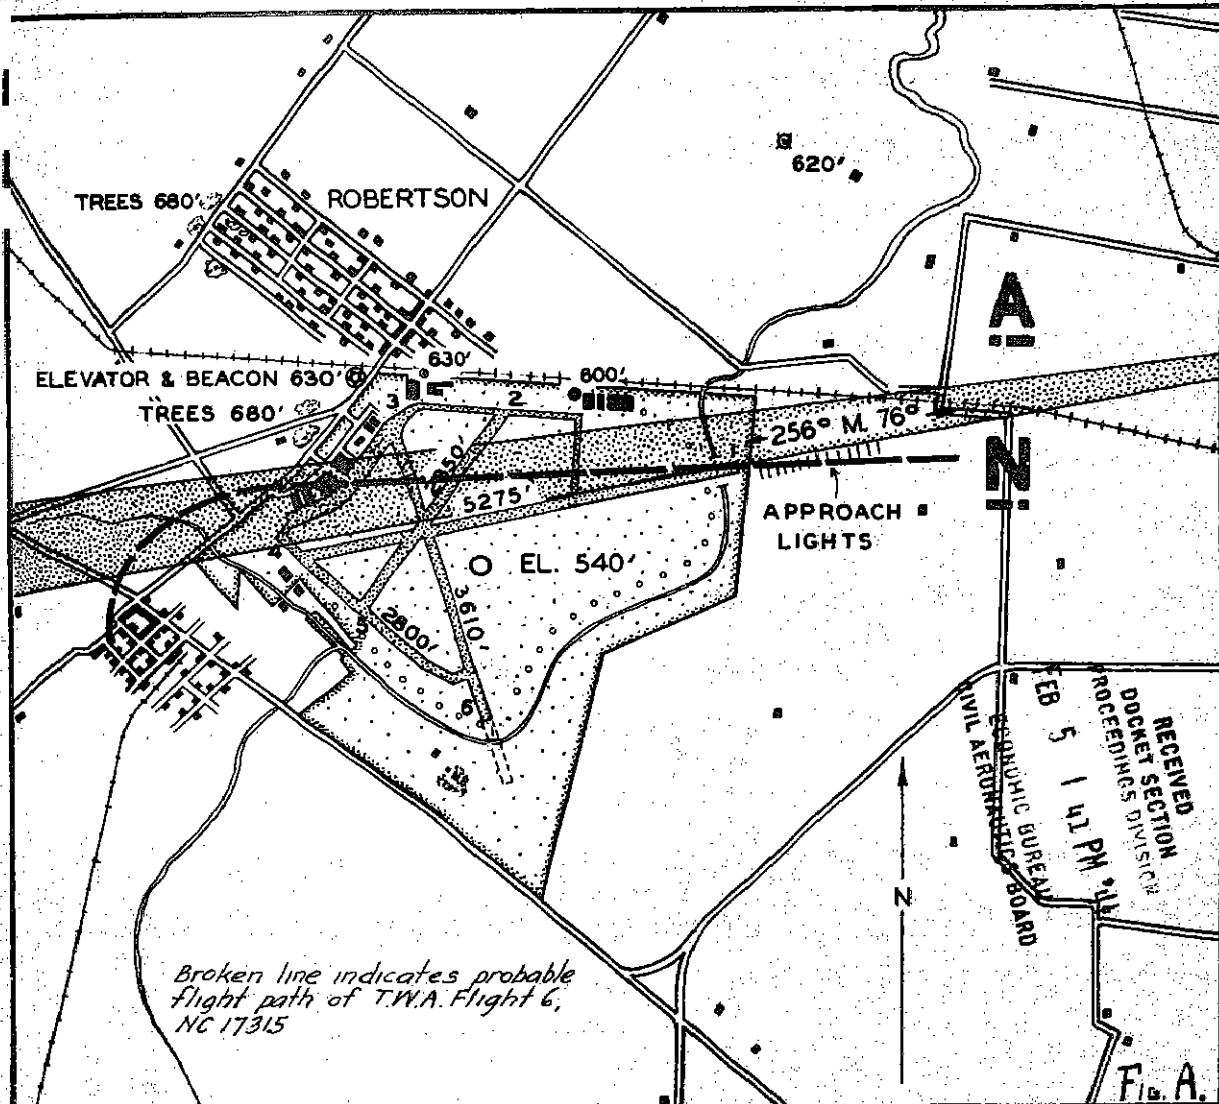
7/ See sketch of Lambert-St. Louis Airport on opposite page showing the probable flight path of the airplane. (Figure A)

Immediately after passing the west boundary of the airport, Captain Scott started a left turn, apparently for the purpose of making a landing from south to north on No. 6 runway. The sequence of events

The evidence shows that while in the left turn the airplane first made contact with a tree which is located 2,200 feet southwest of the end of runway No. 4. There were small branches broken from the top of this tree, which was 113 feet above the level of the airport.<sup>9/</sup> The airplane then careened through several other trees, tearing off a part of the left stabilizer and the elevators from the tail. Approximately 18 feet of the left wing was torn off and remained in a tree, the top of which was 104 feet above the level of the airport. The flight path as marked on the trees beyond the one in which the wing was found, and on the ground, indicates that the plane was in a vertical or beyond-vertical bank to the left and was traveling in a straight line. Just before the airplane came to rest it struck a high tension line and pole and the fuselage was broken in two near the center of the cabin. It is apparent from the manner in which the fuselage struck the high tension line pole and from the position in which the airplane came to rest on the ground that the plane was cartwheeling during the last portion of its travel before coming to rest. The distance from the point where the airplane struck the first tree to where it came to rest was 463 feet. The flight path was definitely indicated by markings on the ground and trees and

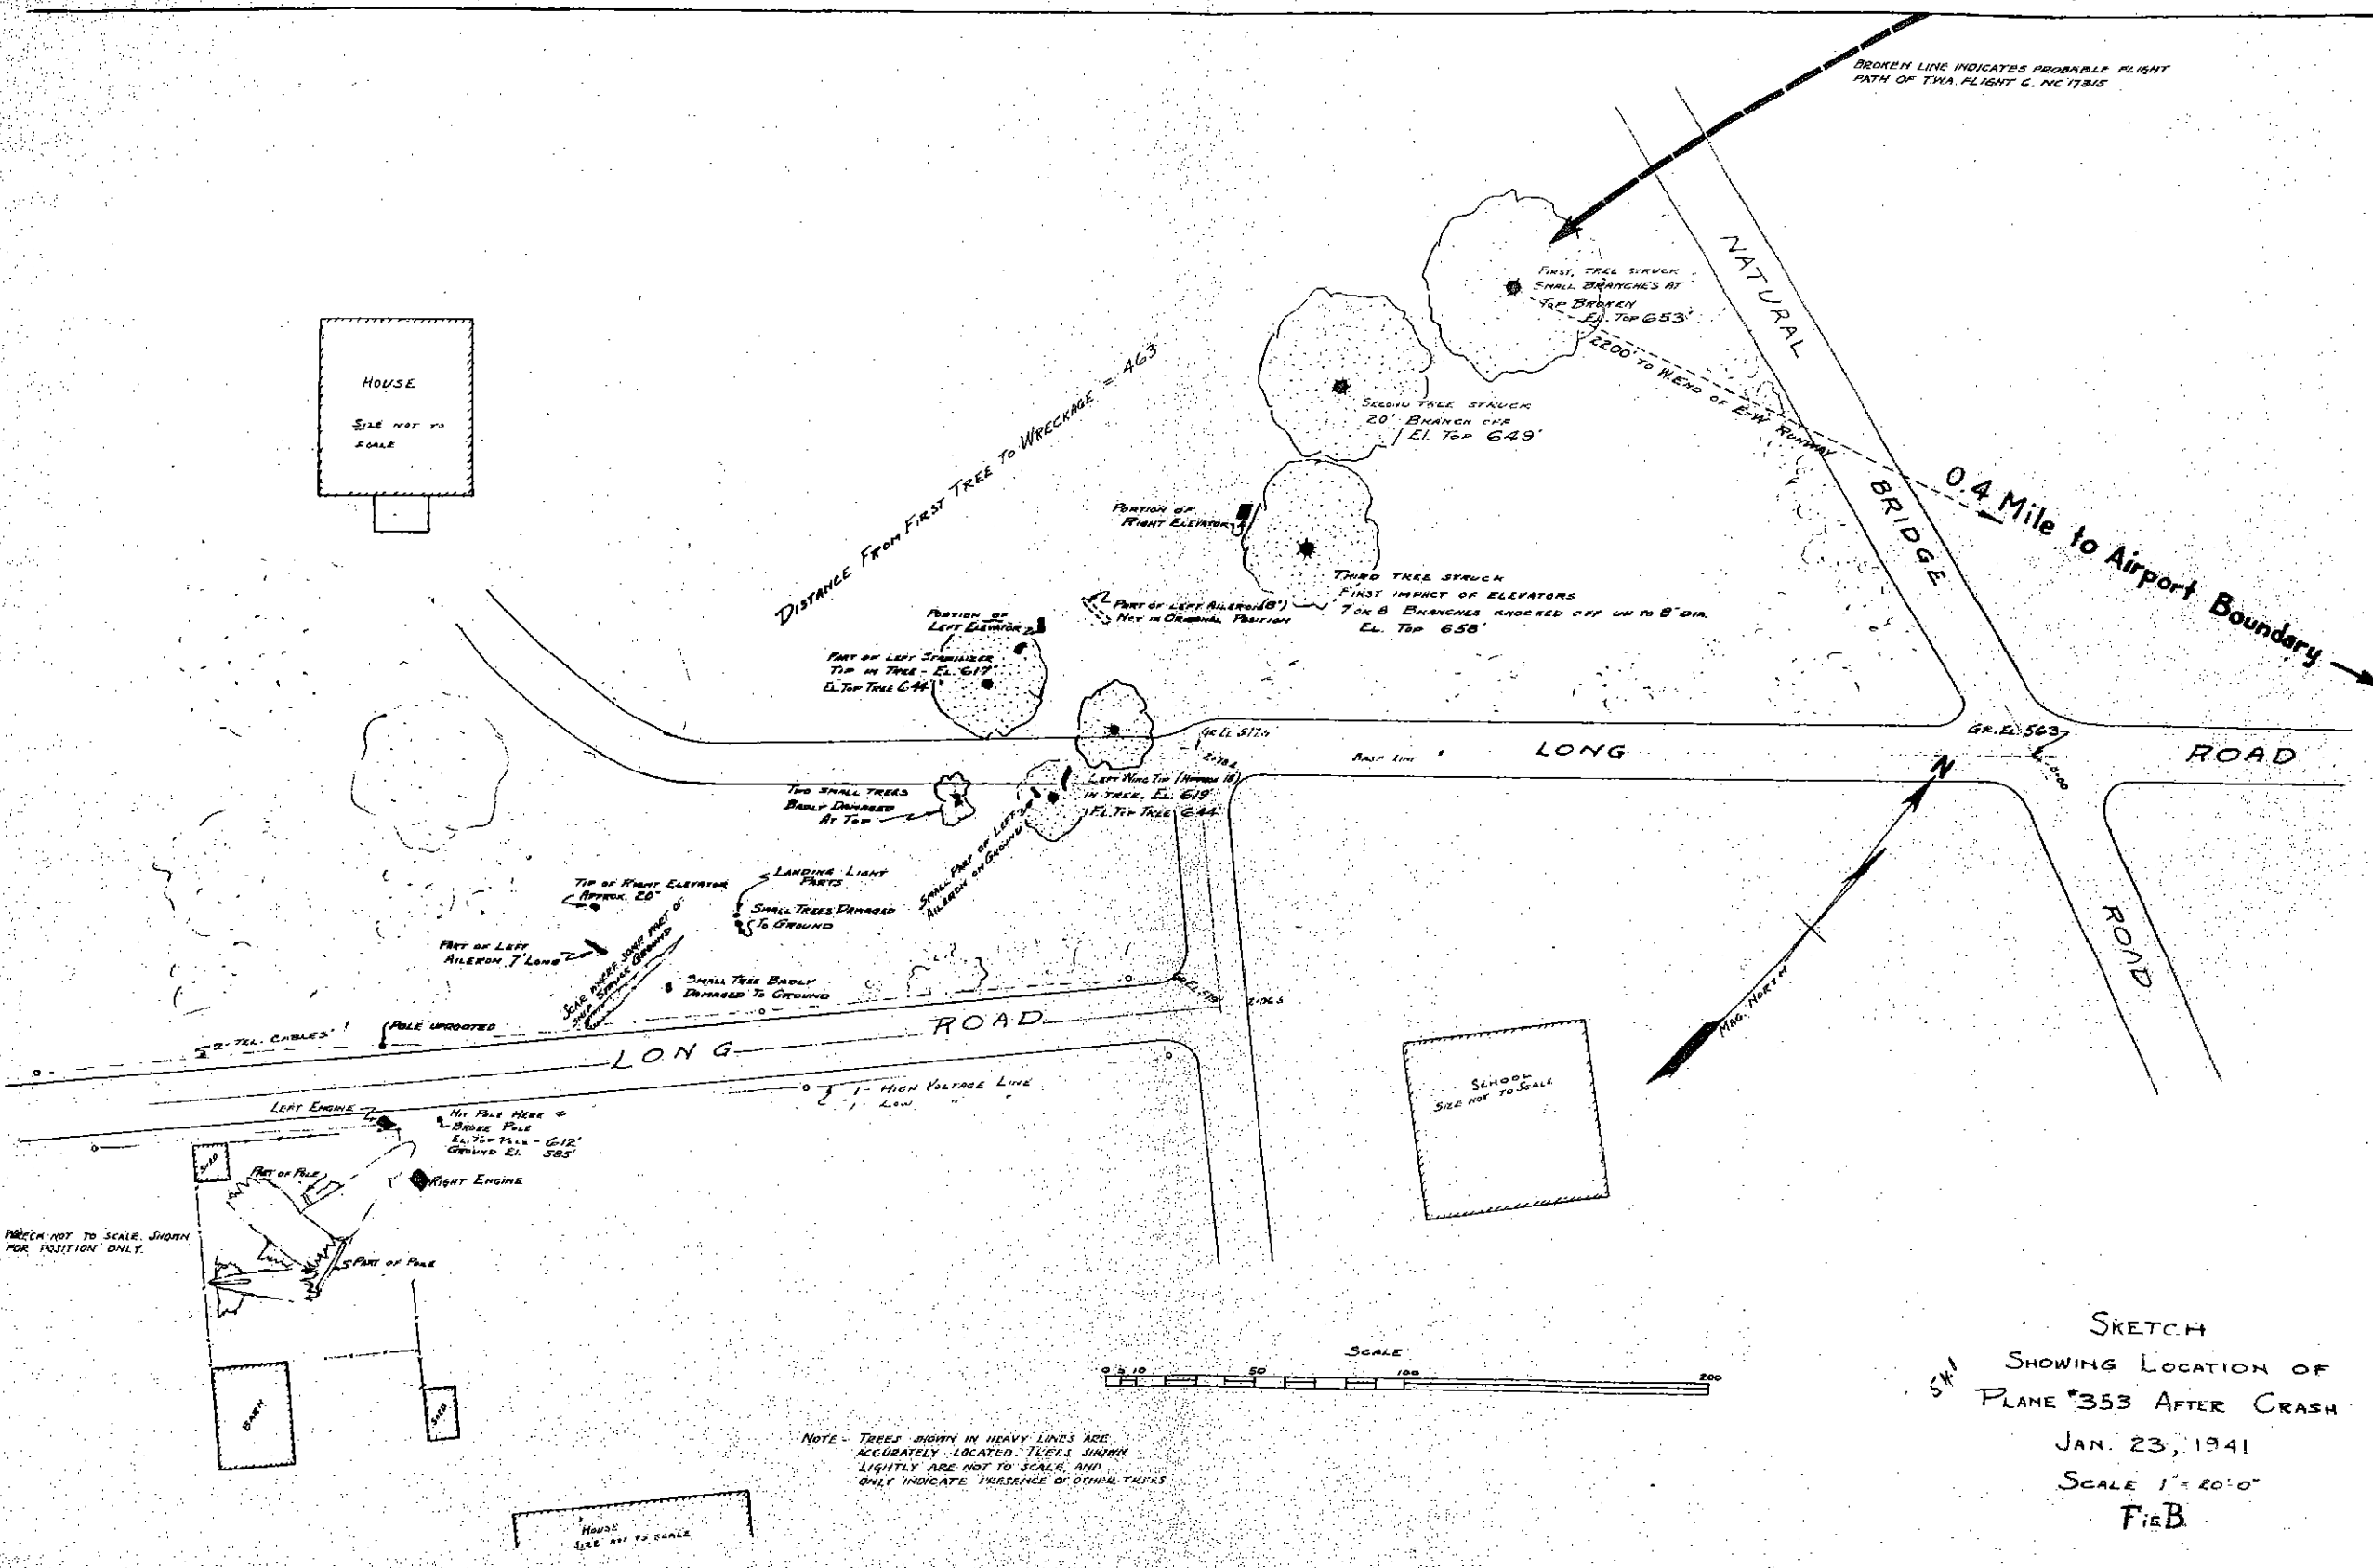
SKETCH  
SHOWING LOCATION OF  
PLANE #353 AFTER CRASH  
JAN. 23, 1941  
SCALE 1" = 20' 0"  
FIG. B

shows that the plane traveled in almost a straight line toward the south for this entire distance. <sup>10/</sup> Although small fires were started when the broken high tension line came in contact with one of the engines on the ground, they were quickly extinguished by ground crews from the airport who arrived at the scene a few minutes after the accident occurred.

DISTANCE FROM FIRST TREE TO WRECKAGE = 463'

FIRST TREE STRUCK  
SMALL BRANCHES AT 653'  
EL. TOP 653'

SECOND TREE STRUCK  
20' BRANCH CUT  
EL. TOP 649'

THIRD TREE STRUCK  
FIRST IMPACT OF ELEVATORS  
TORN BRANCHES KNOCKED OFF UP TO 8" DIA.  
EL. TOP 658'

While the failure to have the tree obstruction lighted cannot be reasonably held in any way responsible for this accident and while it has not caused any accident to airplanes approaching No. 4 runway, it appears desirable to the Board that the group of trees of which this one was a part should, in the interest of the greatest degree of safety, be removed, trimmed or lighted in the future.
