Descent Below Visual Glidepath and Impact With Seawall
Asiana Airlines Flight 214
Boeing 777-200ER, HL7742
San Francisco, California
July 6, 2013

NTSB/AAR-14/01
PB2014-105984

Aircraft Accident Report

Descent Below Visual Glidepath and Impact With Seawall

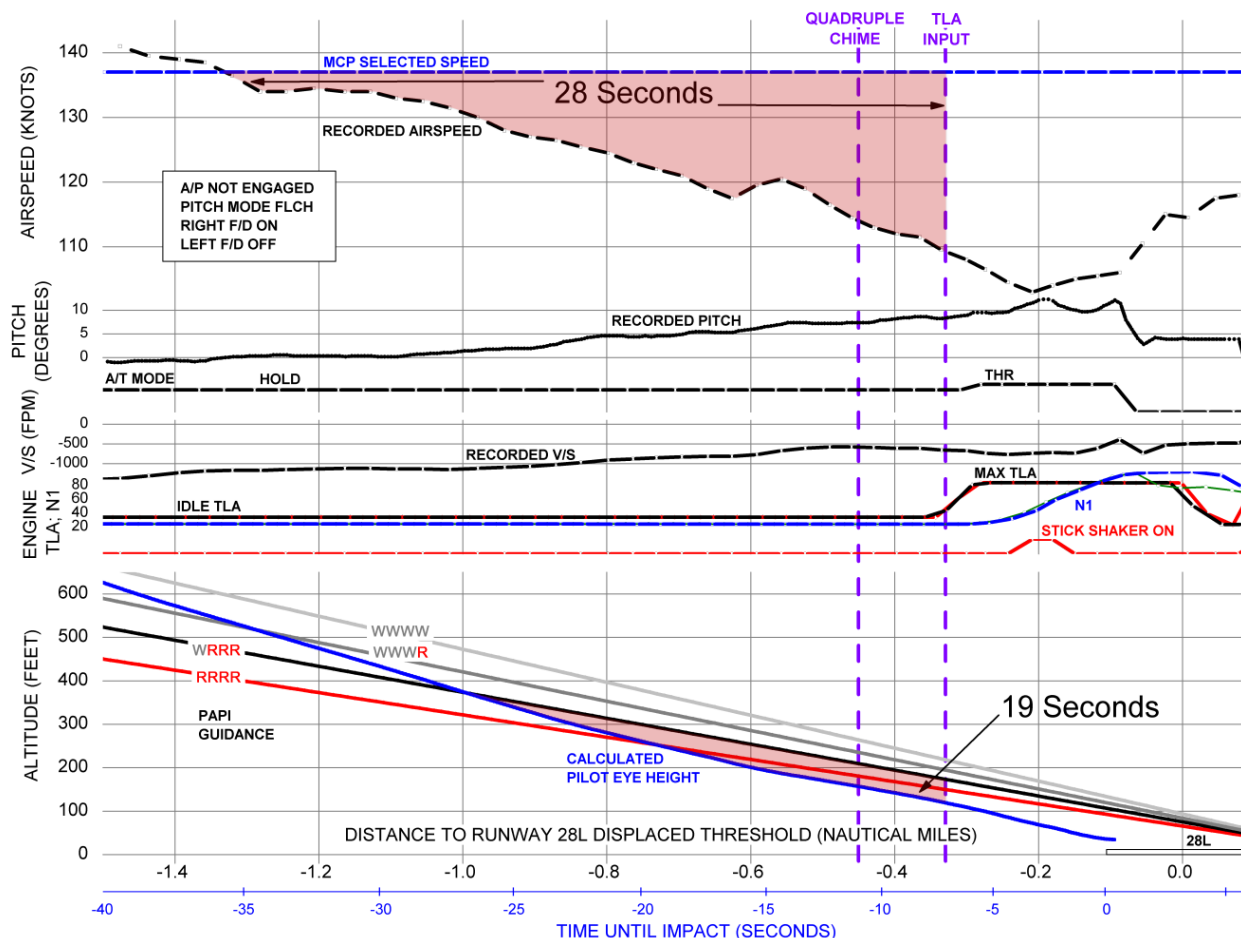
Figure 4. Profile view of the last 40 seconds of flight 214.

During a postaccident interview, the observer stated that he saw two white lights and two red lights on the PAPI as the flight descended through 500 ft RA. He recalled that beginning sometime after the airplane descended below 500 ft, he could no longer see the runway or the PAPI lights through the windscreen. The PM stated that at 500 ft RA, the airplane was slightly low, and he saw one white light and three red lights on the PAPI. The PF stated that he began to see one white light and three red lights on the PAPI at 500 ft RA and recalled thinking that if he allowed the PAPI indication to go to four red lights, he would fail his flight and would be embarrassed.²³ The PF pitched the airplane up to avoid going low. He stated that about that time, he “saw some light and was in blindness for a second.” The light prompted him to stop looking outside and instead look down at the instrument panel. He stated that the blindness was only momentary, and he could see the airspeed tape and noticed that the airspeed was low. The PM stated that he did not see any bright light. The PM further stated that about 200 ft RA, the airspeed was about 120 knots; he saw four red lights on the PAPI and thought perhaps the A/T was not working.

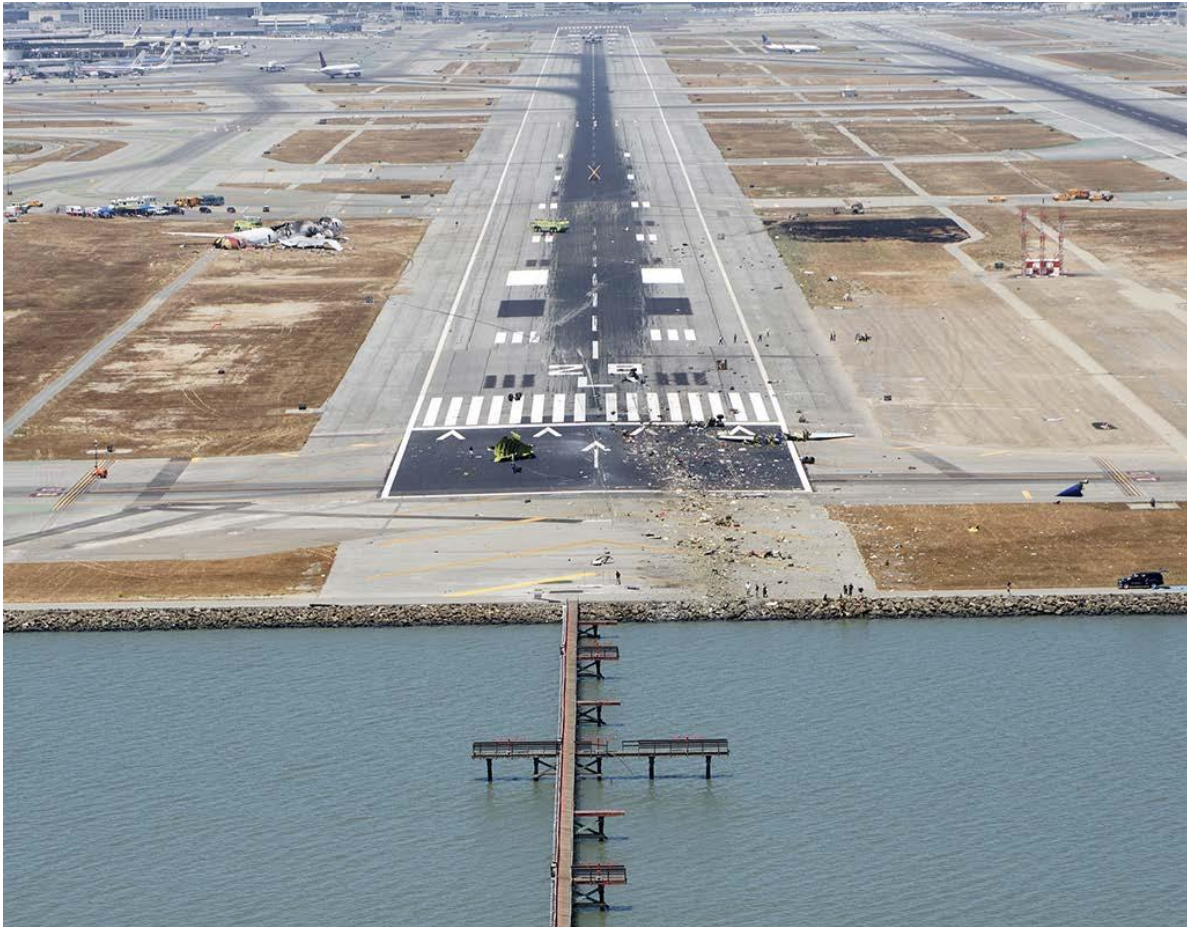
Figure 5. Aerial view of the flight 214 wreckage.

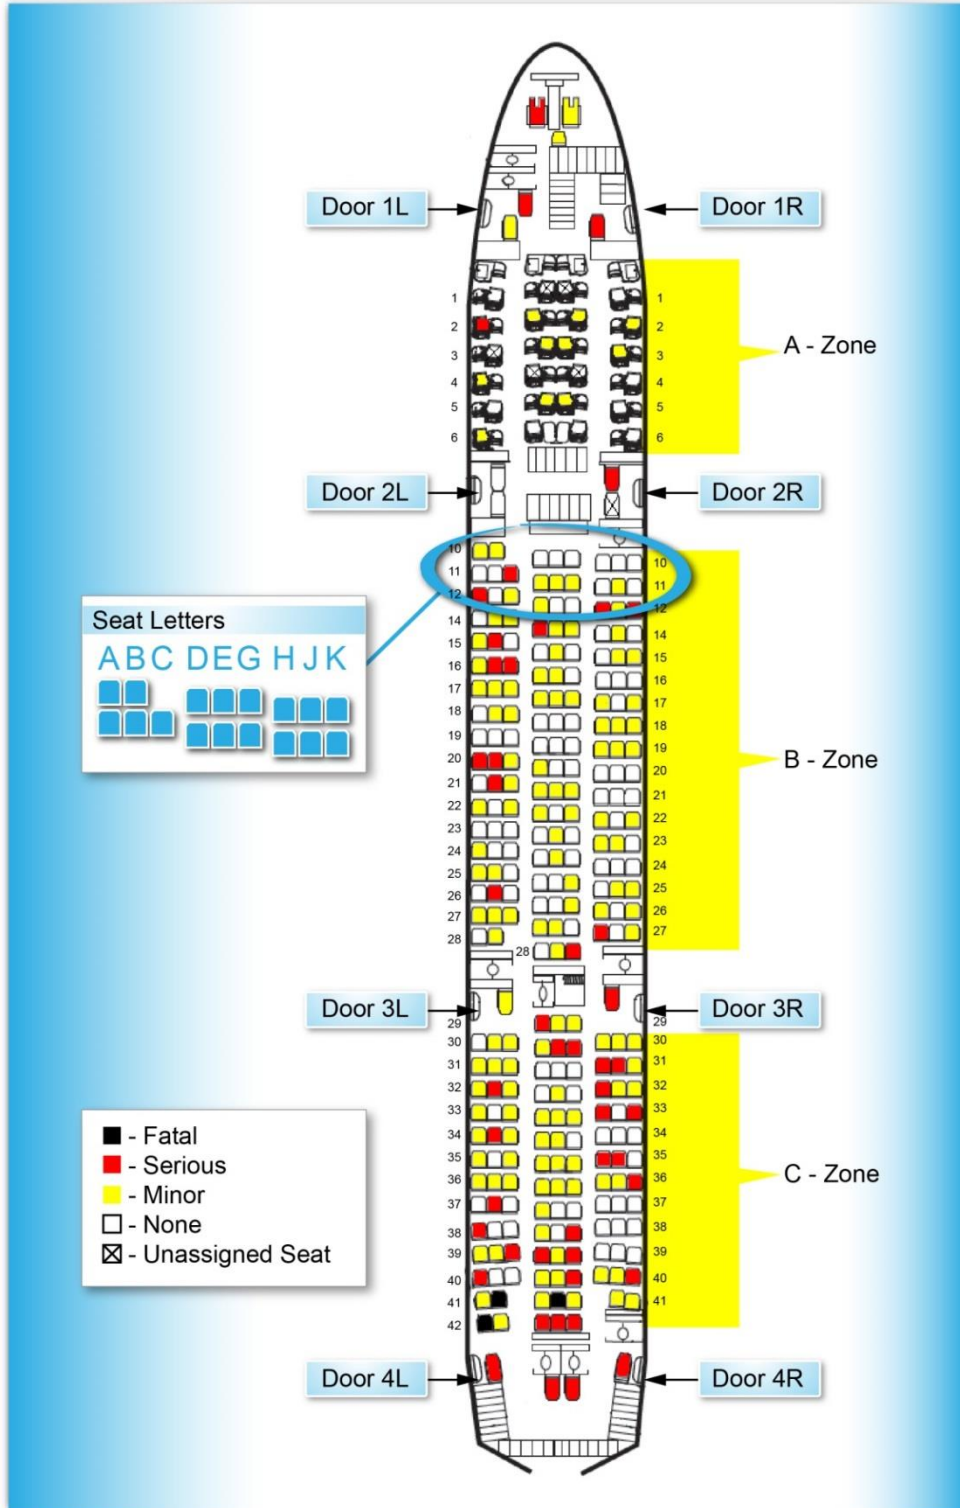
Figure 12. Diagram of flight 214's cabin configuration including injury classification based on assigned seat.

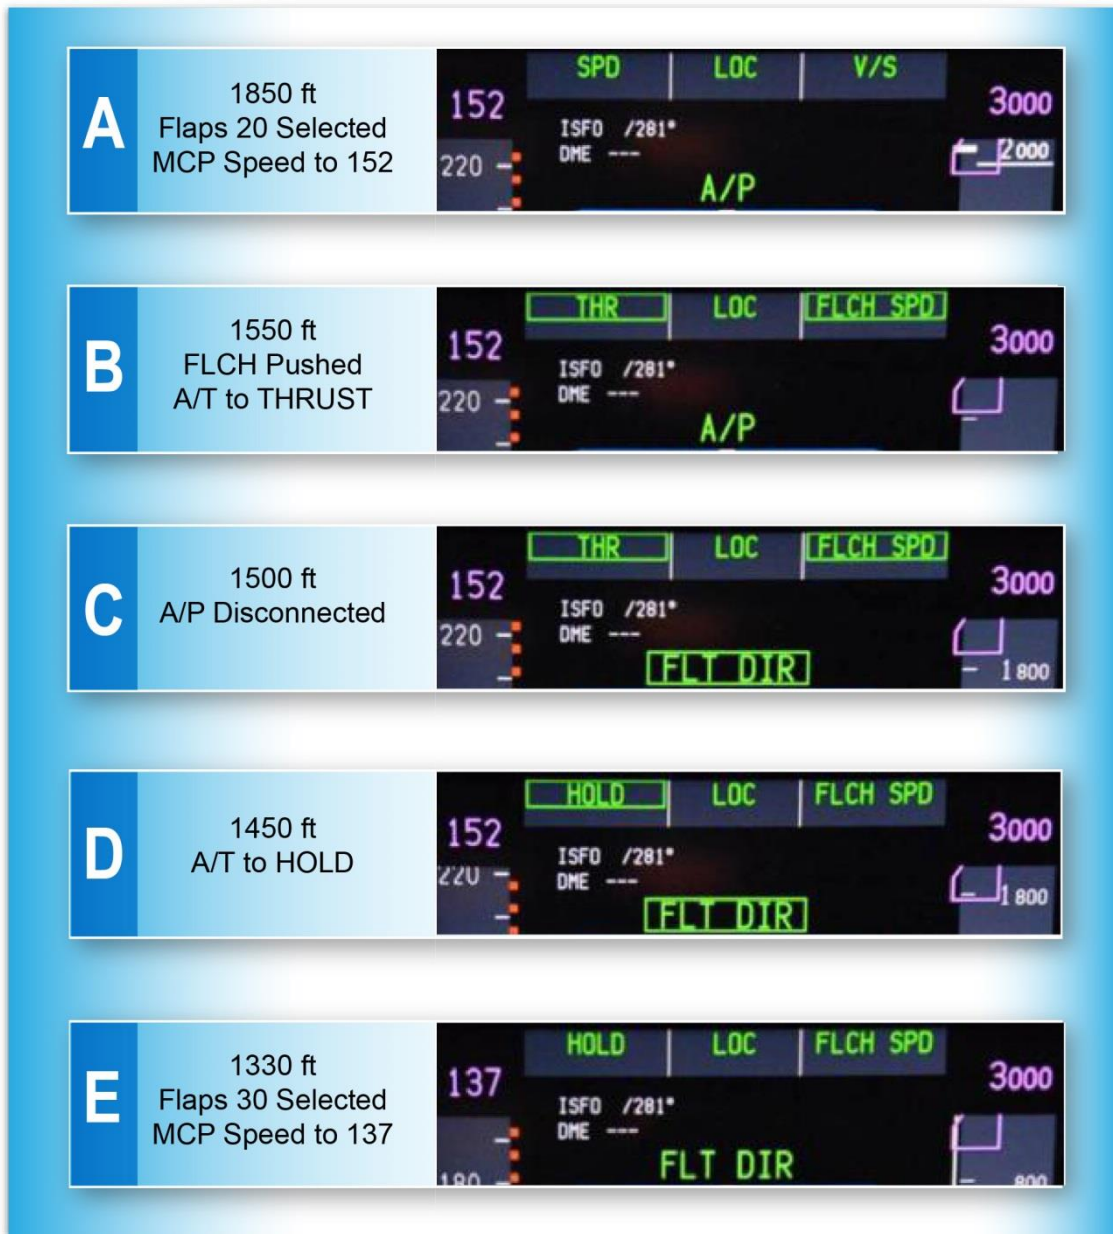
The flight crew's difficulty in managing the airplane's vertical path continued as the approach progressed. The PF was aware of the need to lose excess altitude and attempted to do so using FLCH SPD pitch mode, which initiated a sequence of events that had the unintended consequence of deactivating automatic airspeed control. The changes on the FMA that occurred during the airplane's descent from 1,850 to 1,330 ft msl, when it was between about 4.5 and 3.0 nm from the runway threshold, are shown in figure 14 and discussed below.

Figure 14. Automation sequence from 1,850 to 1,330 ft msl.

After passing the DUYET waypoint, the PF called out and set the MCP altitude to 3,000 ft, the planned altitude in the event of a go-around. After passing the 5 nm point, the PF commanded flaps 20; the PM moved the flap lever to the flaps 20 position; and the PF set the MCP speed to 152 knots (panel A of figure 14), the target speed for flaps 20.⁹³ The PF then commanded flaps 30, but the PM delayed setting them to the flaps 30 position because the airspeed had not yet slowed to below the flaps 30 limit speed.

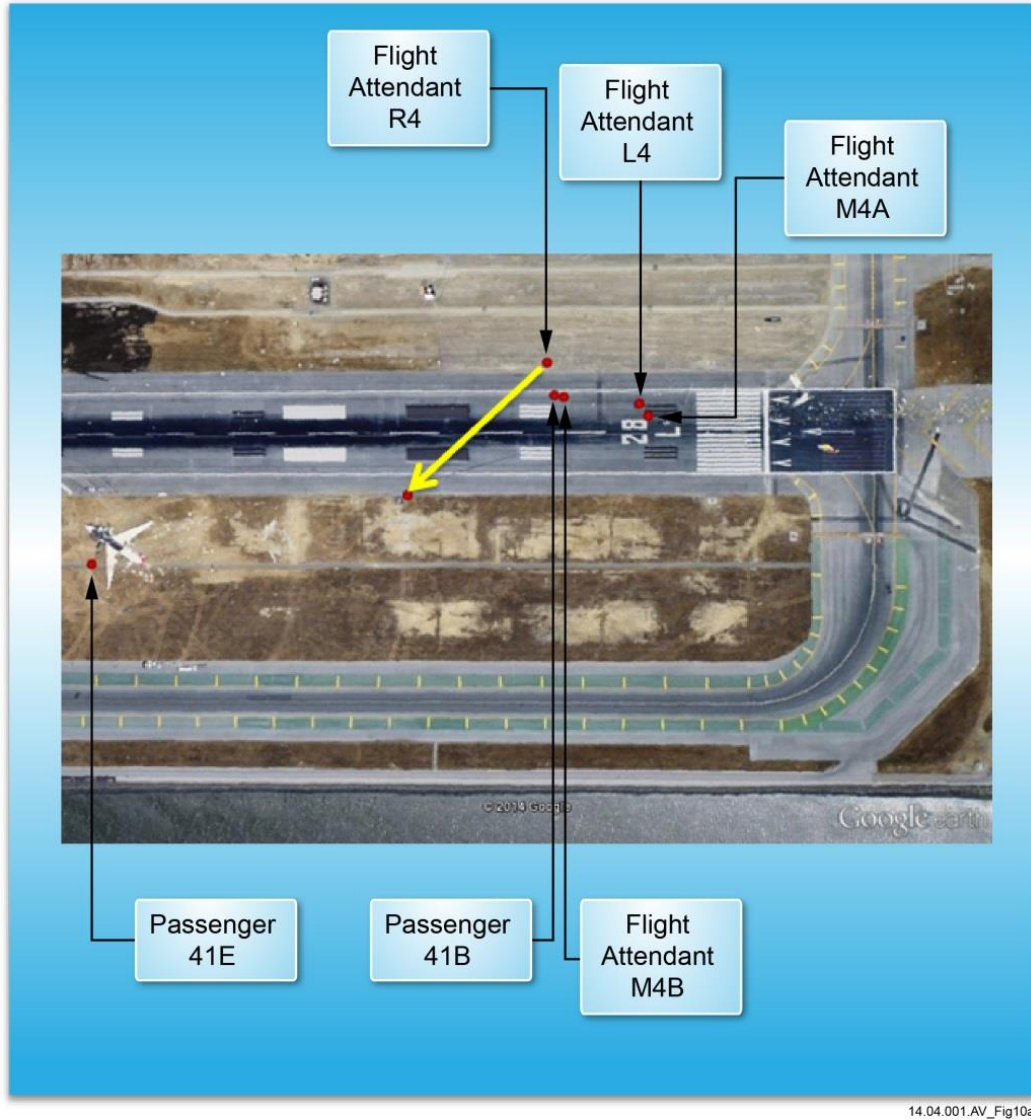
Passenger 41B,⁵⁵ a 16-year-old female, was found on the right side of the runway about midway between the seawall and the main wreckage. An autopsy was performed by the San Mateo County Coroner's office, and the cause of death was determined to be "multiple blunt injuries" and the manner of death to be "accident." The autopsy report described skull fractures, as well as extensive contusions and abrasions to the torso and extremities.

Passenger 41E, a 16-year-old female, was found about 30 ft in front of the airplane's left wing and about 50 ft from the left side of the fuselage. An autopsy was performed by the San Mateo County Coroner's office, and the cause of death was determined to be "multiple blunt injuries" and the manner of death to be "accident." The autopsy report noted that there was a moderate amount of dirt and plant material on the outside and inside of passenger 41E's clothing. The autopsy report described skull fractures, a lacerated aorta, a fractured pelvis, and extensive contusions and abrasions of the extremities and anterior torso as well as open fractures of the right humerus and left wrist and closed fractures of the left humerus and left femur.

Figure 15. Location where ejected occupants were found.
