# AIRCRAFT DESIGN-INDUCED PILOT ERROR

july 1967

**Bureau of Safety  
CIVIL AERONAUTICS BOARD  
Washington, D.C. 20428**

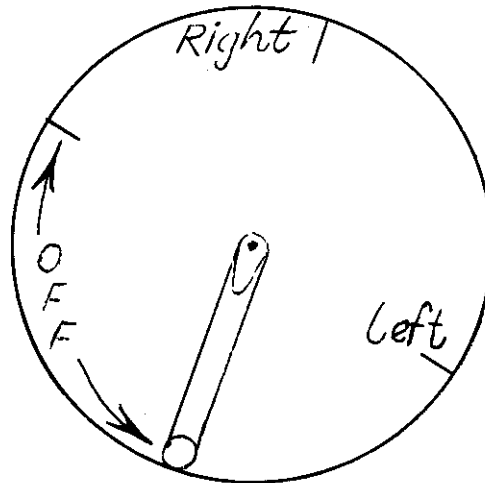
Statements submitted by pilots committing this error included comments that they were used to other airplanes, or different model airplanes, in which the fuel selector position for right or left tanks was different. A typical example is found in the fuel selectors for aircraft 009 and 048. In airplanes 009 and 048, the fuel selector location and operations are nearly identical. However, in Aircraft 009 the selector position deviates from what might be considered as a standard direction orientation with respect to the right and left tank locations. When viewed through the cabin doorway, or from a point opposite the selector, the appearance is as shown below:

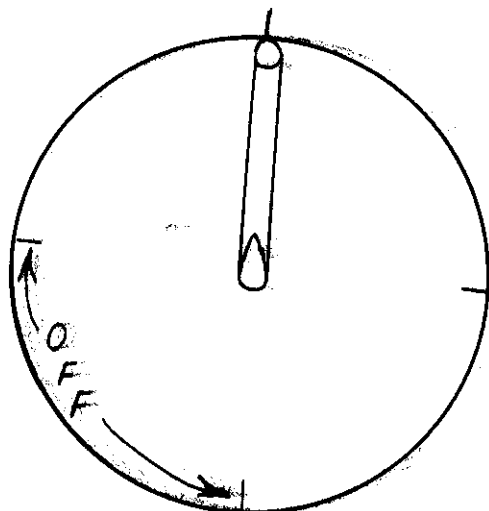
In the course of this study, a similar drawing was shown to 30 pilots and 11 nonpilot individuals. They were advised only that the two otherwise unidentified radial marks on the circle were the two main tank positions, but were not labeled. The participants were then asked to position the selector to the left tank position. Without exception, the selector handle was positioned as shown on the following page.

This error is not unique to the participants in this small experiment, or to some of the pilots involved in the accidents. An article in the September 1965 issue of the Australian Department of Civil Aviation Safety Digest, discussing the confusion resulting from similar appearing, but different, functioning fuel selectors, describes two forced landings (which did not result in accidents). With respect to the selector (shown on the drawings) for aircraft 009, the article states, "The pilot said afterward that in turning on the fuel before starting he had moved the selector to the Vertical Position (actually the starboard tank), thinking it was the port tank." He went on to explain that the word "Right" in the placard warning didn't register as being the starboard tank.
