## Report A-017/2003

Accident involving a Cessna  
P210N Centurion aircraft,  
registration PH-WWW, on  
3 April 2003, in the vicinity  
of Oroquieta (Navarre)

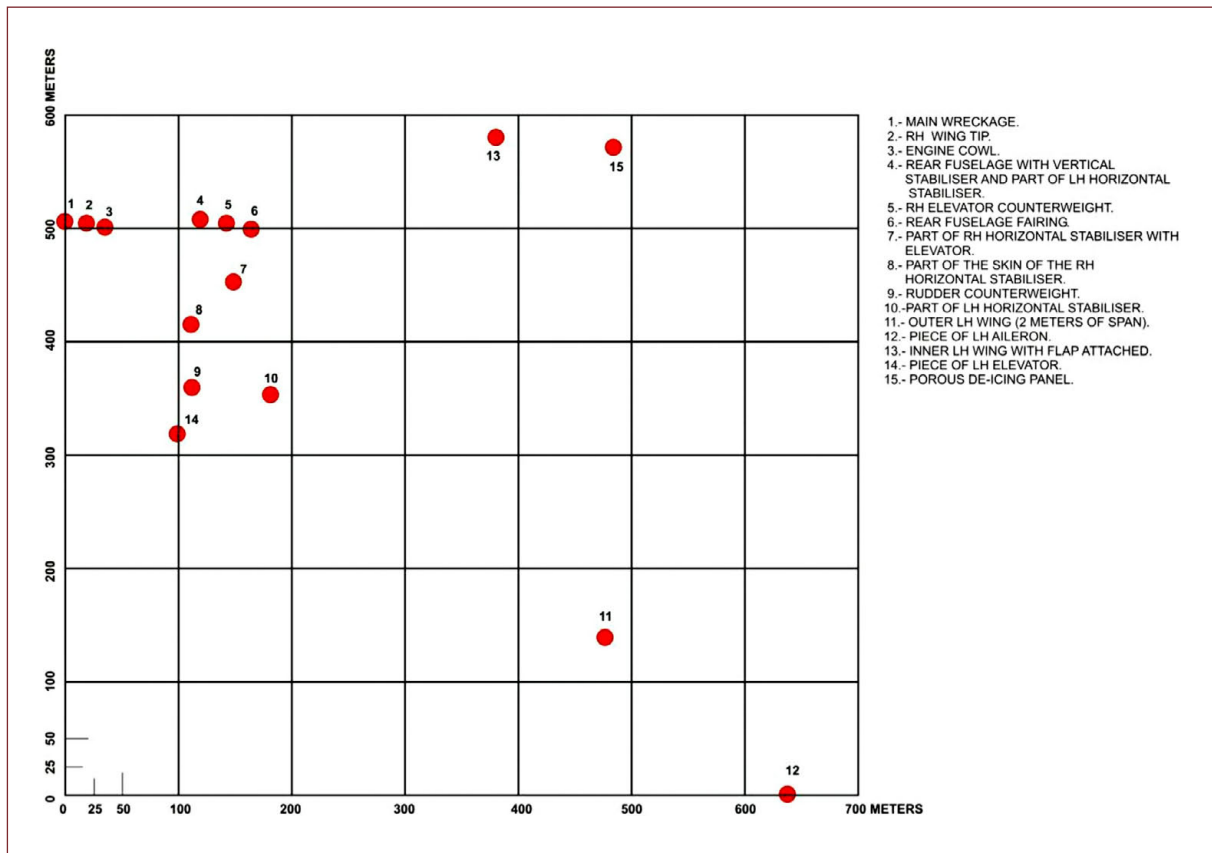
The remains of the aircraft were found fragmented into a large number of separate pieces scattered throughout the relatively flat area where the impact took place, with hills but without any appreciable orographic features. The wreckage was confined to a square 600 m on a side, the main wreckage being located in the northwest corner (see distribution diagram in Figure C-1 of Appendix C). This corner was some 250 m southeast of the town of Oroquieta.

Figure C-1. *Diagram of the relative positions of the remains*

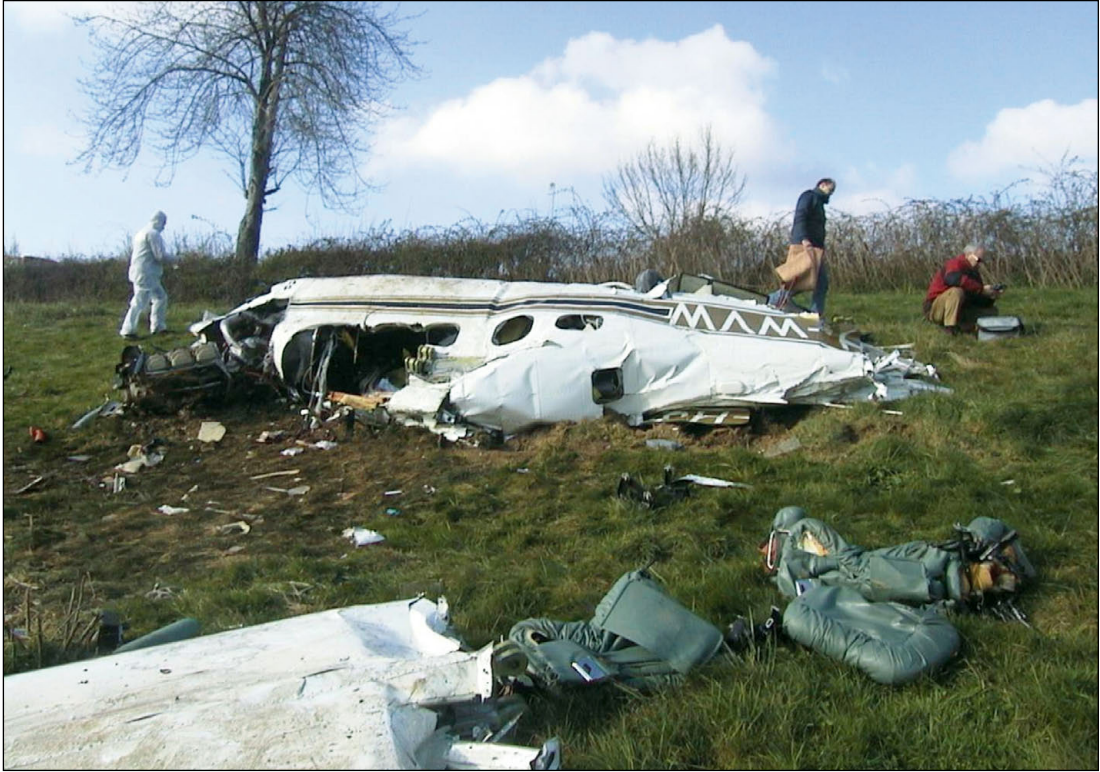
- The main wreckage (1 and Figure C-2) included the right wing, propeller and fuselage, except for the rear fuselage. Judging from the type of damage, these remains impacted the ground at great speed. The aircraft's longitudinal axis, including the nose, was aligned northwest-southeast. The aircraft fell to the ground and came to rest on its left side, resulting in the strong compression of the fuselage on that side. The landing gear was folded back. The central beam, to which the wings were attached, was buried over a meter into the ground on the side corresponding to the left wing. The right wing was still attached to the fuselage in a nearly vertical position. This wing had to be cut by firemen to get to the remains of the occupants inside the cockpit. Figure C-2 shows the arrangement of the main wreckage once the wing had been cut.  
The engine was found next to the fuselage and attached to it by a few control cables. The mount broke on impact. The propeller was buried in the ground next to the engine but separate from it as its attaching elements were broken. Figure C-3 shows the propeller after it was recovered from where it had embedded itself. There were signs that the engine was turning and supplying power at the time of impact.

Figure C-2. *Main wreckage*

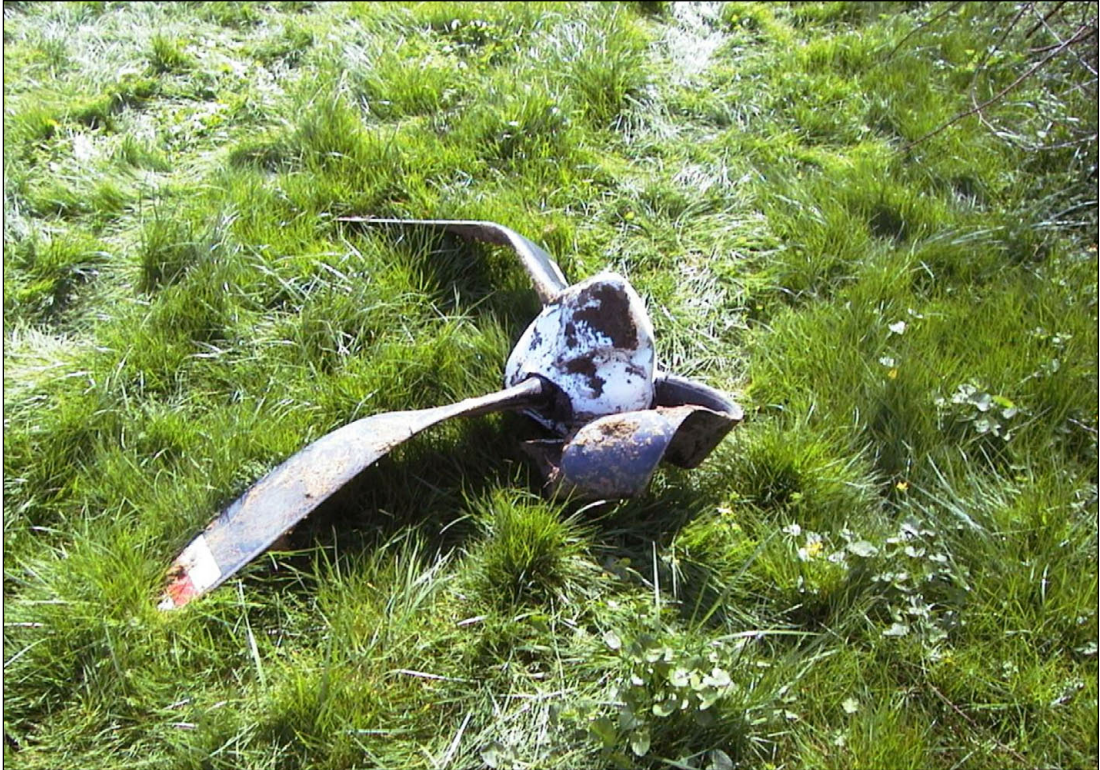
Figure C-3. *Remains of the propeller (not in original position)*

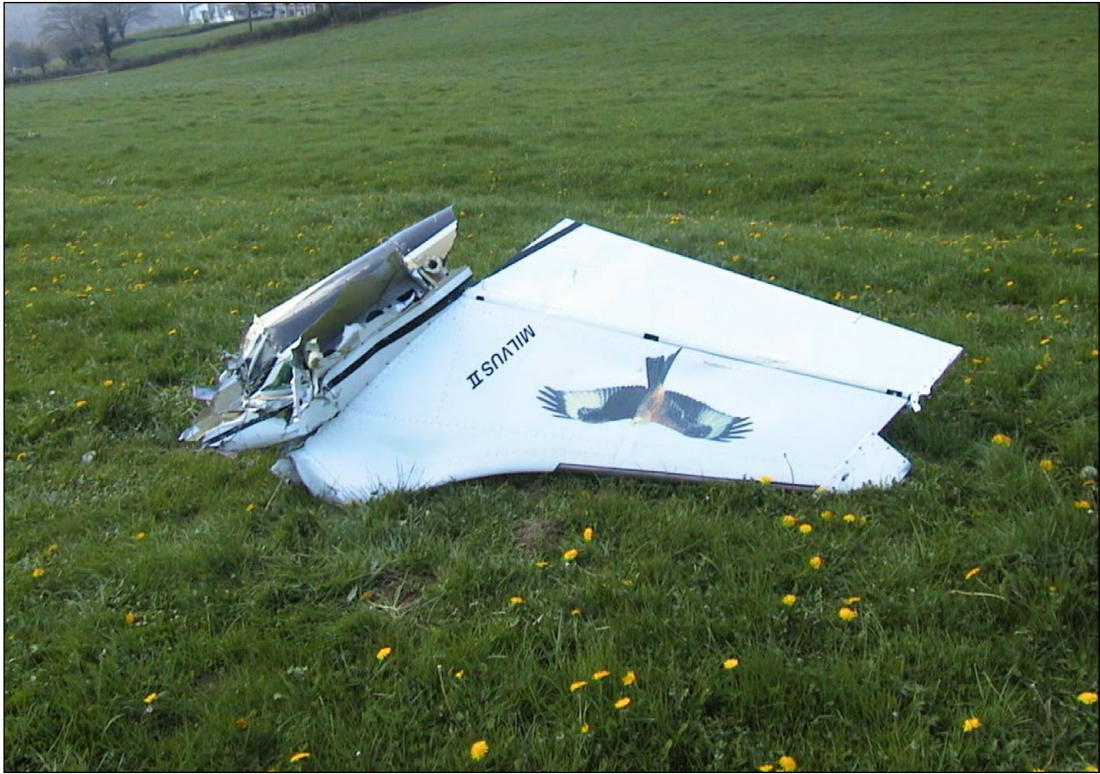
Figure C-4.1. *Remains of the rear fuselage (view of the tail fin)*

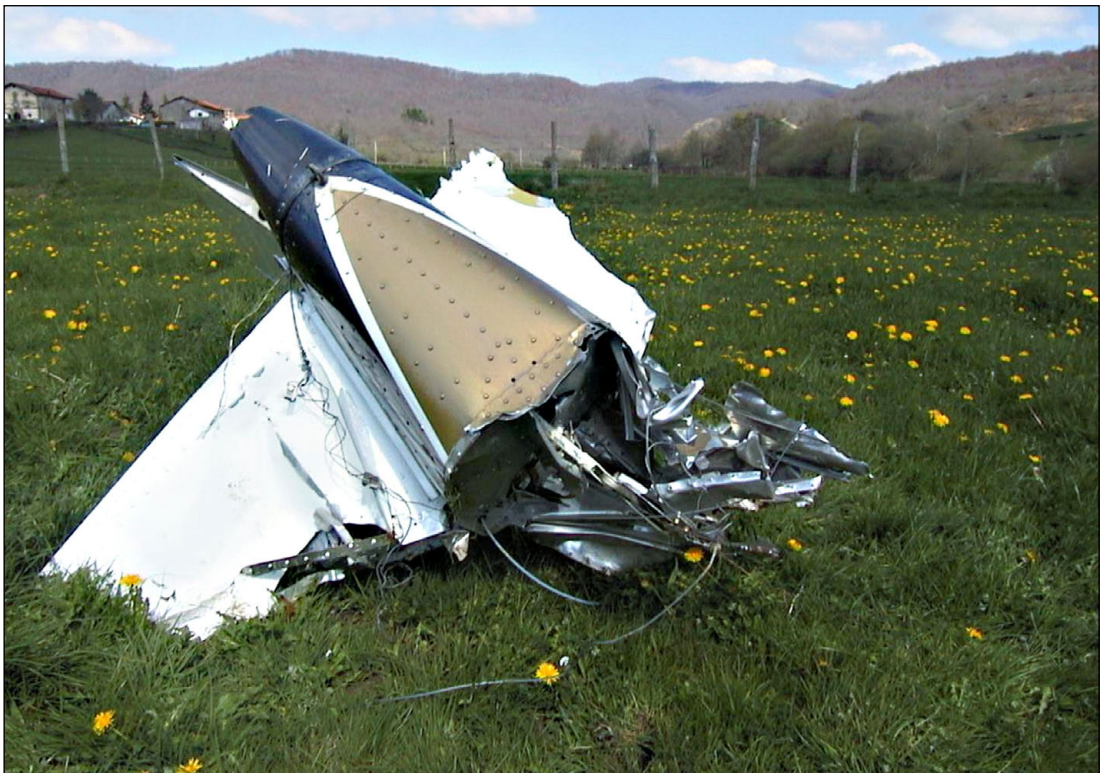
Figure C-4.2. *Remains of the rear fuselage (seen from underneath)*

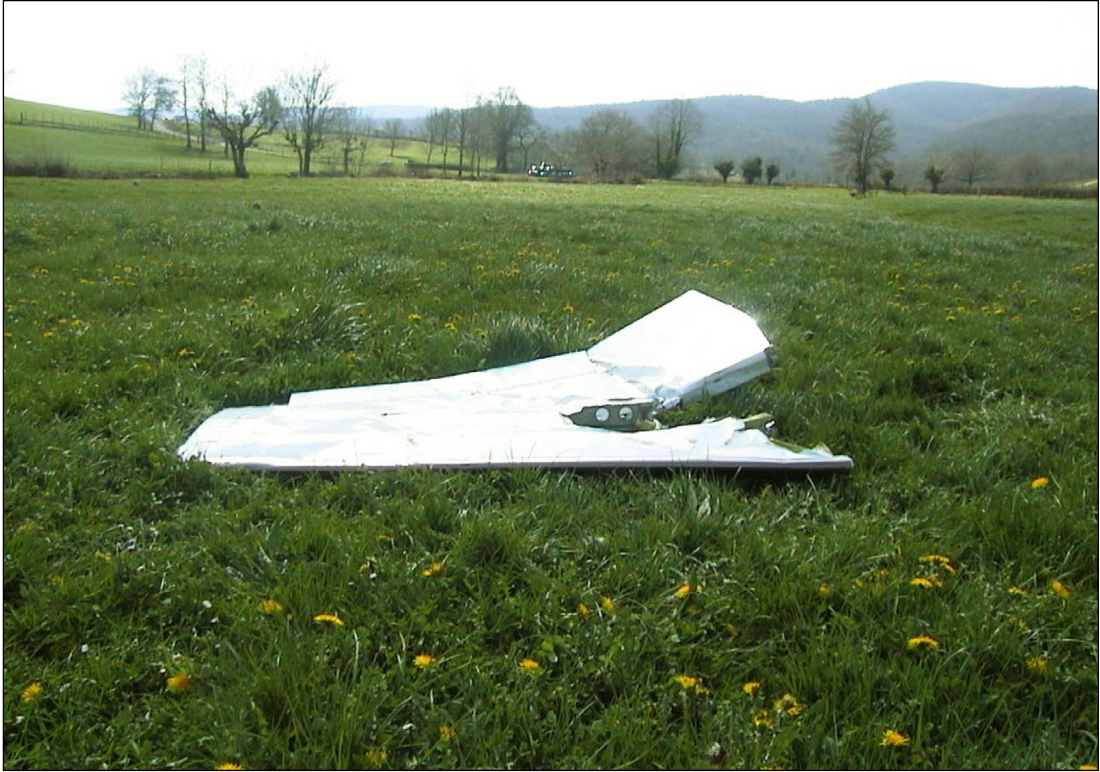
Figure C-5.1. *Remains of the right stabilizer (inboard part)*

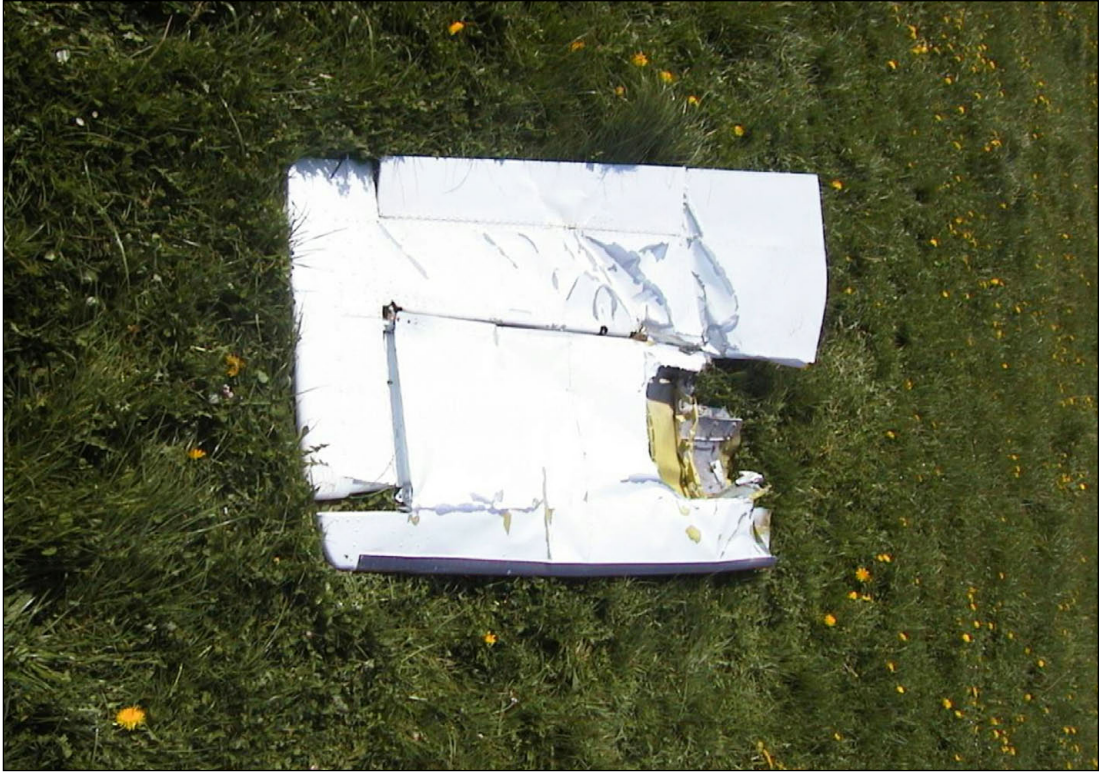
Figure C-5.2. *Remains of the right stabilizer (outboard part)*

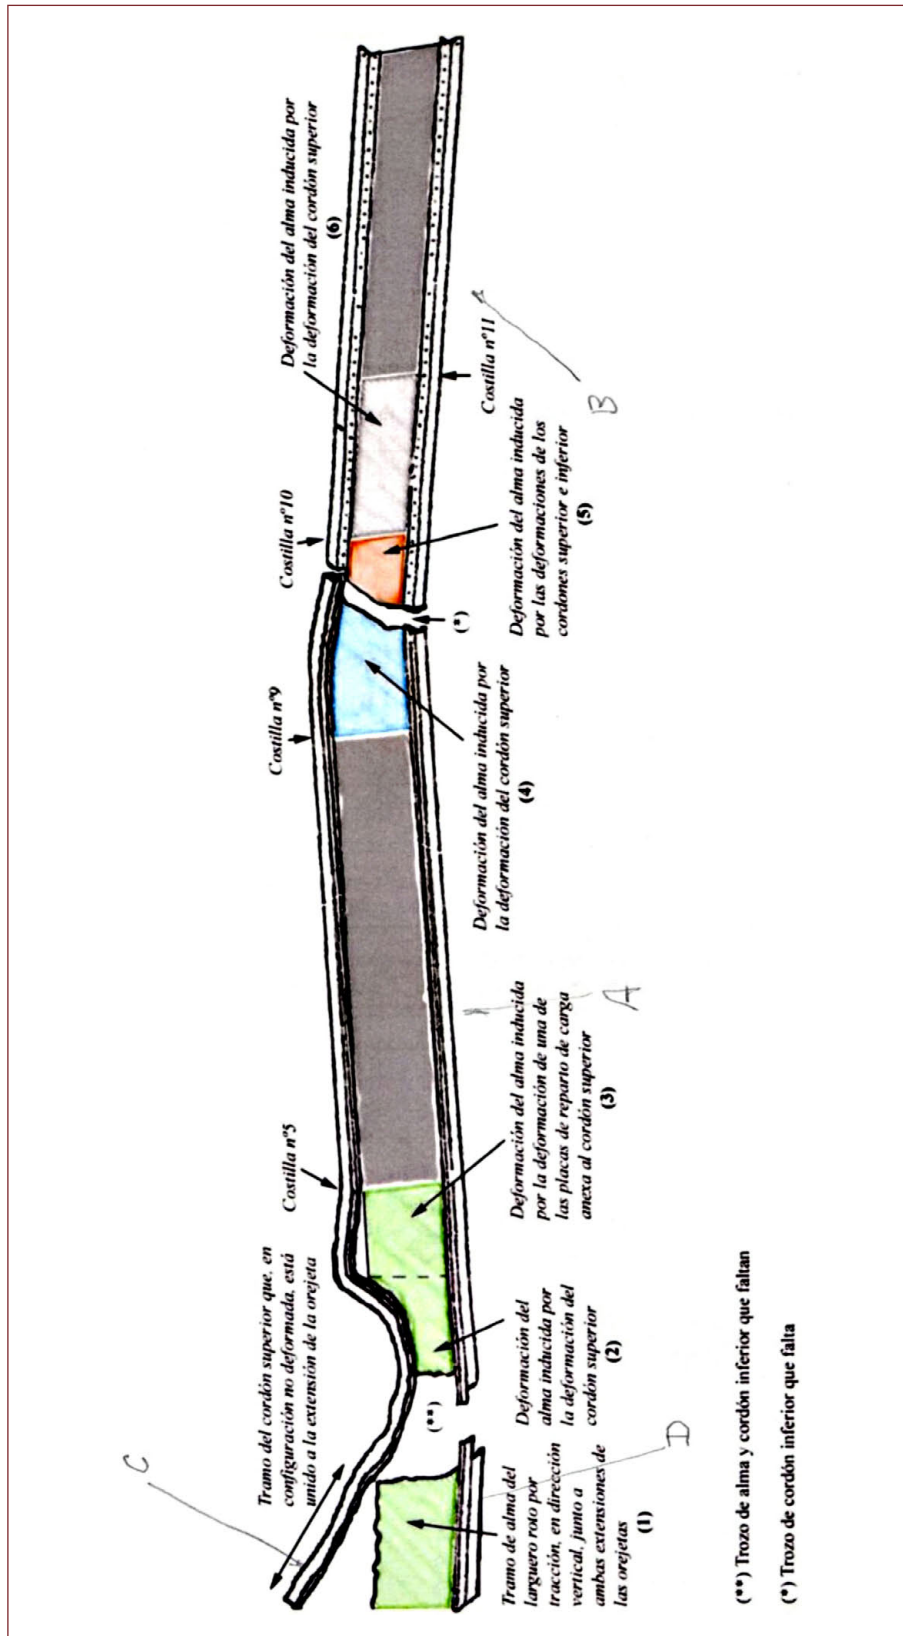
Figure C-7. Reconstruction of the left wing main spar

Figure C-7 is a diagram of the reconstruction of the main spar, seen from the wing's leading edge and showing the fractures and deformation suffered. The figure was reconstructed with fragment D of the spar in its original position with respect to the fuselage, that is, at the very instant the wing started to fracture and break apart.

As shown on the diagram, the analysis indicated that the fracture of the spar where it joins the fuselage was produced by a bending moment from the lower to the upper surface. In other words, the separation was in an upward direction and resulted from a set of positive lift loads on the inboard part of the wing (fragment A). On the other

hand, the analysis indicated, as shown in the figure, that the fracture in the separated section of fragment B, the outer wing, resulted from a bending moment from top to bottom, indicative of negative lift in that fragment. The analysis showed that said load might have been caused by the aileron, which was deflected upward, as indicated by the analysis of the fractures and deformations near the aileron hinge.
