The Locomotive

THE HARTFORD STEAM BOILER
INSPECTION AND INSURANCE CO.

VOL. XL

1934-1935

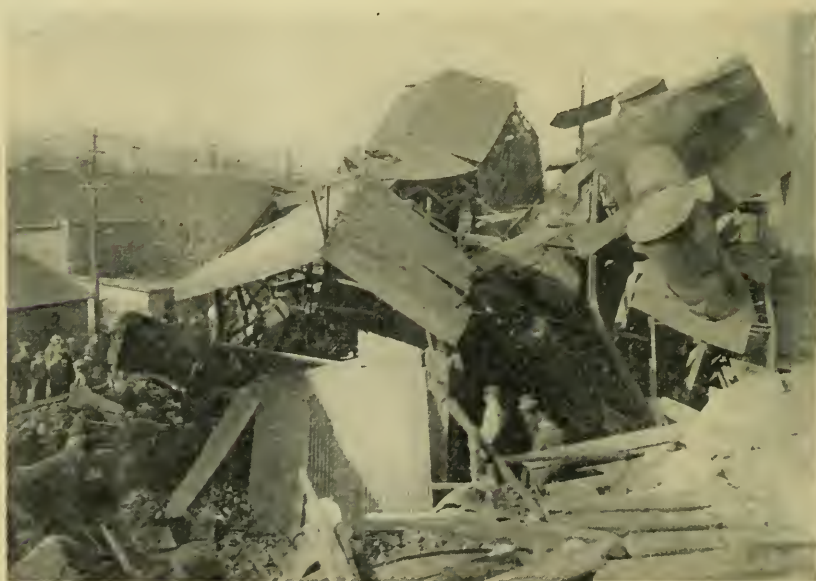
After a corroded mud drum head blew out at an Indiana paper mill.

Investigators were agreed that the boiler had been weakened because of corrosion on the outside of a lower mud drum at the "blind" end of the drum, concealed by the brickwork of the setting, and that this weakening led to the accident. All of the tubes were pulled from the mud drum and the drum itself was thrown a distance of approximately 75 ft, landing on the roof of a paper storage house. Examination of

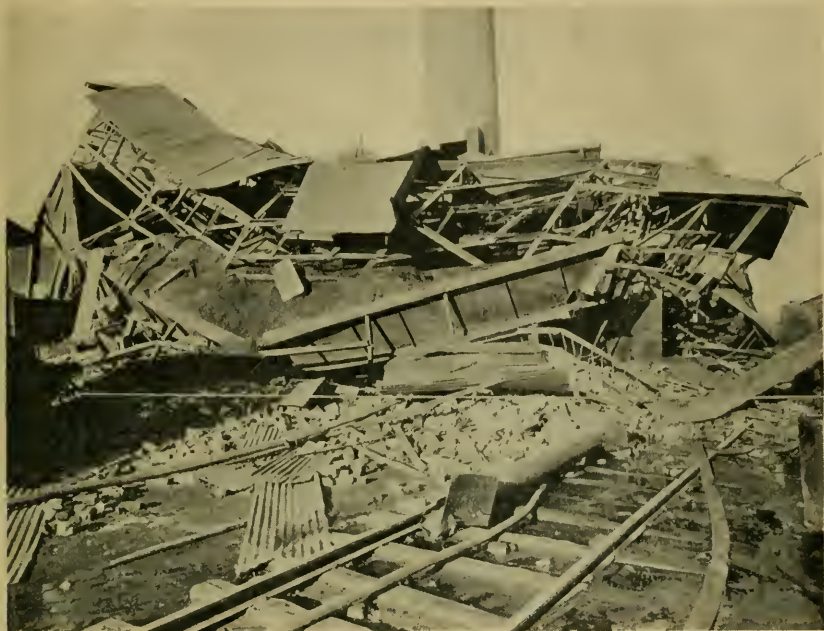
A bunker of coal collapses into the debris to complicate the search for a fireman's body.

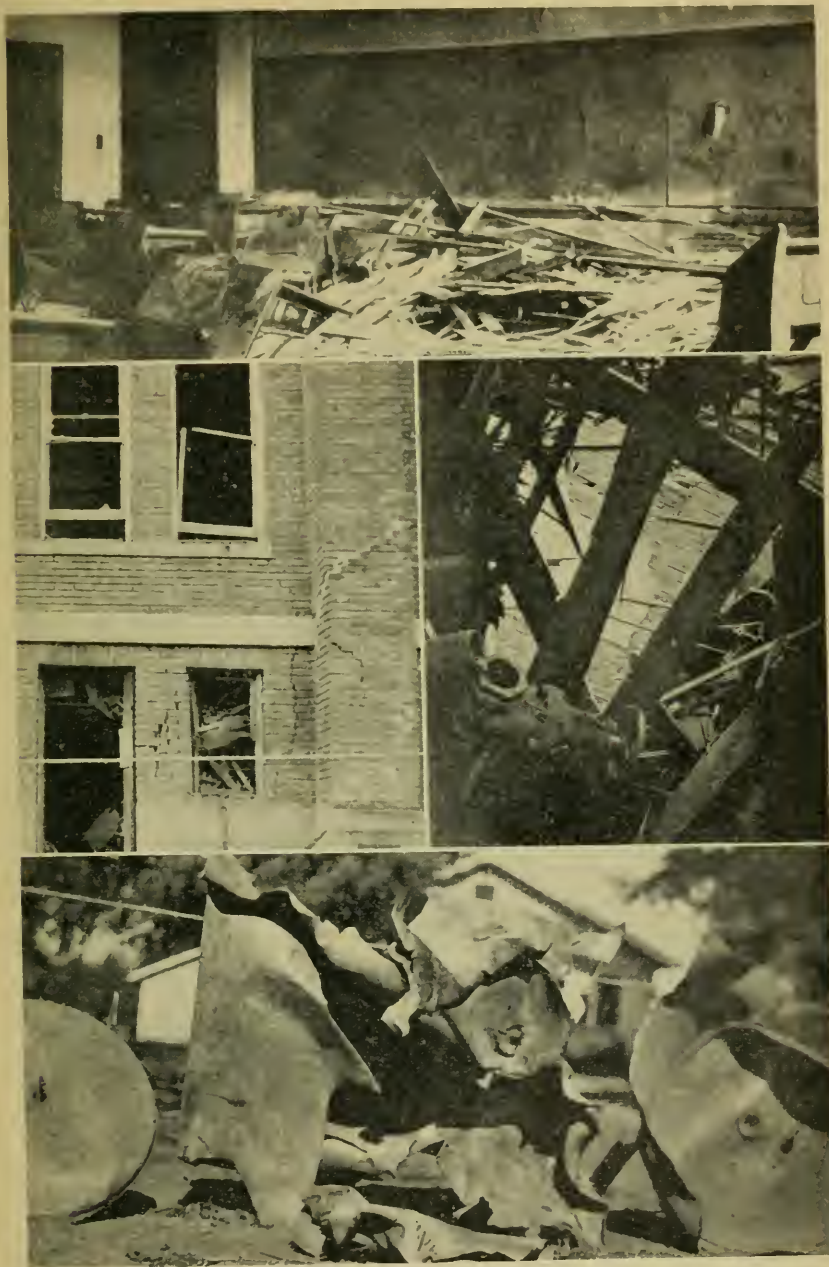
Scenes at Forest, Mississippi. Top and right center—views of the school-room floor. Left center—cracks in the building. Bottom—pieces of the tank.

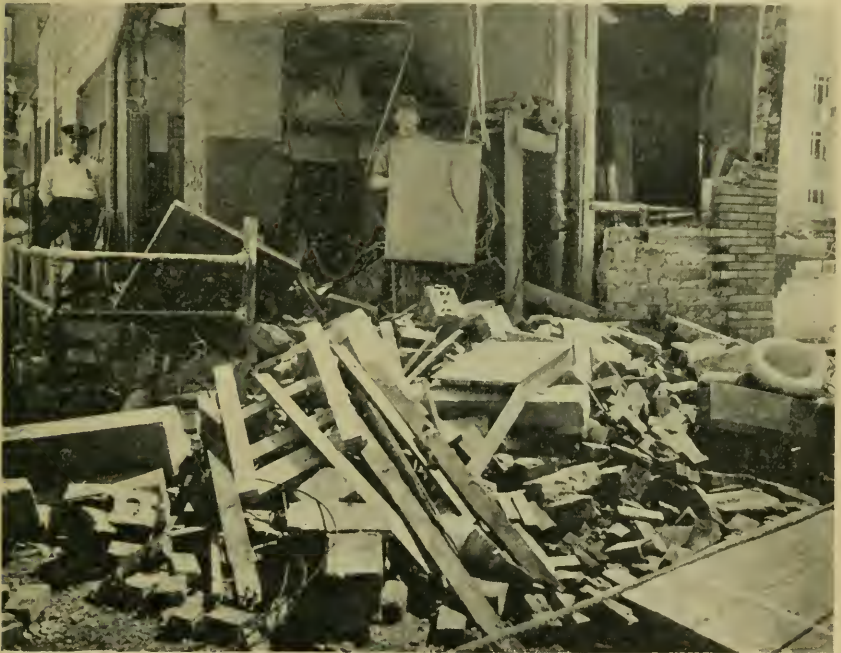
An Indiana automobile service station after a hot water heater burst.

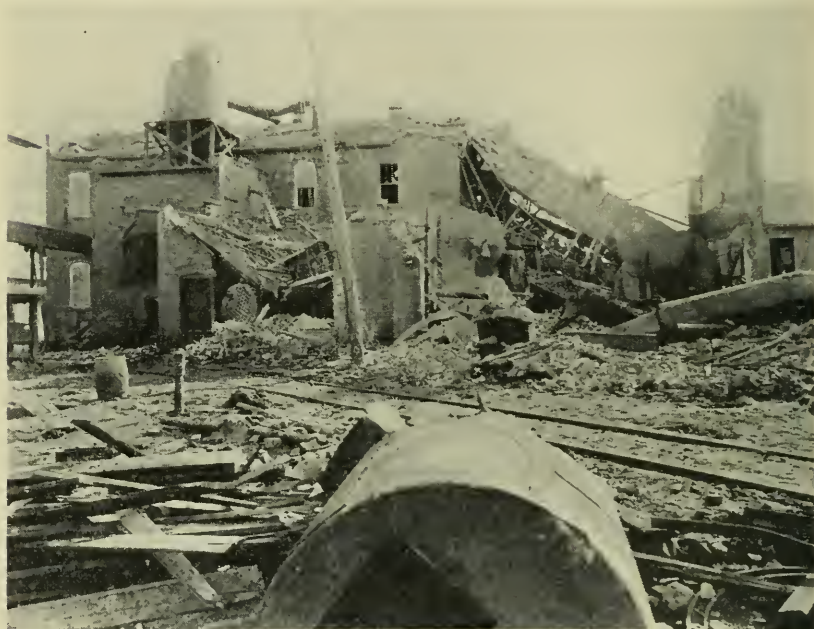
tance of from 4" to 8" on each side of the line of failure. The violence of the separation was sufficient to shear the $7/8$ " rivets in the girth seam. Rivets in the rear head seam sheared around three-quarters of the circumference with the exception of a short distance where the line of failure passed through the ligaments between the tube holes in the outer row. The tubes were pulled from the holes in the rear head.

Wreckage at Hertford, North Carolina. A one-story boiler room formerly stood at the right just beyond the tracks at about the spot where the steel smokestack is lying. Near the left center of the mill building is No. 1 boiler beneath which is the engine. On the roof of the mill building at the extreme left is the rear course of the No. 2 boiler which exploded. The breeching is in the foreground.

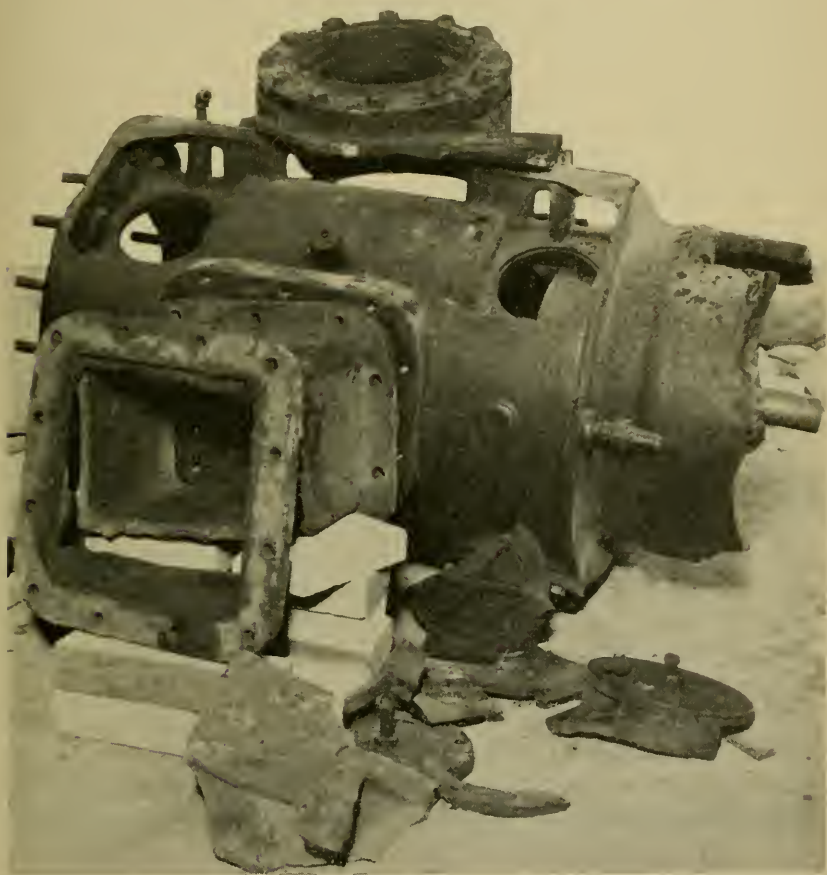
High pressure cylinder of an air compressor demolished by explosion of a mixture of oil vapor and air.

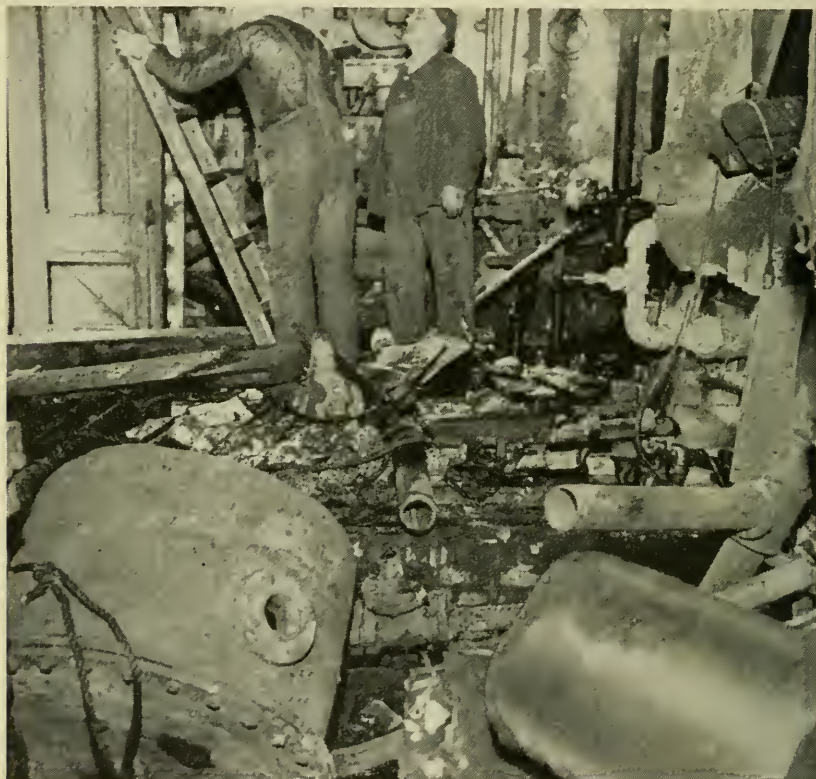
Result of cast iron blow-off tank explosion.

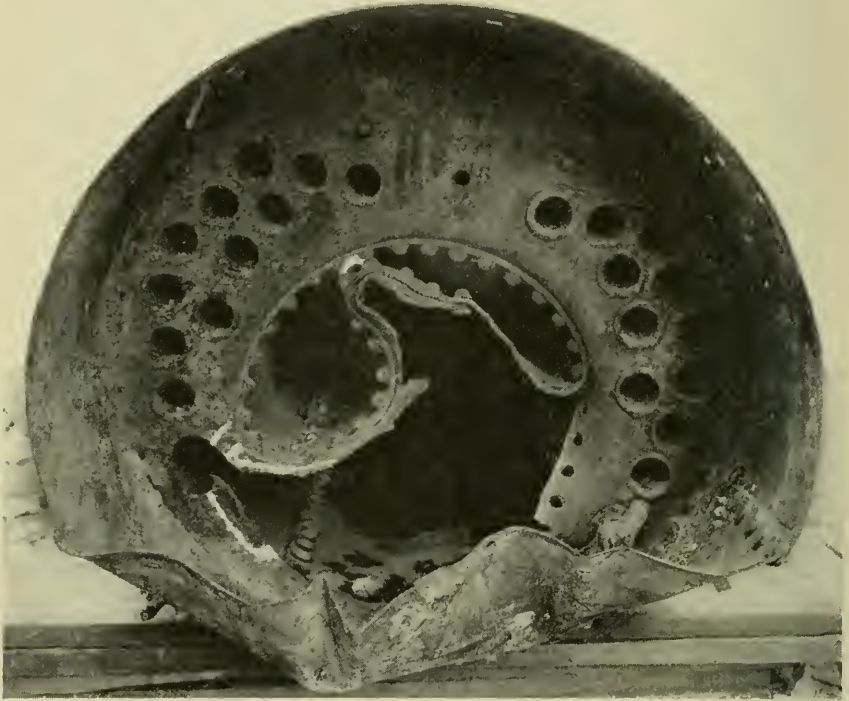
Caused by corrosion and over-pressure.

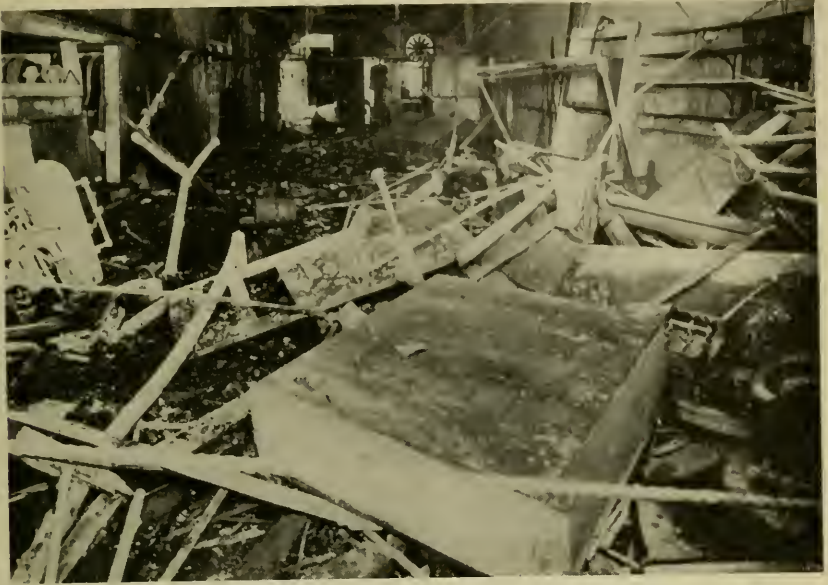
What a boiler did to its owner's dry cleaning establishment.

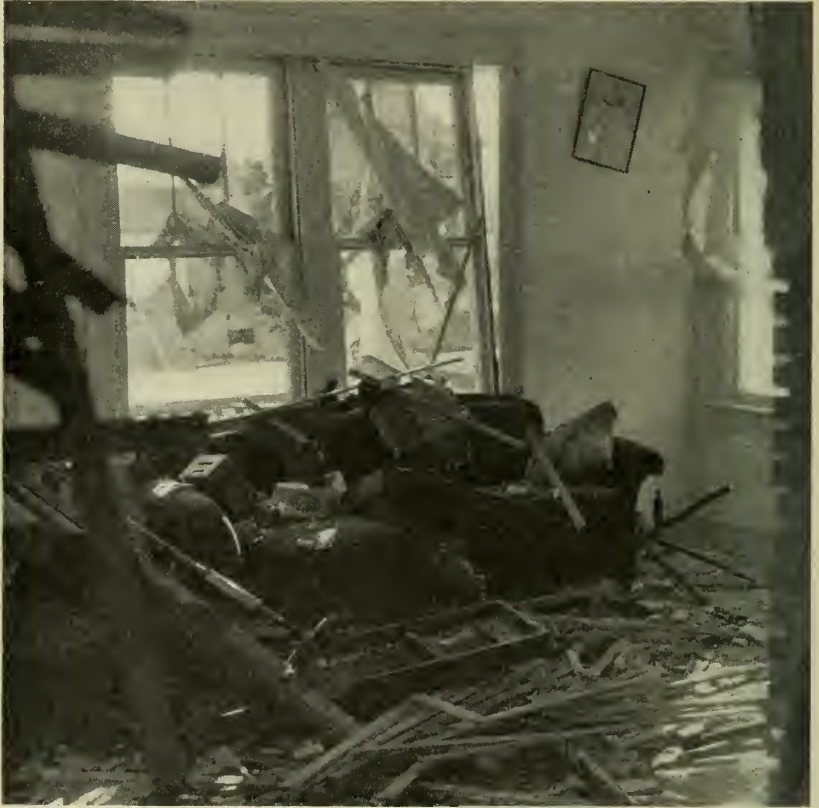
Home wrecked by bursting of hot water tank.

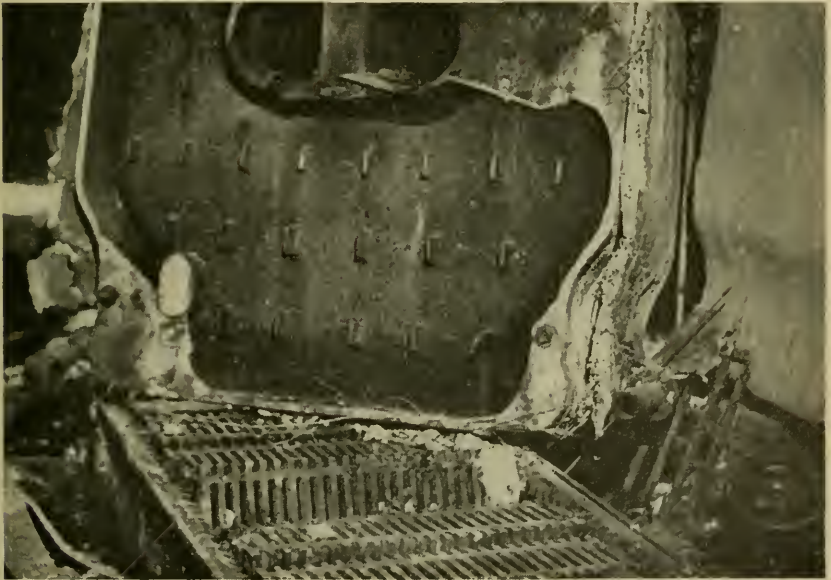
Church's cast iron boiler weakened by broken stays.

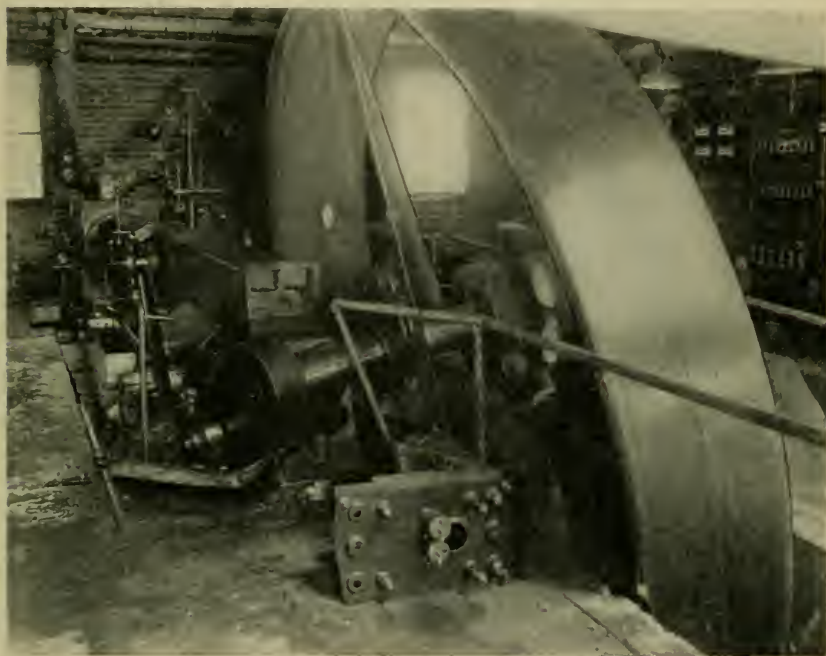
A 350 hp single-cylinder steam engine with a 15' flywheel was totally wrecked on September 7, 1934, at a Virginia trunk manufacturing plant. The operator had stepped into the adjoining boiler room, when the crash occurred. By the time he had reached the engine it had come to a sudden standstill—in the condition shown in the photograph.

The engineer heard a crash; he returned to this wreck.

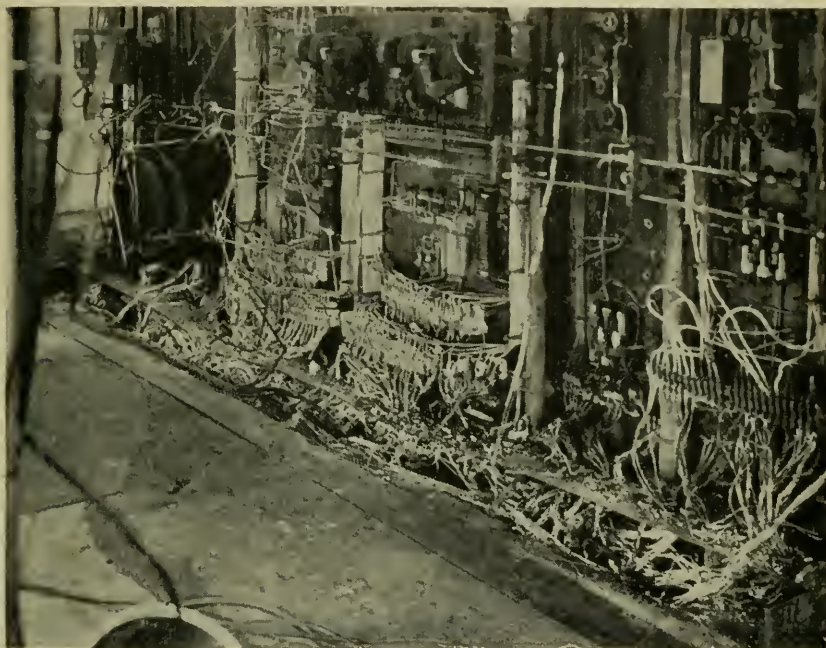
Switchboard wrecked by a short circuit and fire.

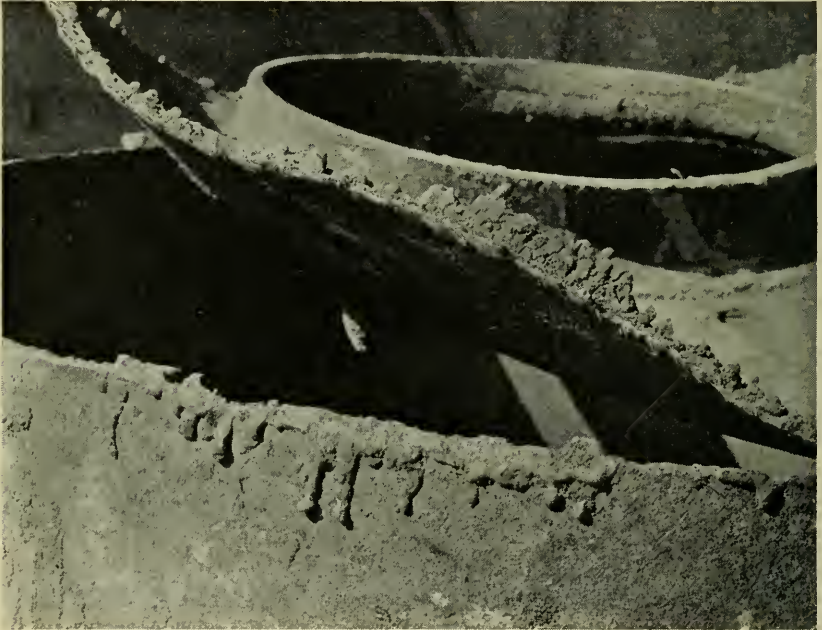
THE failure of the welded seam on a rendering tank head on May 2, 1934, near Wayne, Nebraska, led to an explosion, which killed an employe, burned the proprietor of the plant, and caused considerable property damage when the head went through the roof. An

Close-up view of welded seam failure.

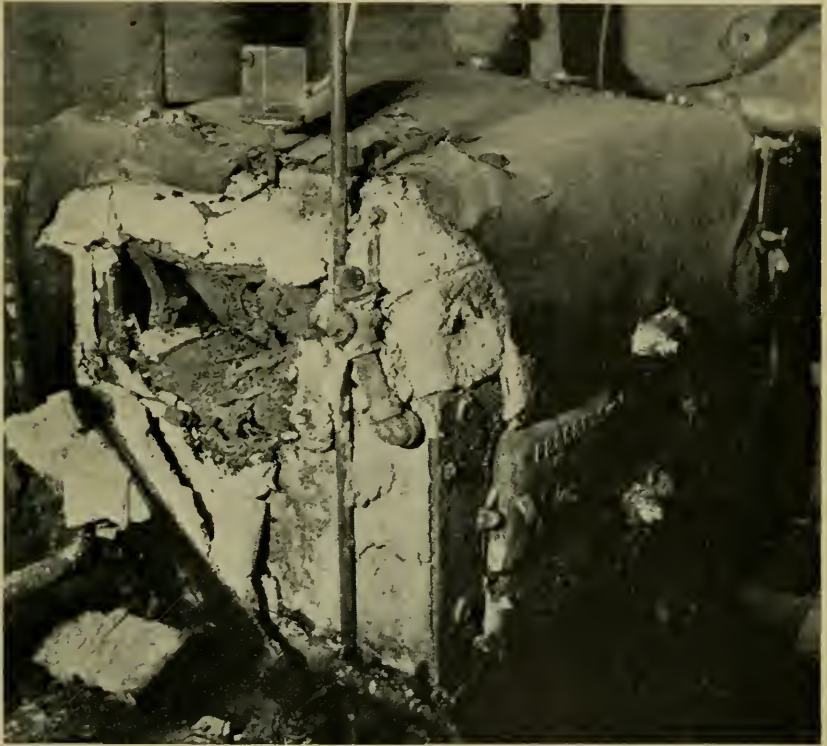
After the boiler drained the oil burner kept on operating. The sections were fused into a shapeless mass.

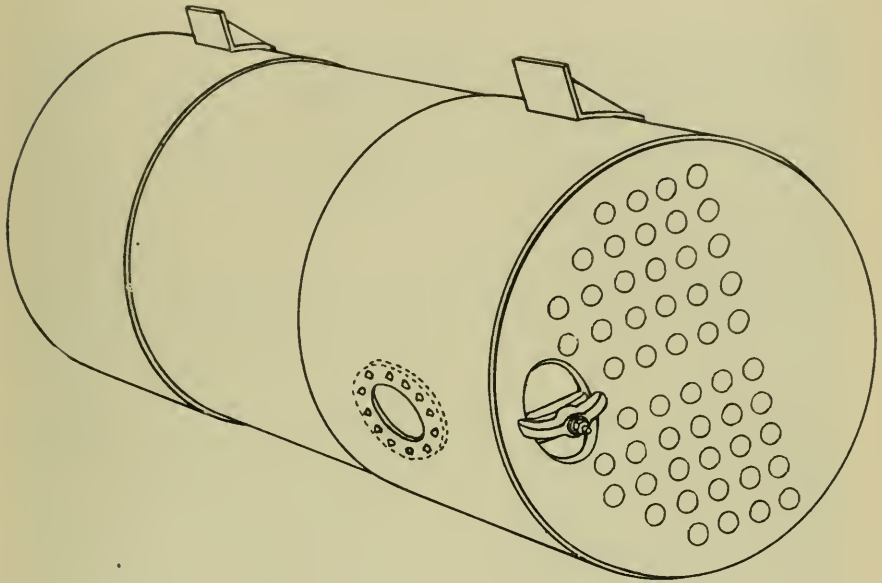
Figure 3—Repair of a bulge caused by overheating because of scale.

If the depth of such a bulge is not more than 25% of its diameter, it may be possible to restore the plate to practically its original shape by proper heating and hammering. Even if there is no rupture at the apex of the bulge it is well to drill a hole of about 1" diameter at that point in order to determine the thickness of the plate and to facilitate the upsetting of the bulged metal. A welding torch, secured to a long

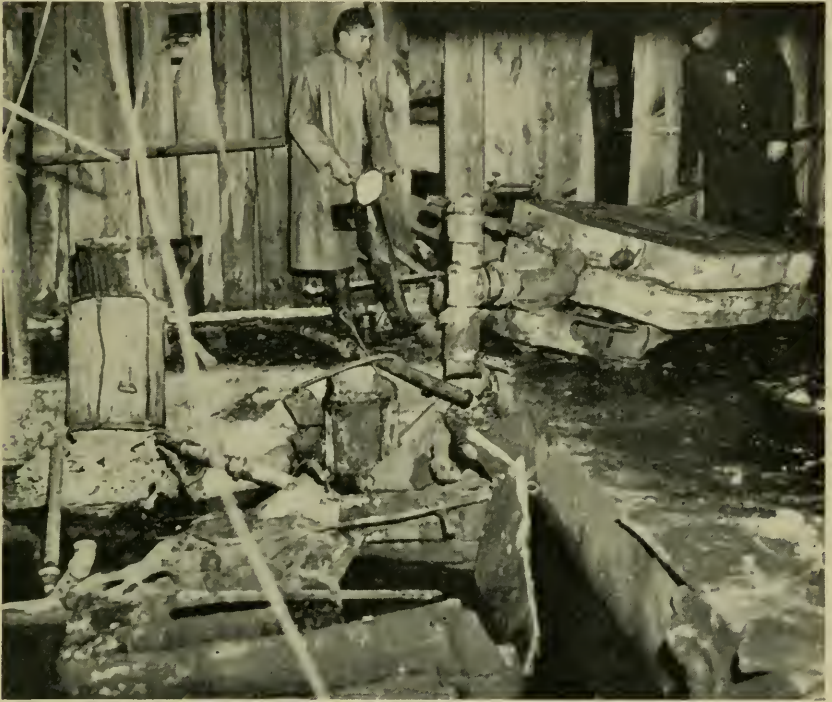
Wreckage following a heating boiler explosion at Clifton, N. J.

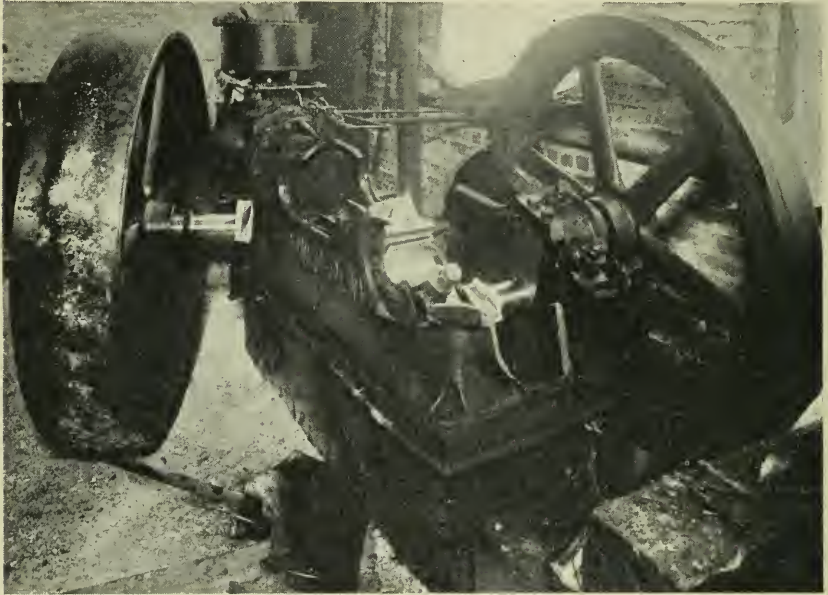
AN old and originally small flaw in the metal gradually extended in the crank of an air compressor at a North Carolina mill until the crank could no longer sustain the load and broke suddenly with the result shown in the accompanying photograph. The break caused a

An air compressor wrecked when the crank broke as shown.

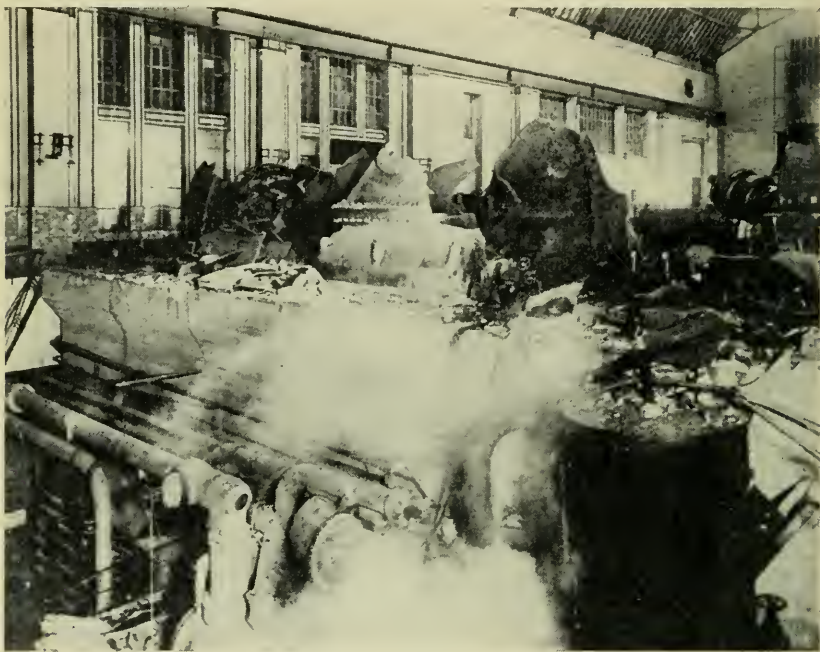
photograph of a turbine that exploded some months ago in a power station at Stettin, Germany. This 23,000 kw unit was undergoing a 10 per cent overspeed trial when it let go, severely injuring two attendants and causing damage estimated at \$200,000.

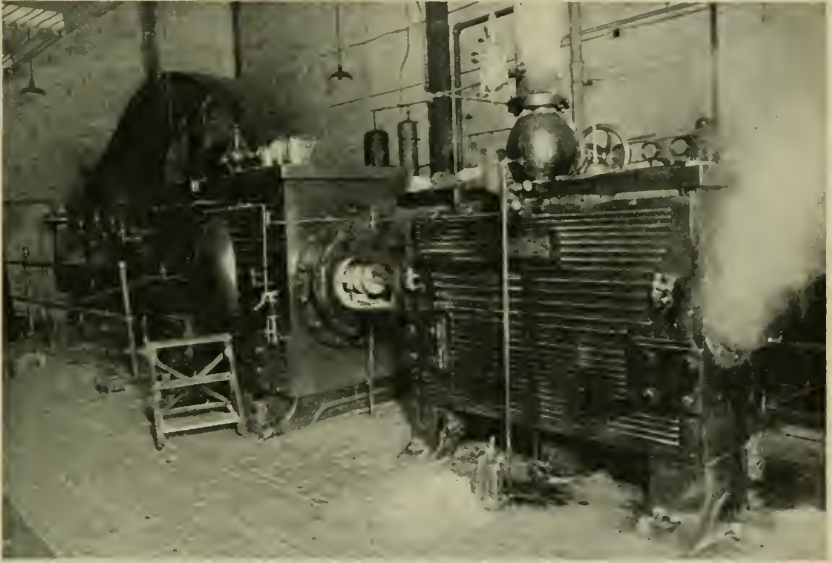
What unharnessed reciprocating parts can do to a steam engine

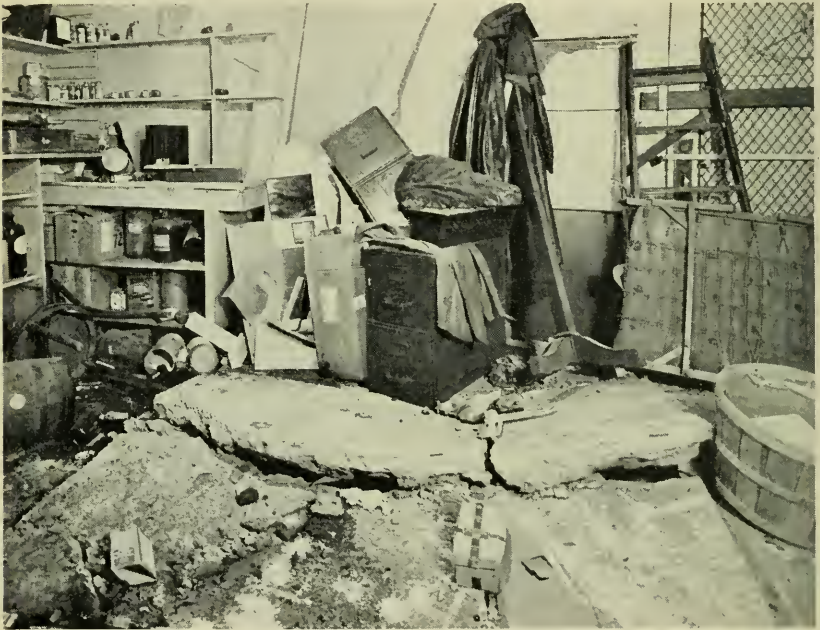
Part of drug store floor damaged by hot water heater blast.

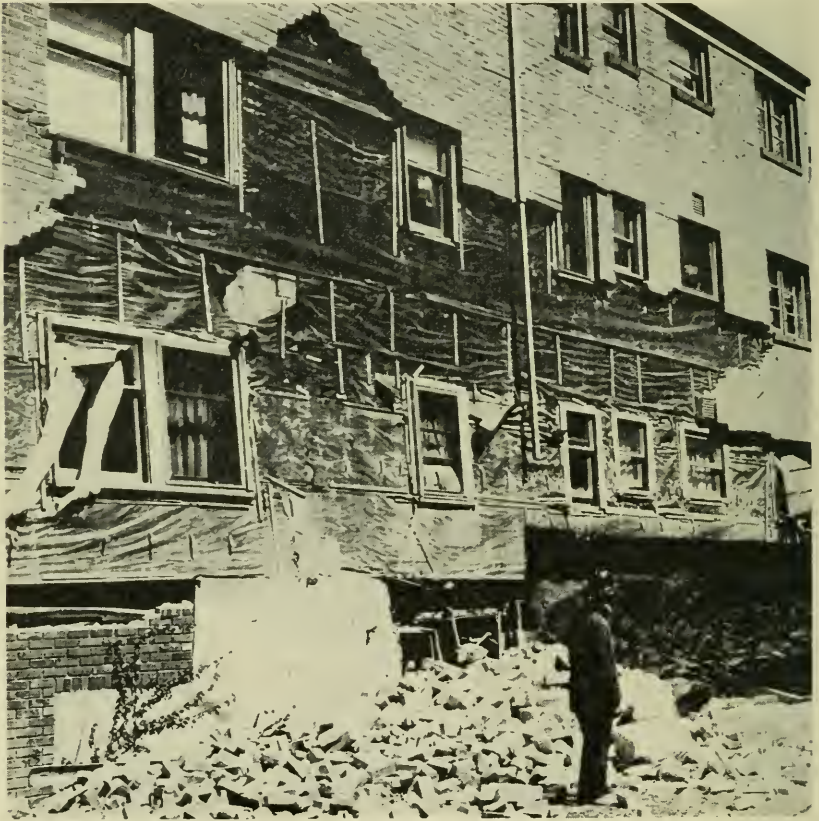
Part of \$30,000 damage after heating boiler exploded in Seattle apartment.

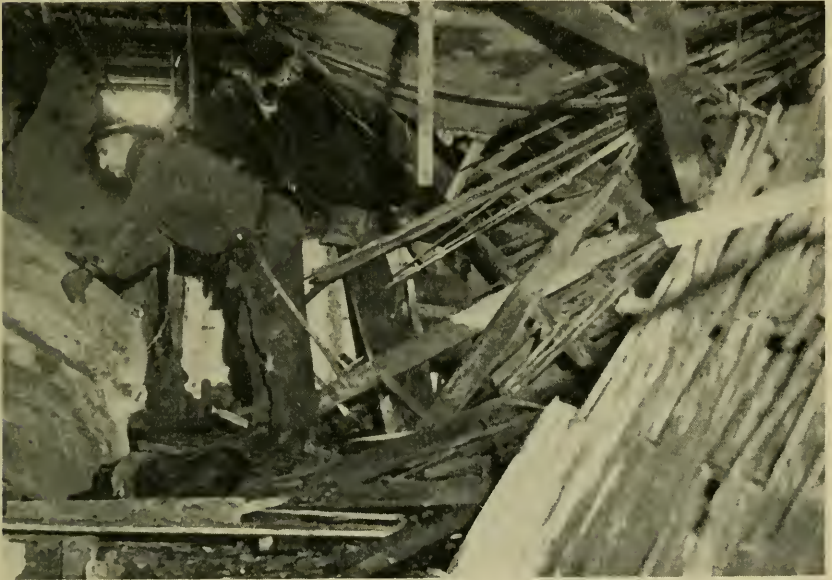
Debris inside apartment following the accident.

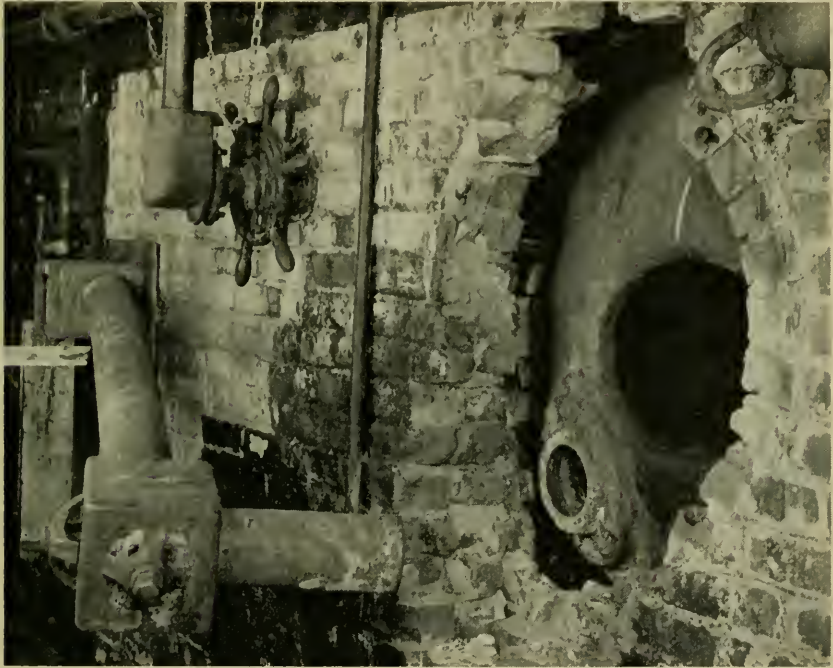
Circulating tube which pulled out of drum. Prompt drawing of the fire prevented serious overheating of the draining boiler.

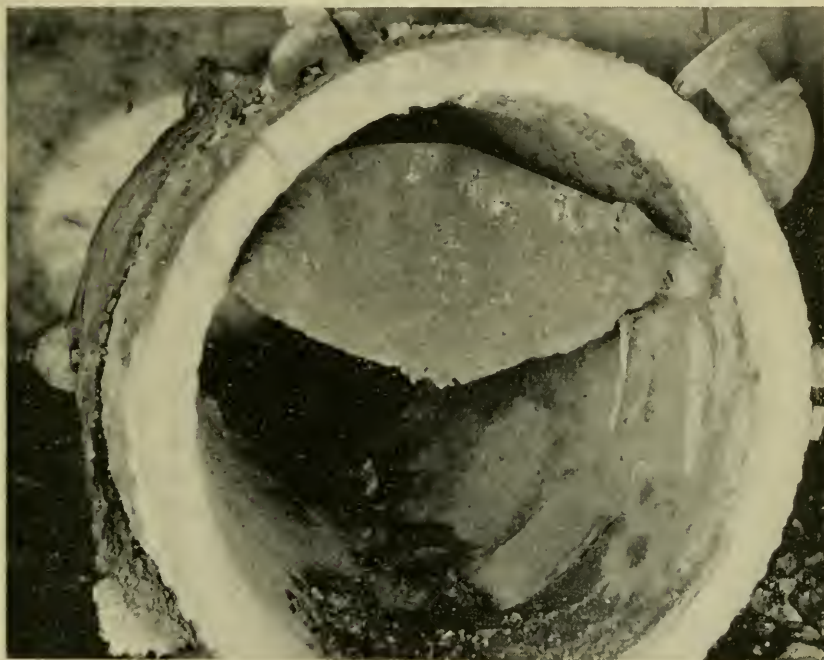
An accident clearly attributable to corrosion.

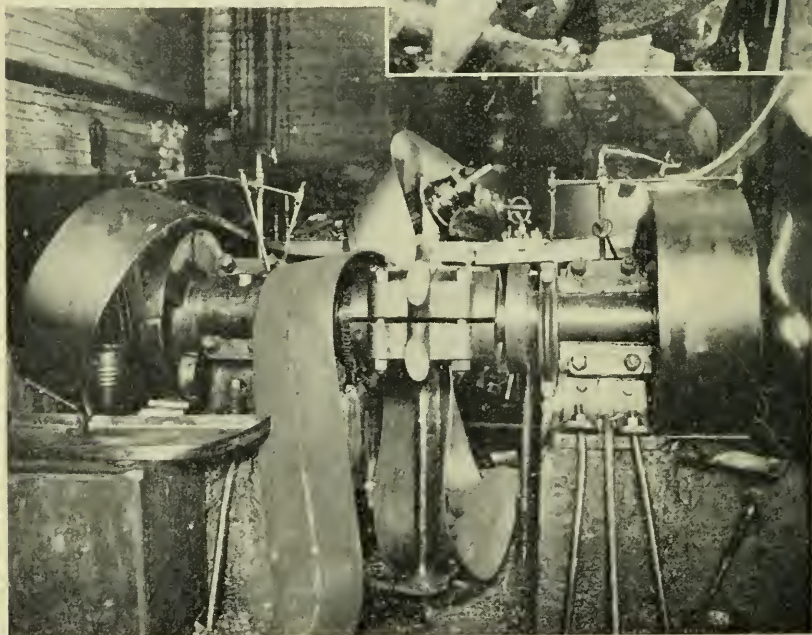
Spoke stumps and a tangle of belts and machinery after the engine stopped suddenly. Above—The cracked crank disc.

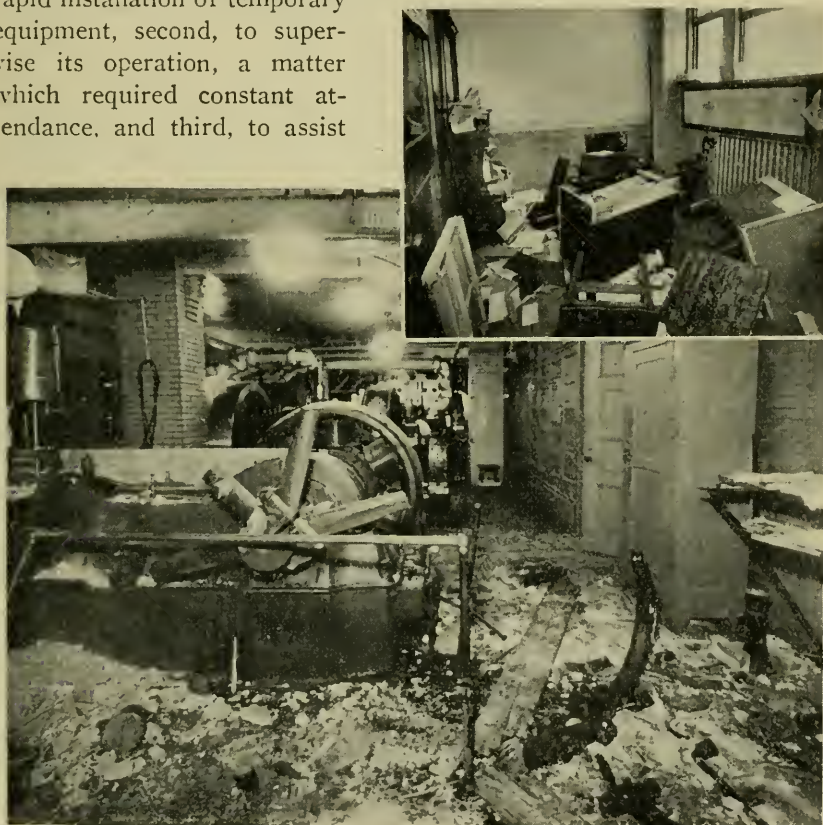
Only the spokes remain. Part of the wheel jarred the room shown above by heaving the concrete floor.

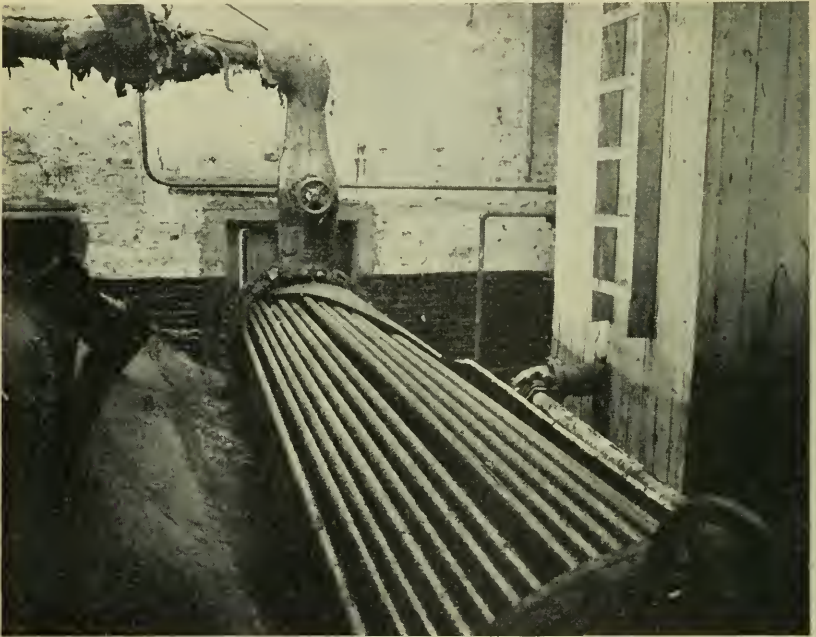
Figure 1—Caused by an unsound weld.

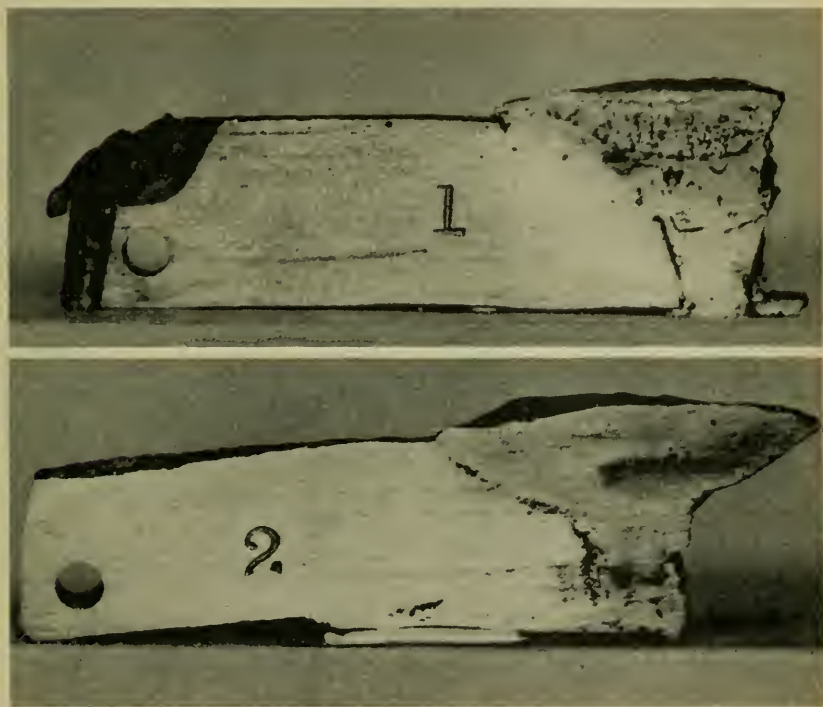
Figure 2—Etched specimens of the seams from the vessel shown in Figure 1.

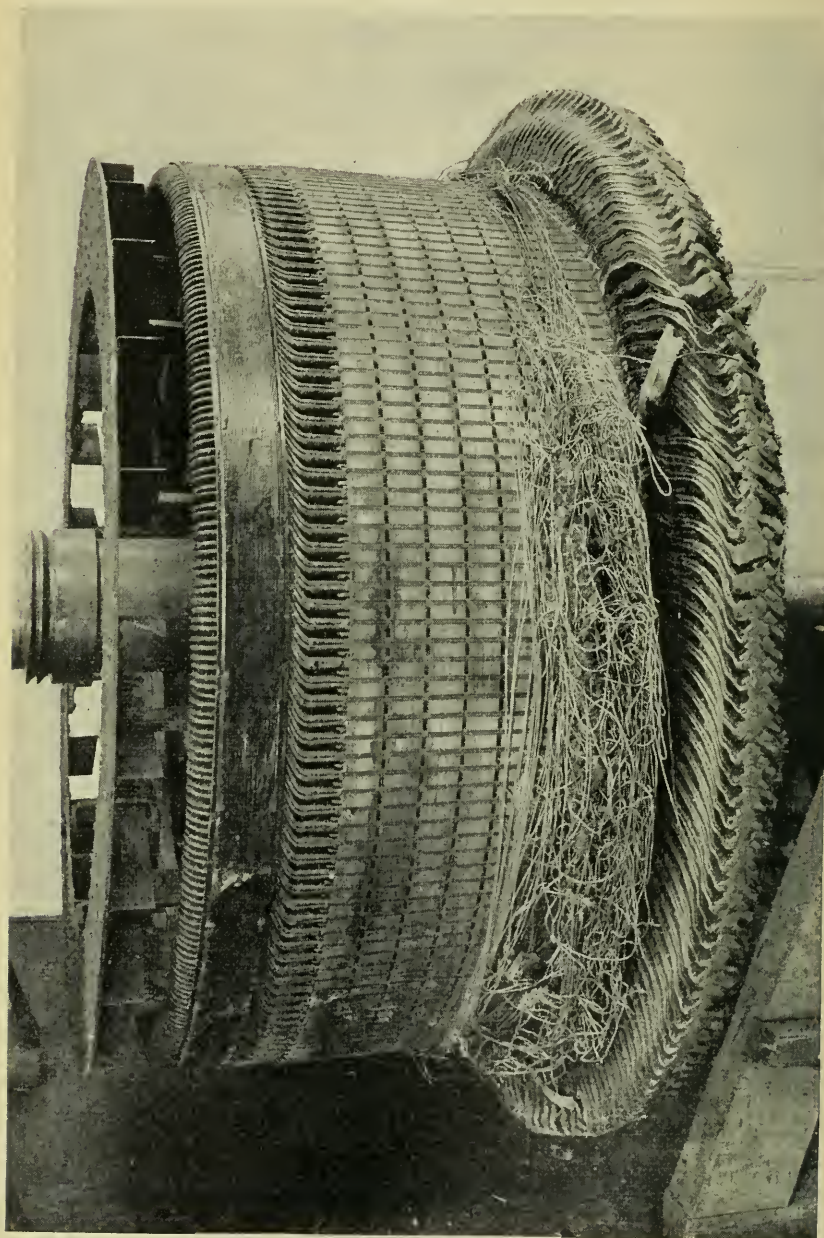
900 Hp Hoist Motor Damaged Because of Overspeed.

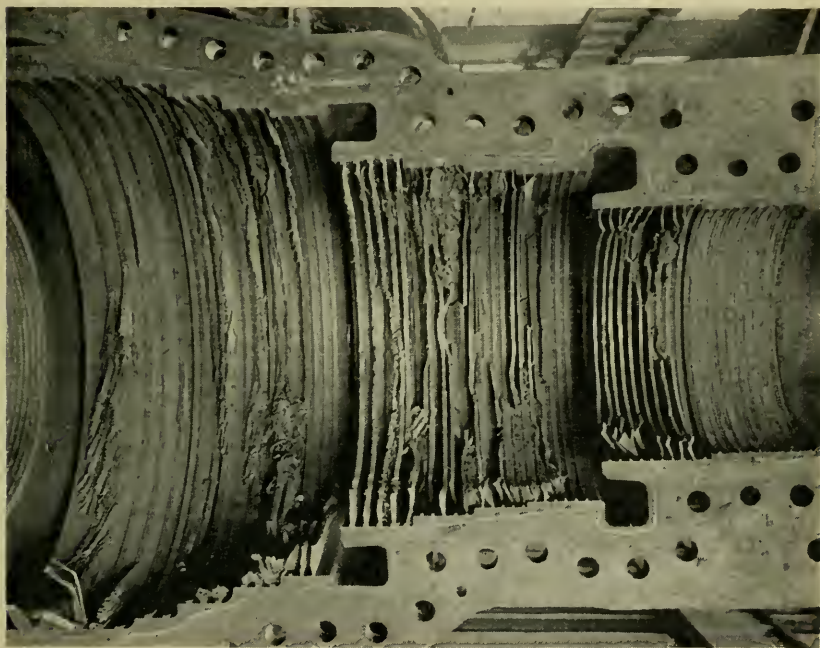
Mashed rows of reaction blading after temperature strains had contracted the casing and rotor unevenly.

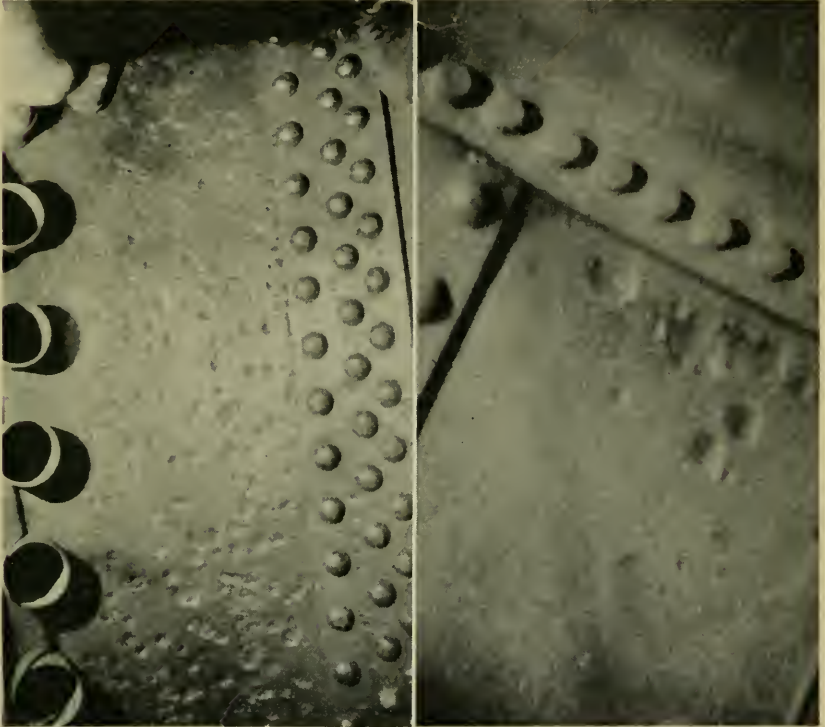
Characteristic pitting in boilers operated intermittently.

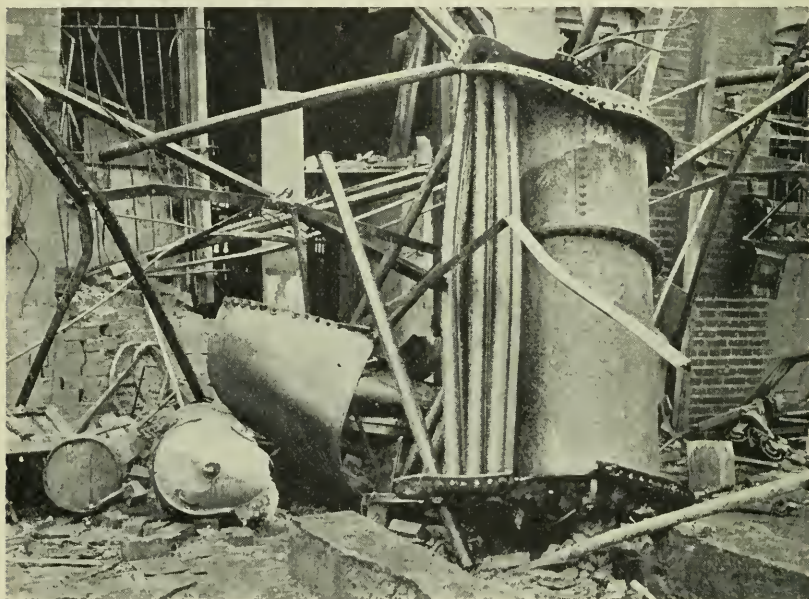
A check-up of the welding in a patch that failed might have prevented this \$25,000 boiler accident.

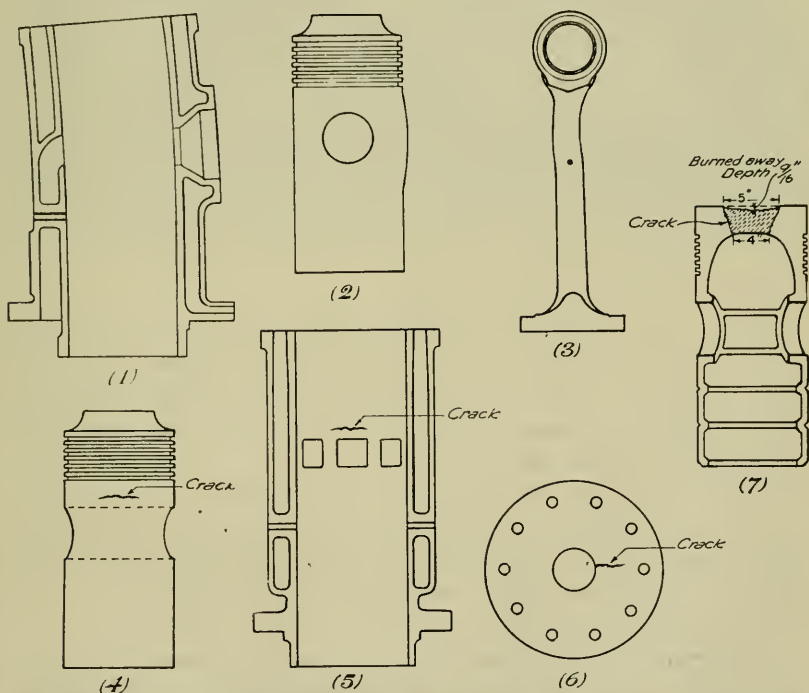
Six evidences of over-heating in a single Diesel cylinder—(1) Distortion of the cylinder because of "growth"; (2) "Growth" of piston; (3) Bend in connecting rod; (4) Crack in piston; (5) Crack in cylinder; (6) Crack in cylinder head; (7) Another evidence of over-heating in another piston. The head was burned to a depth of 9/16" and a crack had extended through the top of the piston.

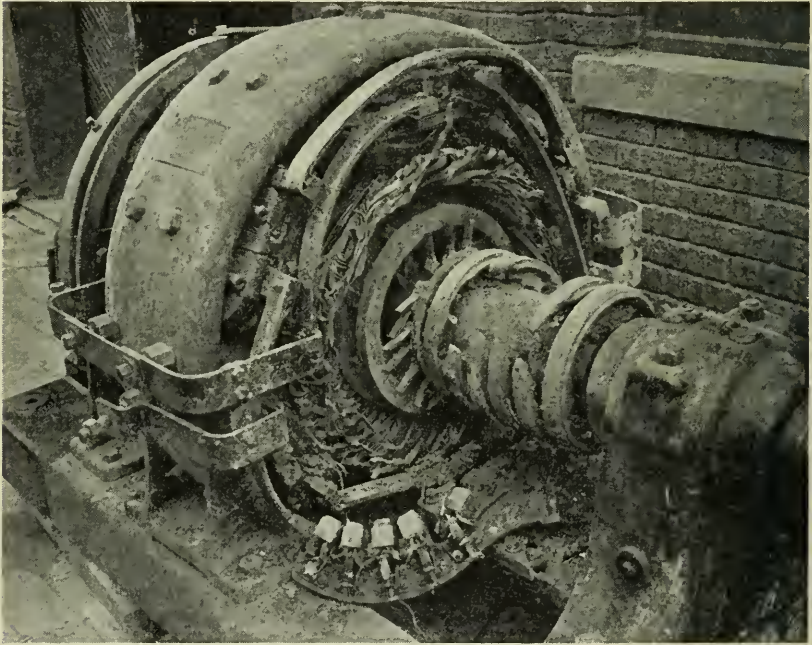
Rotary converter damaged by short circuit and fire.

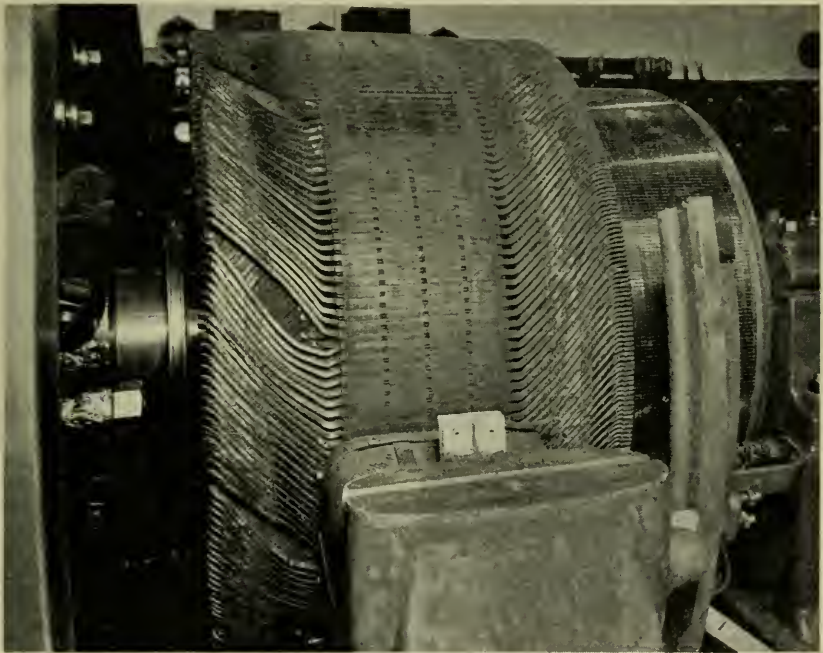
Distortion of coils on a 500 kw direct current generator caused by a surge when the operator threw the wrong switch connecting the idle machine to the station bus.

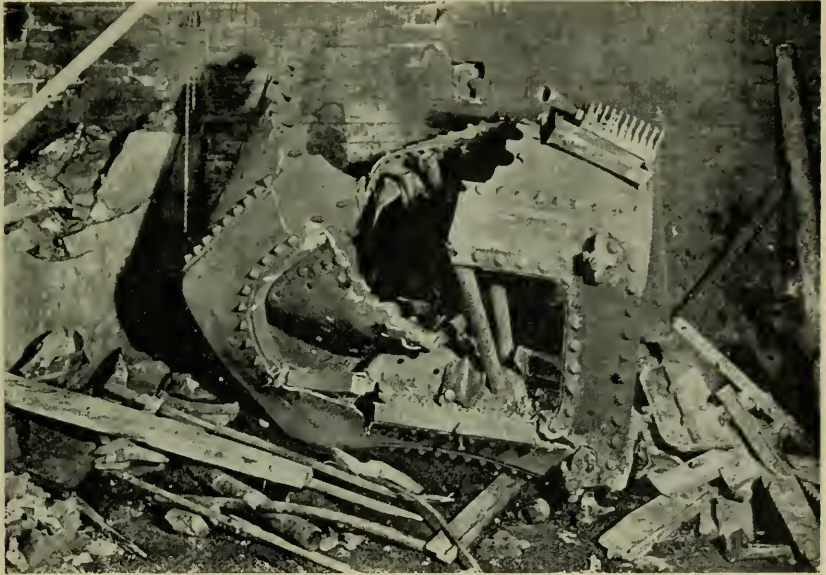
Wreckage of garbage burner—An accident which illustrates the need for a relief valve in operative condition and of care in the manipulation of valves in the pipe connections.
