The Locomotive

THE HARTFORD STEAM BOILER
INSPECTION AND INSURANCE CO.

VOL. XL

1934-1935

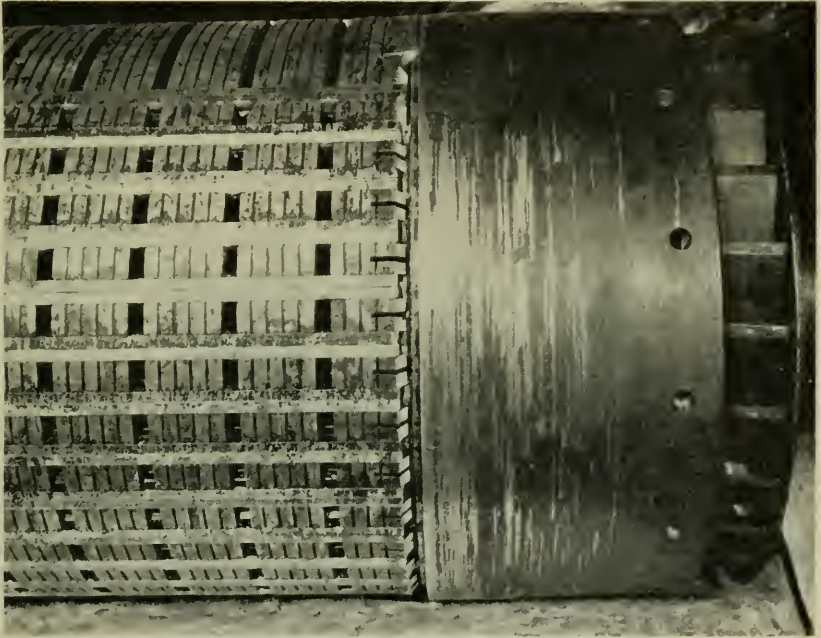
Damaged rotating field after over-speed. The core is a solid steel forging so machined that the forged steel end rings are fitted into a rabbet-joint on the ends of the rotor forging. The centrifugal forces exerted against this rabbet were sufficient to break off sections of the steel rotor forging, which immediately jammed between the field and stator where they were rolled into small balls or were embedded in the stator laminations.

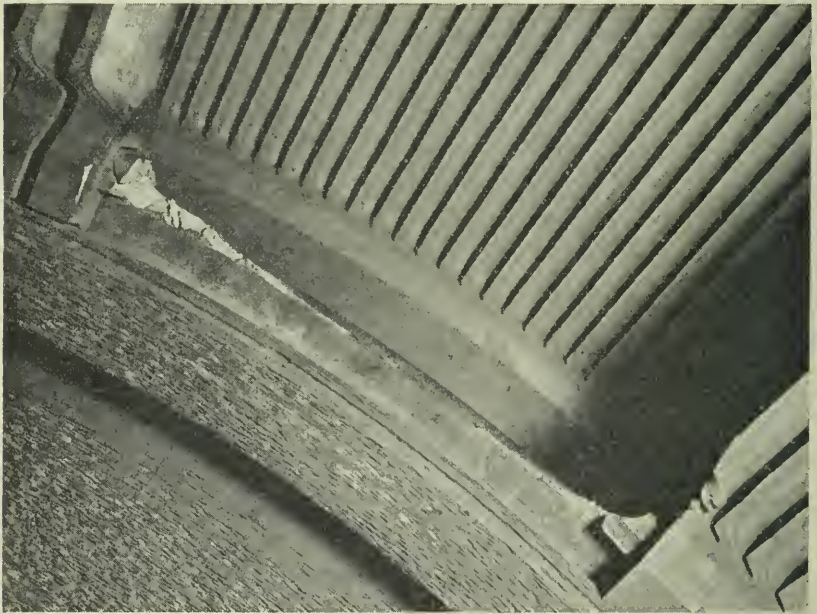
Figure 1—The broken disc. The dovetail arrangement of fastening the blades is clearly visible at the left.

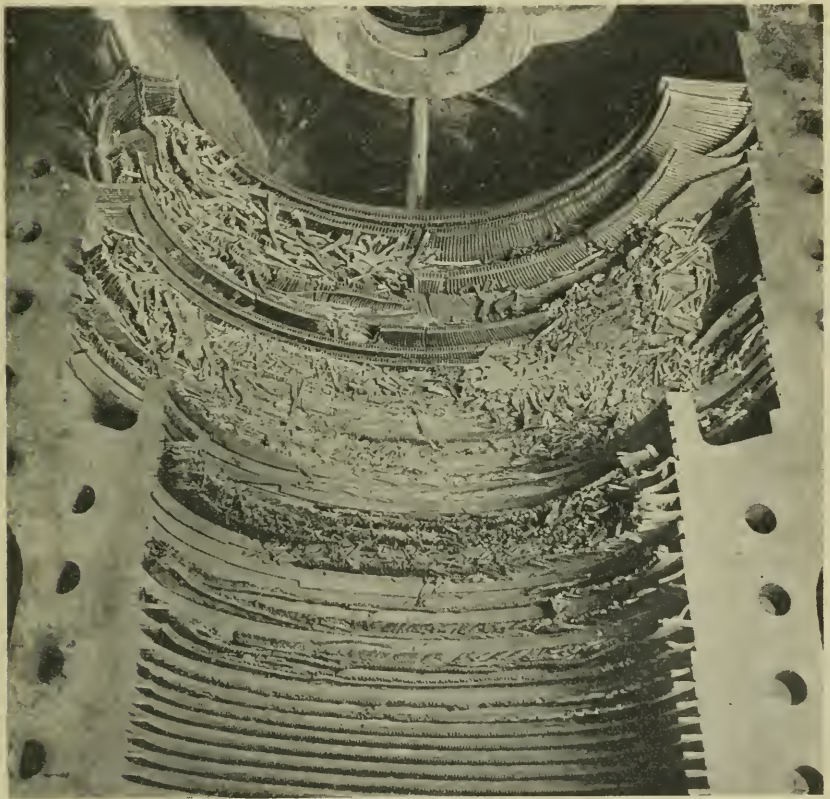
Figure 3—Casing of 1875 kva turbine after several blades broke out. The rotor was stripped of practically all of its blading.

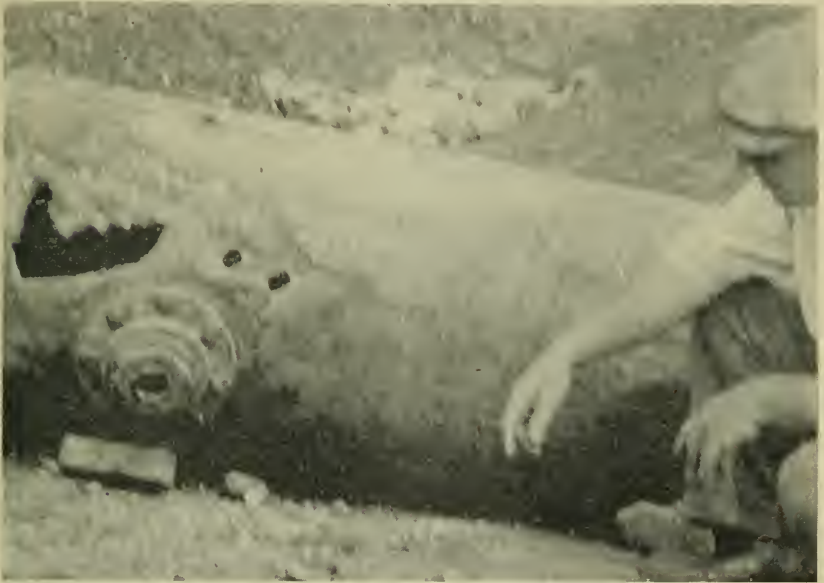
Extreme external corrosion in a buried blow-off tank. Conditions with respect to this form of wasting away are particularly serious whenever a vessel is installed underground.

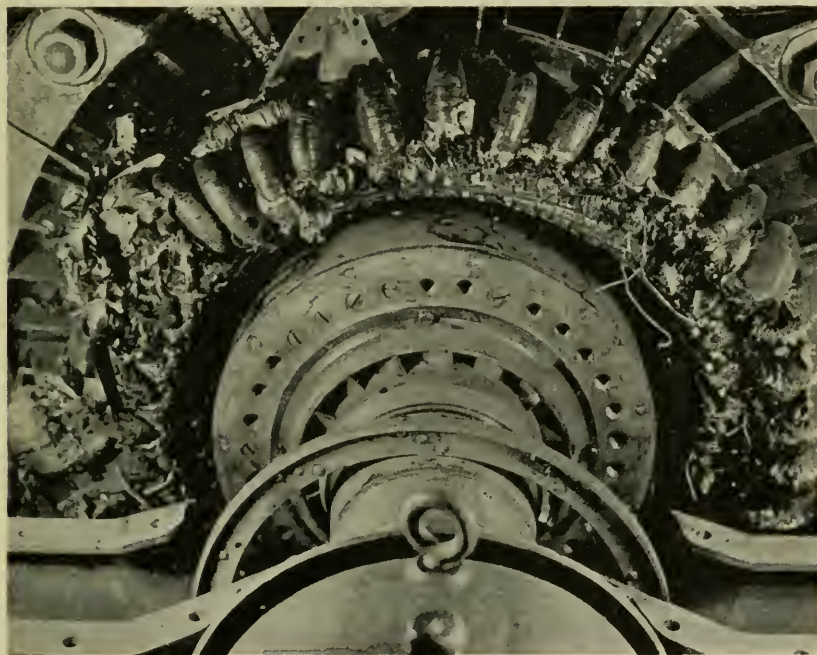
After the cooling fan cut into the windings. A piece of the broken fan may be seen at the top of the stator.

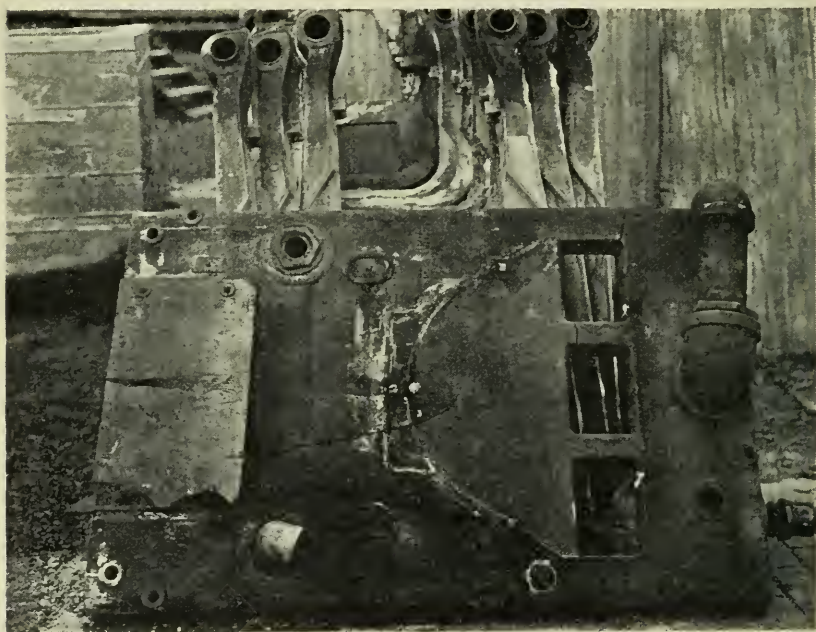
Figure 1. Cracks in a cast iron section—never a spectacular accident but the most frequent of all failures of heating boilers.

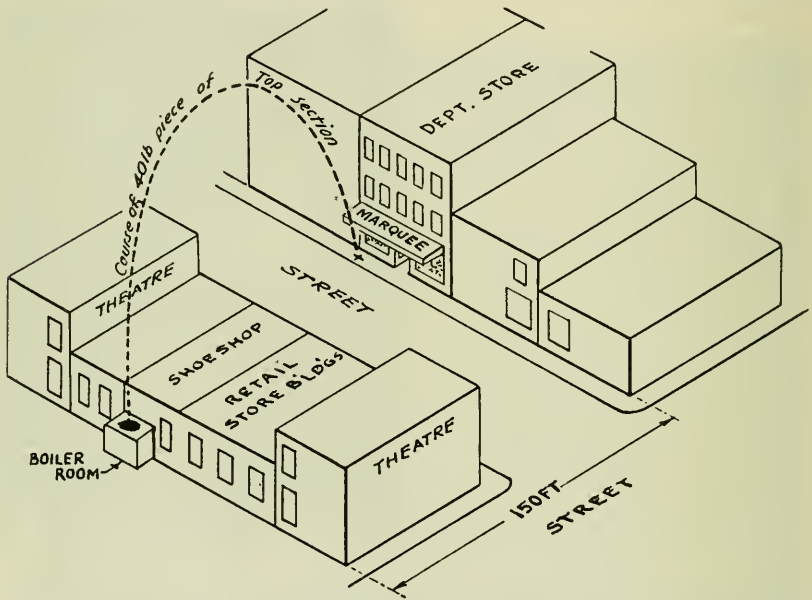
Figure 3. Course of travel of the top of a hot water heating boiler that exploded because of over-pressure.

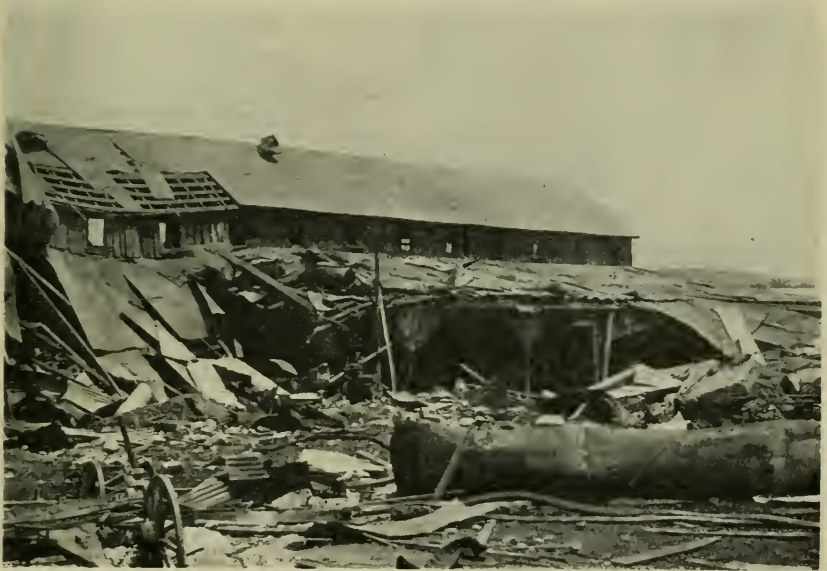
Figure 1. Result of a lap seam failure early in June.

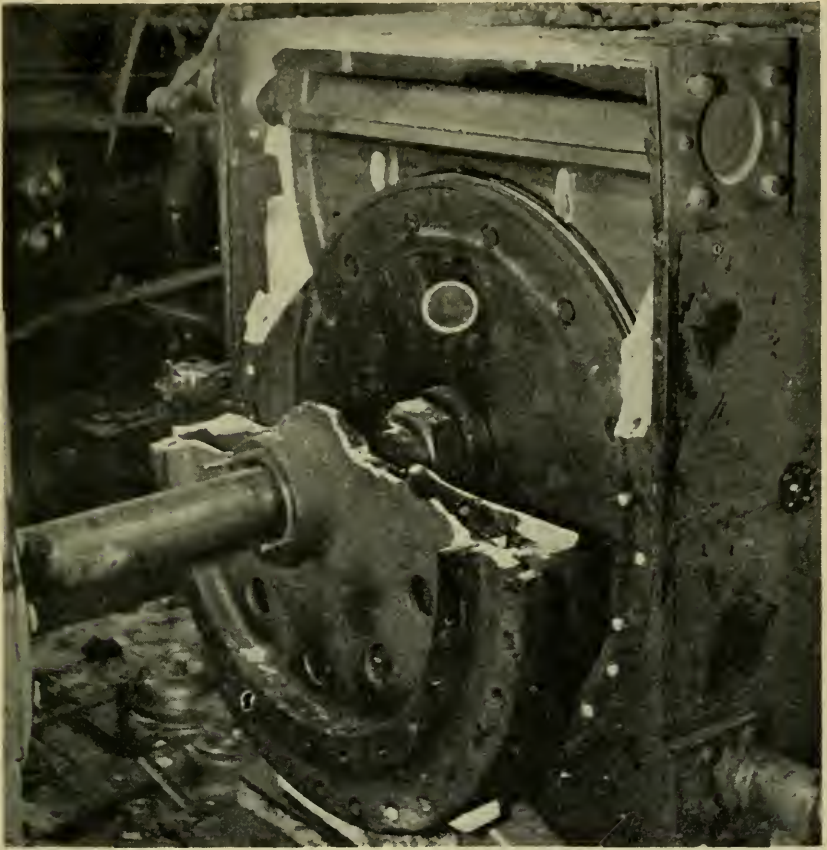
Figure 1—Cylinder wrecked because of connecting rod failure. The damage is typical of accidents from this cause.

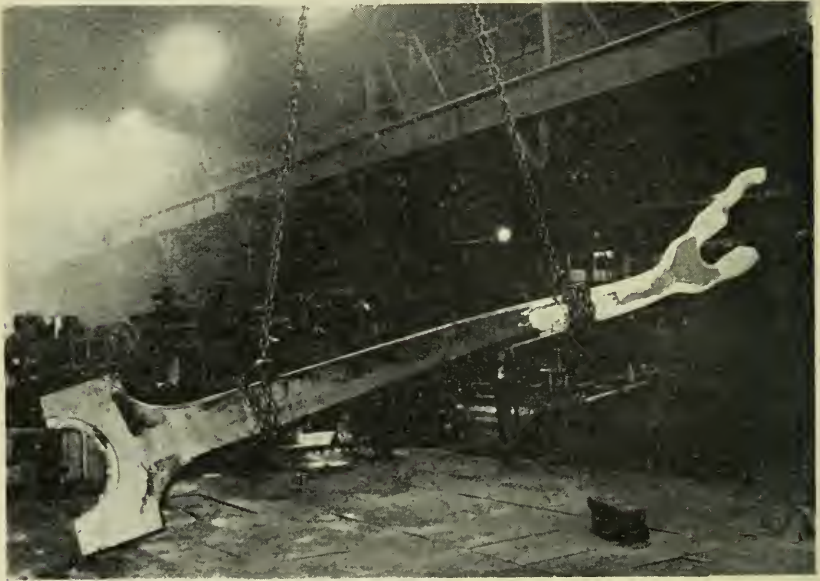
Figure 4—Typical break of the rod-end in a large Corliss engine.
