CHART SHOWING AIR-RAID DAMAGES
ON THE RY. BRIDGE OVER THE RIVER KOMARU

Report of the investigation of the damage
to KOMARU BRIDGE

Report of the Investigation of Damage to KōMARU
River BRIDGE

Komarugawa Bomb Damage Conditions

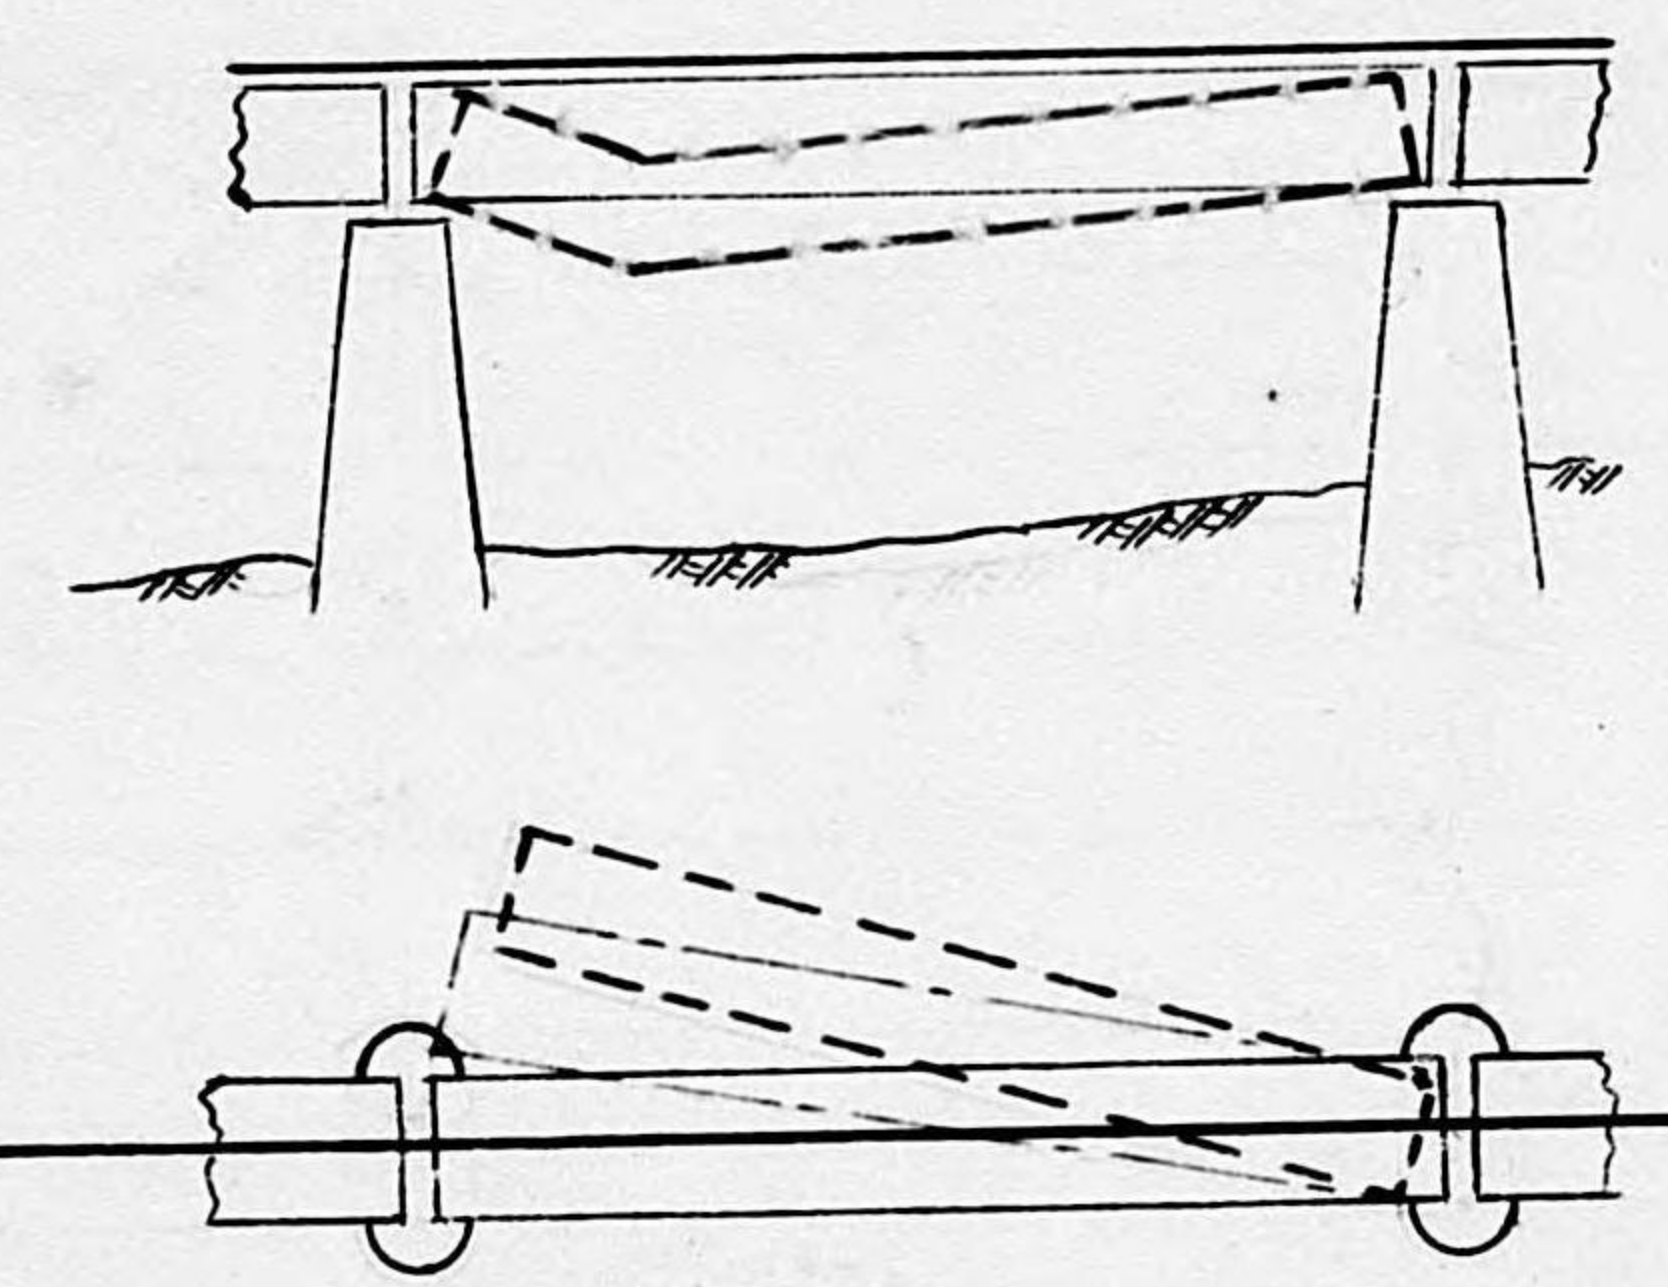
NO 3

No 3 桁、起桌側、桁位置の橋脚上 = 僅 = カリ 転落寸前、1 根 = シテ 桁、歪曲也。

Damage: #3 beam was displaced on the side of
the starting point and hung over the
bridge-legs a little and seemed to
have rolled forward a bit. The
beam was bent.

No 3 桁、正位置 = 復也シ。

Restoration: #3 beam was restored to its proper position

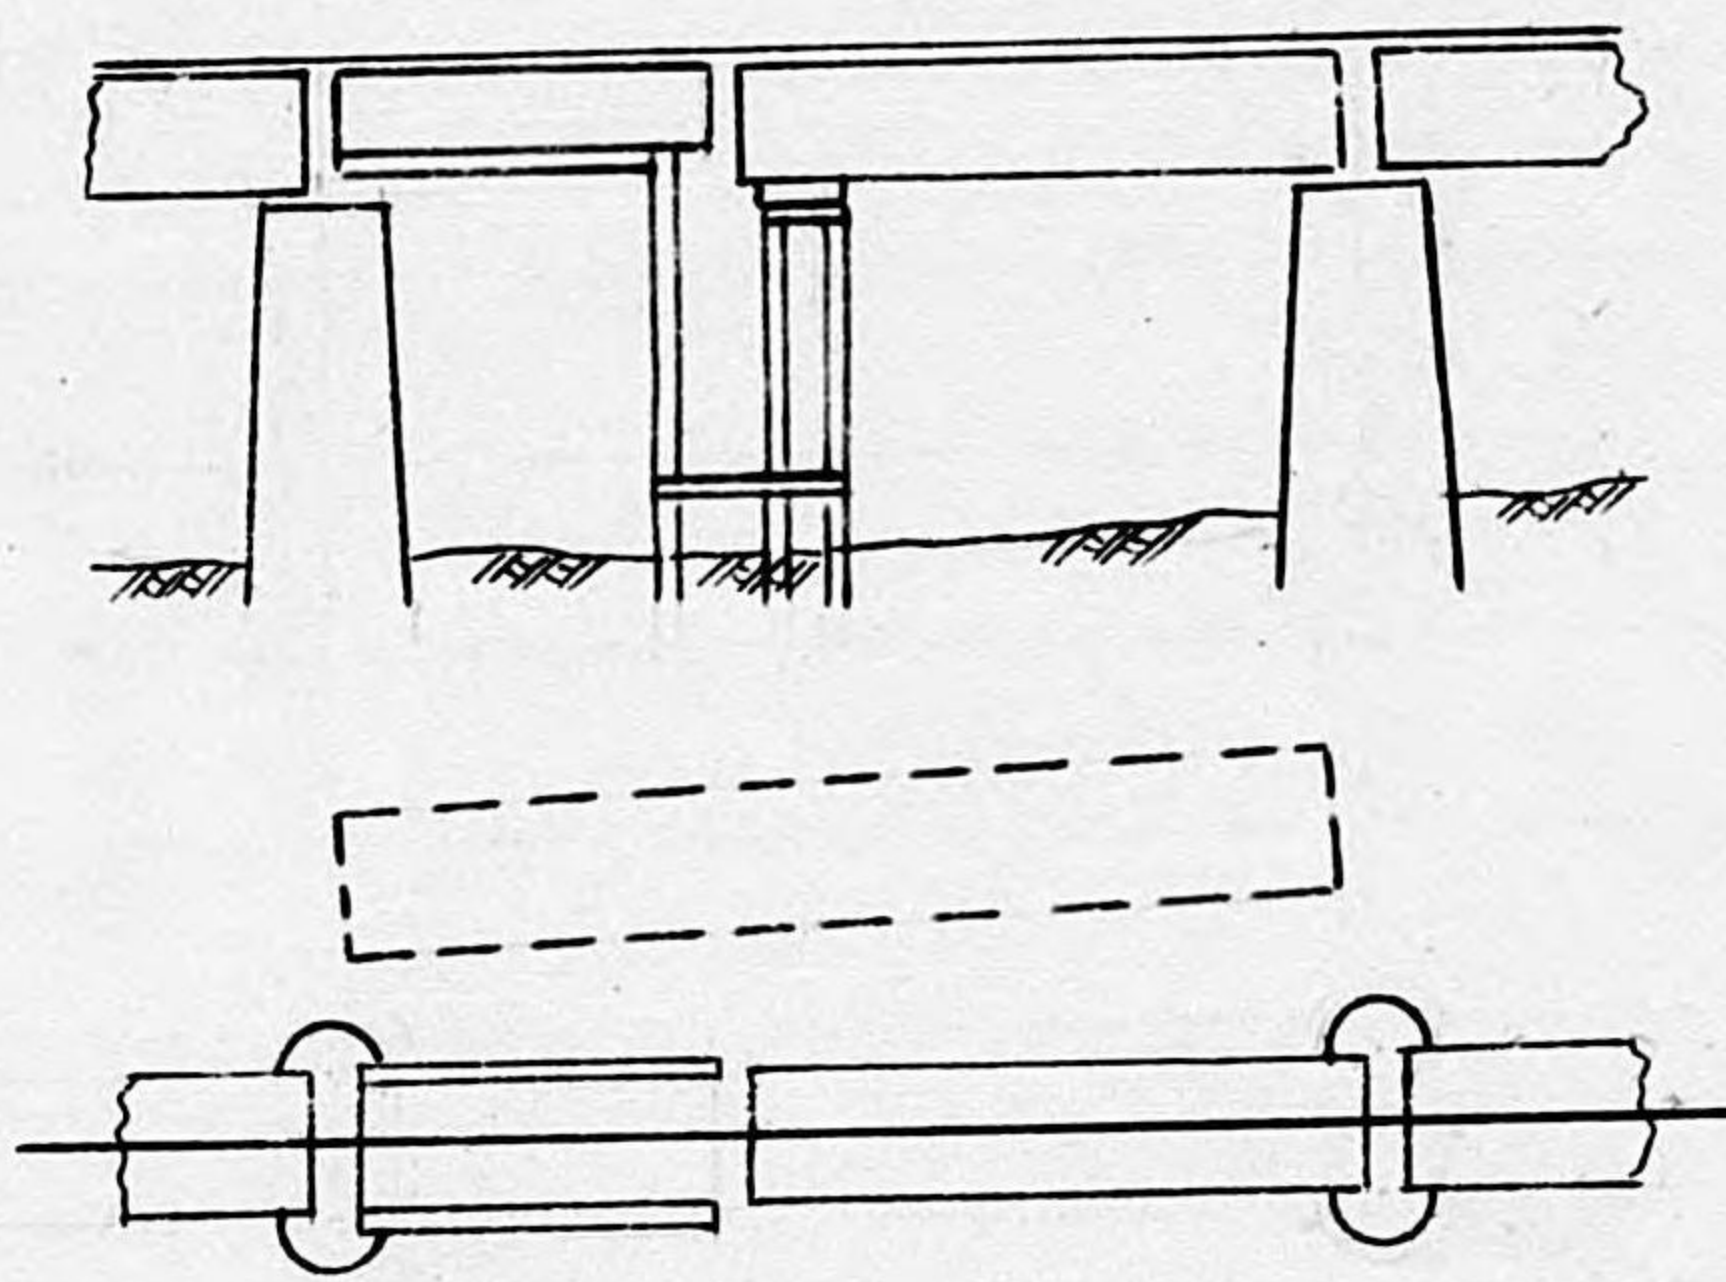
NO 6

No 6 桁、川下 = 完全転落 = 起桌側 30 約 13m 間、腹鉸、斜弦材 共 = 歪曲ス。

#6 beam fell down stream completely
and for about 13 m. from the ^{side of} starting
point the abdominal girder and the
slanting-string-material (TH. SHACHŌZAI)
were bent.

No 6 桁、歪曲甚ダシク部分ヲ切断 = 短径間トシテ 架設、残部 = 木桁ヲ架設也。

#6 beam was badly bent and part was severed and, being too short, was rebuilt. The remaining section was built with a wooden beam.

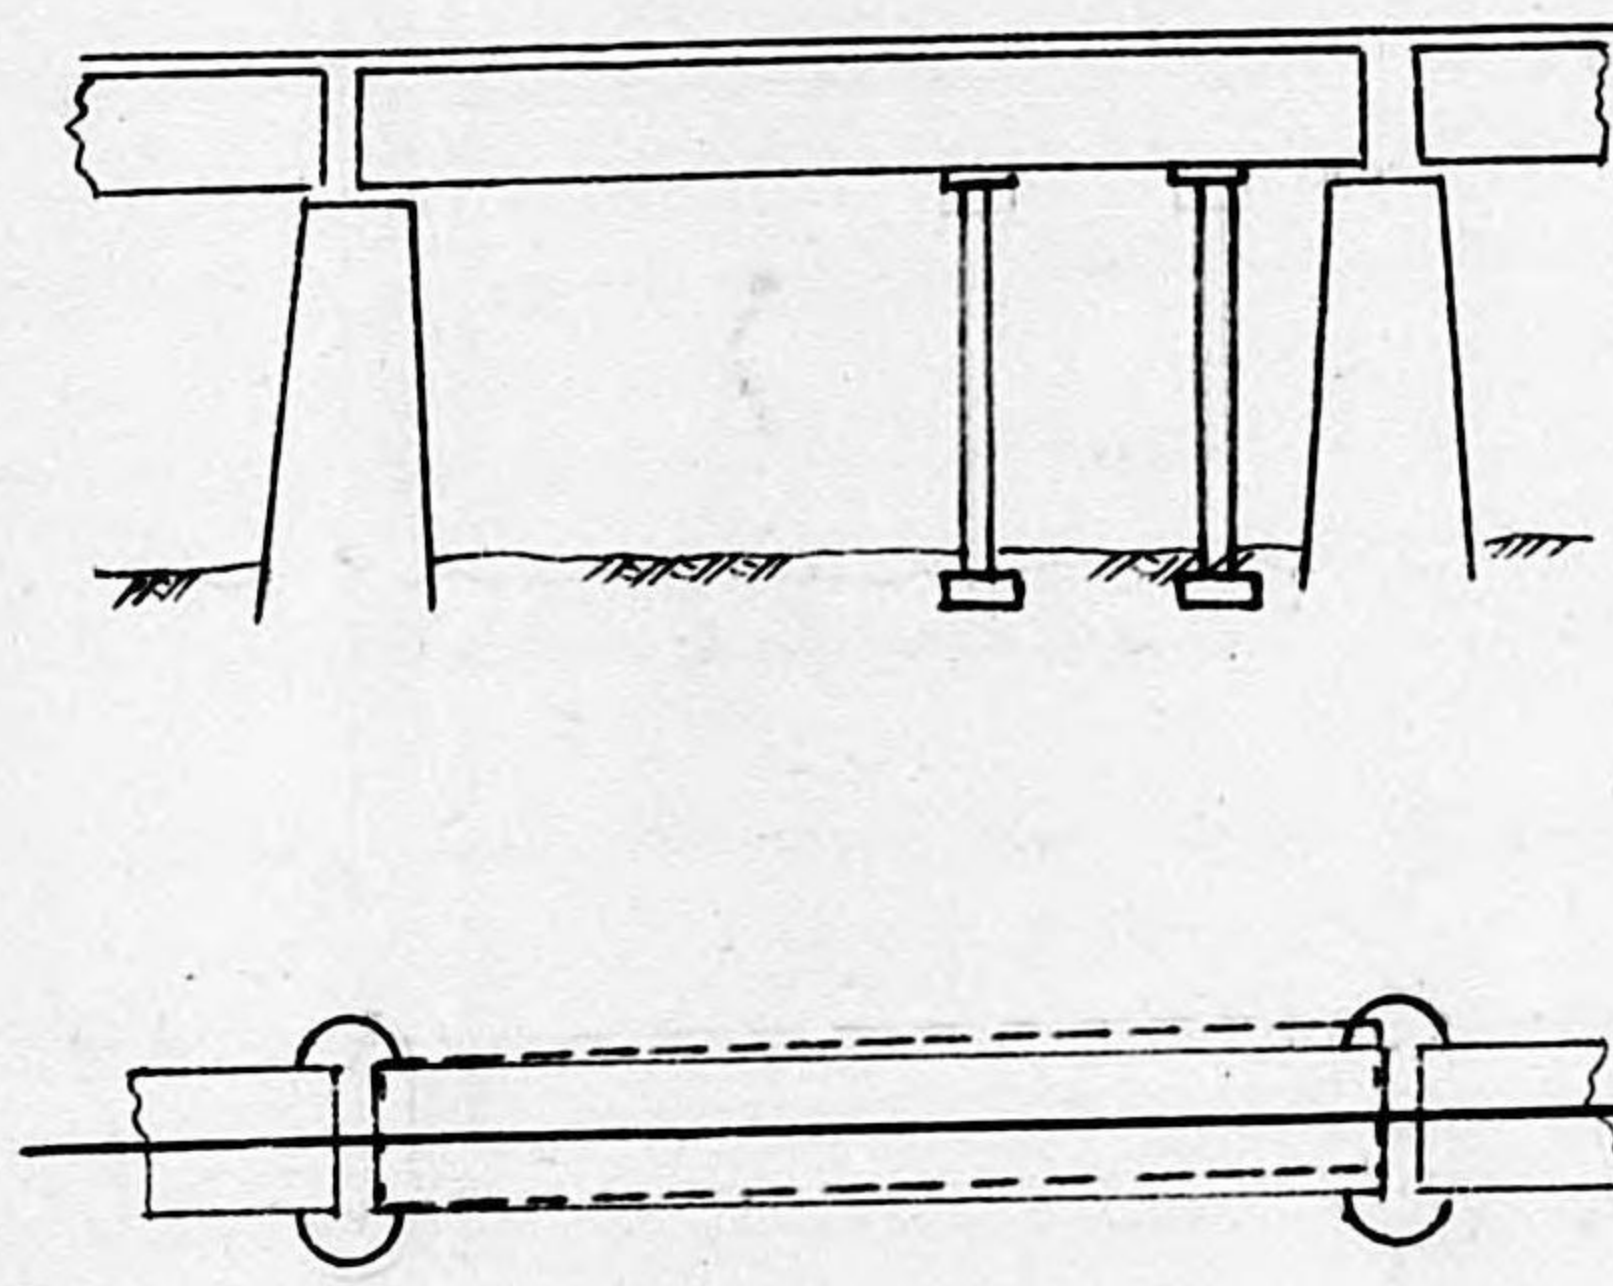
NO 7

State of Damage: Because of cannon hits there were
holes in the abdominal girders of
the #7 beam.

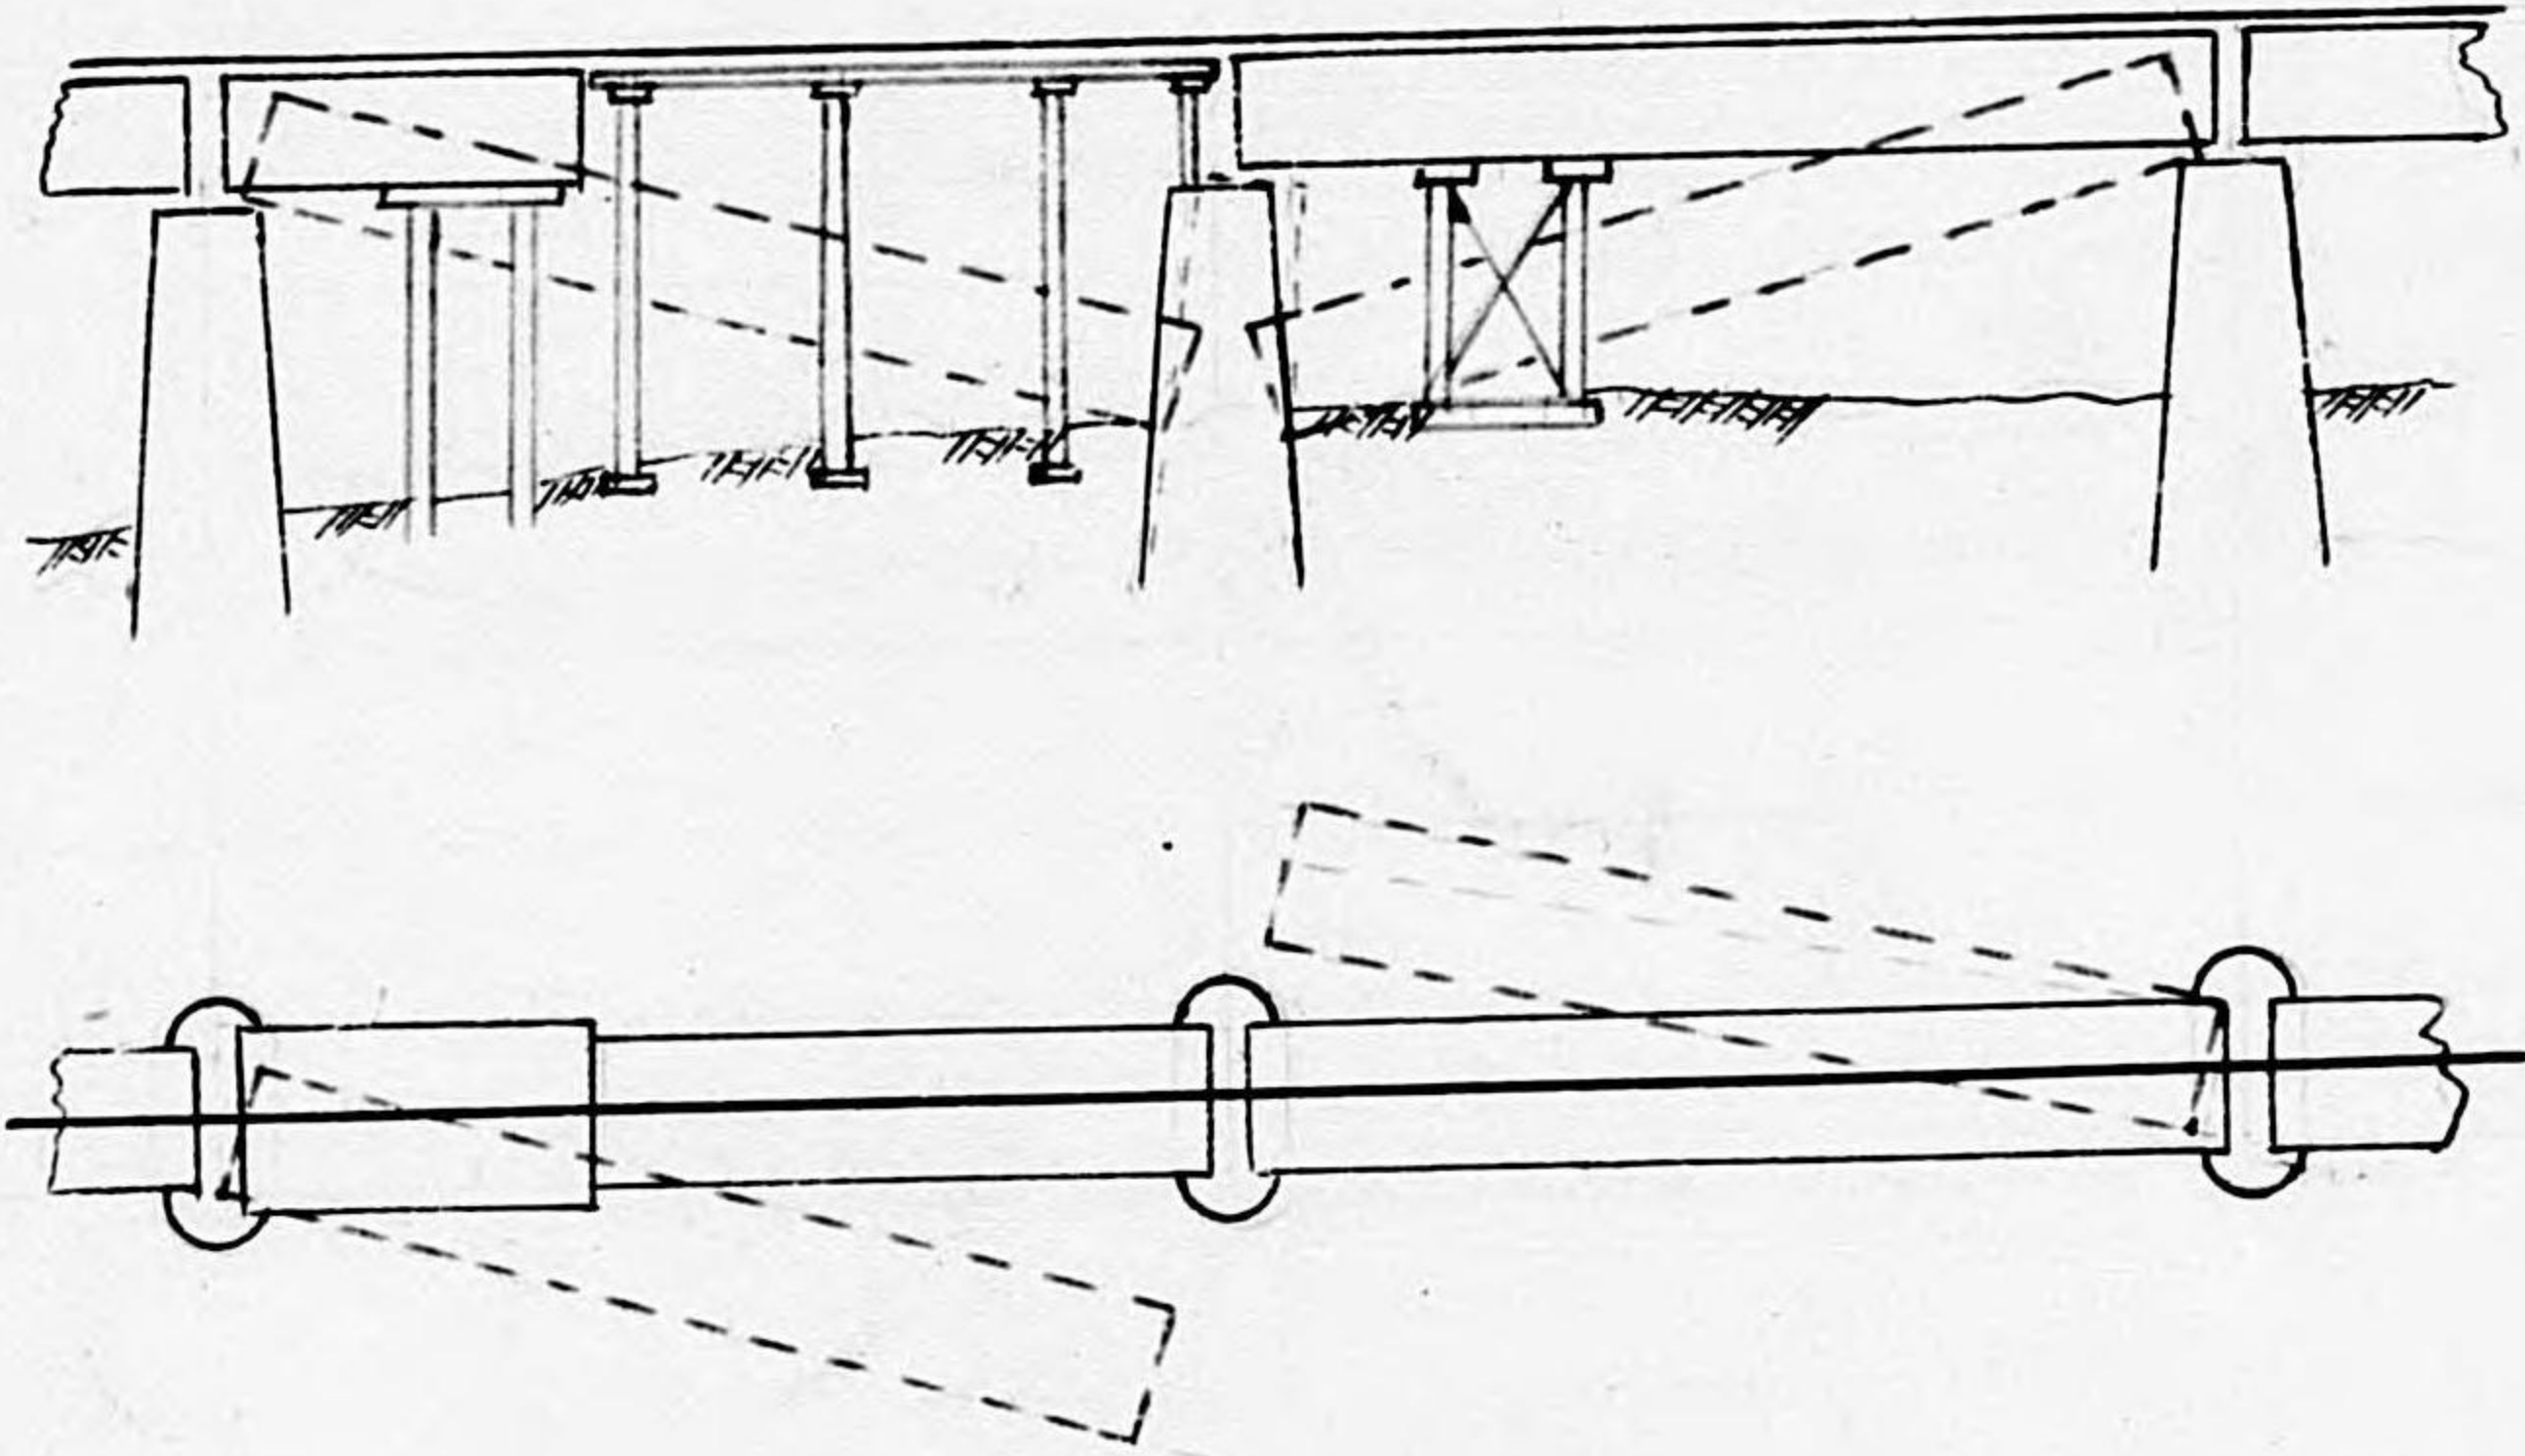
NO 9

No 9 桁、始桌側、橋脚上 = 71 終桌方、落下 = 約 11m 間、腹鉸、歪曲也。

#9 beam was over the bridge legs ^{on} the side of the starting point. It had fallen on the ending point side and the abdominal girder was bent for about 11 m.

No 9 桁 歪曲部分ヲ切断 = 短径間トシテ 架設他一部分 = 木桁ヲ架ス。

#9 beam. The bent section was severed. Being too short it was rebuilt. The other part was built with a wooden beam.

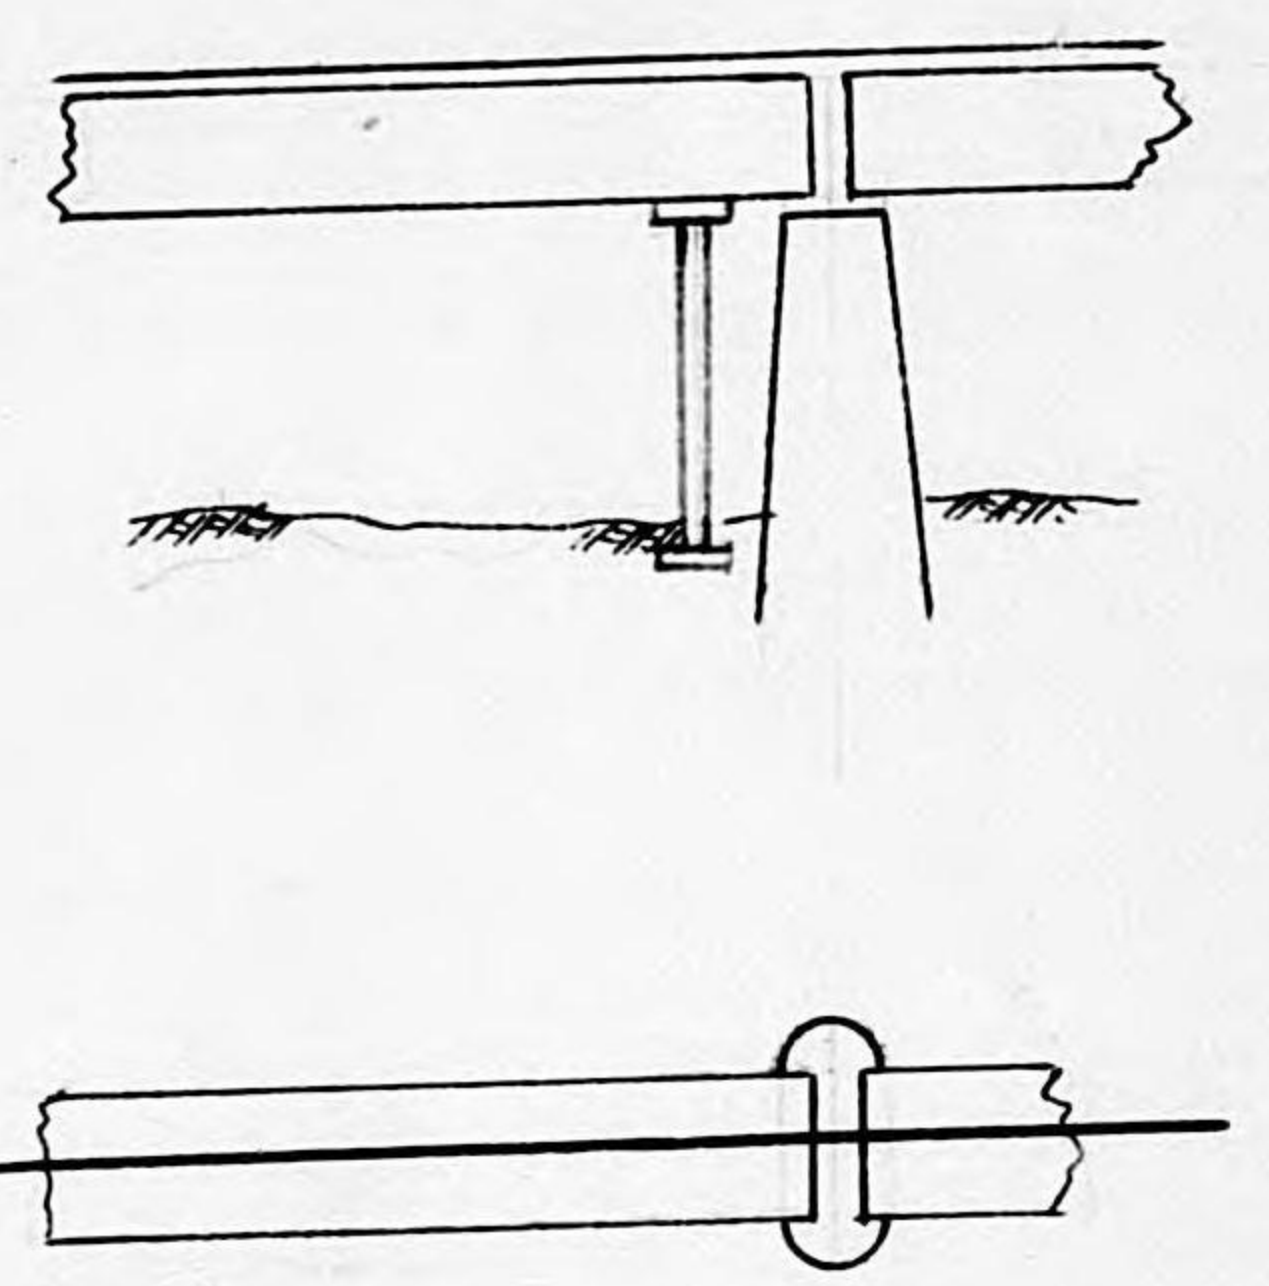
NO 10

#10 beam fell down

Emergency measures: #10 beam was raised to a
straight position and restored to
use by staging

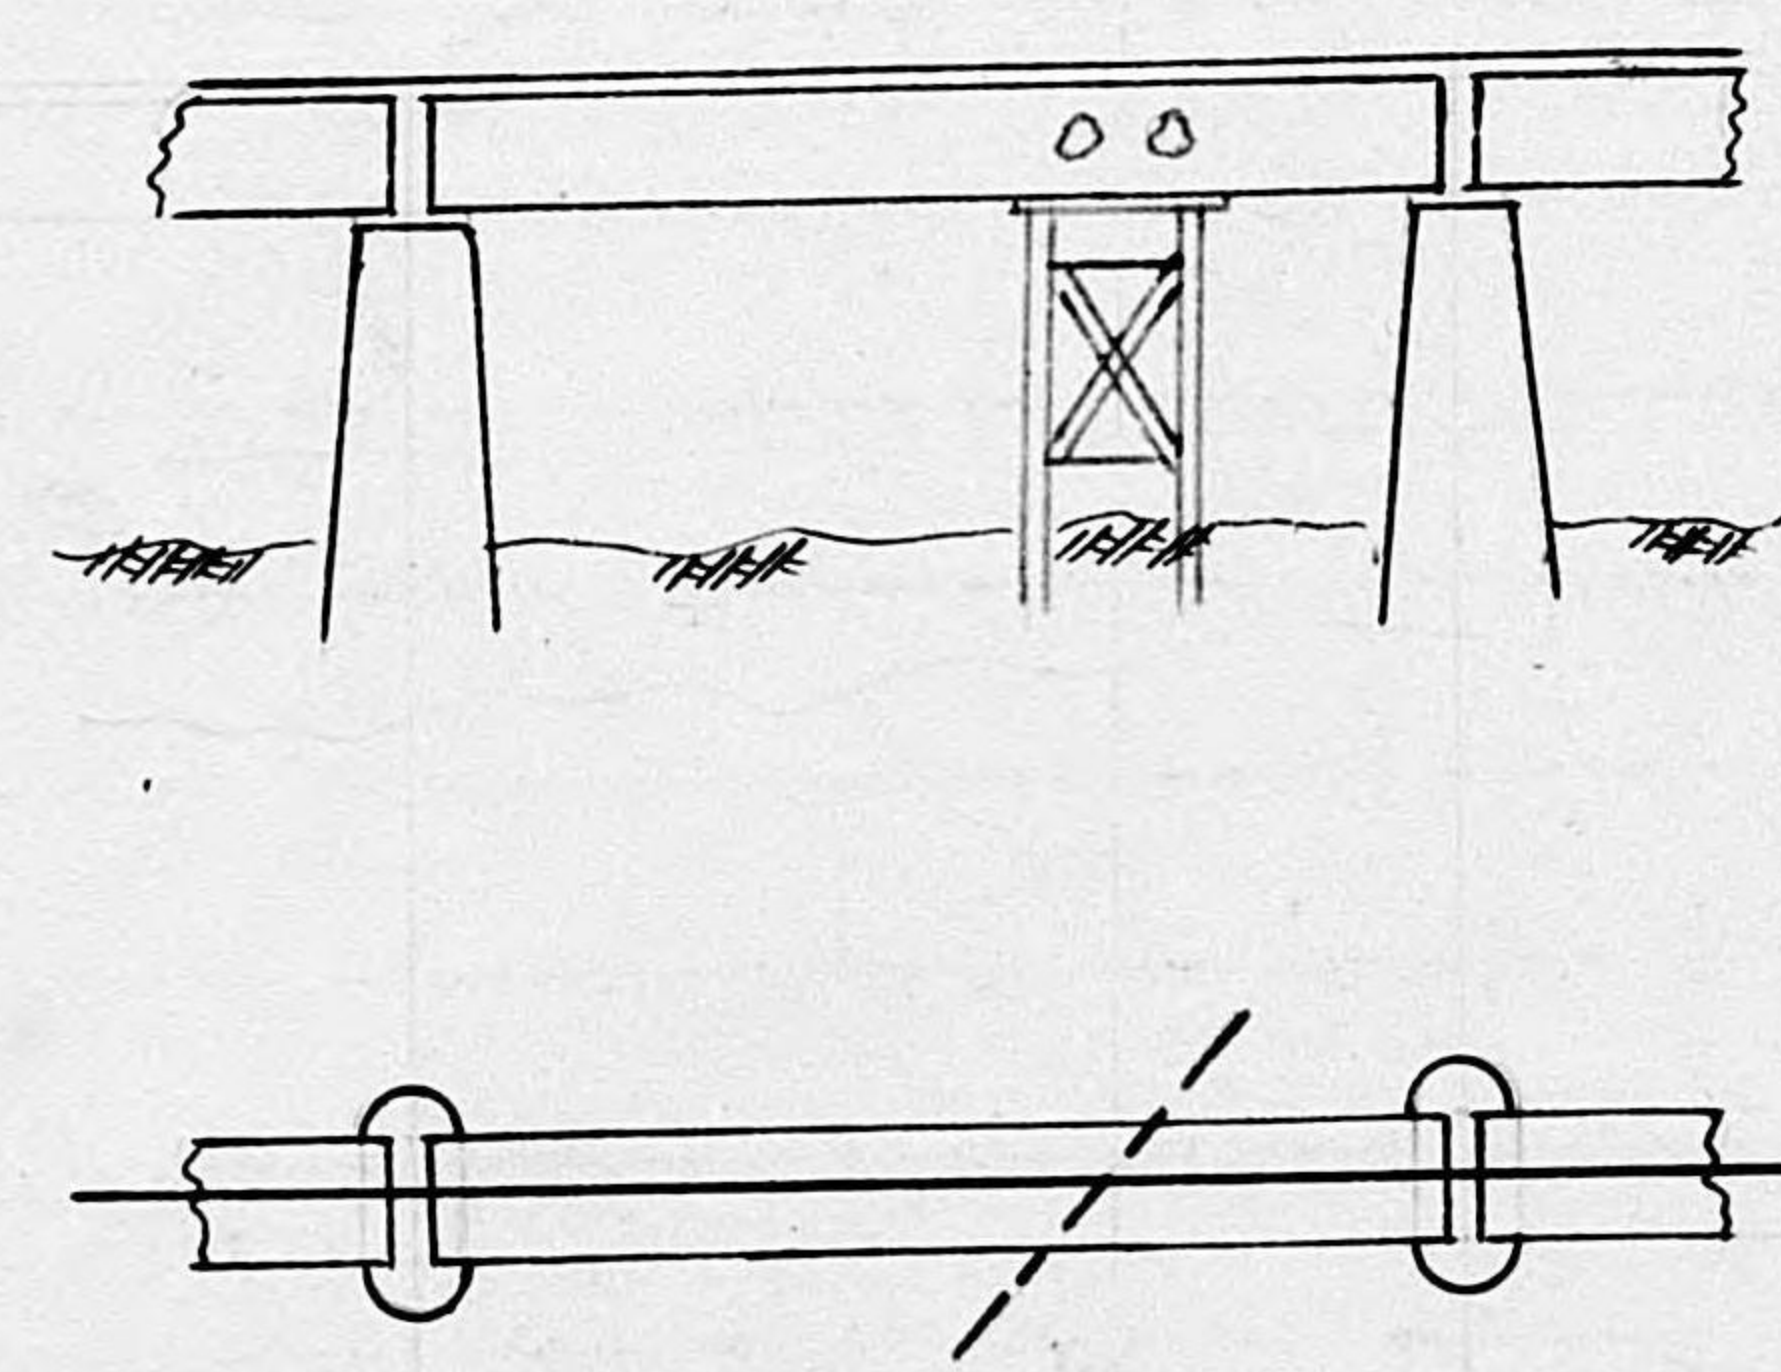
NO 15

No 15 桁、直撃弾、貫通 = シテ 左右、主桁 = 径約 80cm (左側) 50cm (右側) 大孔ヲ生也。

#15 beam, because of the passage of a direct hit, had large holes in the principle beams both right and left (80 cm on the left and 50 cm on the right)

No 15 桁、弾孔ナル部分 = 次圖 1 如ク 補強也。

The section of #15 beam which had shell holes in it was reinforced as in the accompanying diagram.

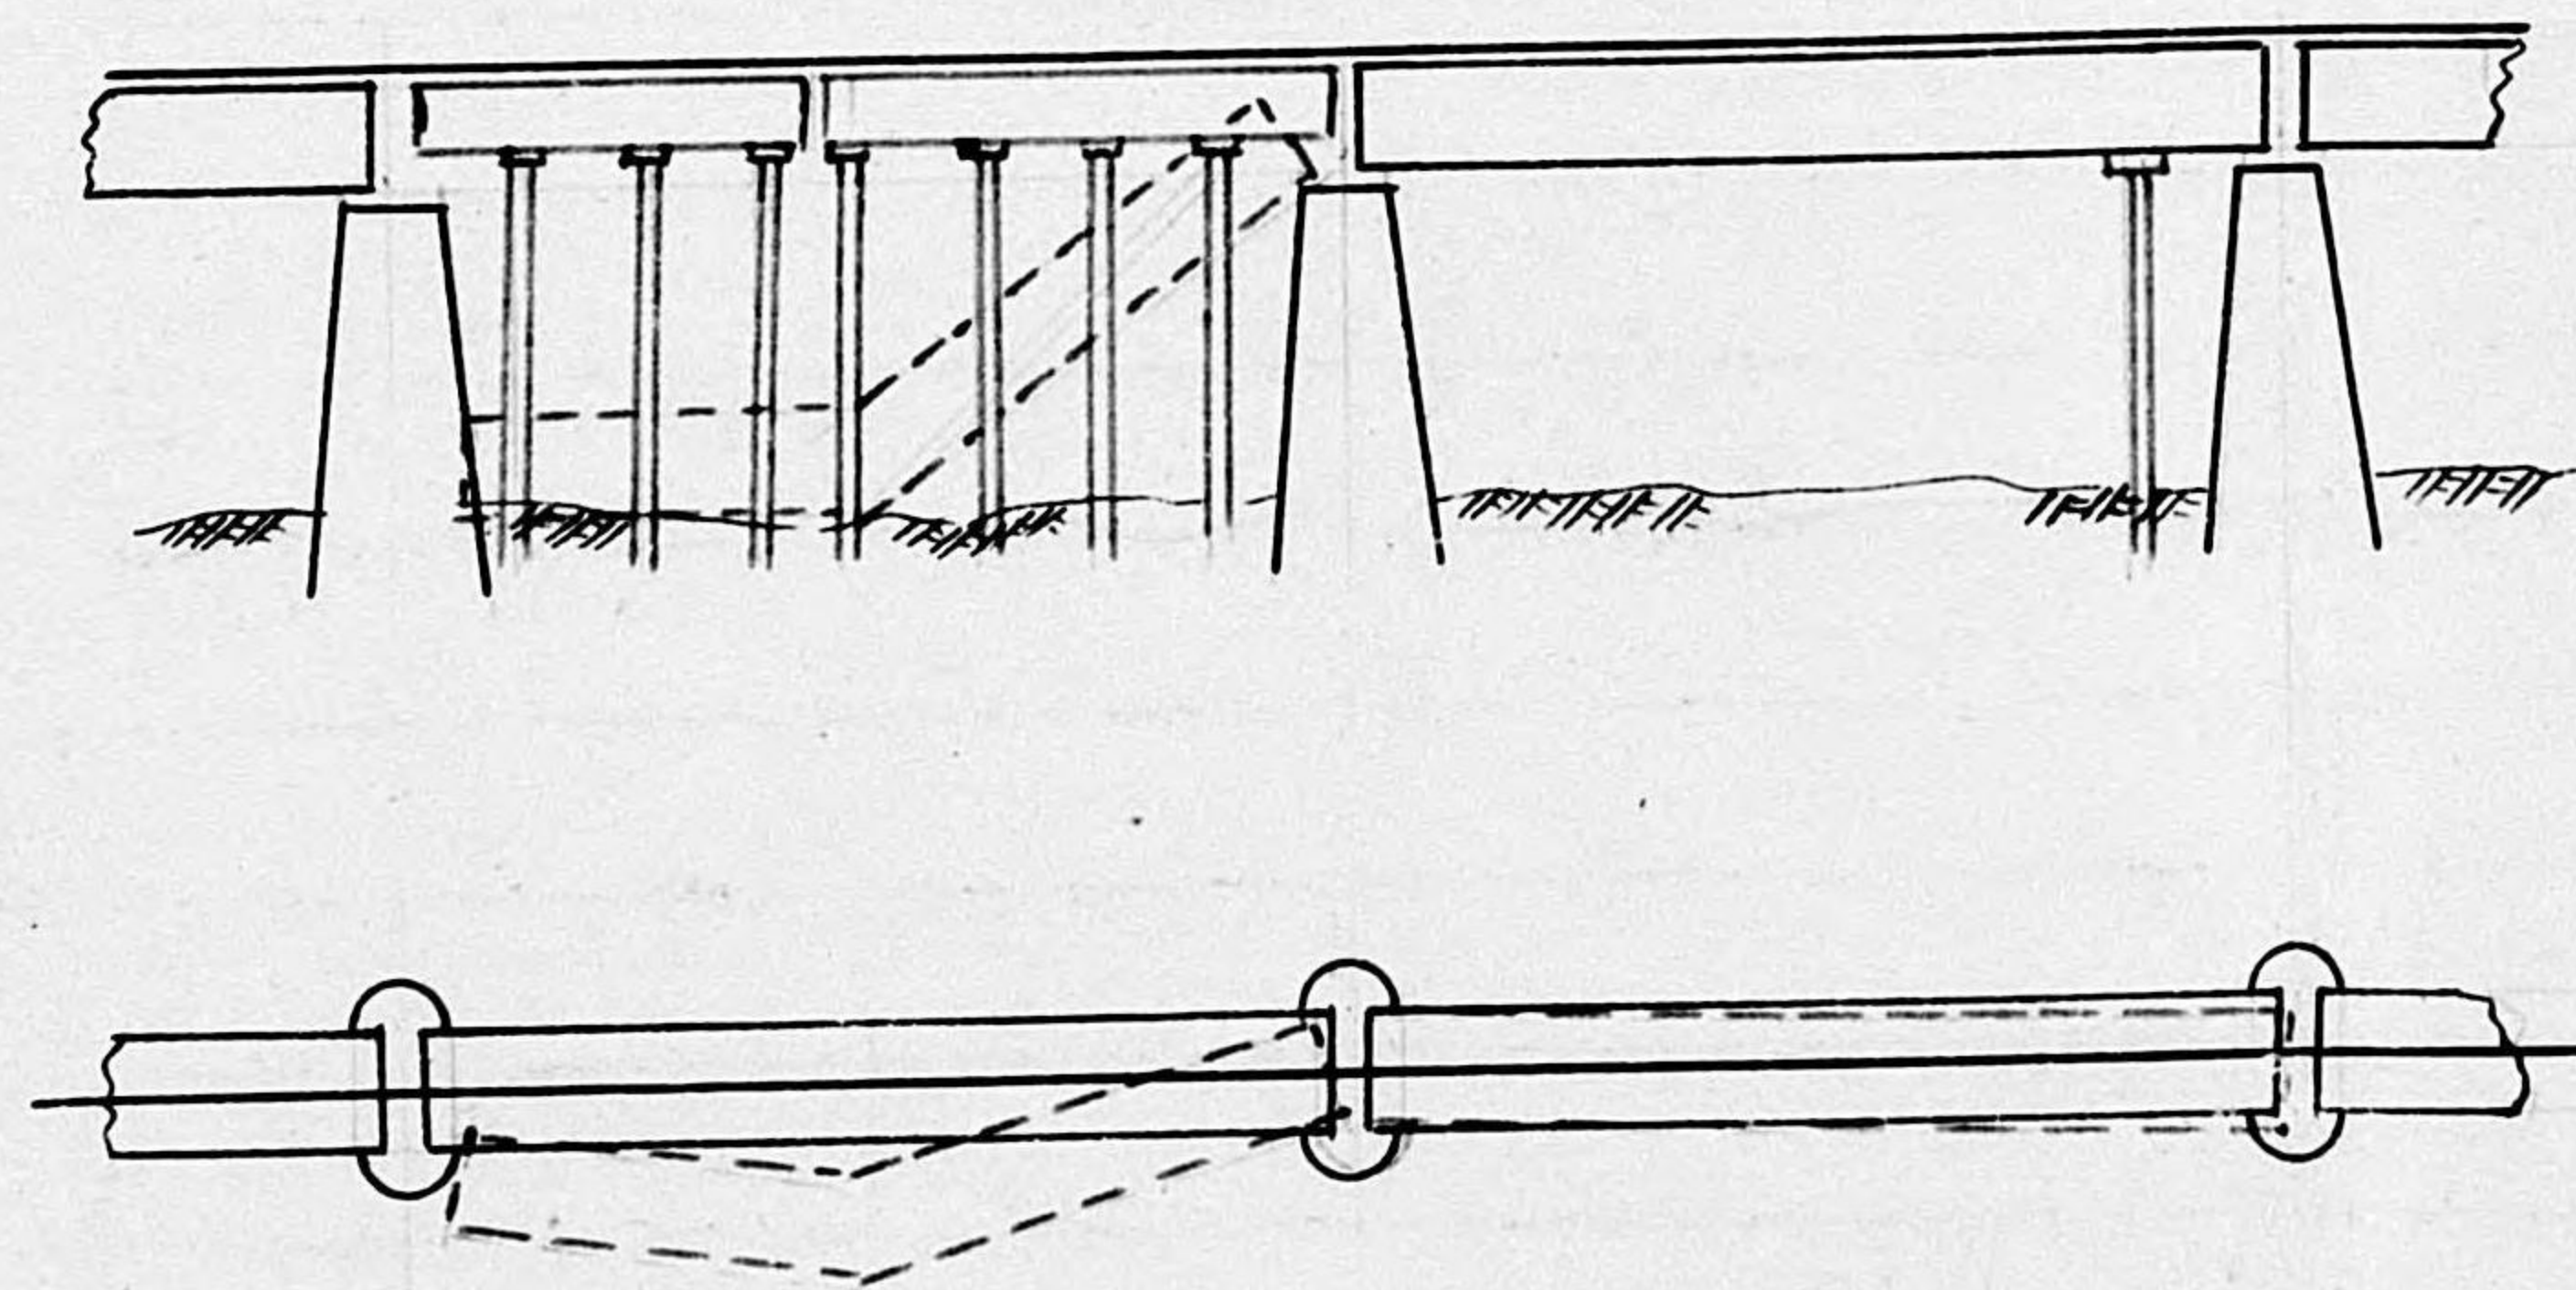
NO 17

No 17 桁 径間 前回被害ヲ受テ 緊急復旧トシテ 短径間、鉸桁及軌條桁ヲ架セシカ、今回中央枕木オビル附近 = 直撃ヲ受テ、鉸桁及軌條桁後台飛散 = 鉸桁、更生使用不可能ナリ。

#17 beam had received damage in the former raid and was restored to use by emergency measures using the rail beam and the short plate beam, but this time there was a direct hit near the center of the cross-tie sandal. The foundation of the plate beam and the rail beam flew around and cannot be used again.

No 17 径間、木桁 (30cm x 38cm 4本集成桁) 架設也。

#17 The space was filled ~~was attained~~ with wooden beams (4 beams $30\text{ cm} \times 30\text{ cm}$)

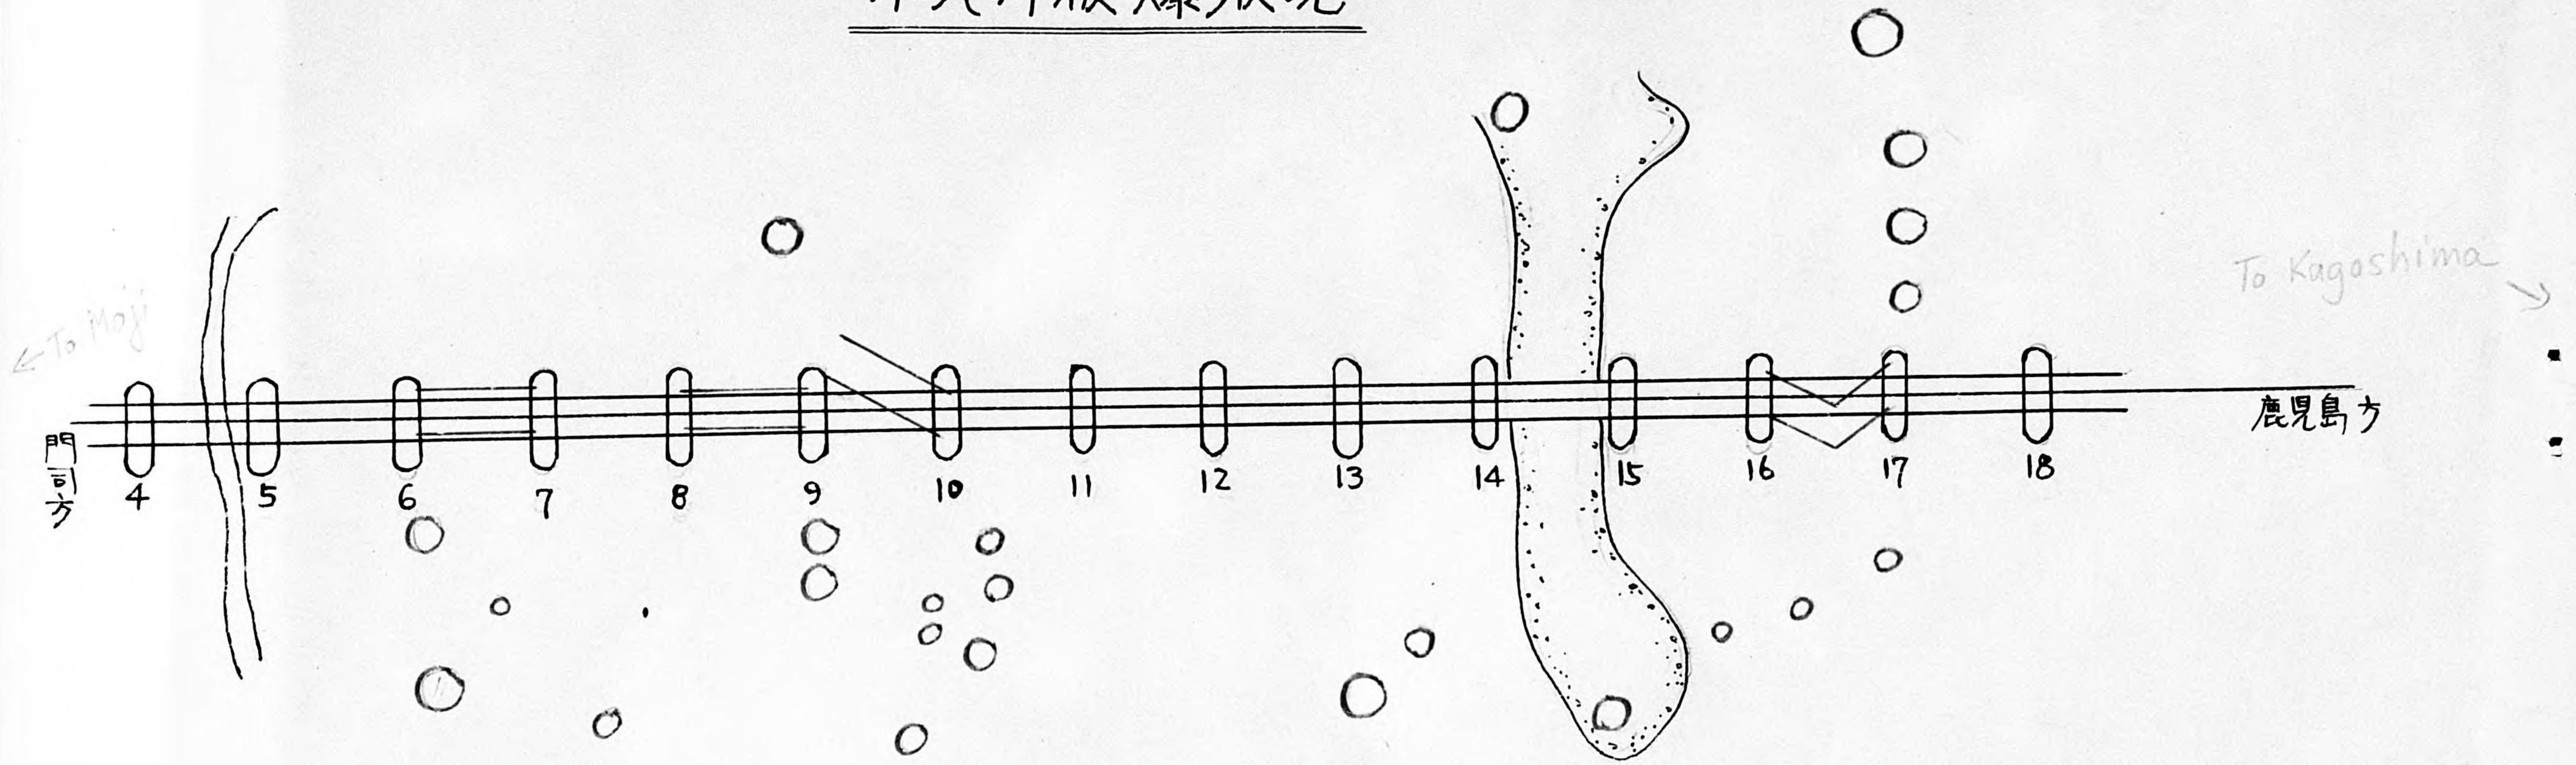
Countless shell traces
at 9th pier

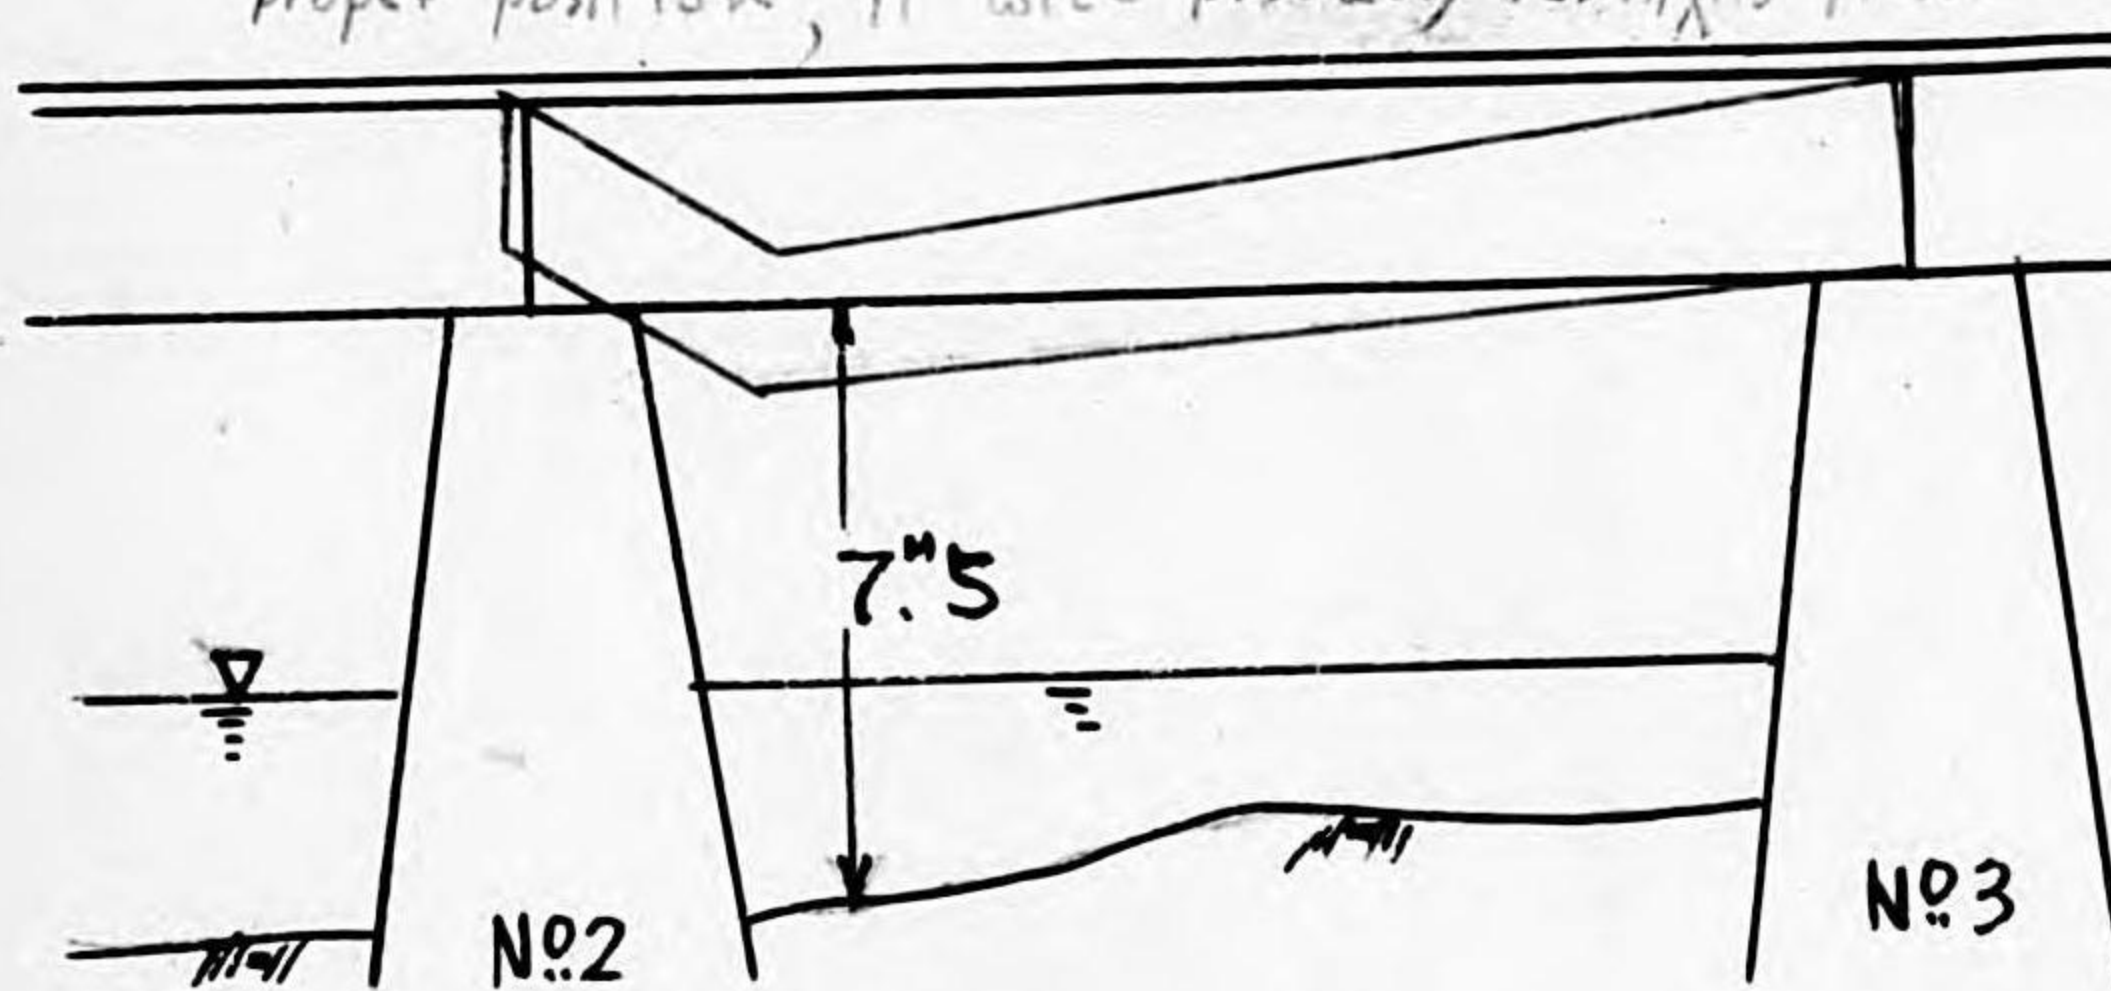
NO3
 NO3 桁起点側ハ橋脚上ニ僅カカリ轉落寸前、形ニ歪曲シアルモ正位置ニ復歸セバ現状ニ復ス

The starting point of No3 beam fell down temporarily a little on top of the bridge leg and appeared to be a little in front of it. Although it is bent, if restored to its proper position, it will probably return to its present condition.
