CHART SHOWING AIR-RAID DAMAGES
ON THE RY. BRIDGE OVER THE RIVER KOMARU

Report of the investigation of the damage
to KOMARU BRIDGE

Report of the Investigation of Damage to KōMARU
River BRIDGE

Komarugawa Bomb Damage Conditions

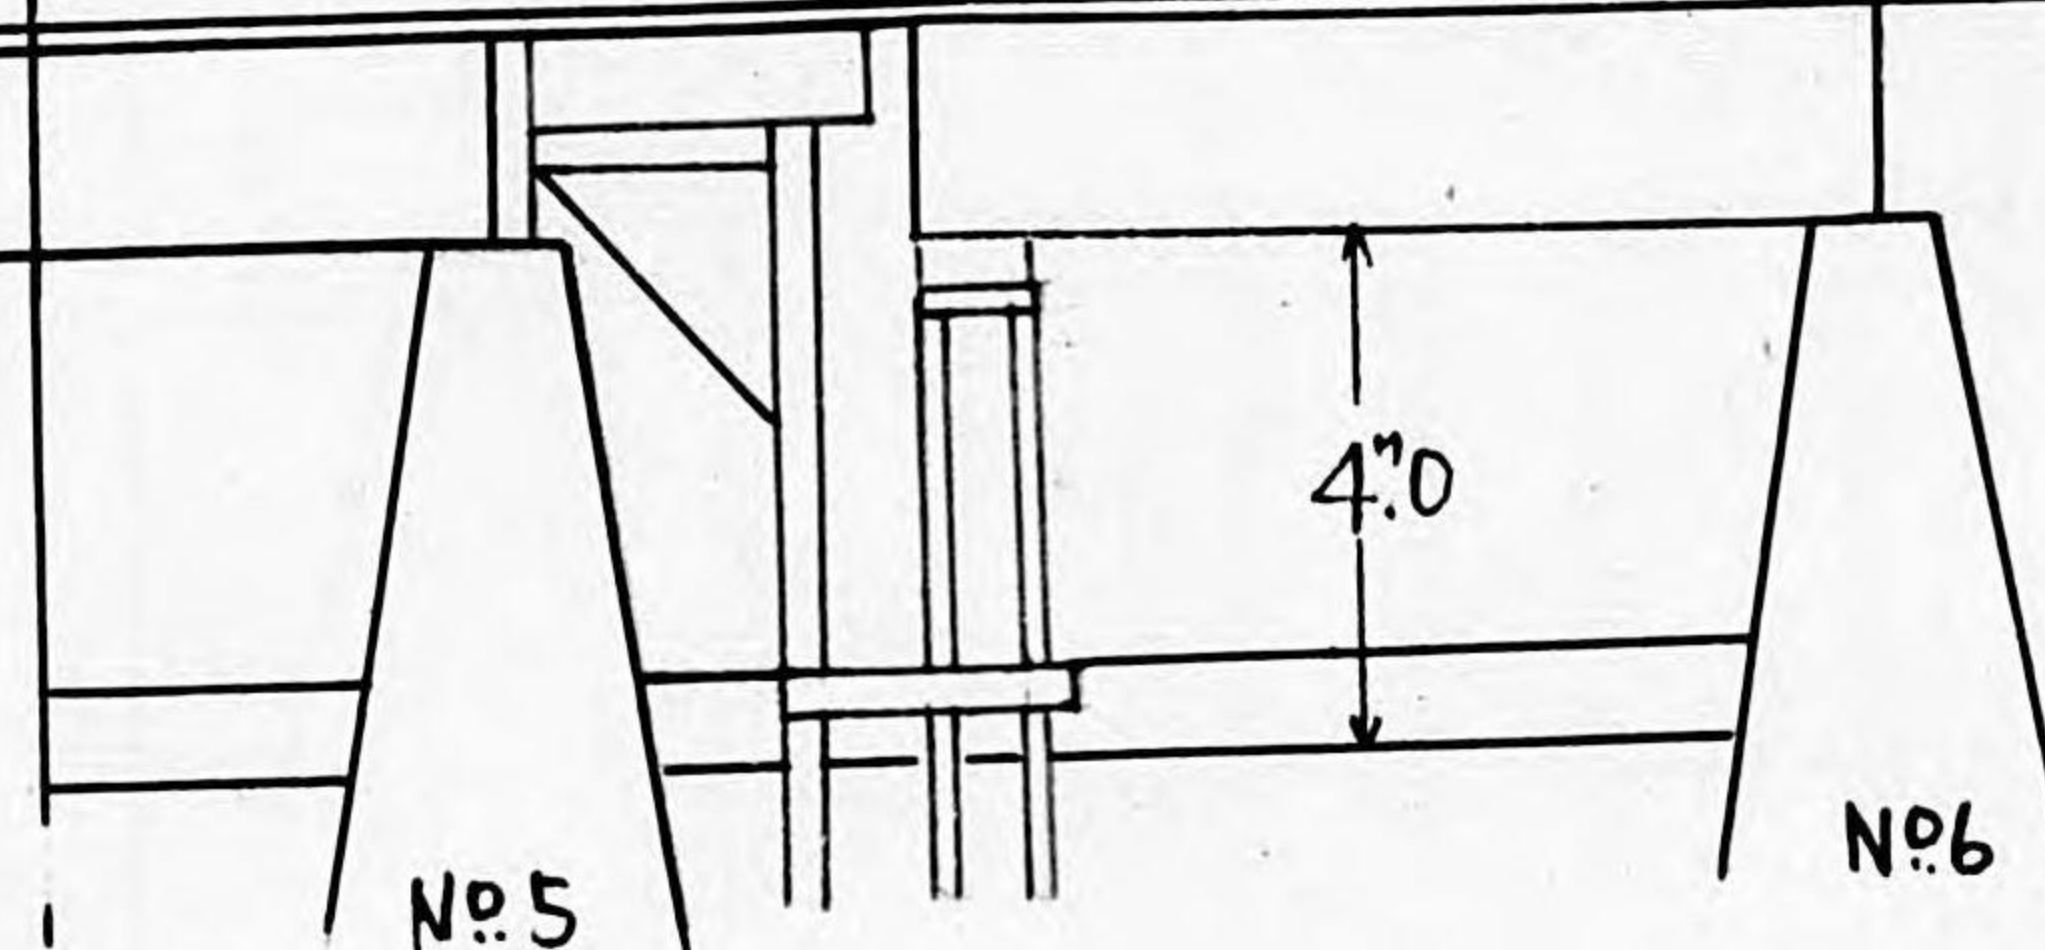
NO6
 NO6 桁ハ川下約40'位置ニ完全轉落シ起点ヨリ約3'間ハ腹板、斜弦材共ニ歪曲ス

No 6 BEAM fell down completely into a position about 40' down-stream. THE abdominal steel plate(s) and the "SLANTING STRING" material for a distance of about 3' from the STARTING POINT were BENT.

上部ハ屈曲 Bent upward

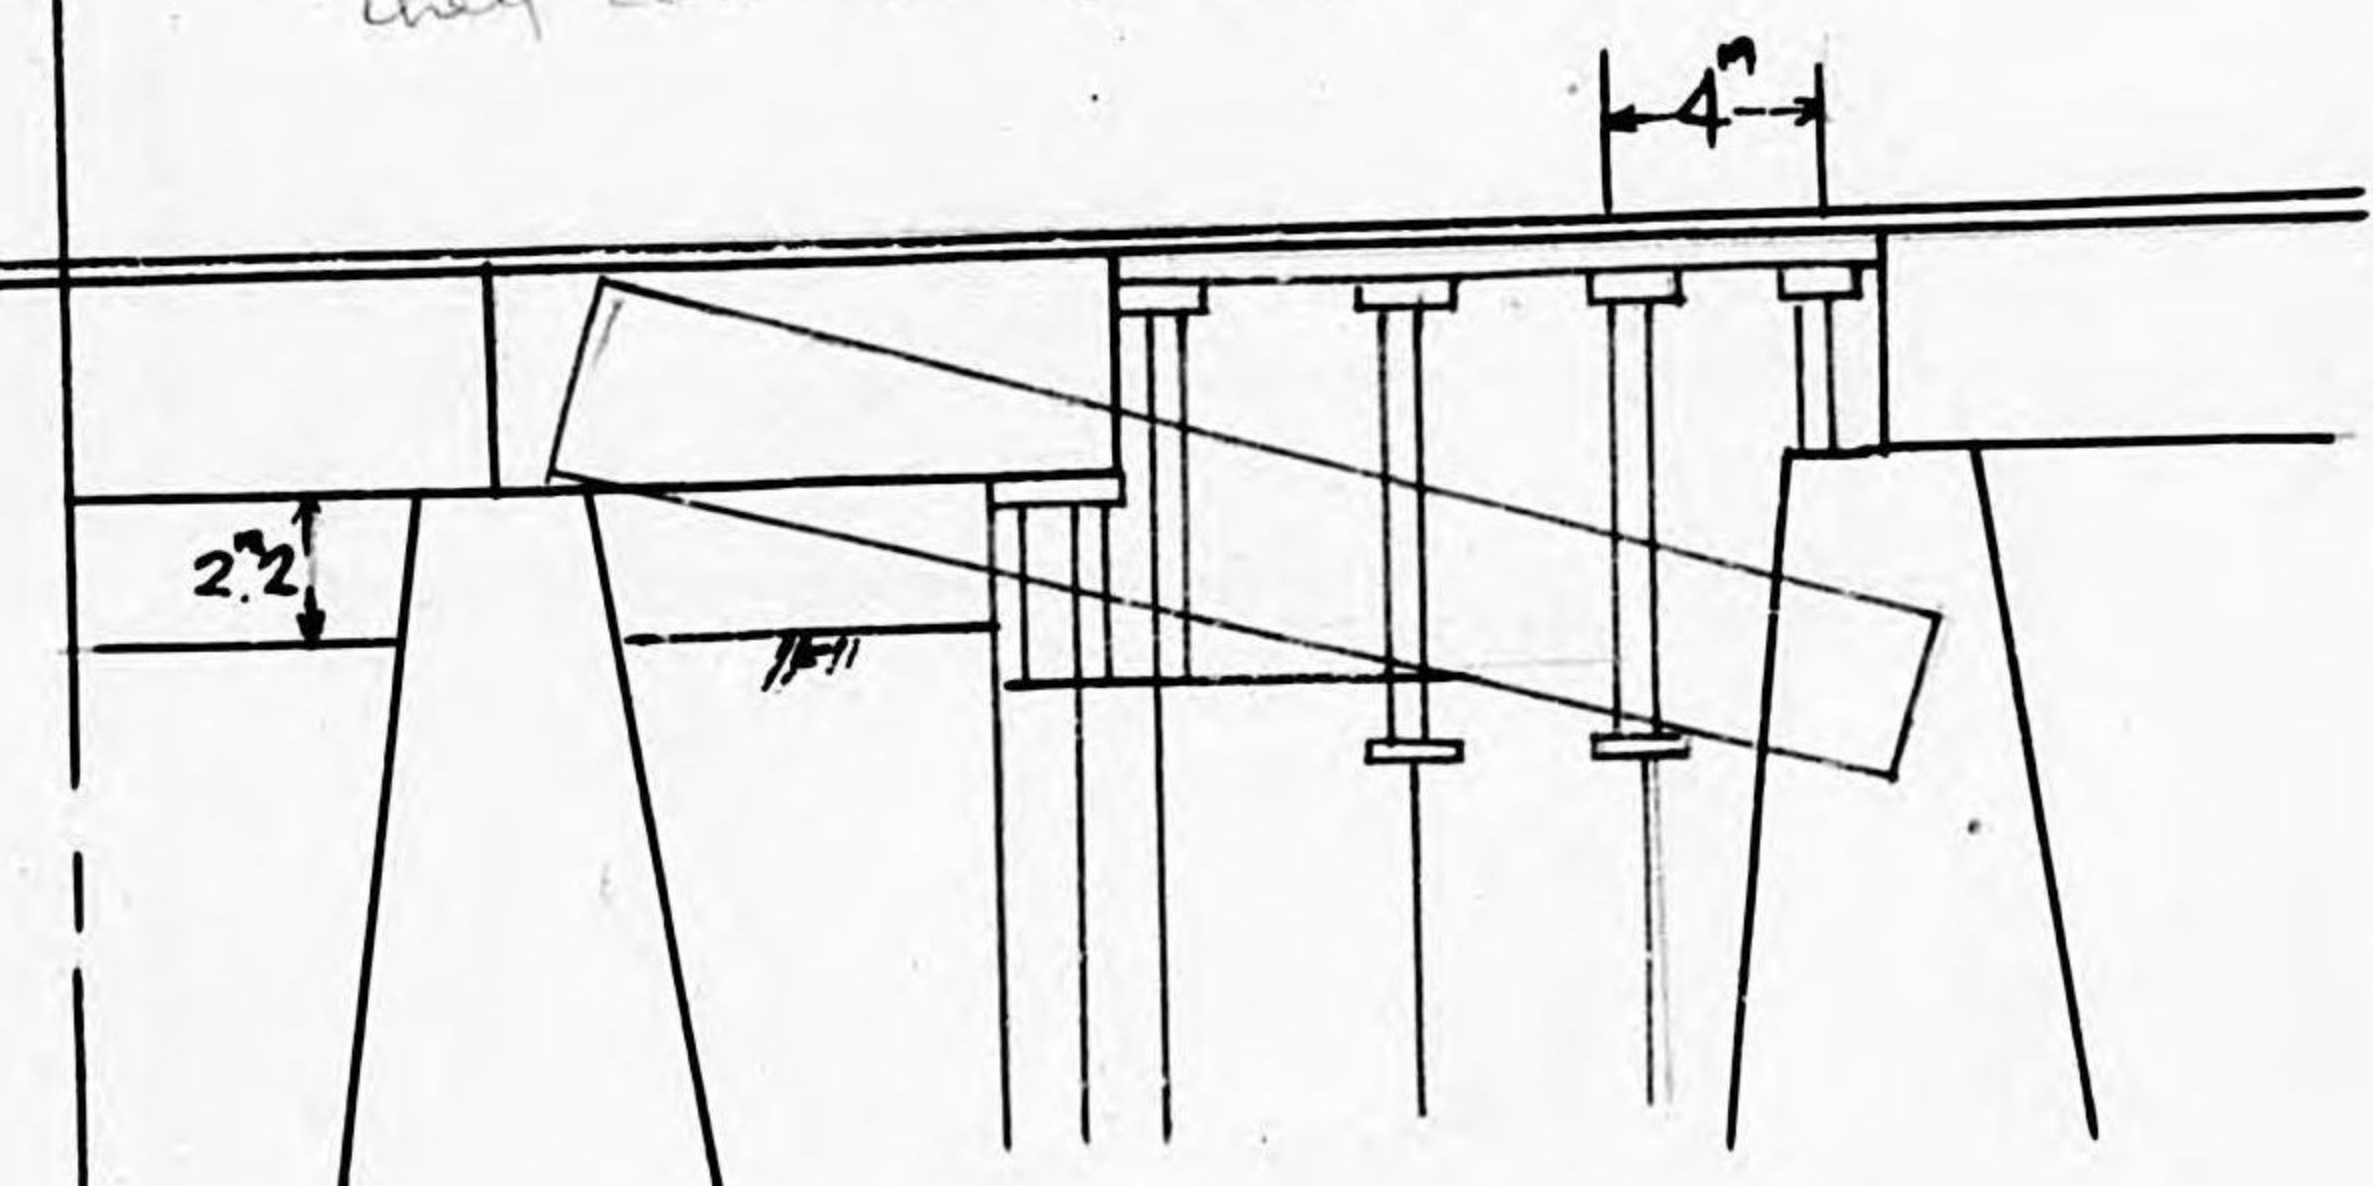
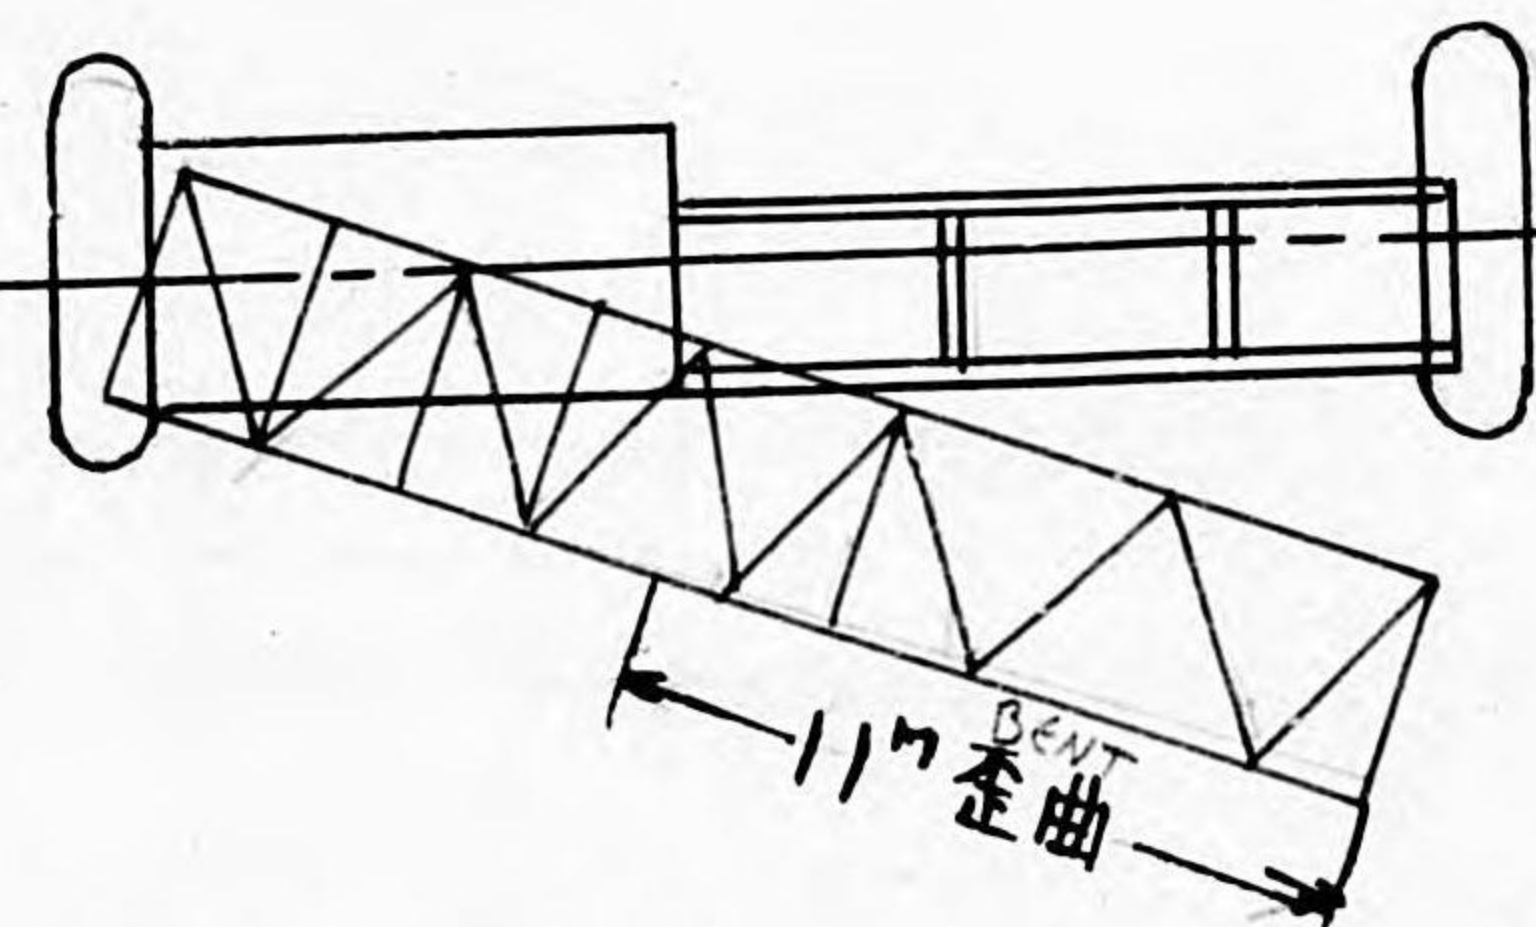
NO9
 終点方川上ニ轉落 終点方ヨリ約11米、間ハ腹板歪曲ニ補強セザレバ使用ニ得ズ

THE END fell down in the upstream direction, and the abdominal steel plate(s) for a distance of about 11 meters from the end were BENT. UNLESS re-enforced they can not be used.

鋼桁ハ使用ニ得ル長サヲ9.3ニトリ切断扛上、他部分木桁ヲ架設ス基礎ハ並枕木土台トス

The part of the steel plate beams which could be used was cut to a length of 9.3 and raised; for the remaining part wooden BEAMS were installed. For a BASE RR TIES were lined up and made into a WOODEN FOUNDATION

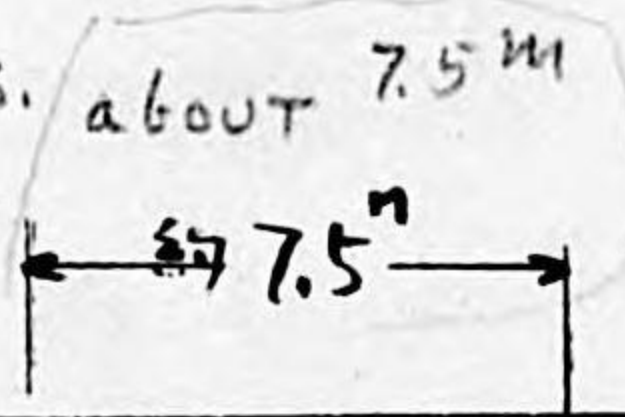
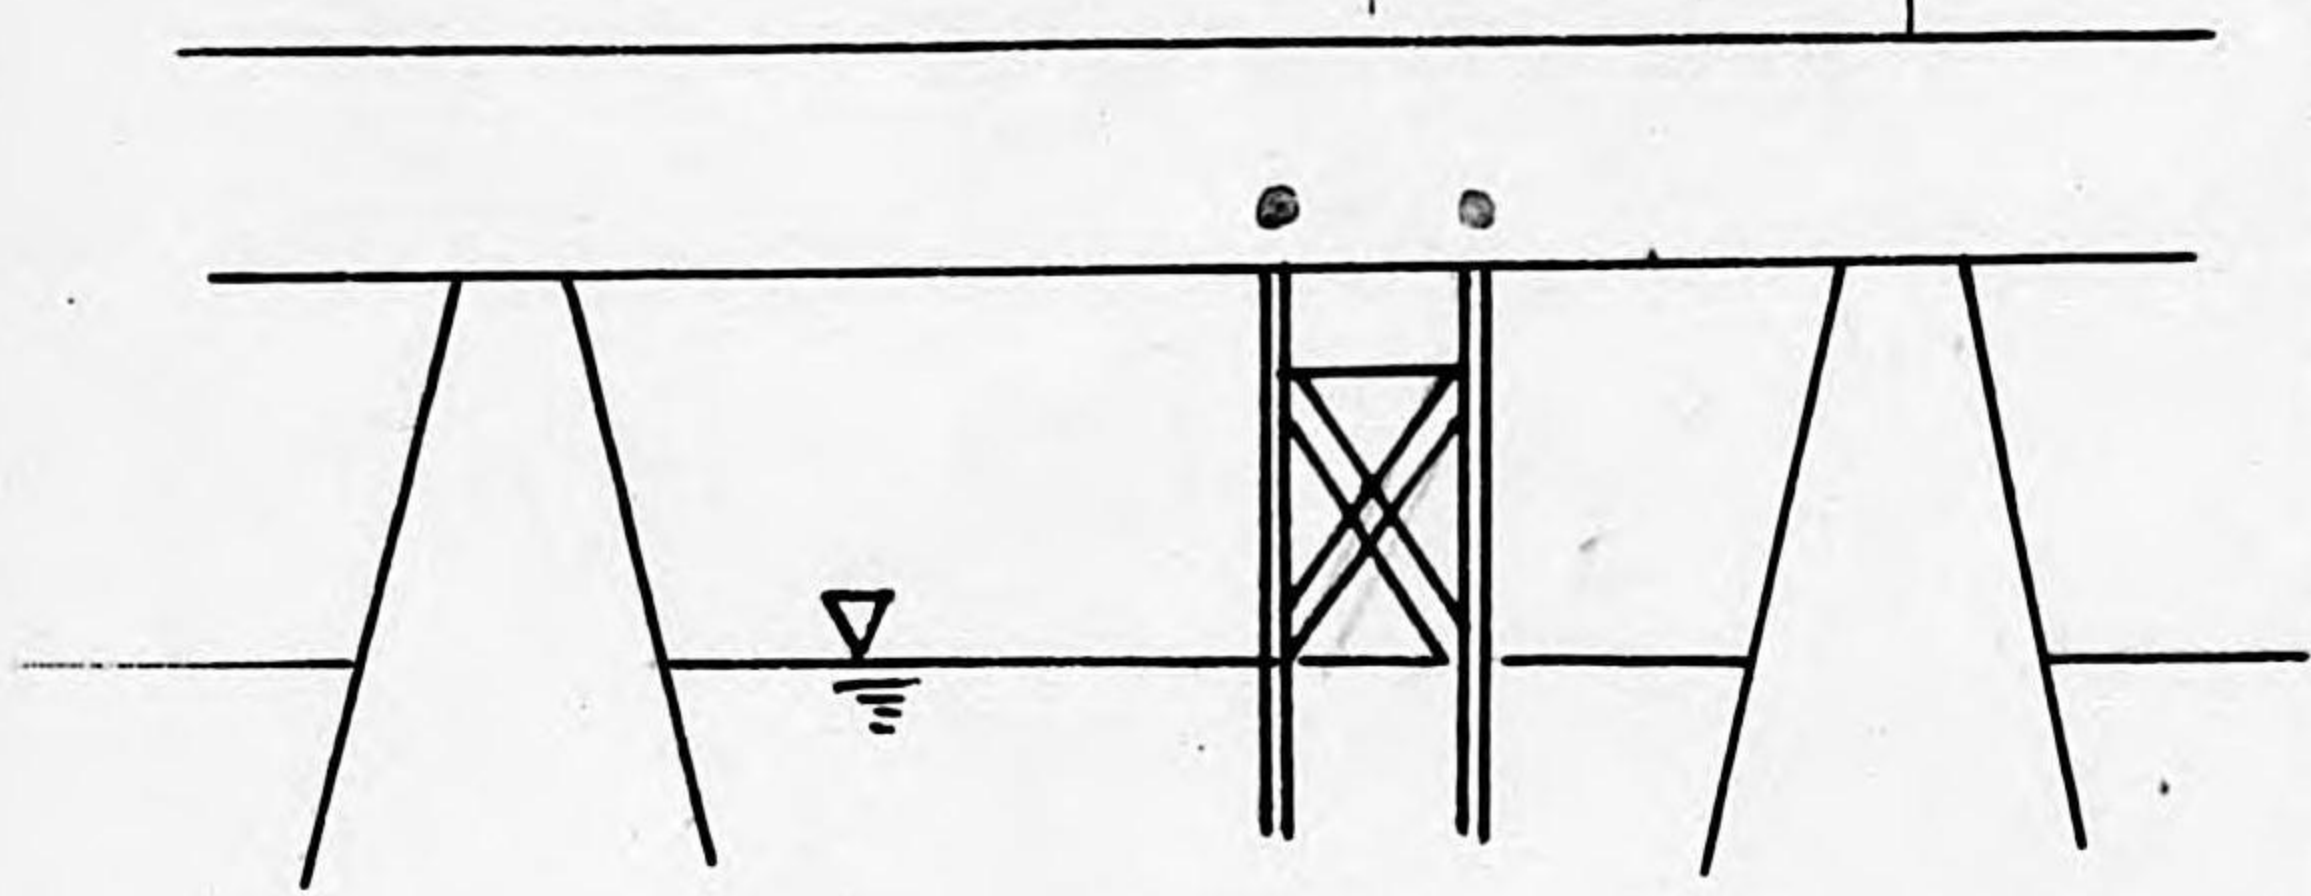
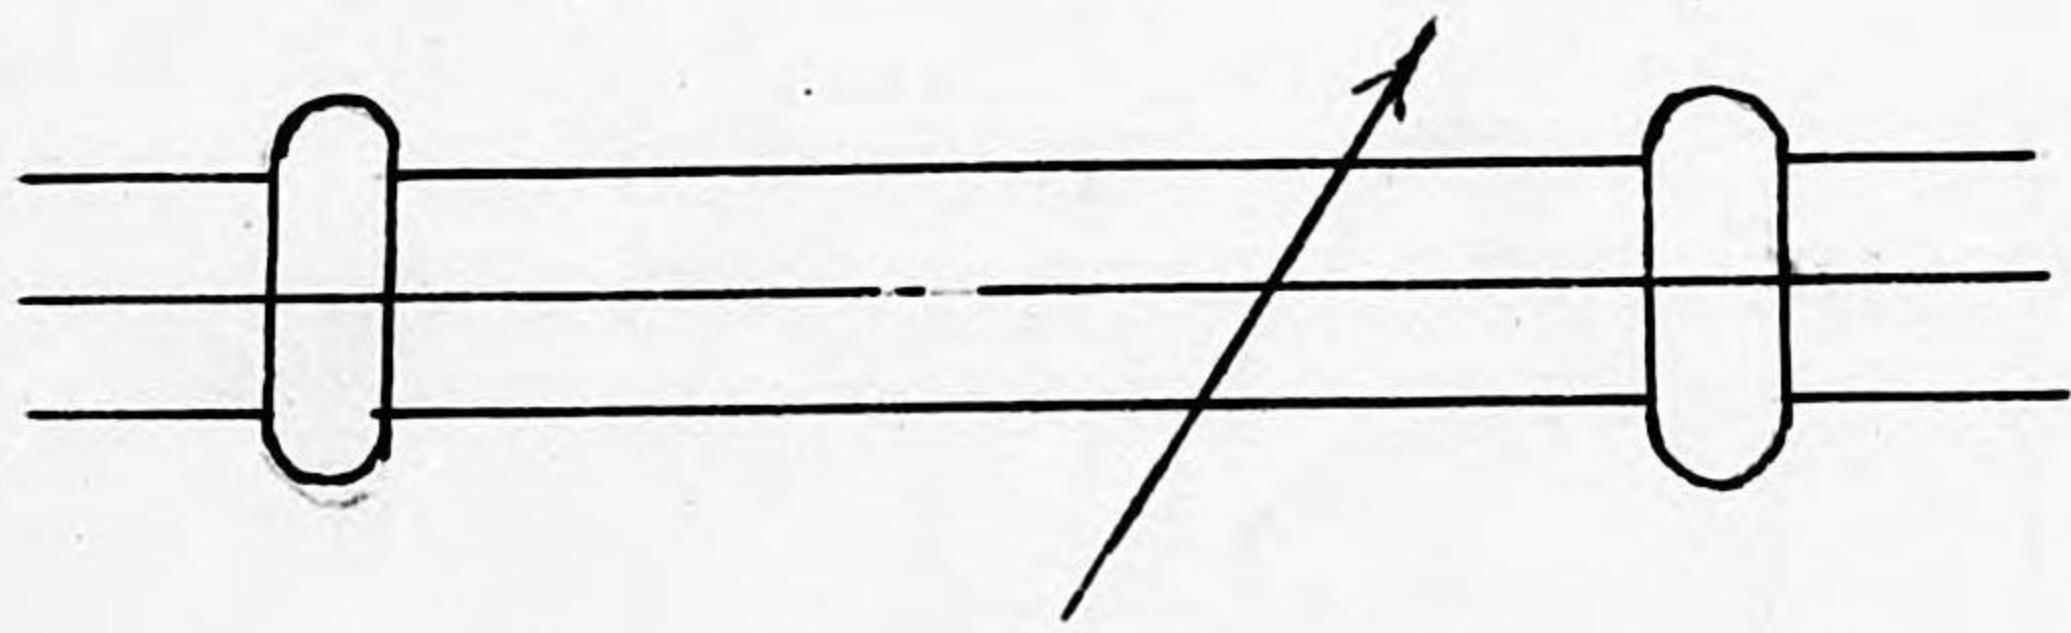
NO 15

直撃弾⇒腹板=大孔ヲ生々至約0.8^m

Large Holes, for a length of about 0.8^m, were made in the abdominal steel plates. about 7.5^m

桁受台=柱ト杭打5本ト

5 piles as supports (pillars) for the BEAM foundations

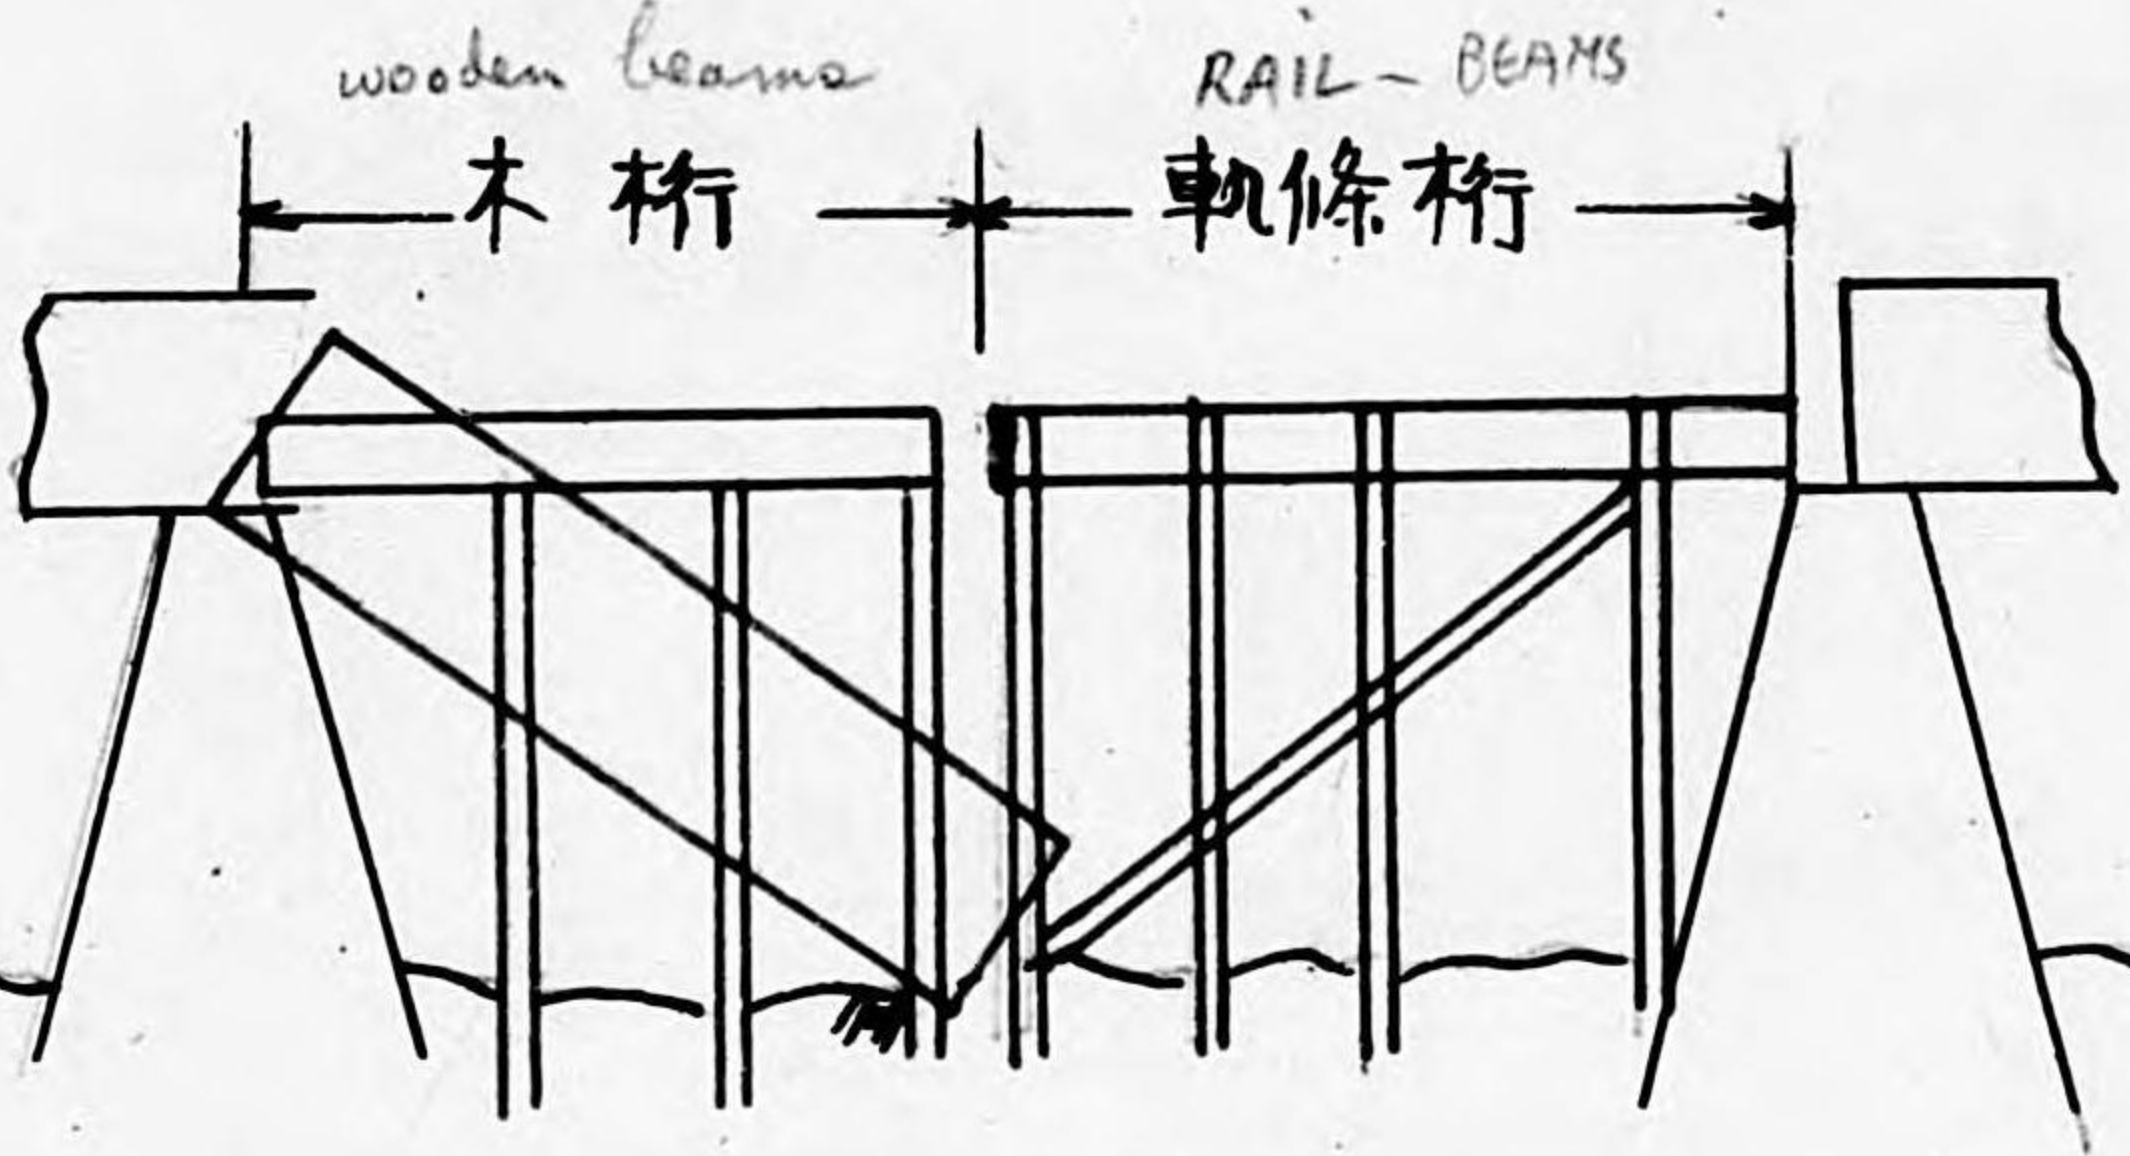
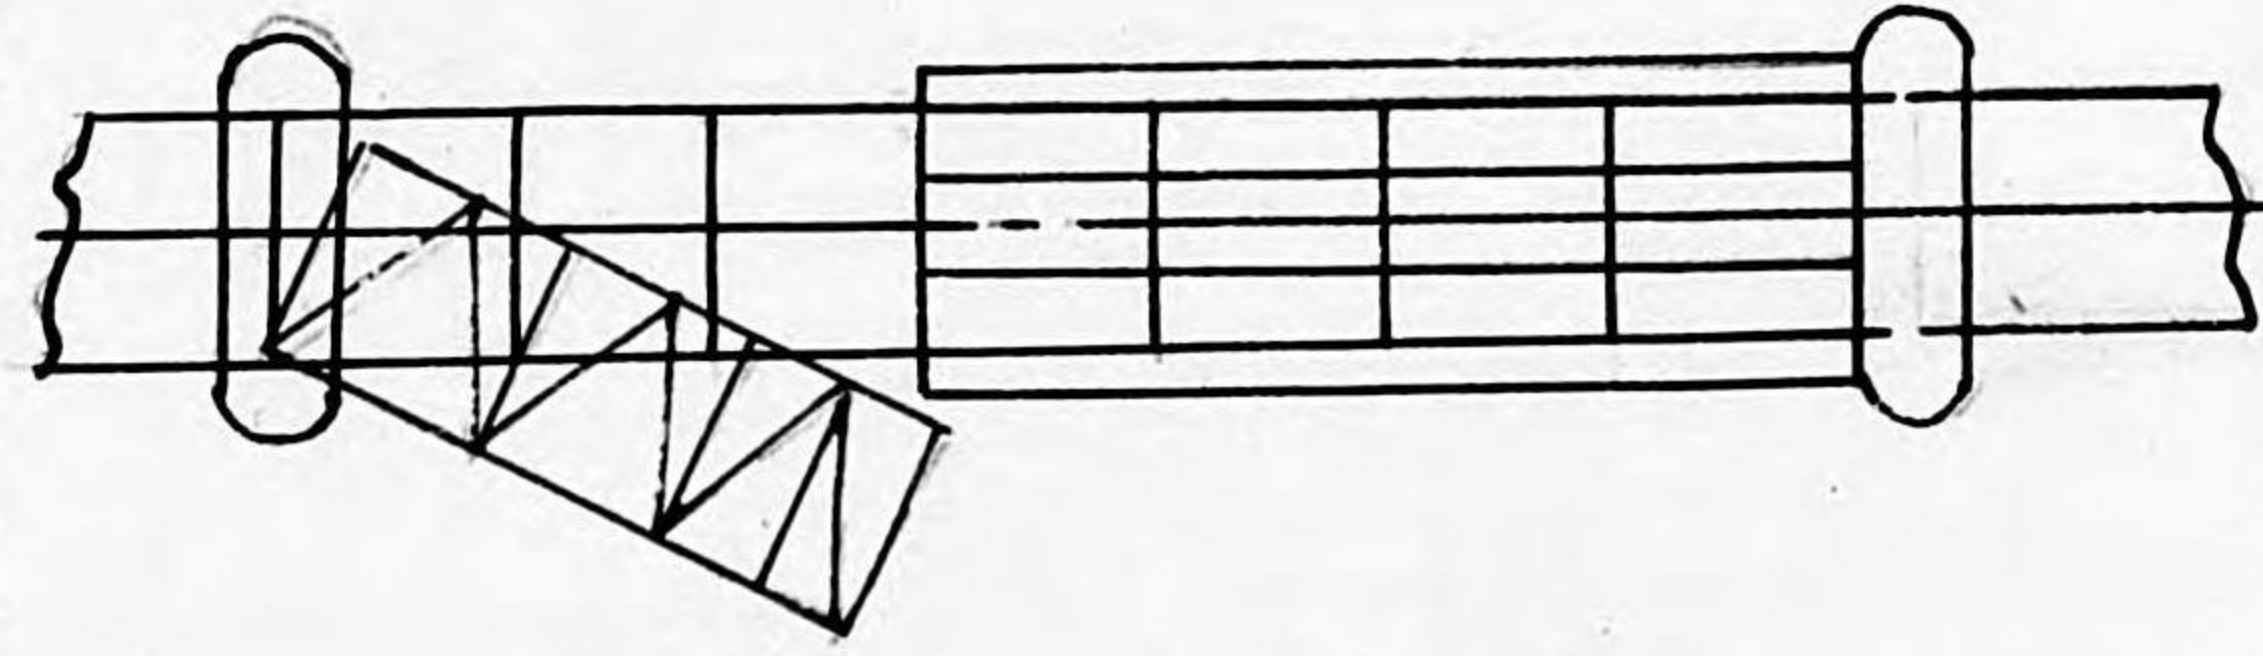
Together with the BEAMS and RAIL-BEAMS which received DIRECT HITS NEAR THE CENTER of the tie-SANDALS (CAPS) the RAIL-BEAM FOUNDATIONS FLEW APART (12 Aug). The steel-PLATE BEAMS and the "SLANTING STRAIN-MATERIAL" were damaged and cut; the BRIDGE LEGS were BENT and could not be used. NO 17. (TN* Japanese says "NOT BENT" BUT character for "NOT" would appear to be MISTAKE for the compound NO 18 USED Elsewhere for "BENT" 否 歪 曲 曲)

中央枕木サドル附近=直撃ヲ受テ
桁及軌條桁共(8月12日)軌條桁受台飛散シ
釘桁、斜弦材折損切斷橋脚歪曲、使用不能

釘桁ハ撤去スル代リ=木桁ヲ架設ス軌條桁ハ8月12日復旧ス

Instead of removing the steel BEAMS, WOODEN beams were INSTALLED. RAIL BEAMS RESTORED 12 Aug.

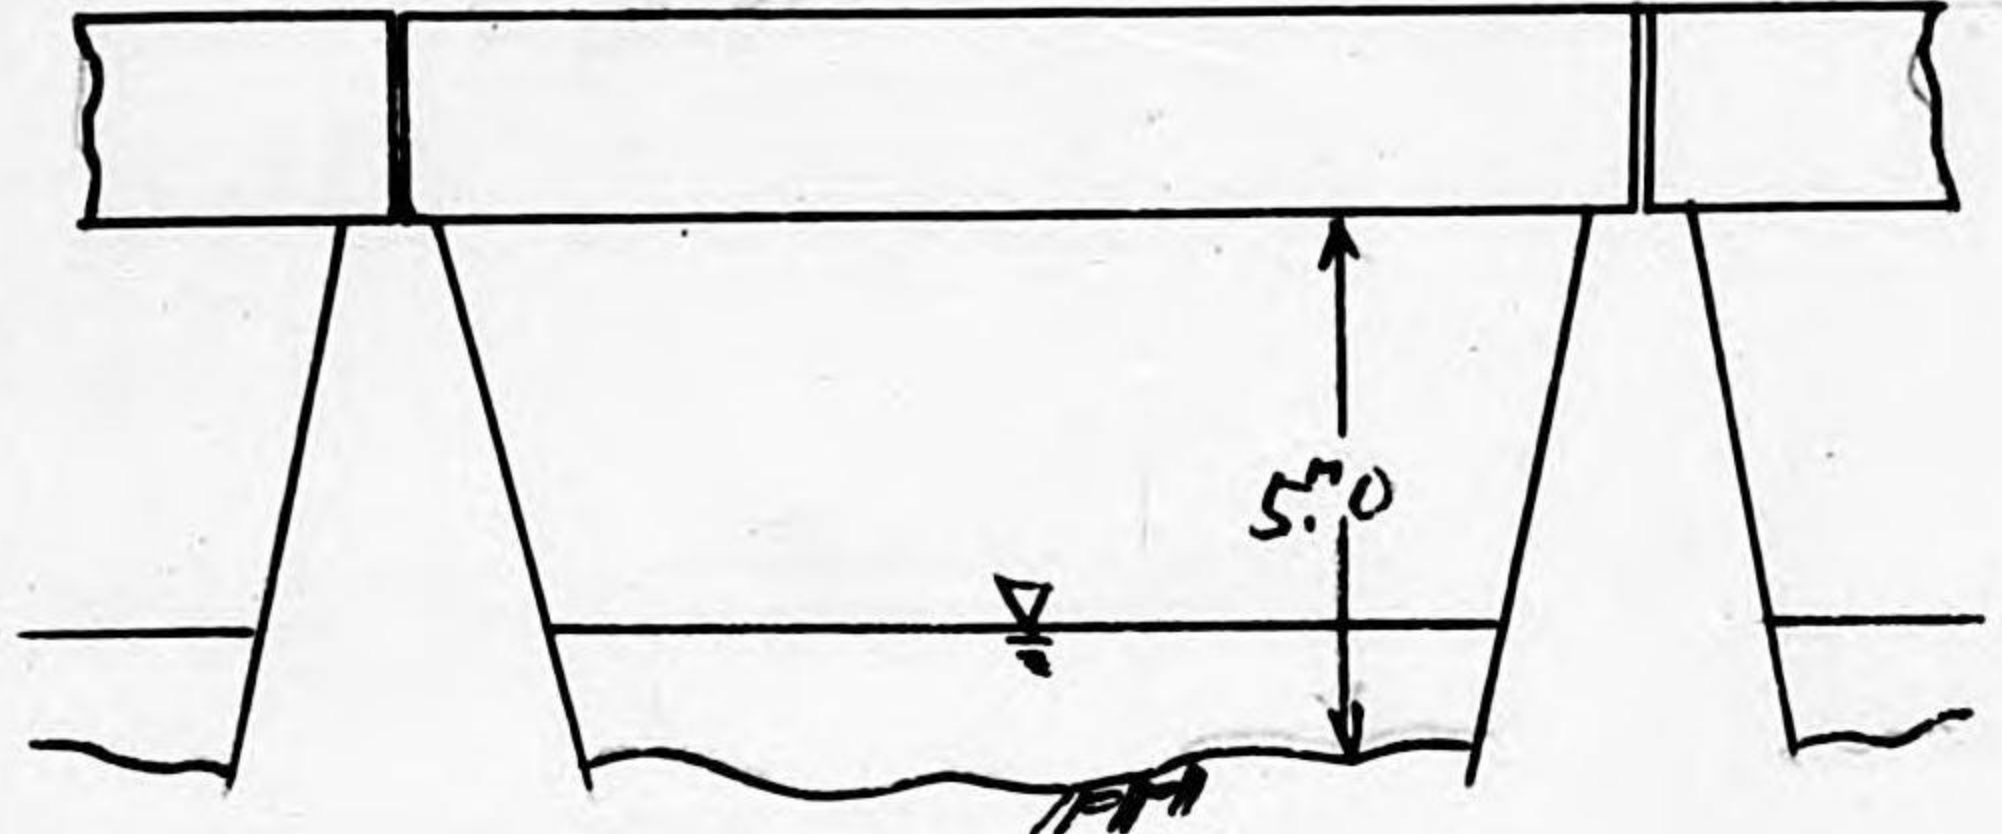
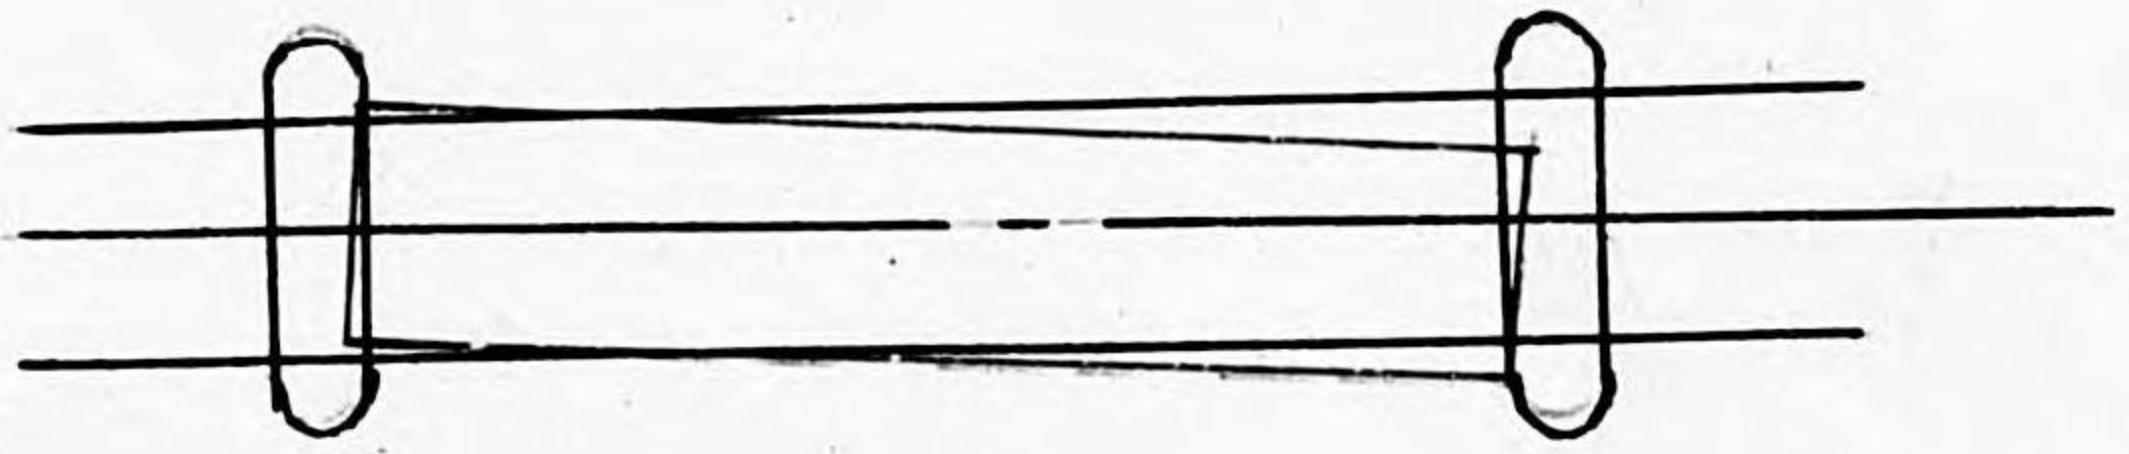
終端側ヨリ川上=約70^m移動

MOVED about 70 m upstream from the end side.

正位置=移動ス

MOVED TO correct position
