HISTORIC STRUCTURE REPORT

THE SHERIFF'S HOUSE  
FIRST STATE NATIONAL HISTORIC SITE  
NEW CASTLE, DE

FINAL

*Submitted by:*  
JOHN MILNER ARCHITECTS, INC.  
SEPTEMBER 16, 2016

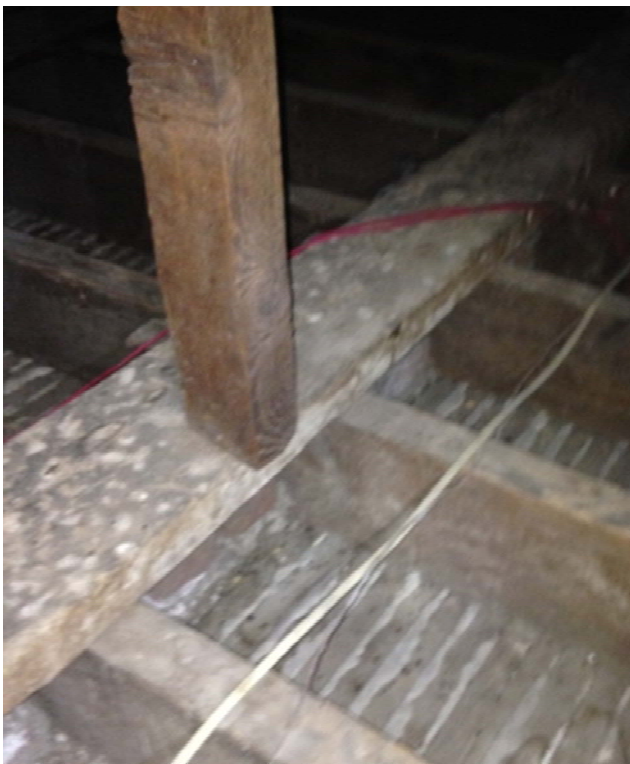
*Figure 1.2-21: The fact that the post supporting the north valley of the front gable does not land on the bearing wall suggests strongly that the brick bearing wall is from an earlier structure. The post bears instead on a recycled floor joist a few inches away from the masonry that should be supporting it.*

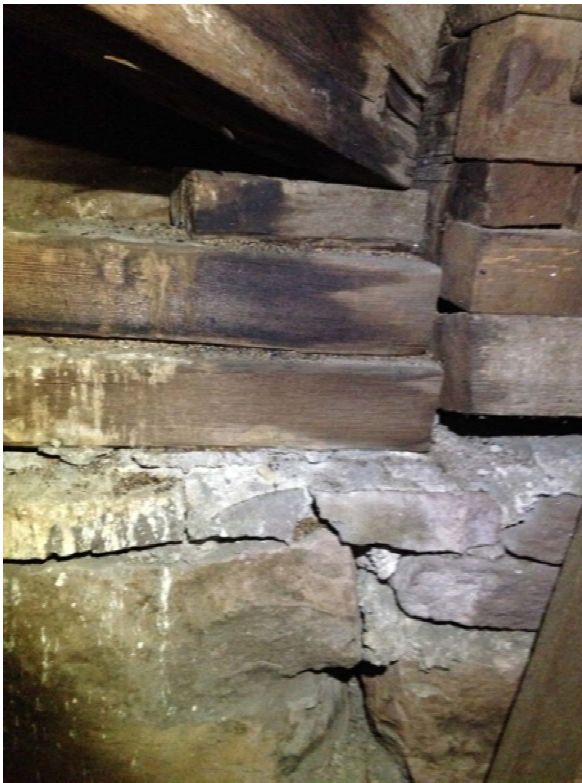
*Figure 1.2-23: The north valley beam bears on a pile of scrap wood set on the exterior masonry wall. The contractors made liberal use of recycled materials, presumably to save money.*

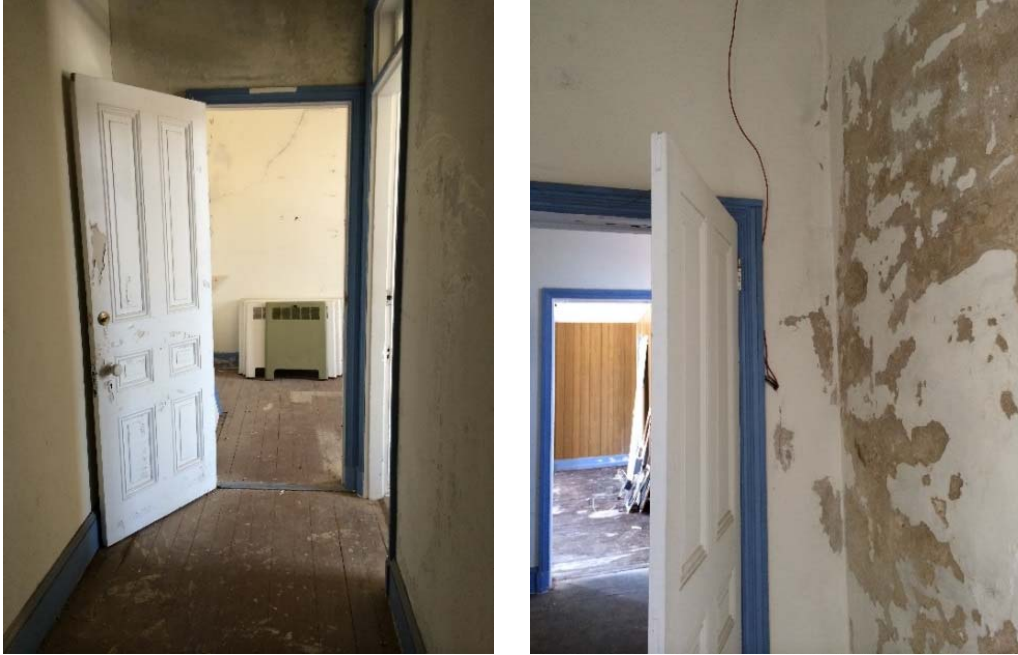
*Figure 1.3-39: Views of Room 203 looking north with Room 201 beyond (left) and detail view of plaster damage at west wall (right).*

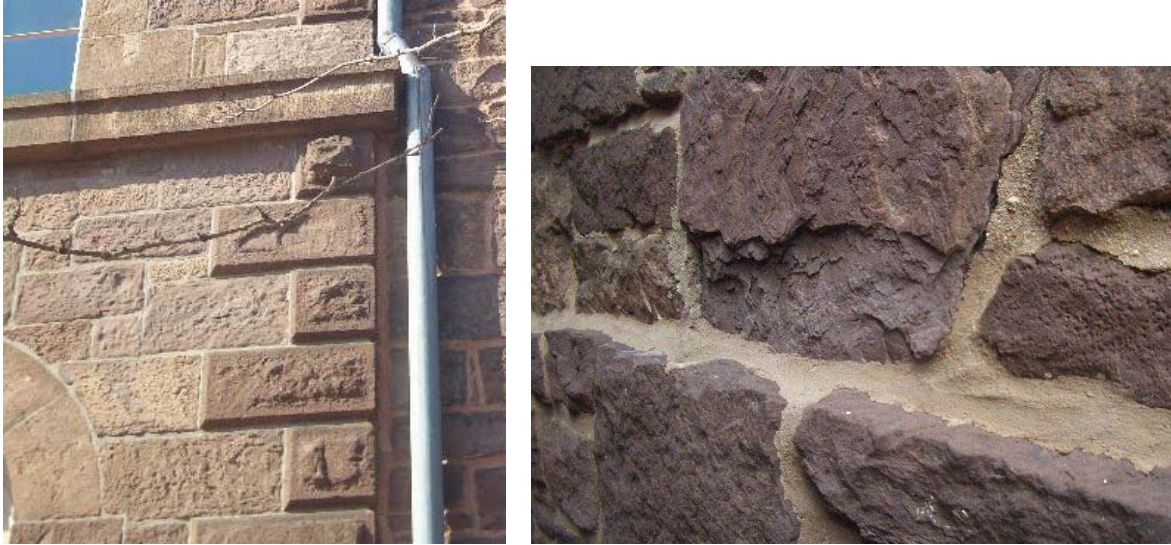
- Figure 1.5-4: The brick paving under the downspout is extremely slippery due to a heavy build-up of algae and constitutes a safety hazard.
- Figure 1.5-5: (Left) The ashlar stone used on the east façade is uniformly grained and properly bedded. It remains in very good condition. The rubble stone is less uniform and some isolated units exhibit significant delamination.

*Figure 1.5-5: (Left) The ashlar stone used on the east façade is uniformly grained and properly bedded. It remains in very good condition. The rubble stone is less uniform and some isolated units exhibit significant delamination.*

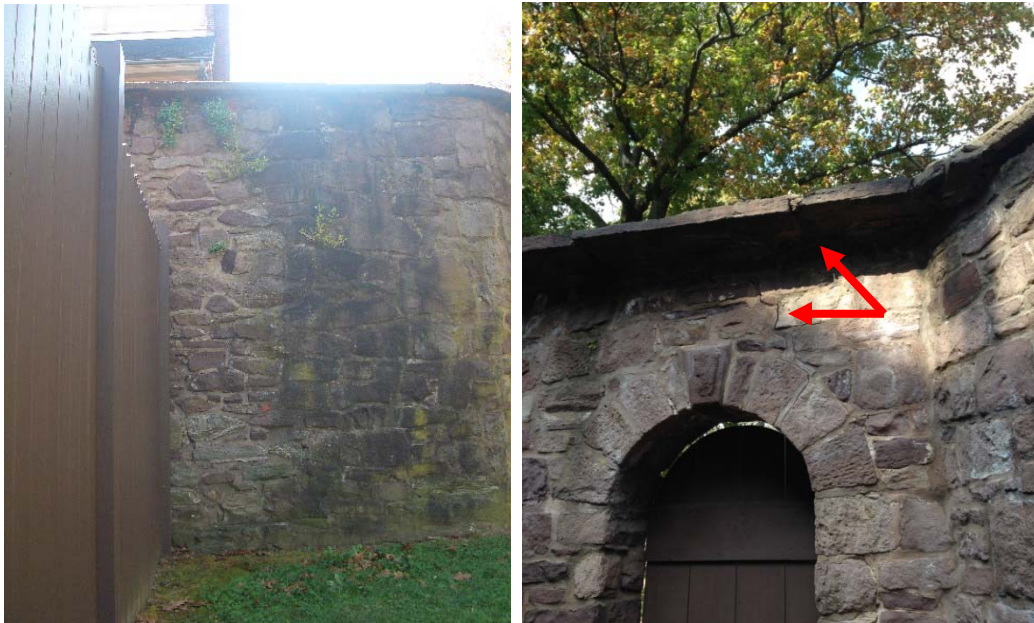
- Figure 1.5-6: (Left) The heavy biological staining on the east face of the courtyard wall is caused by water entering through the coping joint above. (Right) Cracking observed at the gate arch is aggravated by moisture from the open joint above.

*Figure 1.5-6: (Left) The heavy biological staining on the east face of the courtyard wall is caused by water entering through the coping joint above. (Right) Cracking observed at the gate arch is aggravated by moisture from the open joint above.*

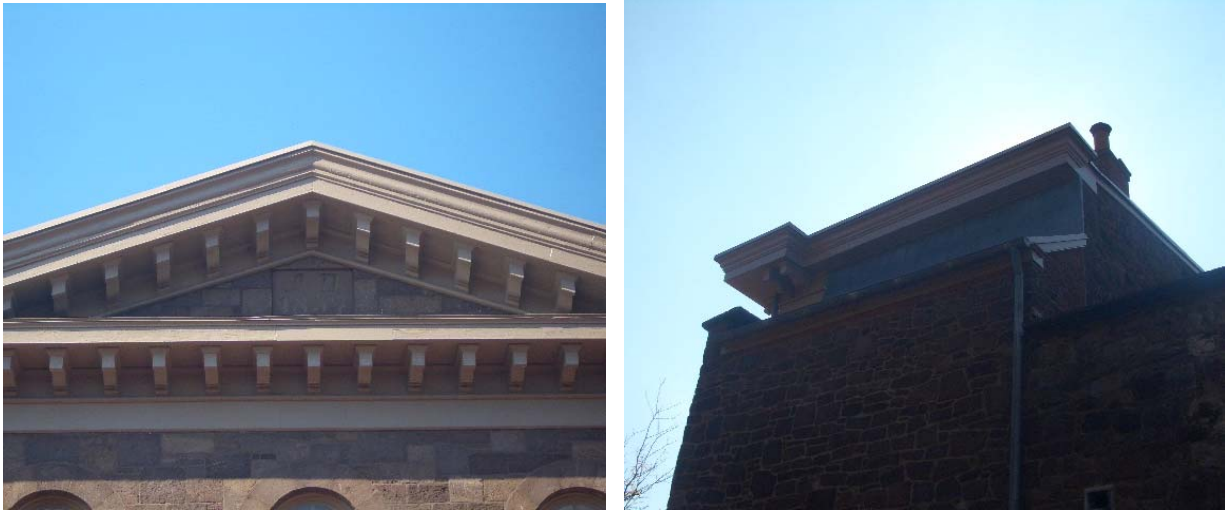
- Figure 1.5-9: (Left) Documentary evidence suggests that the modillion cornice has been at least partially replaced. The existing installation, though not inspected at close range,

appears to be in good condition. (Right) The modillion cornice transitions to a simpler profiled cornice at the sides of the building.

*Figure 1.5-9: (Left) Documentary evidence suggests that the modillion cornice has been at least partially replaced. The existing installation, though not inspected at close range, appears to be in good condition. (Right) The modillion cornice transitions to a simpler profiled cornice at the sides of the building.*

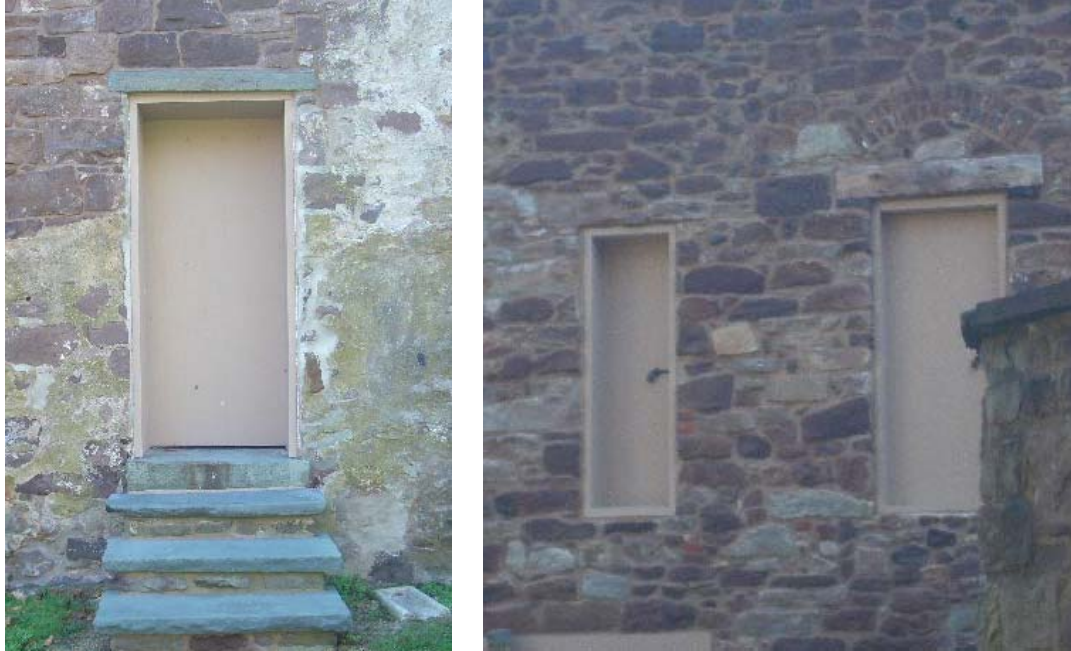
*Figure 1.5-12: (Left) The existing wood door leading into the old cell area consists of a board and batten door in a simple wood frame. The door may be opened from the inside only. (Right) The doors to the second-story prison cells are similarly constructed but with locking hardware on the exterior.*

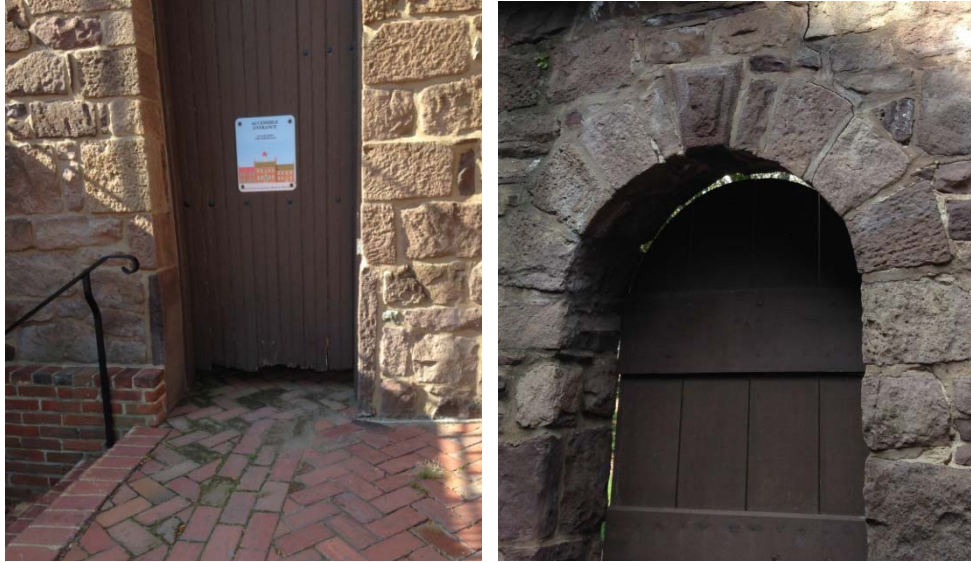
- Figure 1.5-13: (Left) The board-and-batten door to the access ramp displays moderate deterioration at bottom edge due to water penetration through the end grain. (Right) The board-and-batten door at the courtyard wall is in good condition despite minor deterioration at the bottom edge.

*Figure 1.5-13: (Left) The board-and-batten door to the access ramp displays moderate deterioration at bottom edge due to water penetration through the end grain. (Right) The board-and-batten door at the courtyard wall is in good condition despite minor deterioration at the bottom edge.*

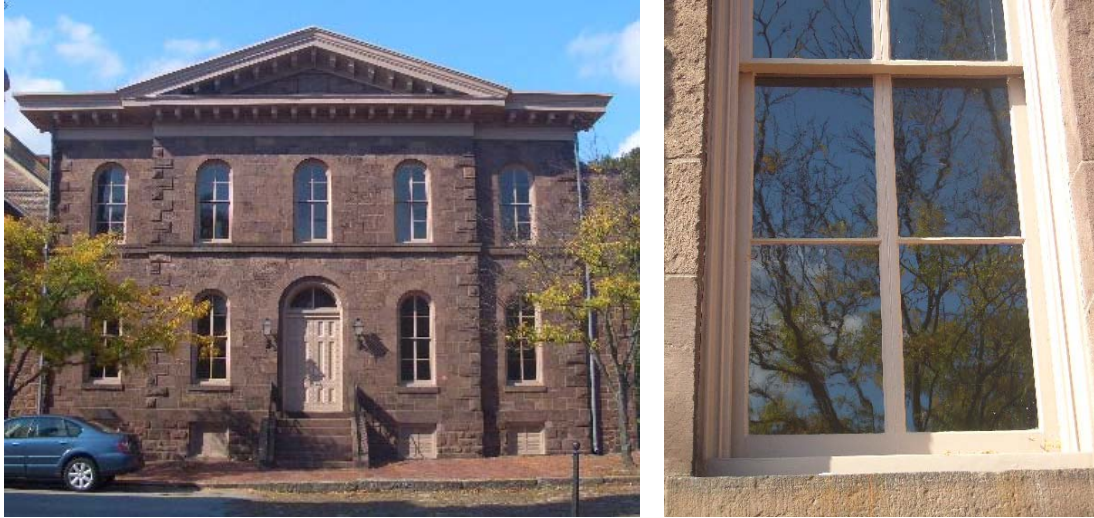
- Figure 1.5-14: (Left and Right) The arch-headed windows on the east façade appear to be relatively recent replacements and are in generally good condition. The use of wide vertical muntins with narrow horizontal muntins is somewhat unusual.

*Figure 1.5-14: (Left and Right) The arch-headed windows on the east façade appear to be relatively recent replacements and are in generally good condition. The use of wide vertical muntins with narrow horizontal muntins is somewhat unusual.*

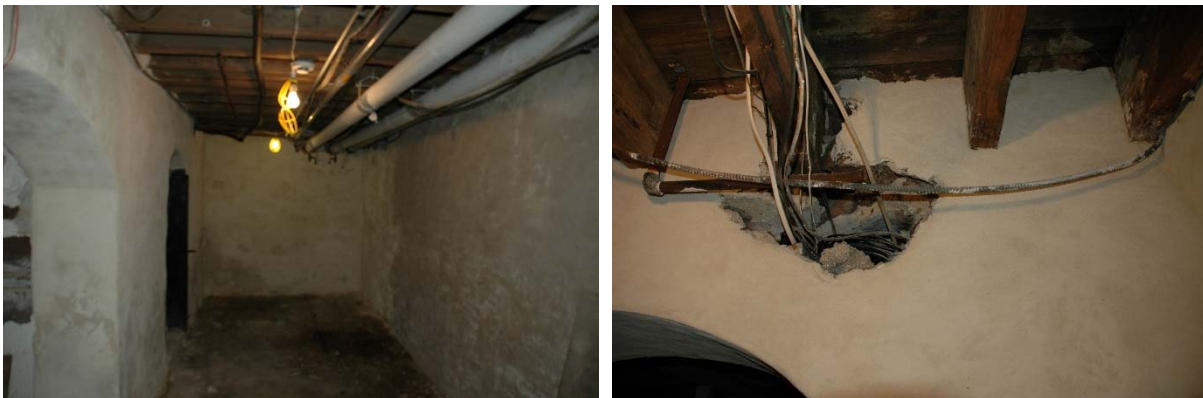
Figure 1.5-17: Views of loose building systems (left) and plaster damage at penetrations (right) in Room 002.

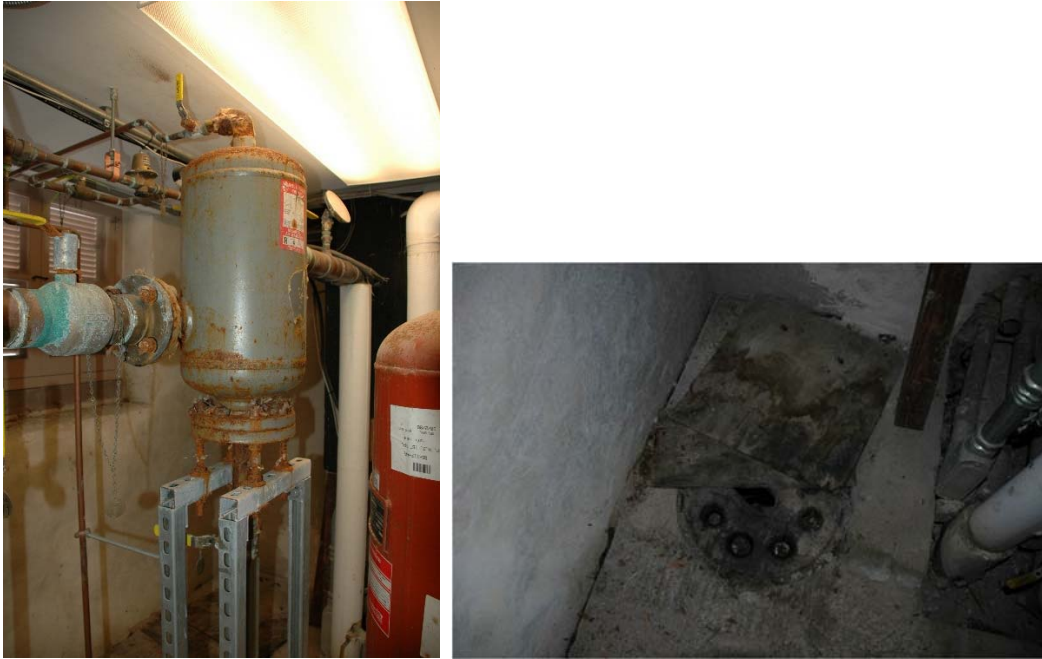
*Figure 1.5-18: View of mechanical equipment (left) and floor sump (right) in Room 003.*

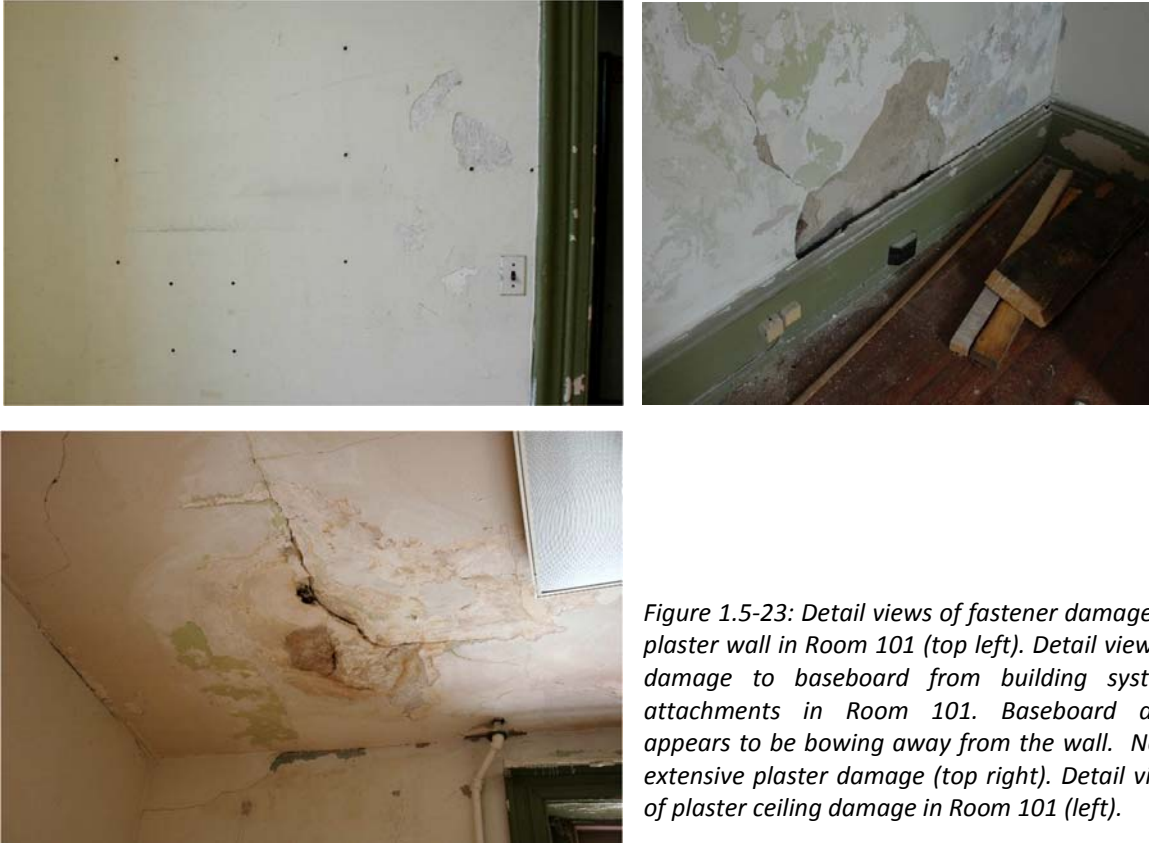
*Figure 1.5-23: Detail views of fastener damage at plaster wall in Room 101 (top left). Detail view of damage to baseboard from building system attachments in Room 101. Baseboard also appears to be bowing away from the wall. Note extensive plaster damage (top right). Detail view of plaster ceiling damage in Room 101 (left).*

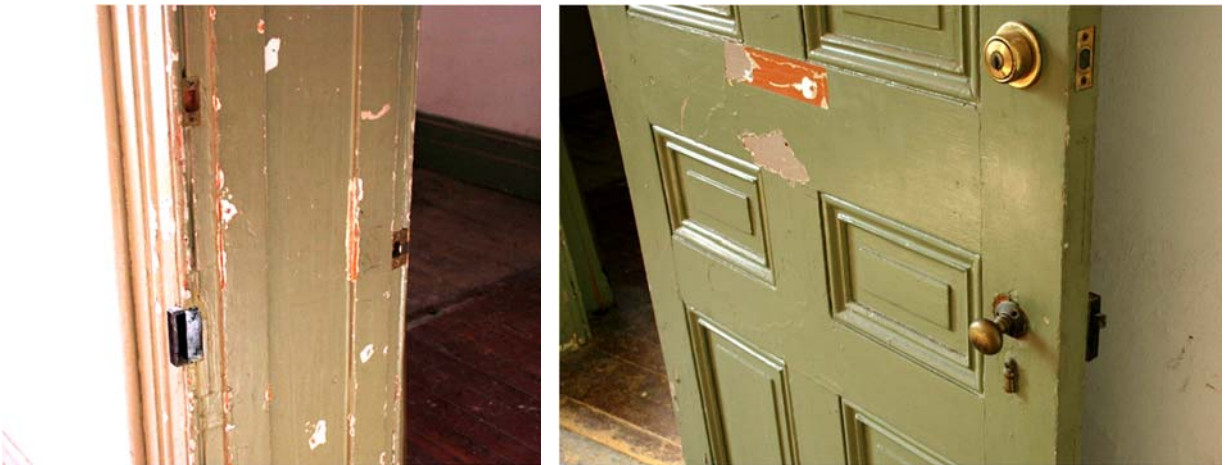
*Figure 1.5-24: Detail view of damage and multiple hardware campaigns at jamb and door at Room 101 (top left and right).*

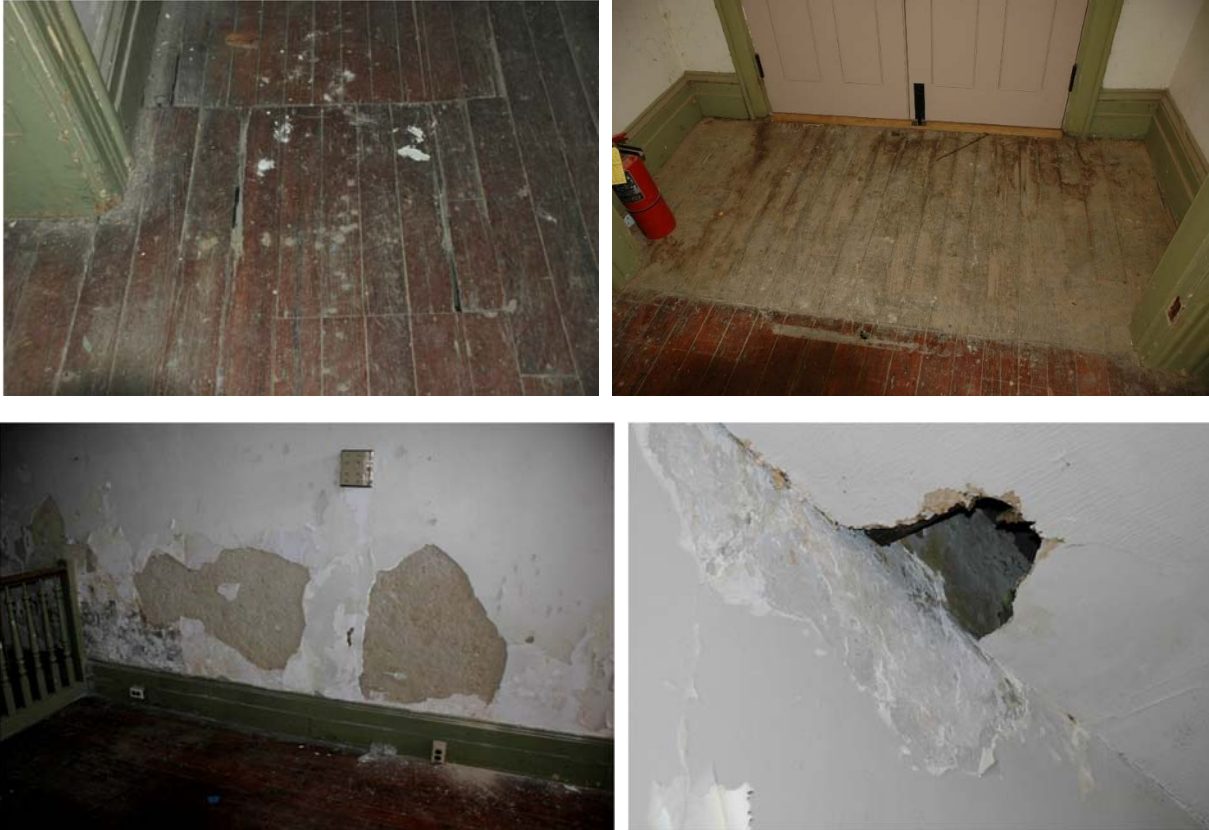
*Figure 1.5-25: Detail view of poorly matched patching and damage to individual boards in Room 102 (top left) and detail view of wear and water damage at east vestibule in Room 102 (top left).Detail view of severe water damage to plaster in Room 102 (bottom left) and detail view of plywood ceiling damage in Room 102 (left). Note original wall plaster above the plywood ceiling and damage (bottom right).*

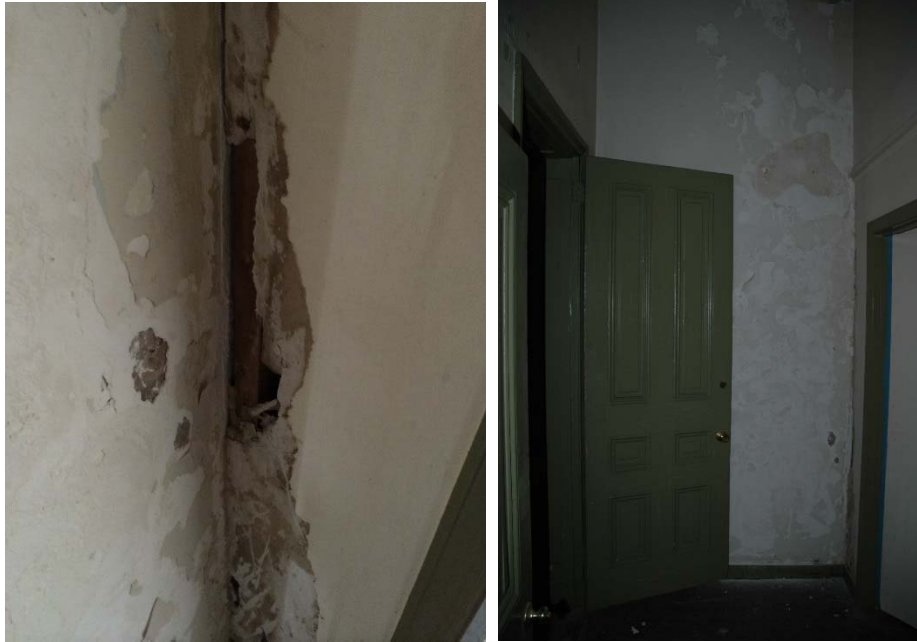
*Figure 1.5-30: View of plaster damage in southwest corner (left) and south wall (right) of Room 107.*

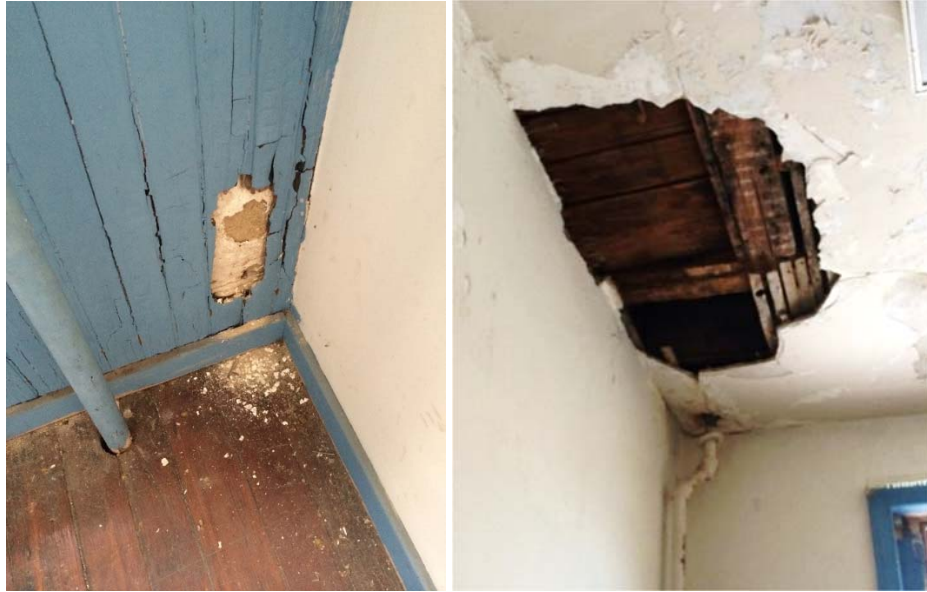
*Figure 1.5-31: Detail view of wood wainscot damage in Room 108. Note plaster wall damage behind the wainscot and mechanical system penetration at wood floor (right). Detail view of plaster ceiling damage in Room 108 (left).*

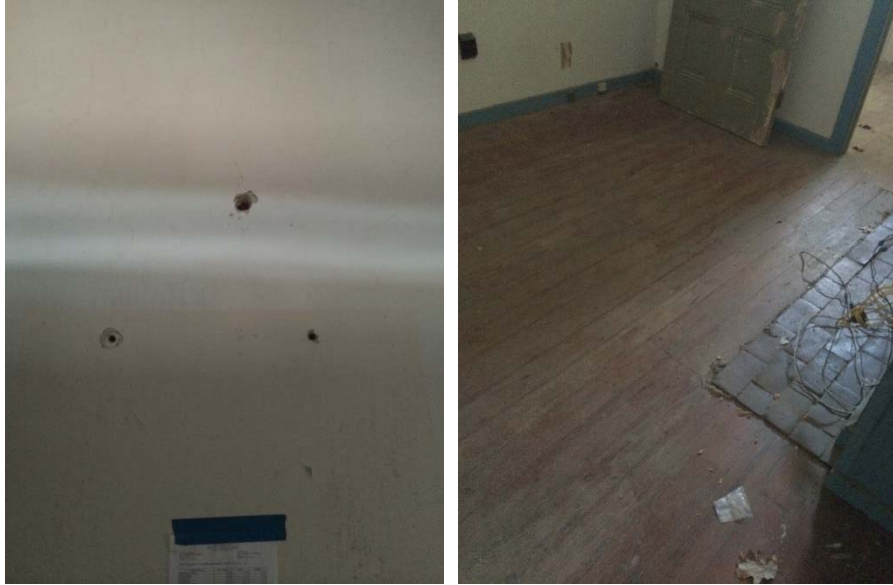
*Figure 1.5-32: View of fastener damage at east wall (left) and flooring wear (right) in Room 109.*

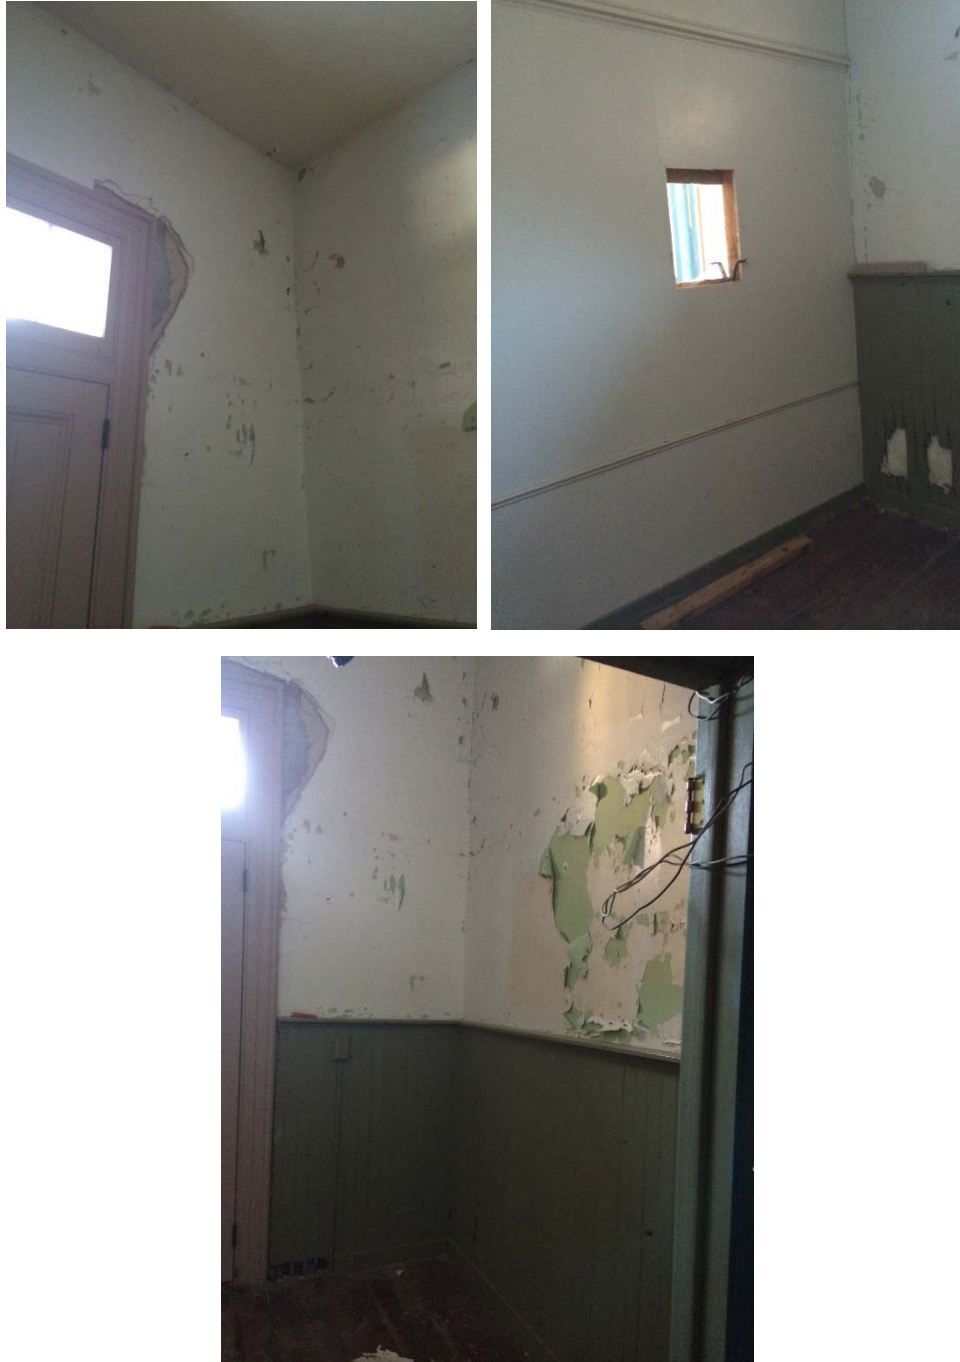
*Figure 1.5-33: View of plaster damage at west door (top left) and north wall (bottom) in Room 110. View of penetration in the south drywall partition.*

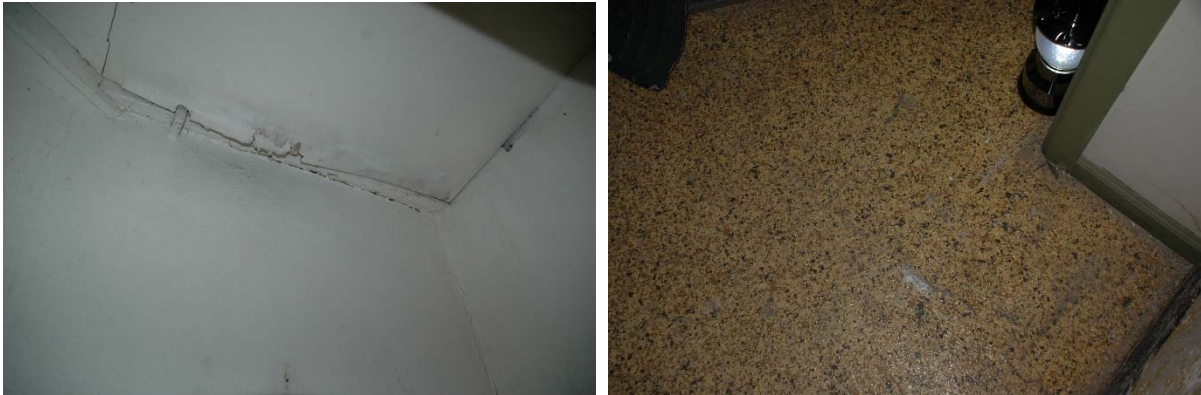
Figure 1.5-35: View of cracking at ceiling (left) and 20<sup>th</sup> century epoxy flooring (right) in Room 112.

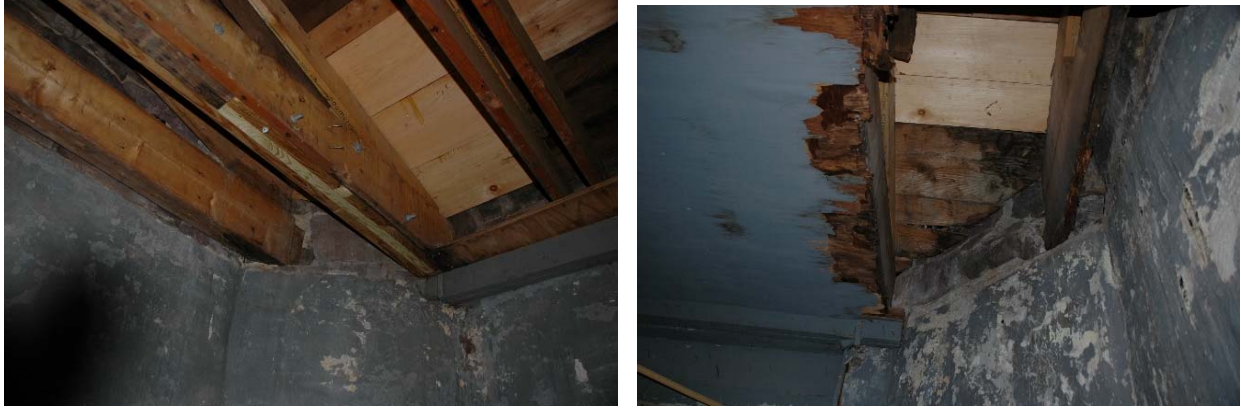
*Figure 1.5-37: View of exposed roof framing and damaged plywood ceiling in Room 114.*

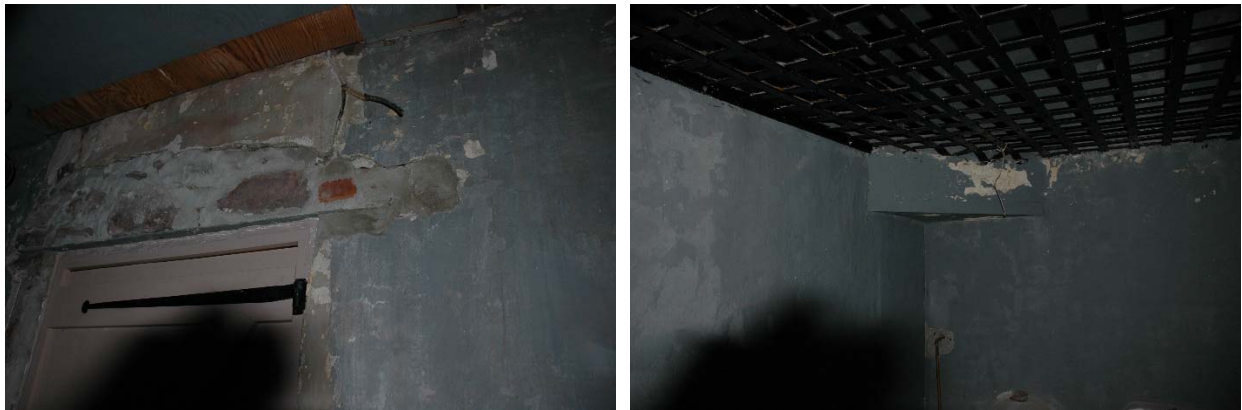
*Figure 1.5-38: Detail view of missing plaster where masonry was rebuilt (left). Detail view of cracking at concrete shelf support for cell ceiling (right). Both views in Room 114.*

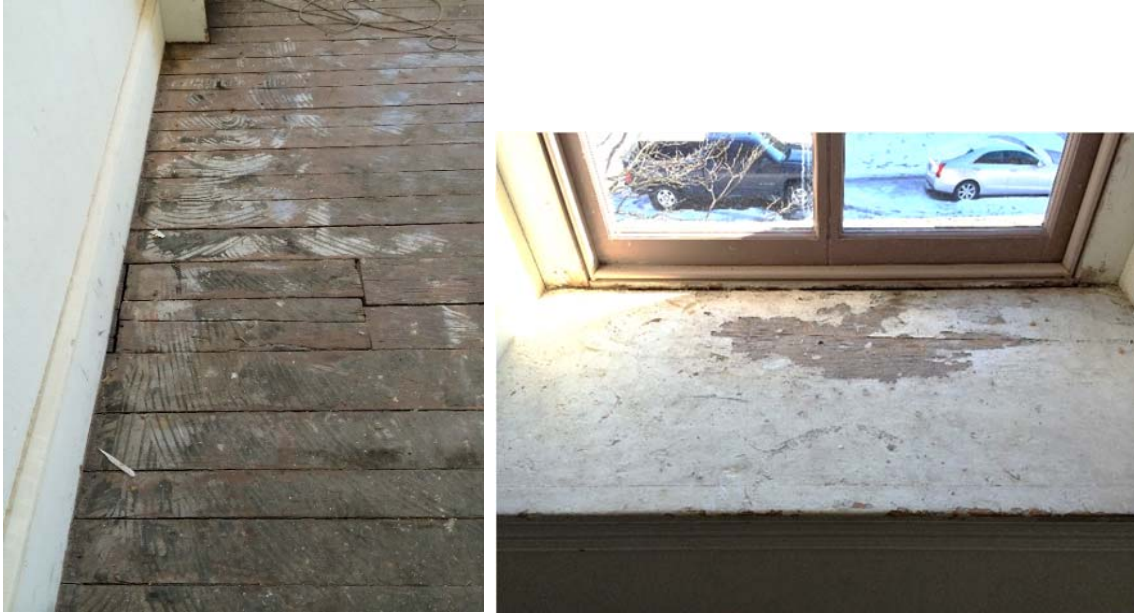
*Figure 1.5-41: Detail view of flooring patch in Room 202 (left)  
Detail view of window stool damage in Room 202 (right).*
