UNITED STATES STRATEGIC BOMBING SURVEY

REPORT 72

EFFECTS OF THE FOUR THOUSAND-POUND BOMB

A Report on Five Incidents

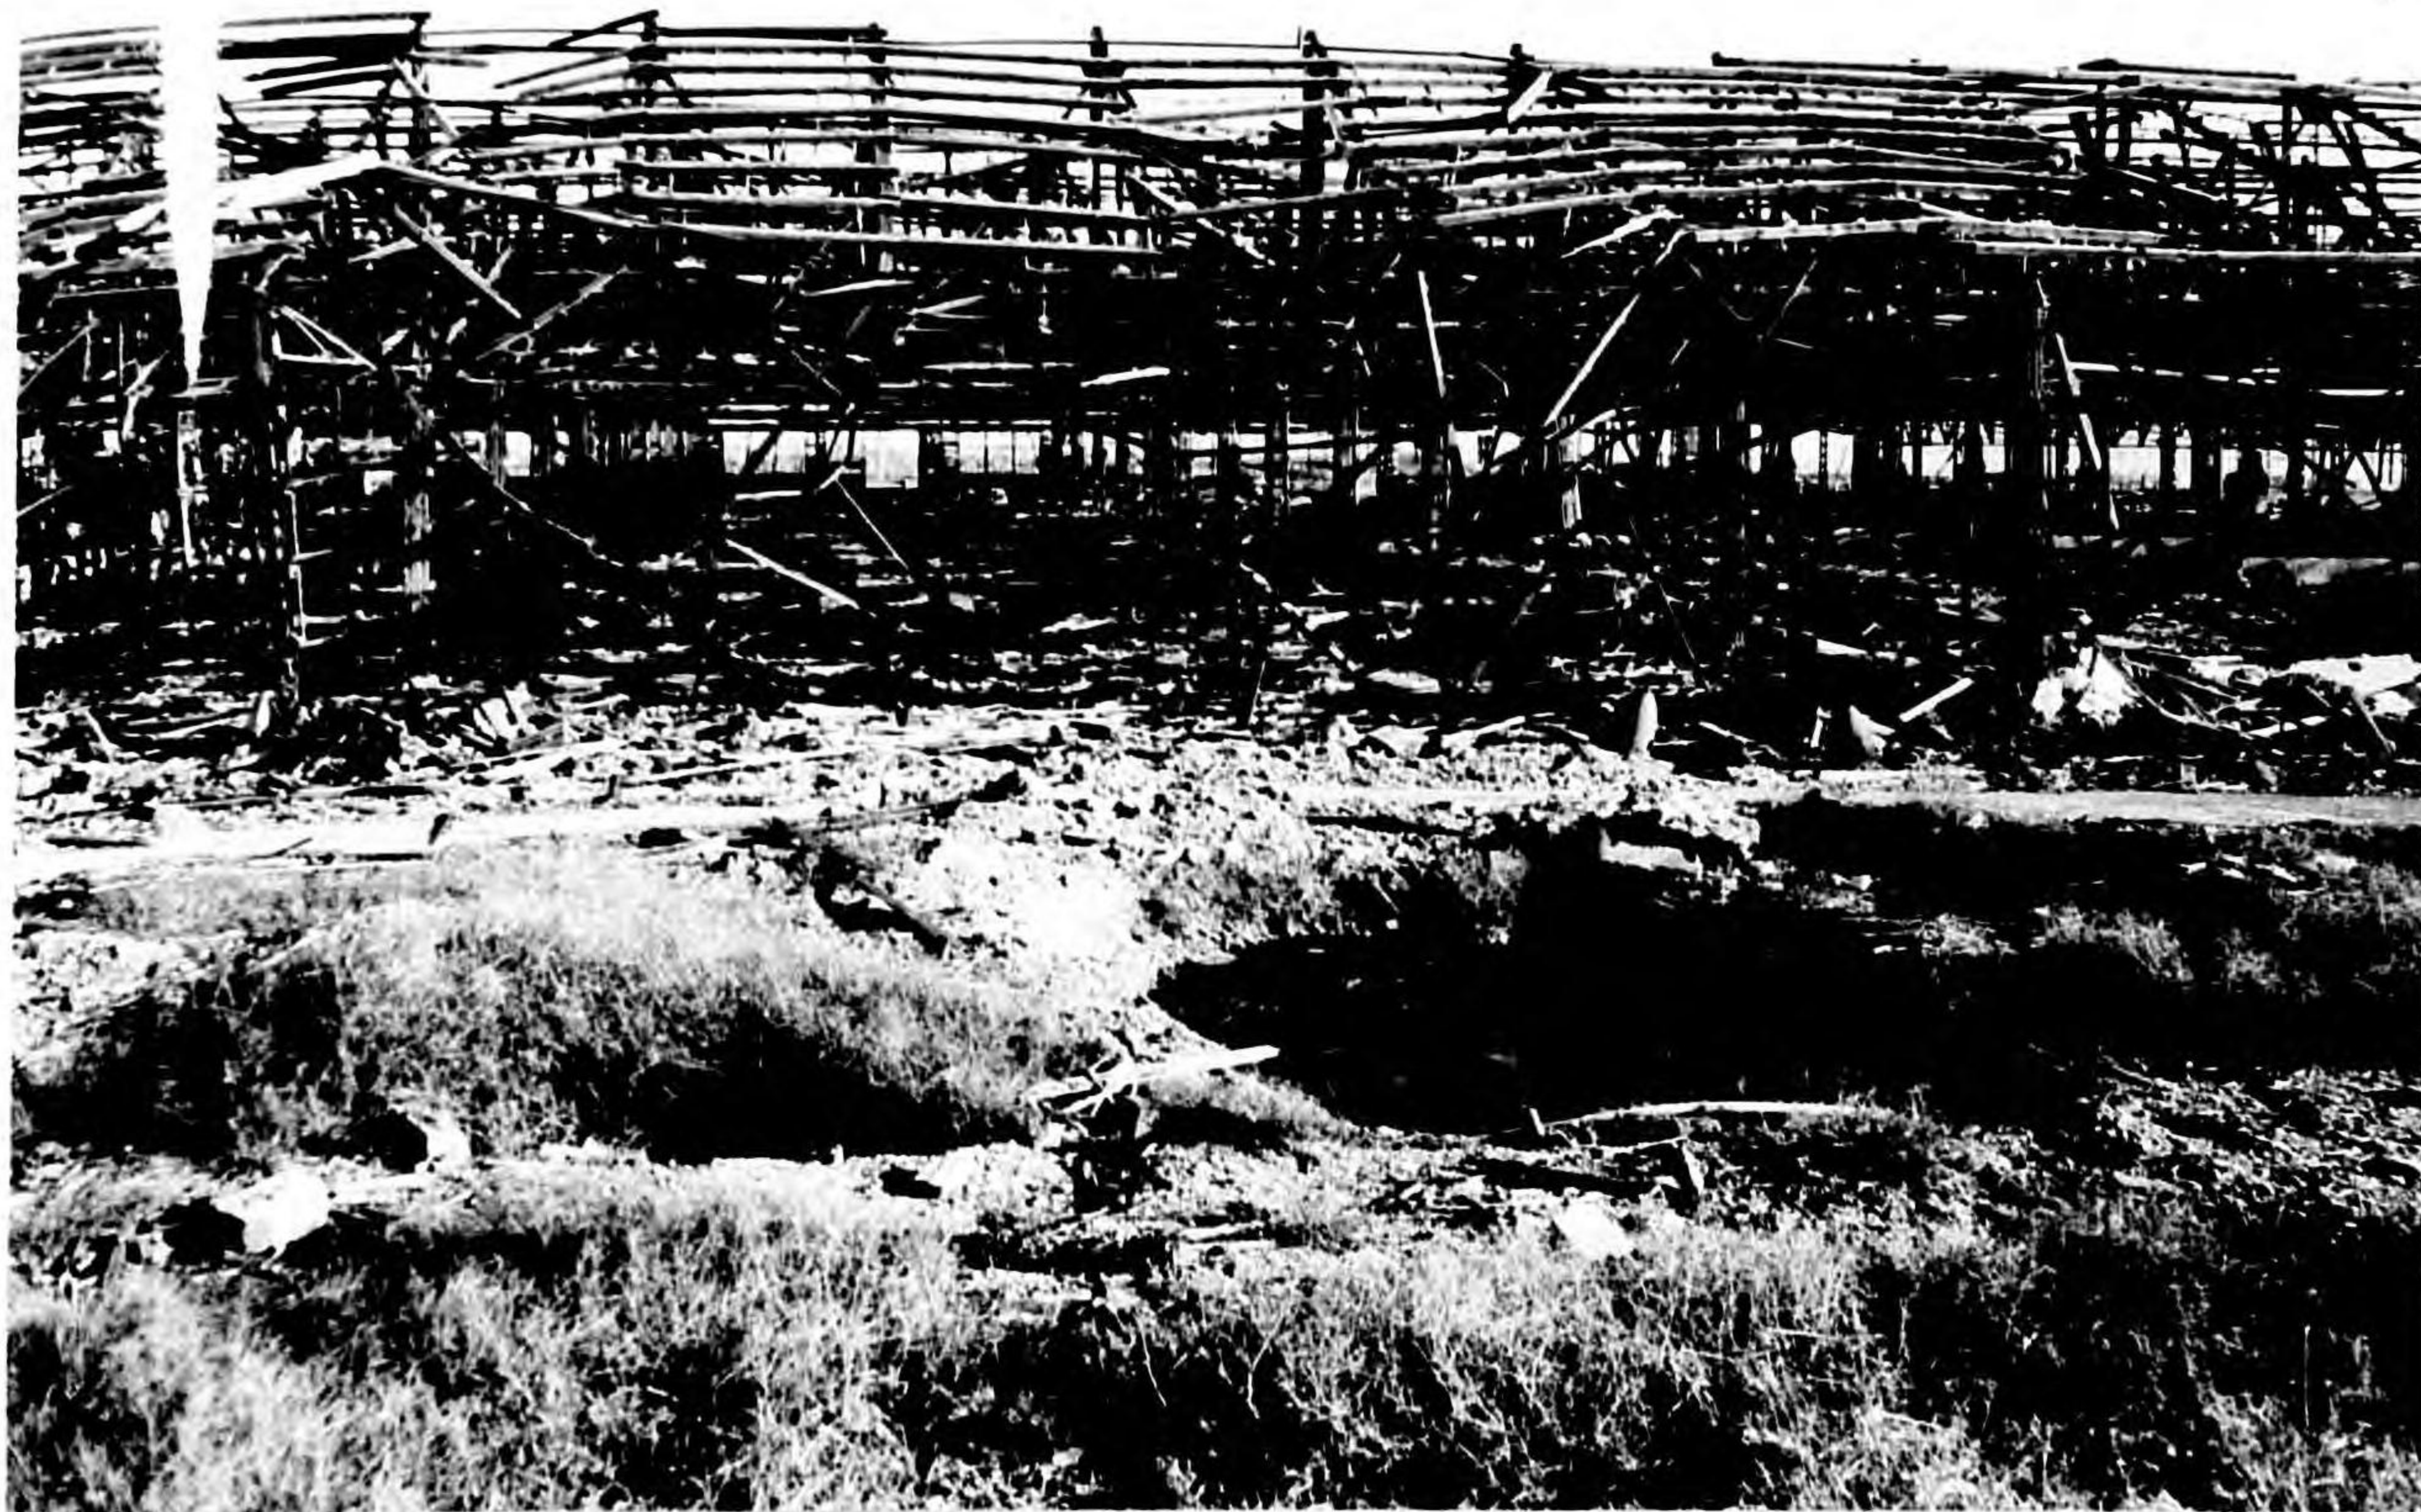
b. Building 3, a structural-steel, one-story building, was damaged by the effect of a near-miss (Bomb 25) approximately 35 feet from the northwest end (Photo 3). No columns were knocked down, but

several were badly distorted, and the roof steel was severely damaged.

Photo 3 - Bldg. 3, Bomb 25 (CRATER IN FOREGROUND) NEAR MISS 35 ft. FROM Bldg.

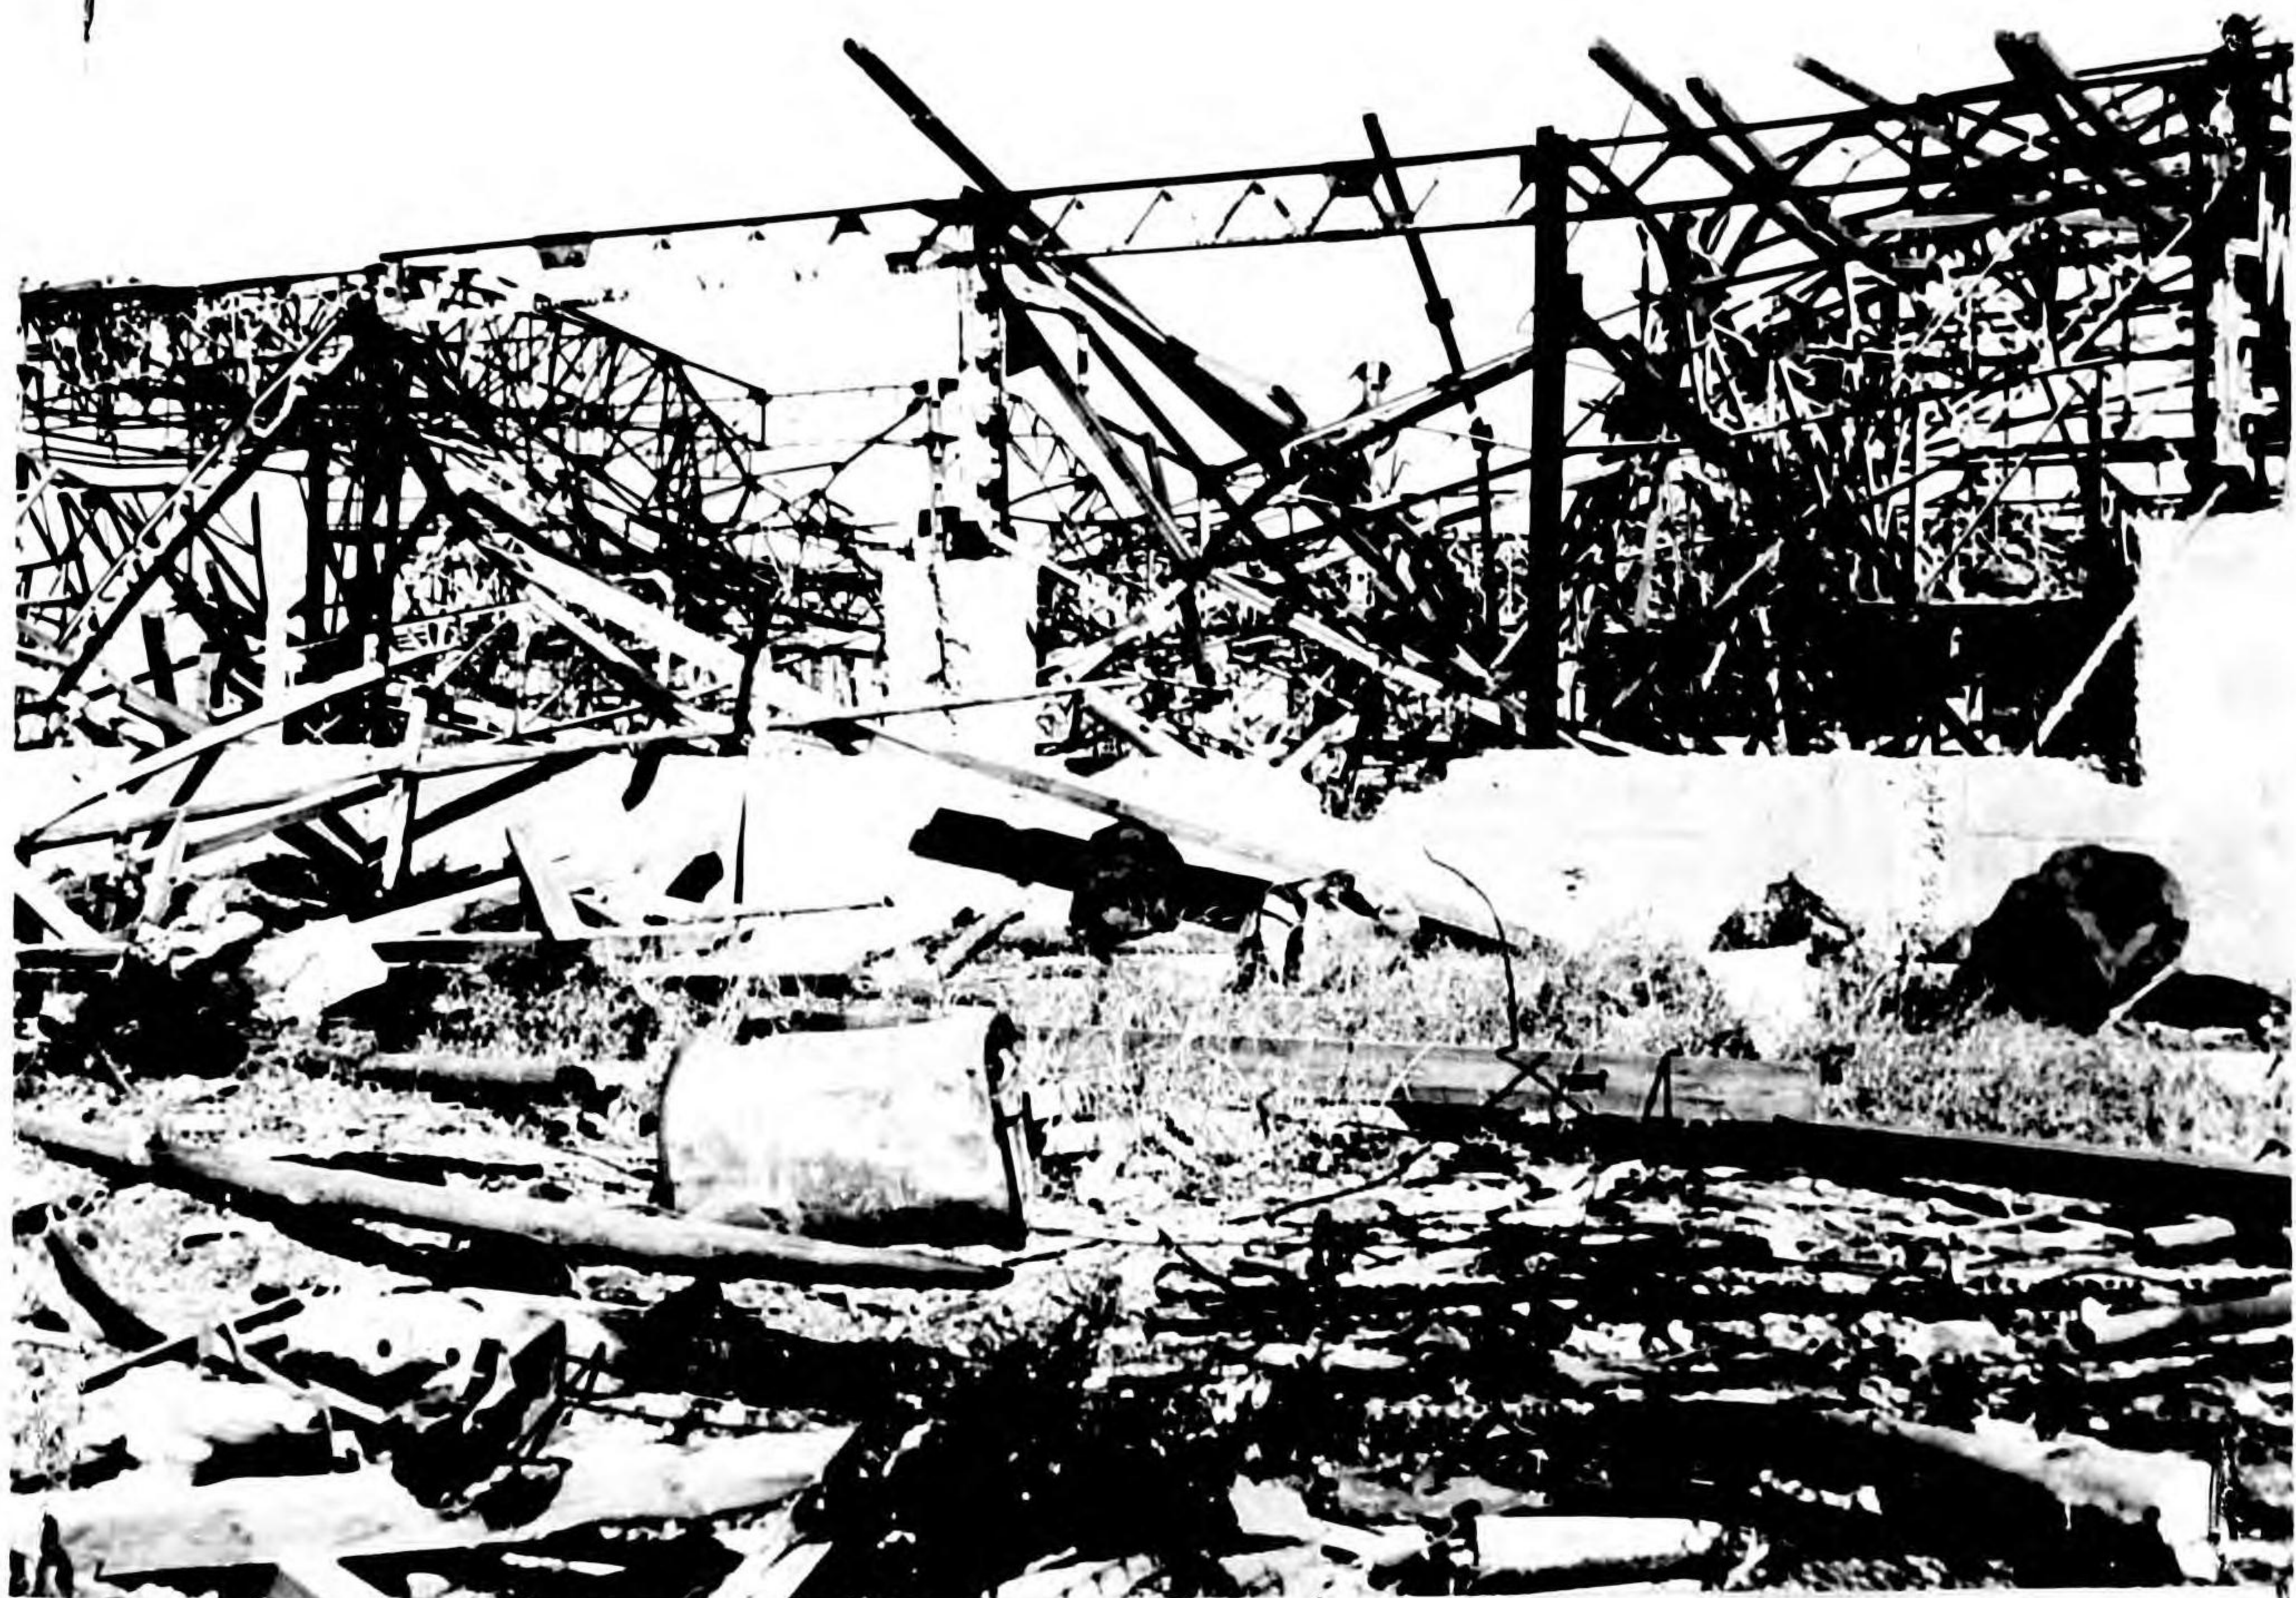
c. Building A, also a structural-steel, one-story building, was struck by Bomb 29 (Photos 4 and 5 present general views of damage from this hit) which knocked down several columns. Photos 6 and 7 show the two interior columns which were displaced, and Photos 8 and 9 show exterior columns. The destruction of these columns and the immediate area of roof steel (Photos 4, 5, 7) resulted in widespread collapse and distortion. There were two near-misses (Bombs 30 and 31) approximately 50 feet distant from the southwest side of the building. It could not be determined whether any structural damage resulted from these near-misses as the positive damage caused by Bomb 29 was very heavy and extended to and covered any area that would have been affected by Bombs 30 and 31.

Photo 4 - Bldg. 4, Bomb 79 GENERAL VIEW. 38

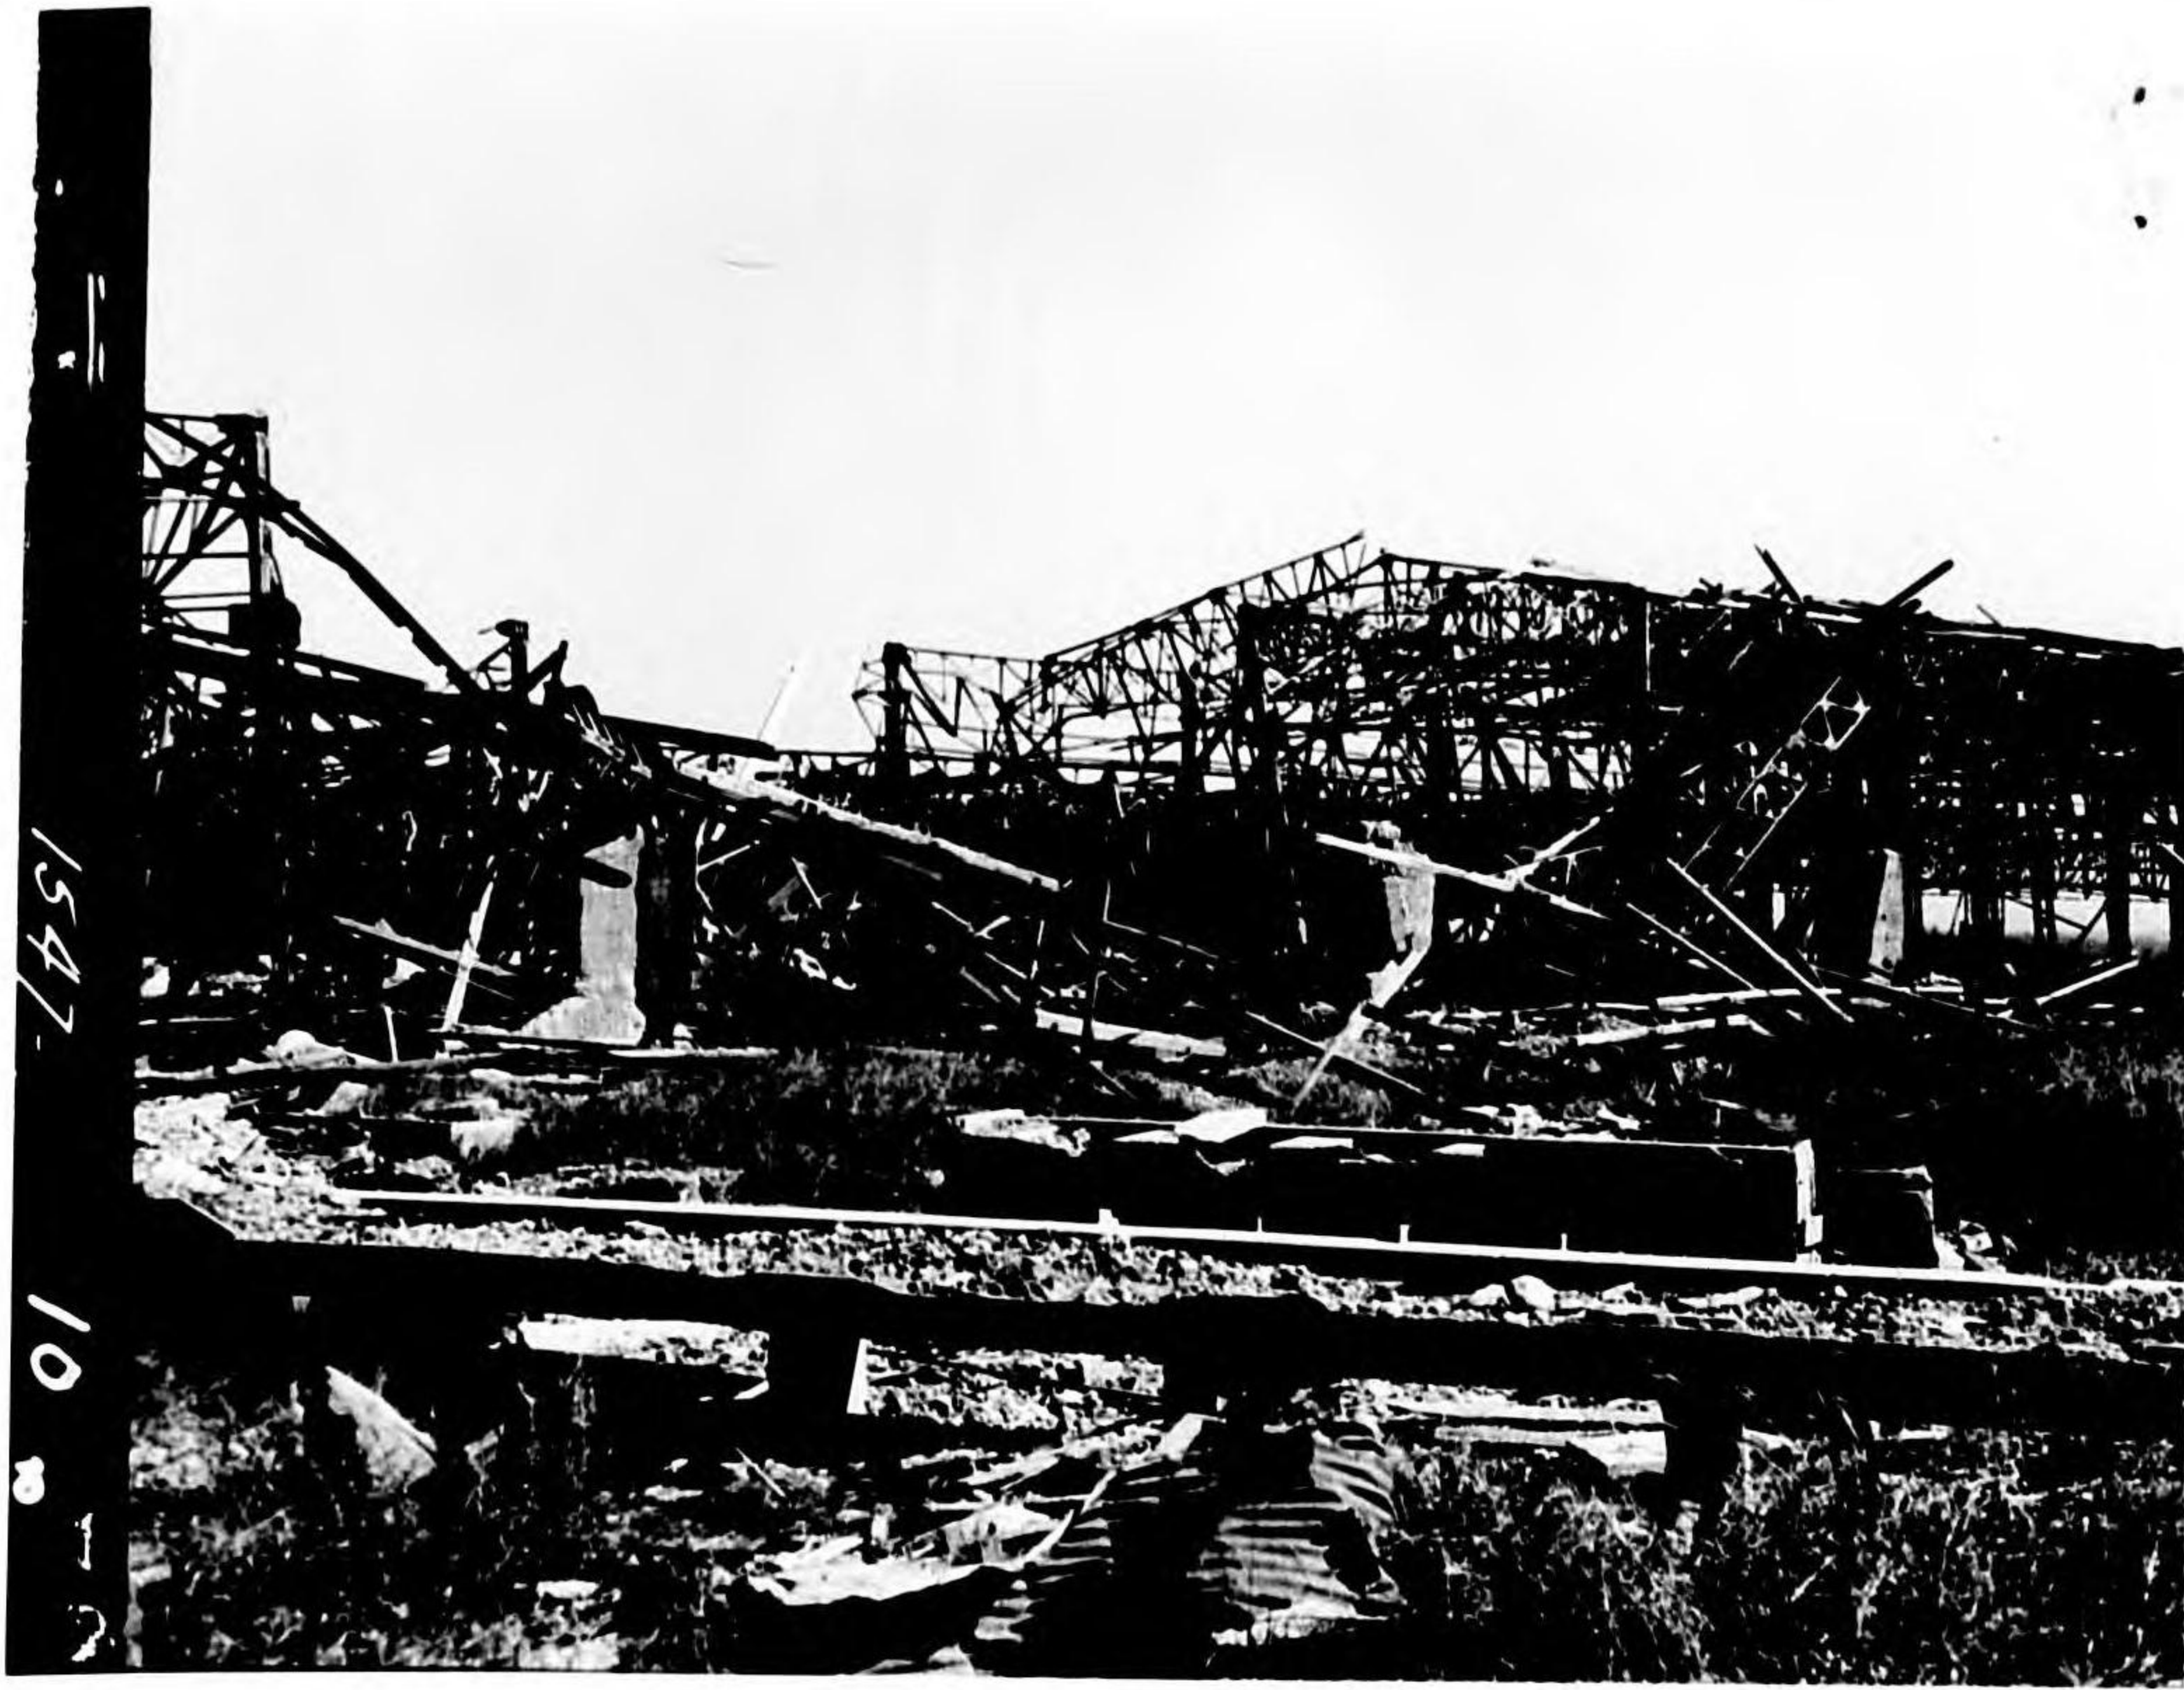
Photo 5 - Bldg 4, Bomb 29, General view.

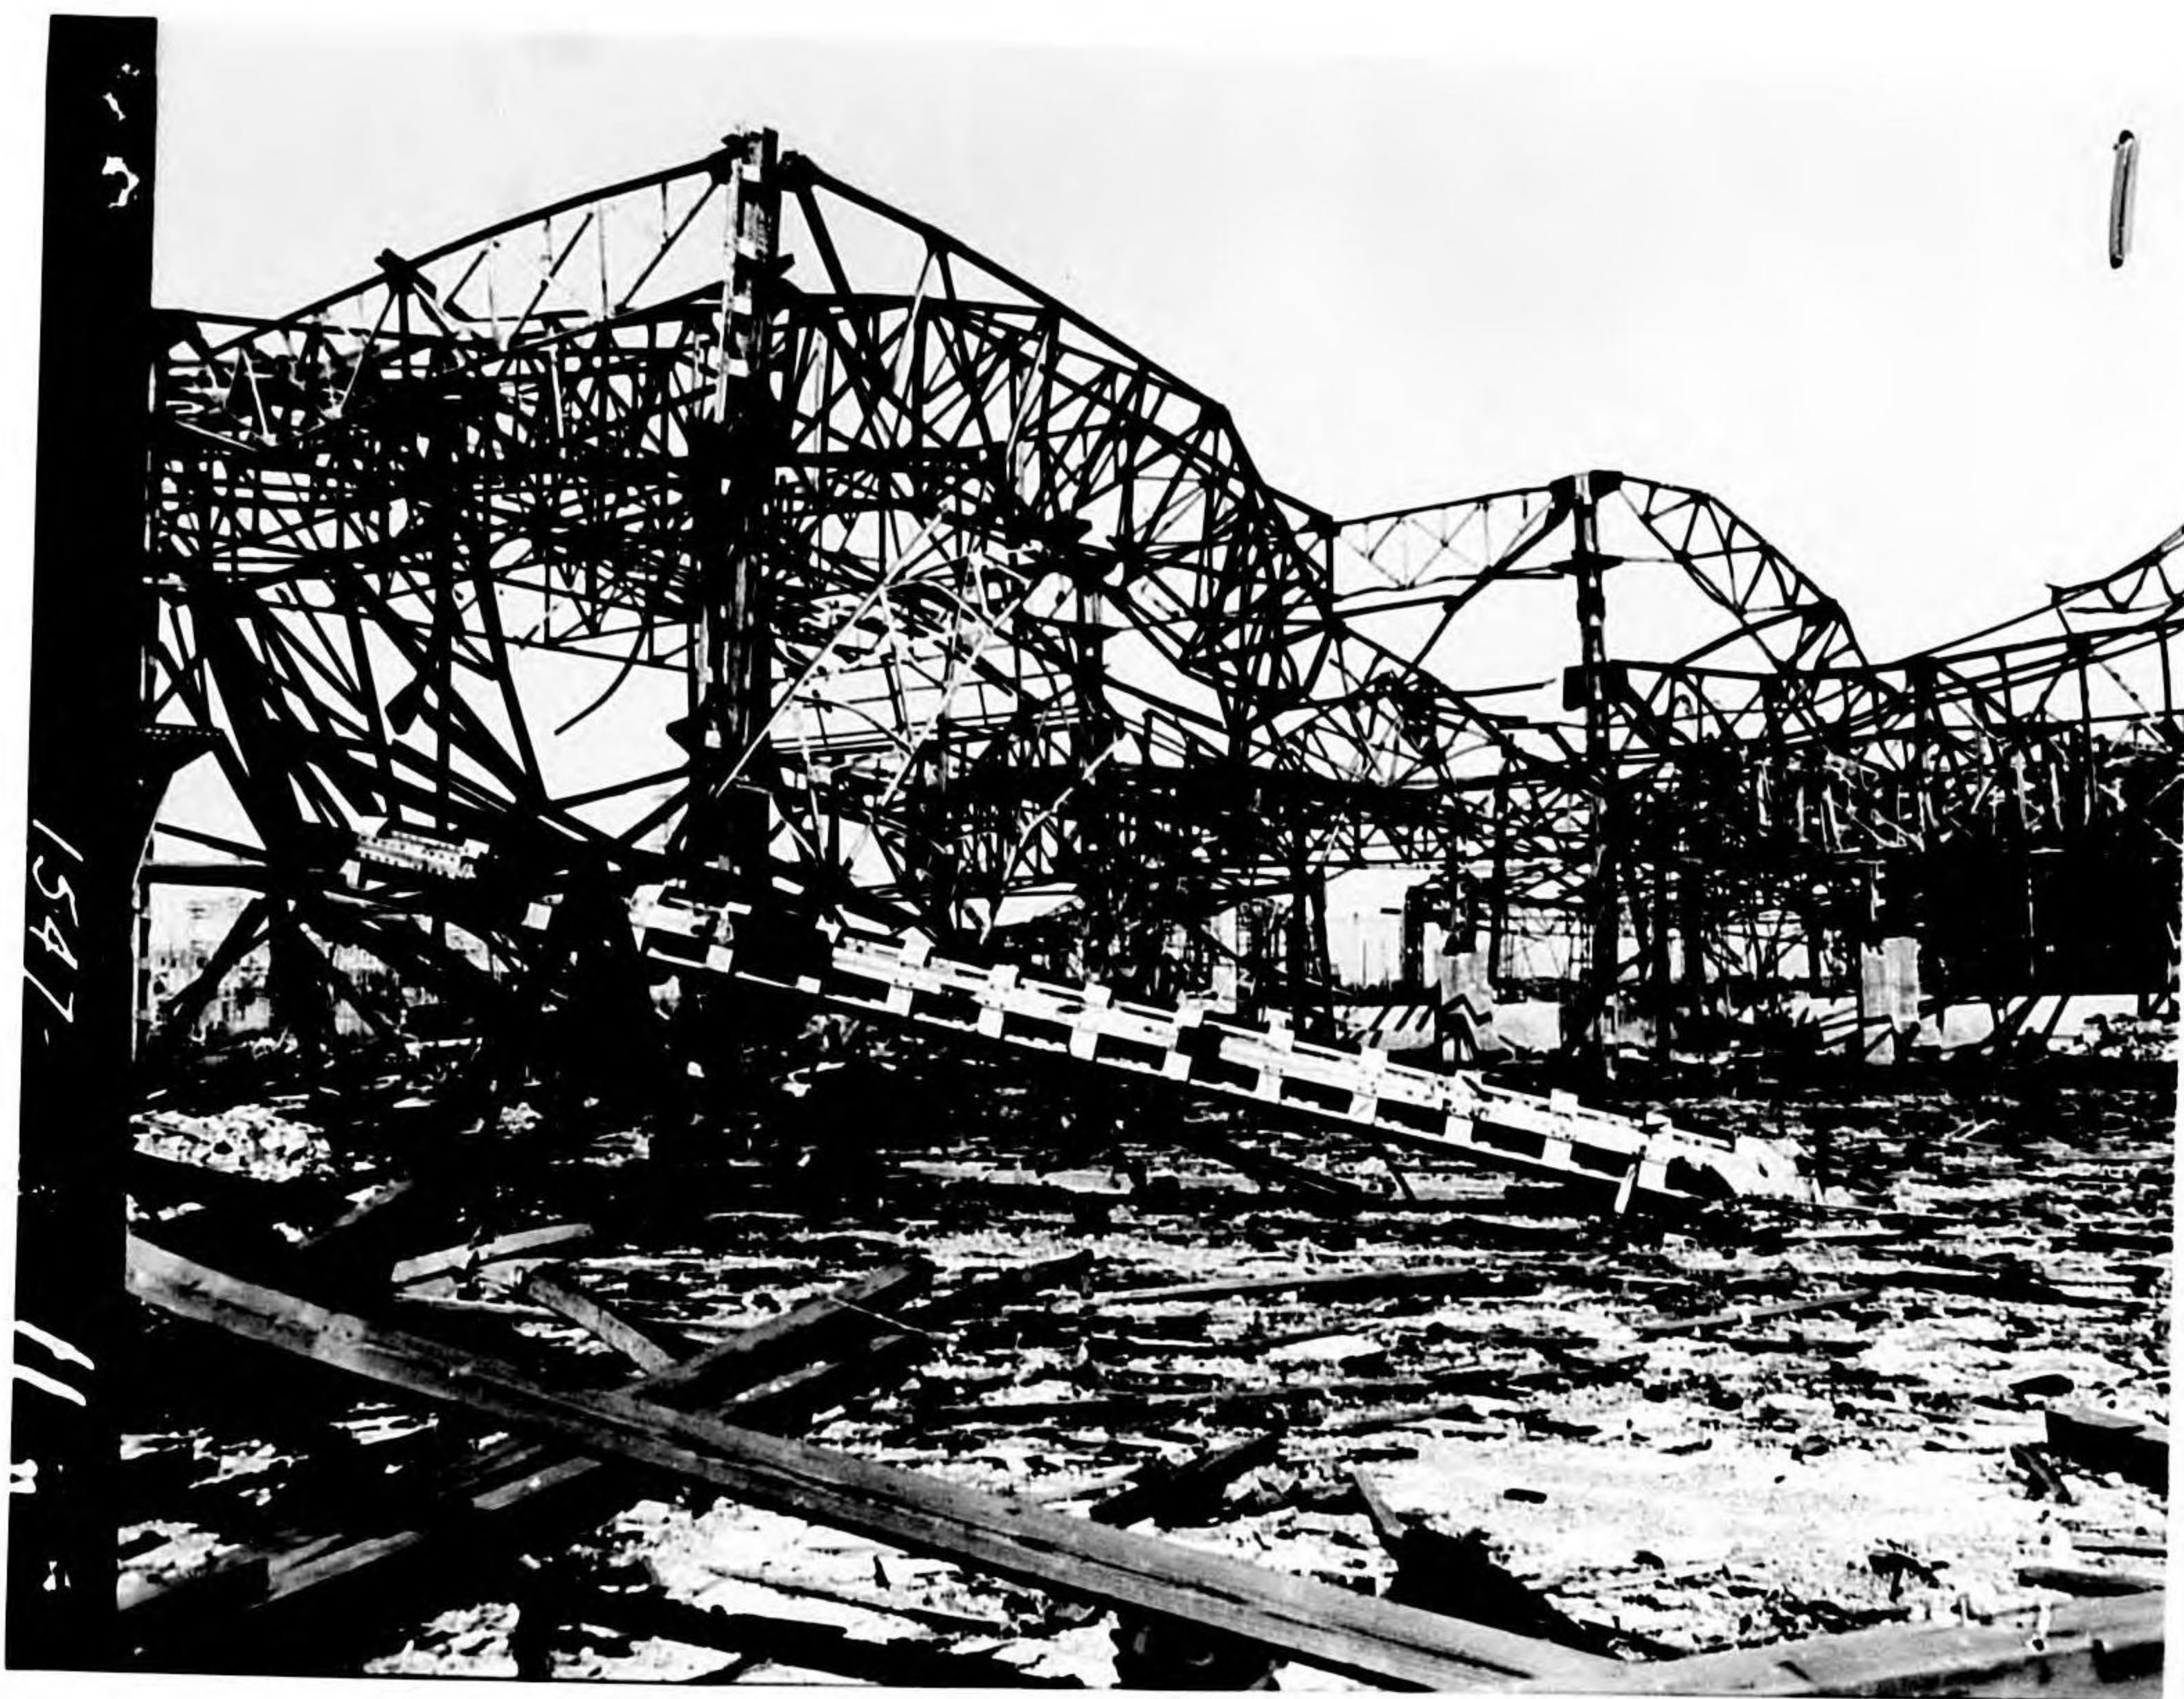
Photo 6 - Bldg 4, Bomb 29, Interior Column
blown over.

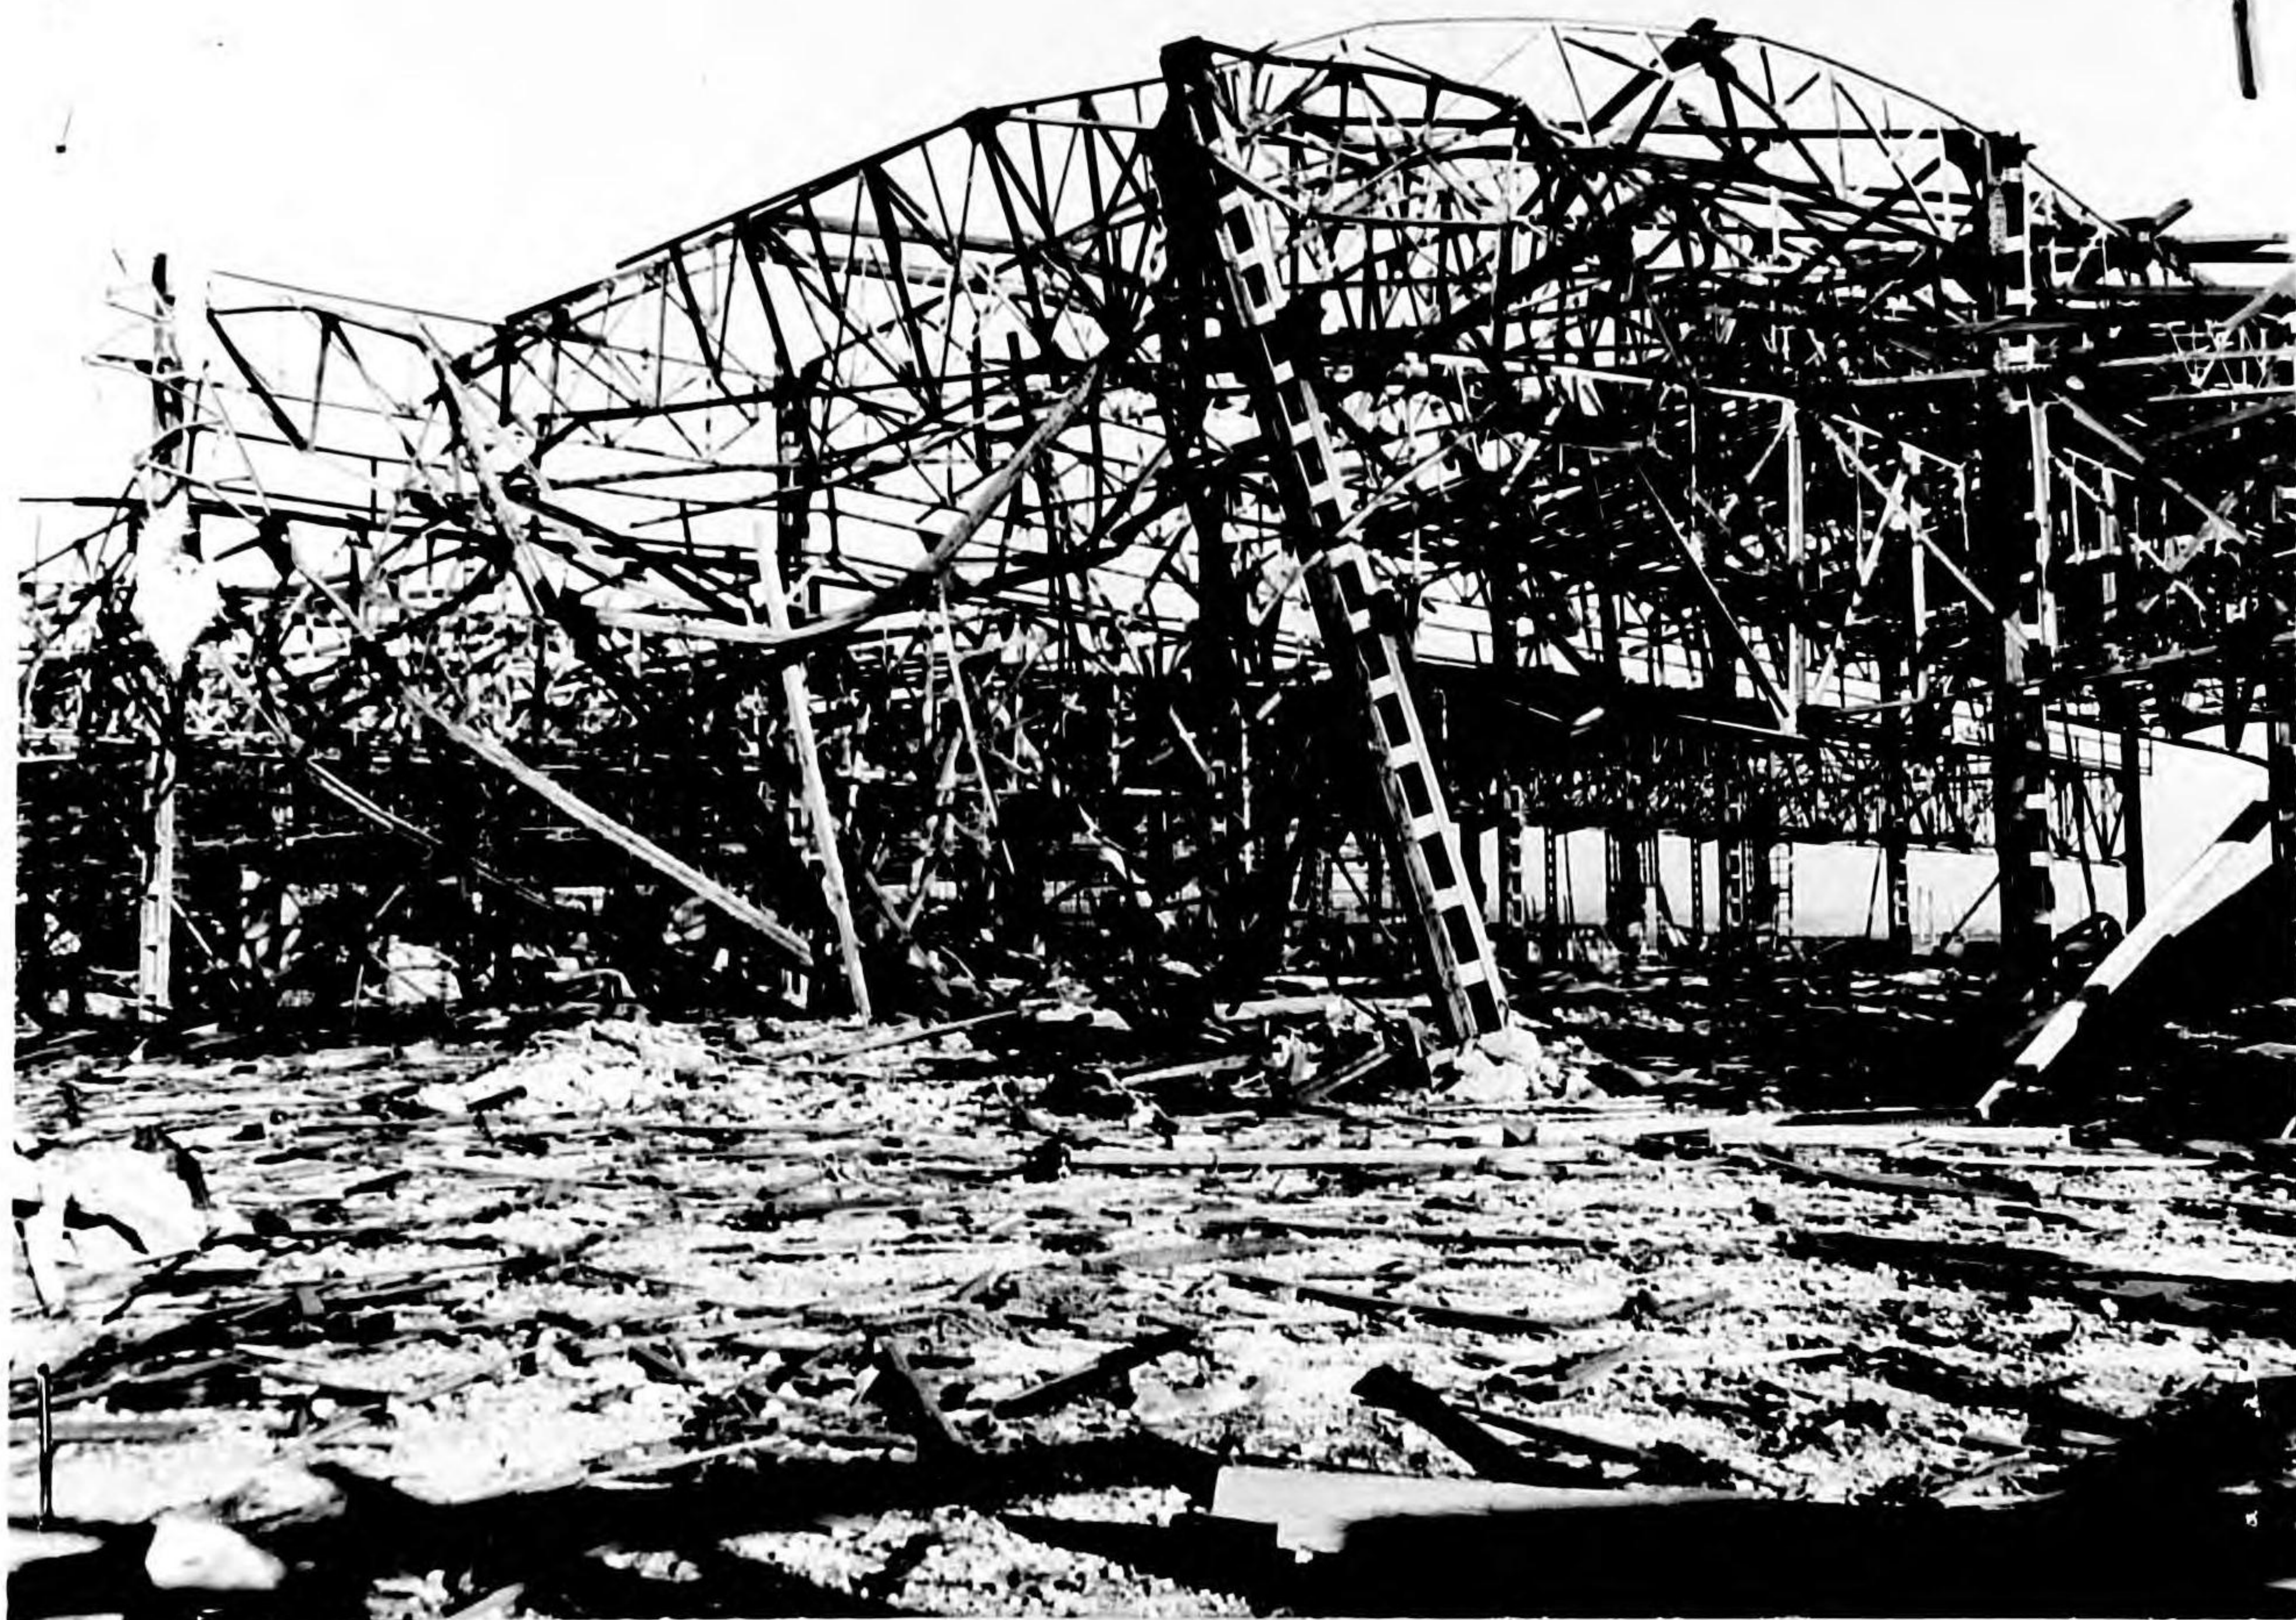
Photo 7 - Bldg. 4, Bomb 29, Interior Column Displaced.

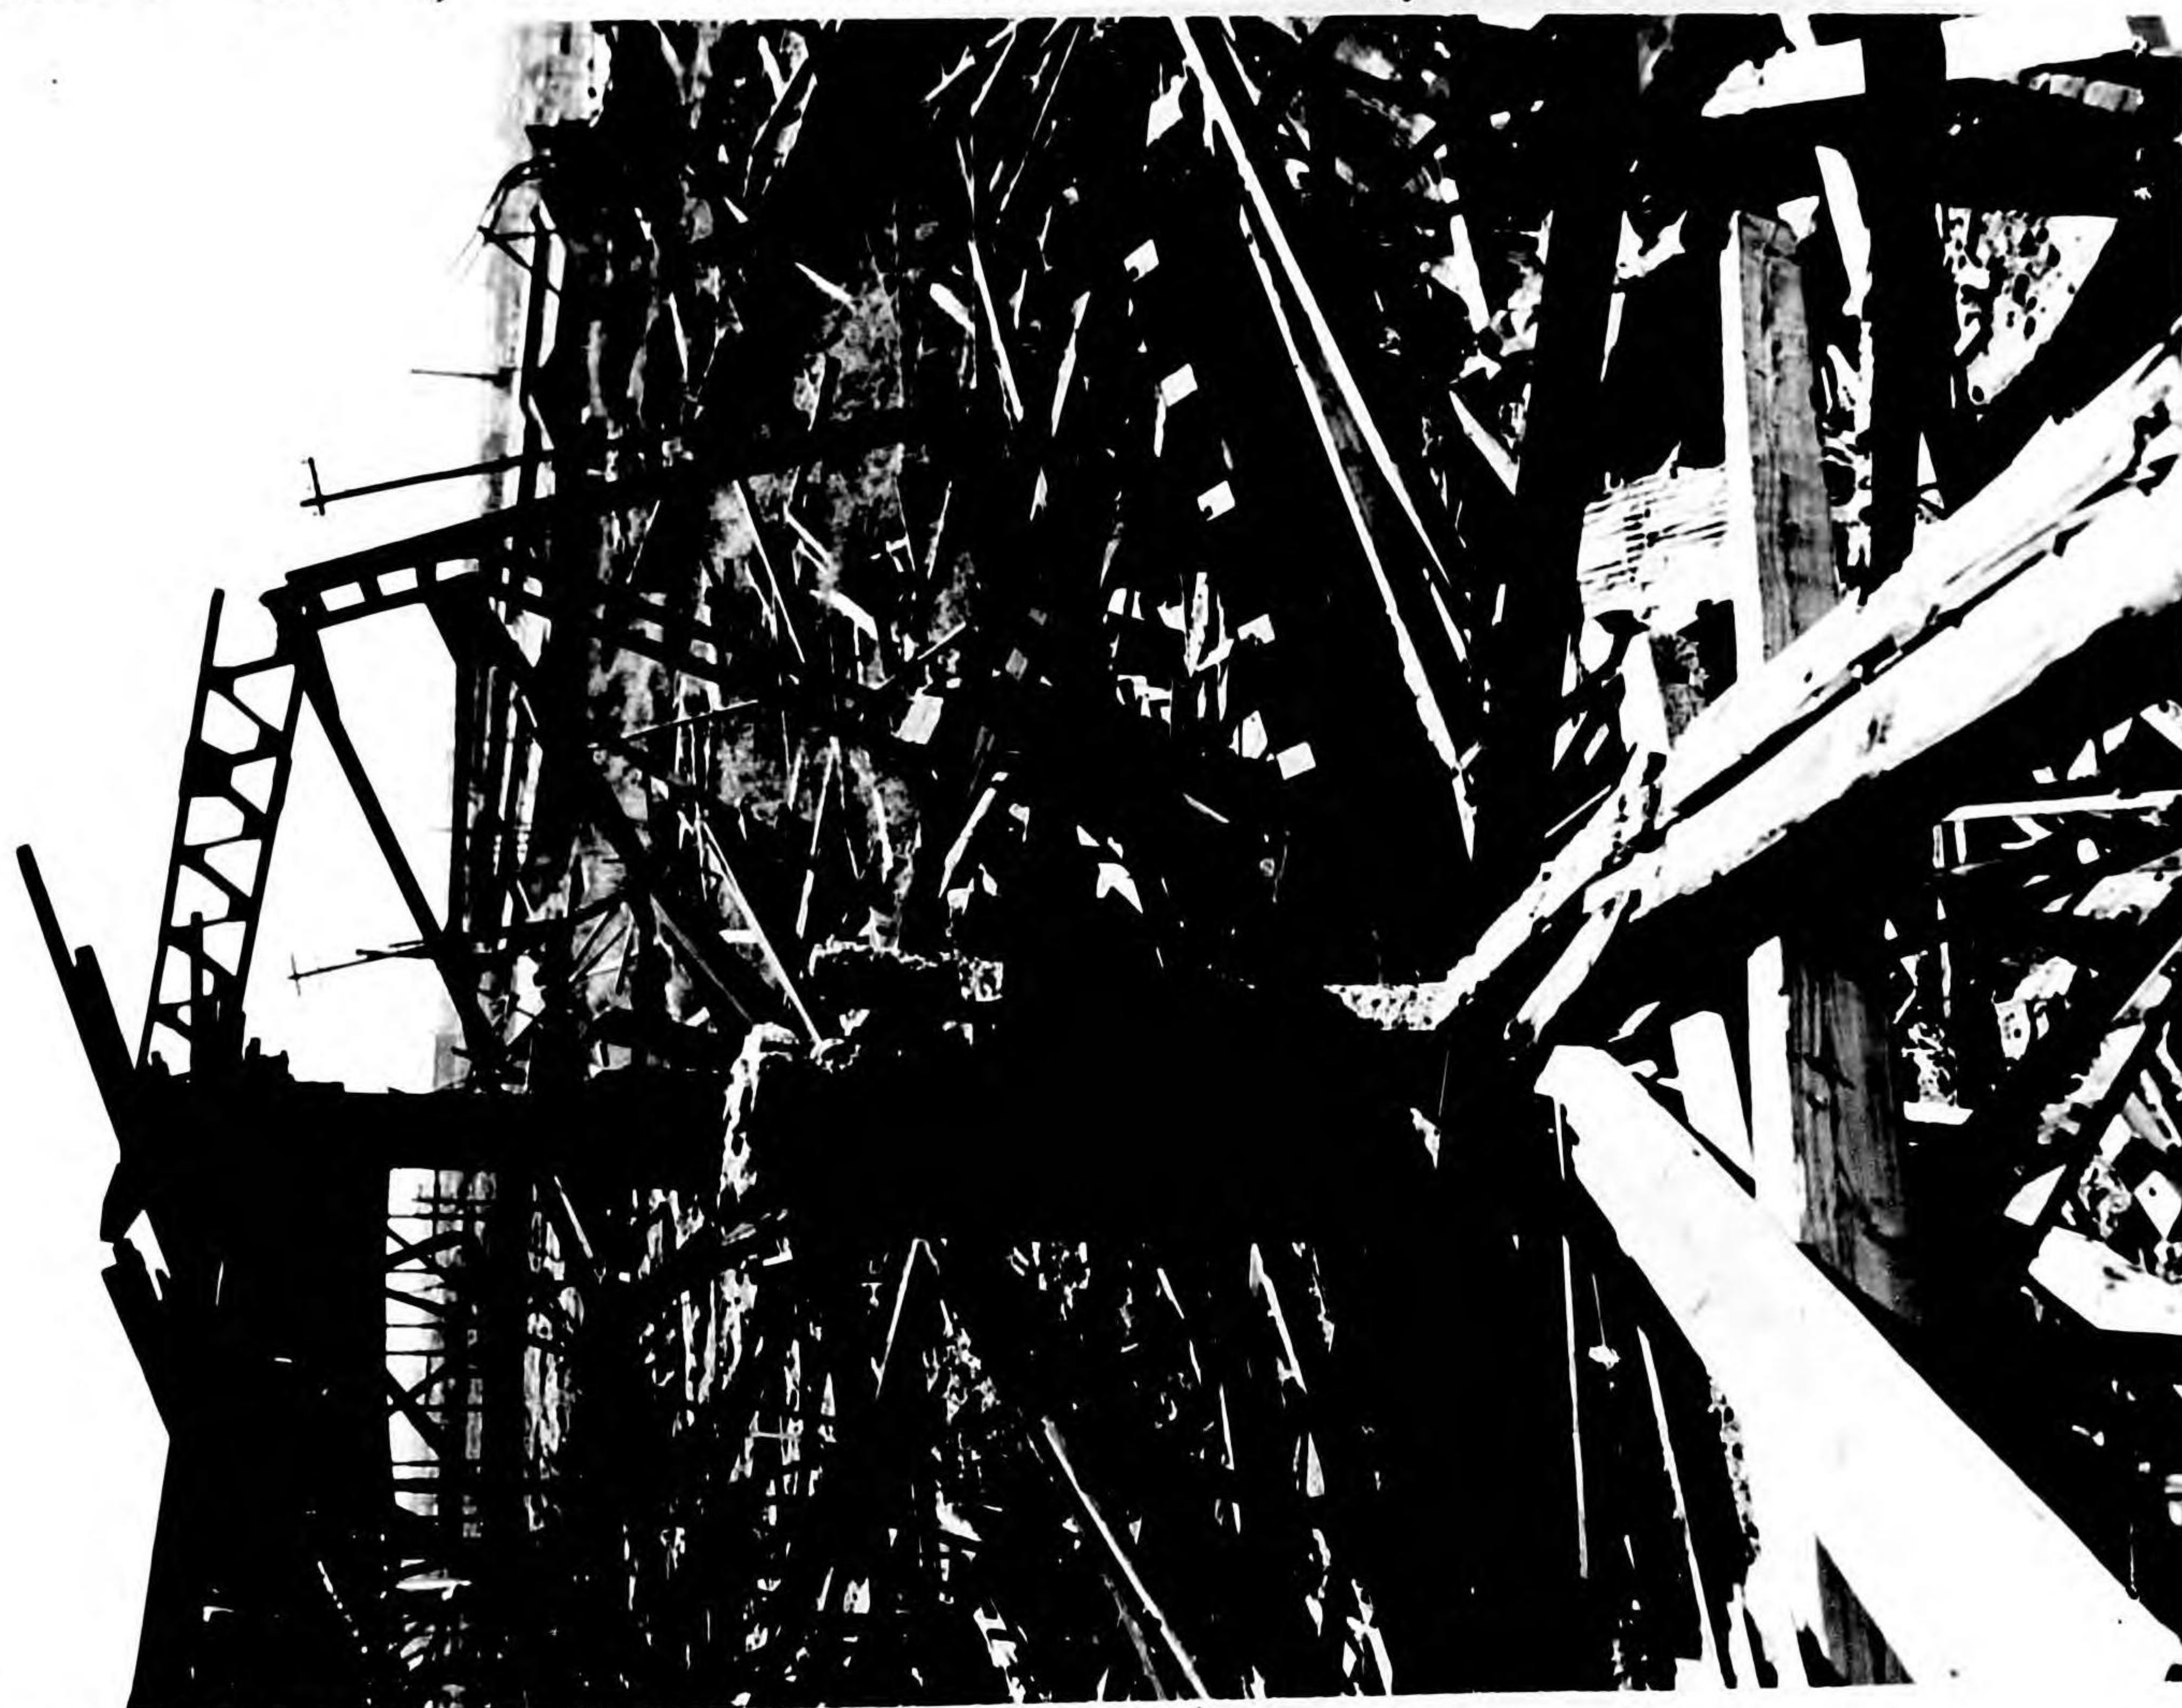
Photo 8 - Bldg. 4, Bomb 29, Exterior Column. 47
