UNITED STATES STRATEGIC BOMBING SURVEY

REPORT 72

EFFECTS OF THE FOUR THOUSAND-POUND BOMB

A Report on Five Incidents

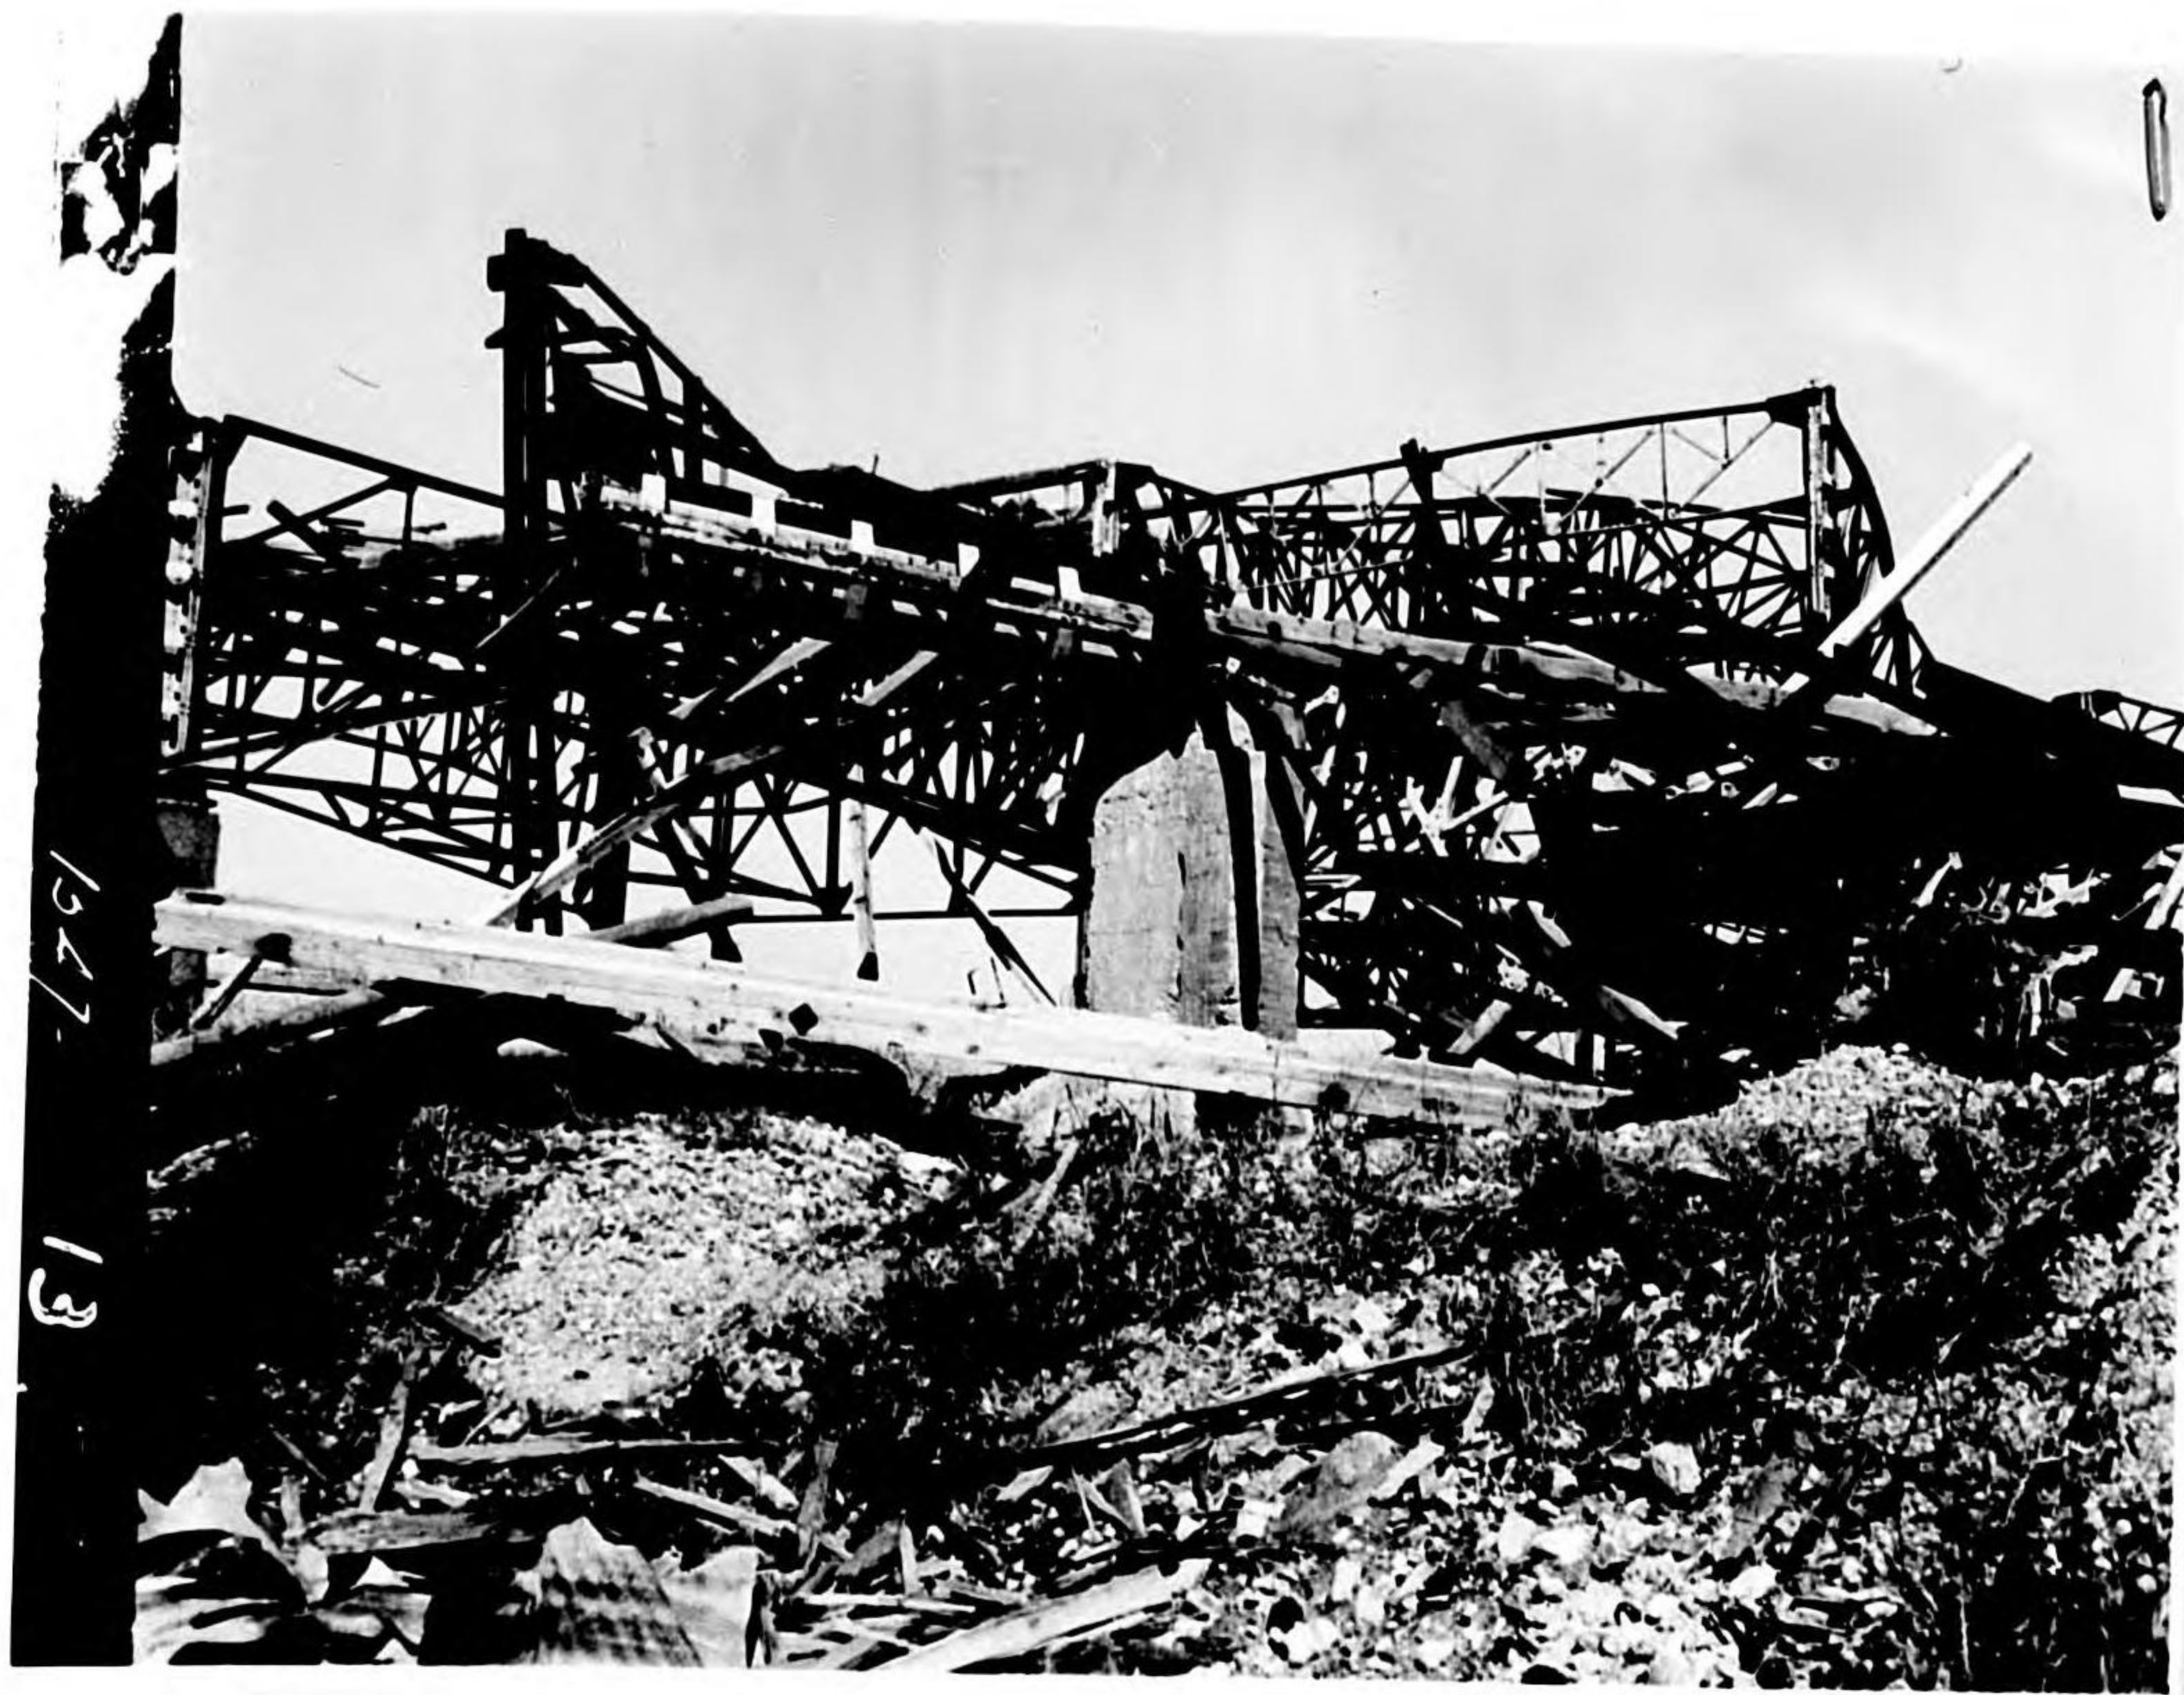
Photo 9 - Bldg. 4, Bomb 79, Exterior Columns blown over

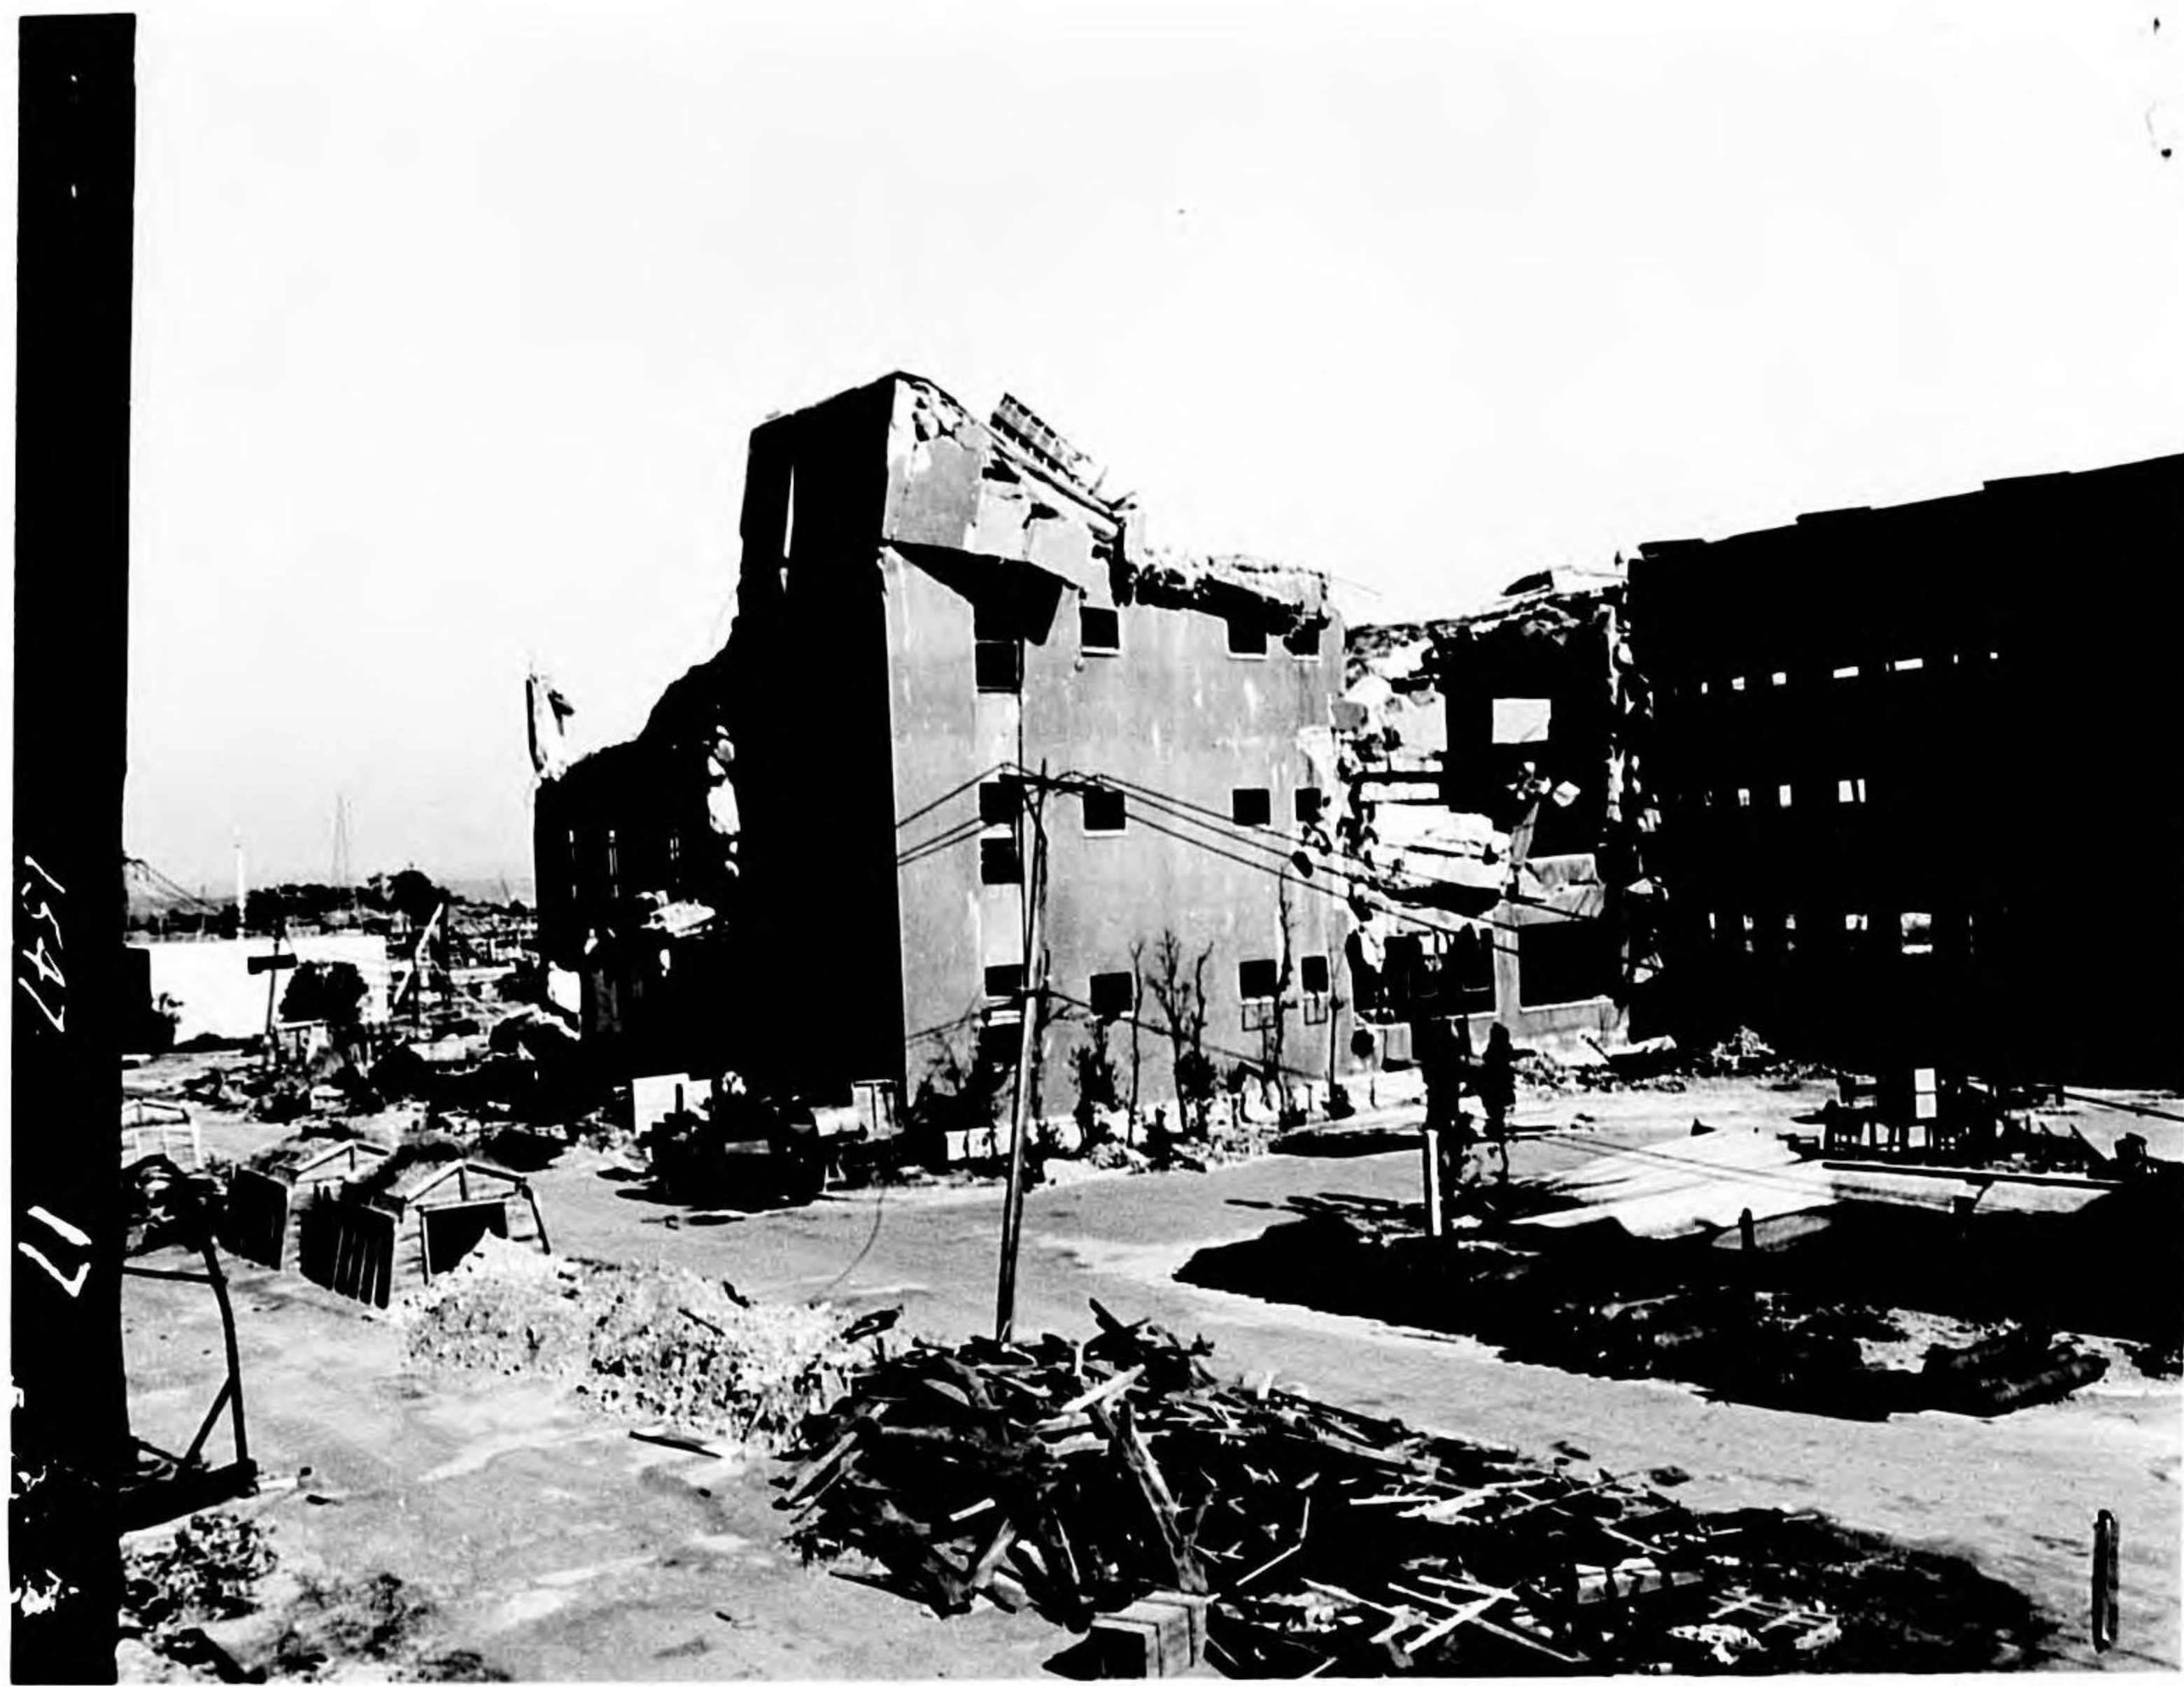
Photo 10, Bldg. 8, Bombs 45 and 46.

d. Building B, a three-story, reinforced-concrete office building, was struck by two 4,000-pound bombs. Photo 10 presents general aspects of the building (the collapse of the perthouse and the damage at extreme right of this photo were the results of 500-pound strikes and are not covered by this report). Bomb 45 exploded in the east wing of the building (Photo 11). (Photo intelligence indicates that a 500-pound bomb struck in approximately the same place as the 4,000-pound bomb. Extent of damage attributable to the 500-pound bomb could not be determined, and is, of necessity, included in this survey.) The roof and the third-story slab were destroyed for one bay, and one third-story exterior column was completely removed by the explosion. In addition, the exterior walls of the second and third floors were

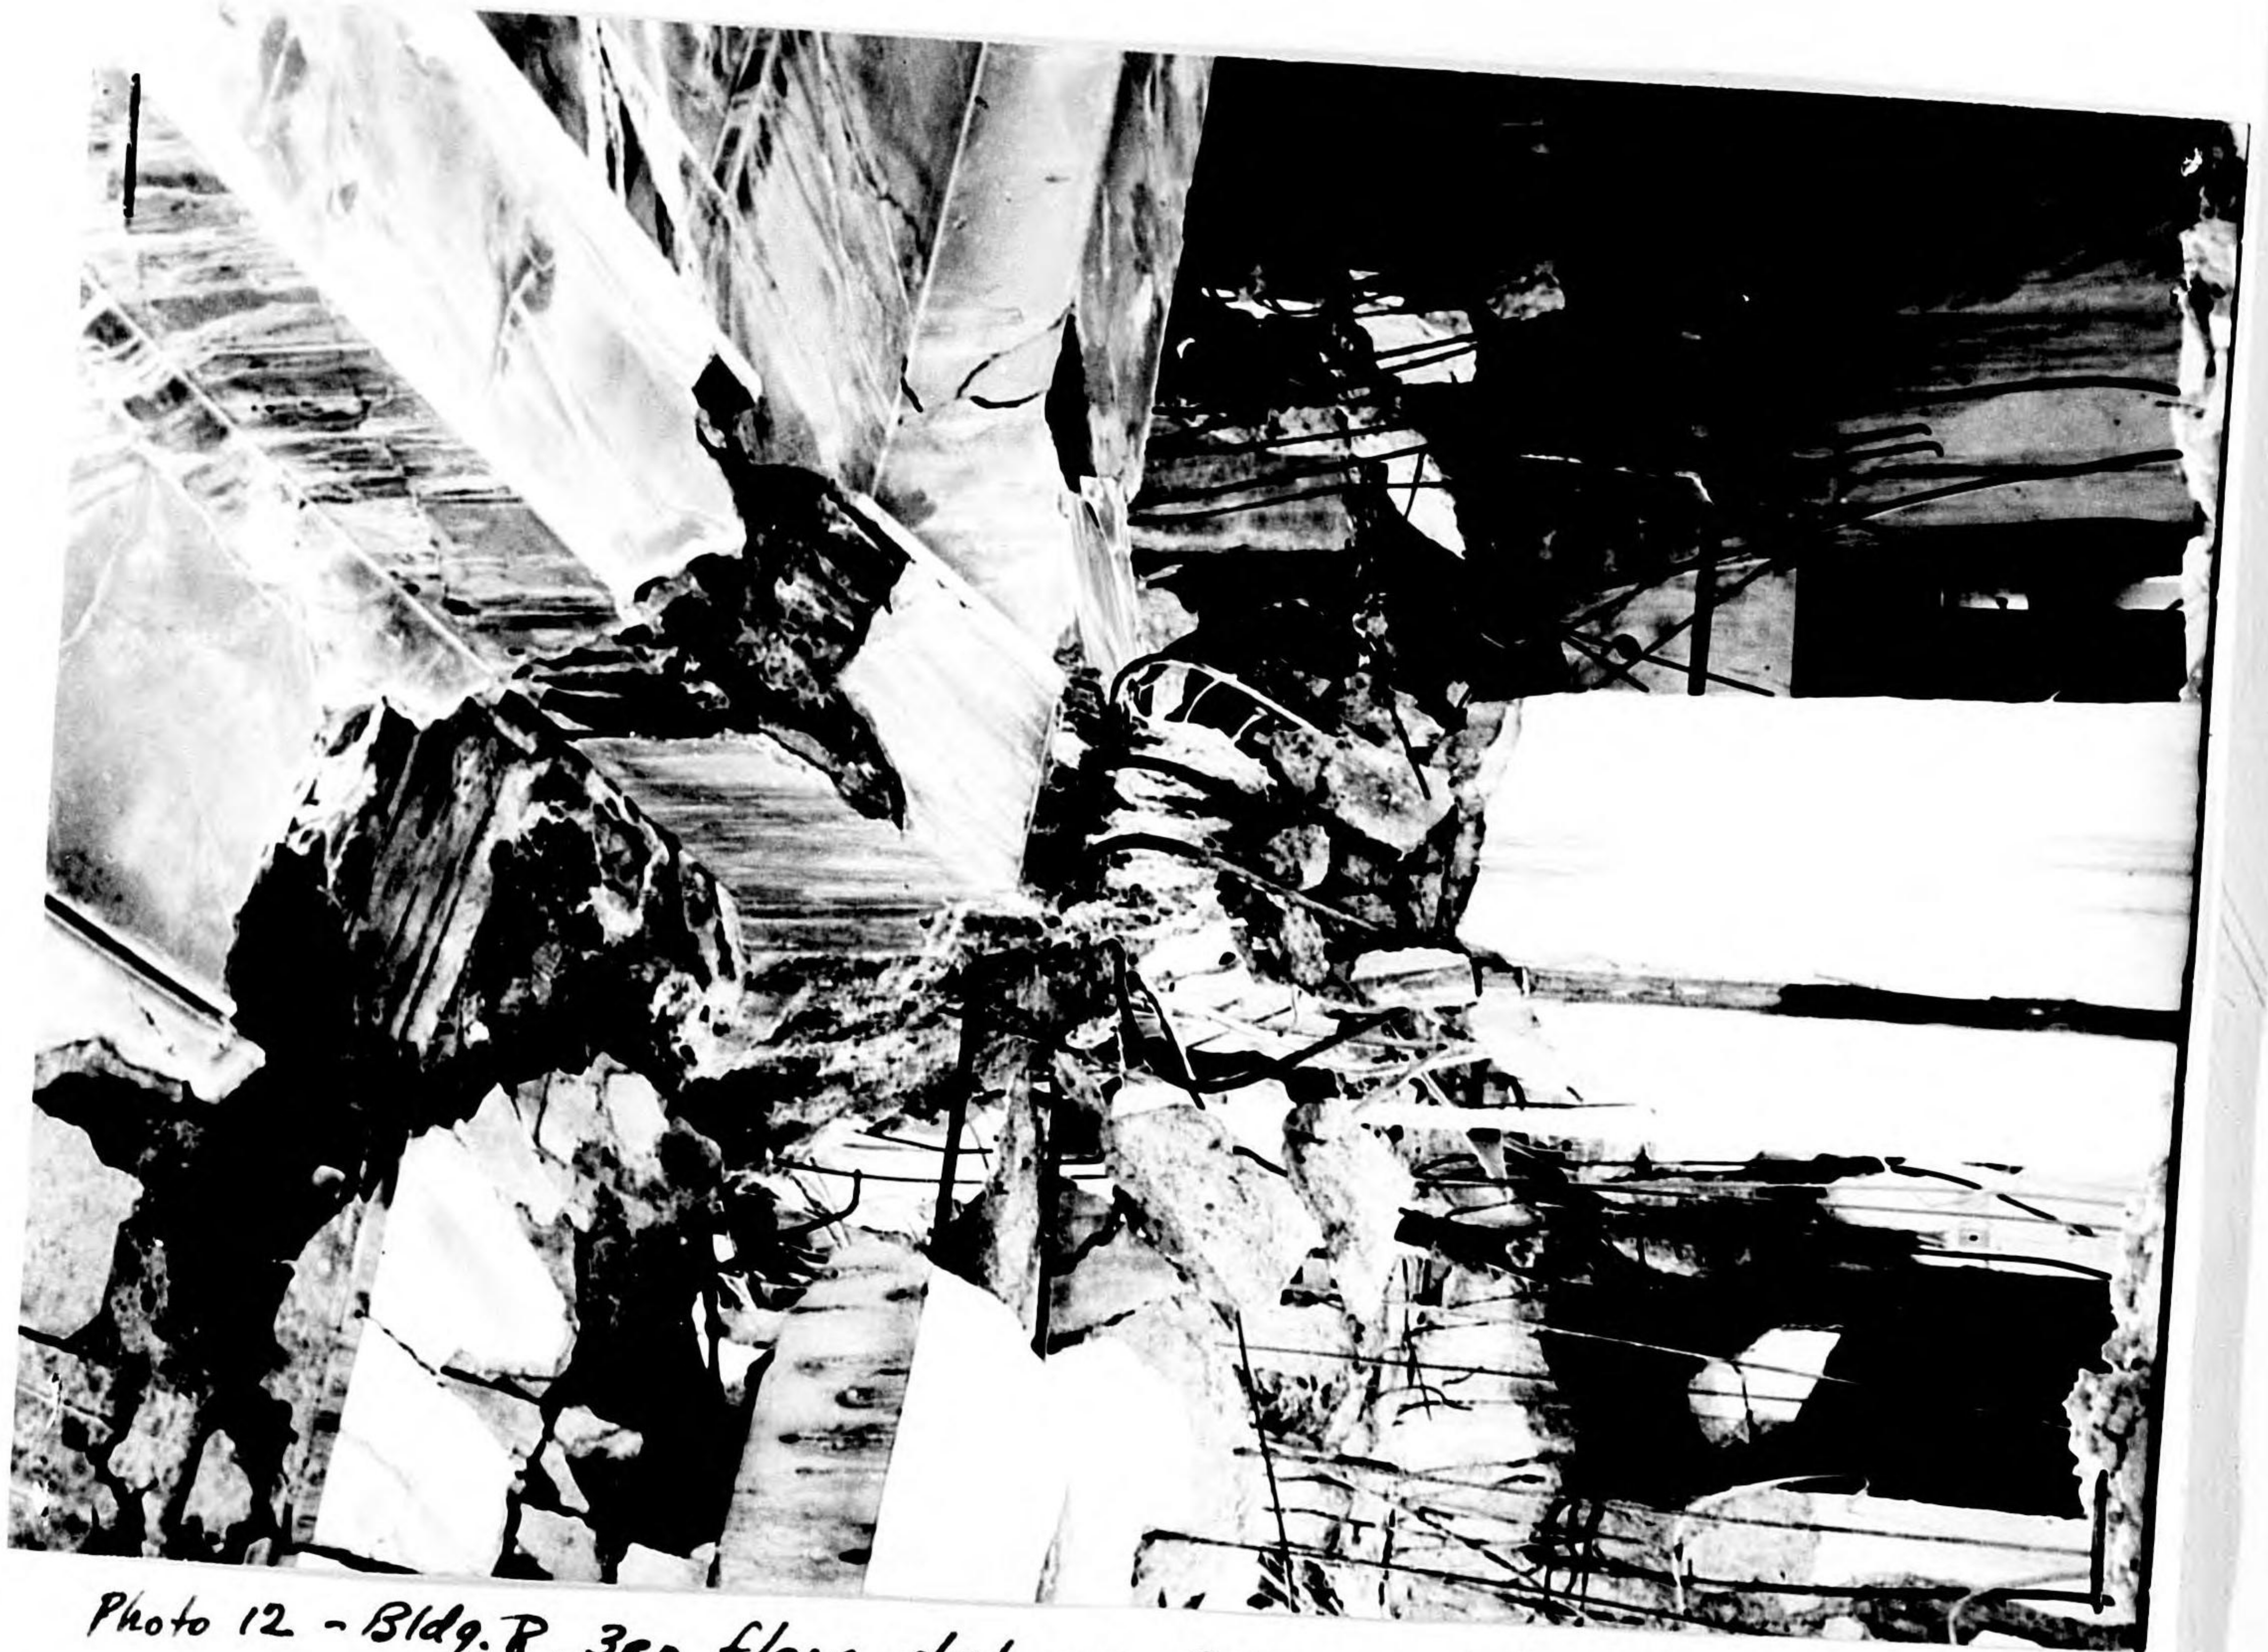
blown out for two bays. The interior slabs and beams suffered in the areas indicated as damaged in Figure 1. One of the more severely damaged columns is shown in Photo 12. Bomb 46 exploded in the extreme north corner of the building as shown in Photo 10. The third-story exterior walls and the included column were blown down and outward for two bays on the northwest face (Photo 12), and one bay on the northeast face. The roof collapsed, leaving the corner column standing (Photo 12). The interior structure was damaged as shown on Figure 1. Bomb 44 was a near-miss which detonated approximately 50 feet southeast of the building and damaged first-story exterior walls and second-floor exterior beams of the adjacent five bays.

Photo 12 - Bldg. 8, 3rd floor slab and Column. 44

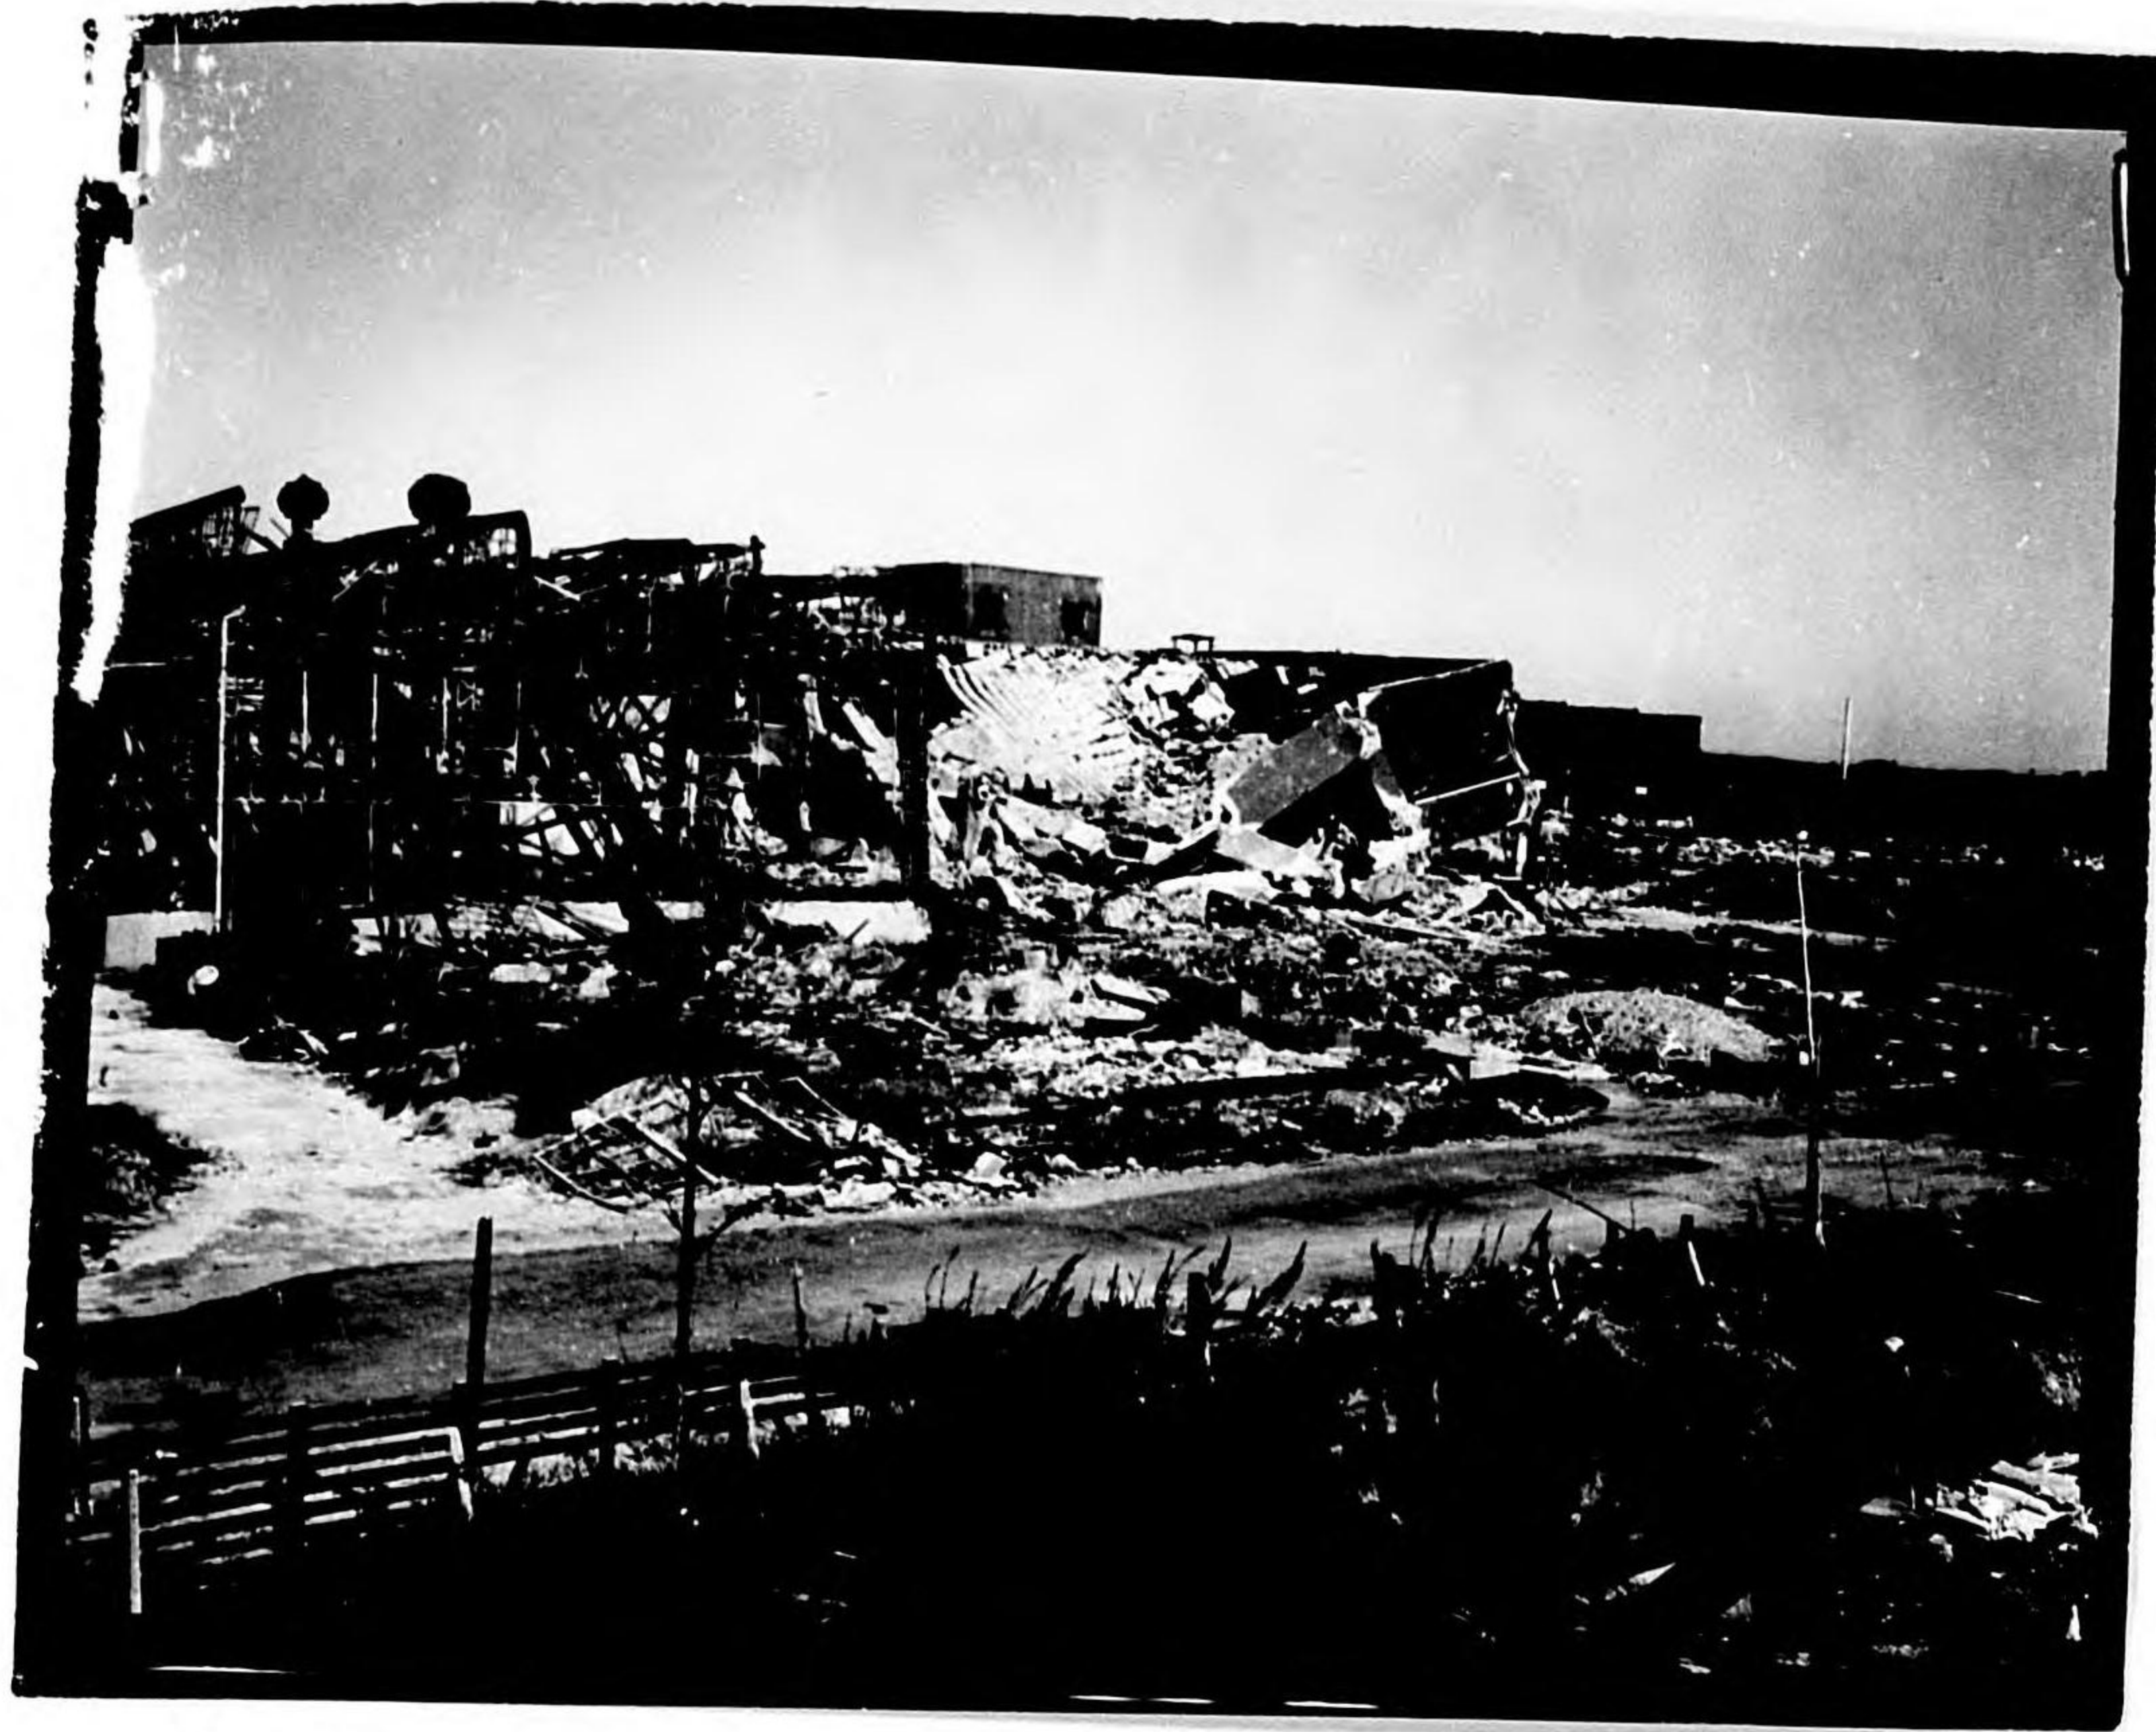
f. Building 23, a one-story, structural-steel building, was also damaged by the blast from Bomb 15 which struck in Building 12. The damage extended for two bays from the eastern edge of the building (Photo 13). The blast had the effect of buckling the bottom chord members of the truss and bending the exterior columns inward. Photo 14 shows the damage caused by Bomb 15 and Photo 15 the damage caused by

Photo 13, Showing damage to Bldg 23 and Bldg 12
by Bomb 15.

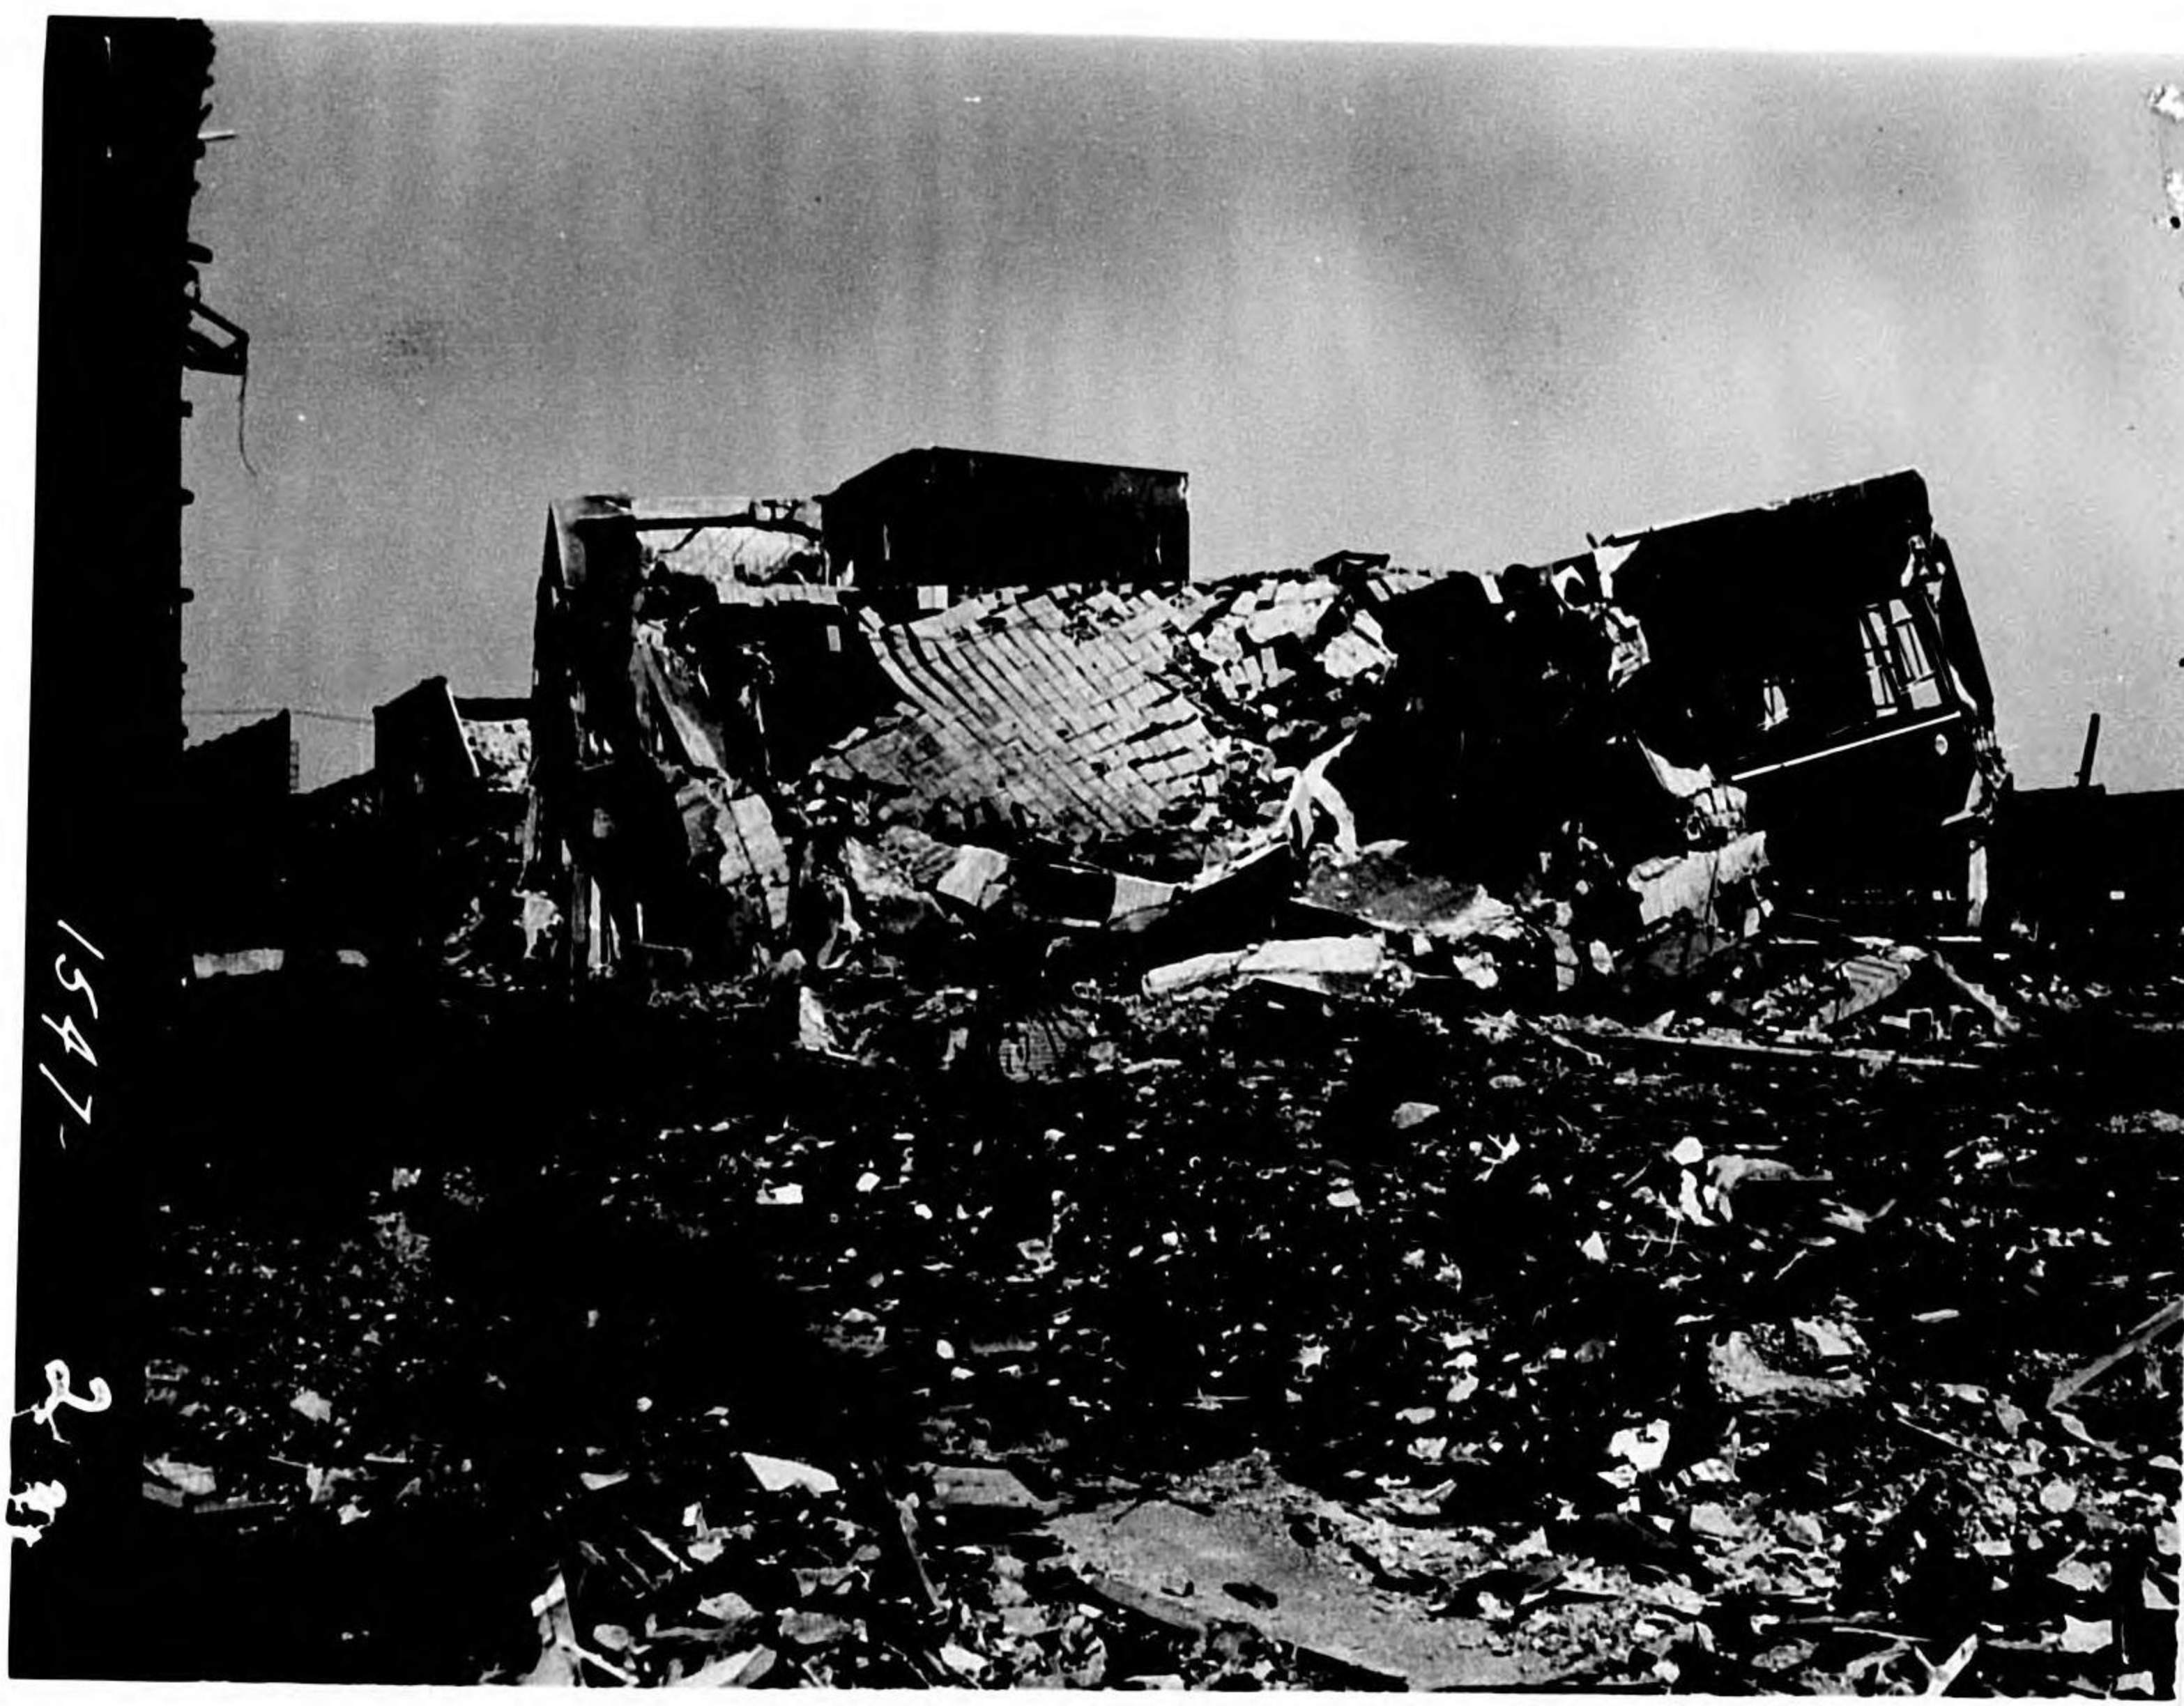
Photo 14, Bldg. 12, Bomb 15. 45'

e. Building 12, a two-story, reinforced-concrete office building, was hit with two 4,000-pound bombs, 14 and 15. Bomb 15 exploded at the southeast end and Bomb 14 exploded at approximately the northwest end. Collapse was noted within three bays of each bomb. Examination of the portion still standing indicated that all of the beams, except those in one bay at the northwest end, had been damaged at the haunches as a result of shock. The building was 95 per cent structurally damaged.
