UNITED STATES STRATEGIC BOMBING SURVEY

REPORT 72

EFFECTS OF THE FOUR THOUSAND-POUND BOMB

A Report on Five Incidents

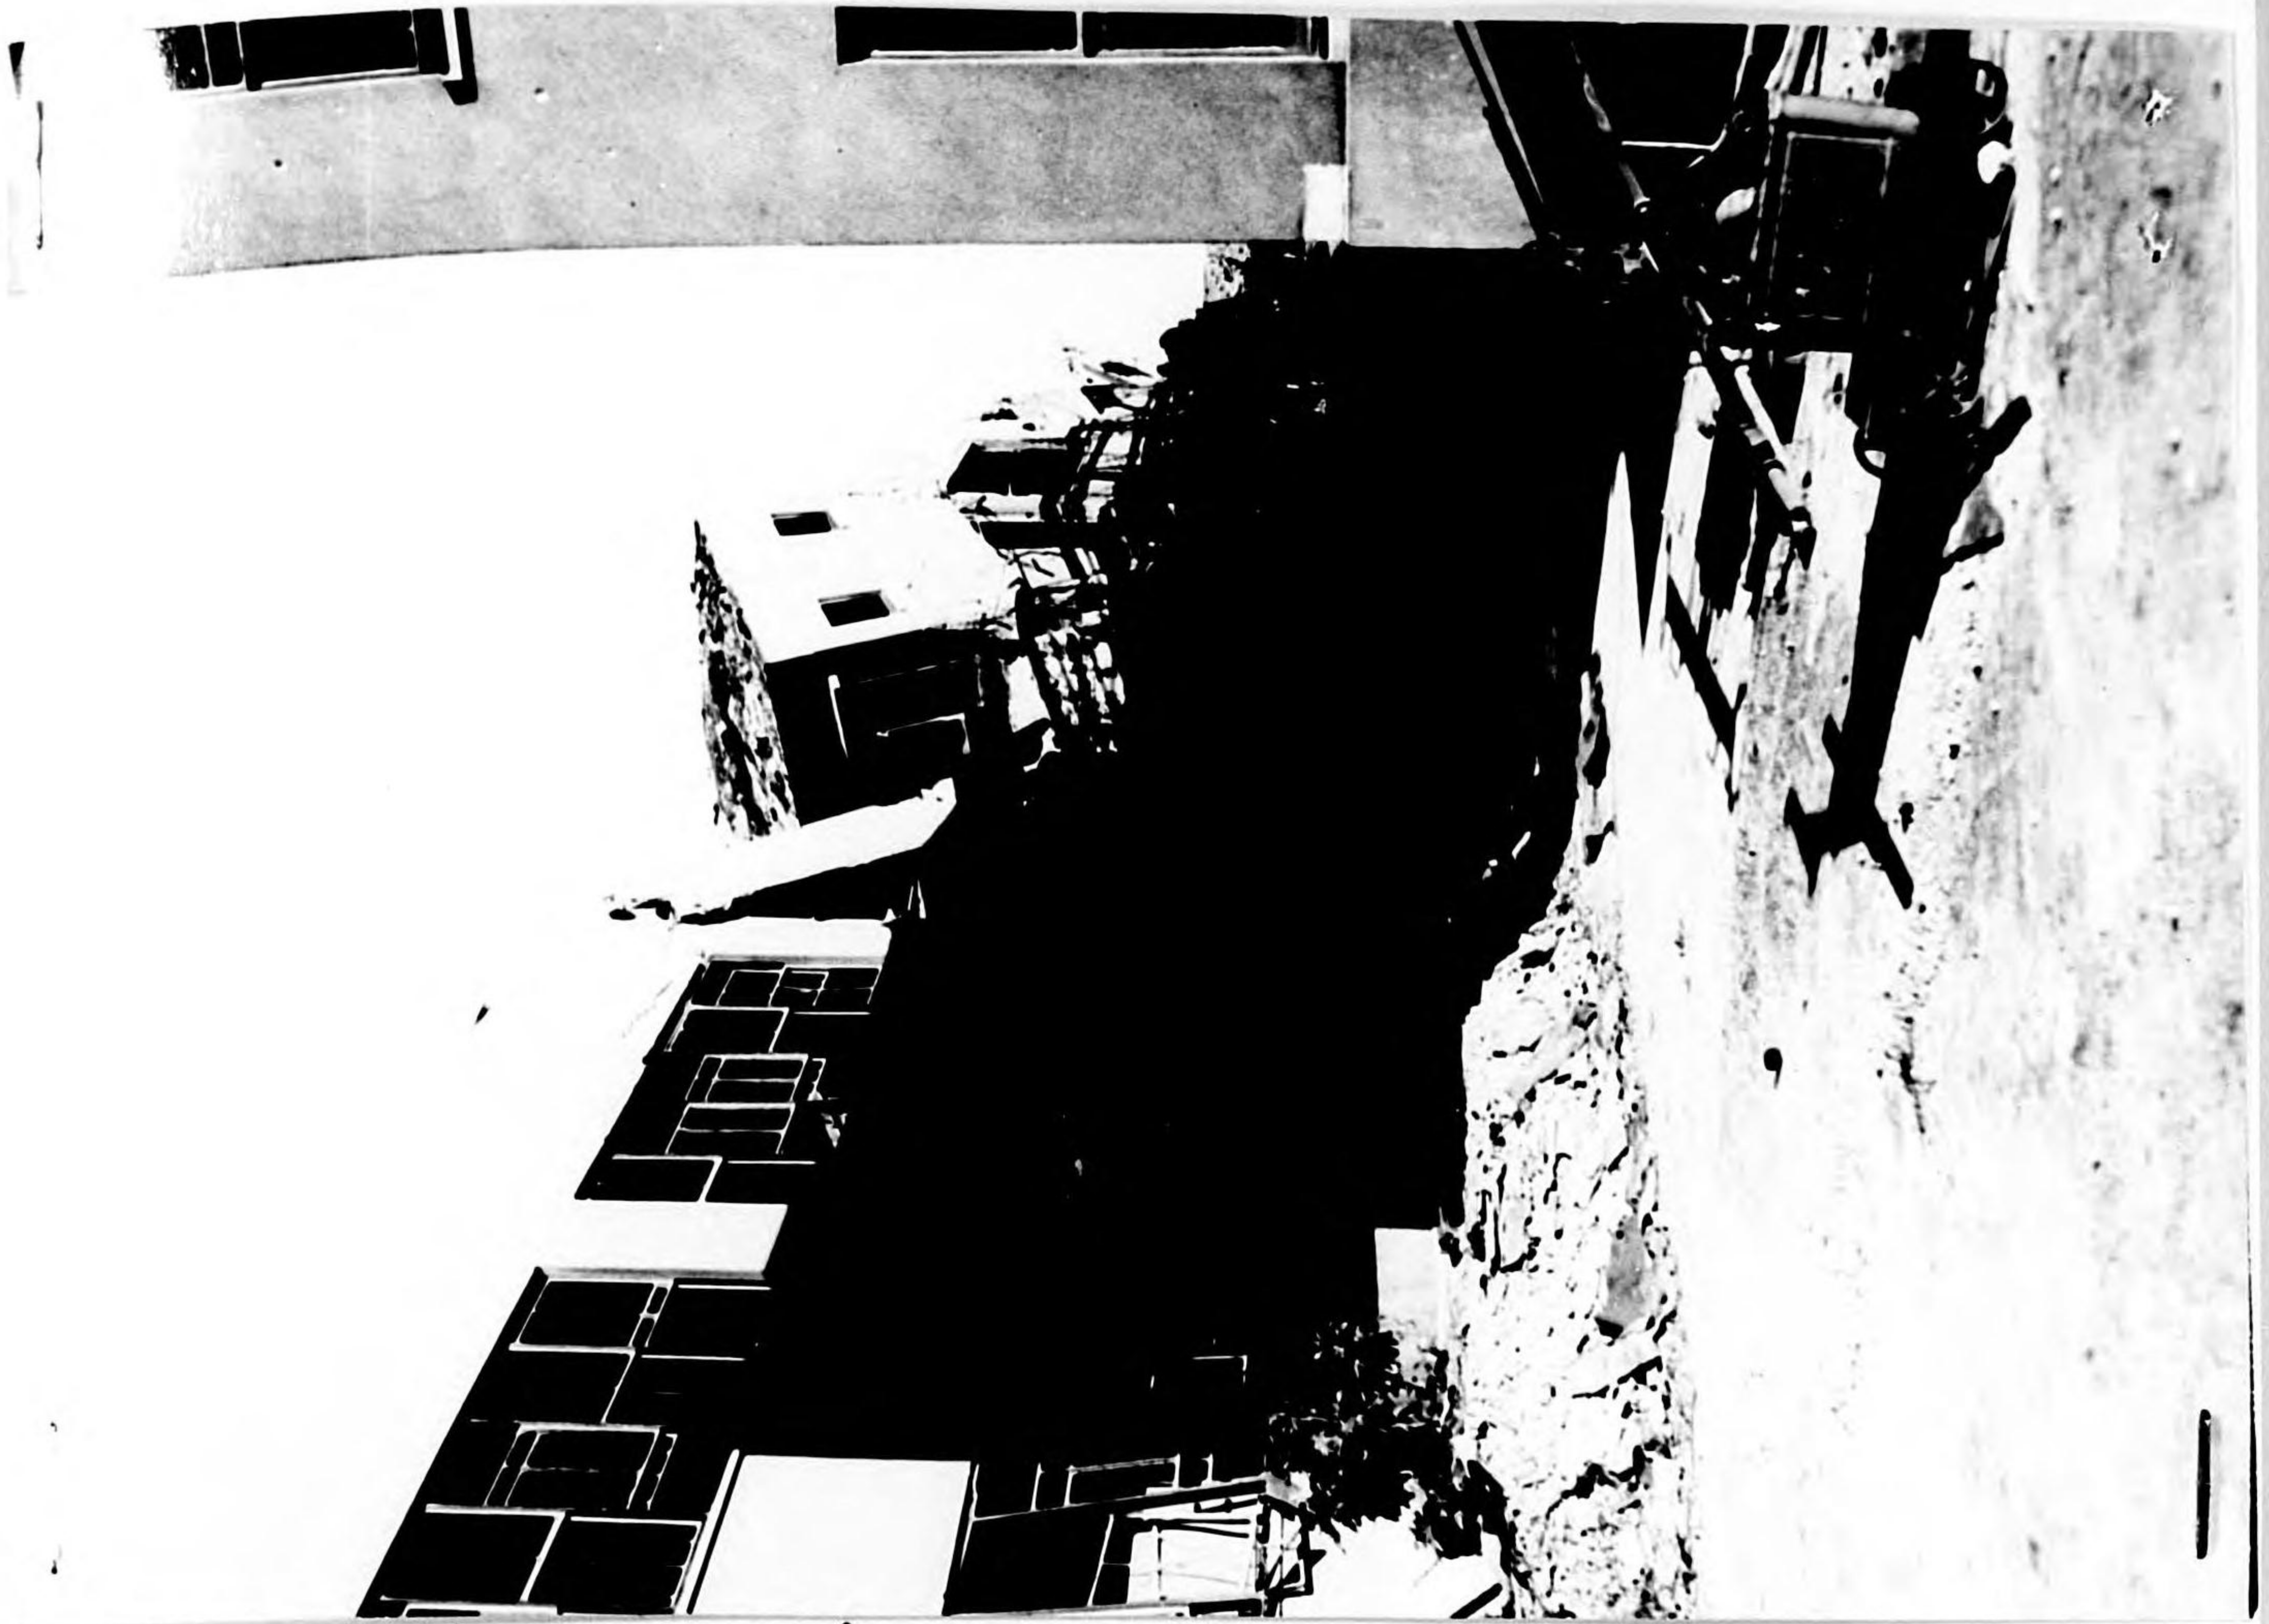
Photo 15, Bldg. 12, Bomb 14.

e. Building 12, a two-story, reinforced-concrete office building, was hit with two 4,000-pound bombs, 14 and 15. Bomb 15 exploded at the southeast end and Bomb 14 exploded at approximately the northwest end. Collapse was noted within three bays of each bomb. Examination of the portion still standing indicated that all of the beams, except those in one bay at the northwest end, had been damaged at the haunches as a result of shock. The building was 95 per cent structurally damaged.

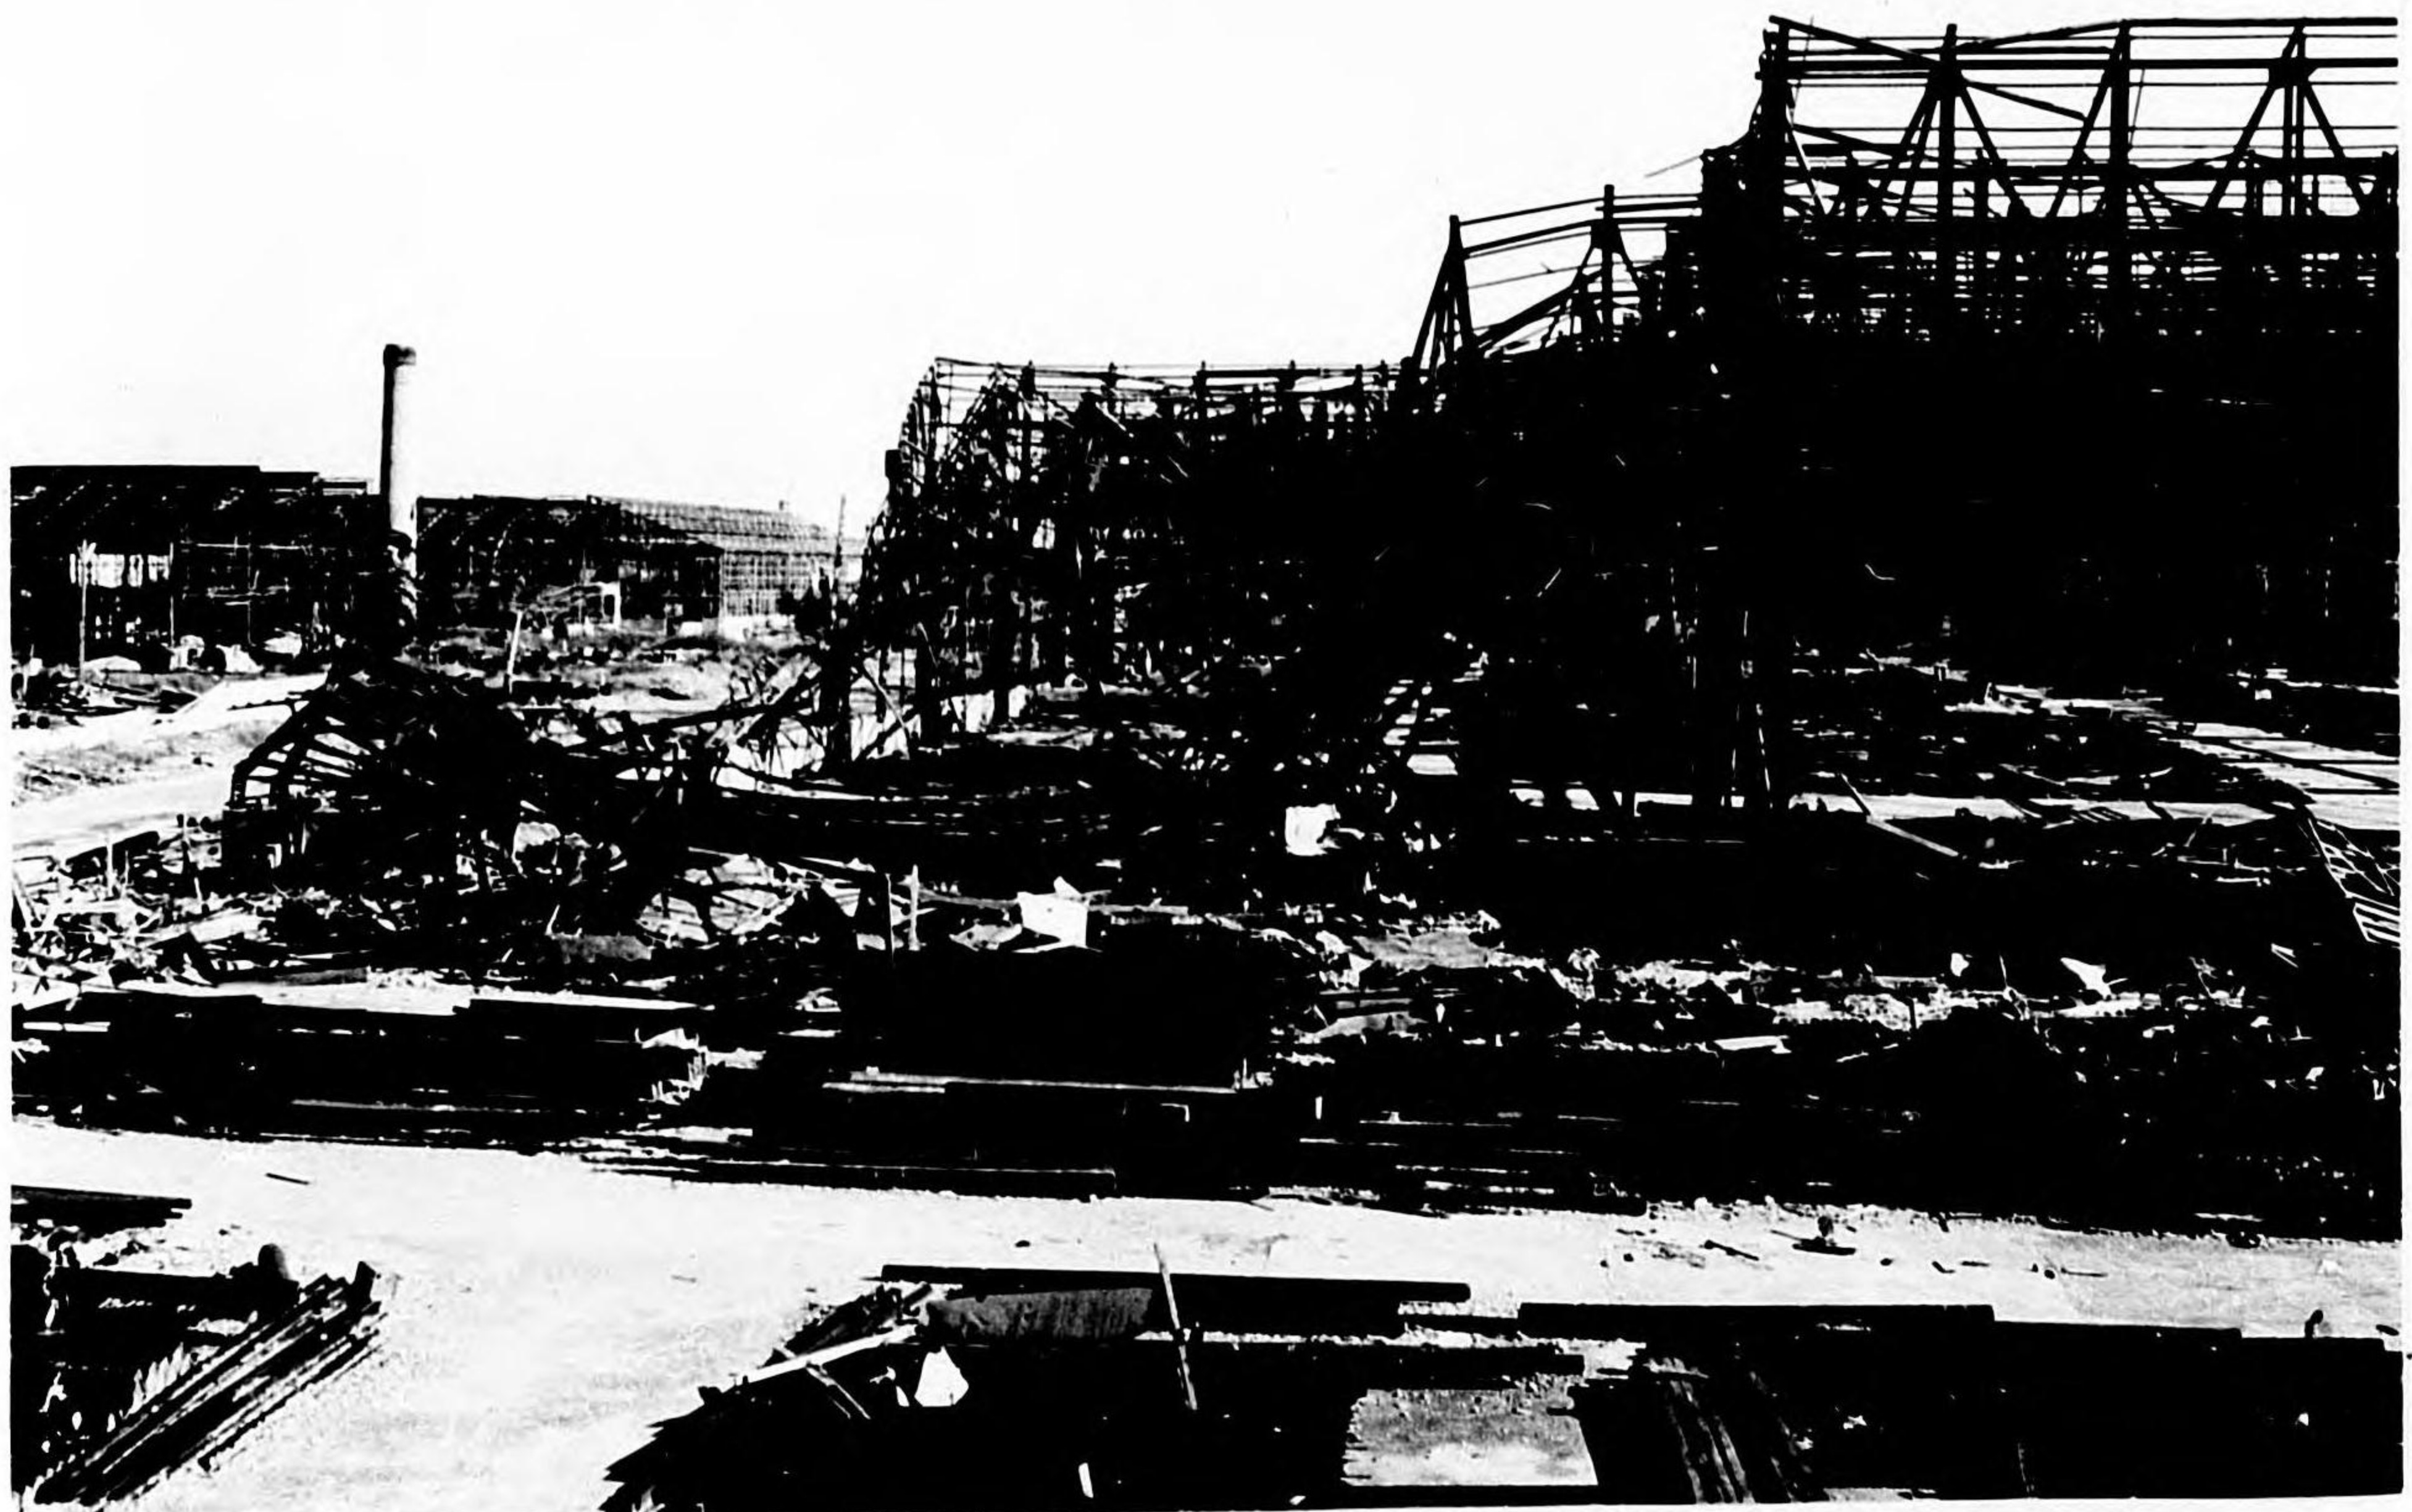
Photo 16 - Bldg. 16, Bomb 9.

g. Building 16 was a one-story, structural-steel building with saw-tooth roof. Photo 16 shows the damage caused by one bomb bursting in the roof. This damage was confined to a small area as the bomb burst about 15 feet from the east side of the building and 30 feet from the north end, causing a large portion of the blast to be expended outside of the structure. This area had previously suffered damage from a 500-pound hit, but the area damaged by the 4,000-pound bomb was much larger than, and included, the area damaged by the former.

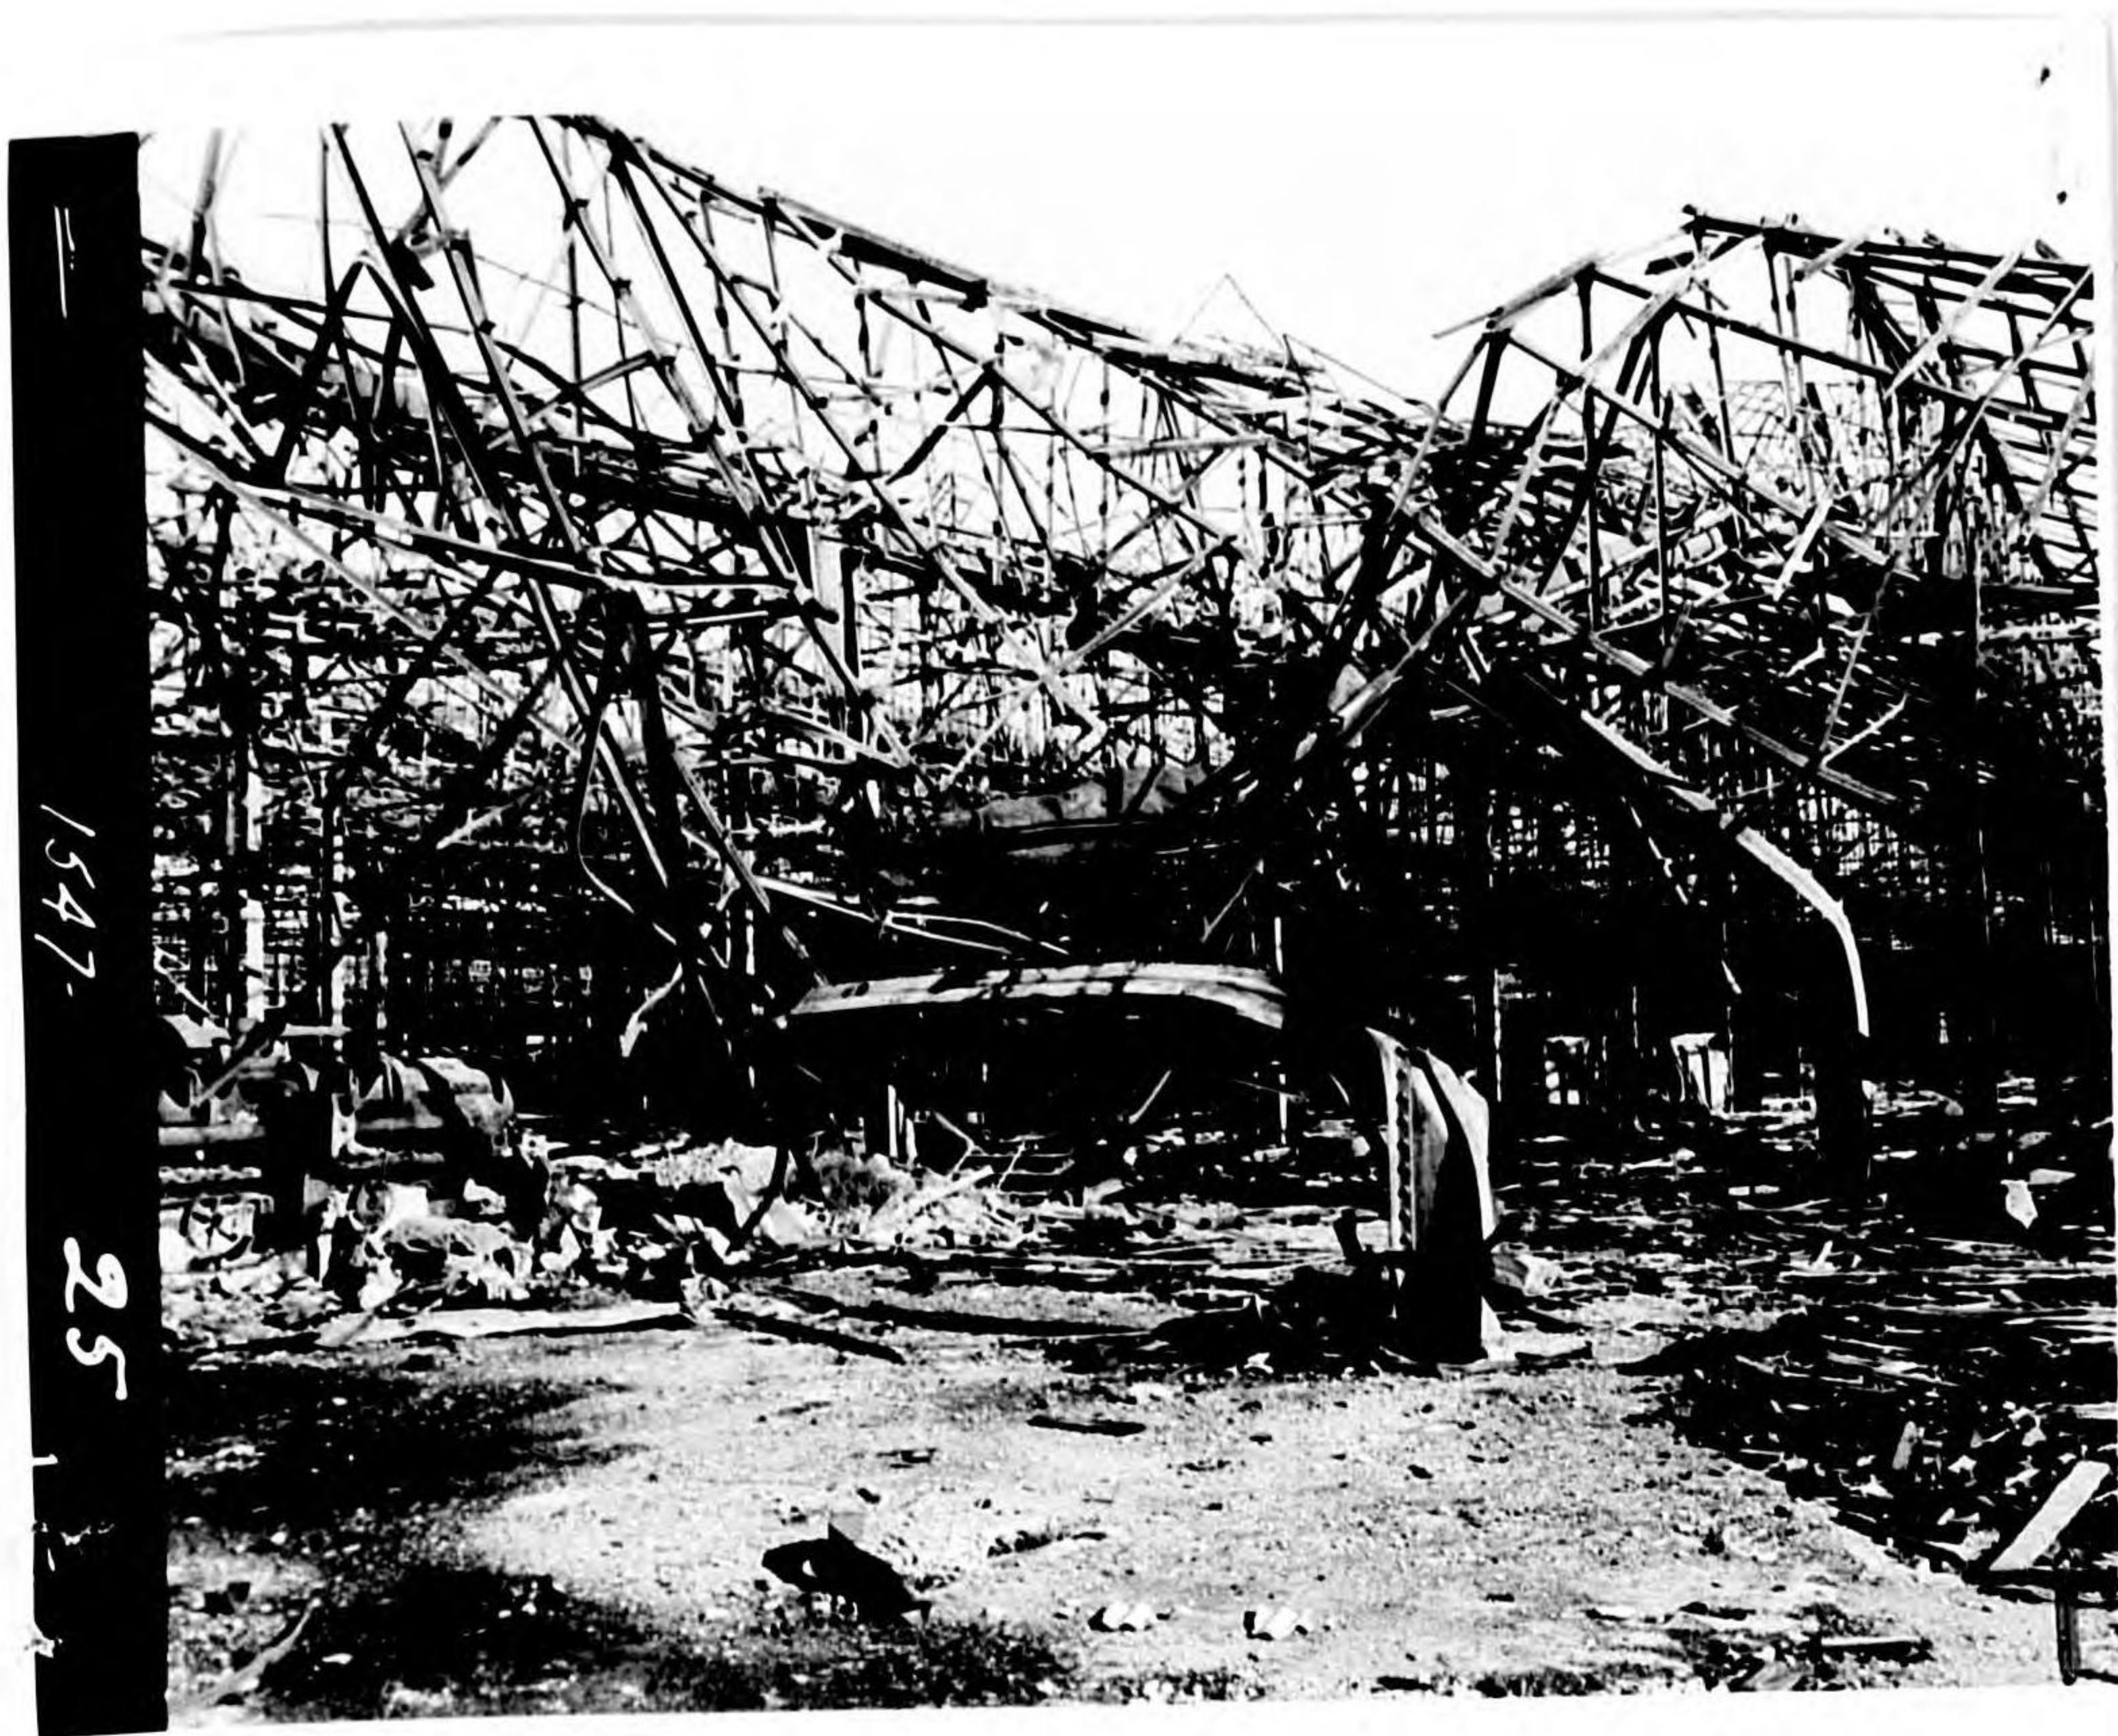
Photo 17 - Bldg. 19, Bomb 2, Point of Detonation in
Right foreground.

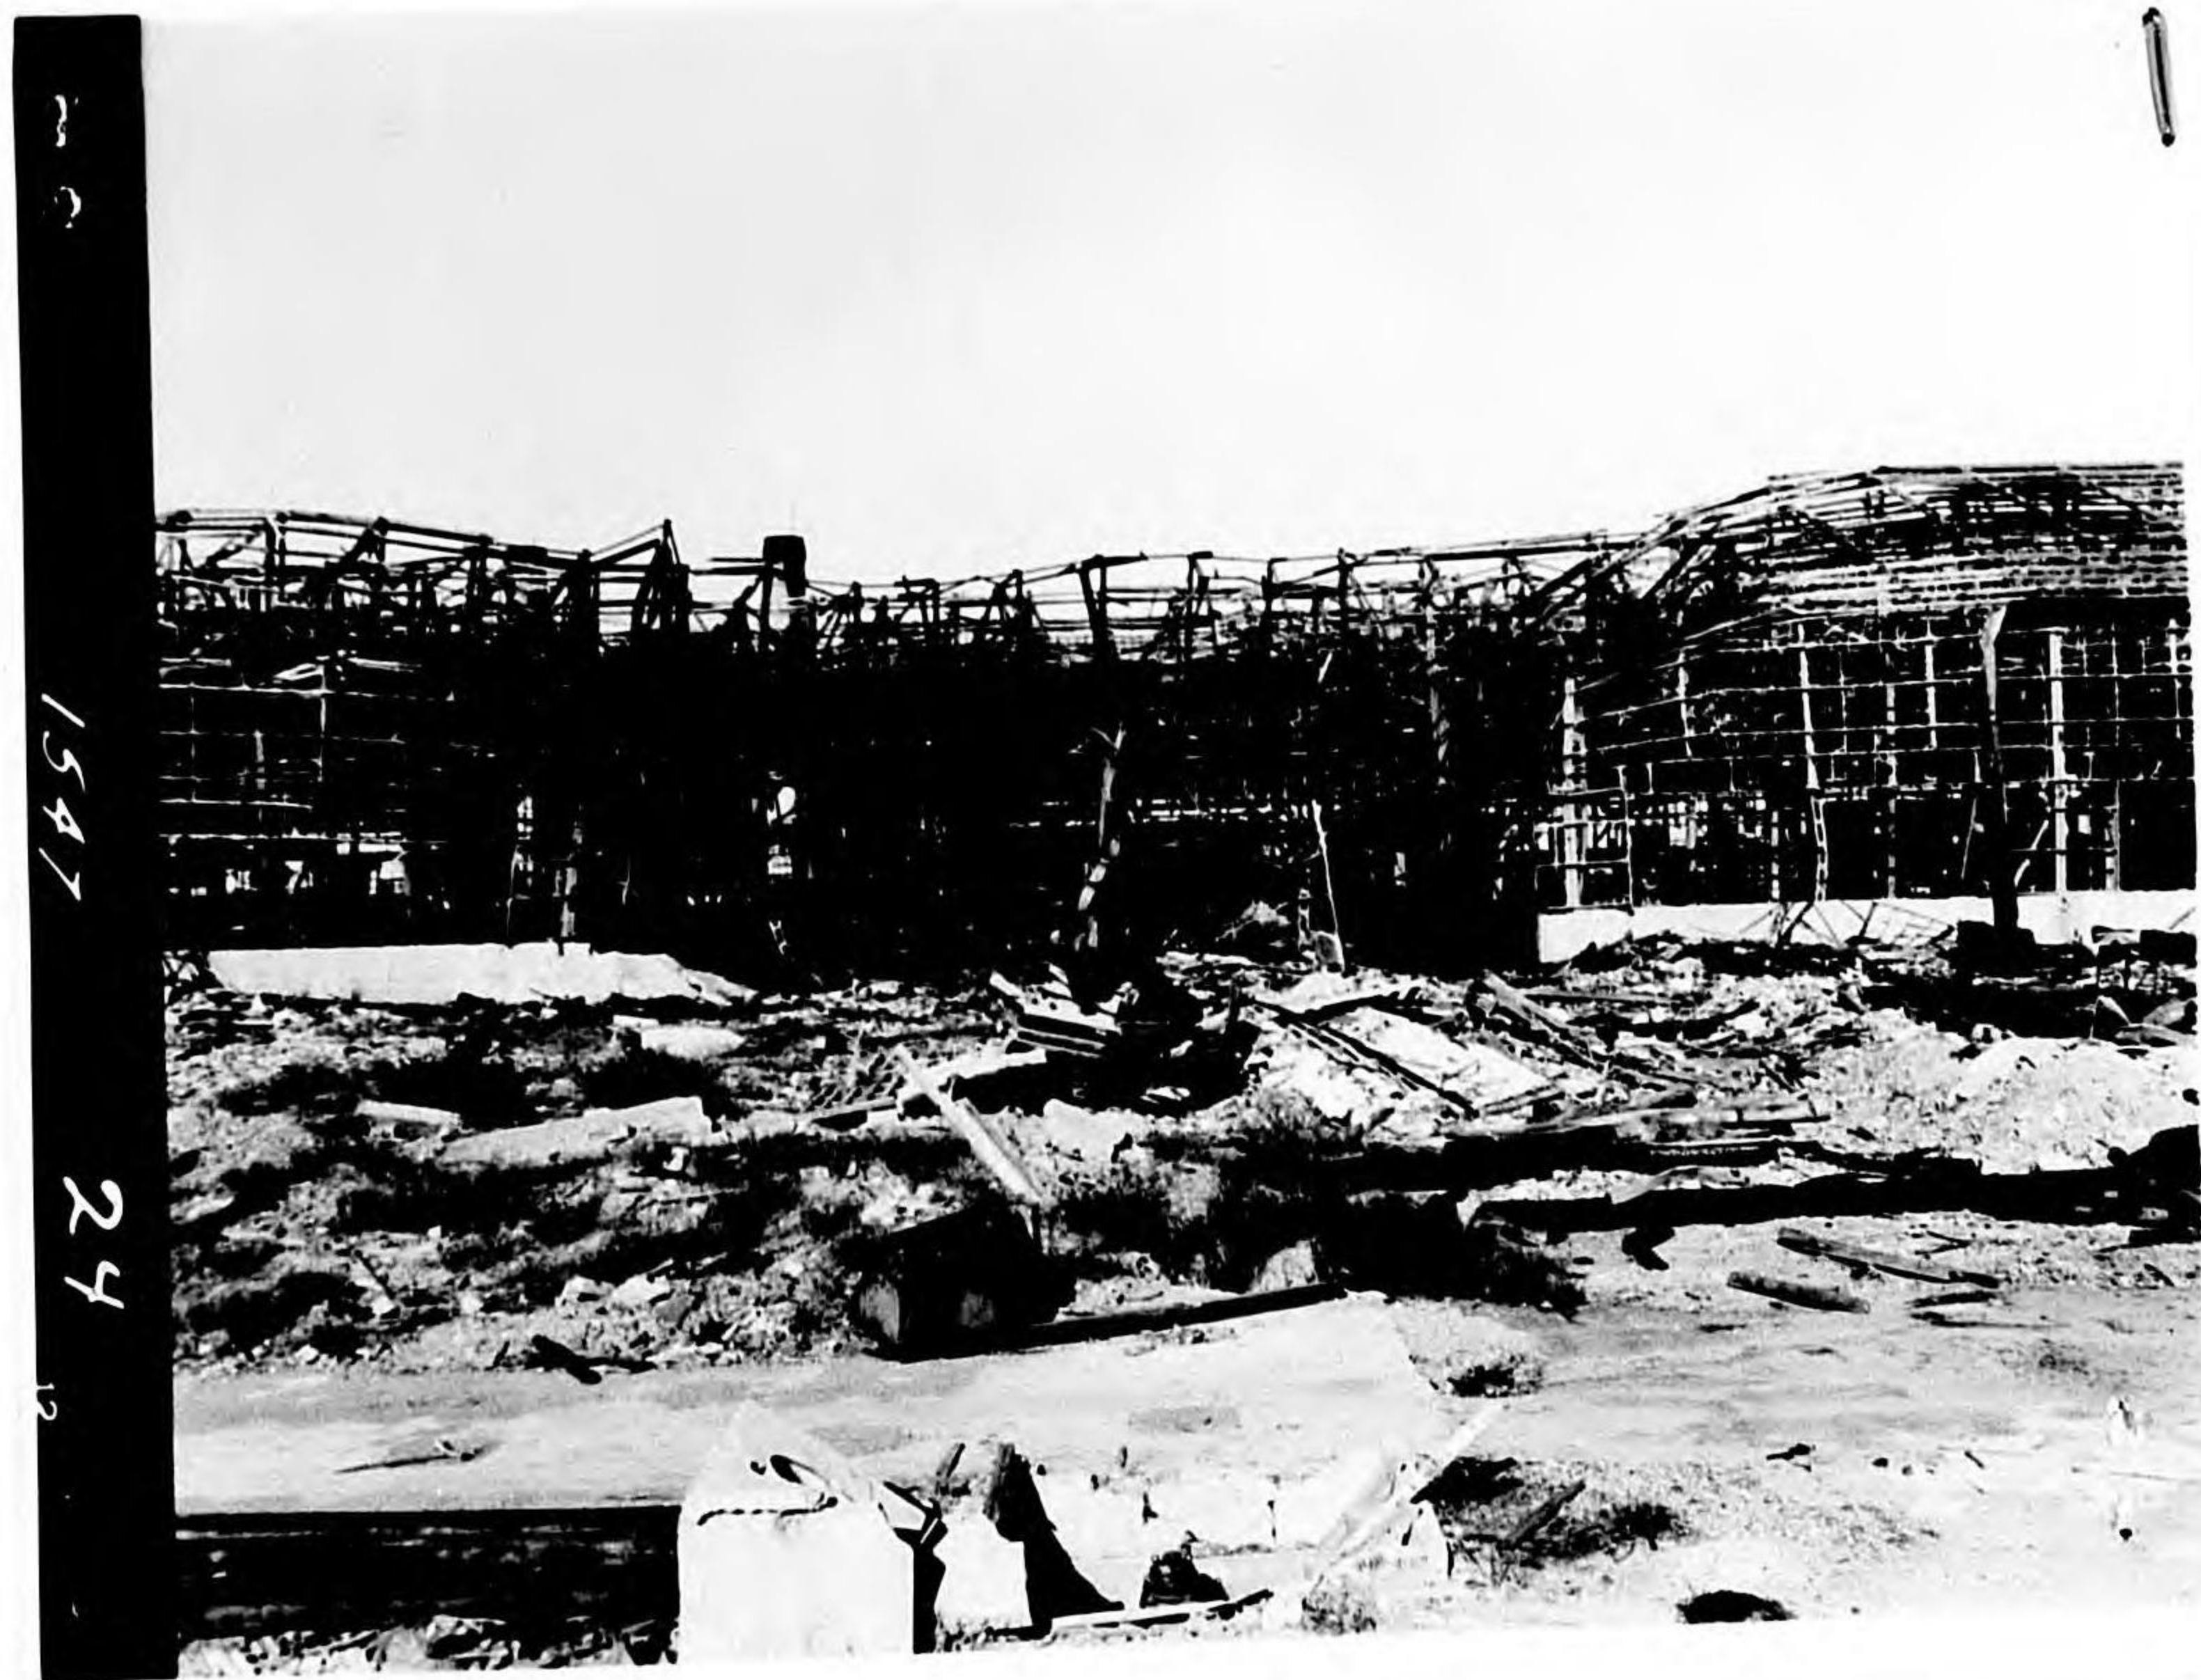
Photo 18 - Bldg 19, Bomb 2.

- (4) Blast was the only cause of damage to this building. Photo 18 taken about 100 feet from the west side of the building gives a general view of the damage.

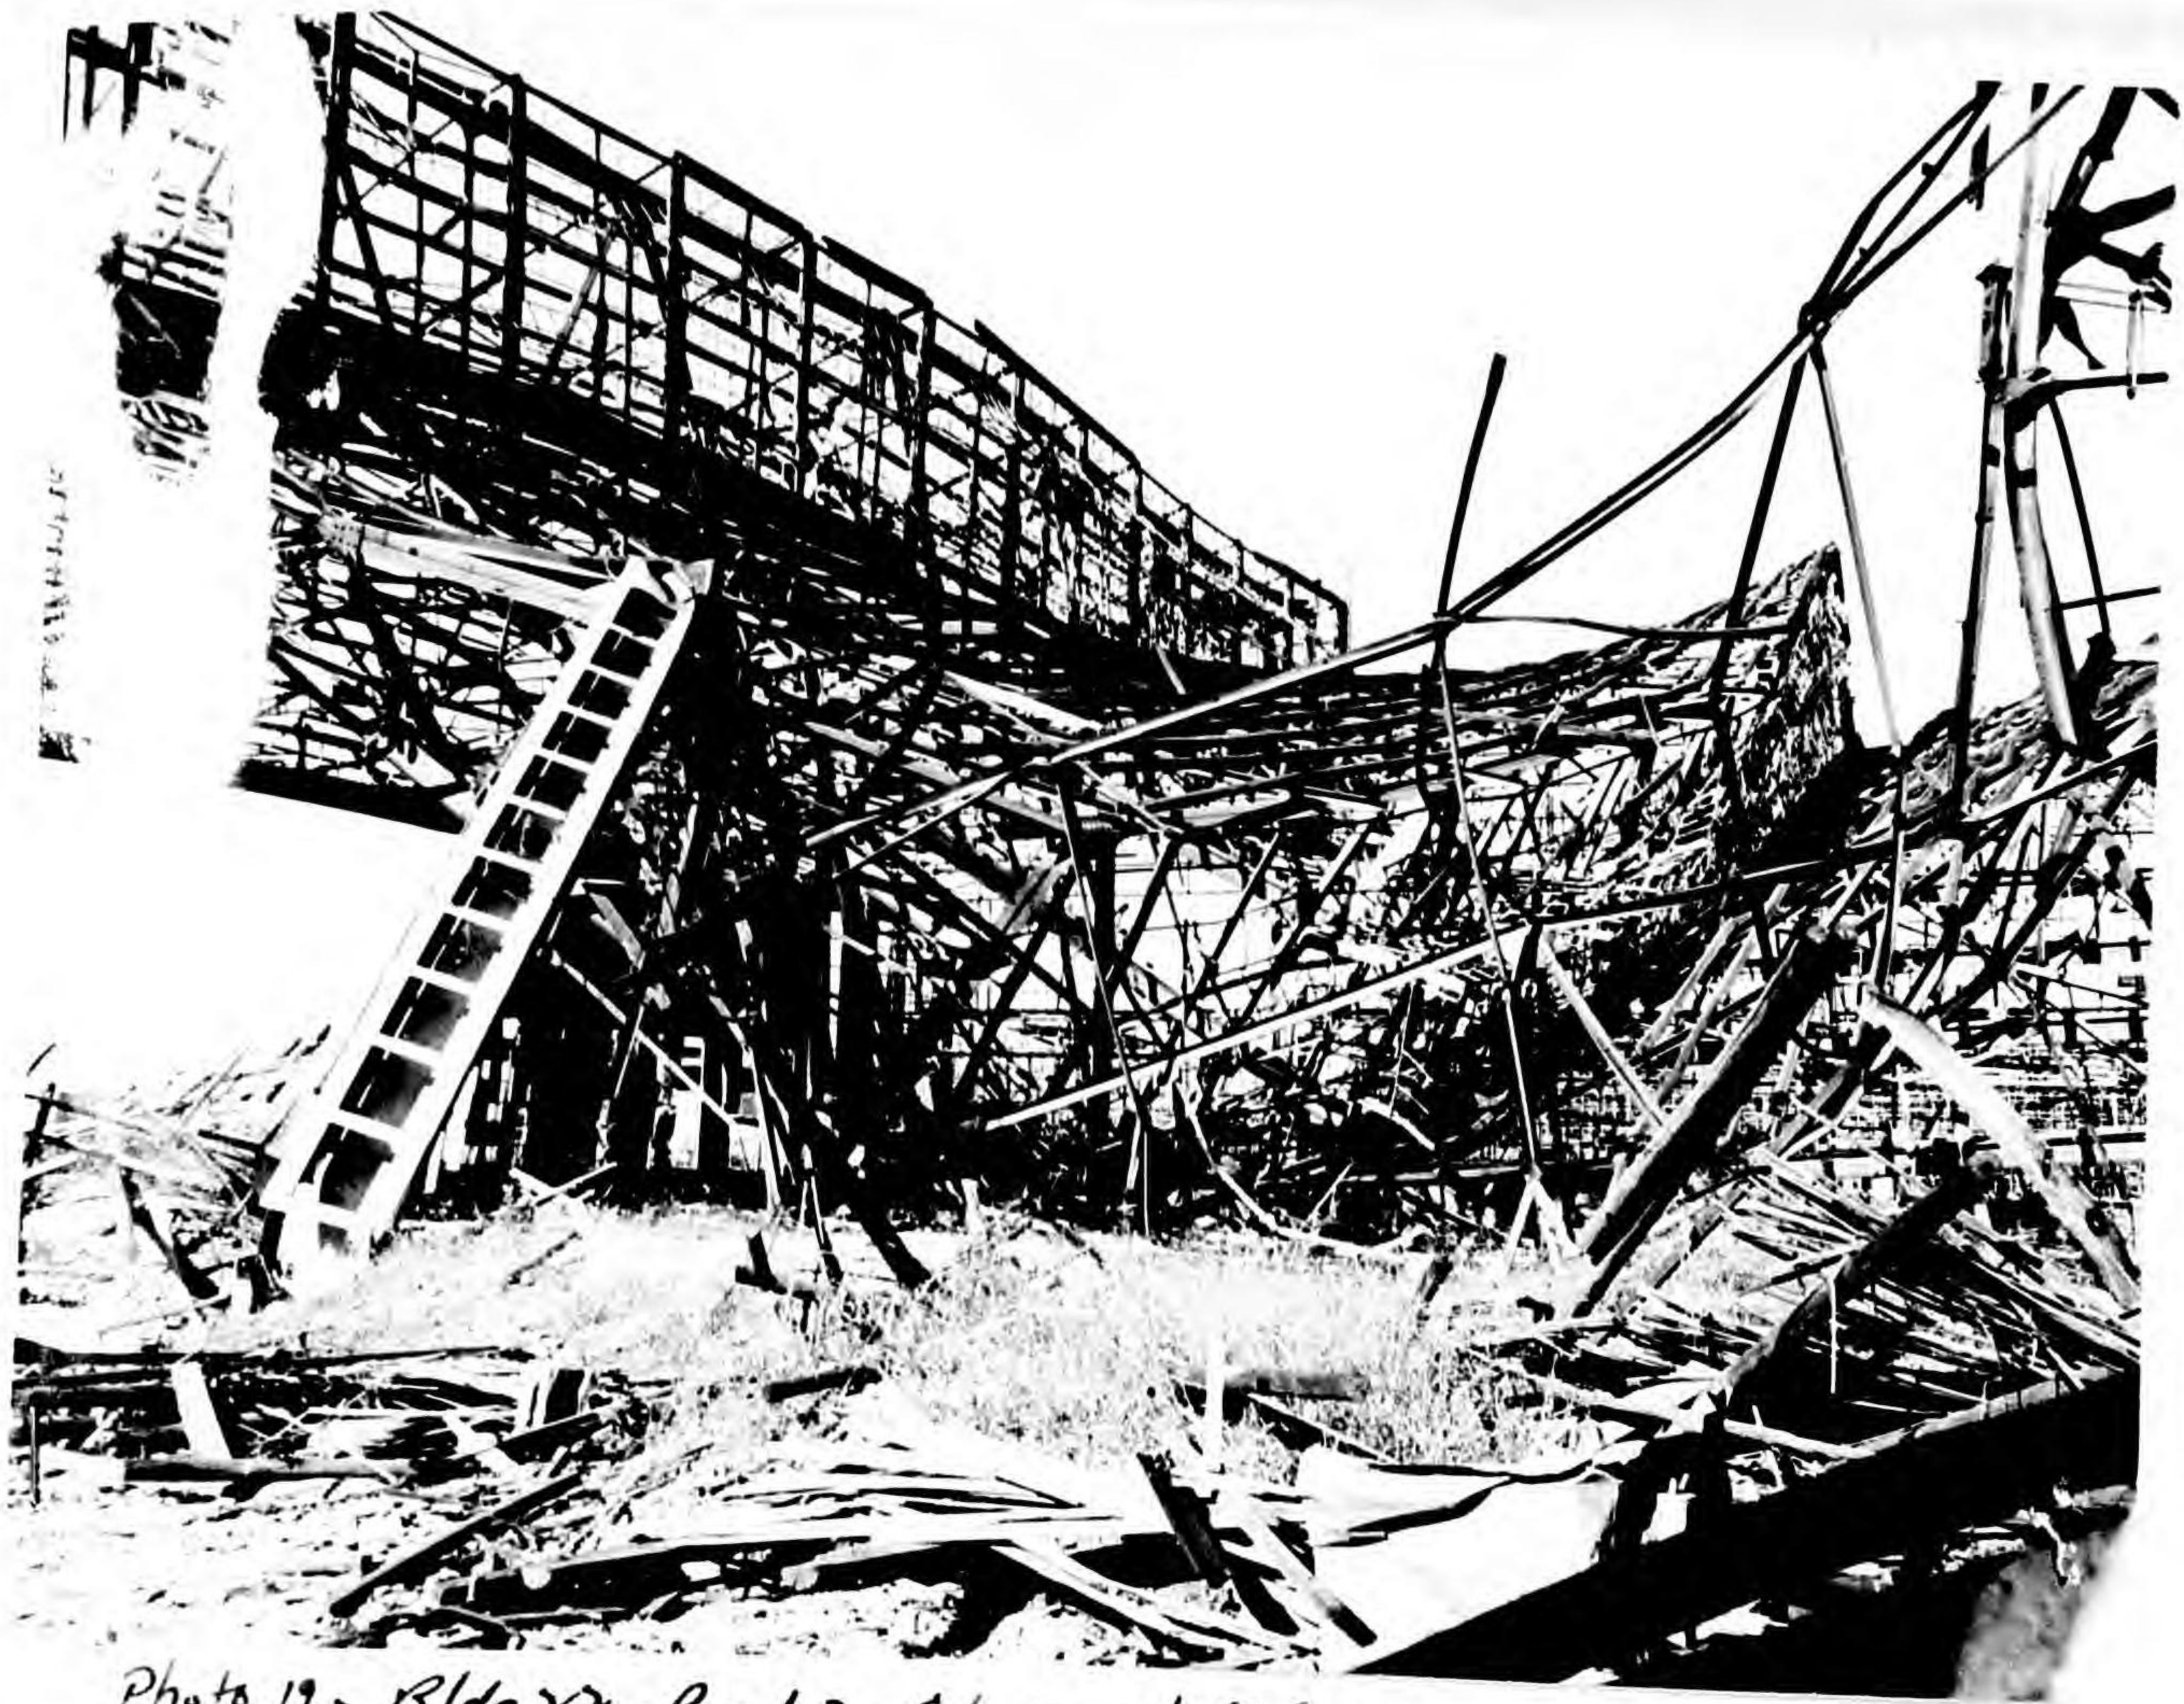
1. Building 22, a one-story, structural-steel building with saw-tooth roof, approximately 320 feet long and 280 feet wide, was used as a flight preparation shop. The trusses running perpendicular to the saw-tooth trusses and supporting them had a span of 140 feet. The height of the bottom chord above the floor level was 32 feet. This structure received one hit, and several near-misses. Bomb 3 burst near one of the interior columns supporting the long-span trusses. The blast from the bomb collapsed the column (Photo 19) which pulled down

Photo 19 - Bldg. 22, Bomb 3, Column in left foreground caused initial collapse.

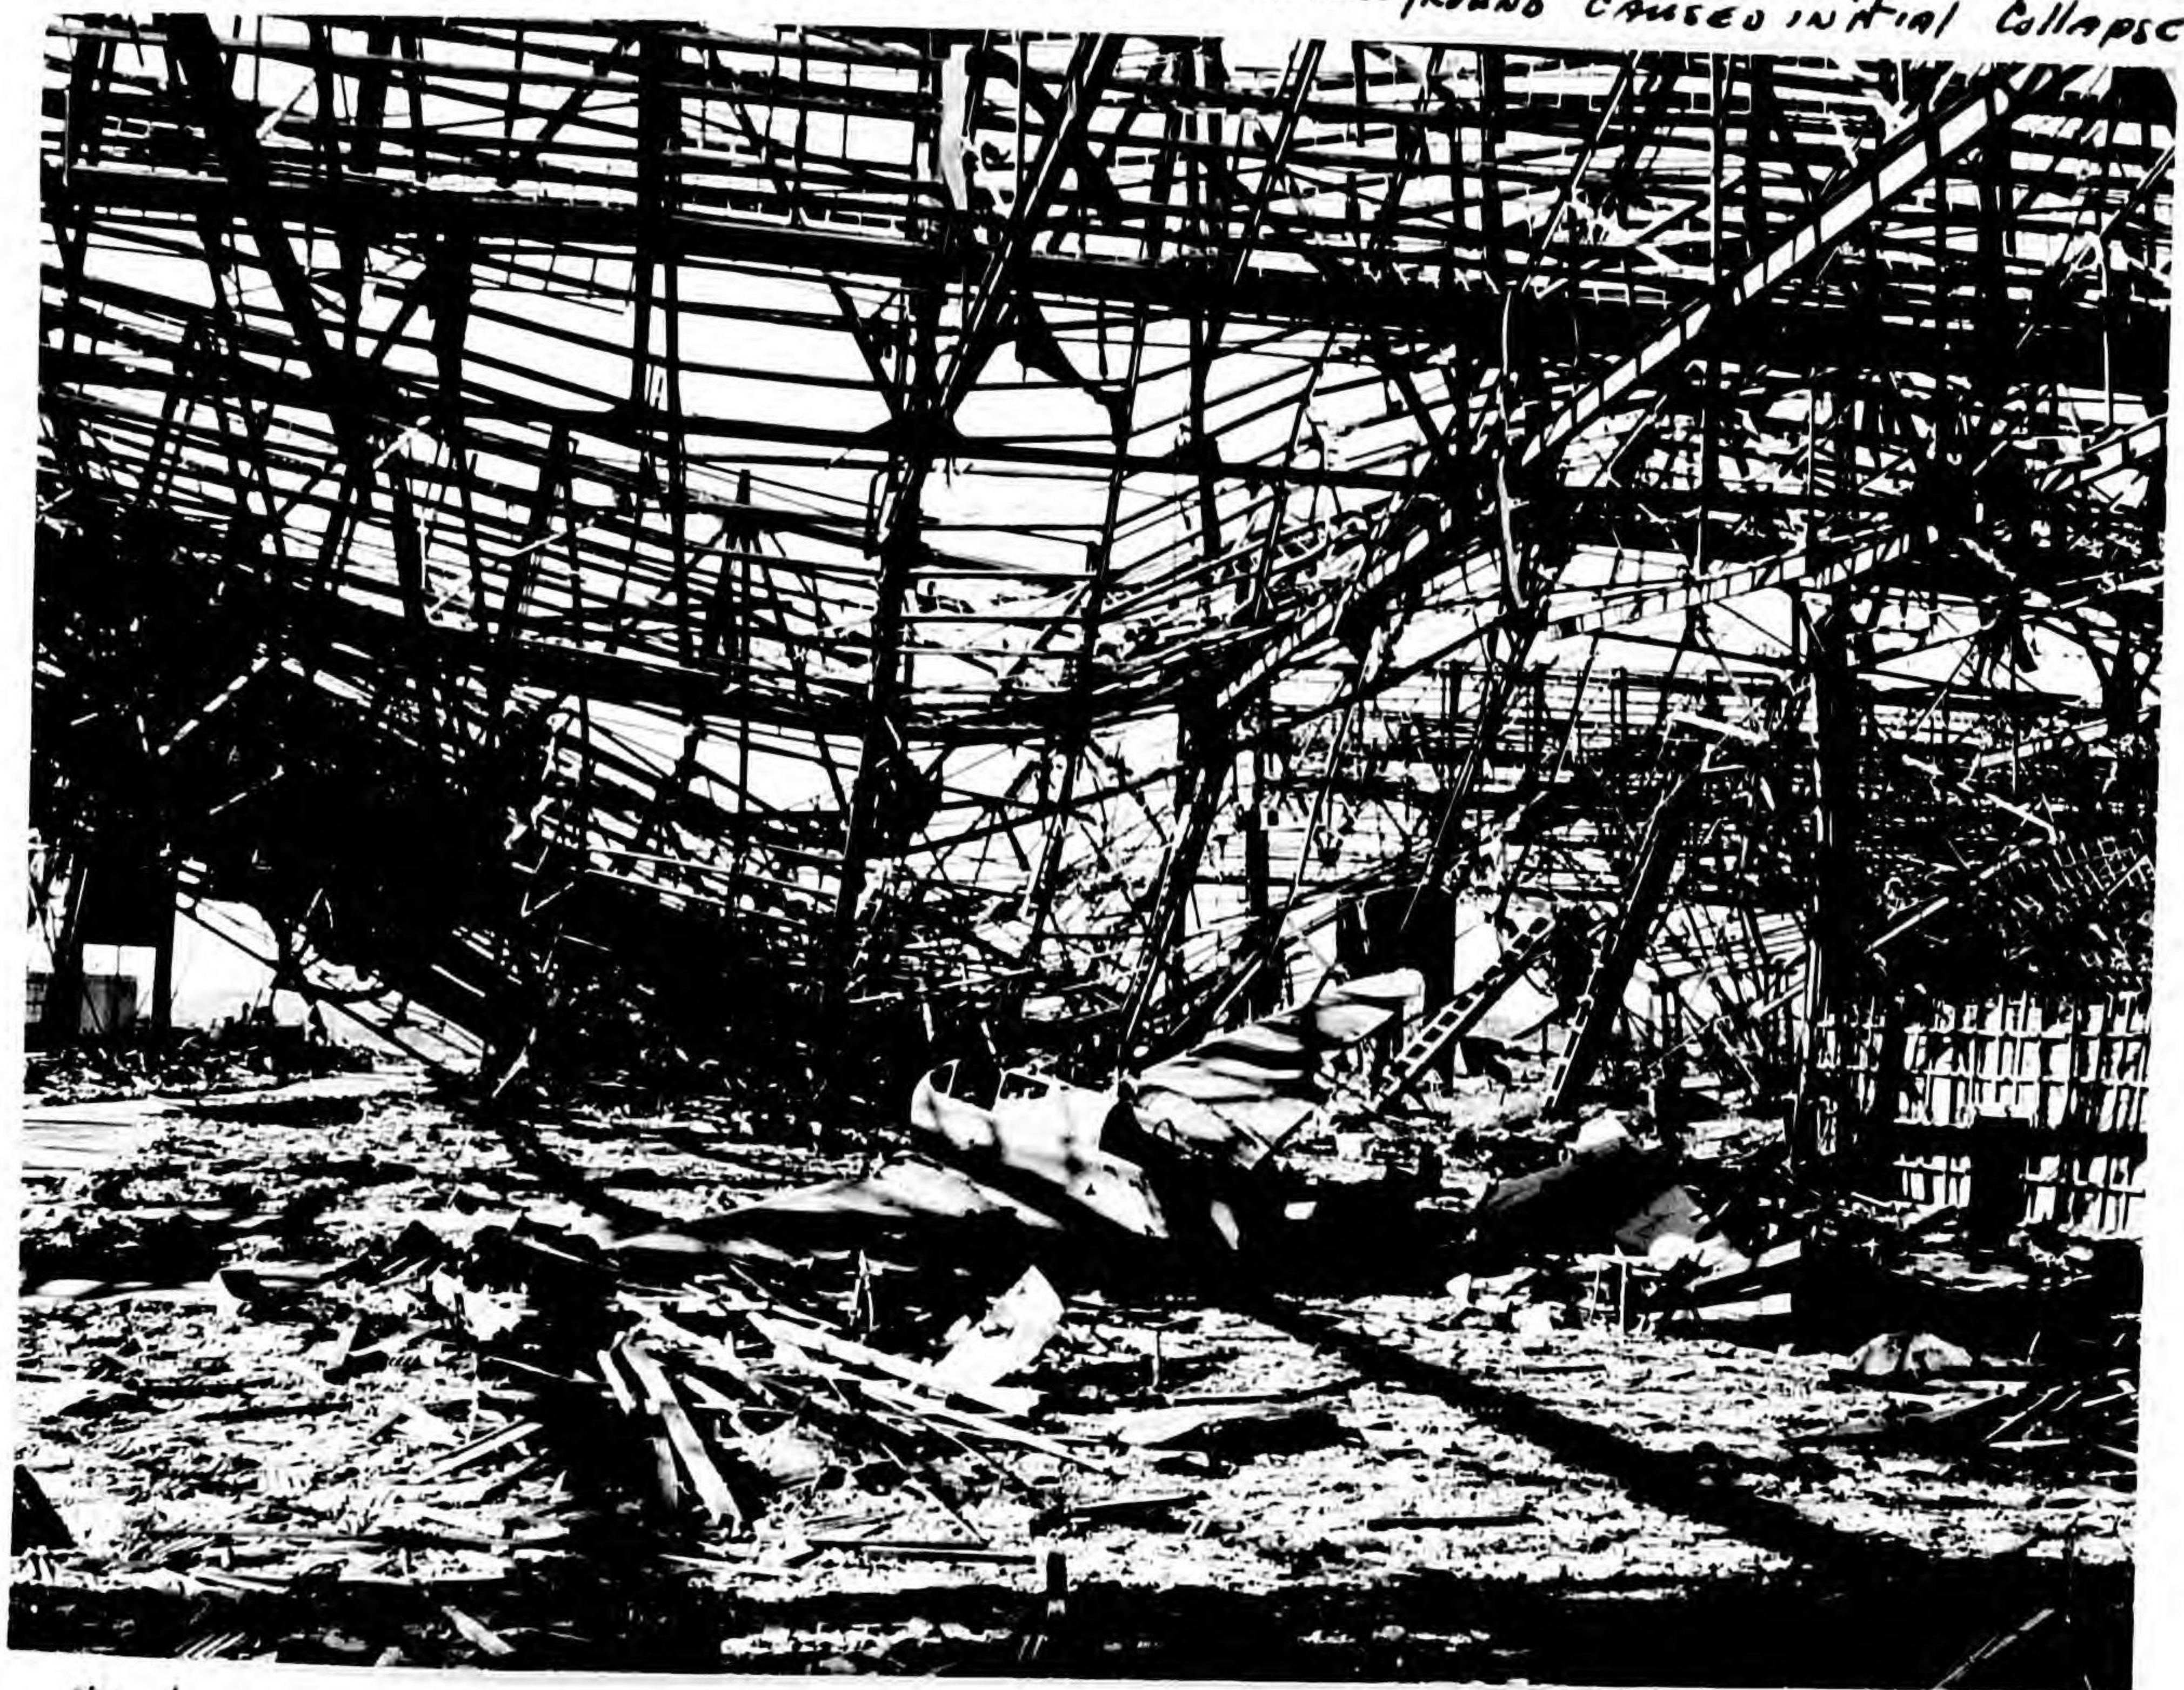
Photo 20 - Bldg. 22, Bomb 3, column with arrow caused initial collapse.
