UNITED STATES STRATEGIC BOMBING SURVEY

REPORT 72

EFFECTS OF THE FOUR THOUSAND-POUND BOMB

A Report on Five Incidents

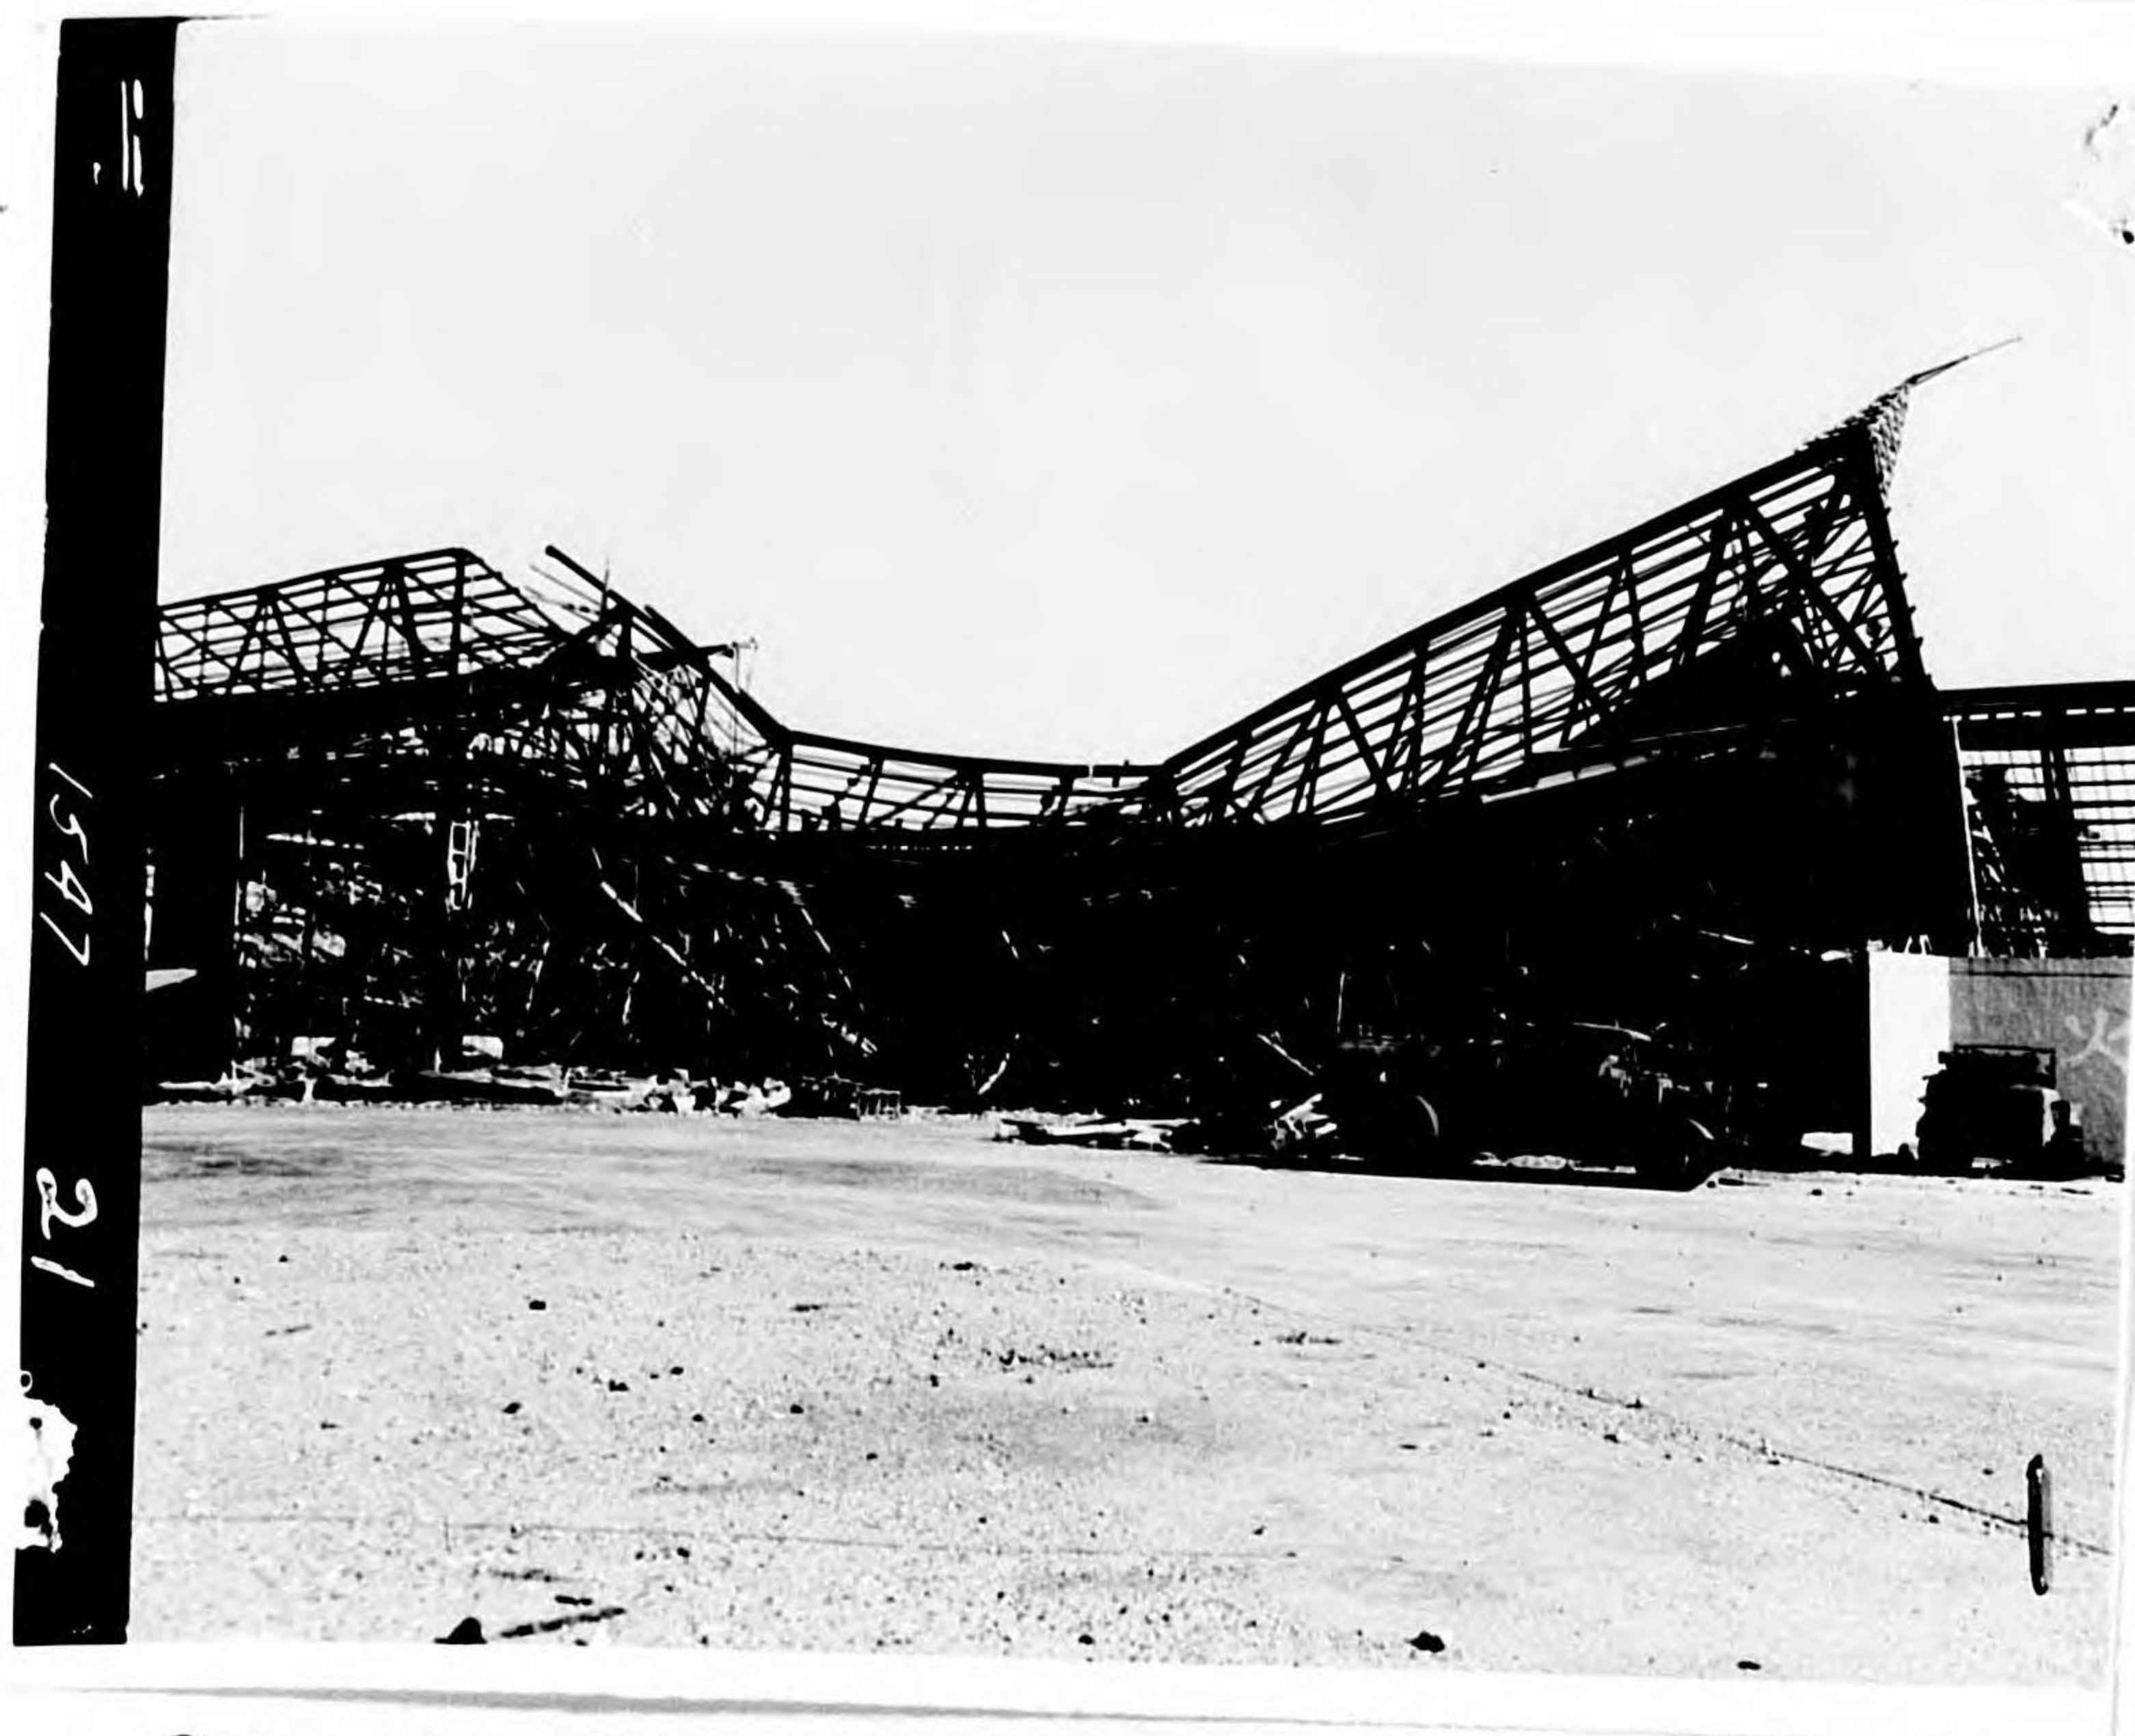
Photo 21 - Bldg 22, Bomb 3, General view of Collapse.

the heavy trusses it was supporting. The trusses, which had been tied into the rest of the structure by the saw-tooth trusses, in turn pulled down and distorted trusses and framework for three more bays on one side of the hit, and two on the other side. Photos 20 and 21 show this collapse. Figure 2 indicates the position of Bomb 3 in relation to surrounding framing. Photo 19 shows the column which had collapsed in its final position. Photo 22 taken from outside the western end of the building shows how five of the exterior columns were pulled over by the collapse of the interior column. A bomb ~~which was estimated to be a 1,000-pound, general-purpose,~~ cratered 30 feet south of this structure, knocked down the hanger doors, and wrecked the southern part of this building. The widespread damage in this building as the result of the collapse of one column was due to the doubling of the span of the truss, together with the higher dead load inherent in the design of long spans.

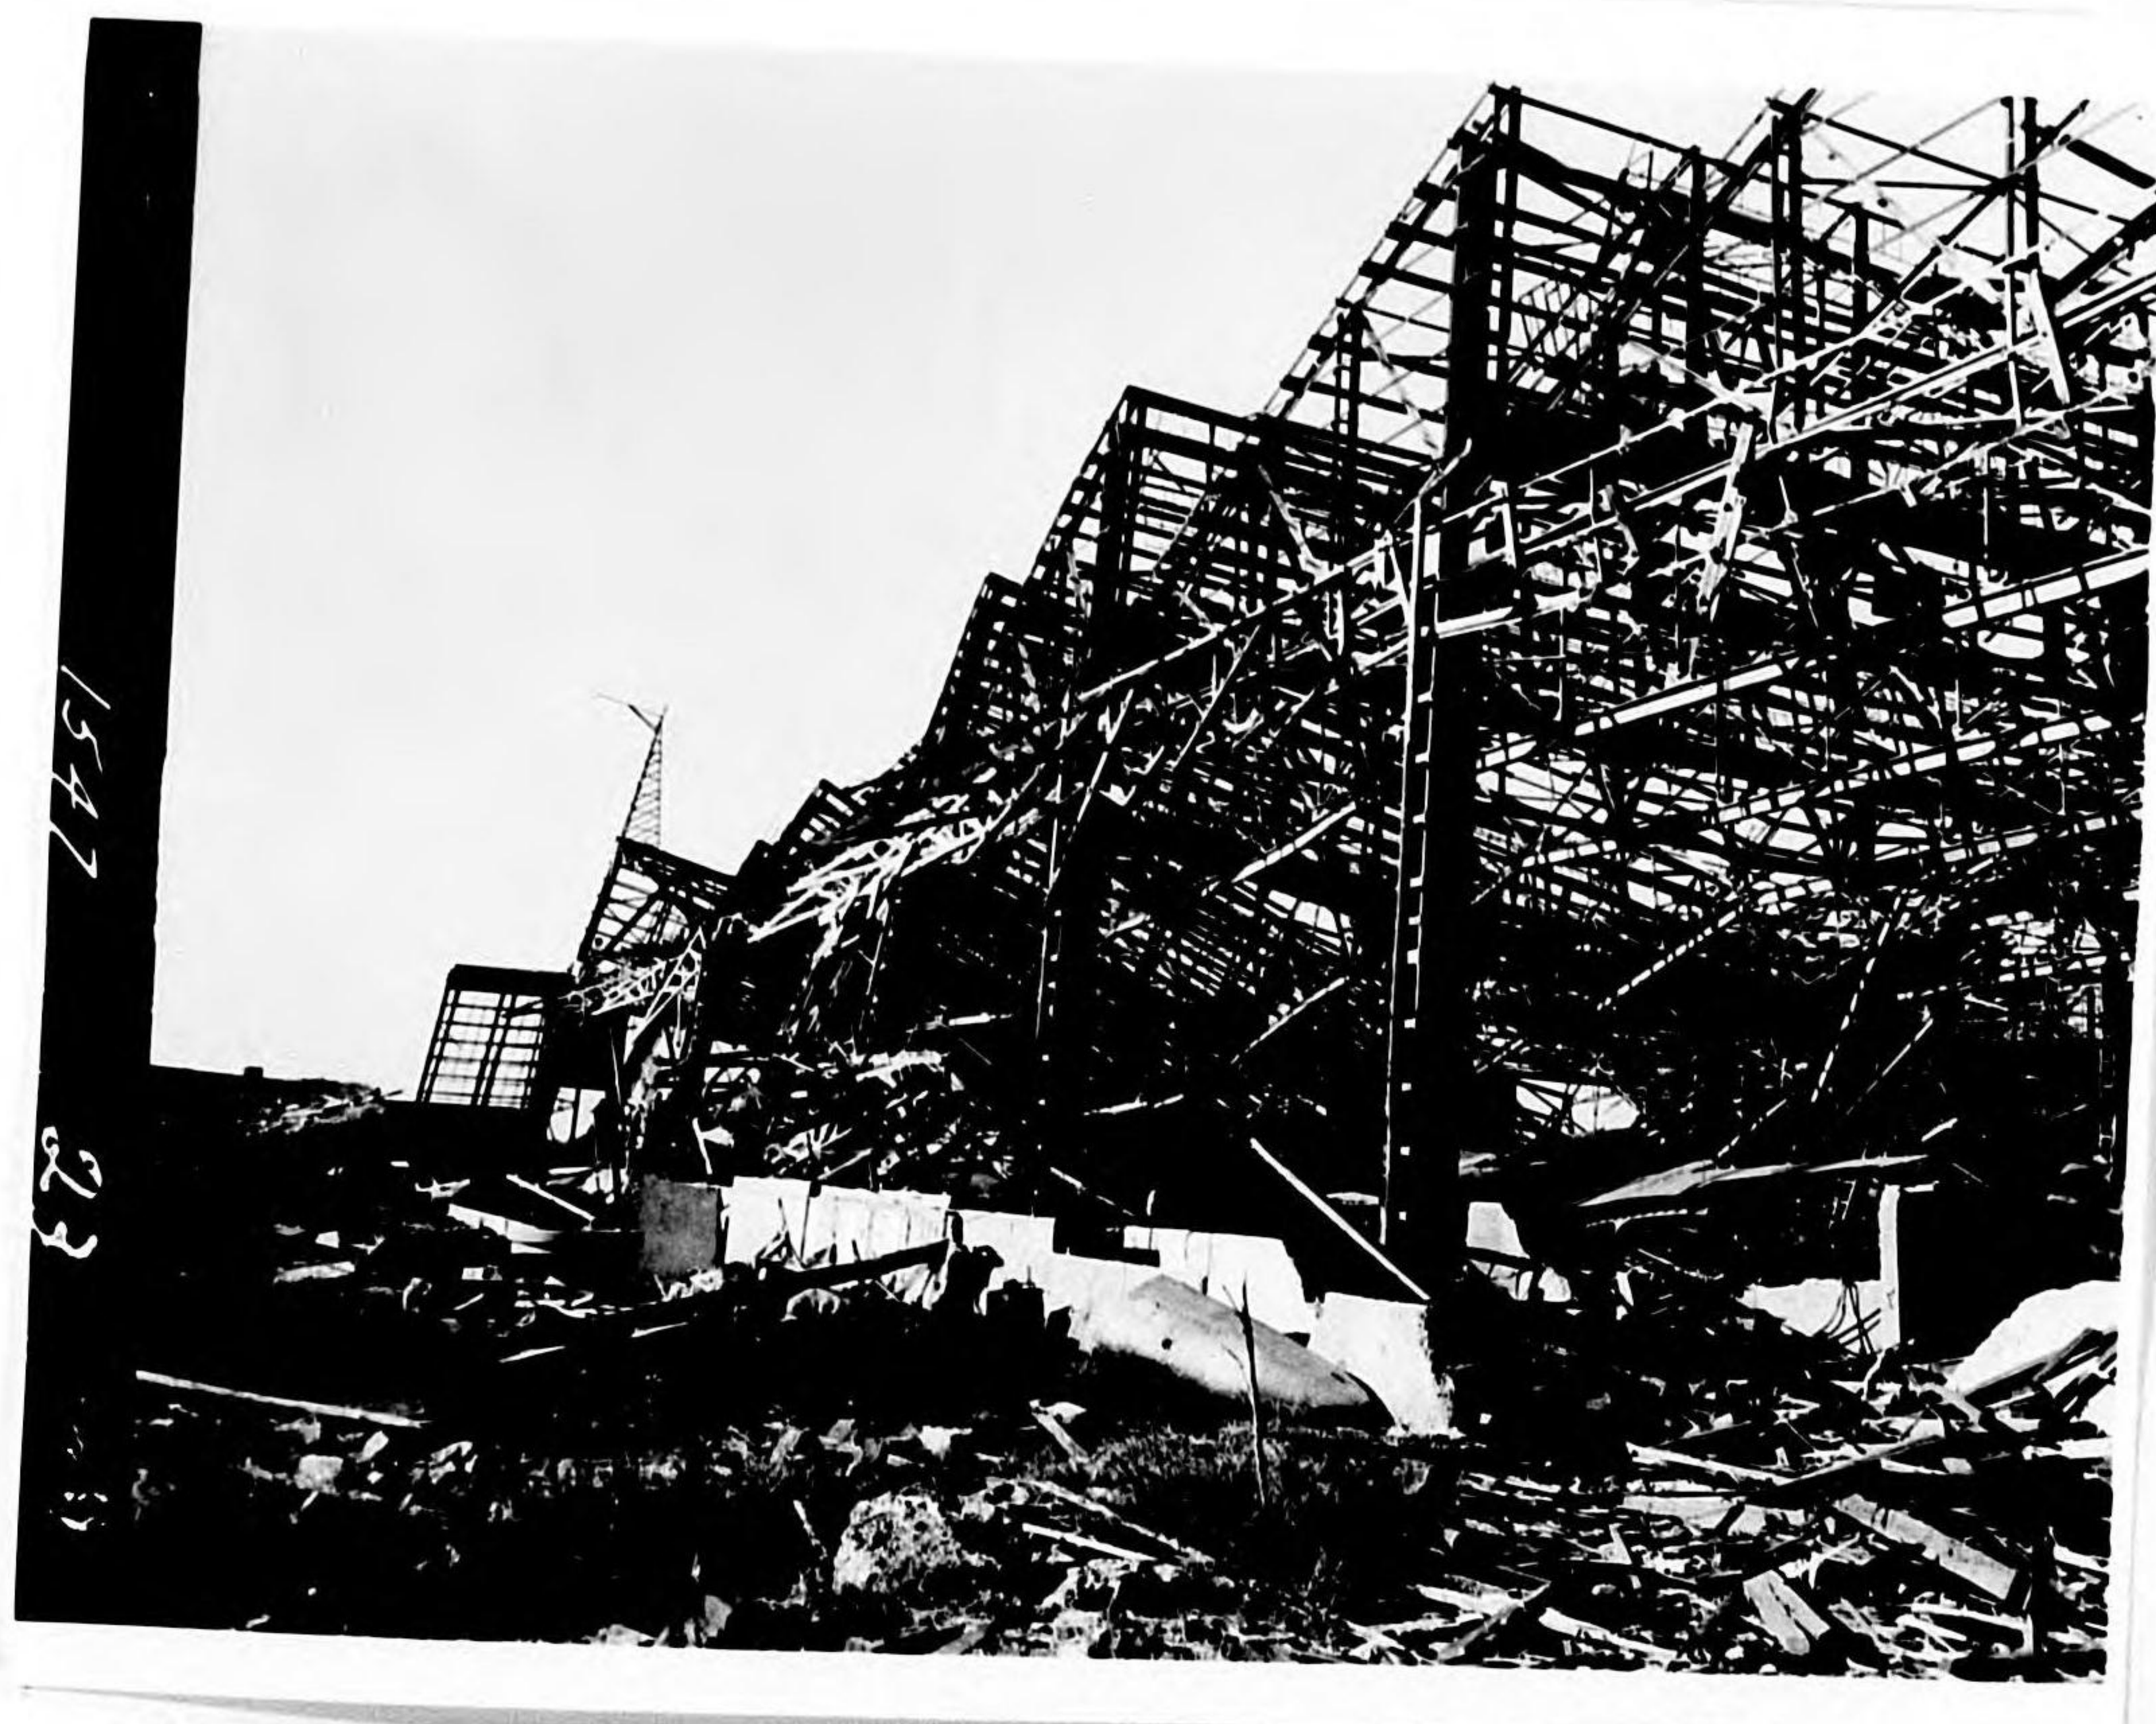
Photo 22 - Side view of Bldg 22, Bomb 3.

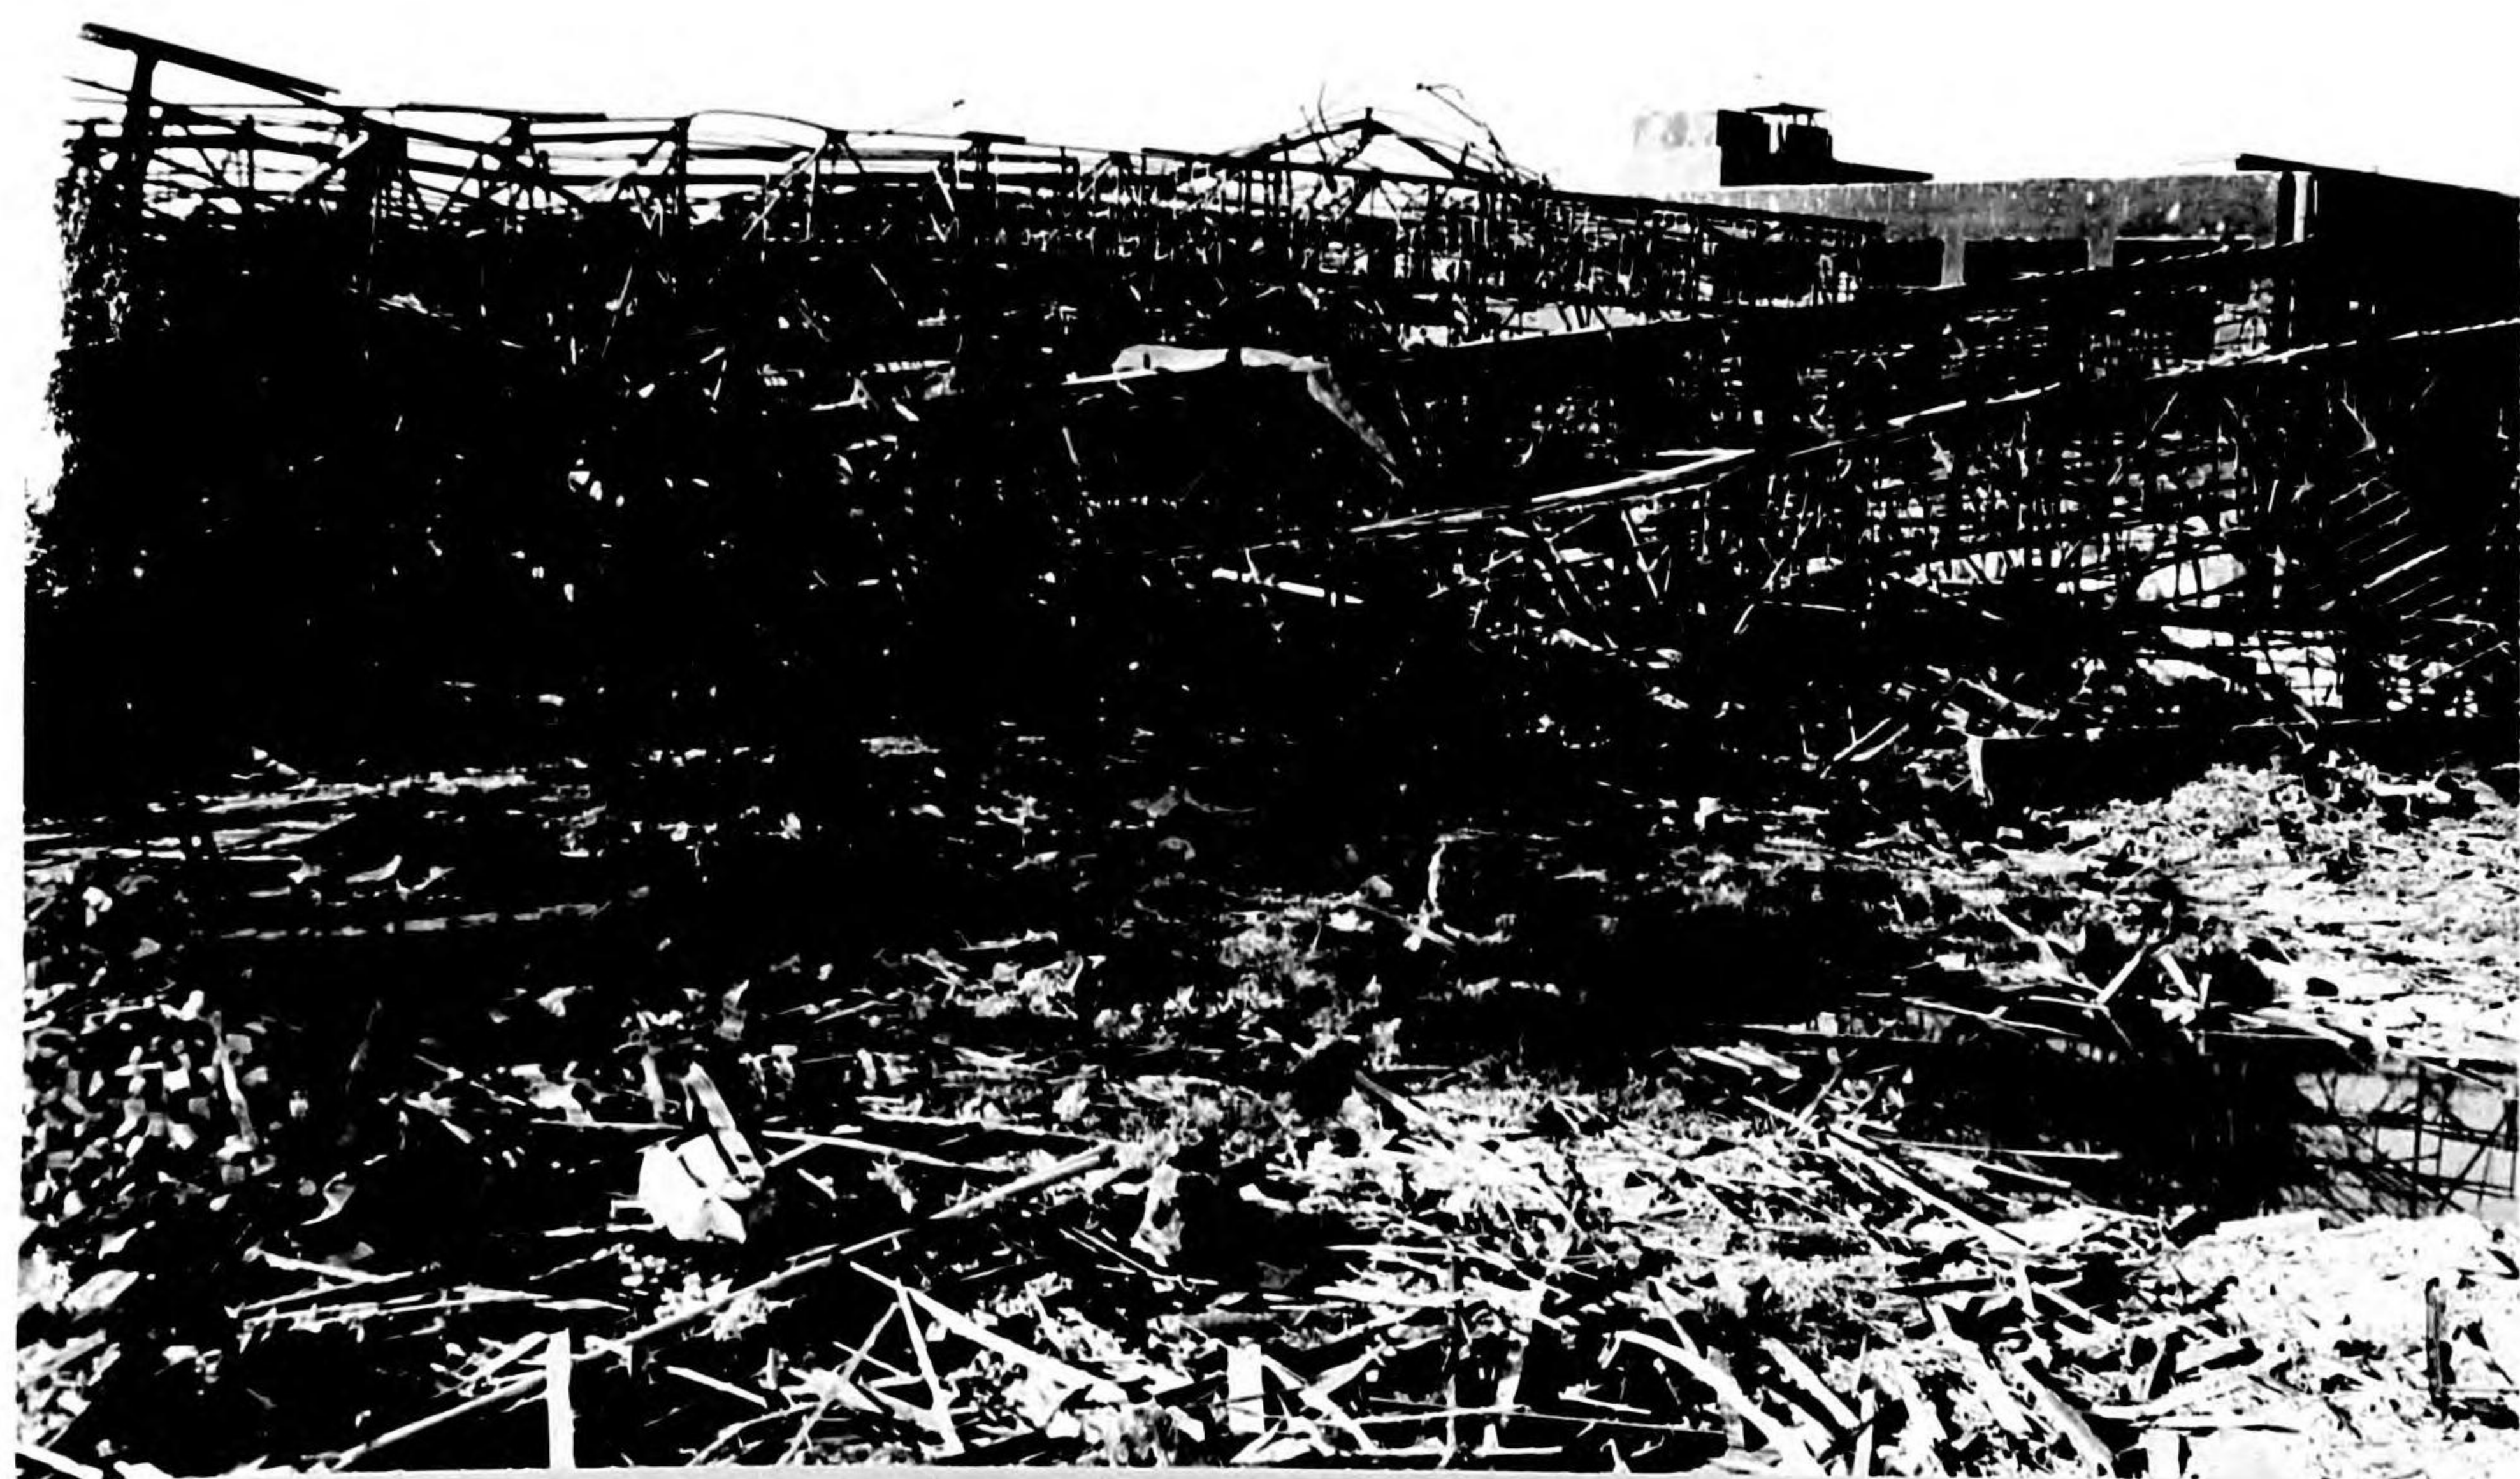
j. Building 27 was a one-story, steel building used as a plating shop. It was divided in two by an eight-inch reinforced-concrete wall running parallel to the roof trusses and as high as the bottom chord of the truss. Bomb 12 cratered 30 feet south of the south side of the building. Photo 23 indicates the effect of the blast from this bomb which pushed the south side of the building in and caused the roof to collapse. No damage occurred on the far side of the concrete wall which acted as a blast wall.

Photo 23 - Bldg. 27, Bomb 12, DAMAGE CAUSED BY NEAR MISS.

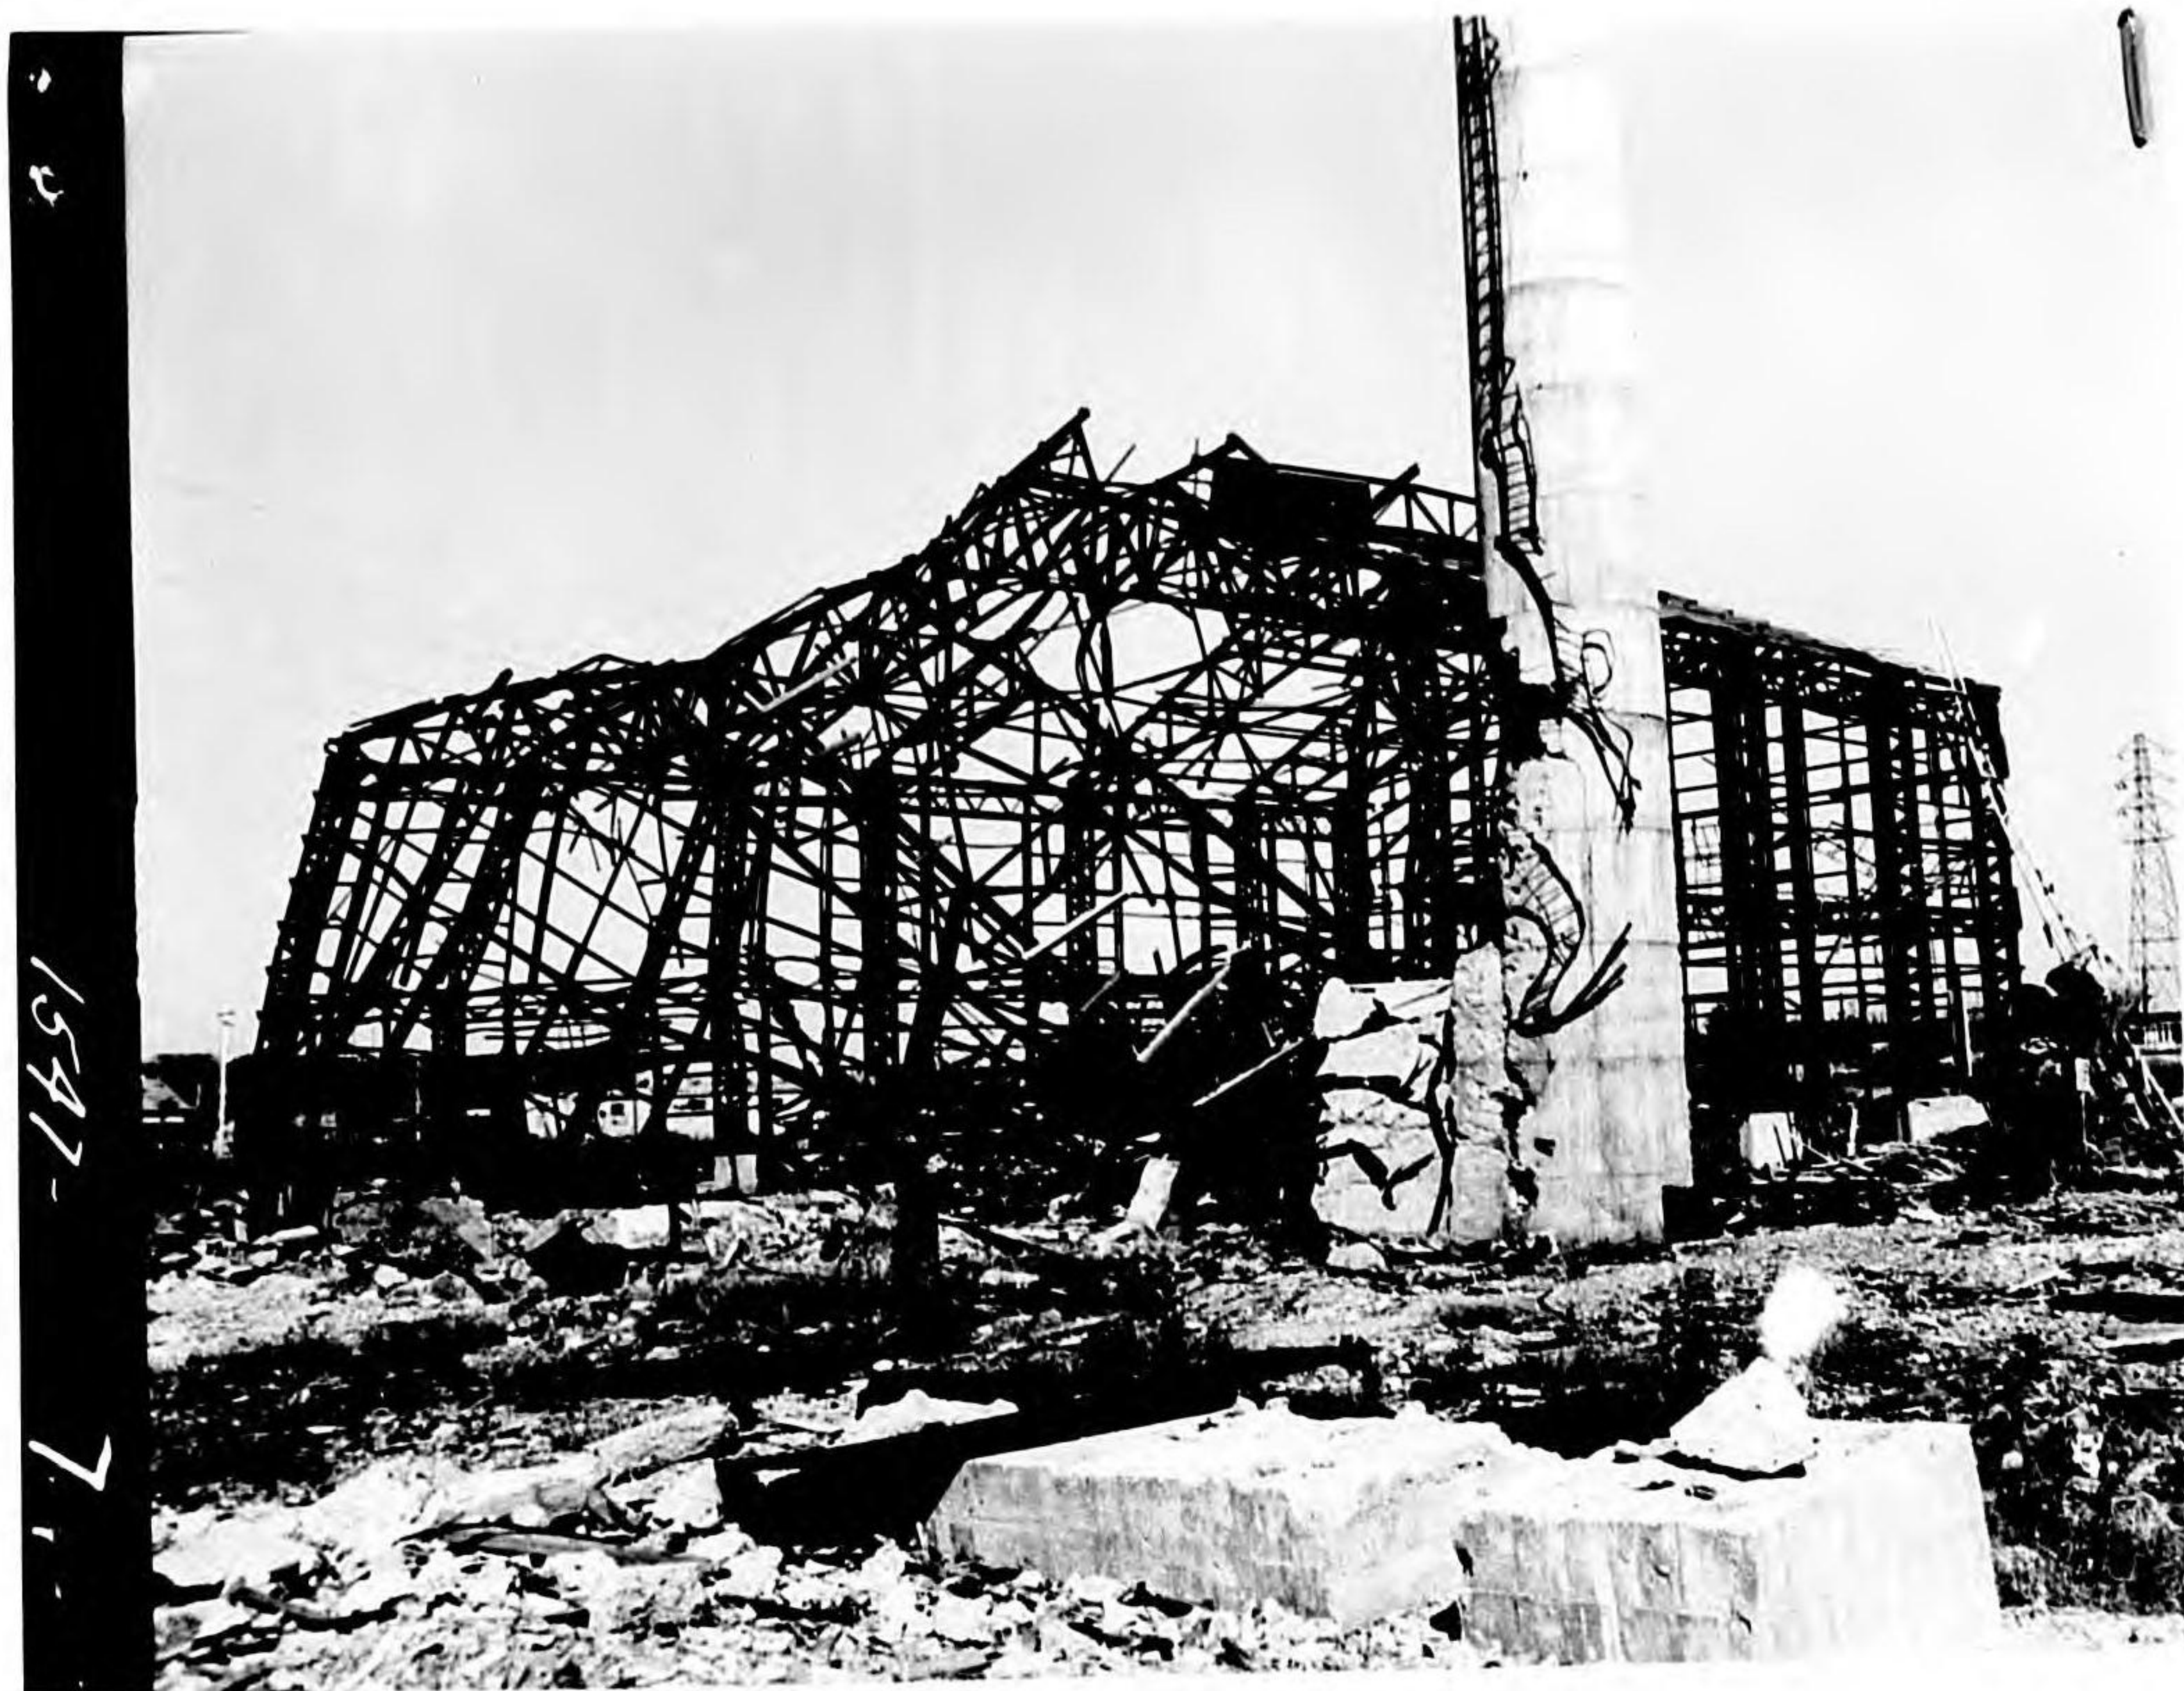
k. Building 132 was a structural-steel boiler house. Photo 24 presents general aspects and over-all damage. The one bomb affecting this structure blew over the boiler (Photo 25) and cut the corner

Photo 24 - Bldg 13v, Bomb 23, GENERAL VIEW.

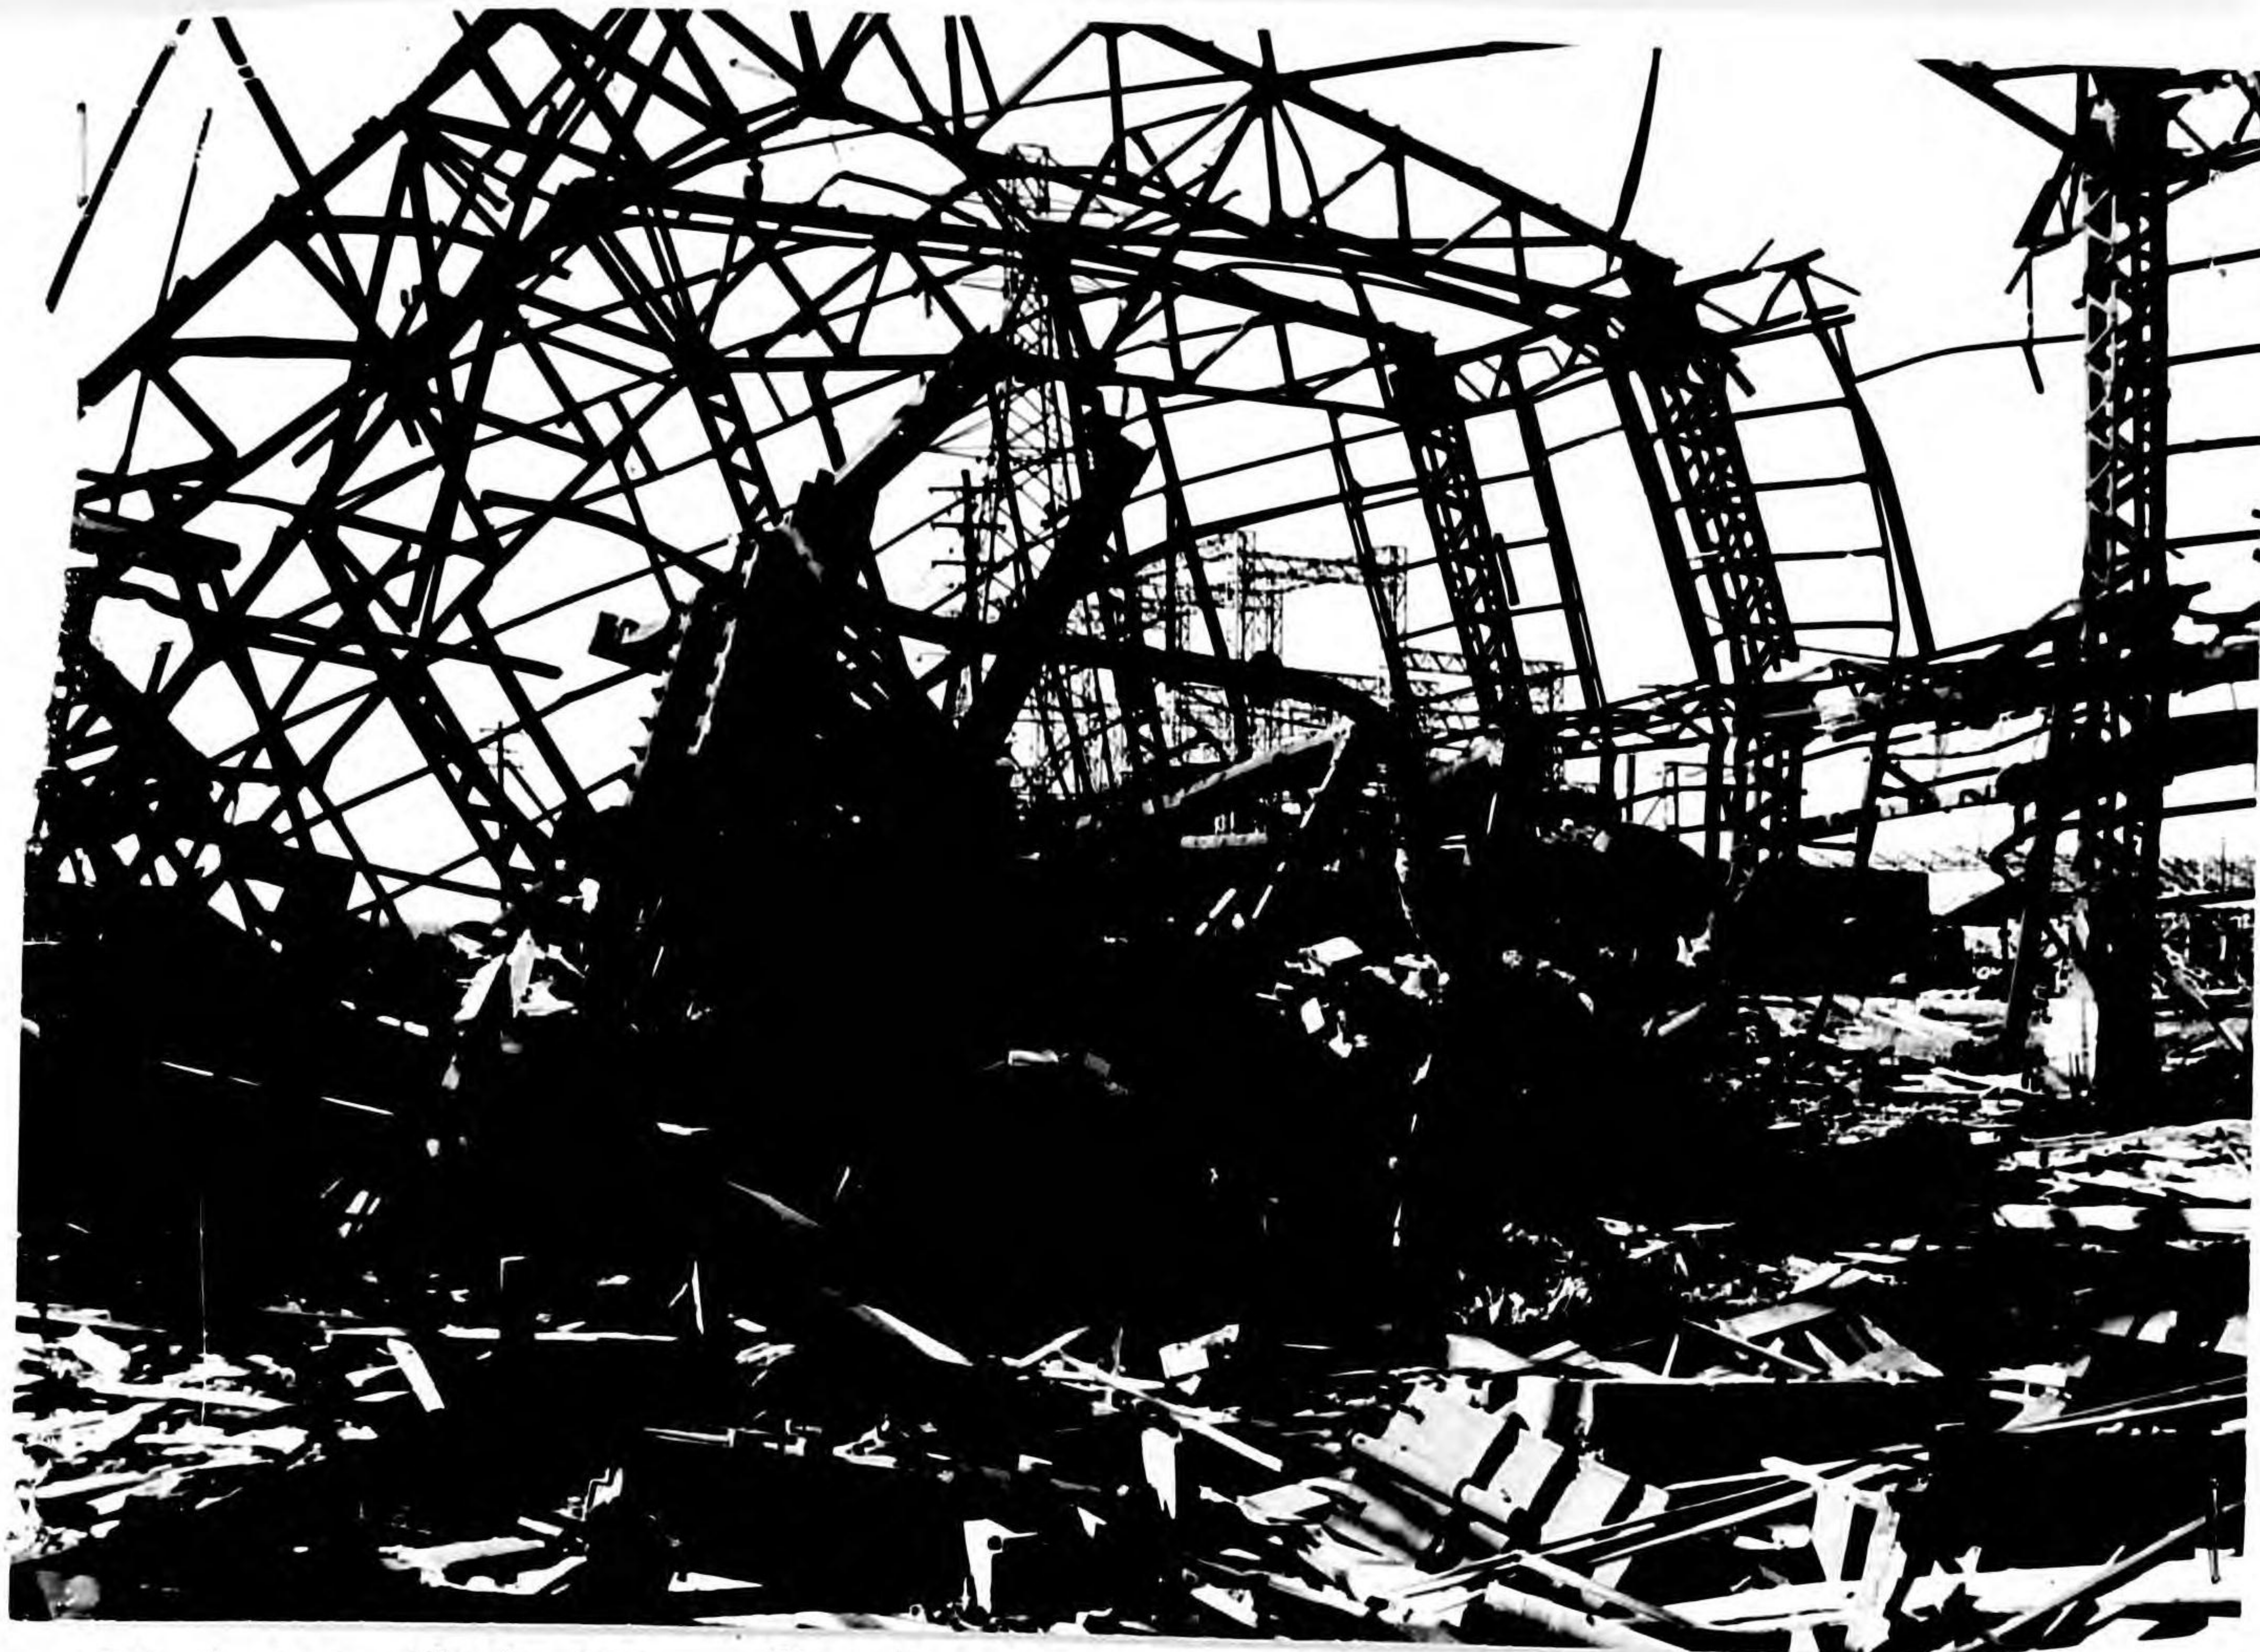
Photo 25, Bldg 132, Bomb 23, Boiler blown over.

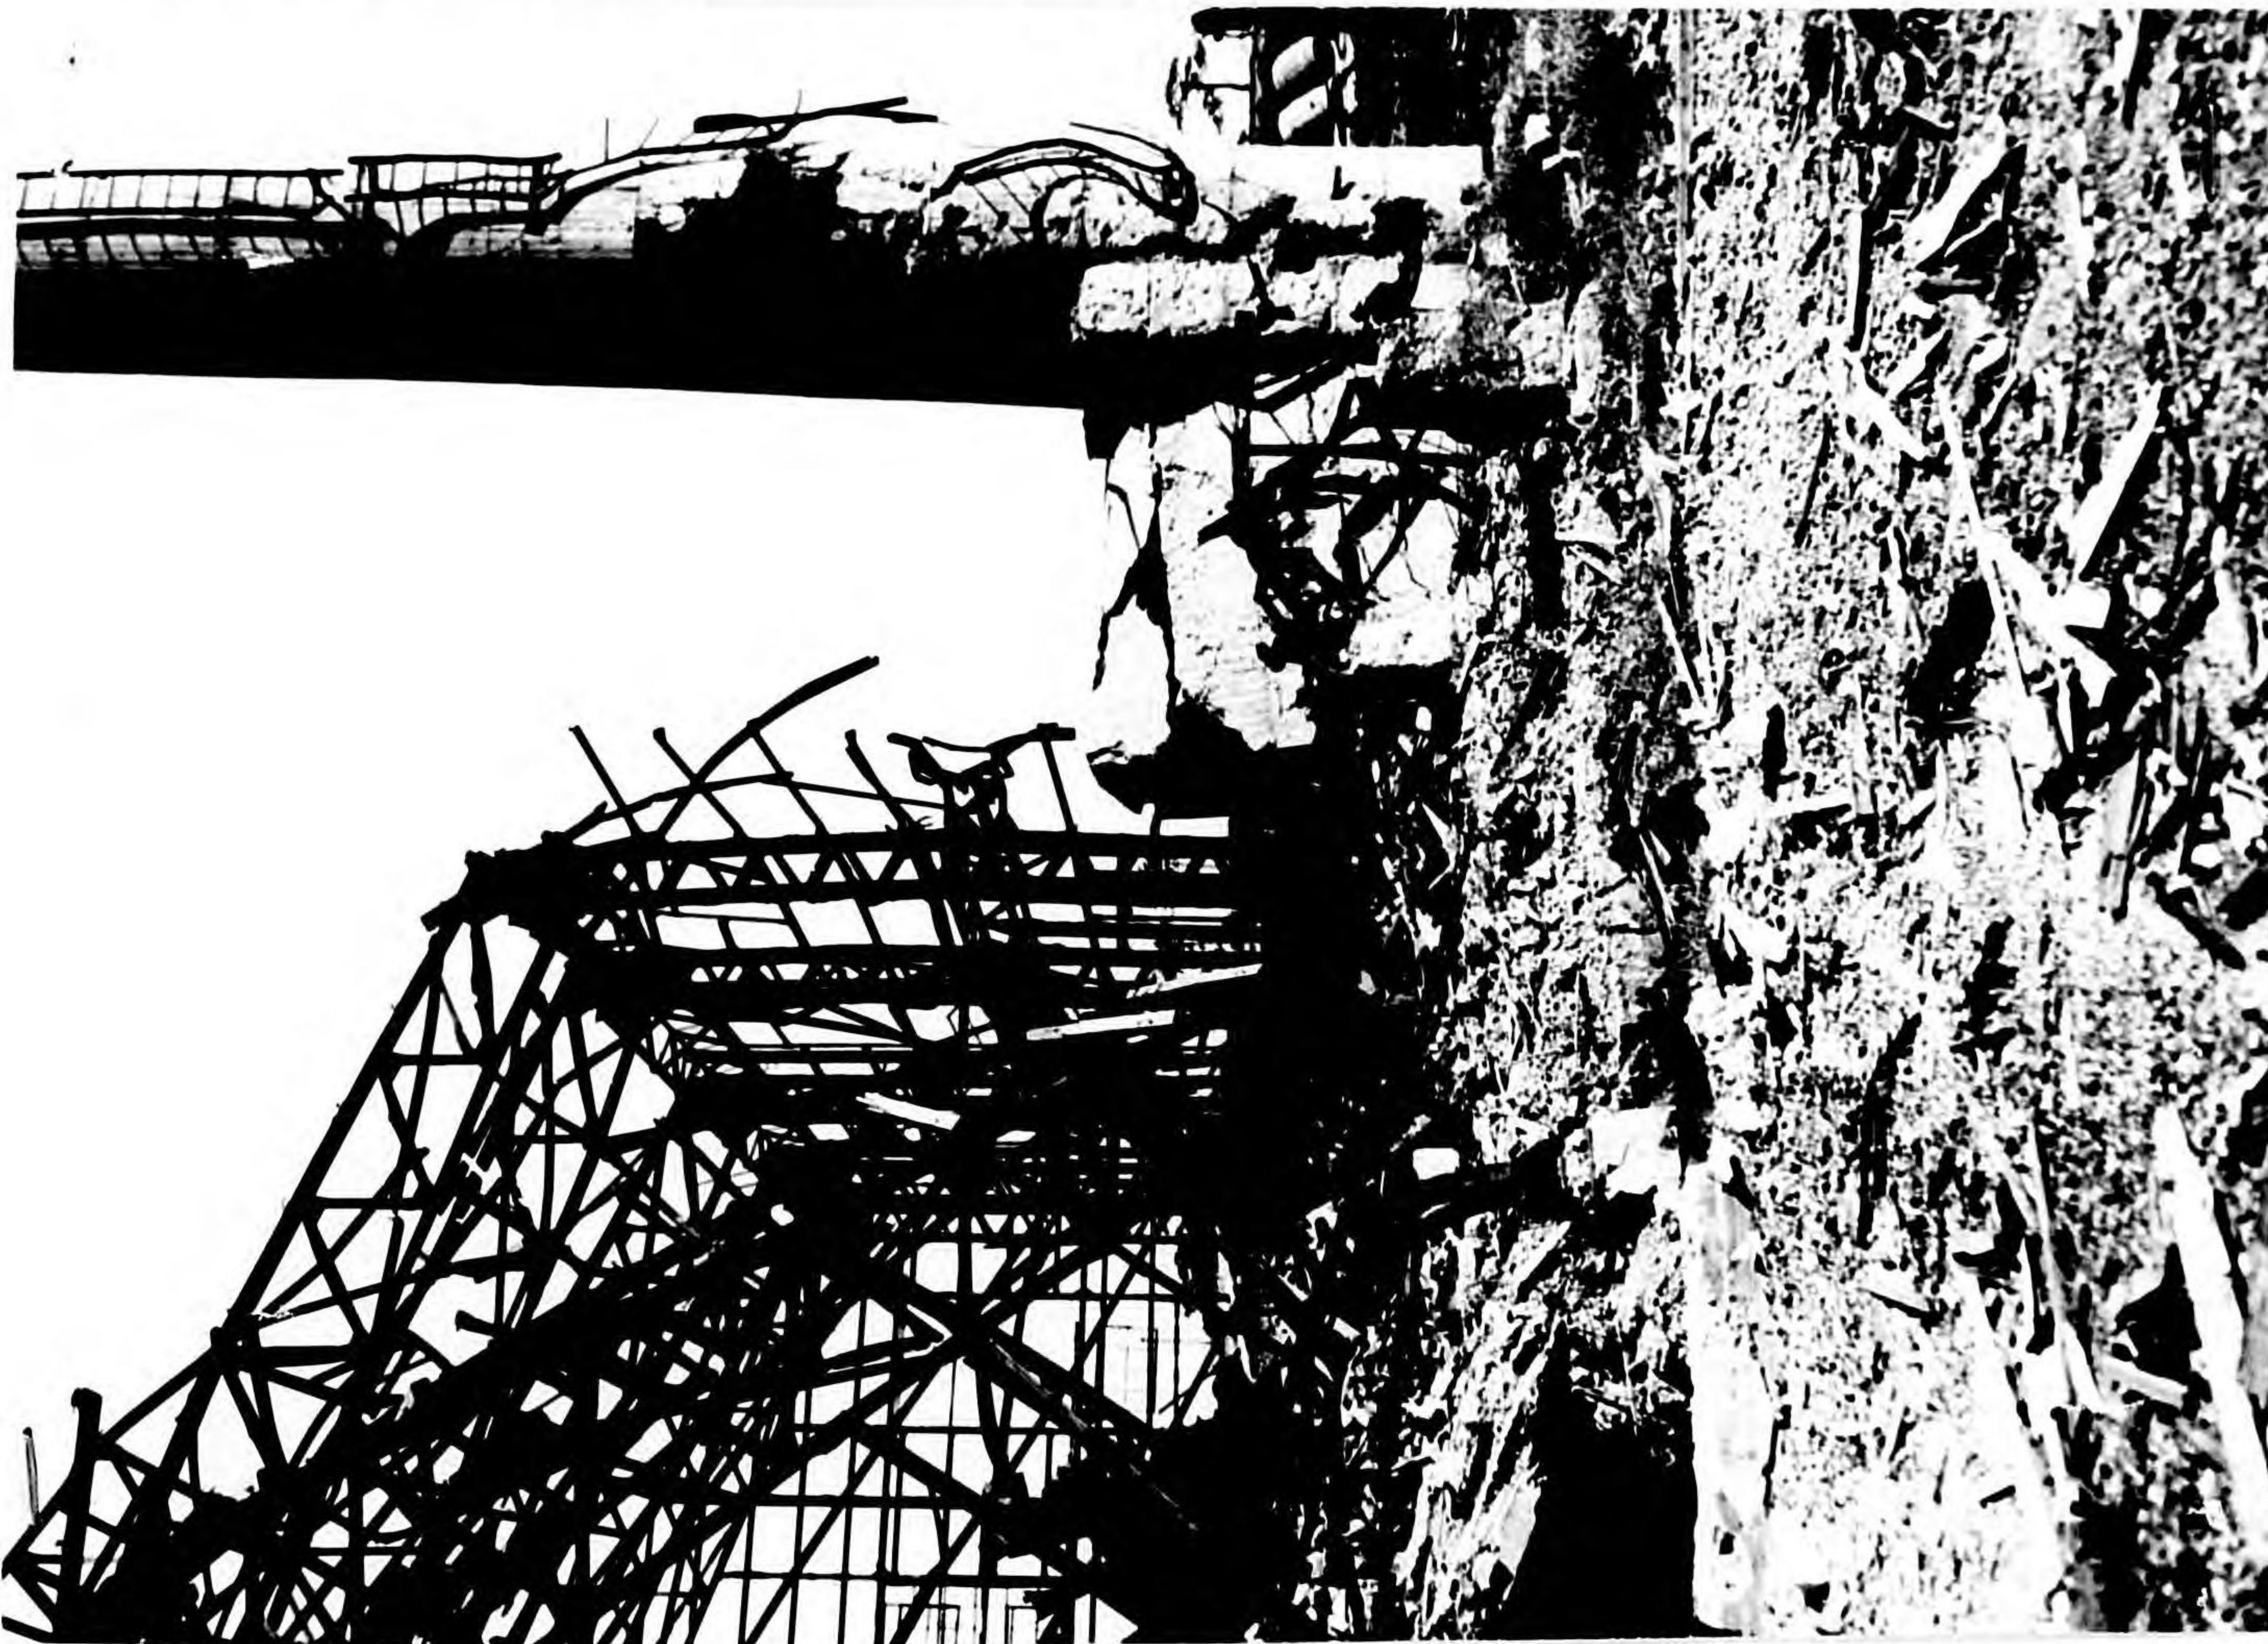
Photo 26, Bldg. 132, Bomb 23.

column, blowing the end of the building inward (Photos 26, 27, and 24). Photo 28 shows the construction and how the failure took place in the side of the building away from the stack. The reinforced-concrete stack was damaged, the concrete being knocked out over an area approximately 15 feet high by 4 feet wide (Photos 26 and 27). The foundation of the stack was apparently undisturbed and the stack appeared to be in plumb.
