UNITED STATES STRATEGIC BOMBING SURVEY

REPORT 72

EFFECTS OF THE FOUR THOUSAND-POUND BOMB

A Report on Five Incidents

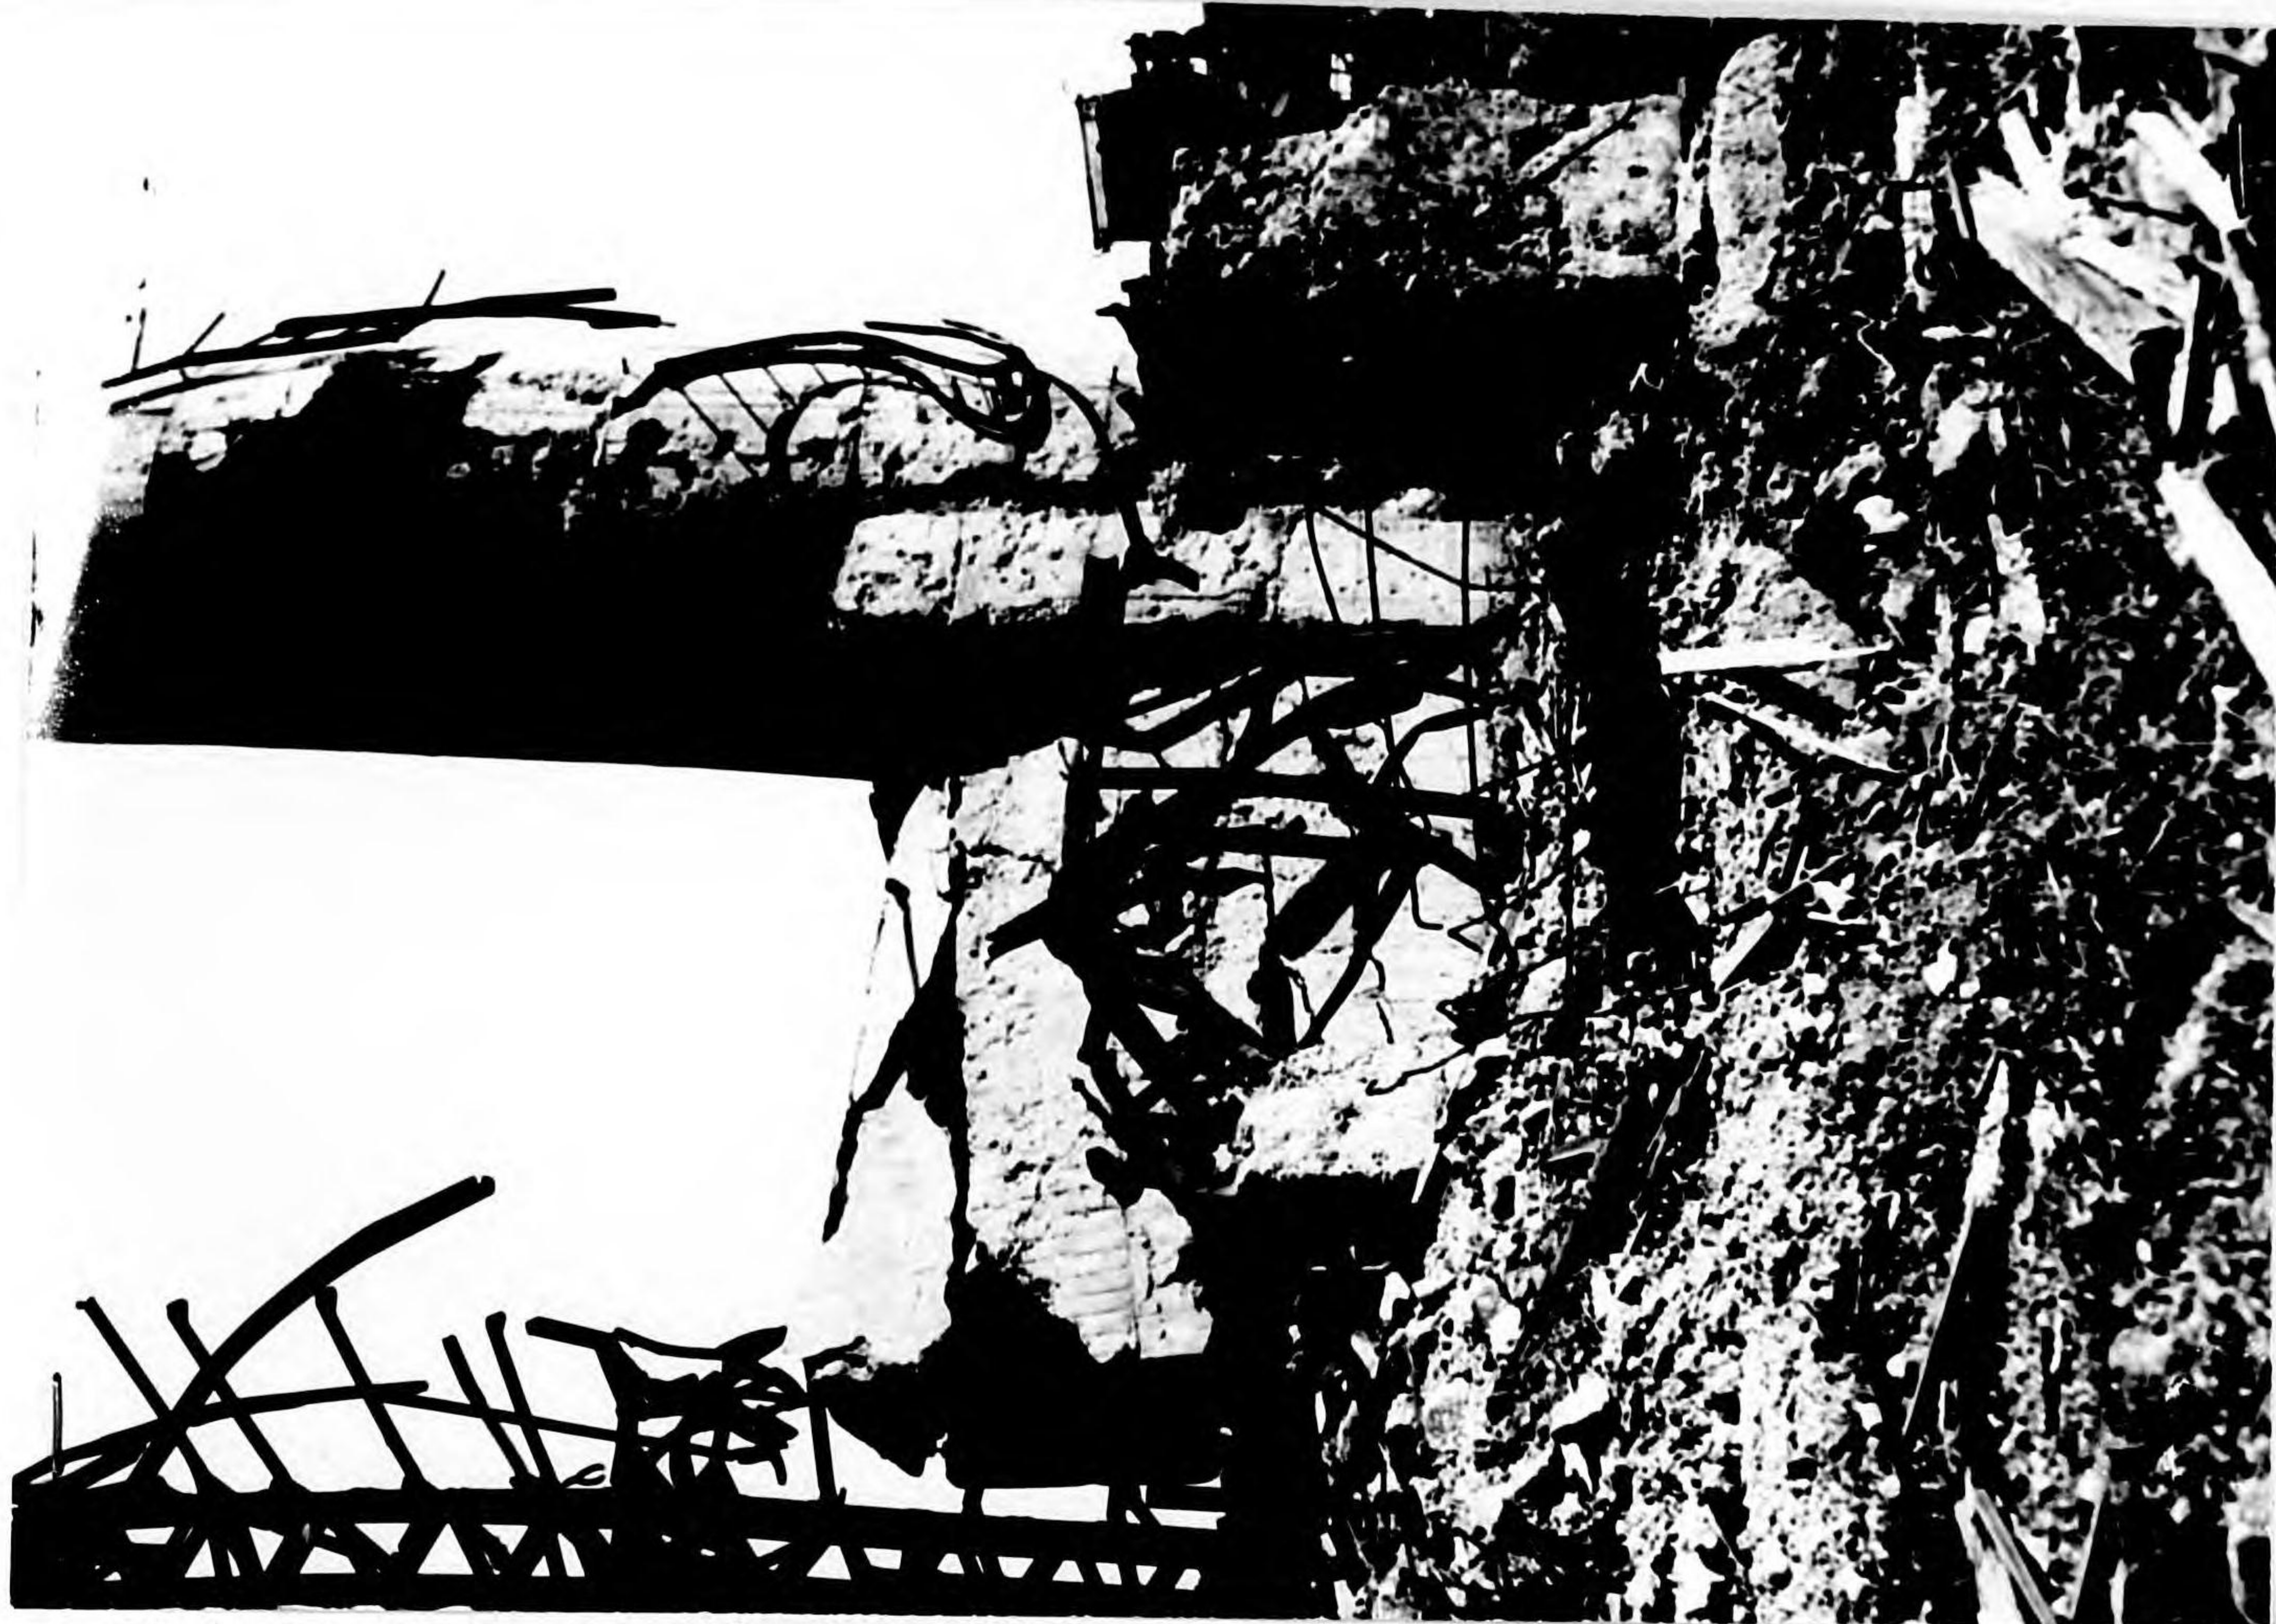
column, blowing the end of the building inward (Photos 26, 27, and 24). Photo 28 shows the construction and how the failure took place in the side of the building away from the stack. The reinforced-concrete stack was damaged, the concrete being knocked out over an area approximately 15 feet high by 4 feet wide (Photos 26 and 27). The foundation of the stack was apparently undisturbed and the stack appeared to be in plumb.

Photo 27, Bldg 132, Bomb 23, damaged Stack and Column.

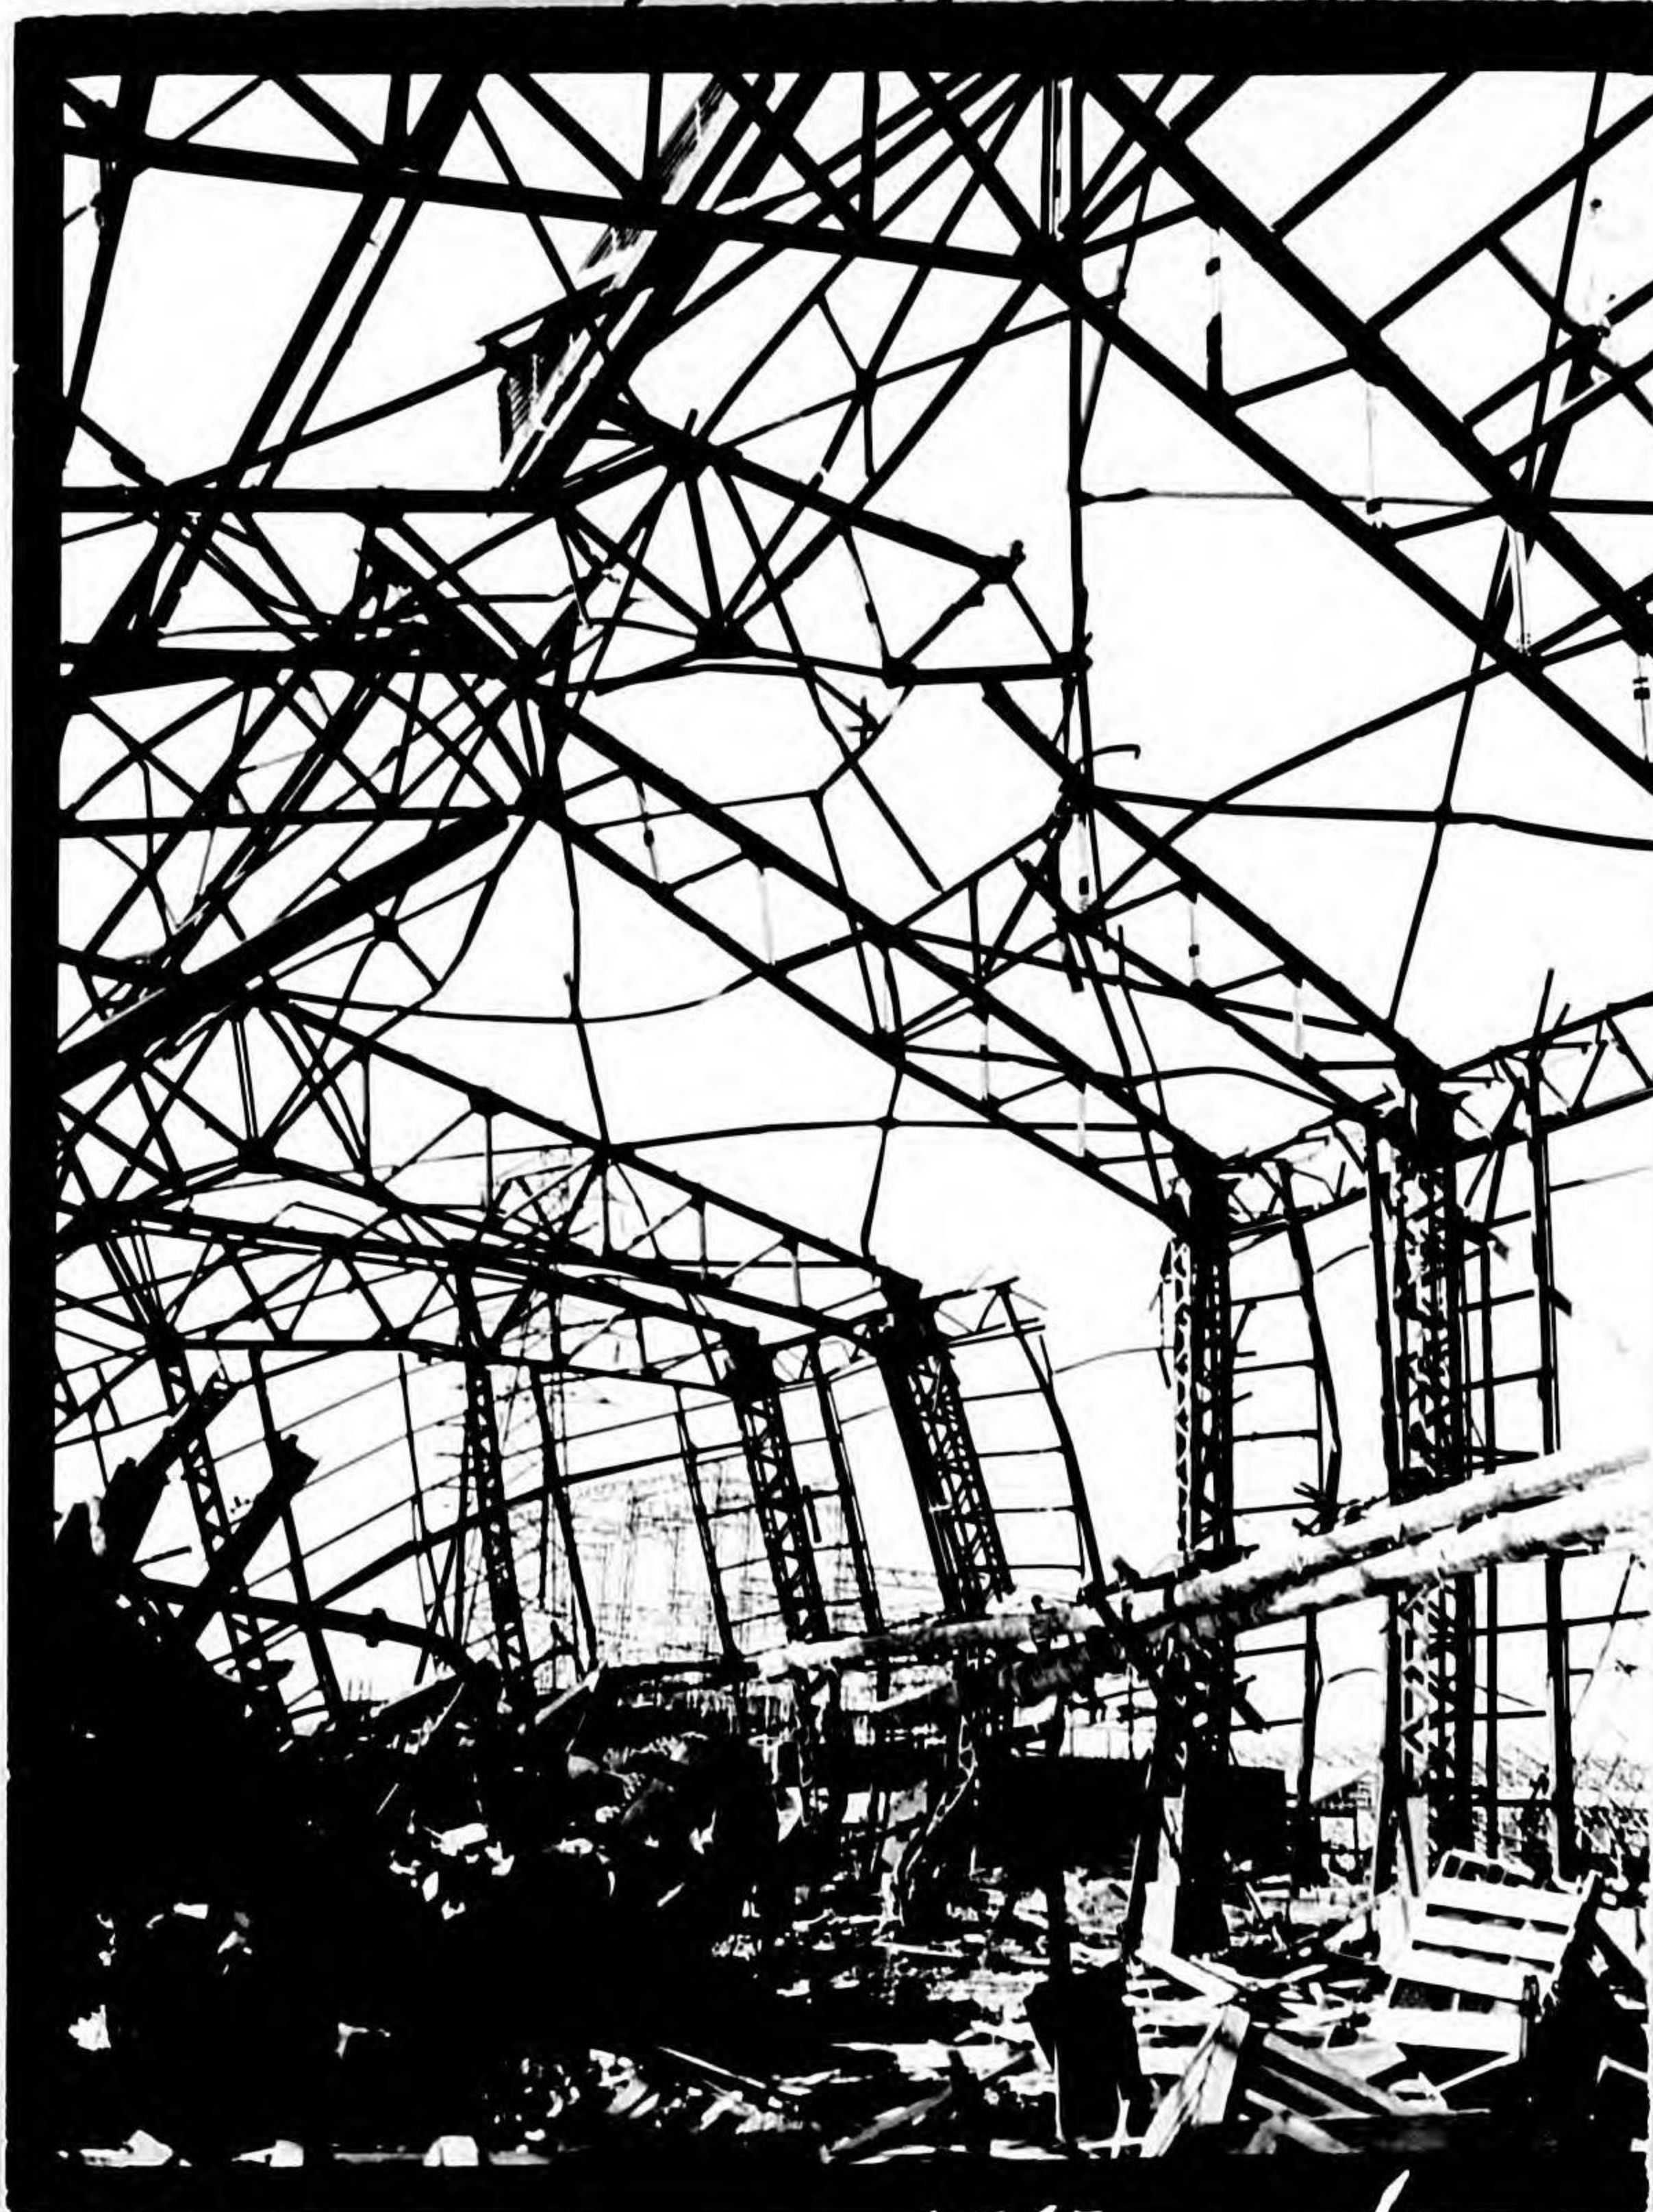
Photo 28, Bldg. 132, Bomb 23, boiler blown over.

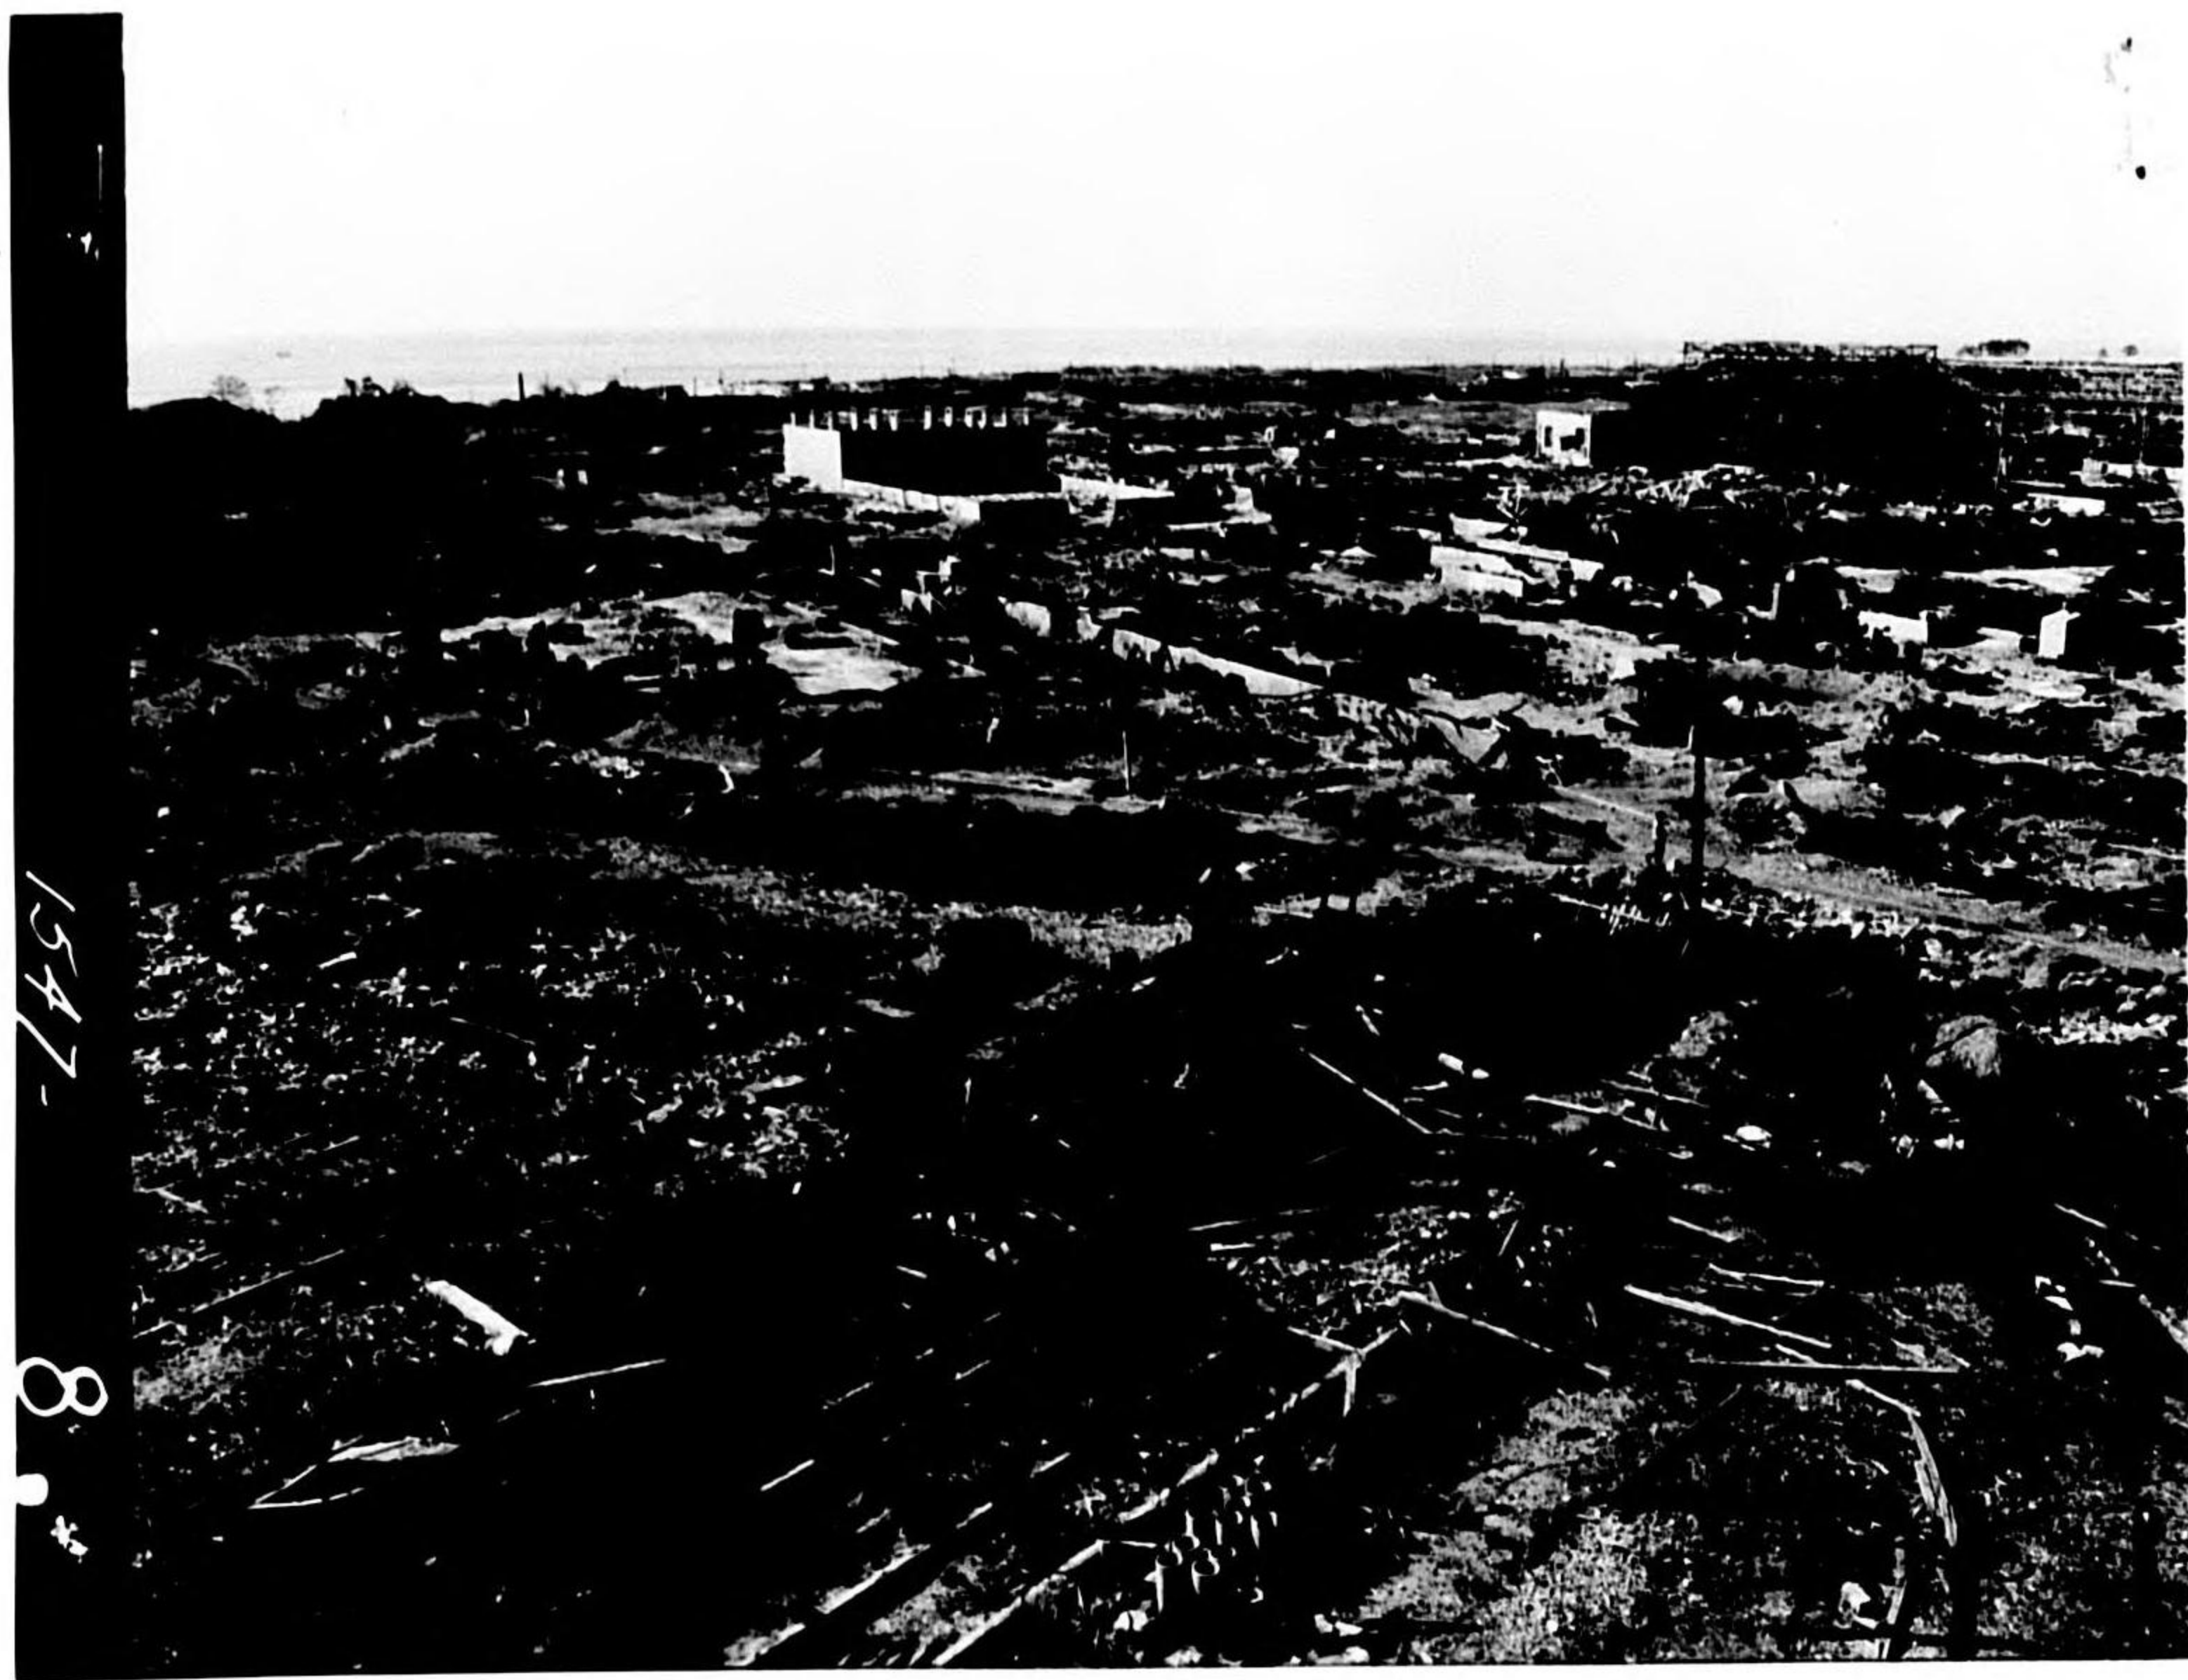
Photo 29- Overall view of fire damage caused
by several 4,000-lb bombs.

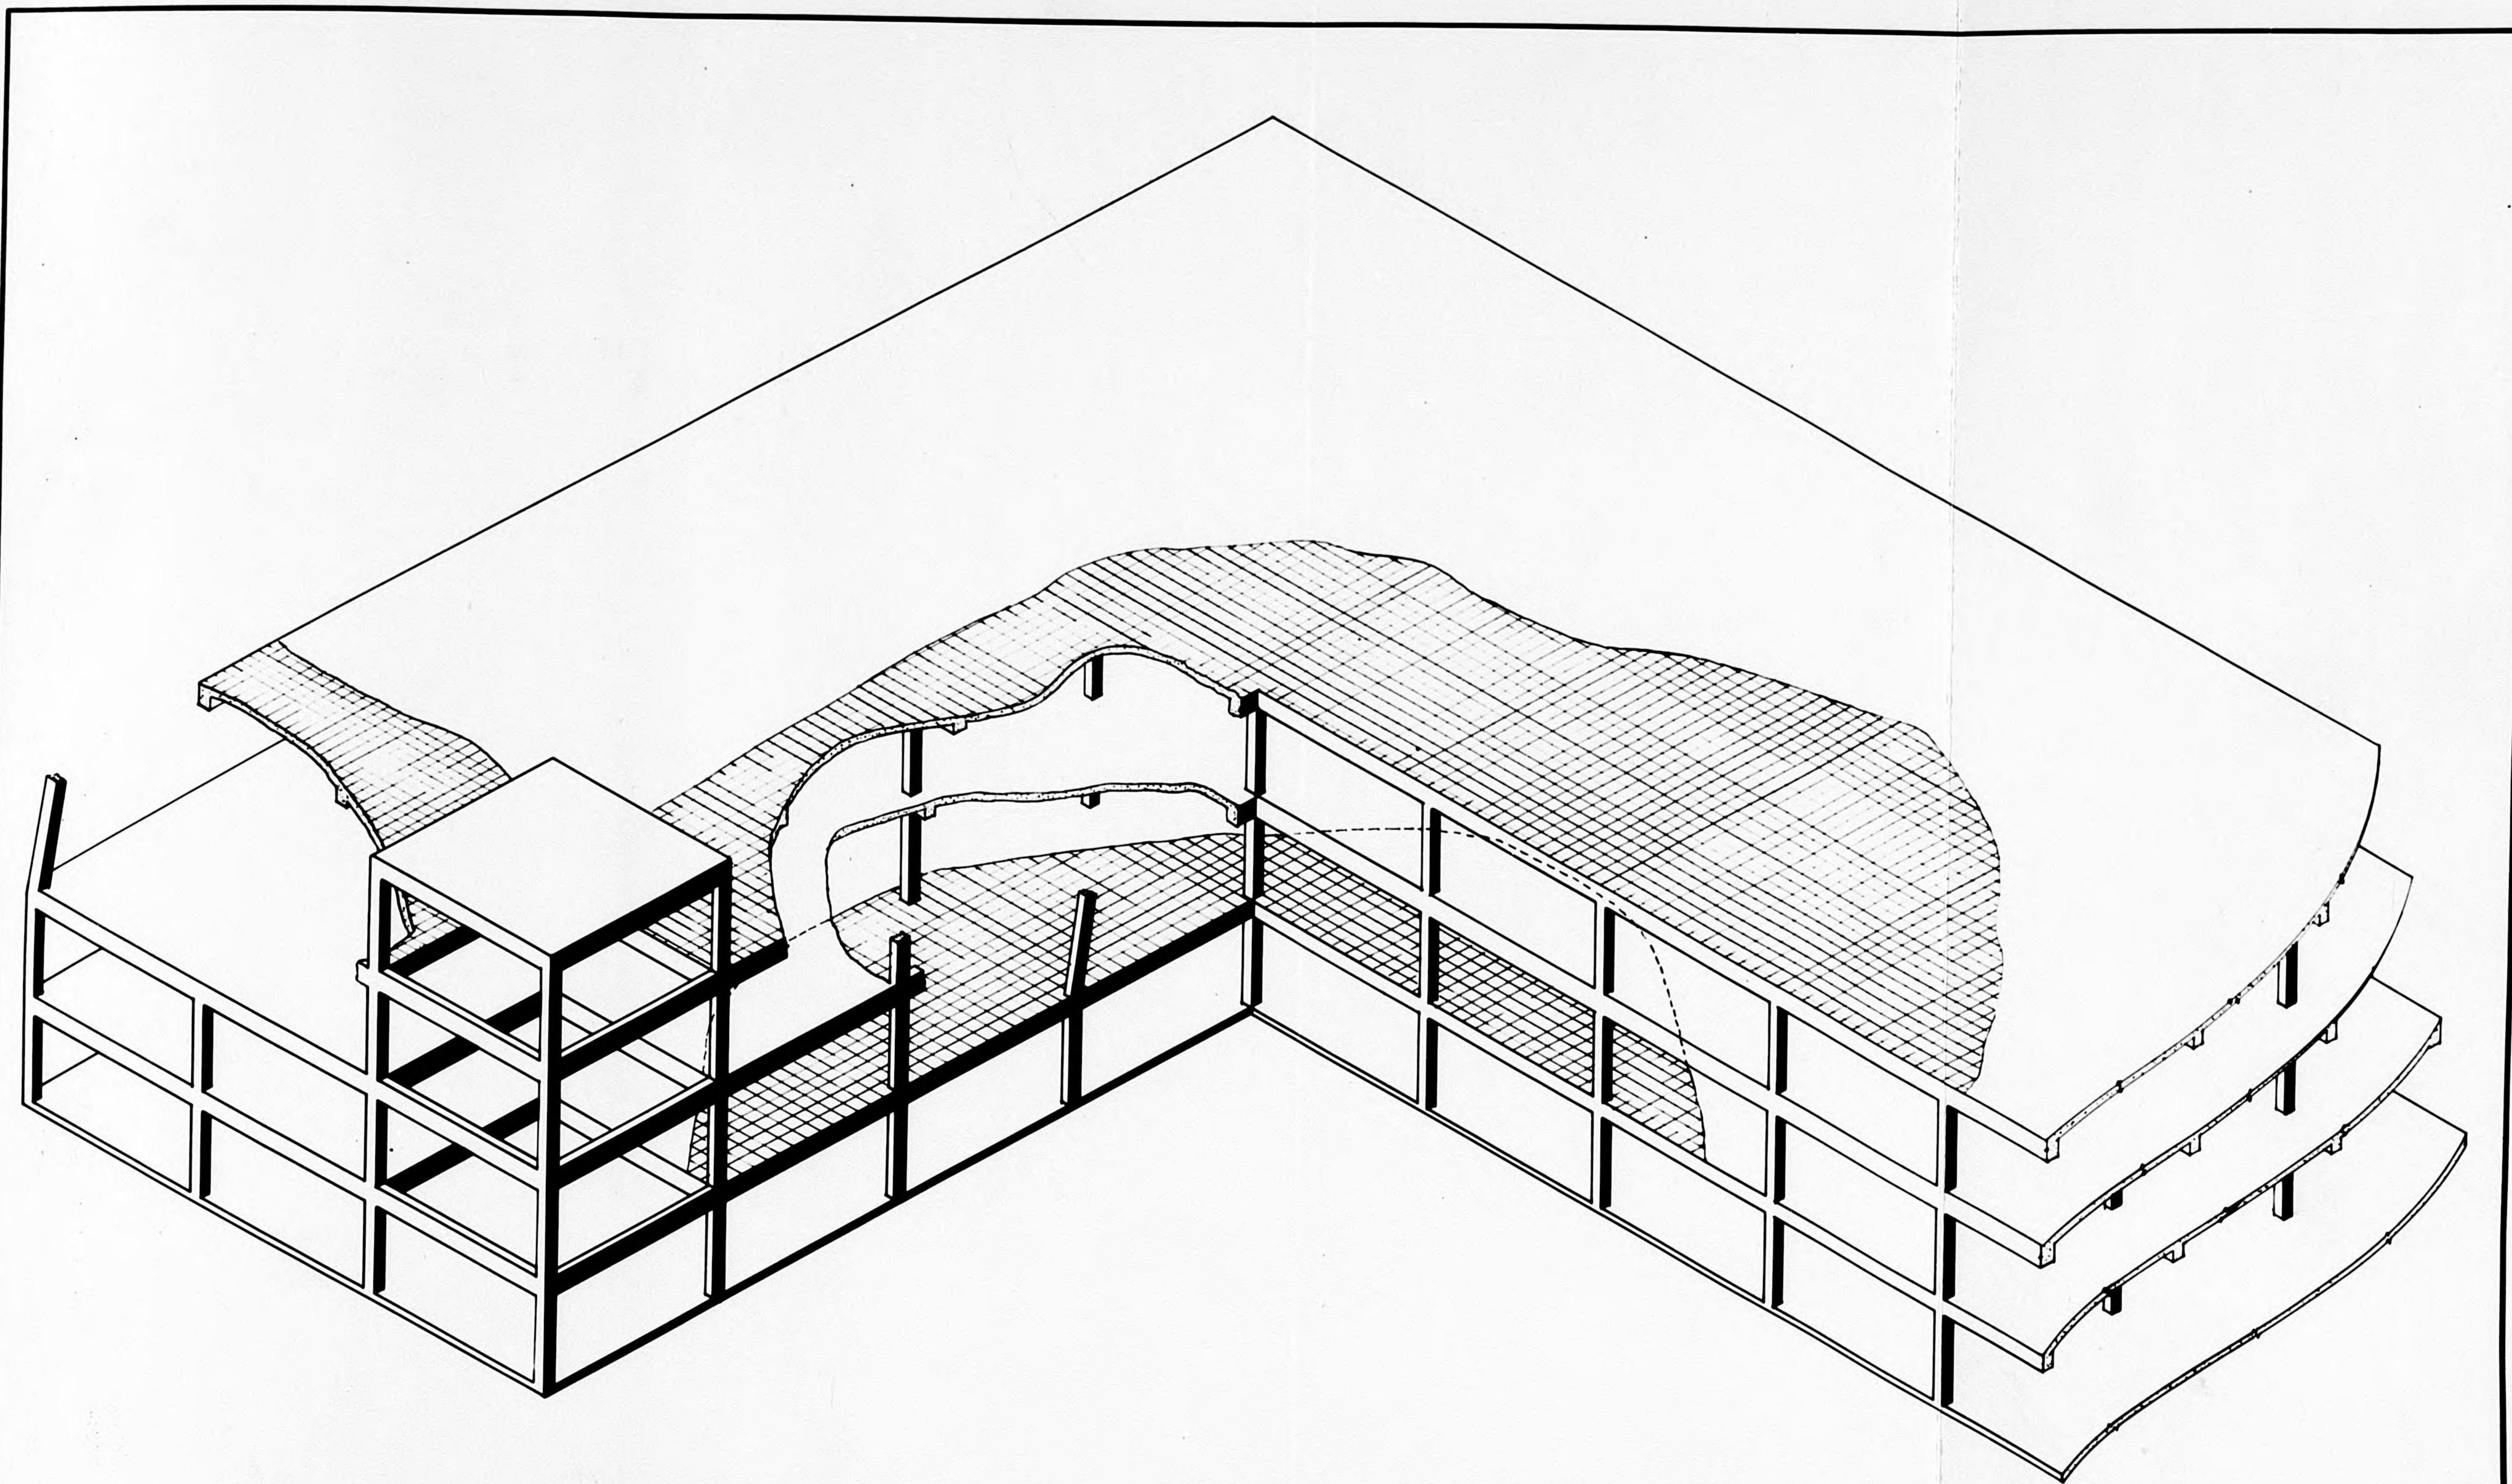
BUILDING # 8
DAMAGED AREAS-4000-LB BOMBS

blown out for two bays. The interior slabs and beams suffered in the areas indicated as damaged in Figure 1. One of the more severely damaged columns is shown in Photo 12. Bomb 46 exploded in the extreme north corner of the building as shown in Photo 10. The third-story exterior walls and the included column were blown down and outward for two bays on the northwest face (Photo 12), and one bay on the northeast face. The roof collapsed, leaving the corner column standing (Photo 12). The interior structure was damaged as shown on Figure 1. Bomb 44 was a near-miss which detonated approximately 50 feet southeast of the building and damaged first-story exterior walls and second-floor exterior beams of the adjacent five bays.

— STRUCTURALLY DAMAGED AREAS
NOTE COLLAPSED PORTIONS REMOVED
ON THIS DRAWING
DAMAGED AREA ON 2ND FLOOR CONTINUES
AS OUTLINED BY DOTTED LINE

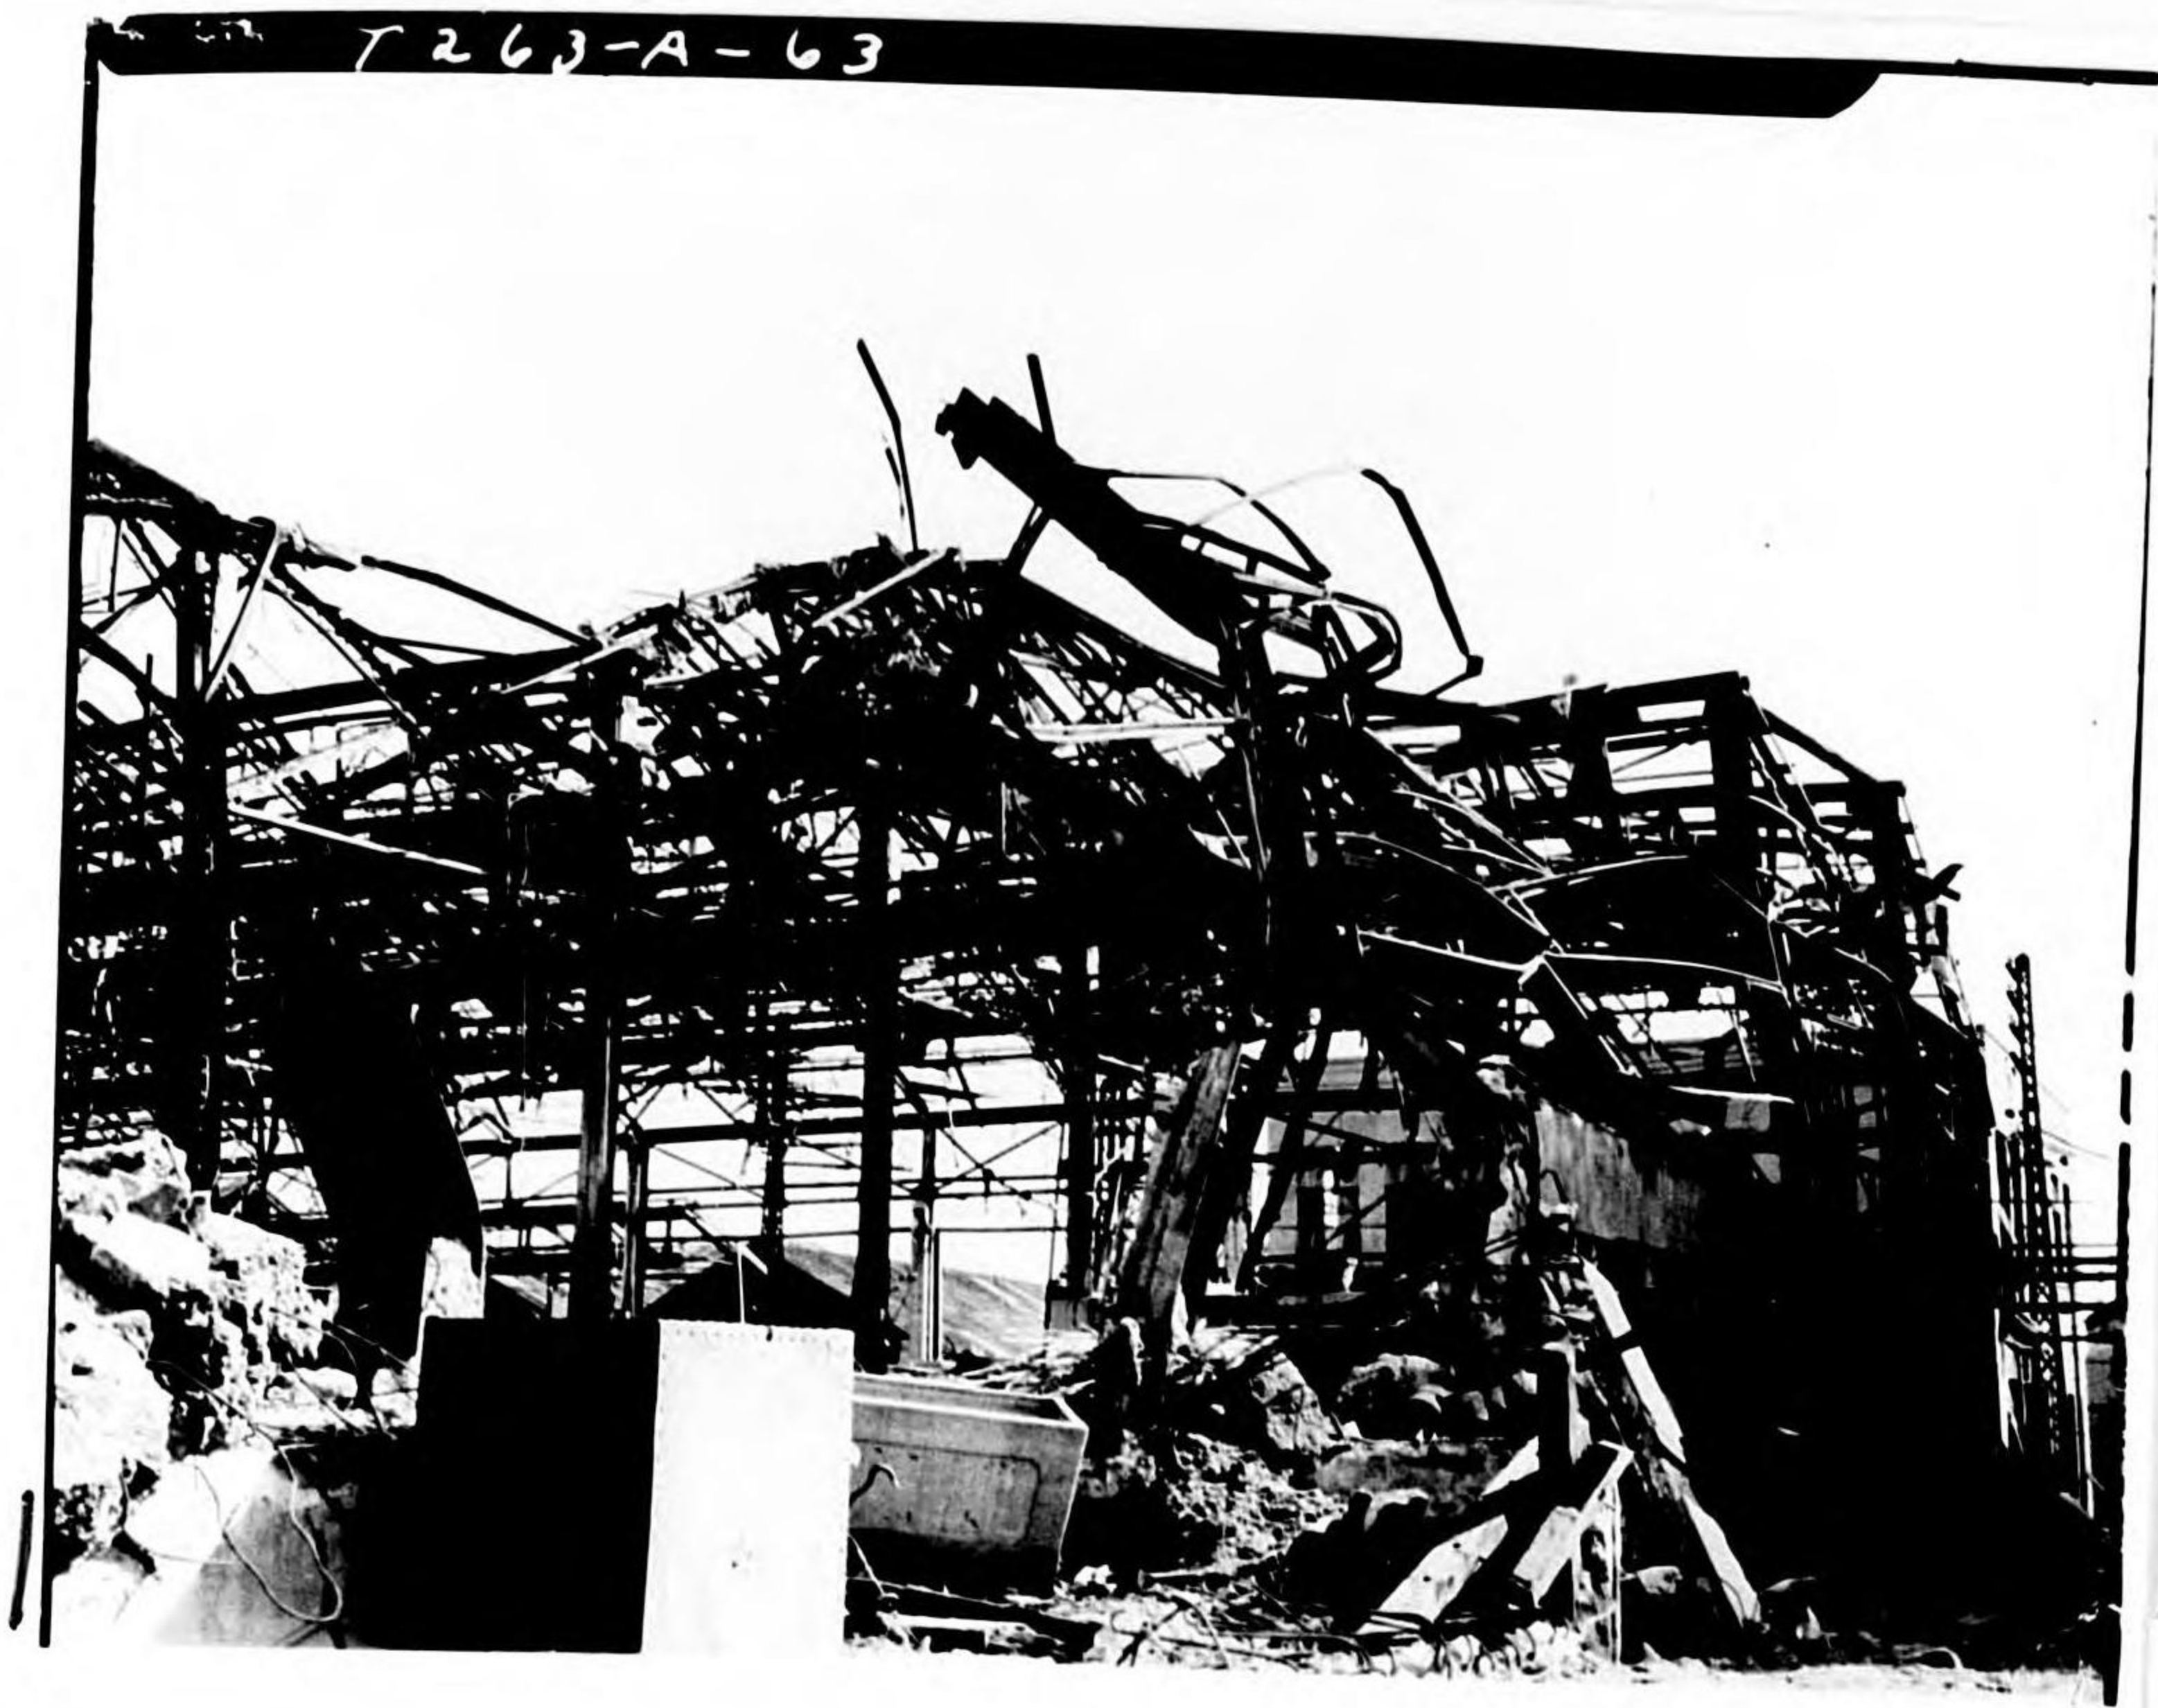
Photo 1 - Bldg. 3. Bomb 42. Blasted bent and folded columns.

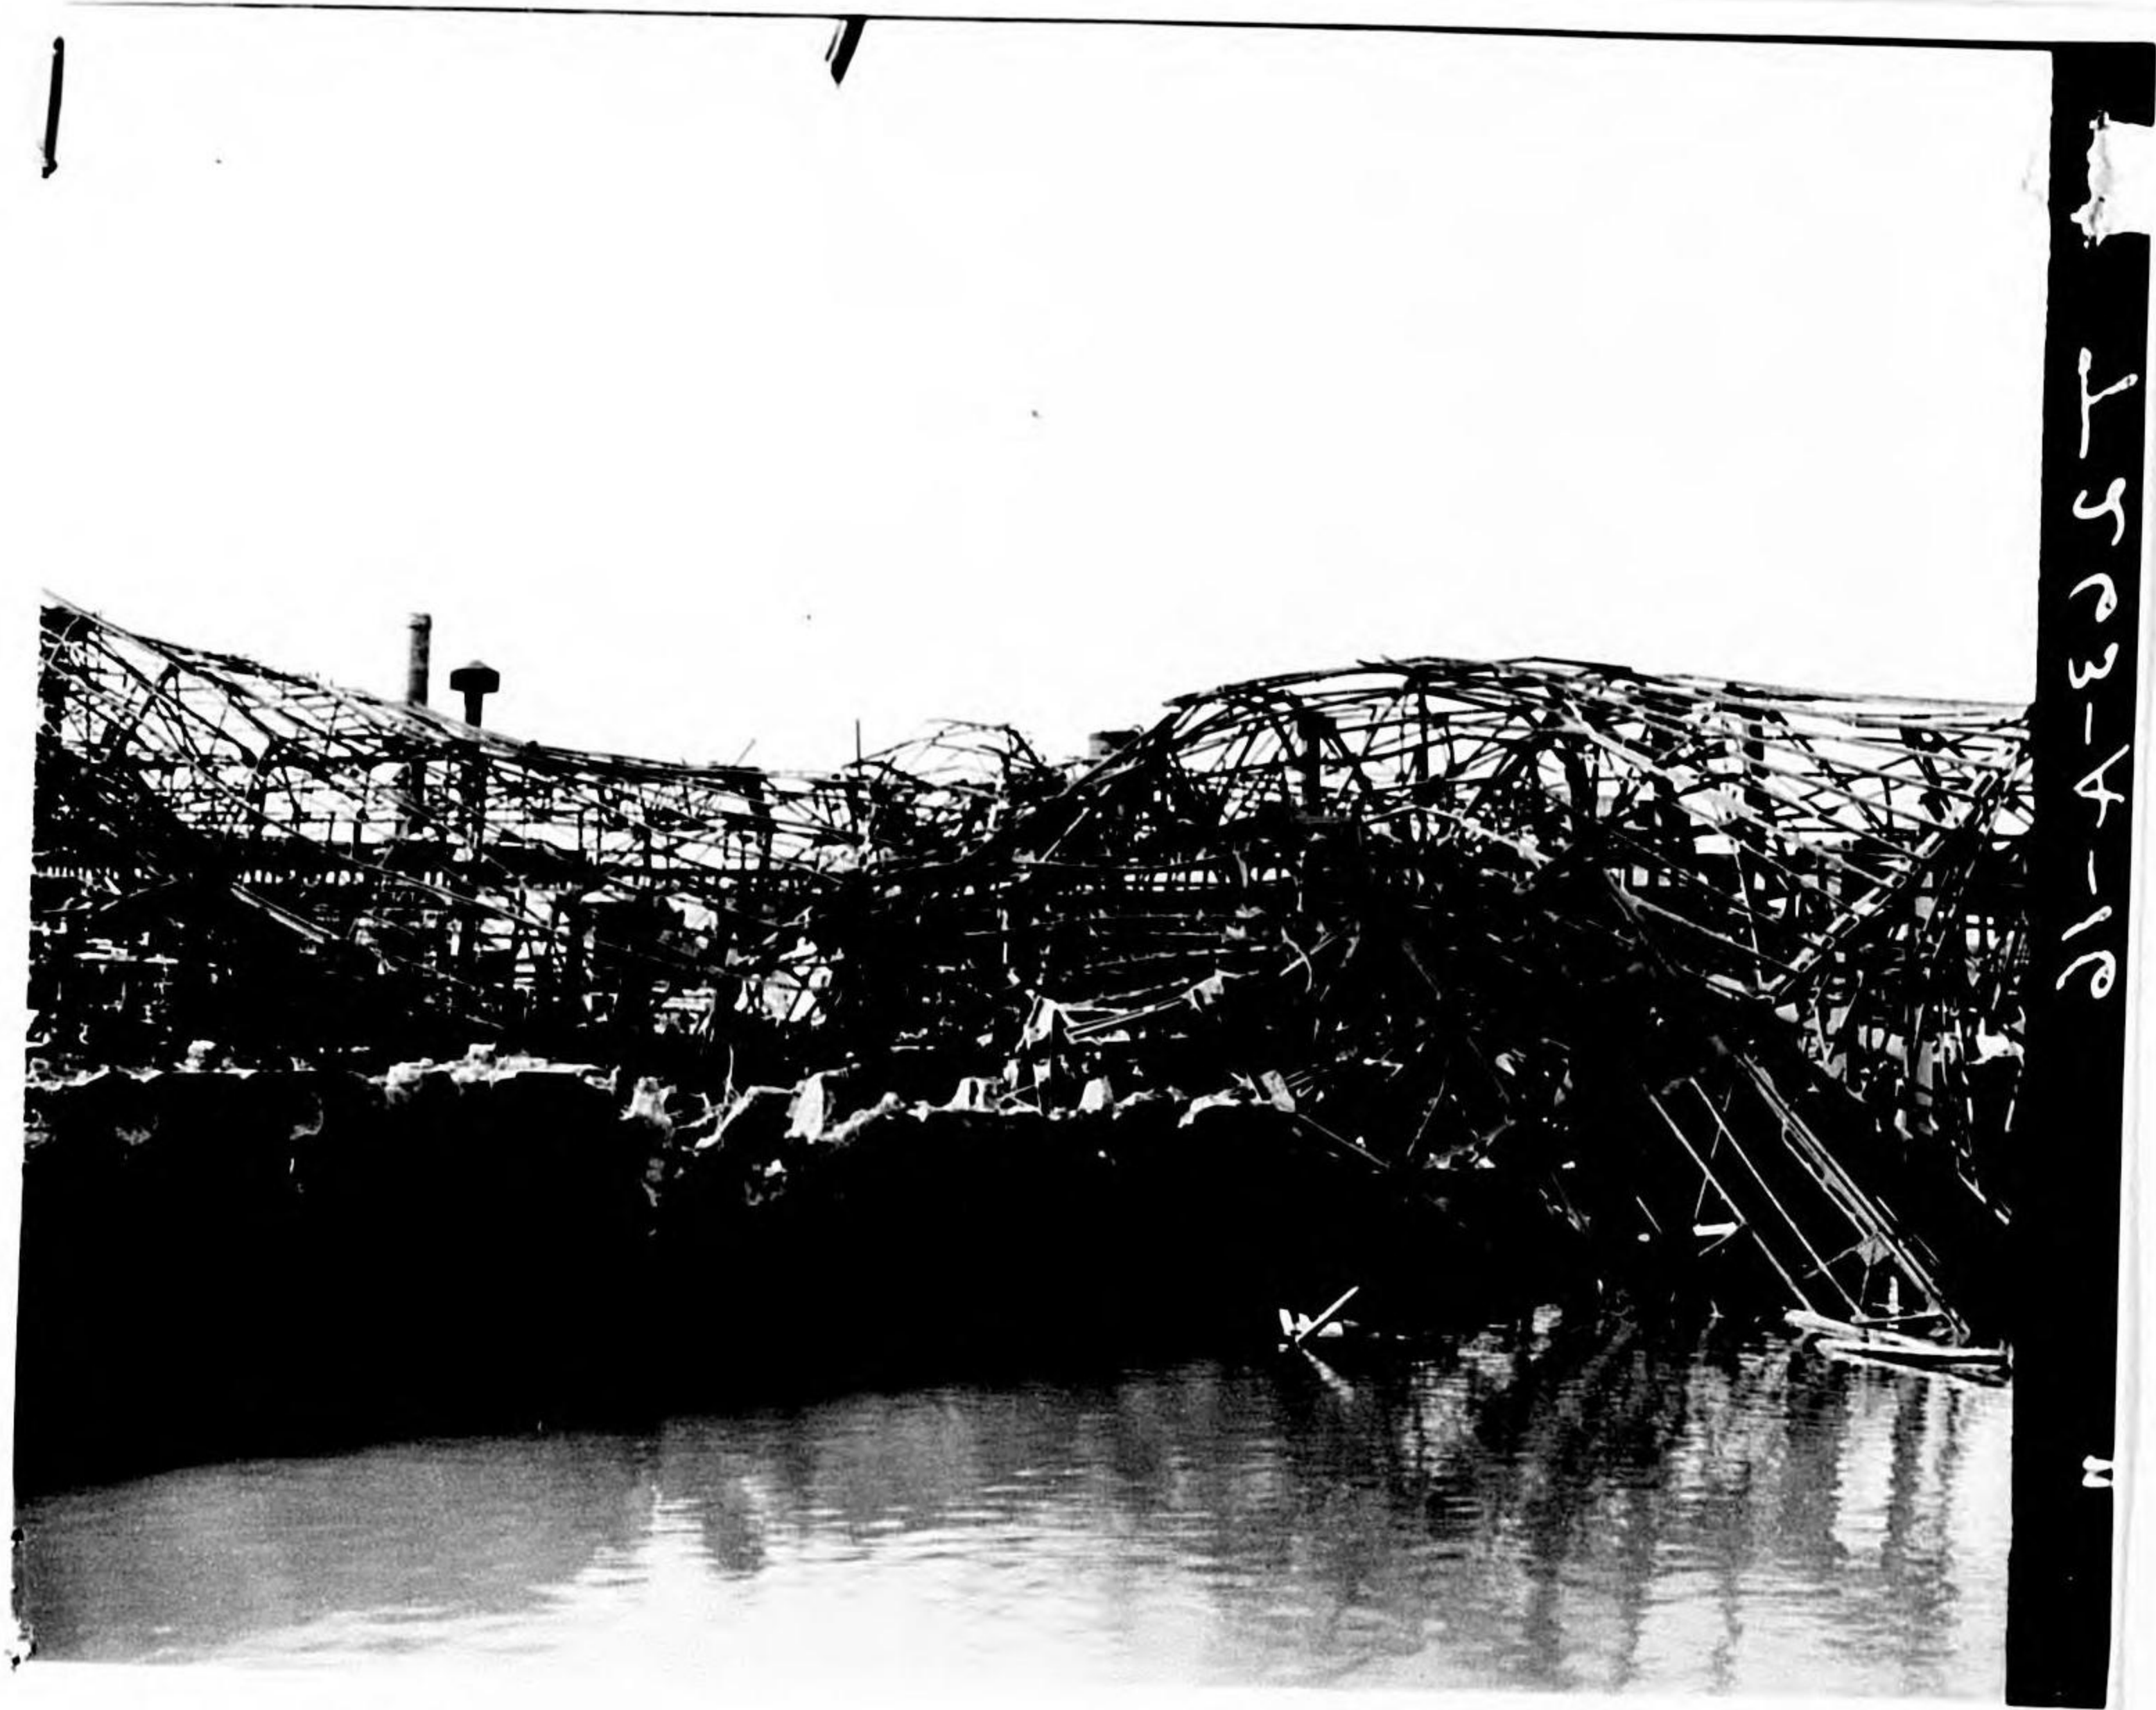
Photo 2 - Bldg. 9. Bomb 46. Collapsed cantilever.
73 (image reversed)
