UNITED STATES STRATEGIC BOMBING SURVEY

REPORT 72

EFFECTS OF THE FOUR THOUSAND-POUND BOMB

A Report on Five Incidents

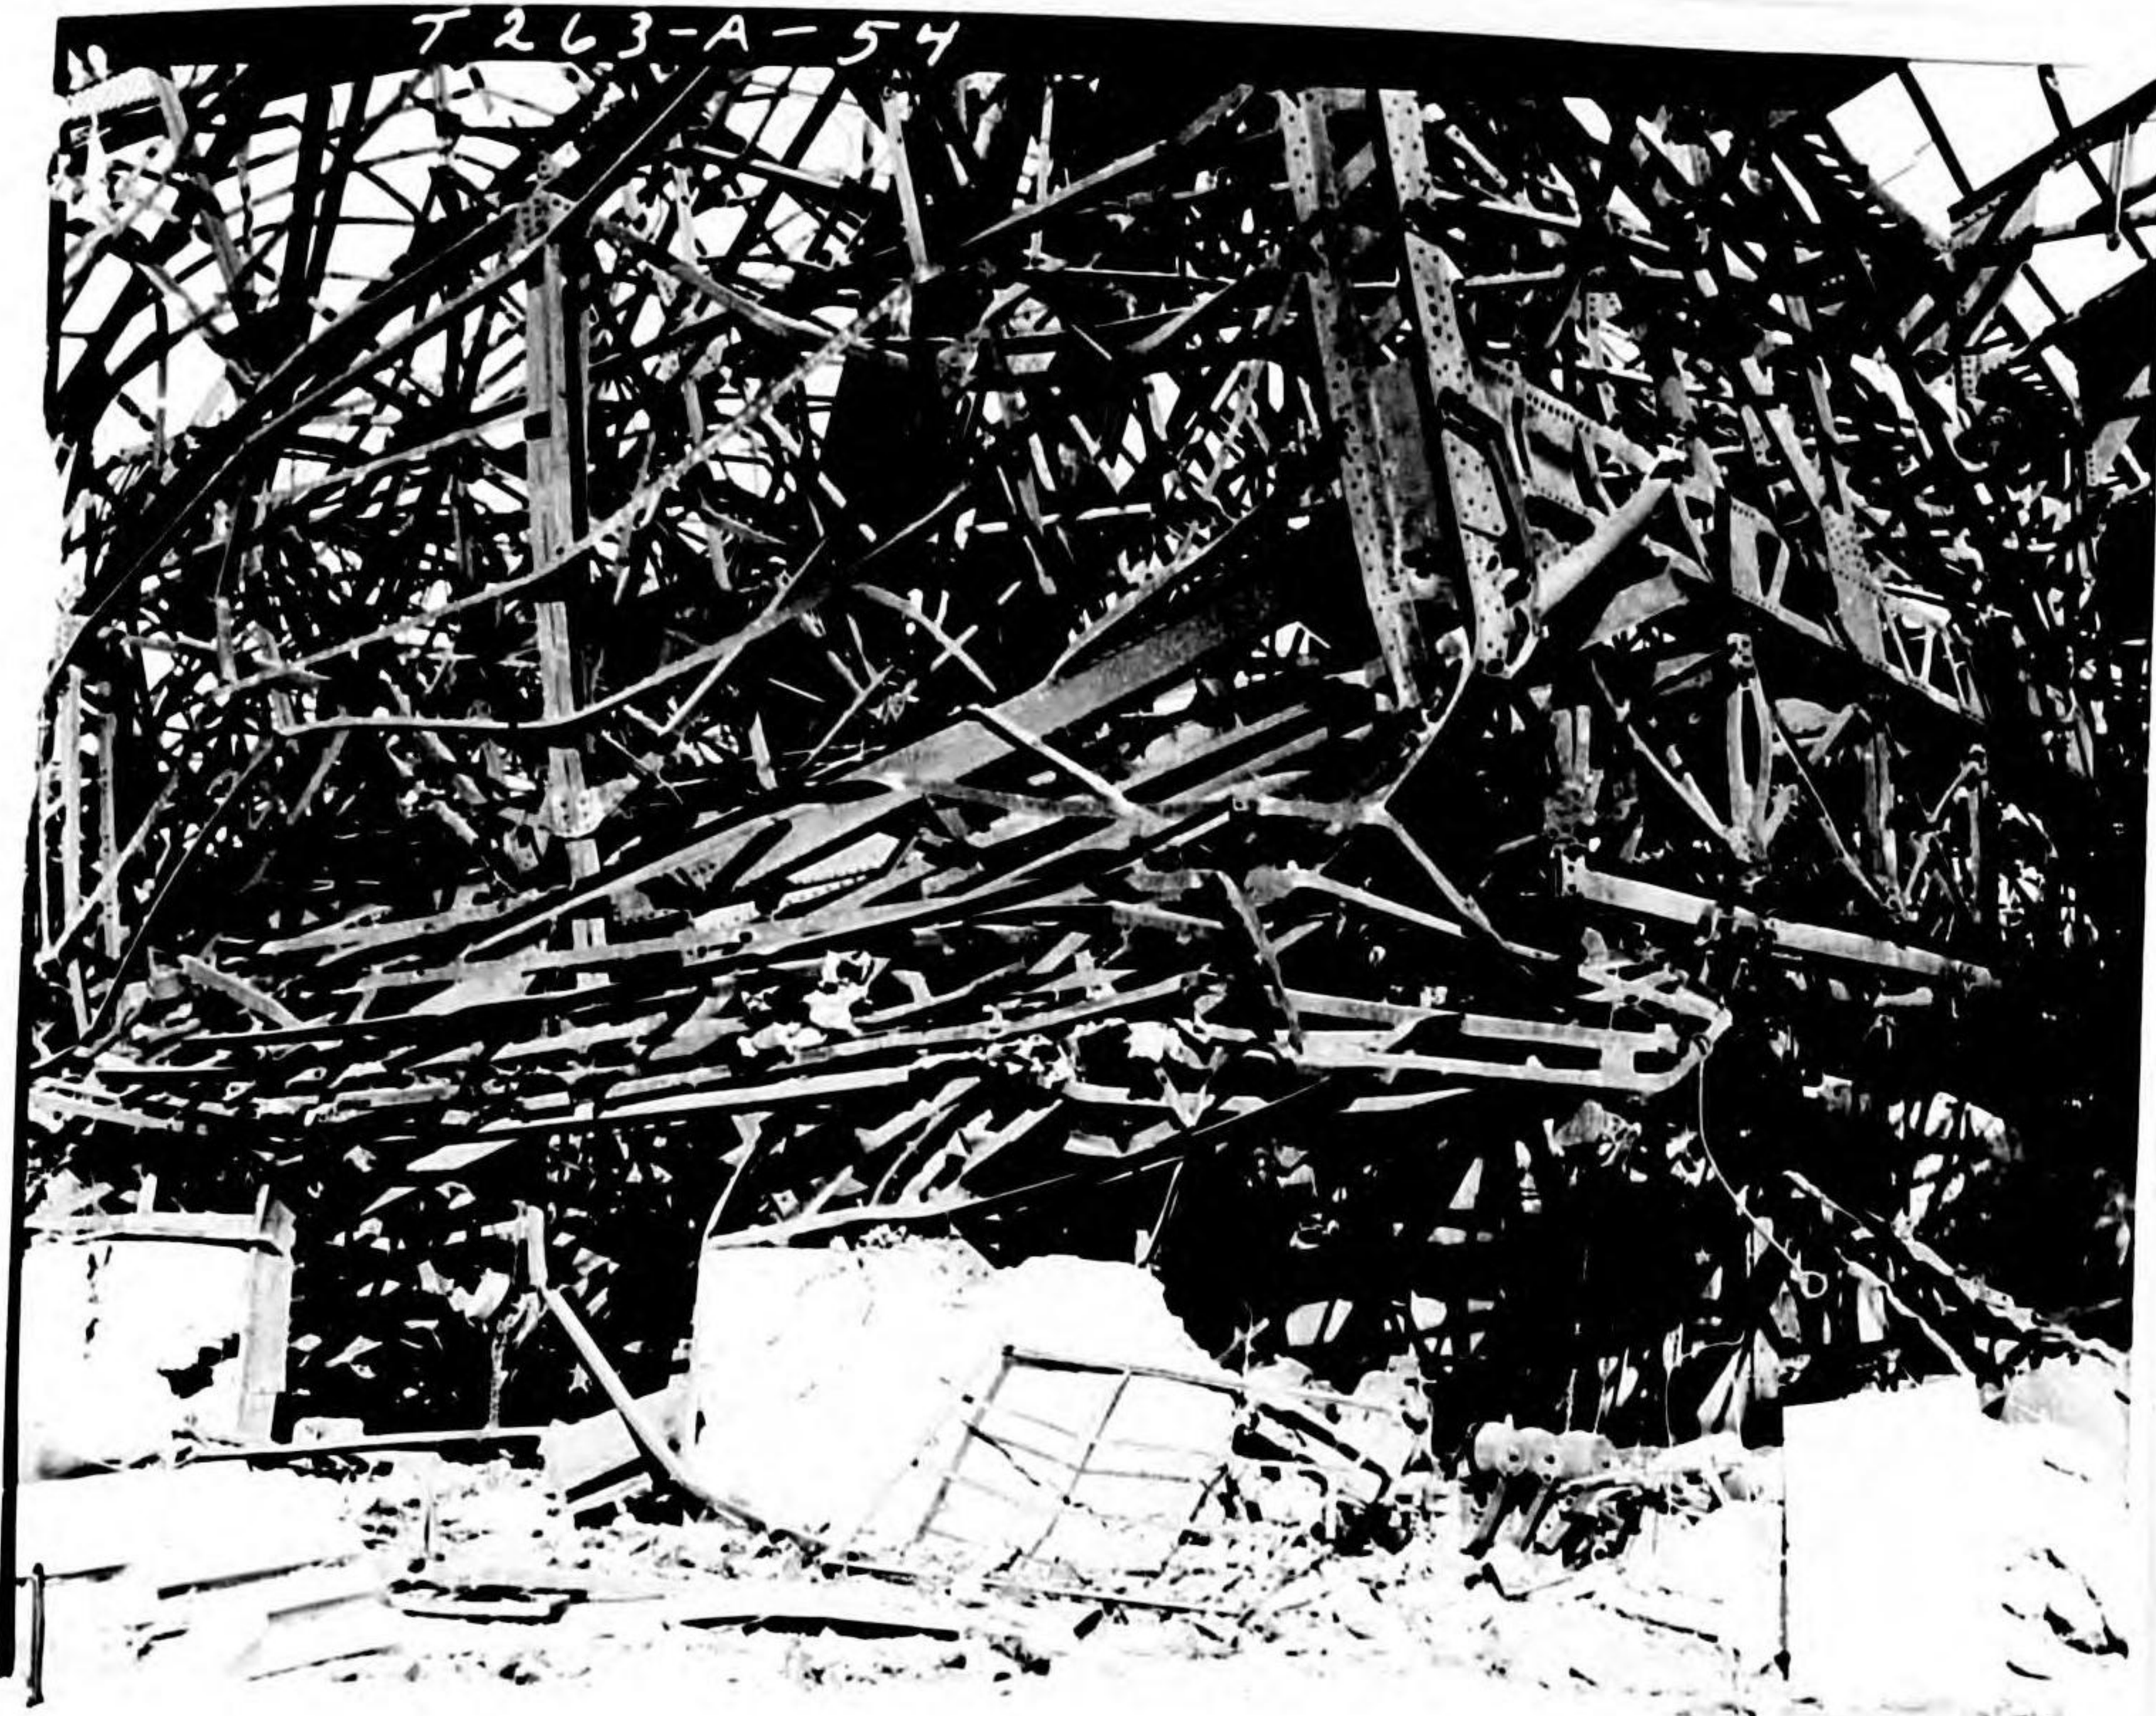
Photo 5 - Bldg. 14, Bomb 43.

e. Building 14, a heat-treating shop, was a one-story, steel-frame mill building. In plan this building was L-shaped, one wing running west, the other south, from the reentrant angle. Two bombs struck the building. Bomb 44 exploded on contact with the ground, cutting several columns and causing collapse or distortion of the entire west wing. Bomb 43 struck in the reentrant angle. Two steel stacks were knocked over, falling south, and the entire south wing of the building was distorted, leaning south, and about four feet out of plumb. In addition, all columns failed (Photos 5 and 6). The building

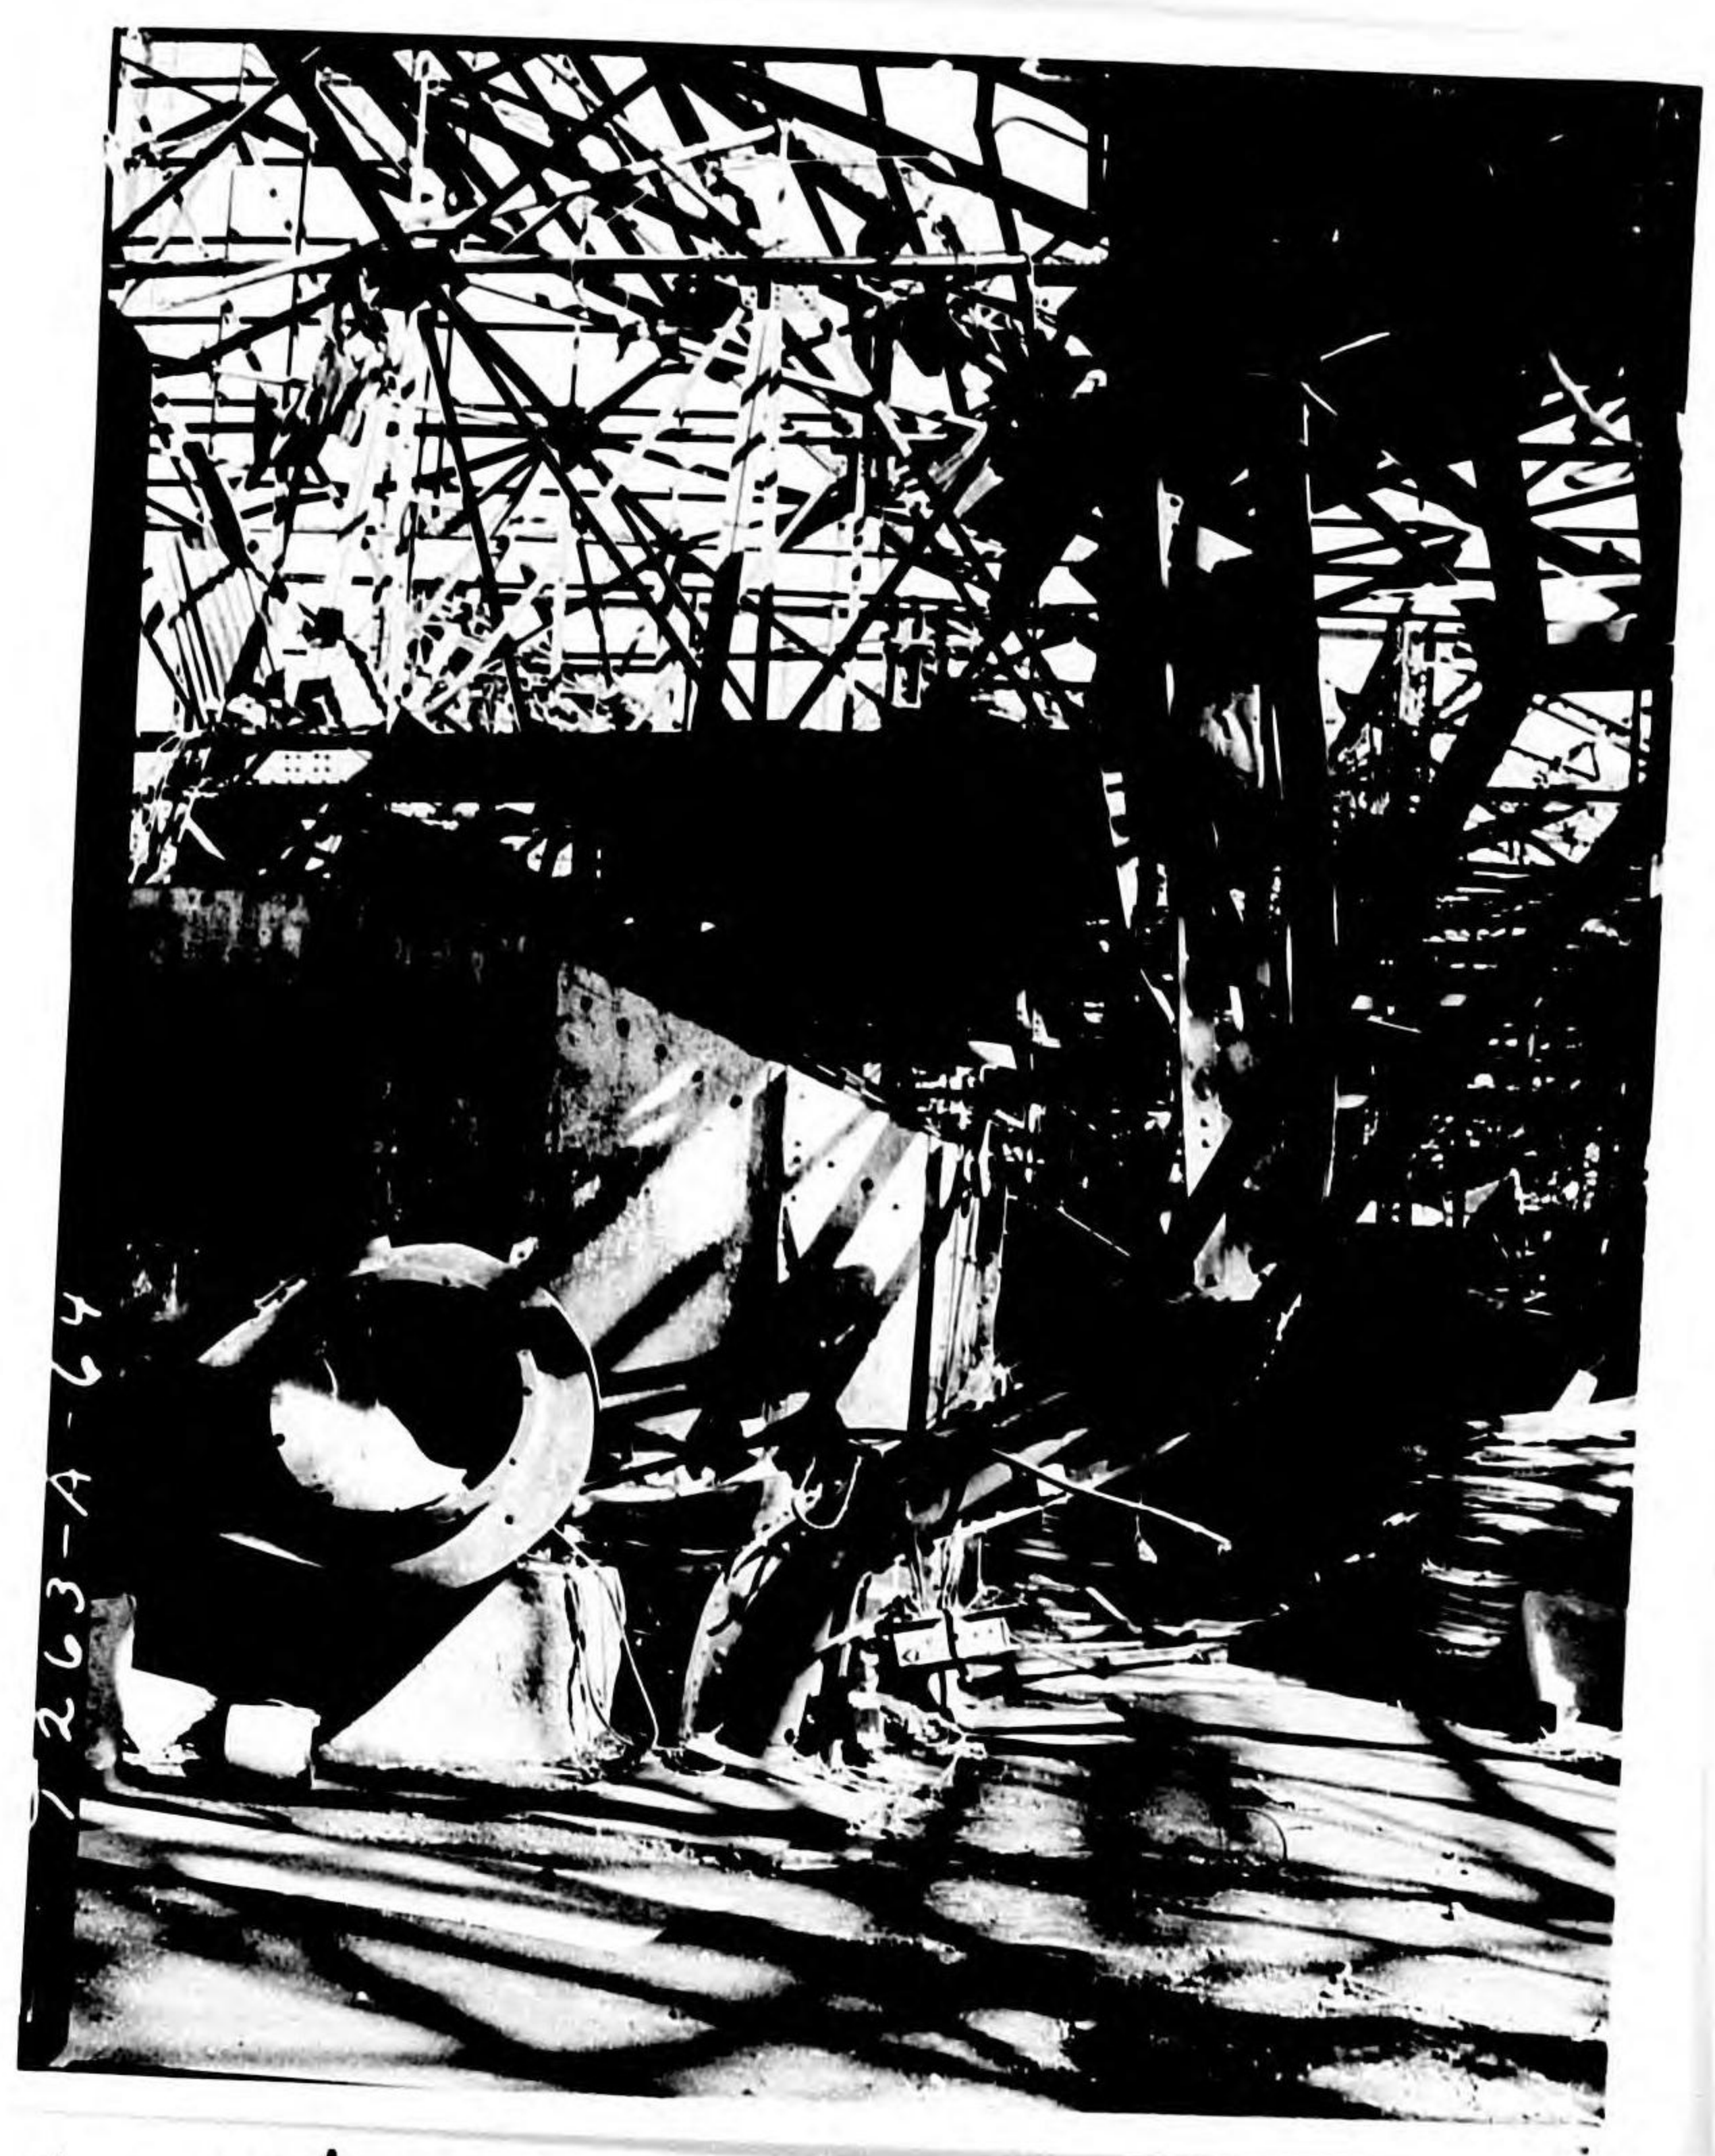
Photo 6 - Bldg. 14, Bomb 43. Column damage.

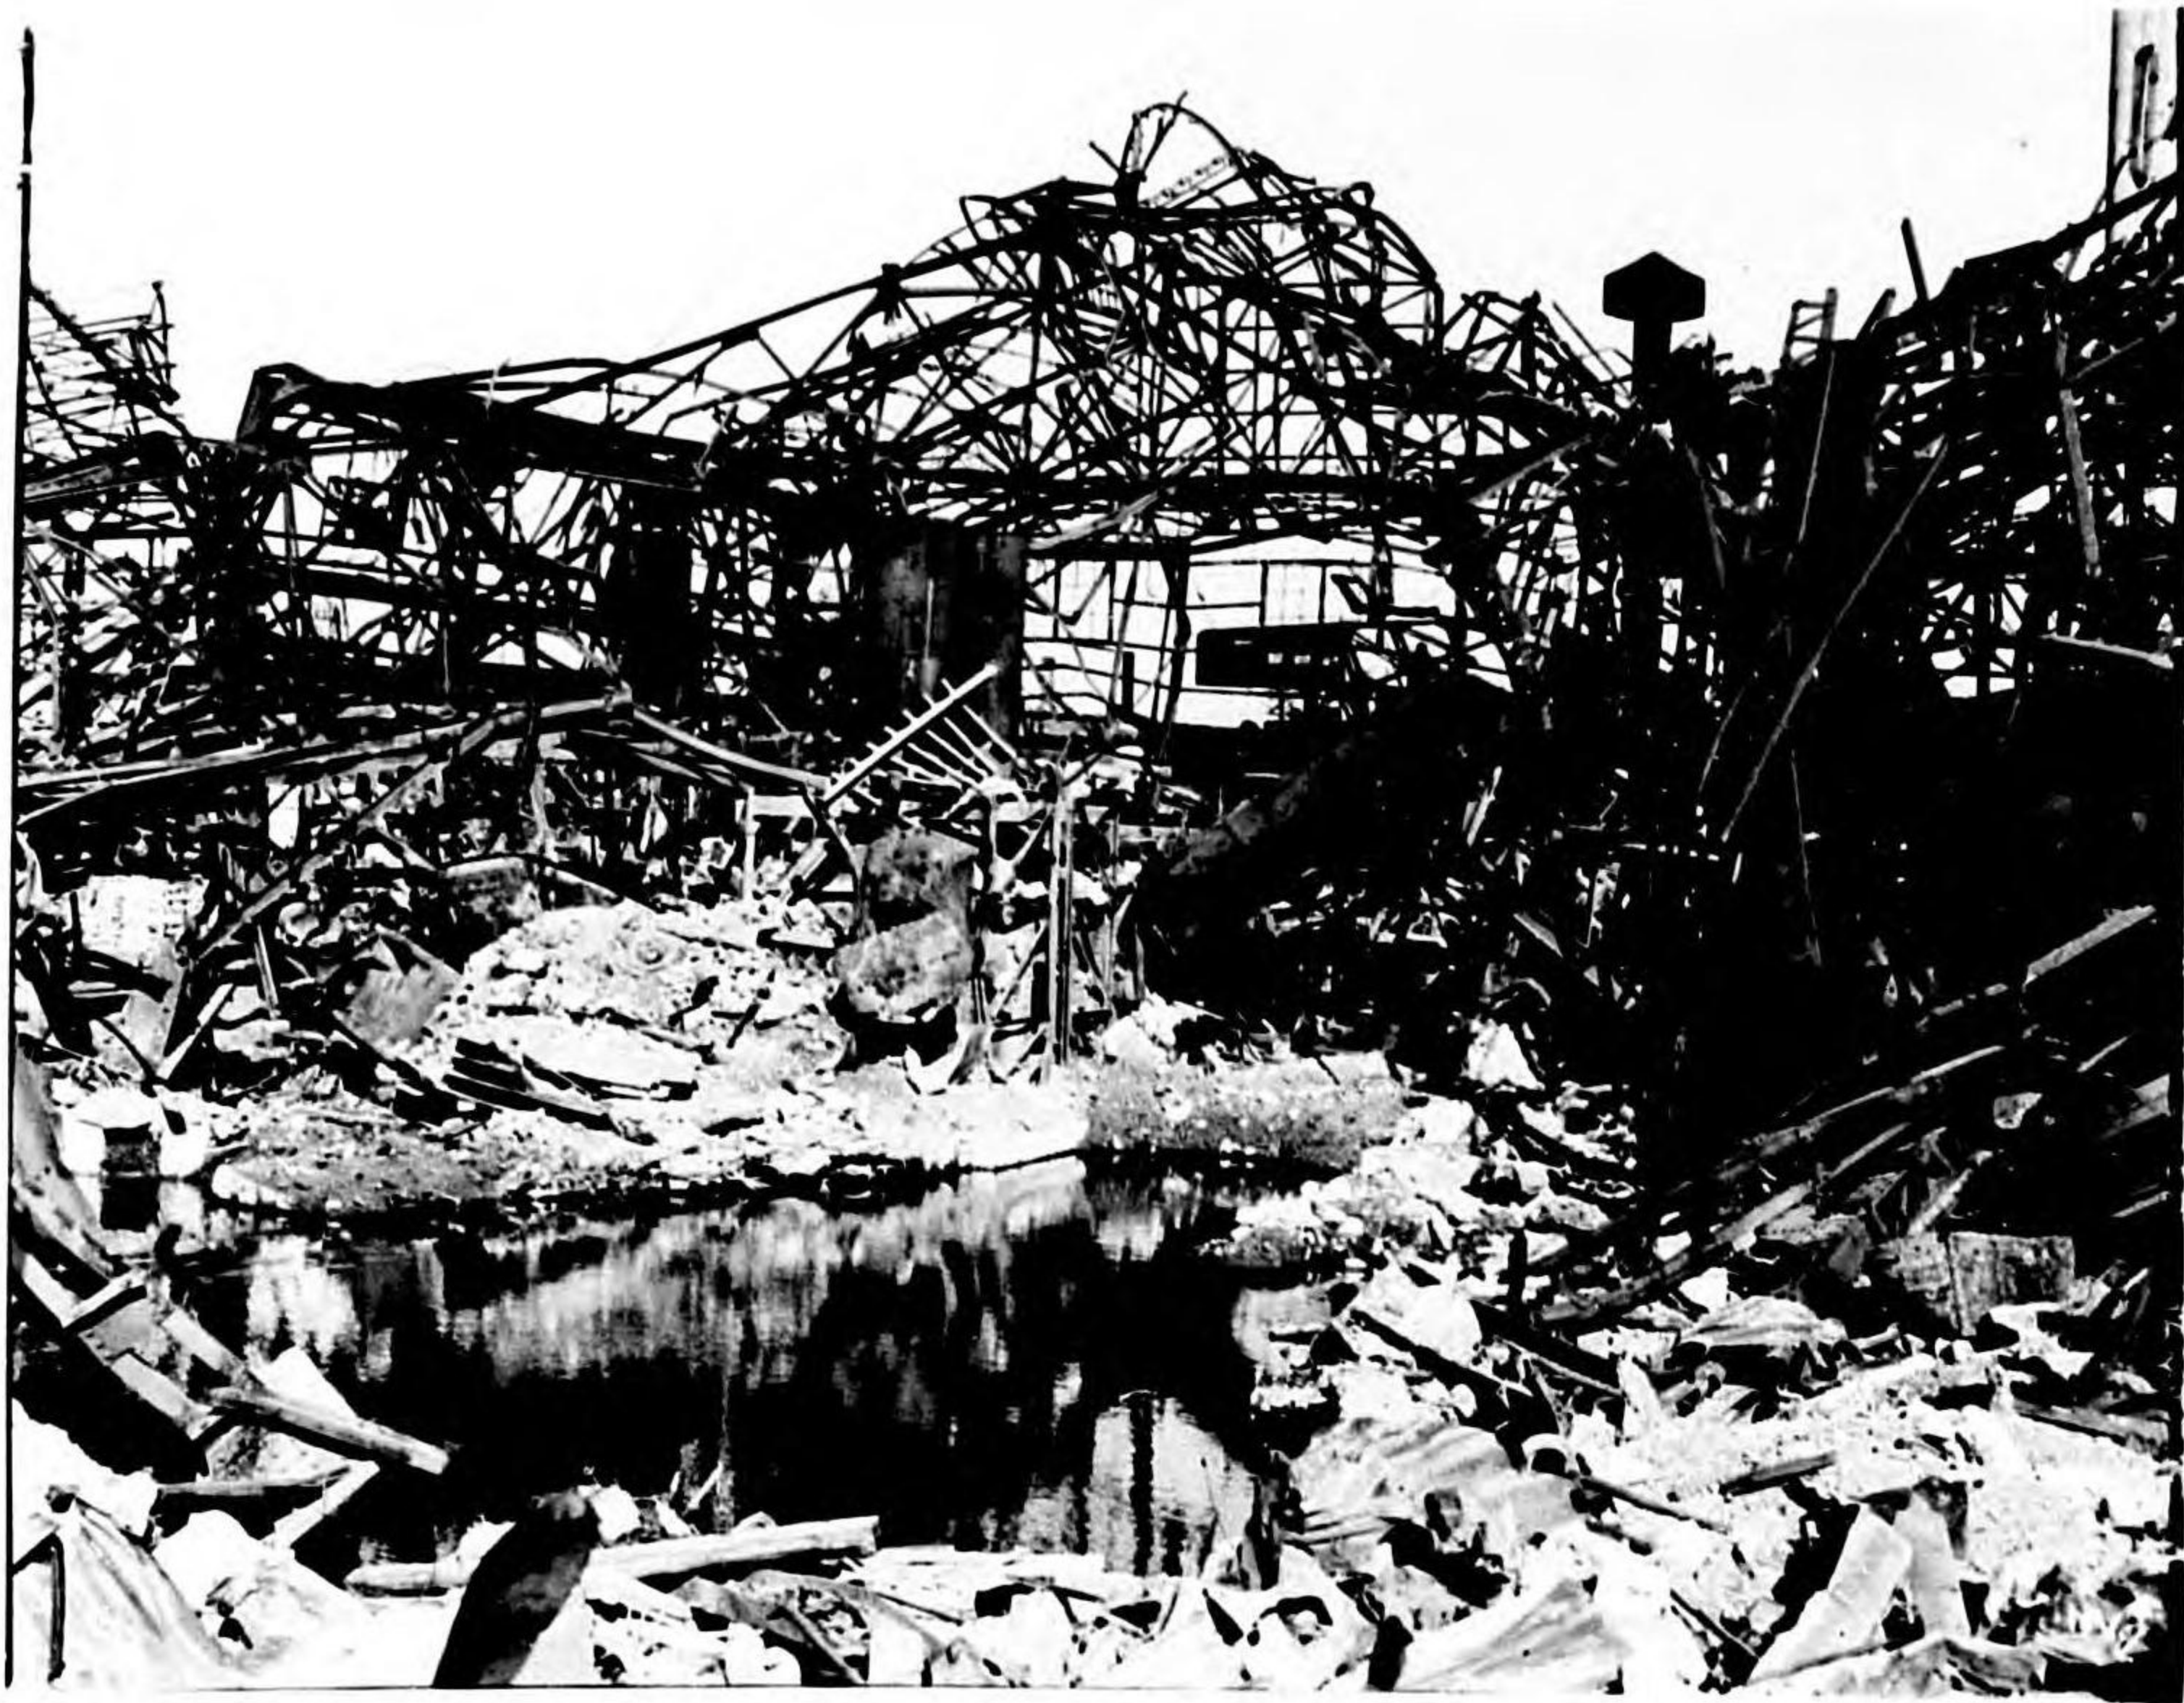
evidently had light connections running north from the reentrant angle, and the two wings were broken apart by the blast of Bomb 43 (Photo 7).

Photo 7 - Bldg. 14. Bomb 43. Damage to furnace and equipment.

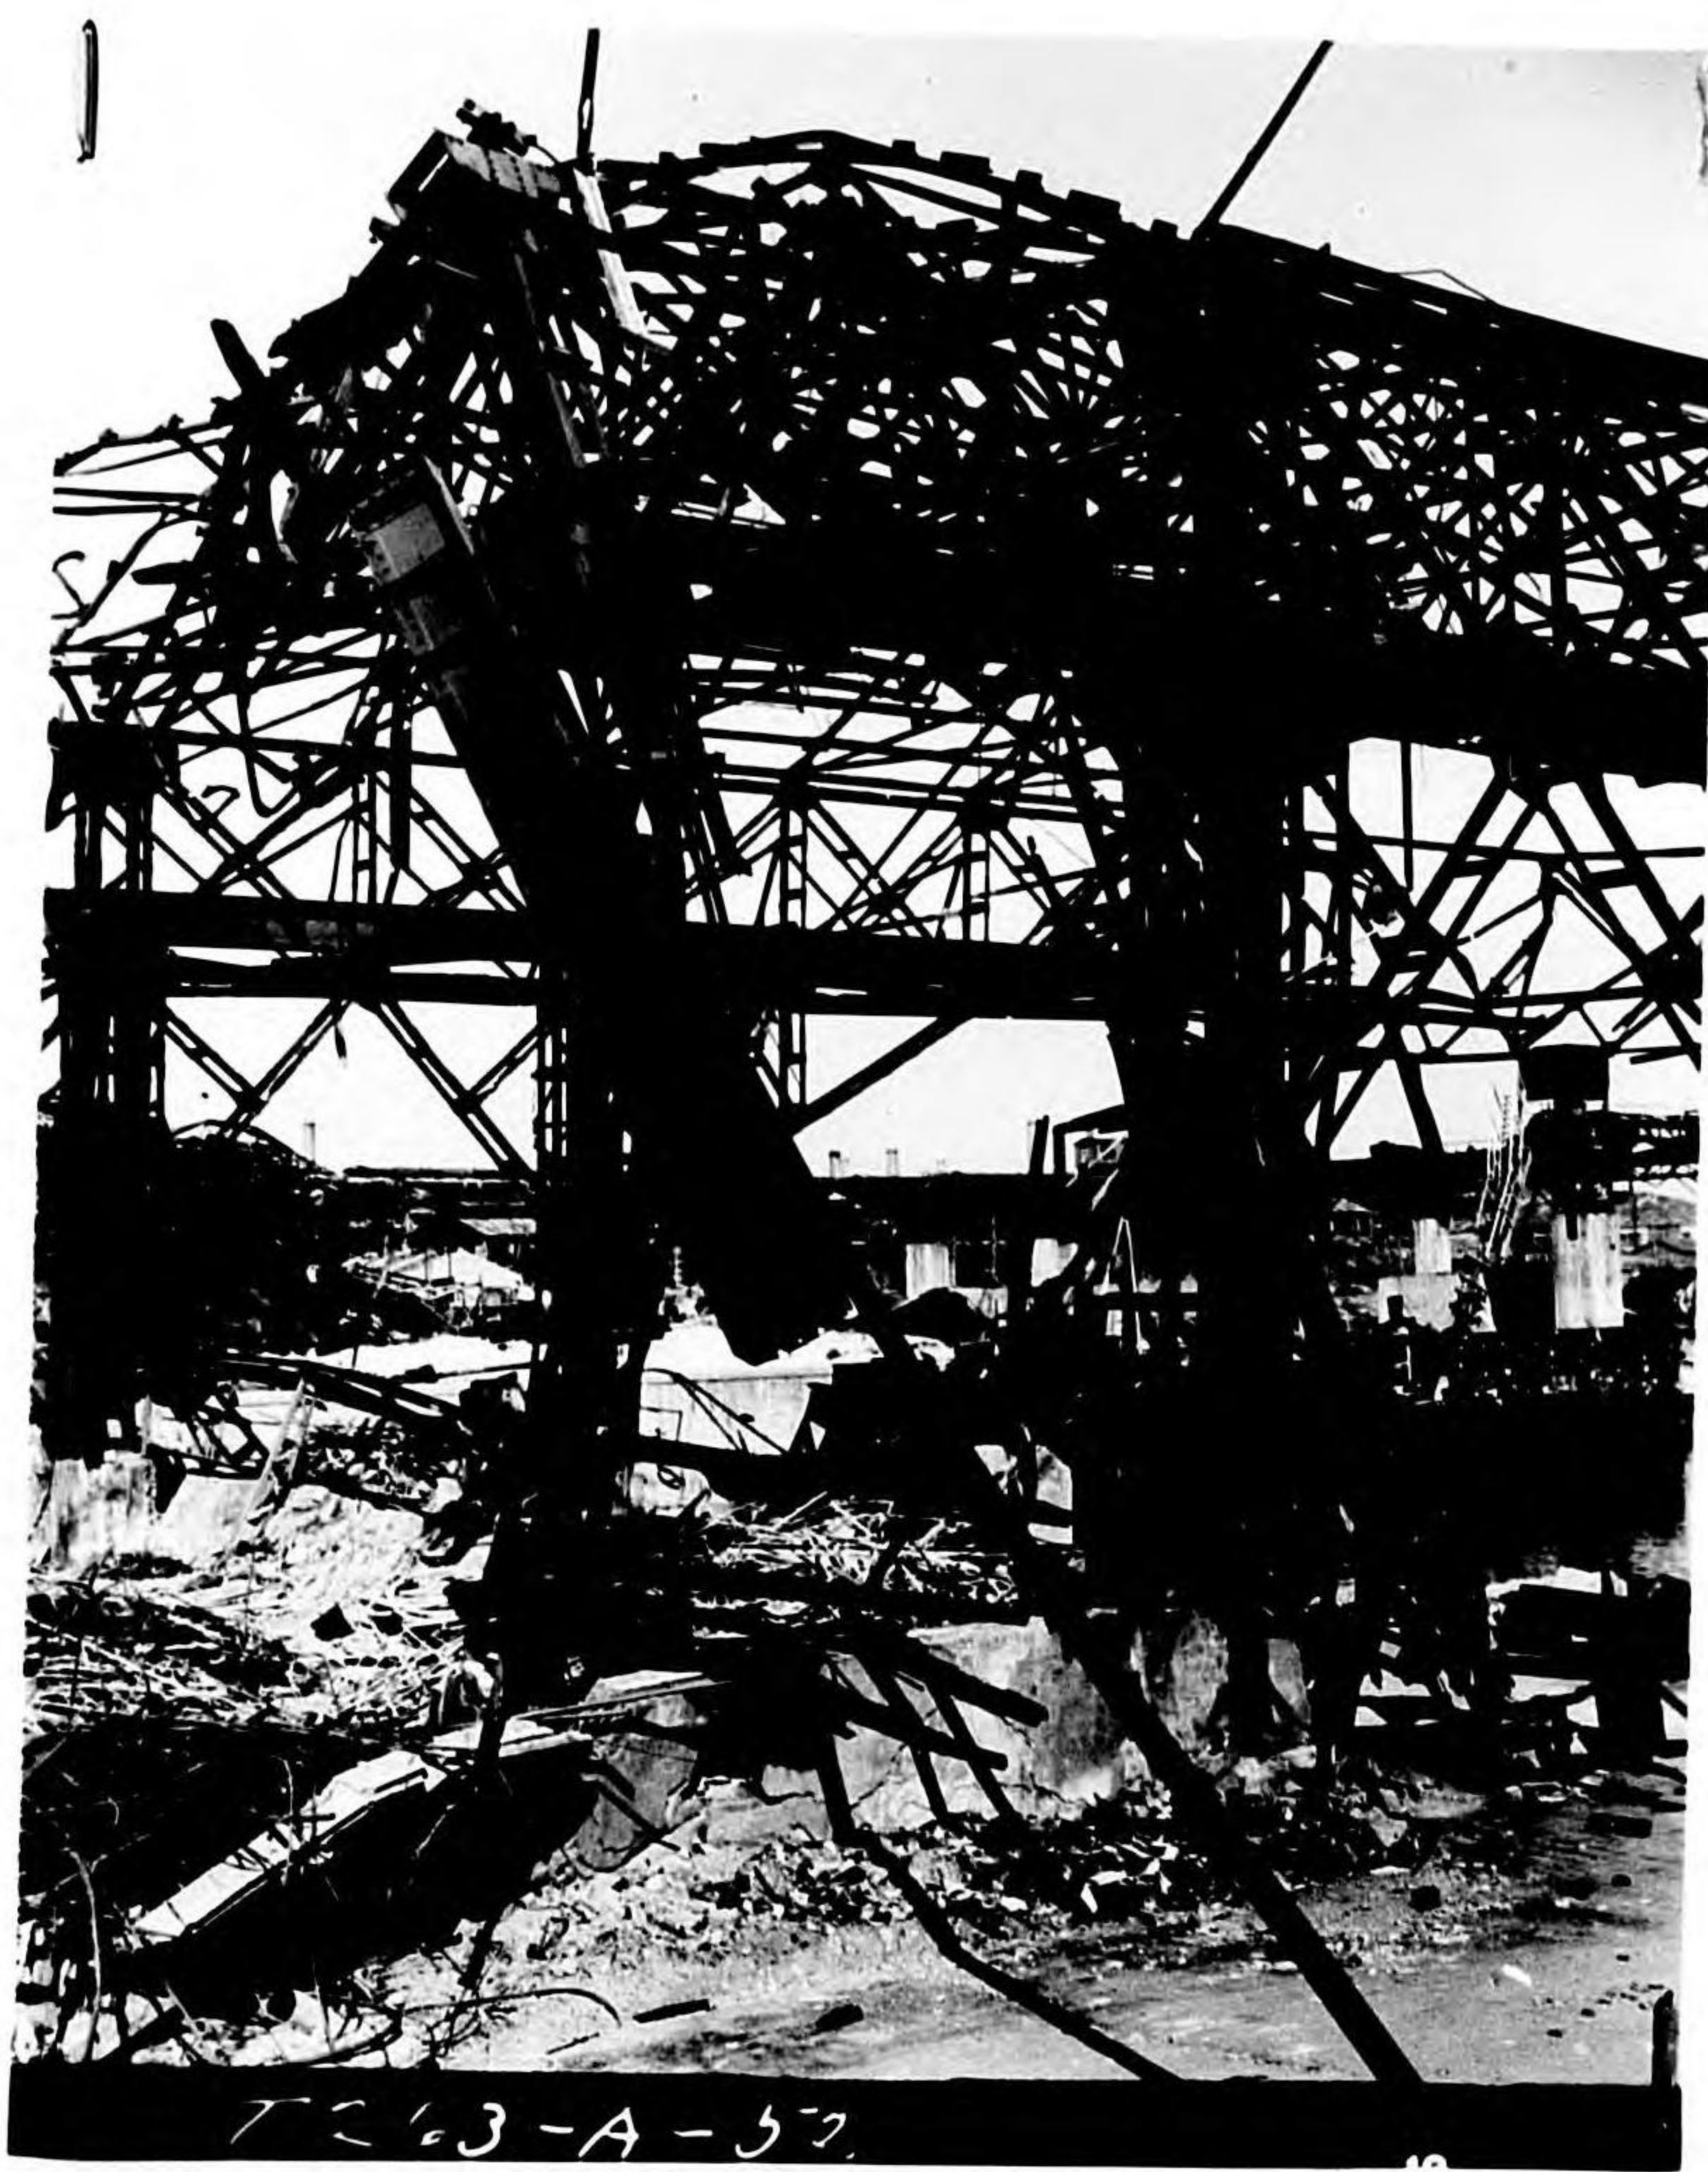
h. Building 33 was a steel-frame structure, the last of a series of warehouses (Buildings 32, 53, 52), and had a loading crane at the water edge. Bomb 71 struck this building, knocking down six columns and damaging the entire structure (Photo 8). One column was hurled approximately 85 feet, crashing into and reducing to ruins a small power house south of the building.

Photo 8 - Bldg. 33, Bomb 71. Roof damage from column.

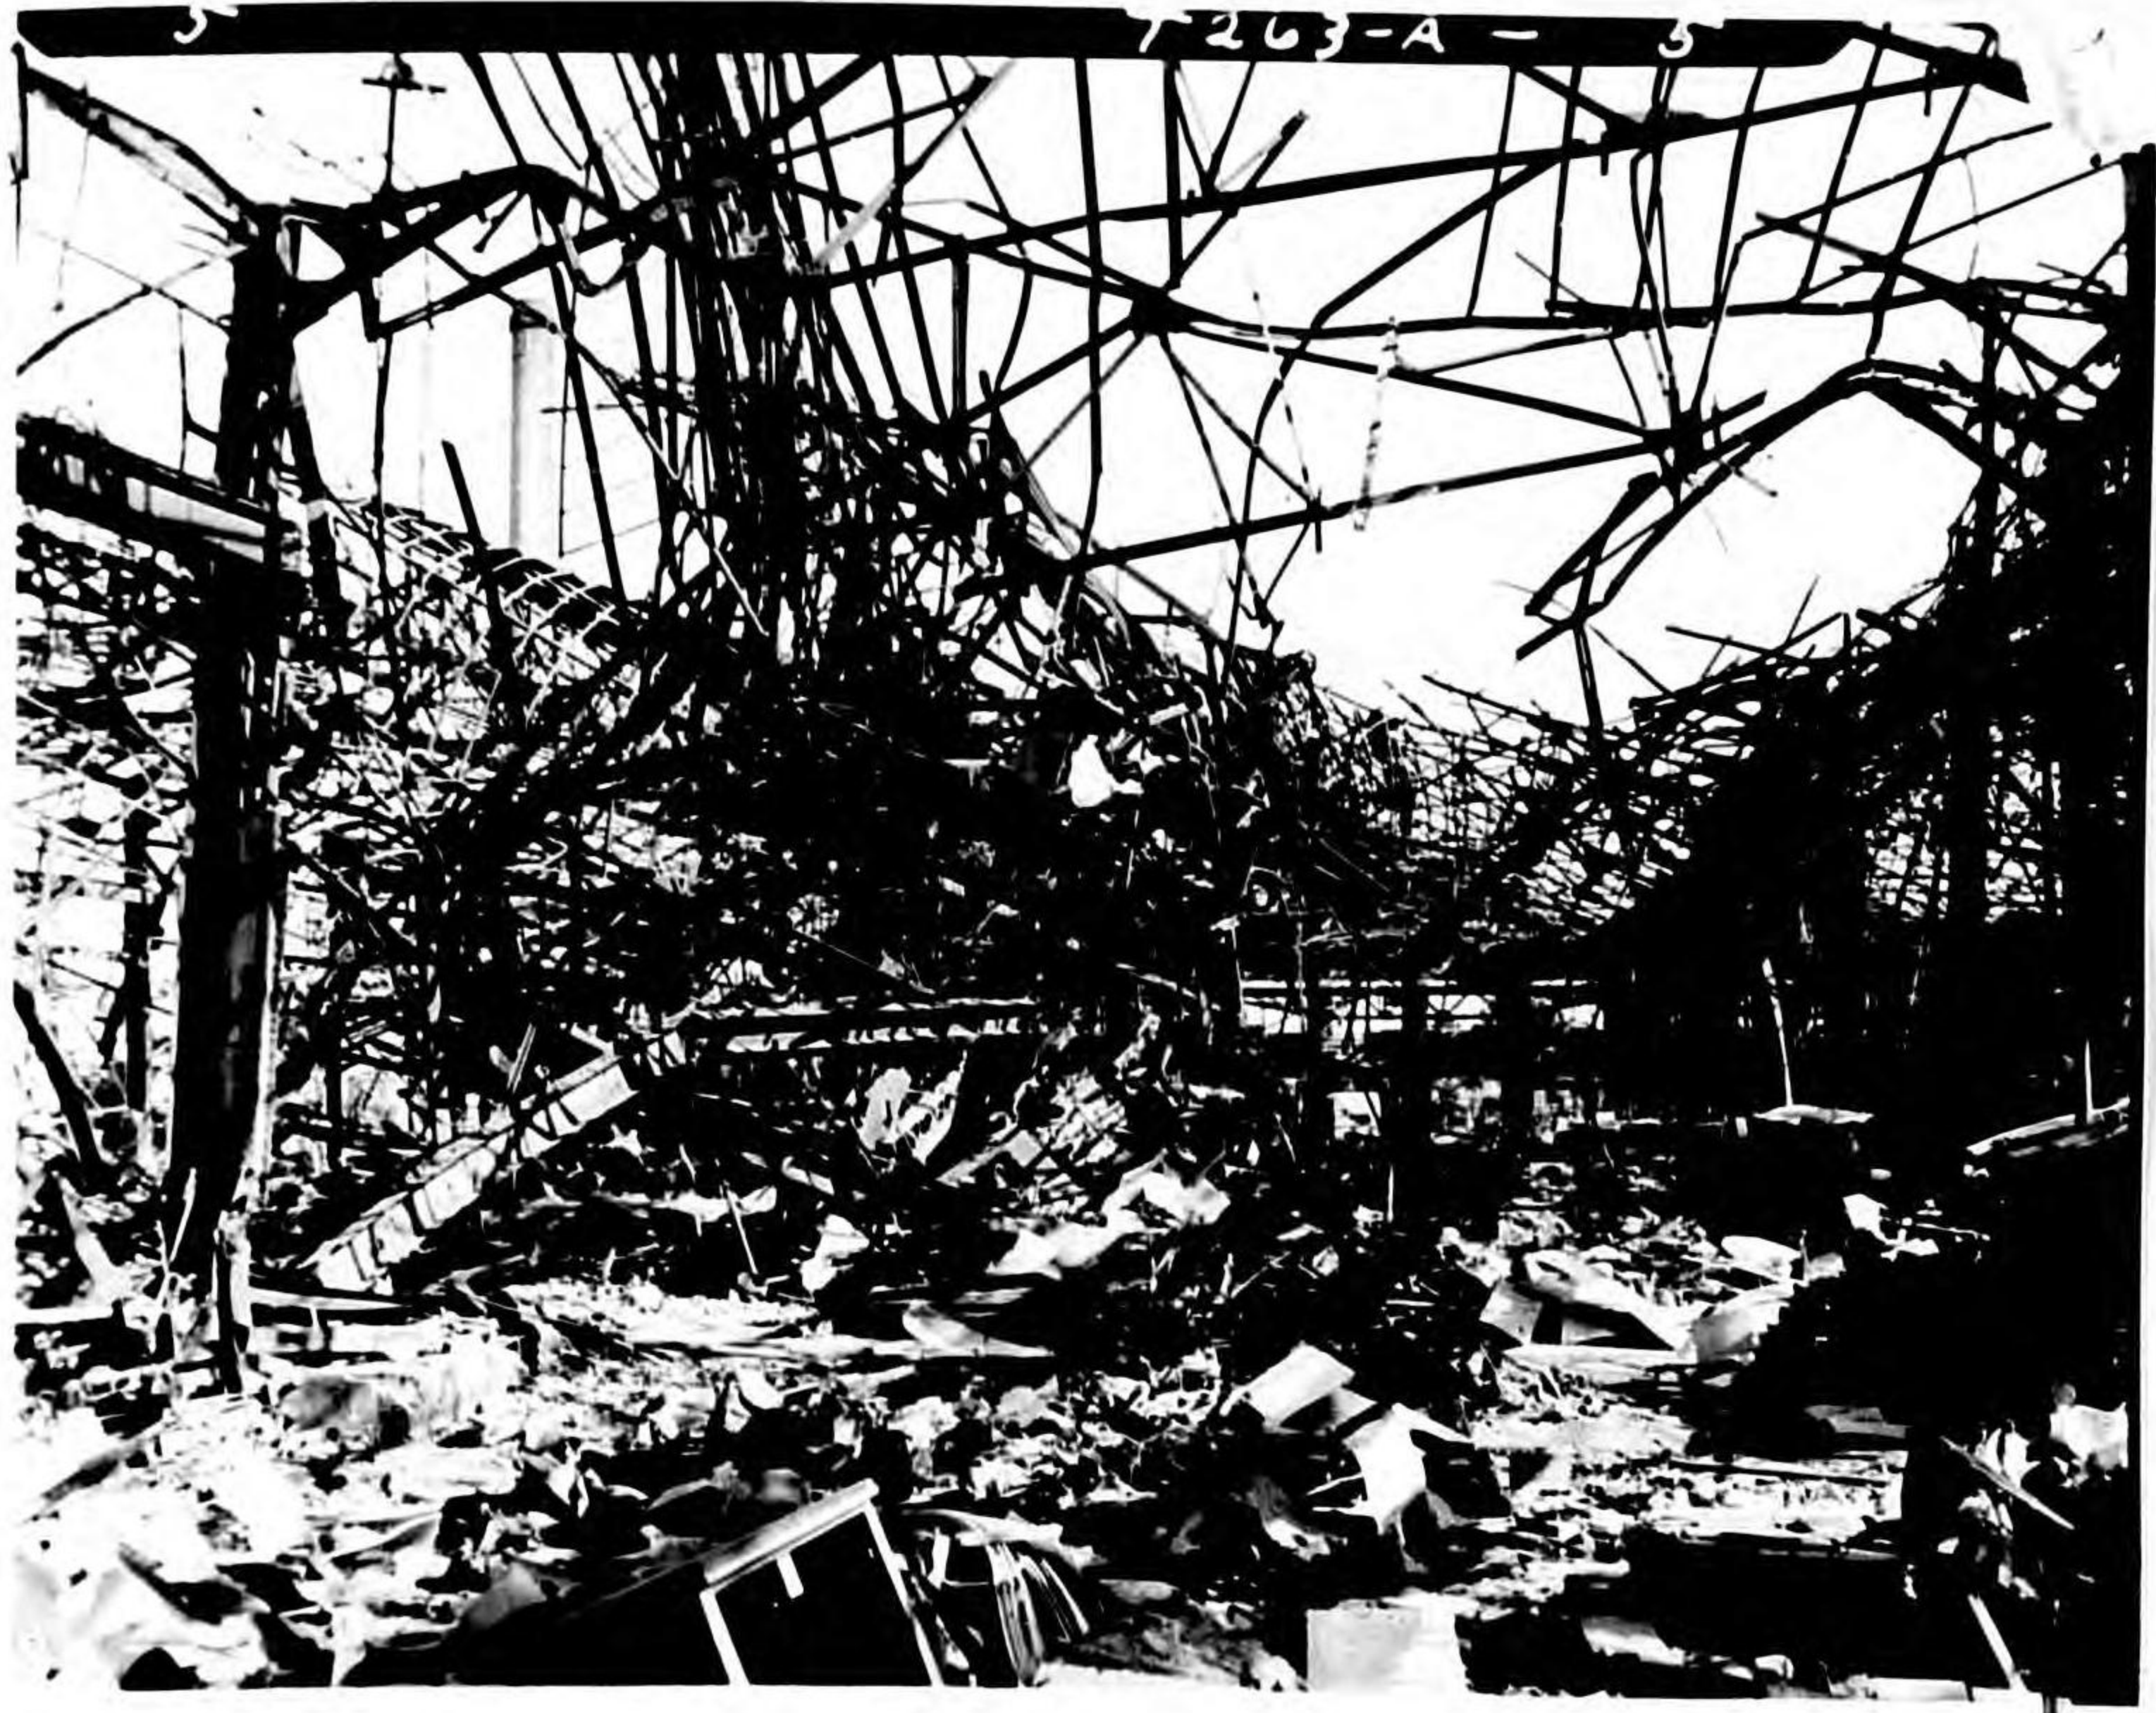
Photo 9 - Bldg. 64, Bomb 5. Severe damage.

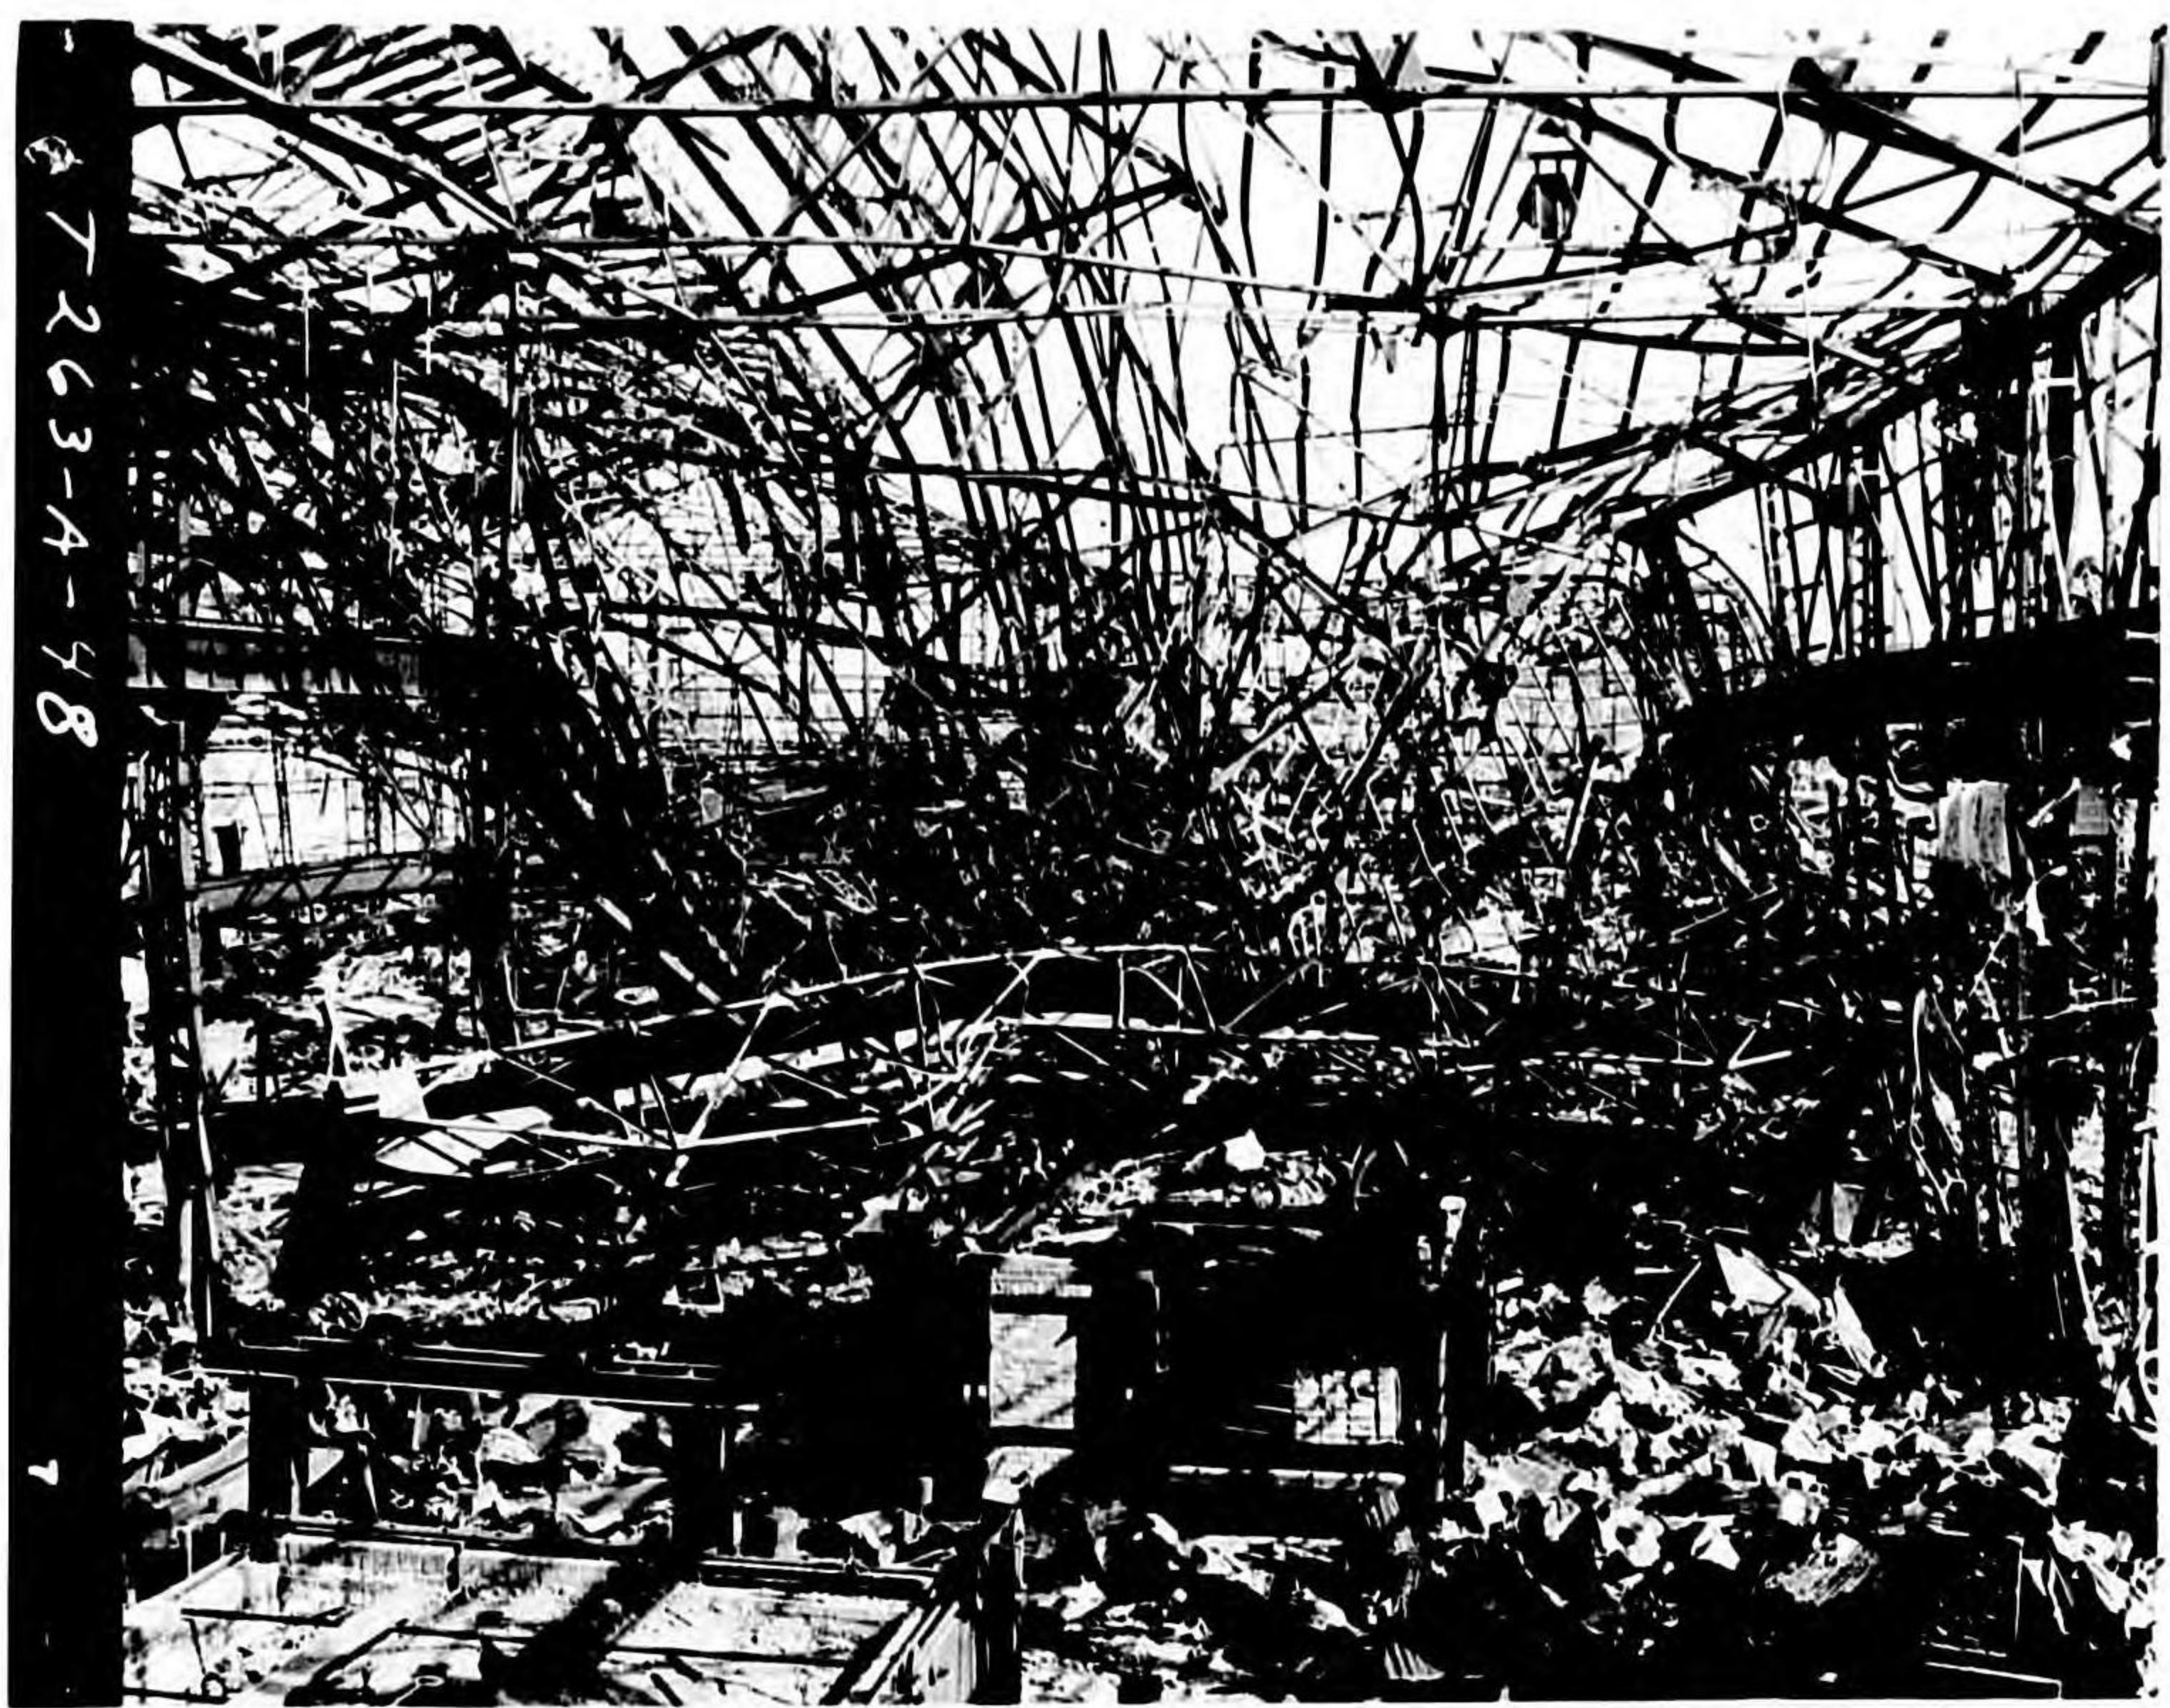
j. Building 43 was a one-story, steel-frame mill building. Bomb 93 struck in this building, severely damaging two exterior columns and two interior columns. The building was also affected by the detonation of Bomb 74. Photos 10 and 11 show damage to the building, all of which was collapsed or distorted.

Photo 10 - Bldg. 43, Bomb 93, Overhead crane damaged.
