UNITED STATES STRATEGIC BOMBING SURVEY

REPORT 72

EFFECTS OF THE FOUR THOUSAND-POUND BOMB

A Report on Five Incidents

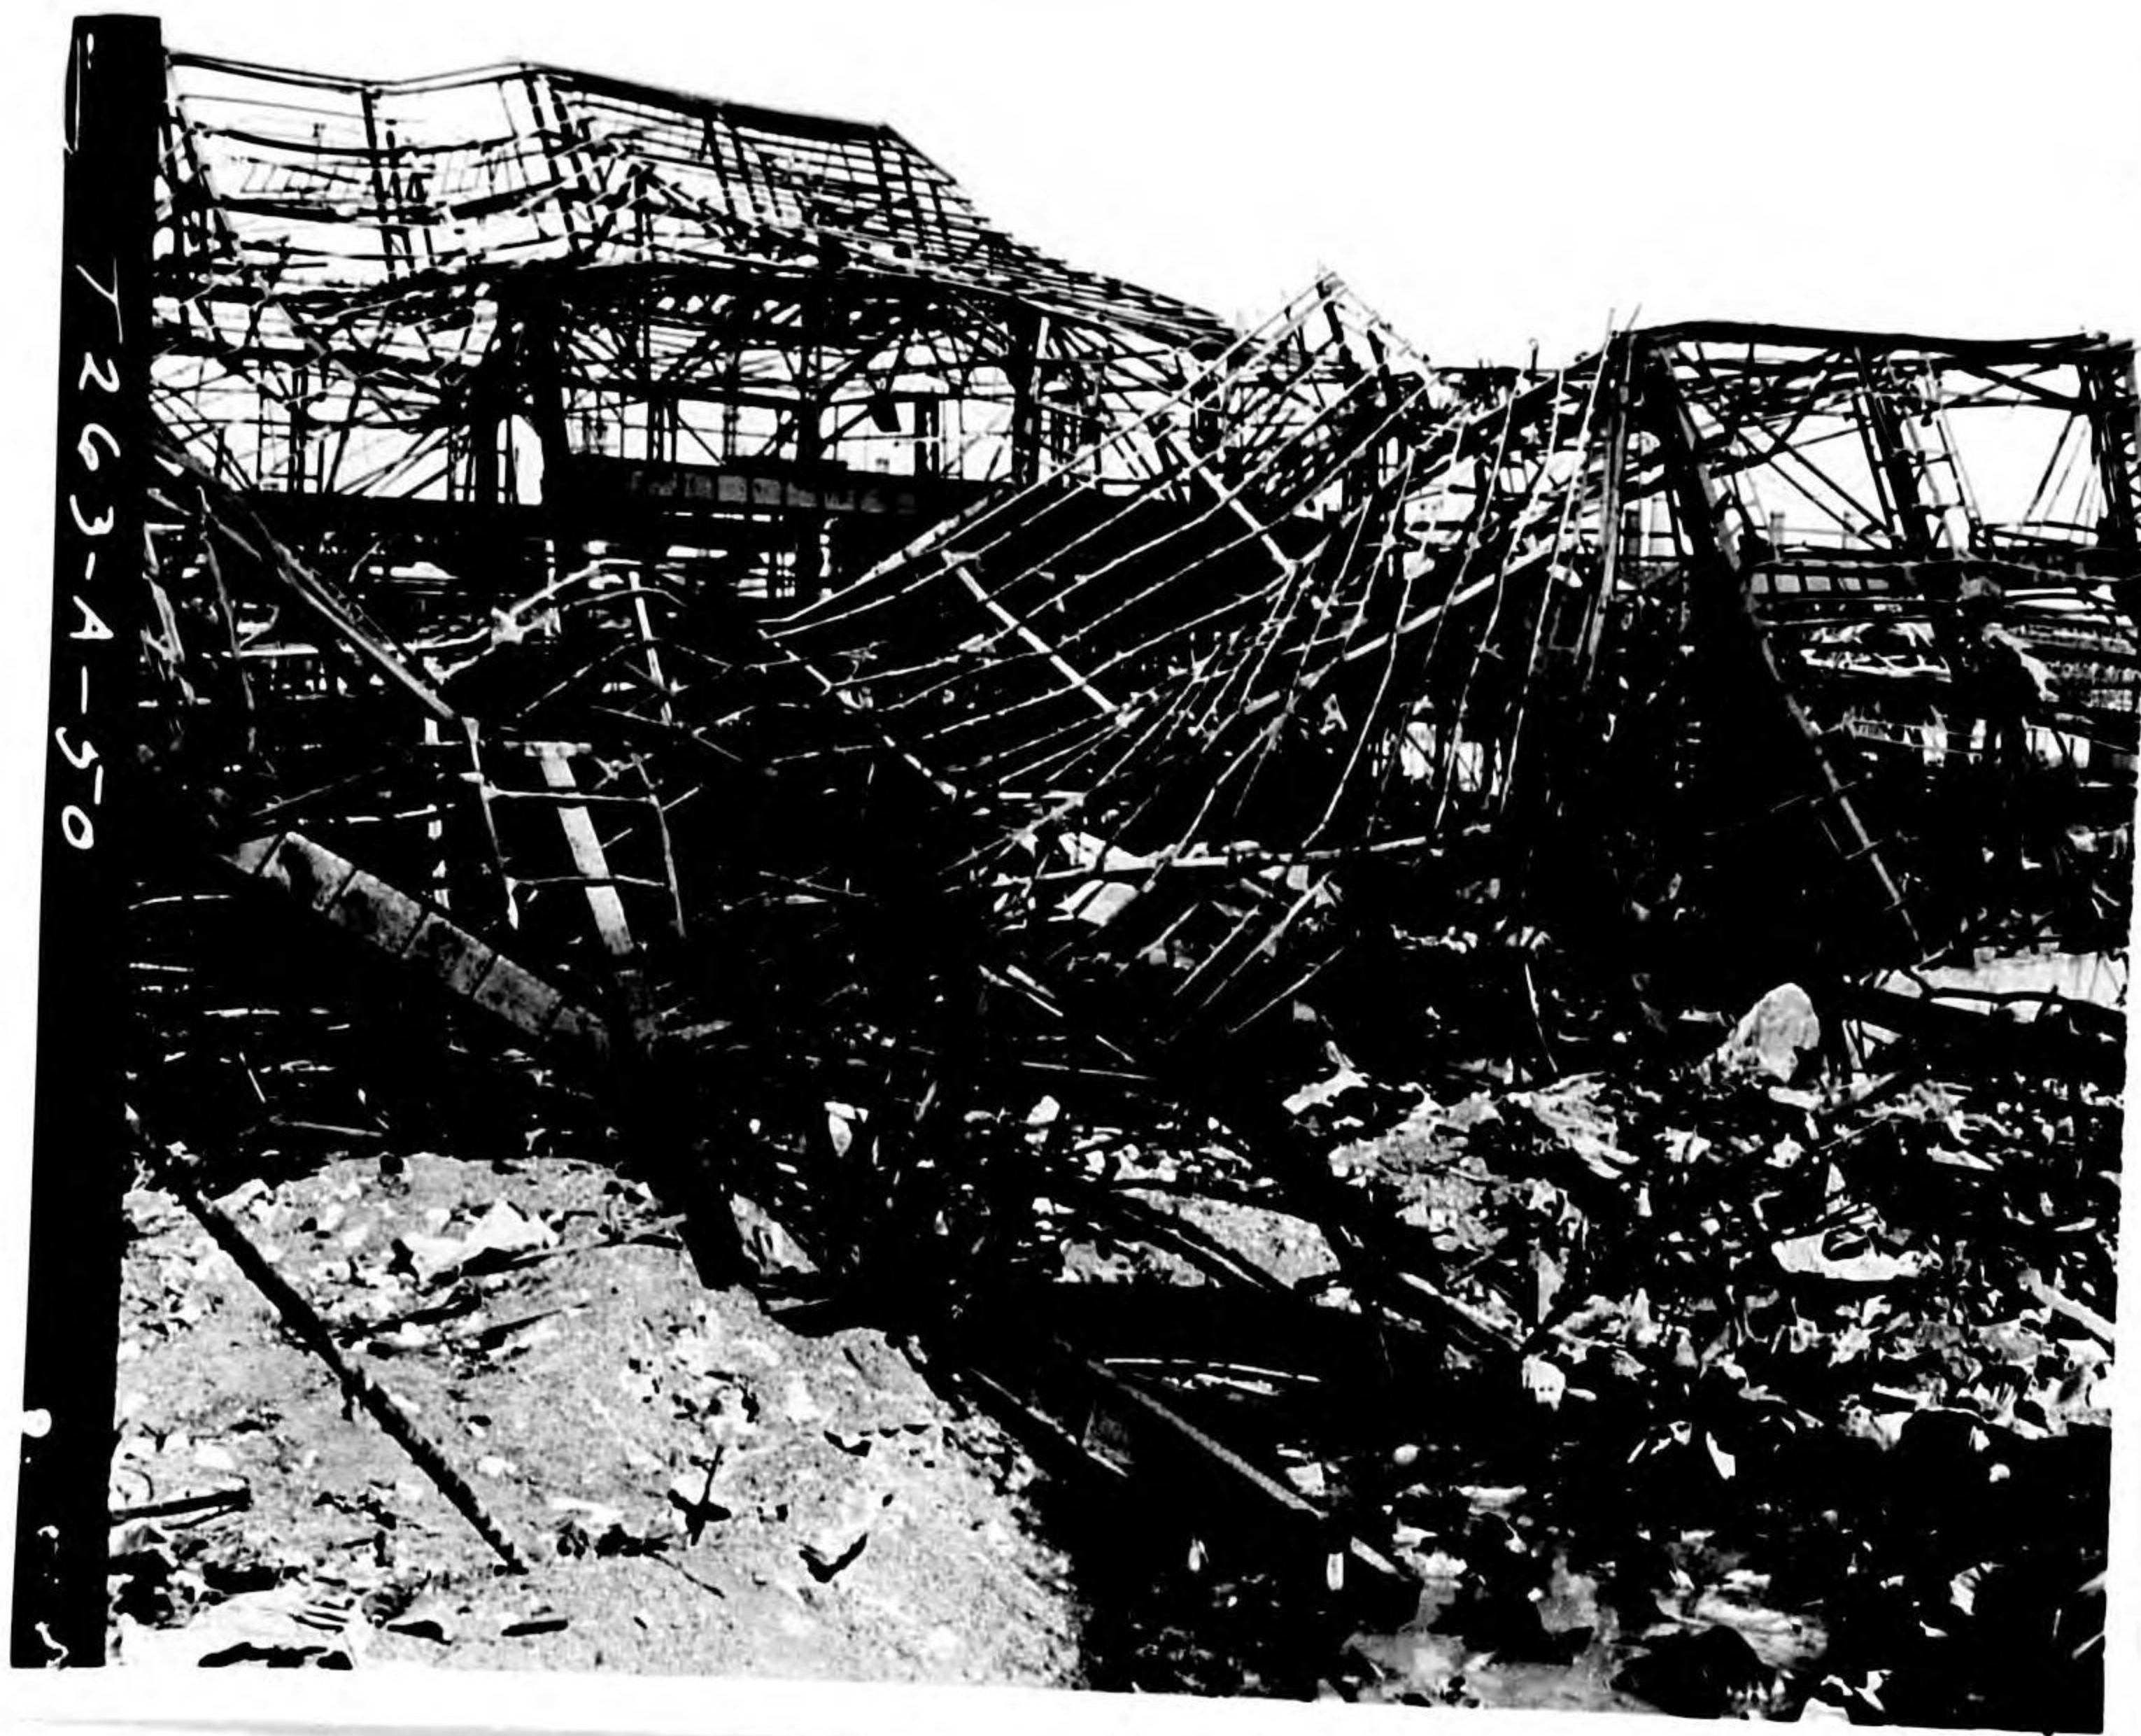
Photo 11 - Bldg. 43, Bomb 74. Cratered

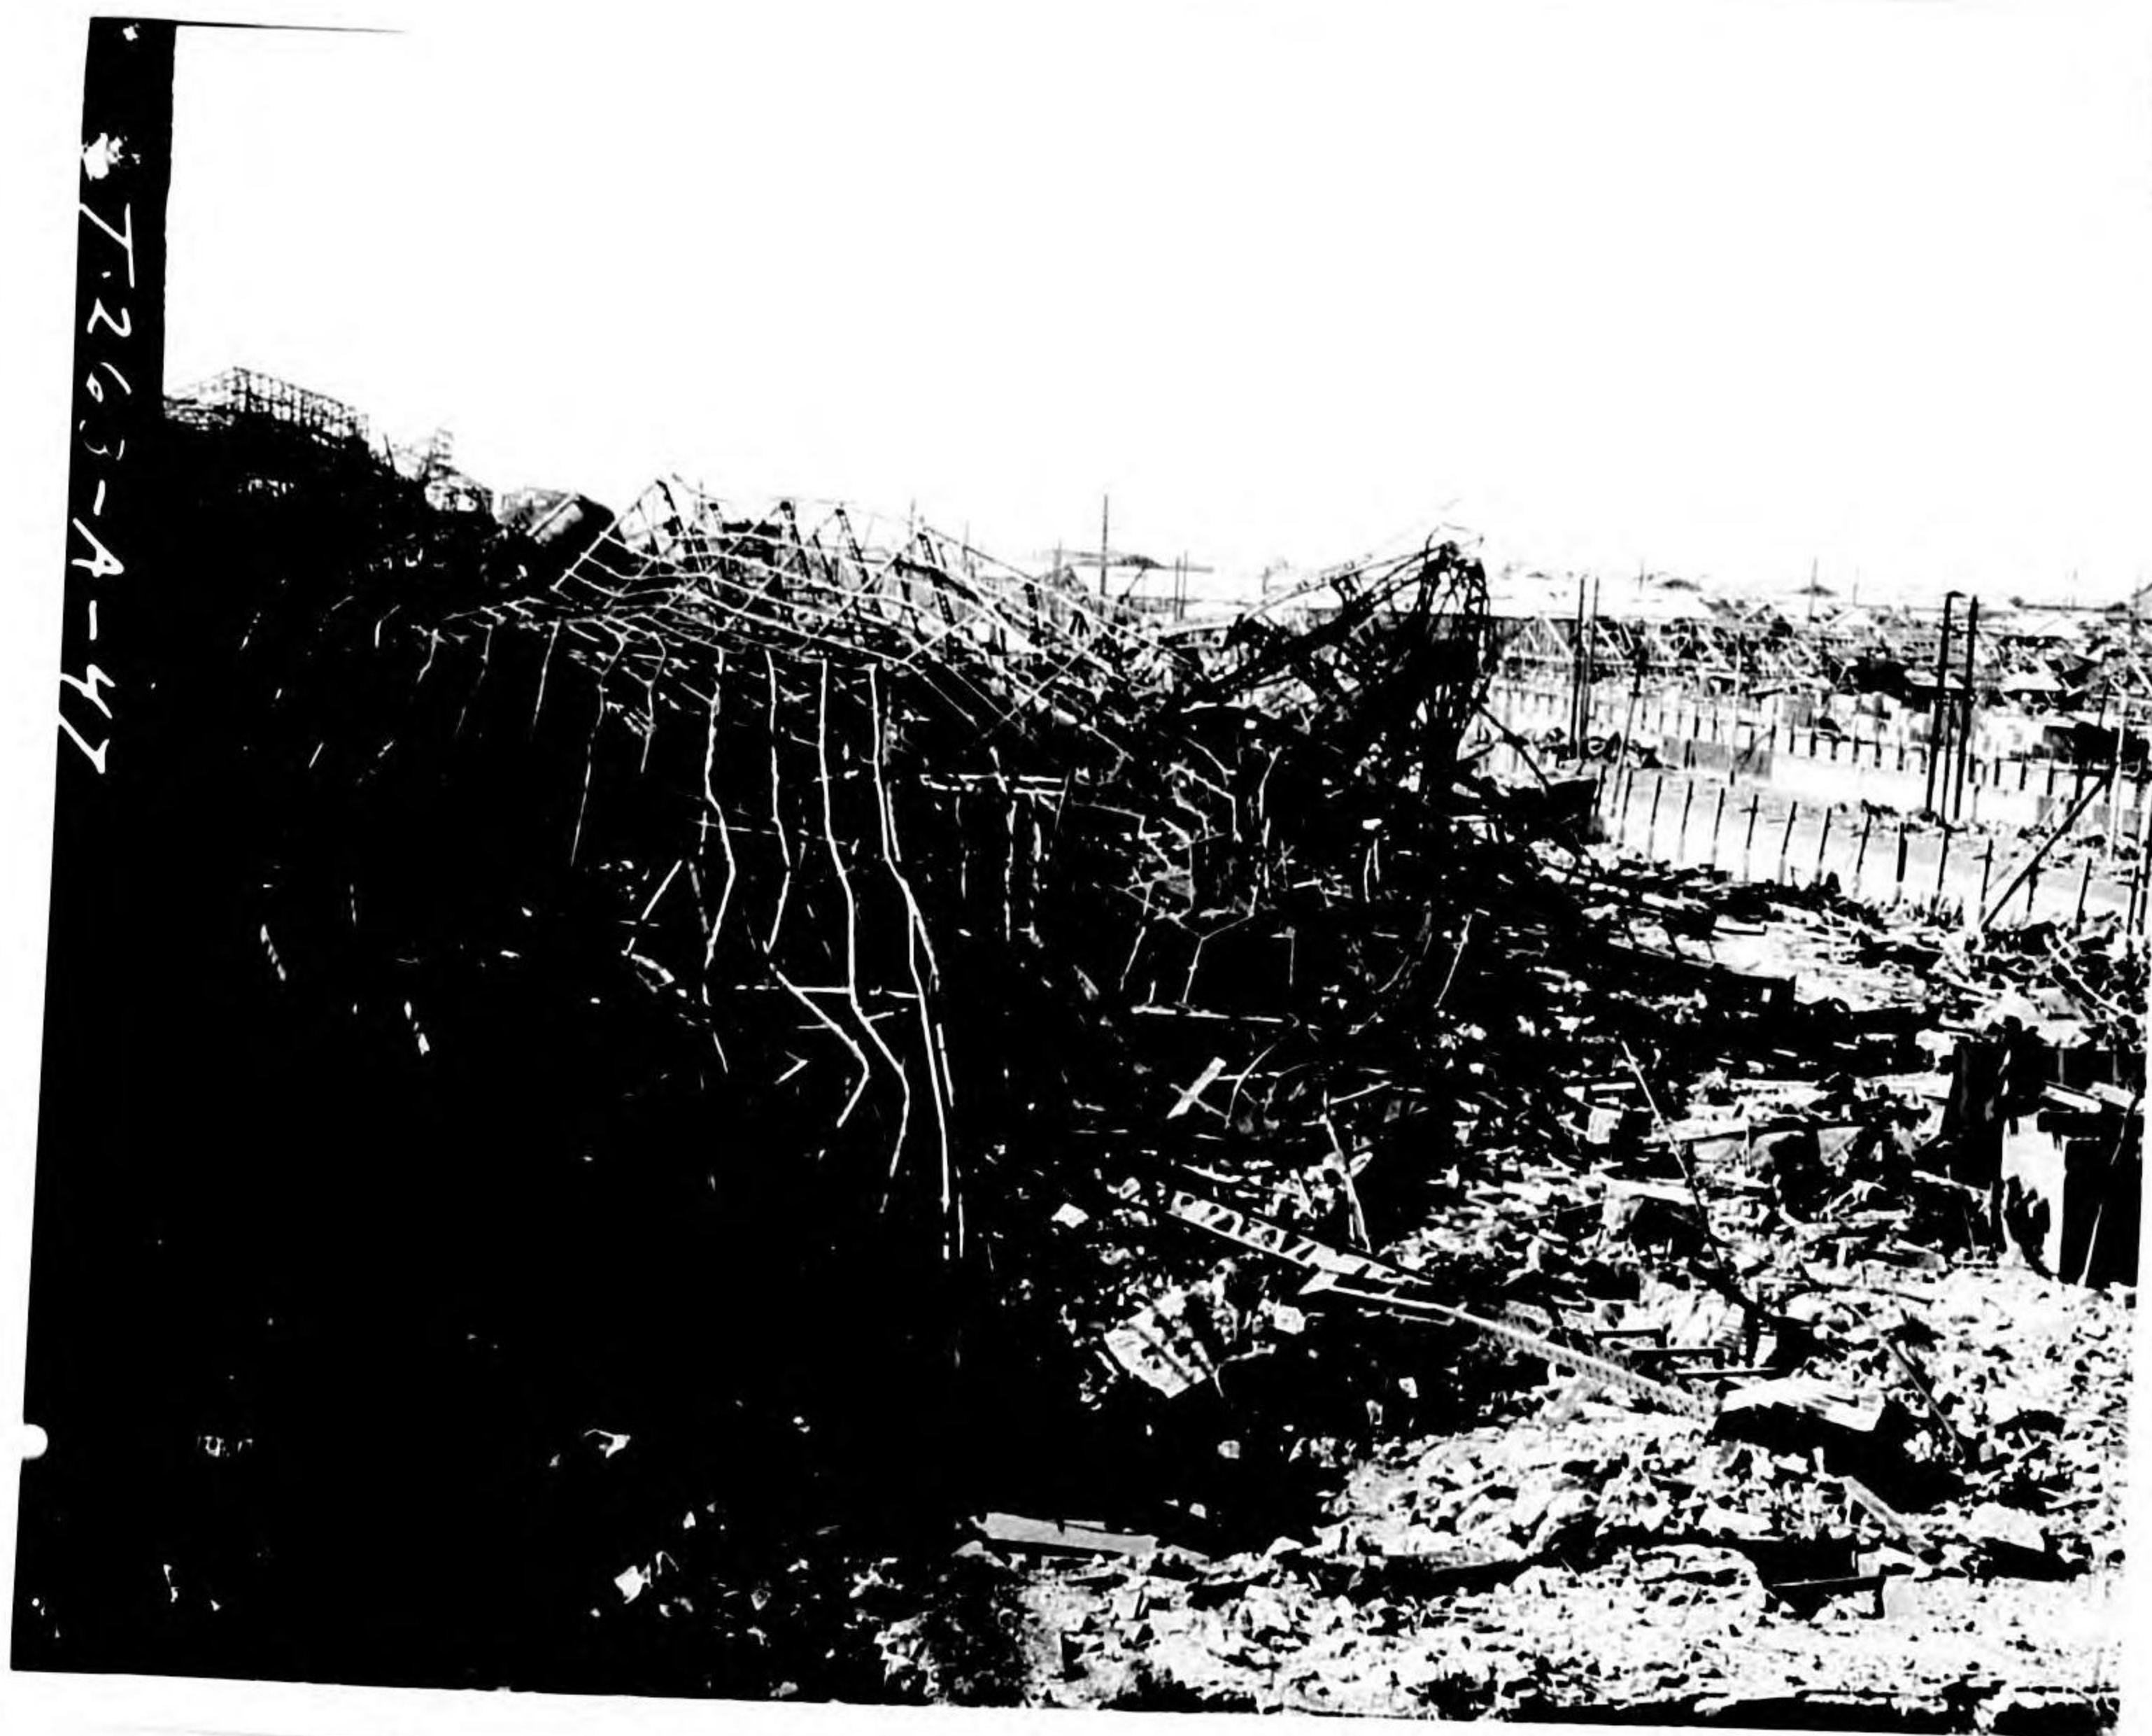
Photo 12 - Bldg. 51, Bombs 91, 92. General collapse.

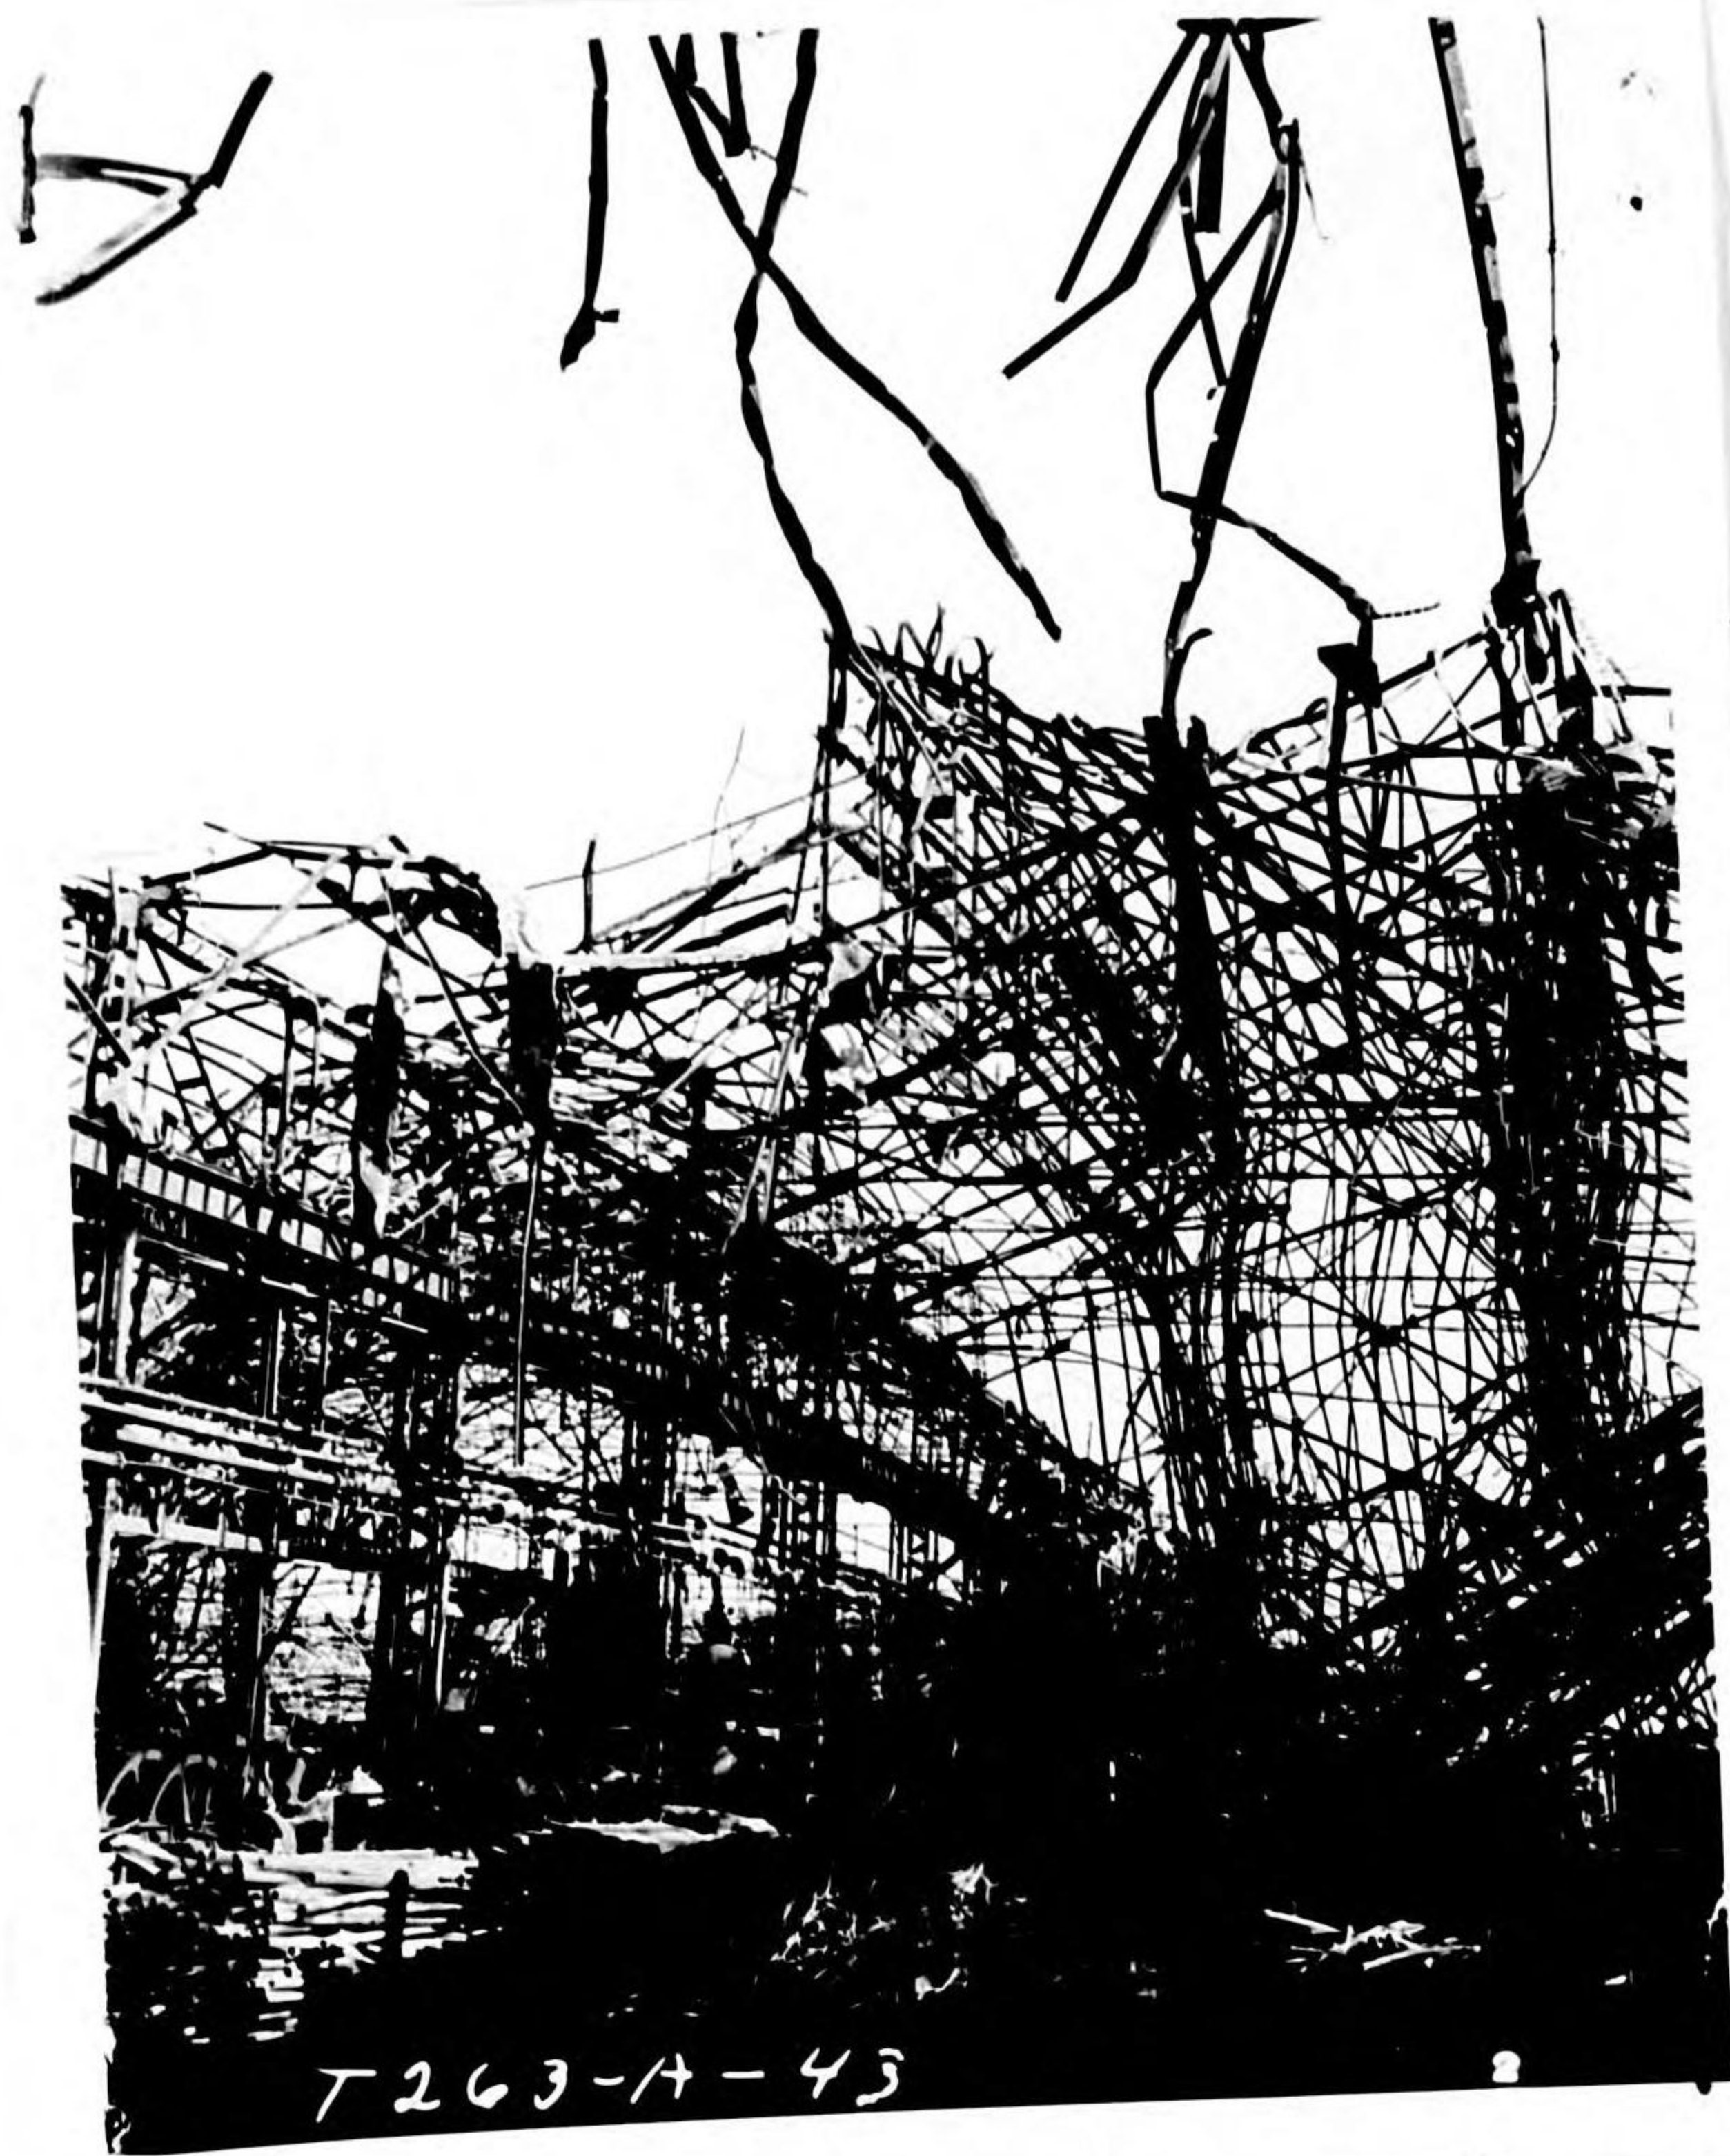
Photo 13 - Bldg. 51, Bomb 77. Structural roof damage.

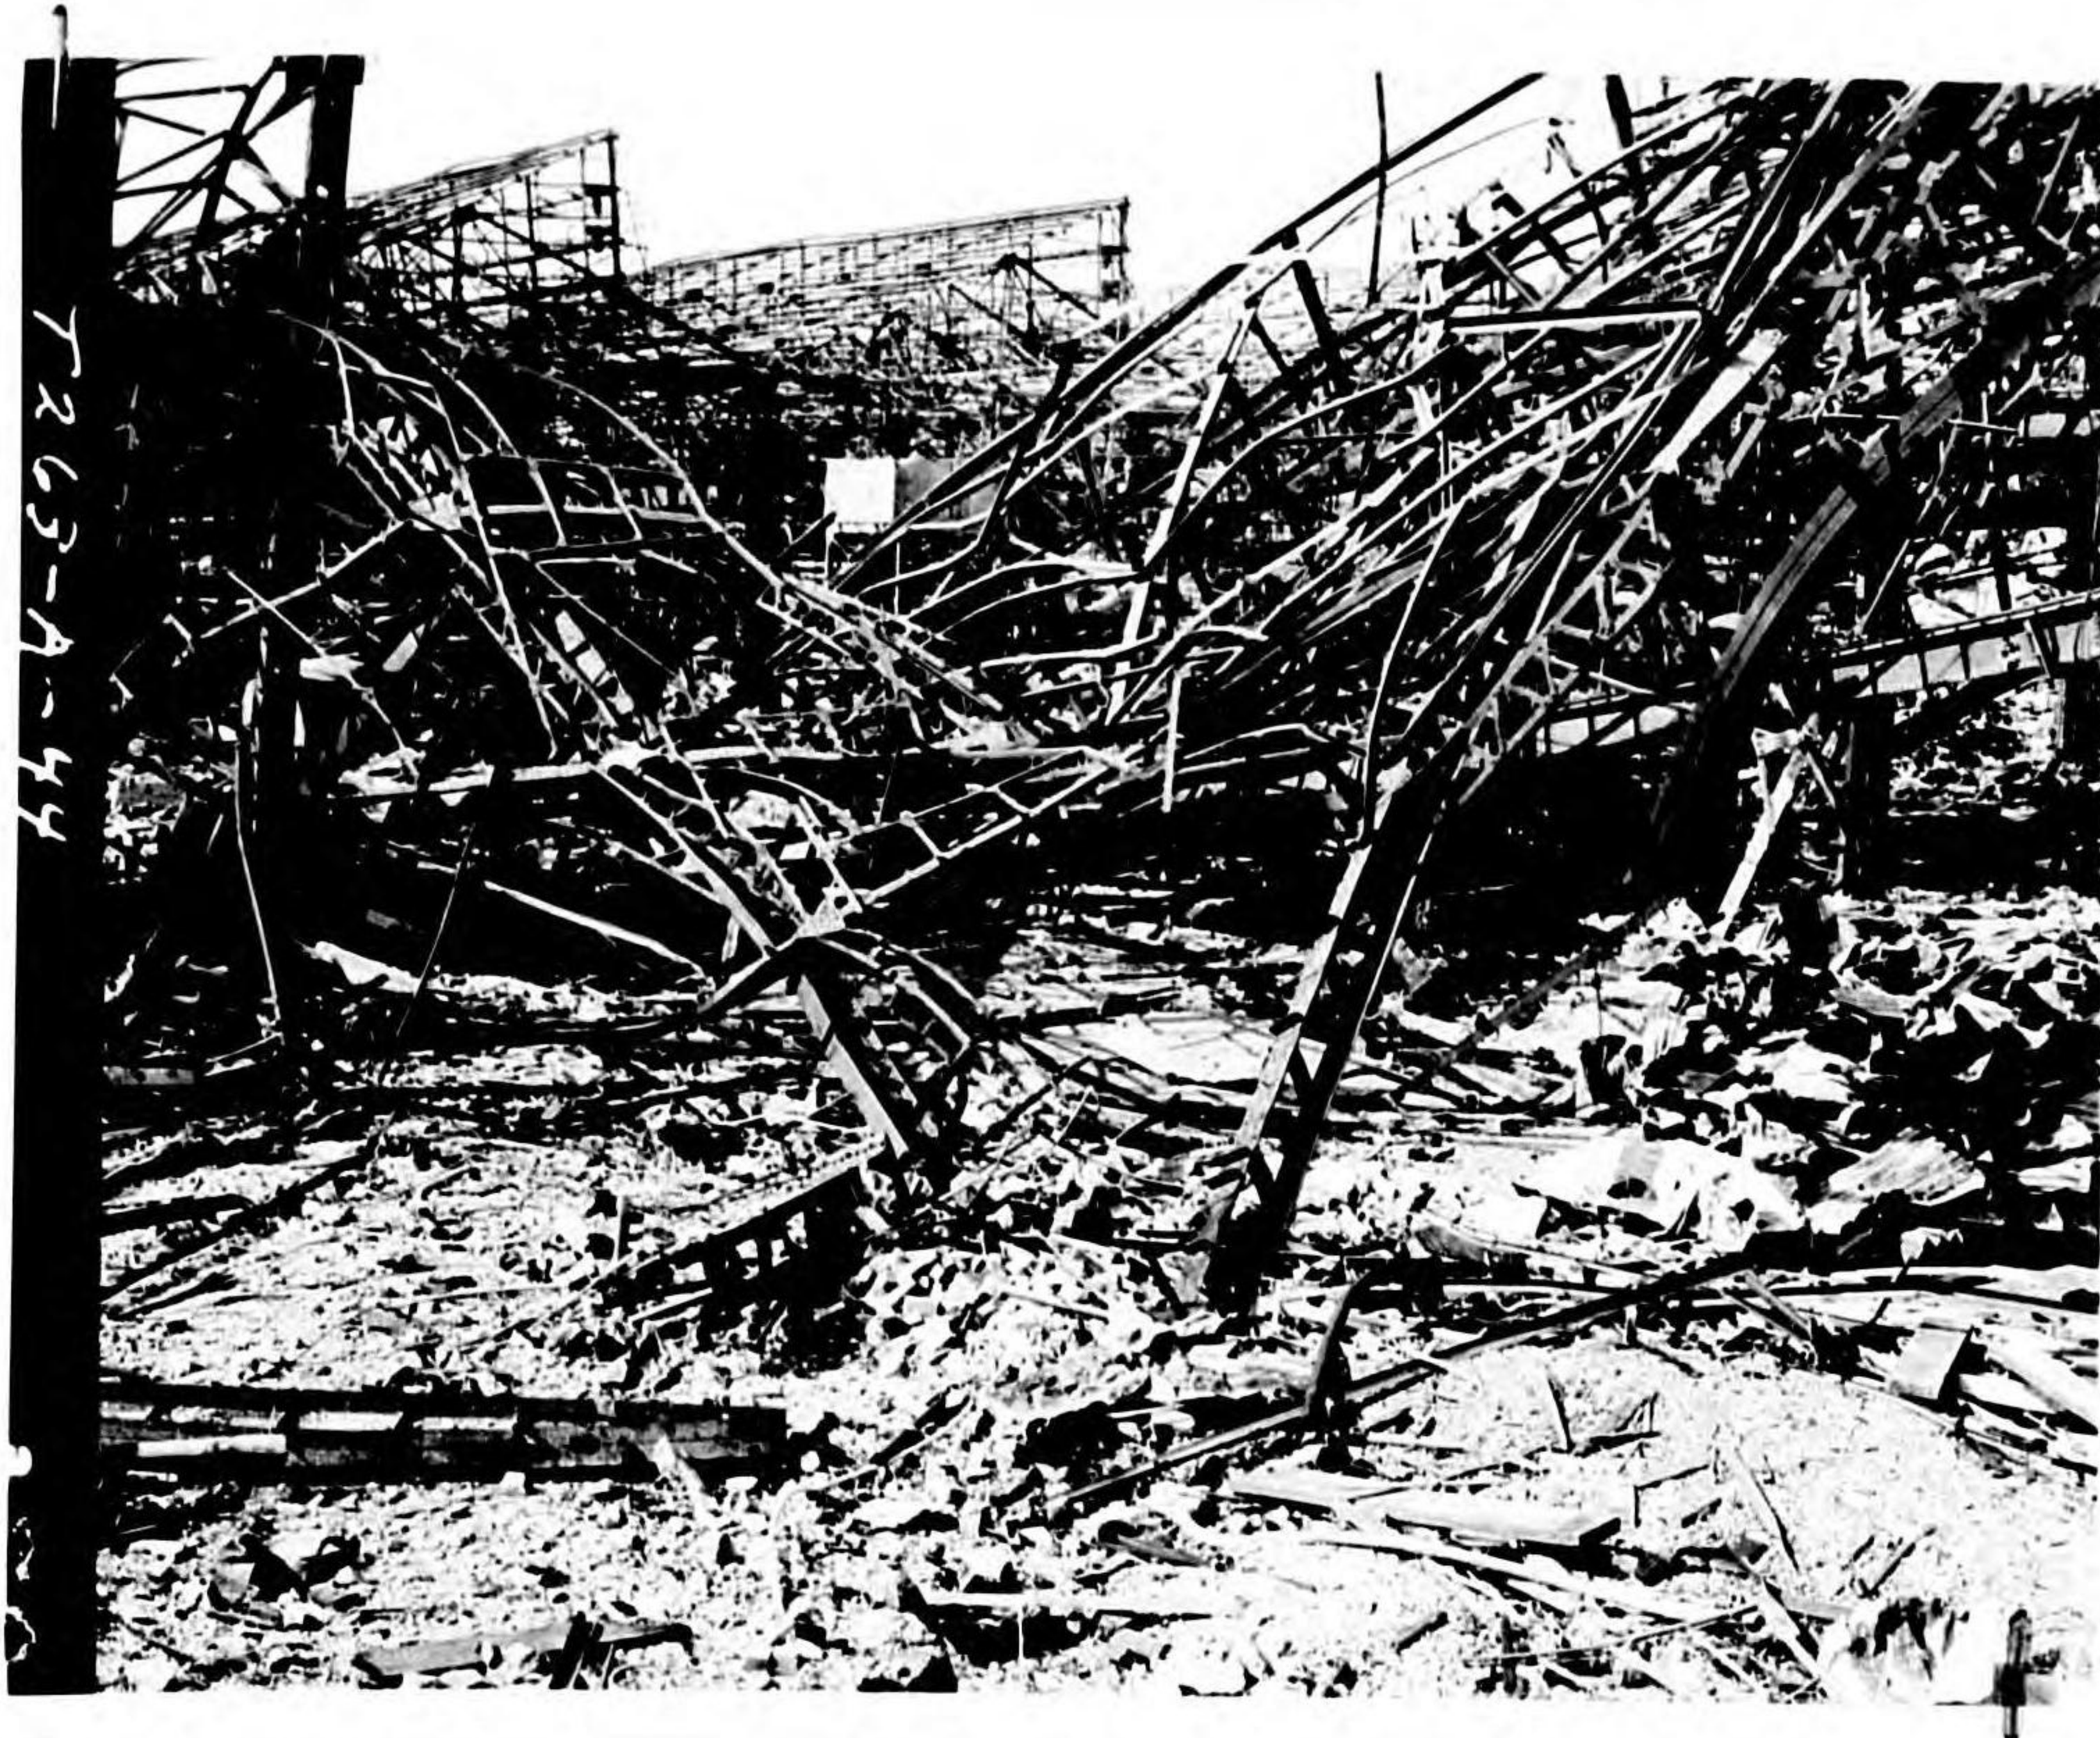
Photo 15 - Bldg. 51, Bomb 66. Blast damage.

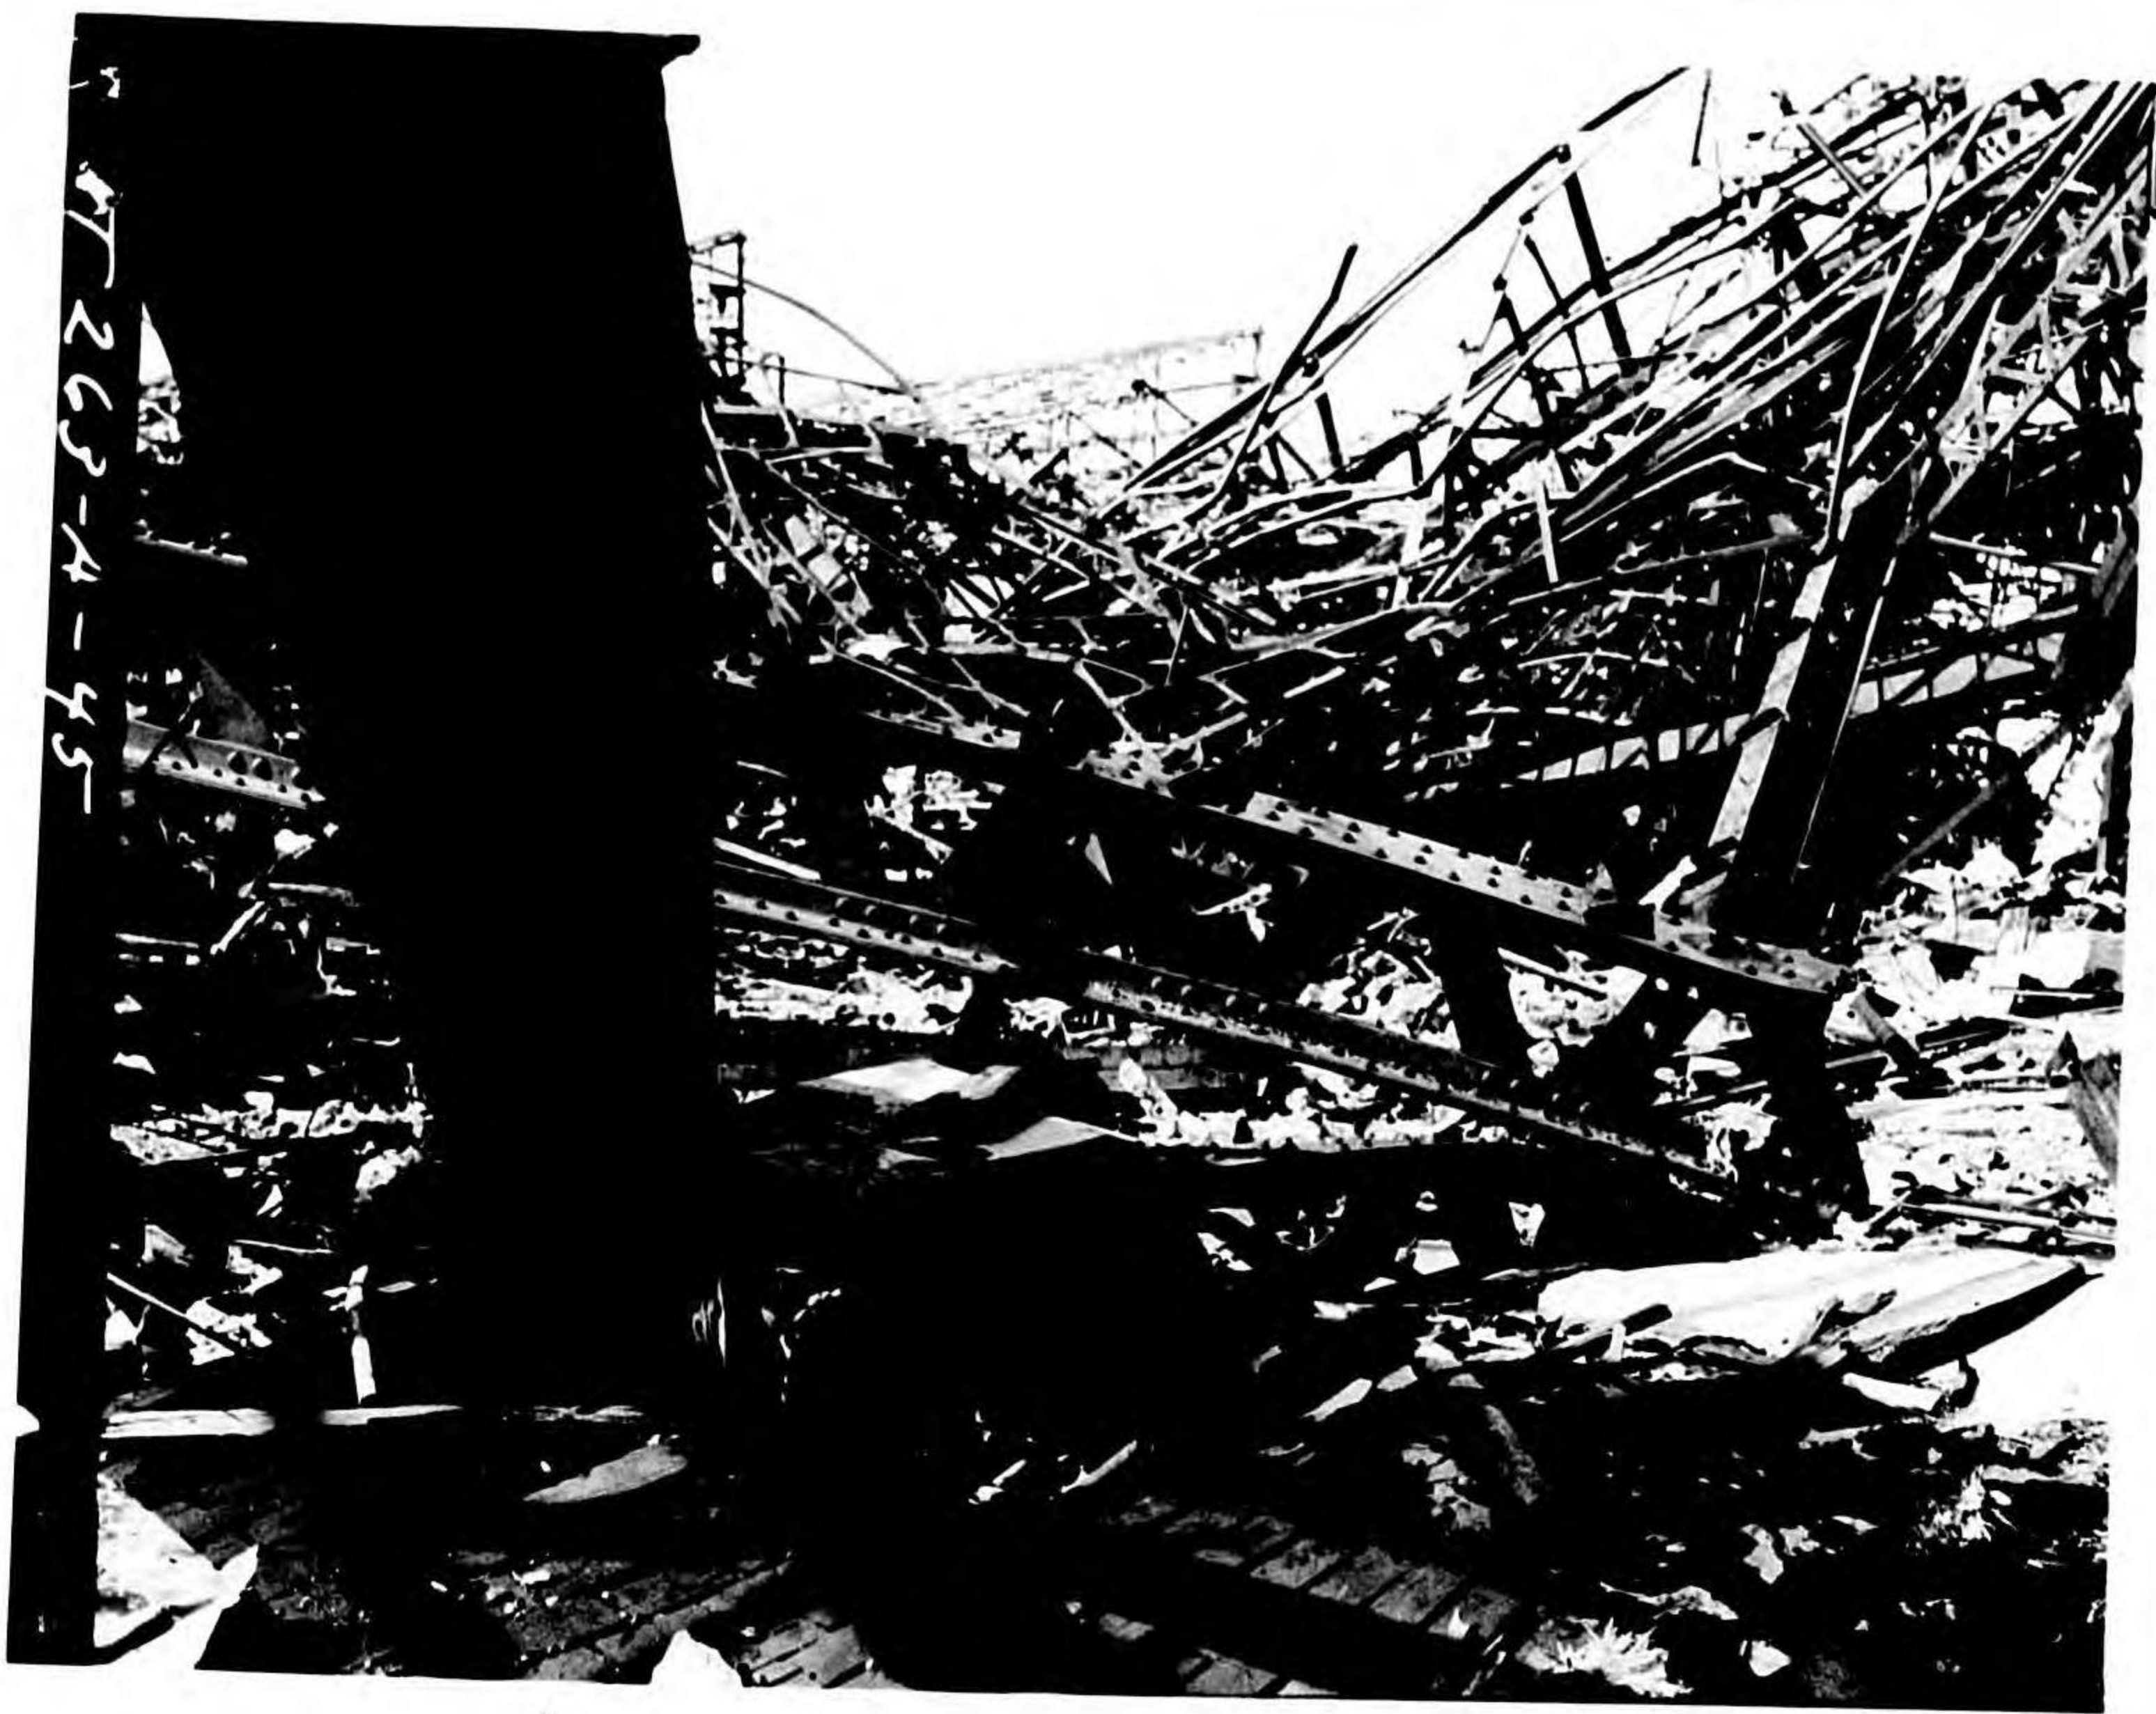
Photo 16 - Bldg. 51, Bomb 66. Detail of column damaged.

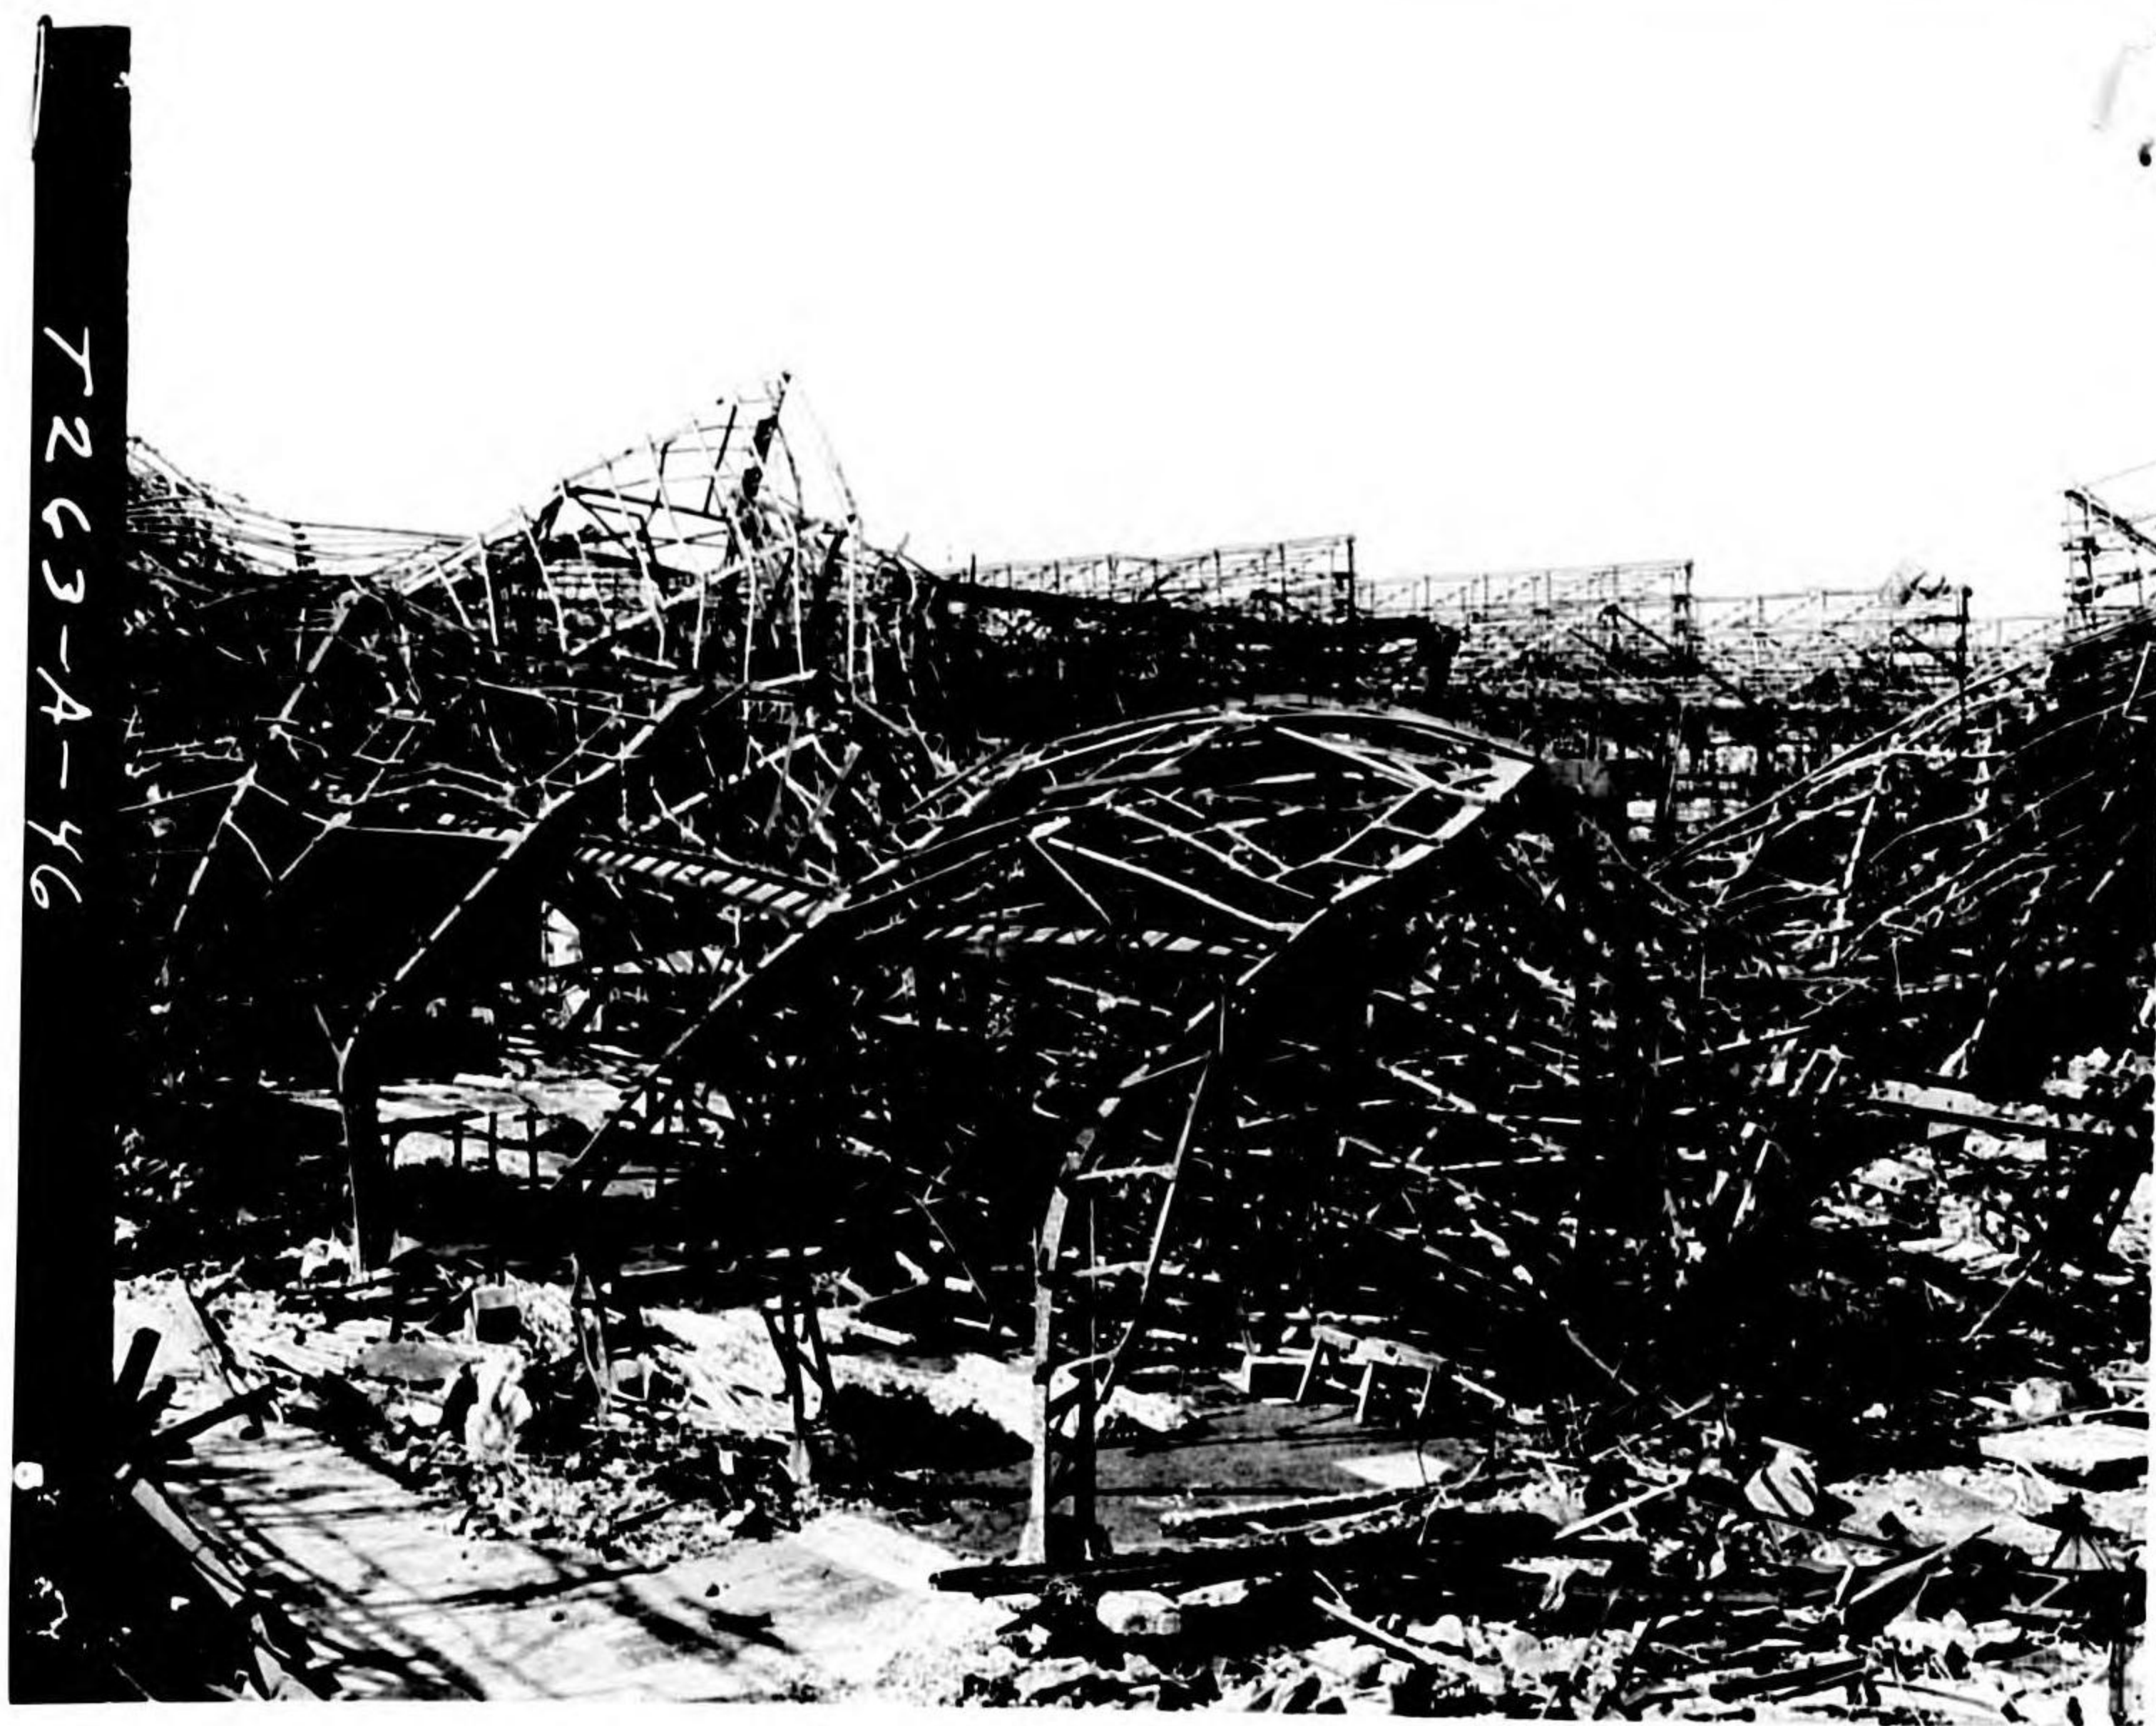
Photo 17 - Bldg. 51, Bomb 66. Exterior columns damaged by collapse.
