UNITED STATES STRATEGIC BOMBING SURVEY

REPORT 72

EFFECTS OF THE FOUR THOUSAND-POUND BOMB

A Report on Five Incidents

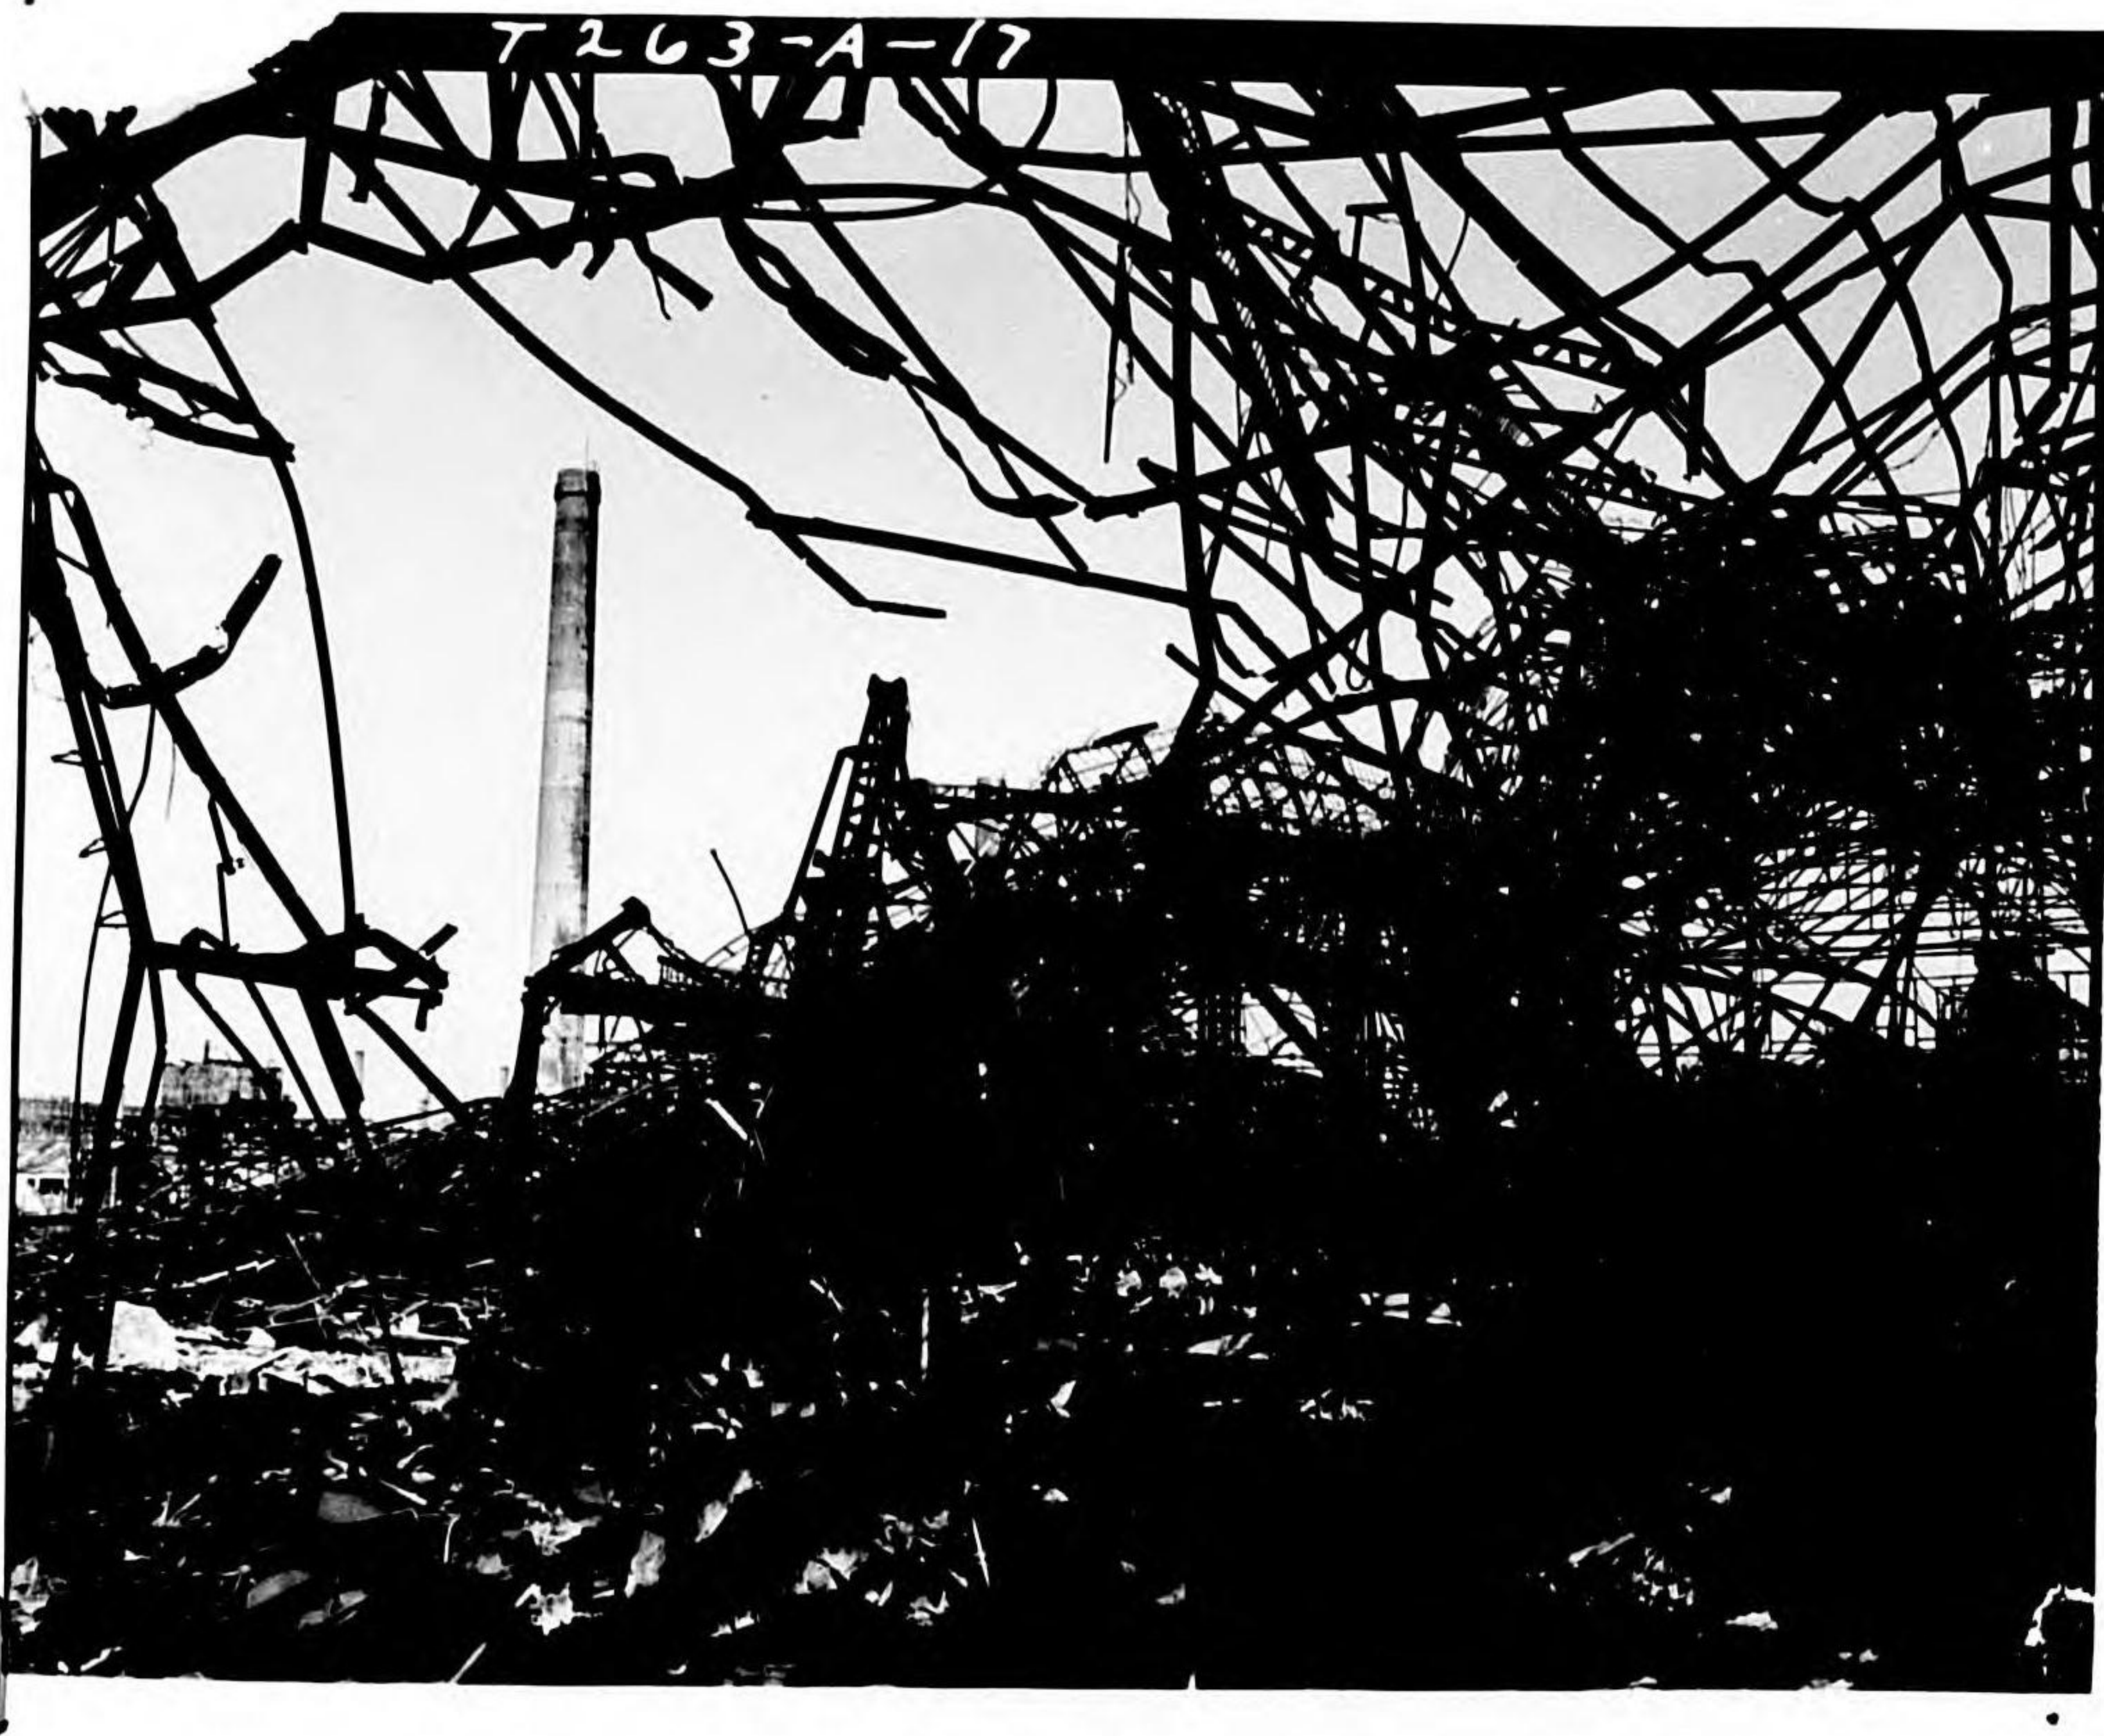
k. Building 51 was a large one-story, steel-frame mill building. Bomb 92 struck in the northeast corner of the building, knocking out nine exterior columns and four interior columns. Bomb 91 knocked out two interior columns. The combined effects of Bombs 91 and 92 collapsed a large area of the building (Photo 12). Bomb 77 knocked out two interior columns, causing collapse of the building in the immediate area (Photo 13). Bomb 80 struck 20 feet from the west side of the building, knocking out three external columns and collapsing the exterior bay. Bomb 78 knocked out four exterior columns and two interior columns, collapsing the building in the immediate vicinity (Photo 14). Bomb 66 collapsed an entire wing of the building (Photos 15, 16, 17). Bomb 68, which struck approximately 20 feet from the south side of the building, knocked out three exterior columns, but caused no collapse. Bomb 76 did not knock down any columns, but severely damaged the roof trusses for three bays, and distorted several columns. The entire building except for a small area on the south side was collapsed or severely distorted (Photos 18, 19).

Photo 18 - Bldg. 51, Bomb 90. Structural failure roof and columns.

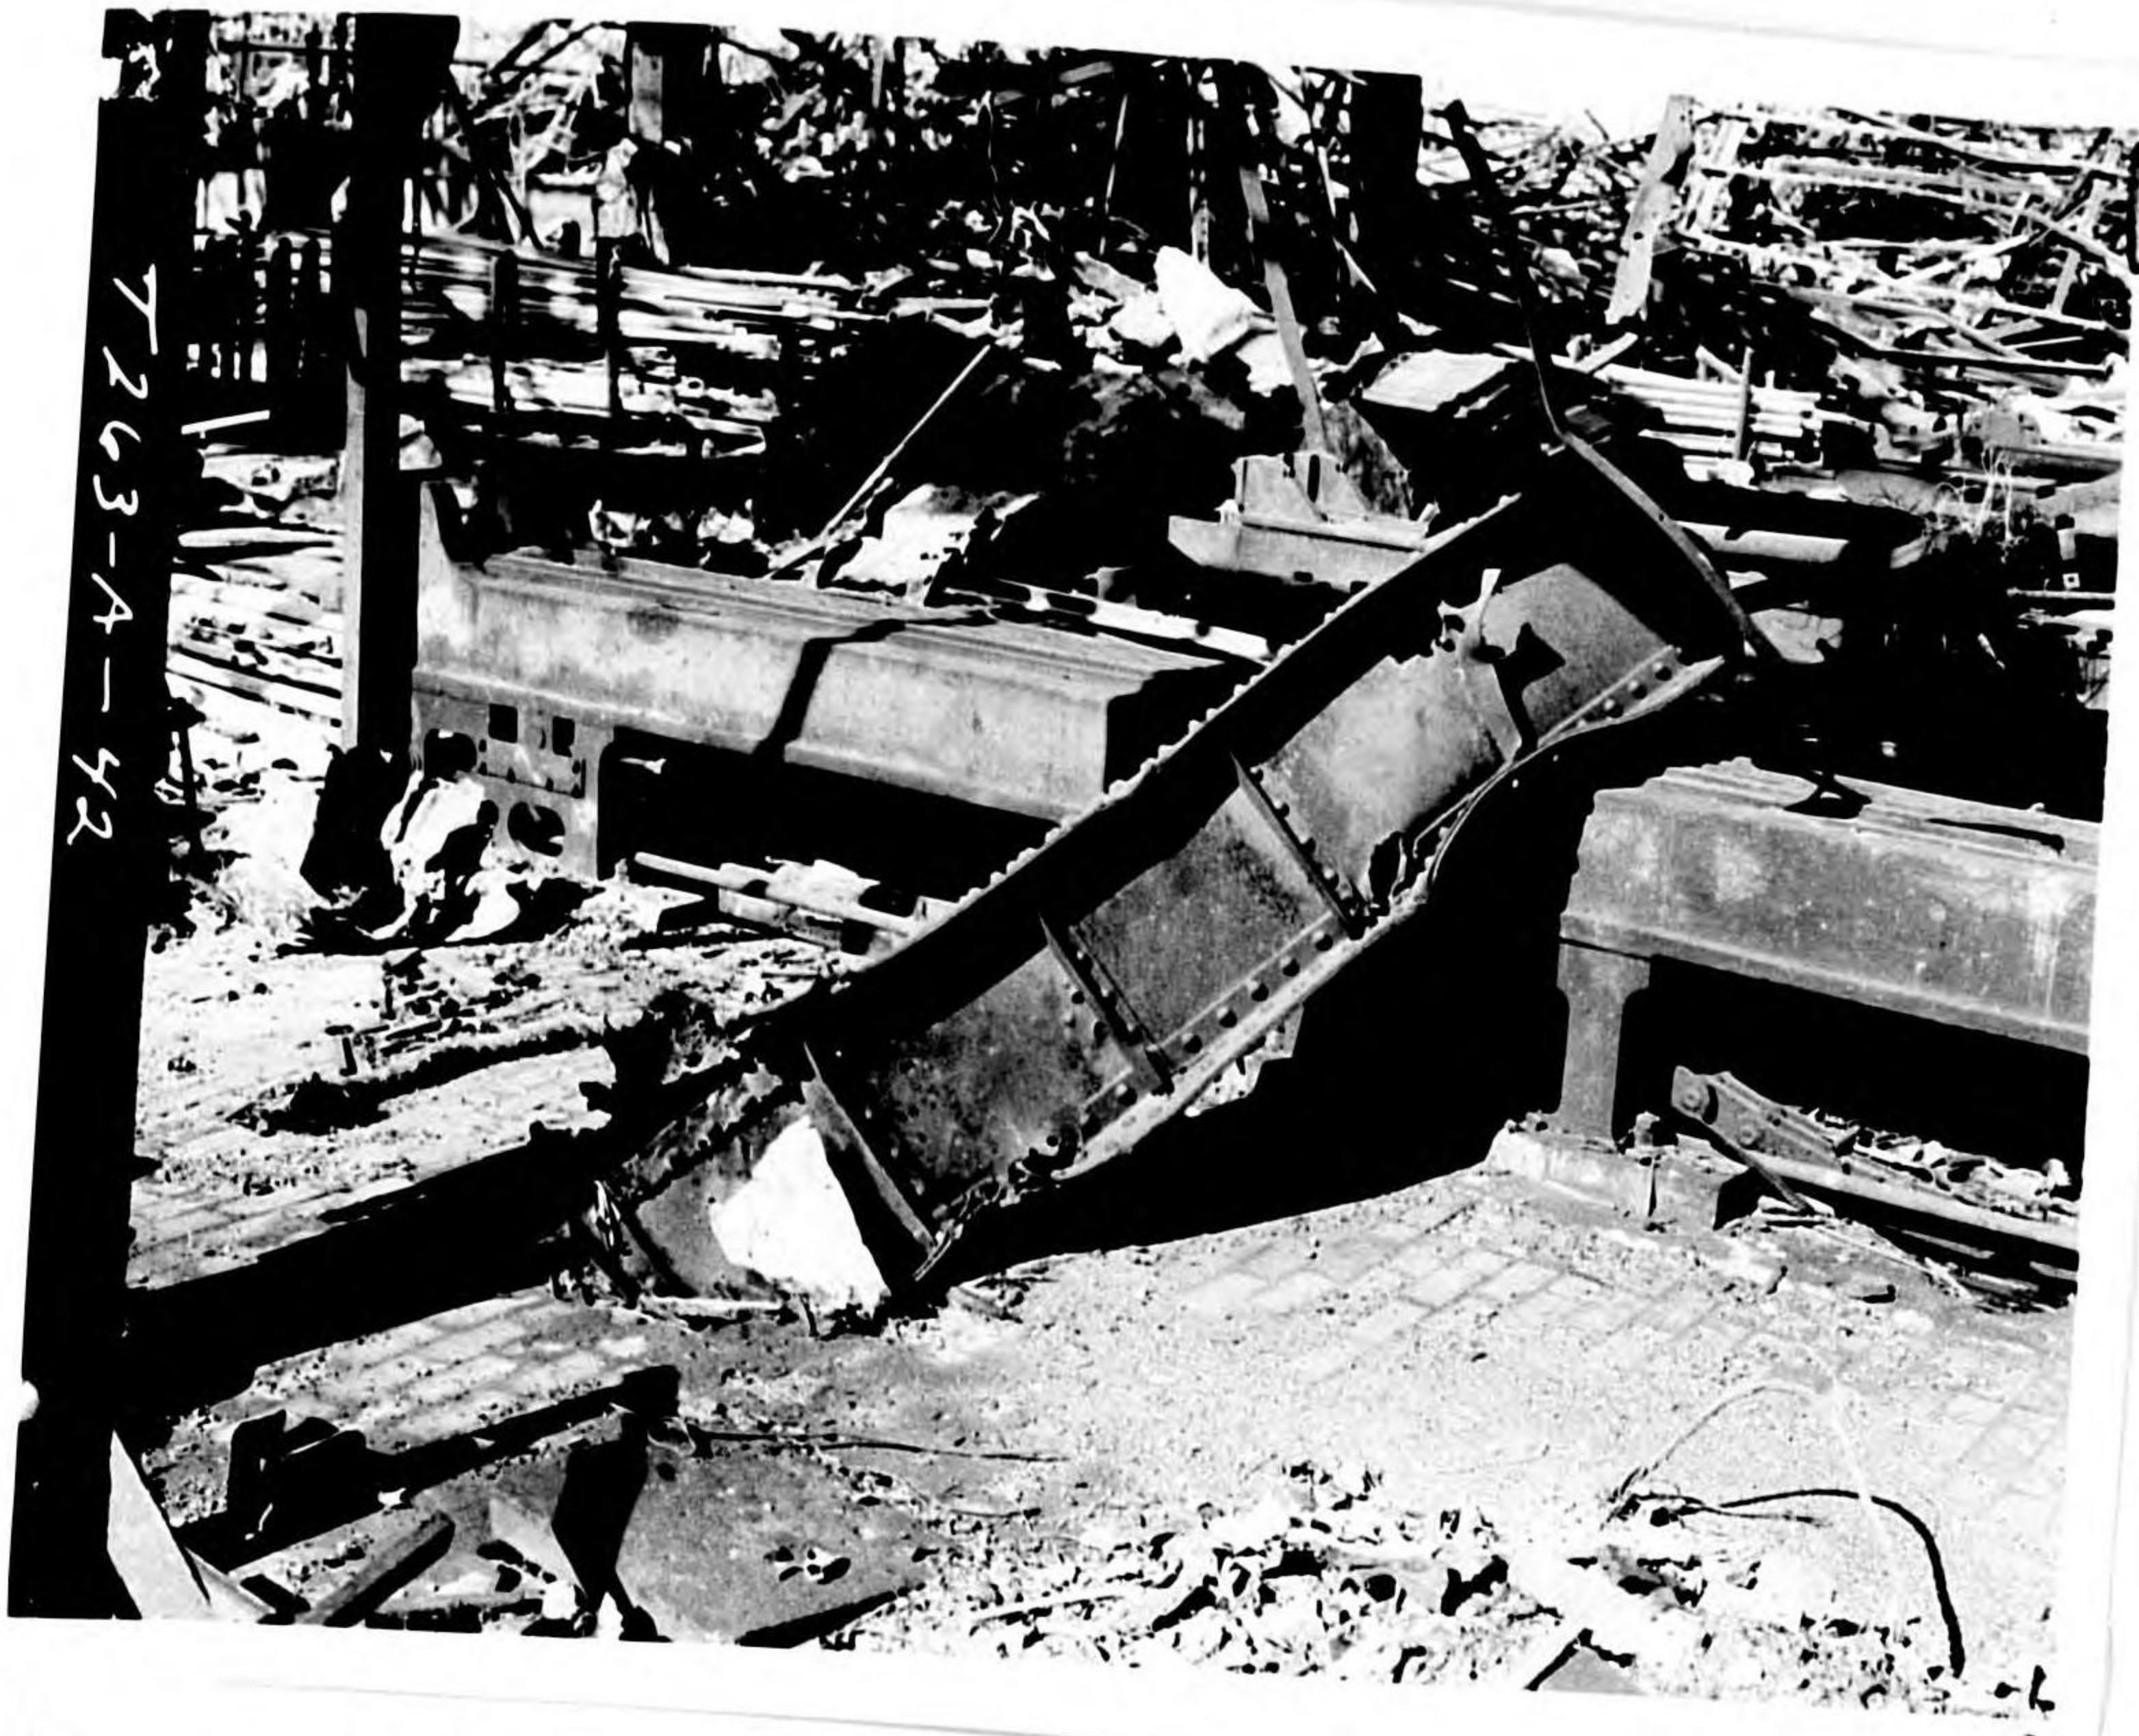
Photo 19 - Bldg. 51, Bomb 90. Detail of girder.
