ACCIDENTS IN MINES,

NORTH STAFFORDSHIRE COALFIELD,

FALLS OF ROOF AND SIDES;

THEIR CAUSES, AND THE MEANS OF DIMINISHING
THEIR FREQUENCY.

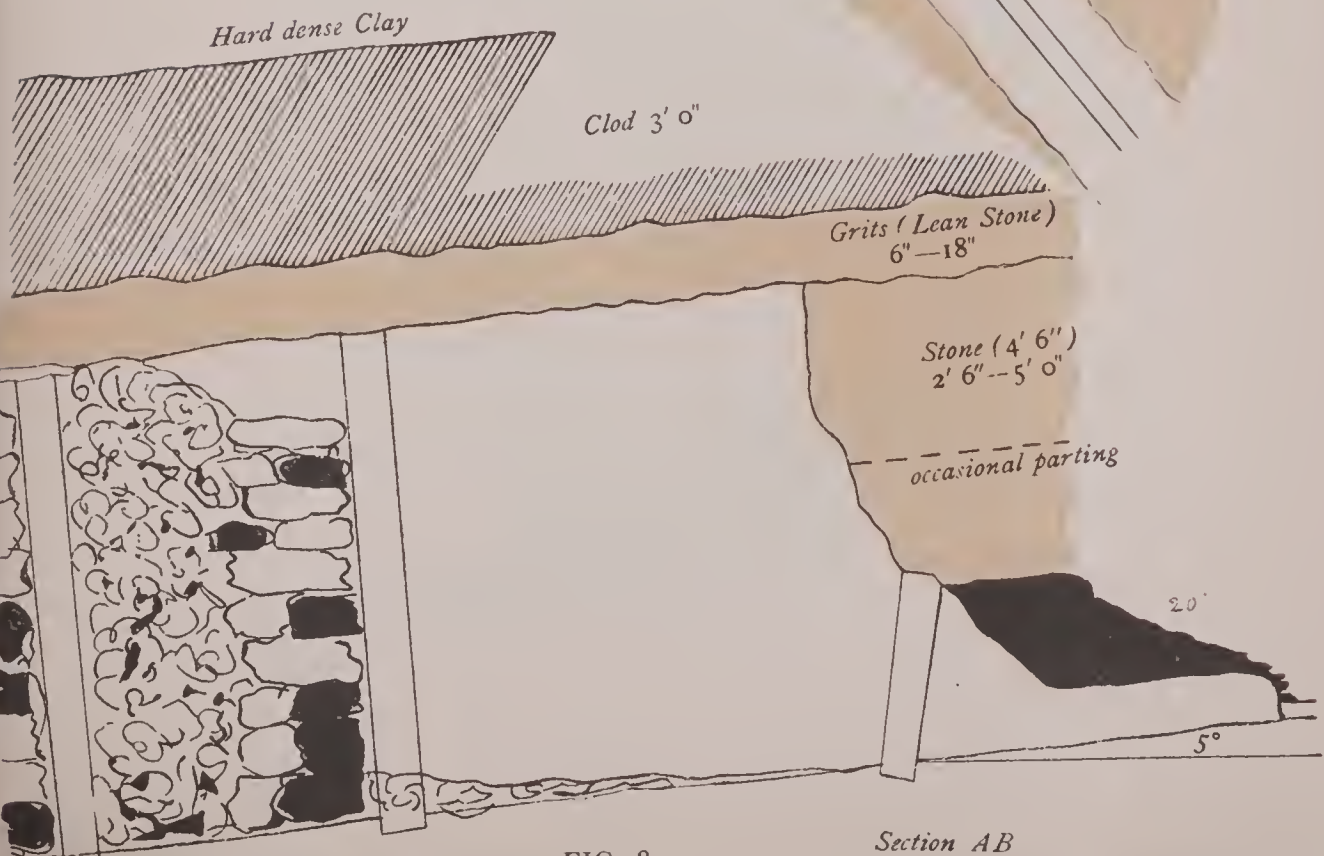
FIG. 7.

Figs. 7 and 8. Plan and Section W. Modified bank and pillar. The latter are 20 x 30 yds. The grits are left up and this insures a very strong roof so that no timber is required at the face or in the strait workings which are five yards wide at the foot. Gob almost completely packed. Chocks are built where the roof is at all loose. Joints very straight, from 6"–18" apart; occasionally slightly open and contain Calcic Carbonates. There are cross joints in places.

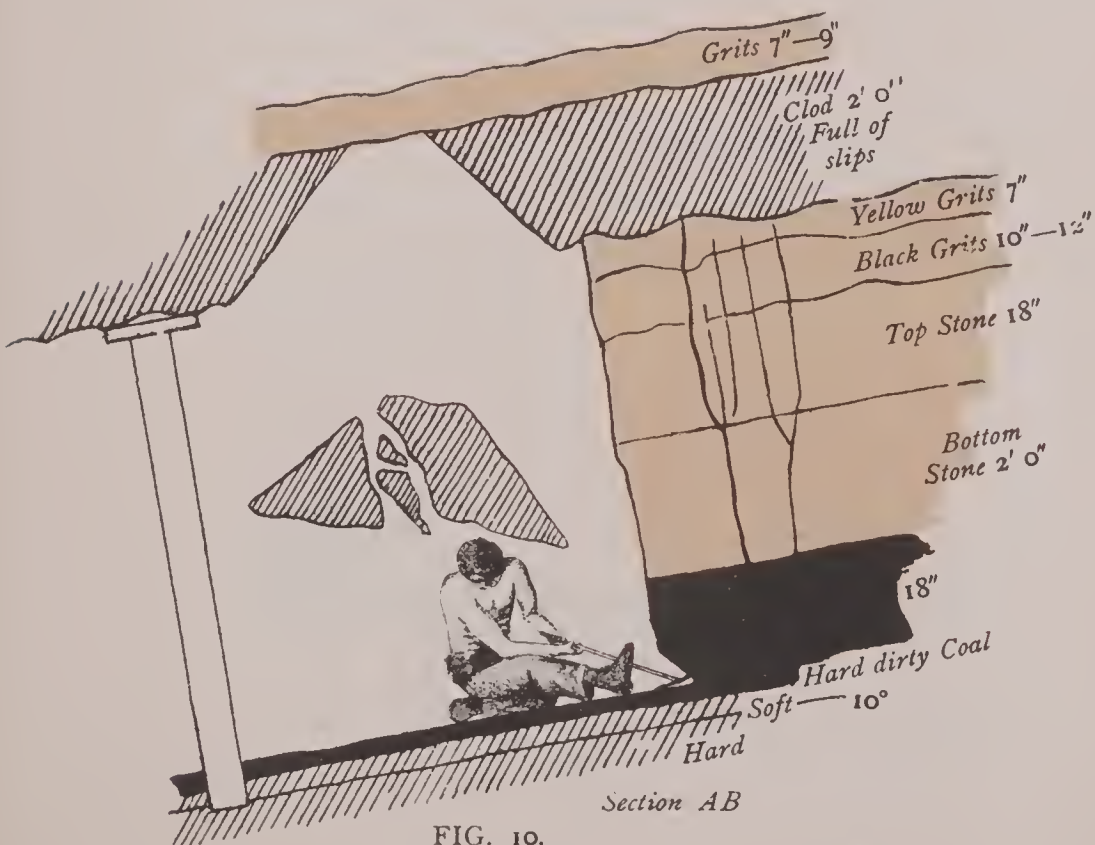
FIG. 10.

Figs. 9 and 10. Plan and Section N. of last Figs. Board and pillar. The latter are about 25 × 30 yds, and are worked off in slices. A small coal pillar 18" square (spurn) is always left at the loose end (C) whilst holing. It is afterwards broken up from a distance by means of a pointed iron rod 9ft. long. These spurns are said to be 5—6 times more efficient than a sprag at a loose end. Main joints run 2'—4' apart, and cross joints 18" to 2'; they often set off or ride over when passing from one band to another. Where the pillars have stood a long while and been subjected to weight by proximity to the gob, the joints open greatly and secondary planes of division of very small extent appear between the joints and branching from them. They are called pincracks, and occur specially in the top stone. Old pillars are consequently easier to work off than new ones, but this method entails more timber and is more dangerous than the other methods. The grits are taken down and leave a clod roof which is full of slips and very treacherous.

Fig. 10 illustrates a fatal accident which occurred through the fall of a large piece of this clod from between 2 slips. The collier started holing without first setting a post close behind him, the last post being about 6ft. from the face.

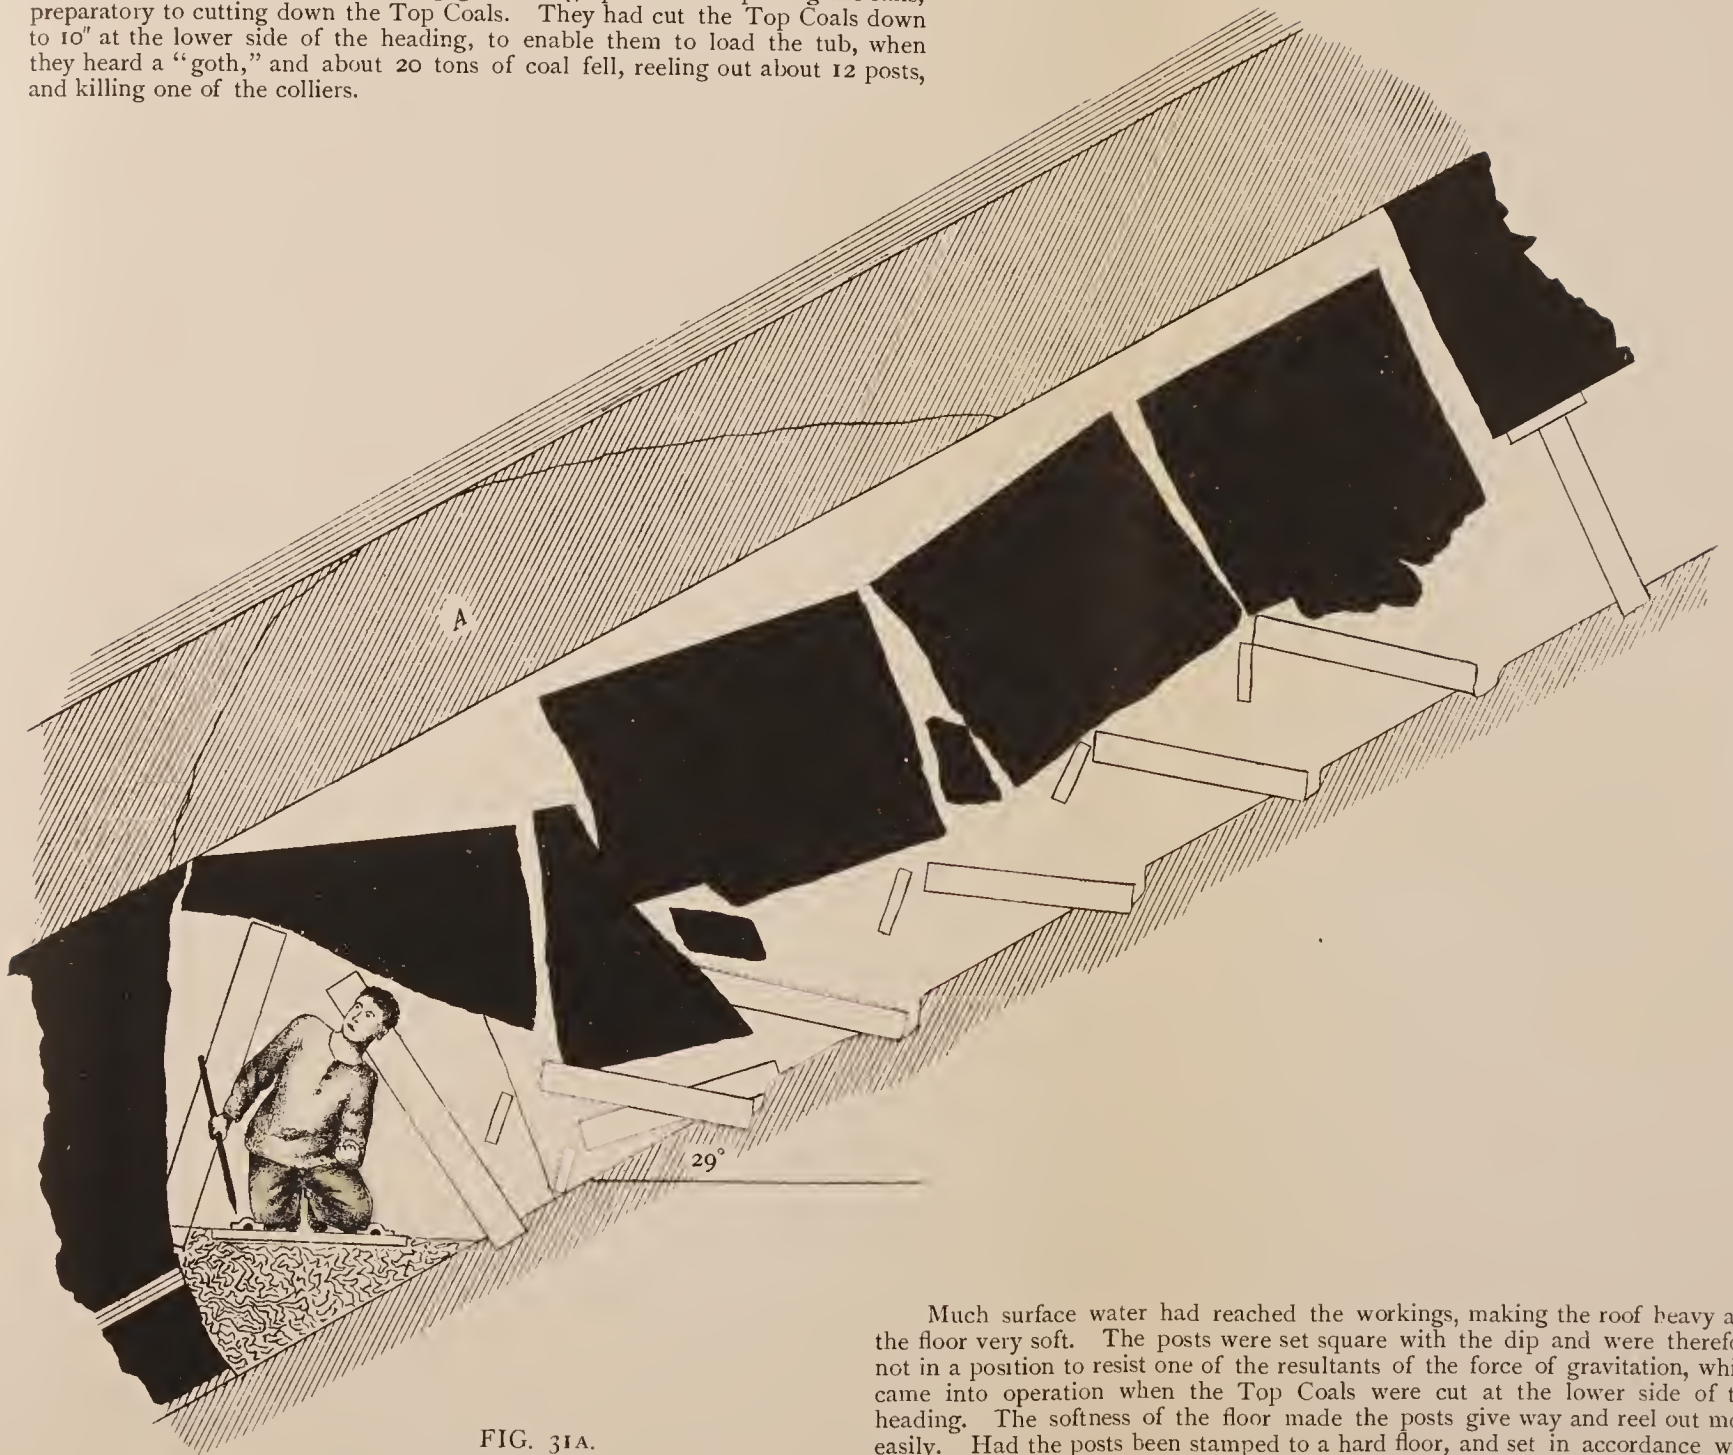
FIG. 31A.

Fig. 31A. Section C, illustrating the occurrence of a fatal accident. The Top Coal, which is taken down behind the Middle and Bottom Coals, was supported up the drift by three rows of posts. There were from five to six posts in each row. Two colliers were engaged taking up dirt and replacing the rails, preparatory to cutting down the Top Coals. They had cut the Top Coals down to 10" at the lower side of the heading, to enable them to load the tub, when they heard a "goth," and about 20 tons of coal fell, reeling out about 12 posts, and killing one of the colliers.

Much surface water had reached the workings, making the roof heavy and the floor very soft. The posts were set square with the dip and were therefore not in a position to resist one of the resultants of the force of gravitation, which came into operation when the Top Coals were cut at the lower side of the heading. The softness of the floor made the posts give way and reel out more easily. Had the posts been stamped to a hard floor, and set in accordance with the table on page 50, the accident could not have occurred. A large piece of roof, *A*, fell soon afterwards.

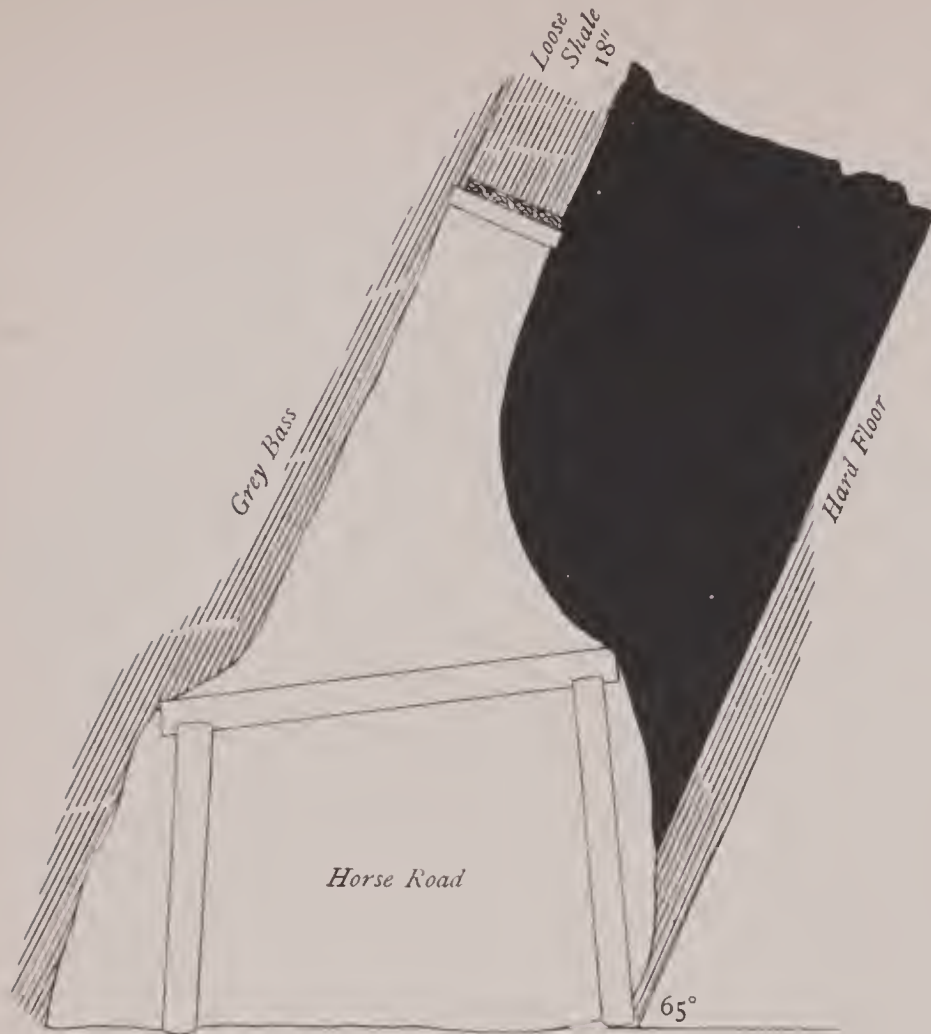
FIG. 53.

Fig. 53. Section W. Shews the result of atmospheric action, on the loose shale, and how it is guarded against. The loose shale is thinner, and the coal thickens to 6 ft. in places.

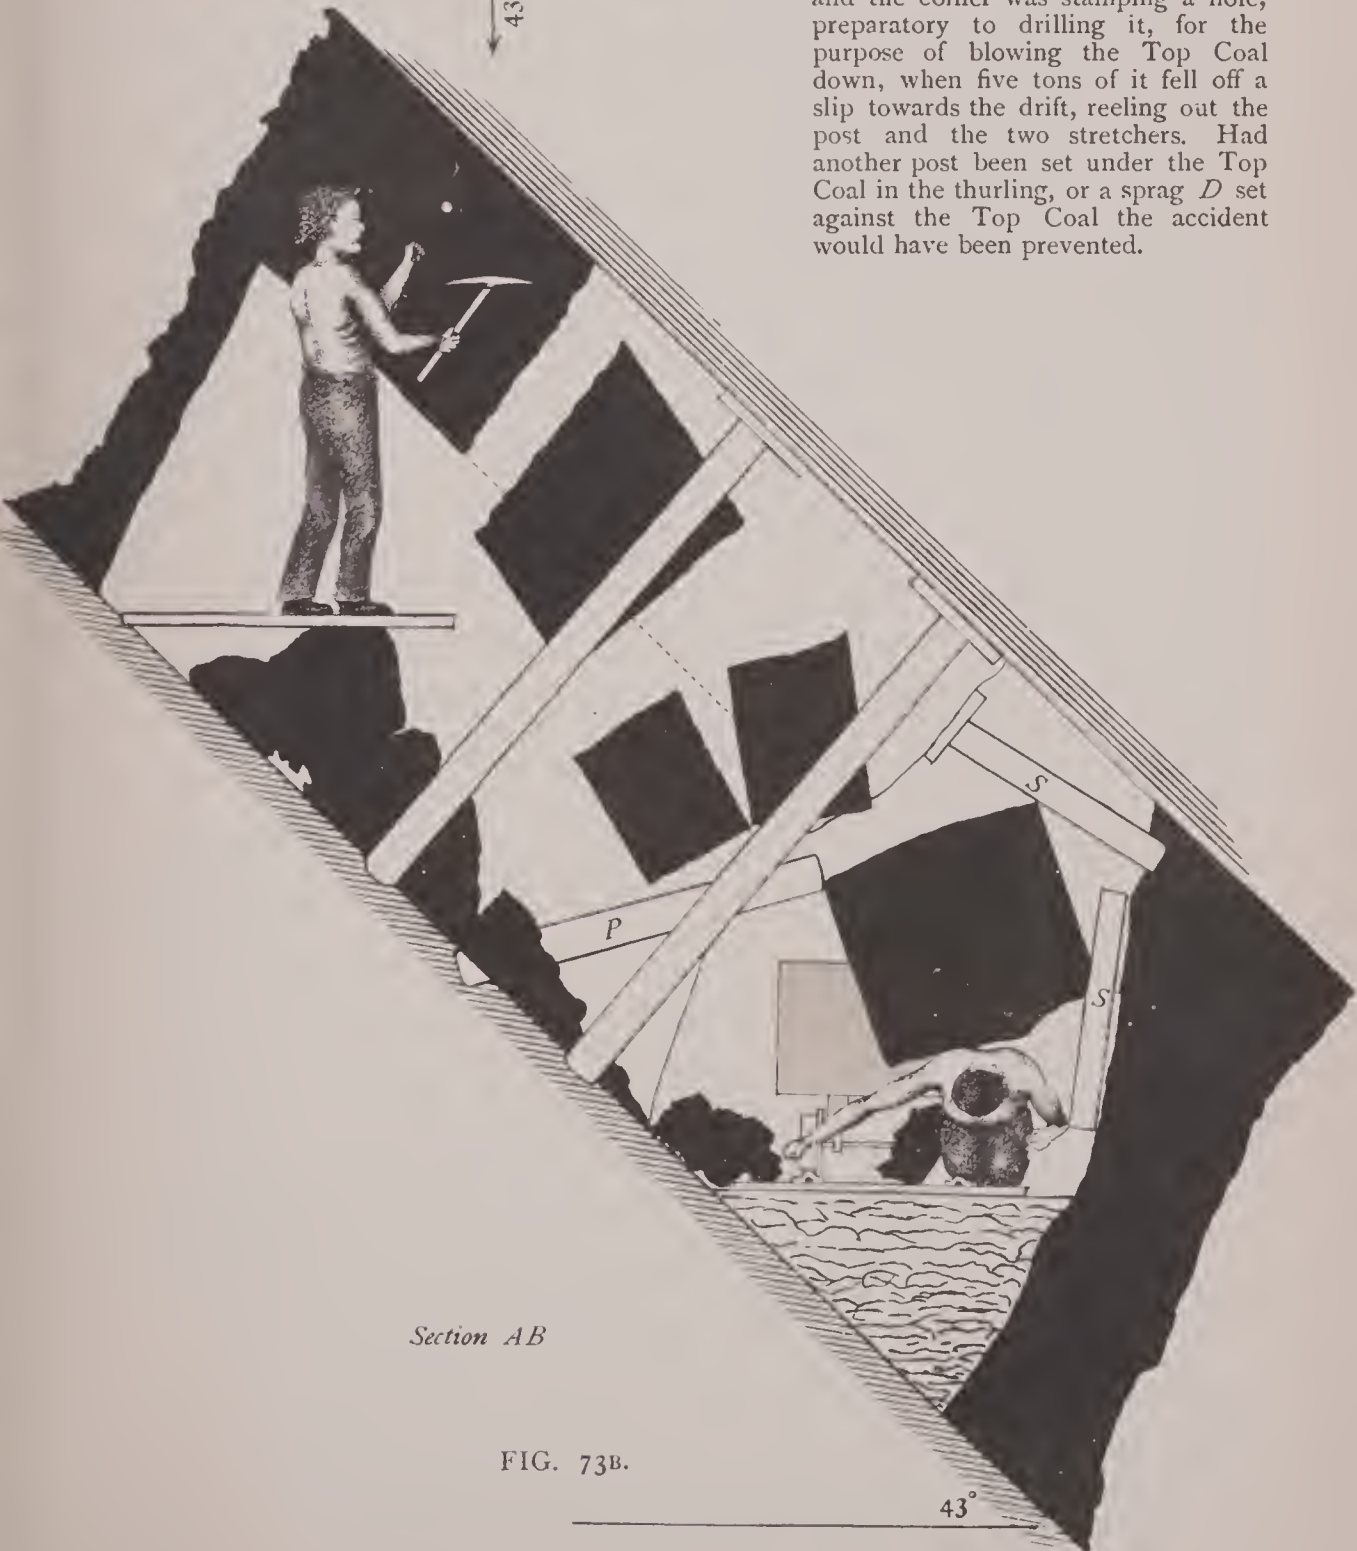
Figs. 73A and 73B. Plan and Section of a drift near Fig. 73, illustrating a fatal accident which occurred to the fireman during his examination, after he had fired a shot higher up the drift. The drift had reached an old thurling, in which the Top Coal was supported by a post *P*, and two stretchers or sprags, such as *S*. The fireman was standing near the tub, and the collier was stamping a hole, preparatory to drilling it, for the purpose of blowing the Top Coal down, when five tons of it fell off a slip towards the drift, reeling out the post and the two stretchers. Had another post been set under the Top Coal in the thurling, or a sprag *D* set against the Top Coal the accident would have been prevented.

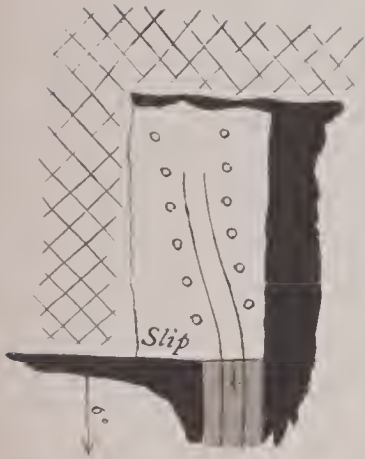
FIG. 92.

Fig. 92. Centre. Plan of drift in which a fatal accident occurred. The coal in this drift was unusually thick, owing to disturbances and irregular inclination, and required 12' posts. The seam is worked by a modified board and pillar method. The pillars, which vary in size and shape, owing to the irregularities of the dip of the seam, are worked off in dressings about 3 yds. wide, as soon as they are formed. One of these pillars was being sliced, the drift being just through to the old gob, when the roof, which had a loose end on one side, fell over the whole area, reeling out all the posts (10 or 12) and killing the collier. The roof fell over an area of 35 square yards, and was 5 yards thick at the face side. It was loosened by a slip, which was not perceptible in the roof, owing to the roof coal being left at that point. This accident shews the importance of erecting chocks where the roof is broken on two sides of the drift, and when working slowly, and of always keeping two or three rows of posts on the gob side of the rails.

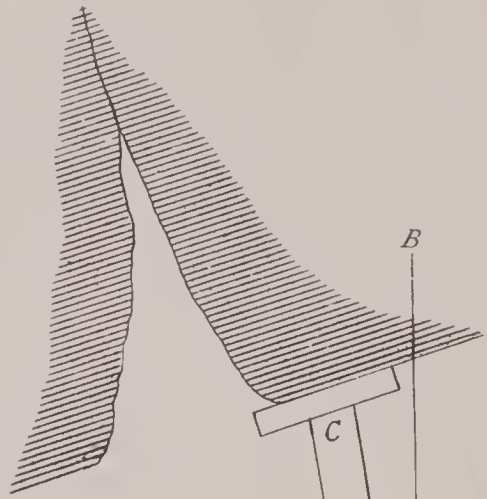
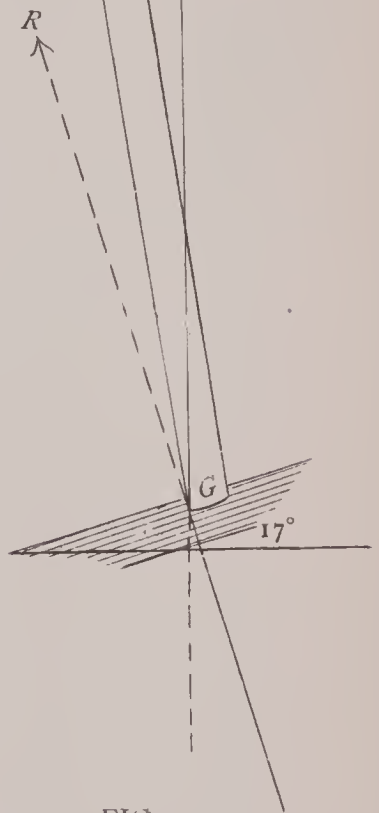
Figs. 93, 94 and 95. Plan and Sections N. The coal attains a thickness of over 9' in places. Slips very frequent; they do not run into the roof, which is pretty free from joints and slips. Lancashire method. Coal punches are left in places. The coal is wedged off. Overhanging or loose pieces are supported as in Fig. 94. Not being properly stamped, one of these sprags gave way, and a collier was killed by the coal which fell in consequence.

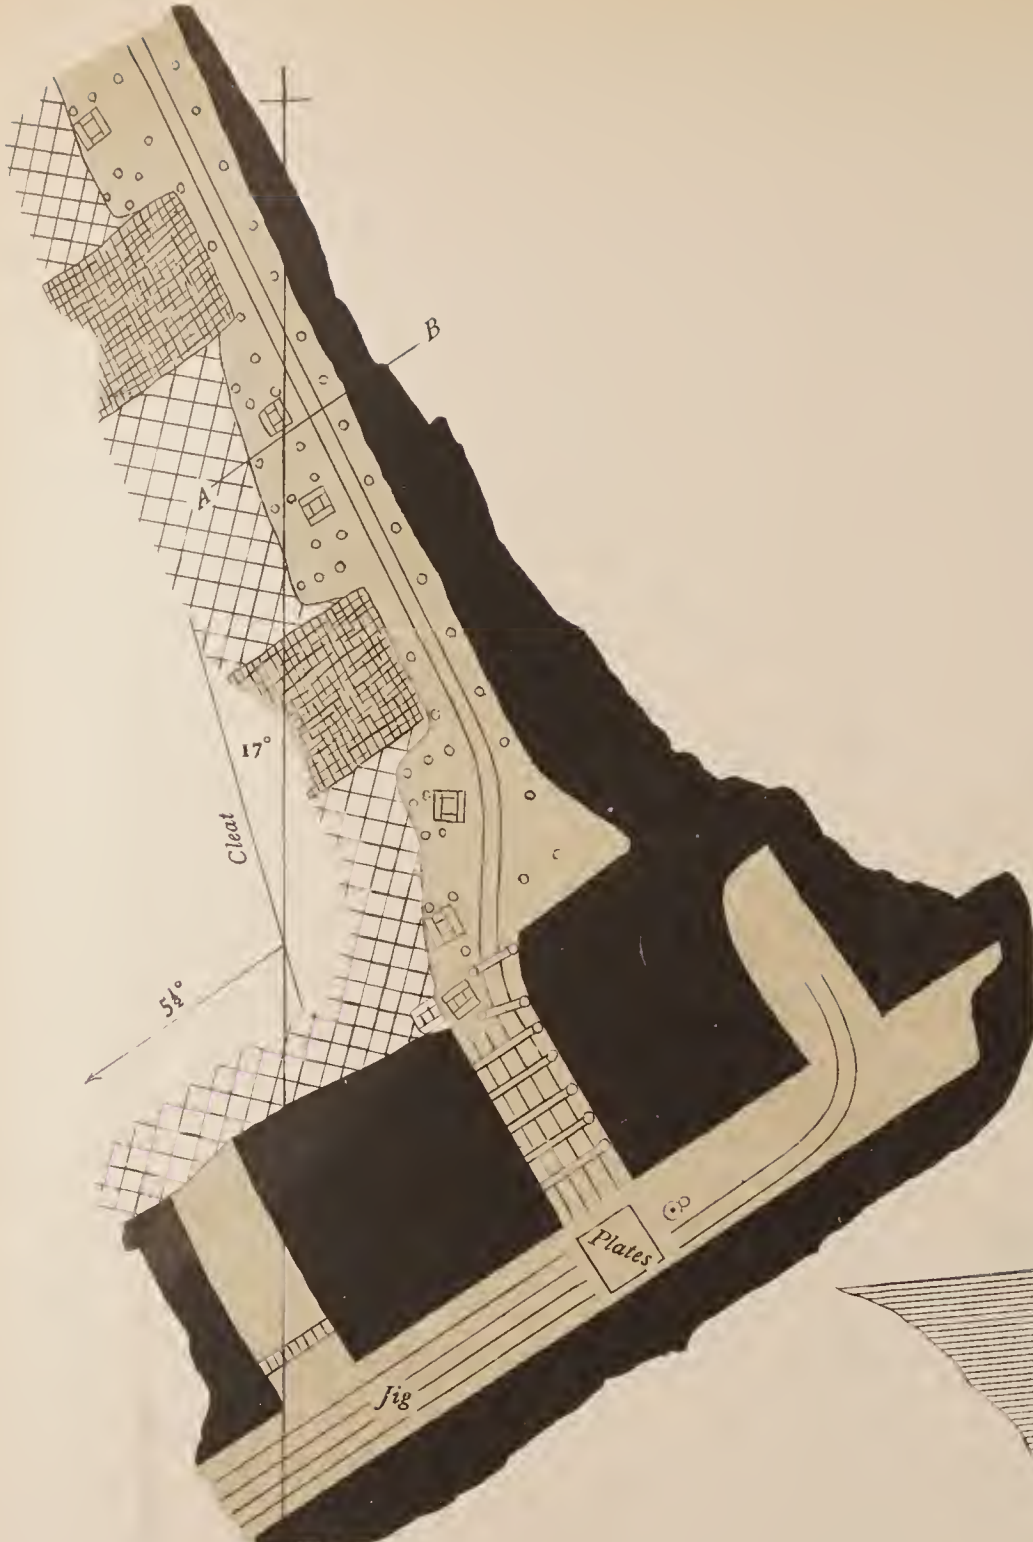
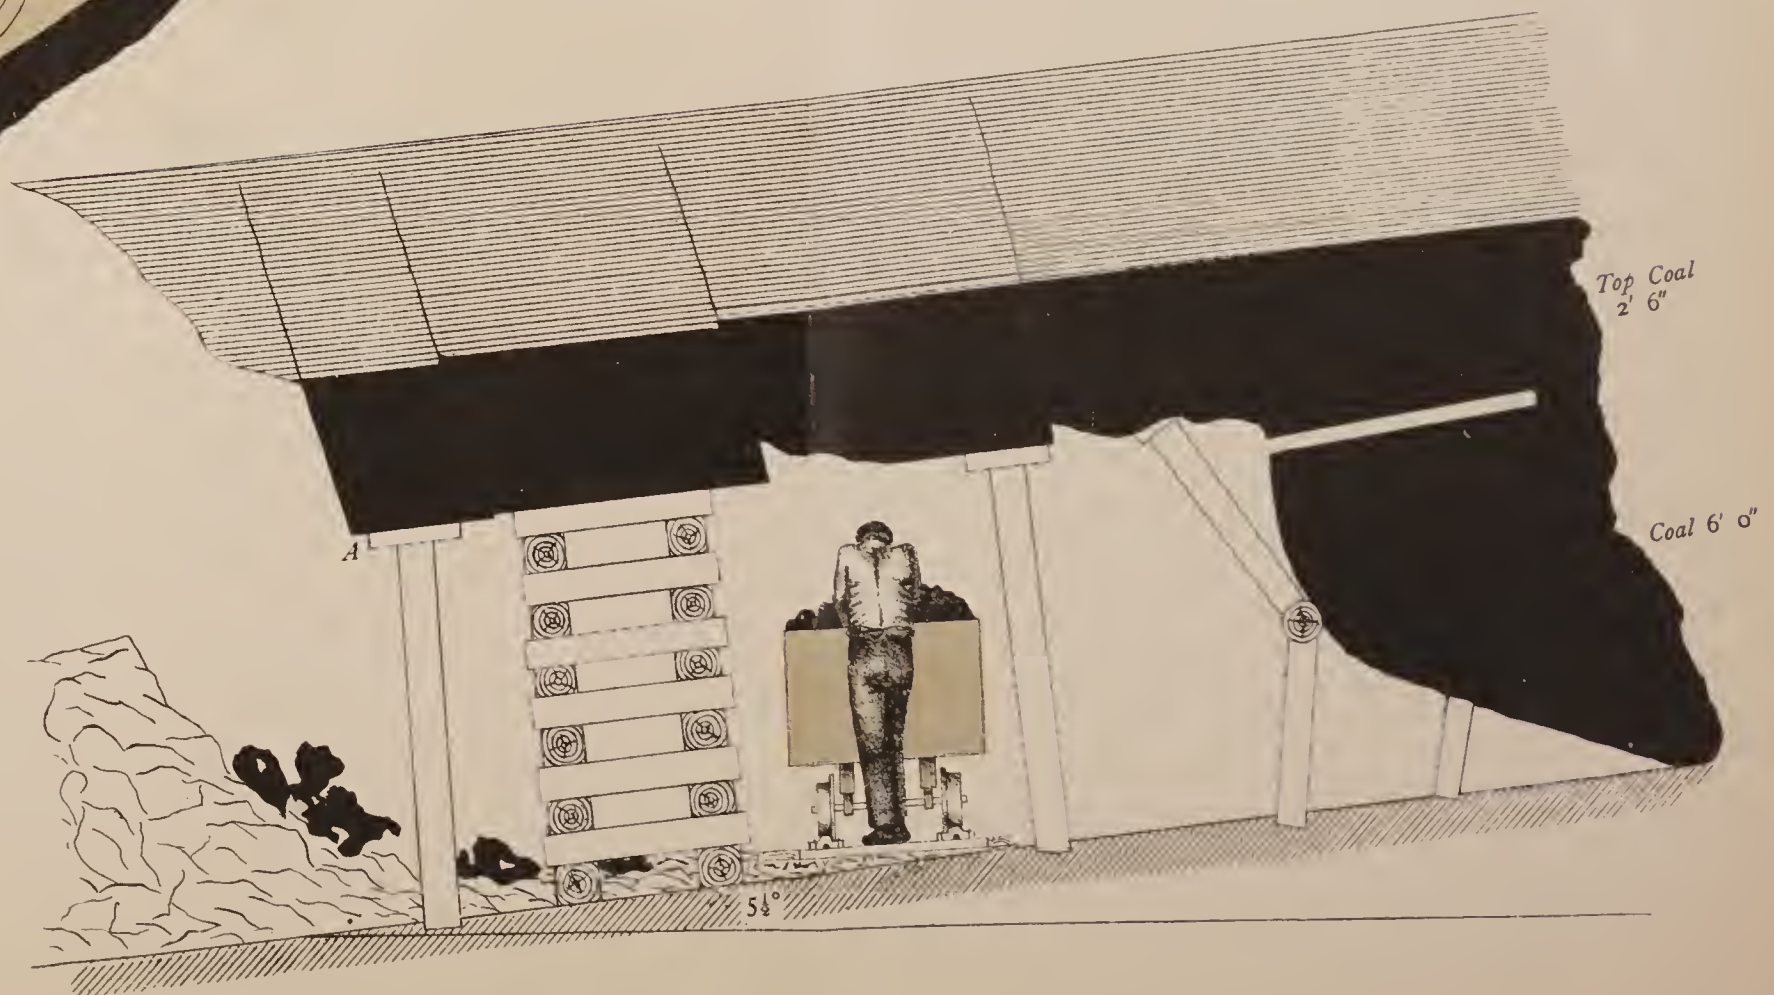
FIG. 106.

Figs. 106 and 107. Plan and Section W. The Top Coal is cut down in the wastes. It is well supported by at least two chocks between the wastes and the rails. A collier was killed by the fall of a piece of Top Coal. The cause of the accident is given on pages 51 and 52. The roof is hard, clunchy and very heavy; it breaks down close behind the Top Coal. The cleat is very distinct. A 10" band of Cannel Coal runs half-way up the seam in places; it contains cleat planes half an inch and more apart.

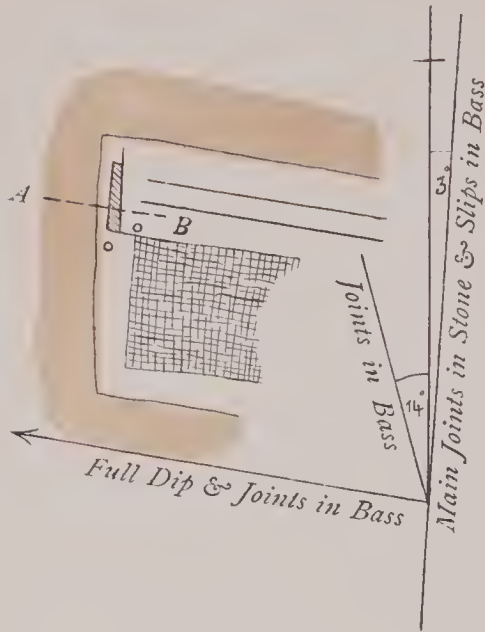
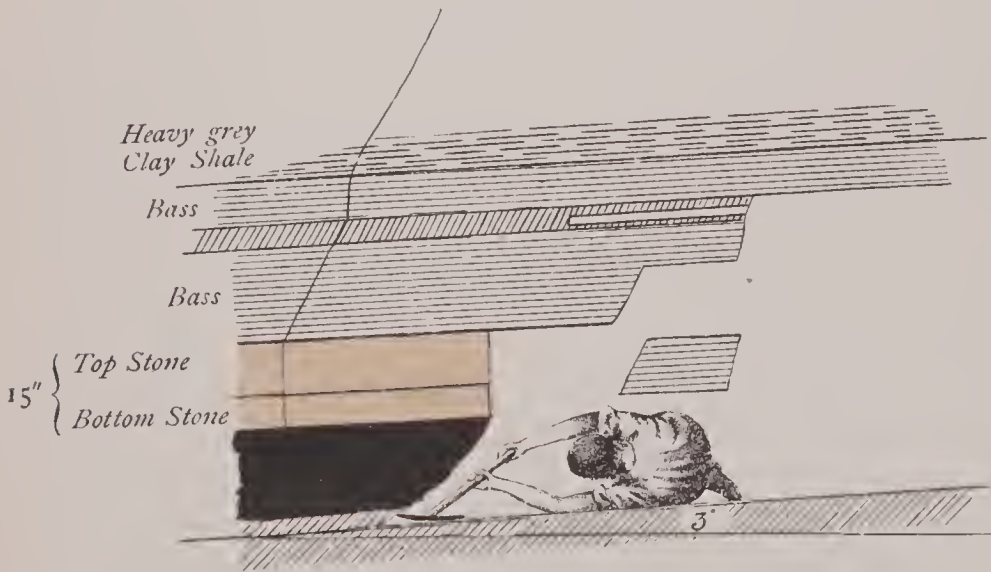
FIG. 172.

Figs. 172 and 173. Plan and Section S, shewing the face of a dip in which a fatal accident occurred. Joints in stone very frequent; they lean over on passing into the roof in the form of slips. (Fig. 173.) A projecting piece of bass, which the collier failed to secure, fell upon him from off one of these slips, and caused him fatal injuries. The cohesion along this slip had been further loosened by water, which dropped from the roof abundantly. Longwall drifts: 20—30 yds. on each side the jig; packs 4'—5'; wastes 9'. Two rows of posts are kept up.

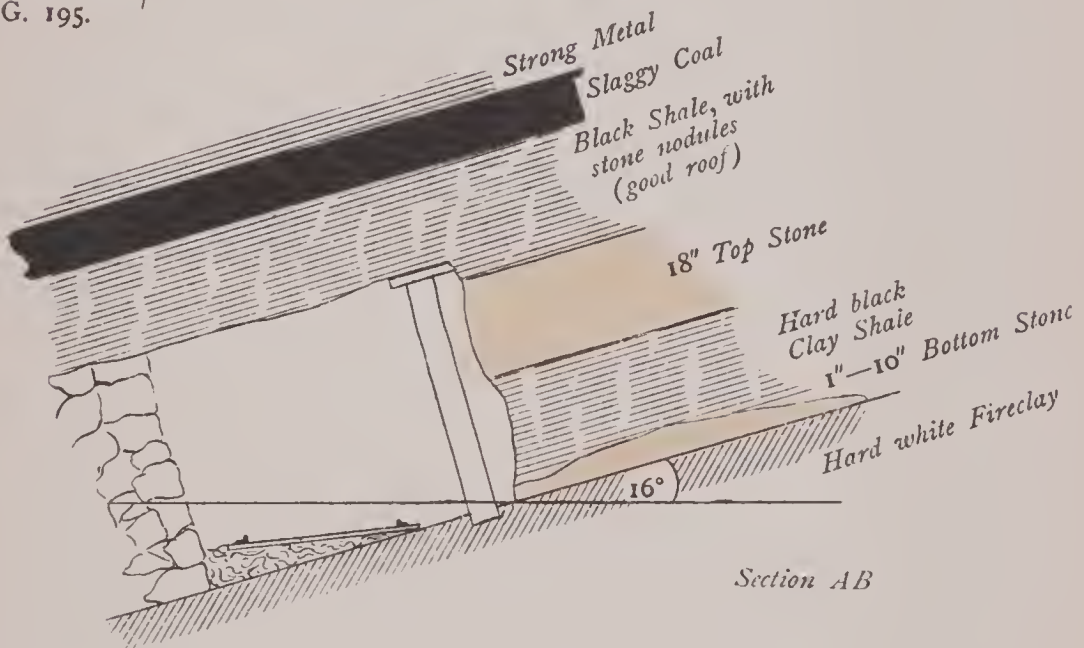
FIG. 196.

A fatal accident occurred in a level 5' wide, with a pack on one side, owing to a deficient post (stoop) which supported a bar being loosened at the foot, without a foreset post being first set under the bar. The roof, which was considerably loosened by water, fell, though it was barred and planked.

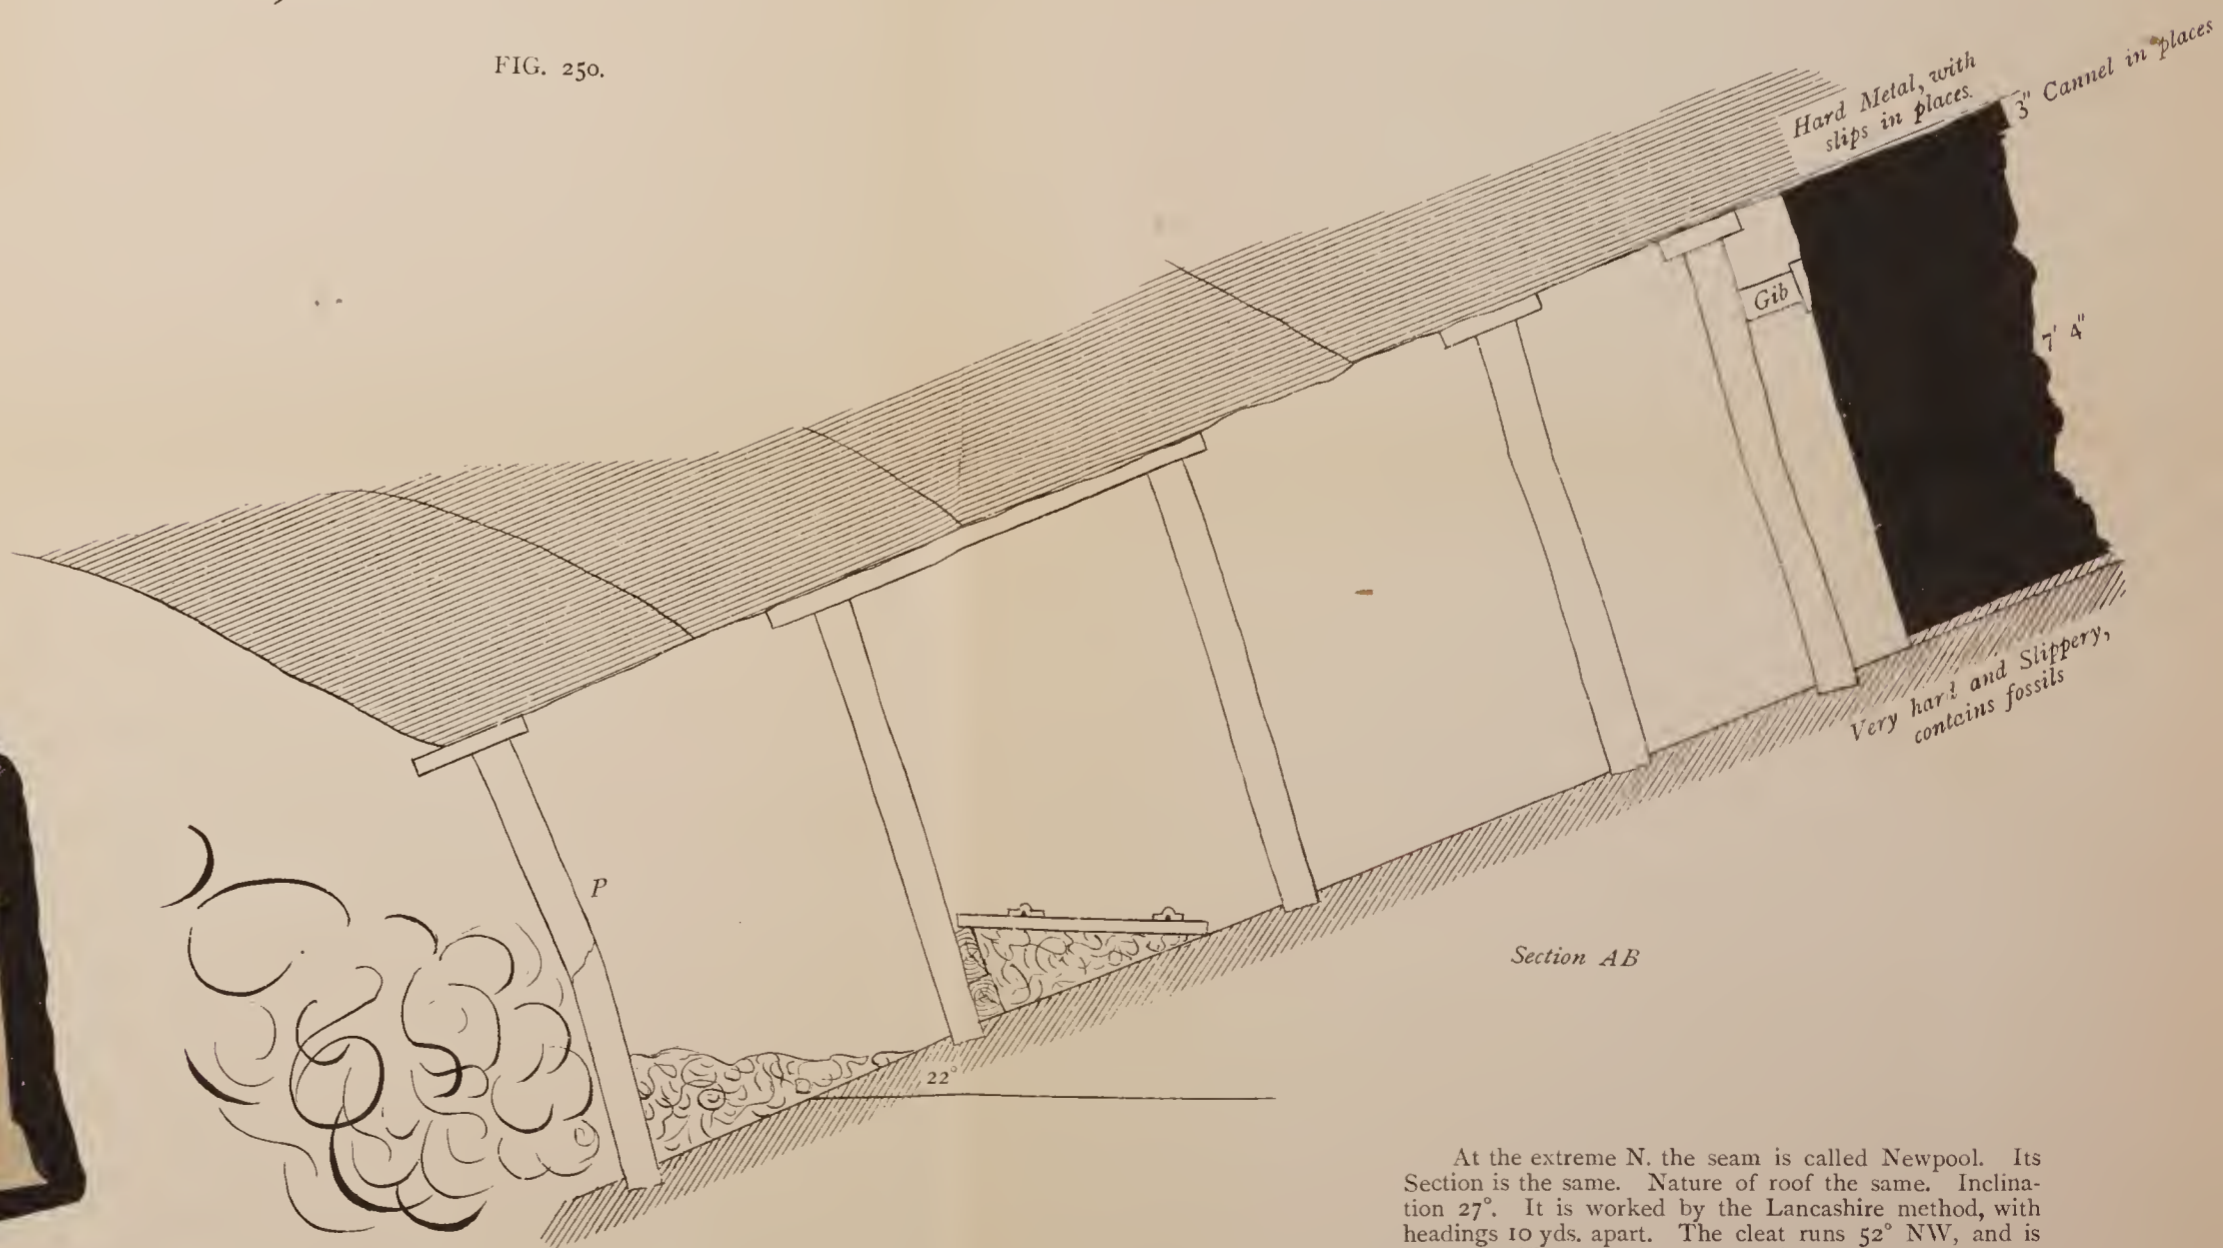
FIG. 252.

Another accident occurred whilst taking up a 5 yds. wall. About 7 cwts. of bass and coal suddenly broke off from the face, and struck a post, which was 4' from it, sideways, reeling it clean out. It fell on to a collier who was ridding some coal lower down, and killed him. The post had only recently been set.

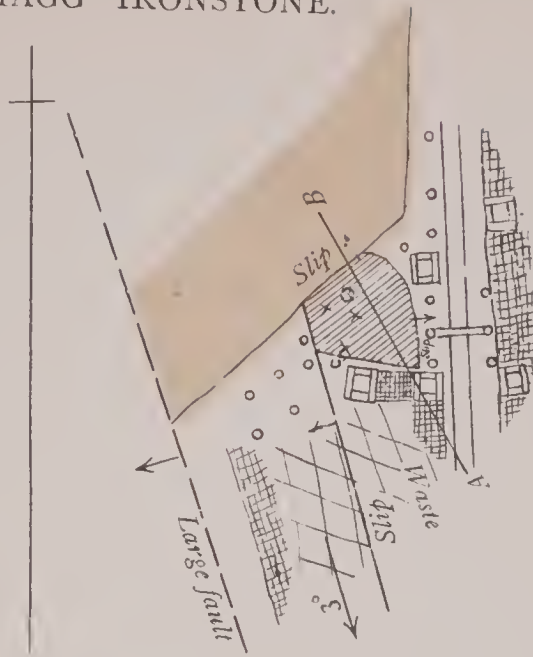
FIG. 256.

Figs. 256 and 257. Plan and Section S, illustrating a fatal accident. The clod which forms the roof contains many slips in irregular directions, some of which form bell mouths. The clod in this instance fell over an area of 60 square feet. It lay between two slips which were seen and another at the face, which was invisible. These slips leaned towards each other, forming a bell mouth. There was a chock 9' from the face; this effectually supported the clod roof, which was found to be detached from the coal above. The clod in the waste behind the chock had fallen easily. The mass being detached from the surrounding clod by the slips, and also from the coal above, rested almost entirely on three posts, which were not under its centre. One side must have given way first, and the lump having once started to move, the posts were immediately uncrowned and knocked out.
