RAILROAD ACCIDENT REPORT
COLLISION OF
ILLINOIS CENTRAL GULF RAILROAD
COMMUTER TRAINS.
CHICAGO, ILLINOIS
OCTOBER 30, 1972

NATIONAL TRANSPORTATION SAFETY BOARD
Washington, D.C. 20591
REPORT NUMBER: NTSB-RAR-73-5

ADOPTED: JUNE 28, 1973

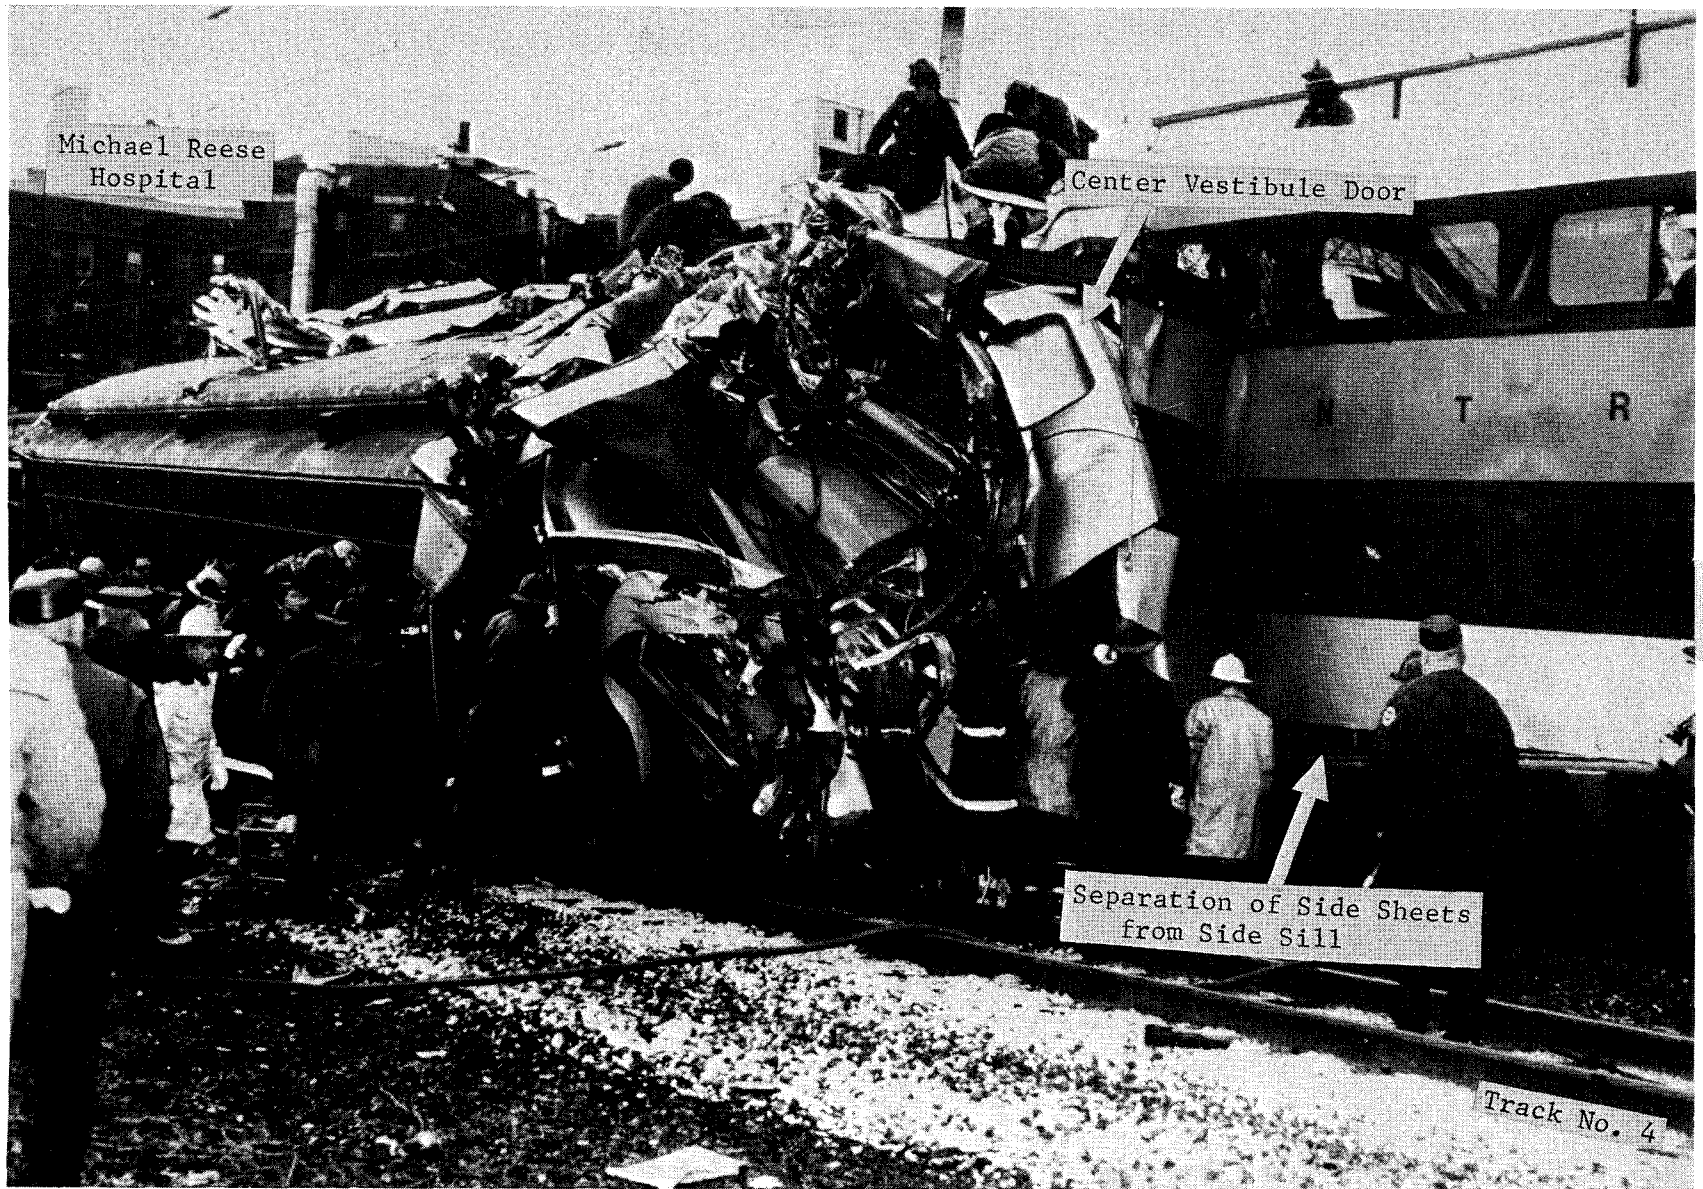
Figure 2. Trains After Collision.

The collision. The leading coupler of the first car of train 720 was broken off by the impact, and the car overrode the underframe of the rear car of 416. The first car of 720 then sheared off the collision posts on the rear car of 416, veered slightly to the right, and moved through the passenger section. (See Figure 2.) The lead truck on 720's first car was thrown from under the car and came to rest along the east side of the track. The rear truck was derailed and came to rest against the rear truck of the Highliner car.

Train damage. The rear half of the last car of train 416 was demolished. The end of the car and most of the right side were sheared off at floor level. A portion of the left side and several seats on the upper level remained intact. All lower-level seats were destroyed. The underframe of the car was not buckled, and the three other cars of 416 received only minor damage and were returned to service.

The first 10 feet of the lead car of train 720 was demolished. The center sills and couplers on several of the other cars of the train were broken, and these cars sustained sufficient damage to prevent prompt return to service.

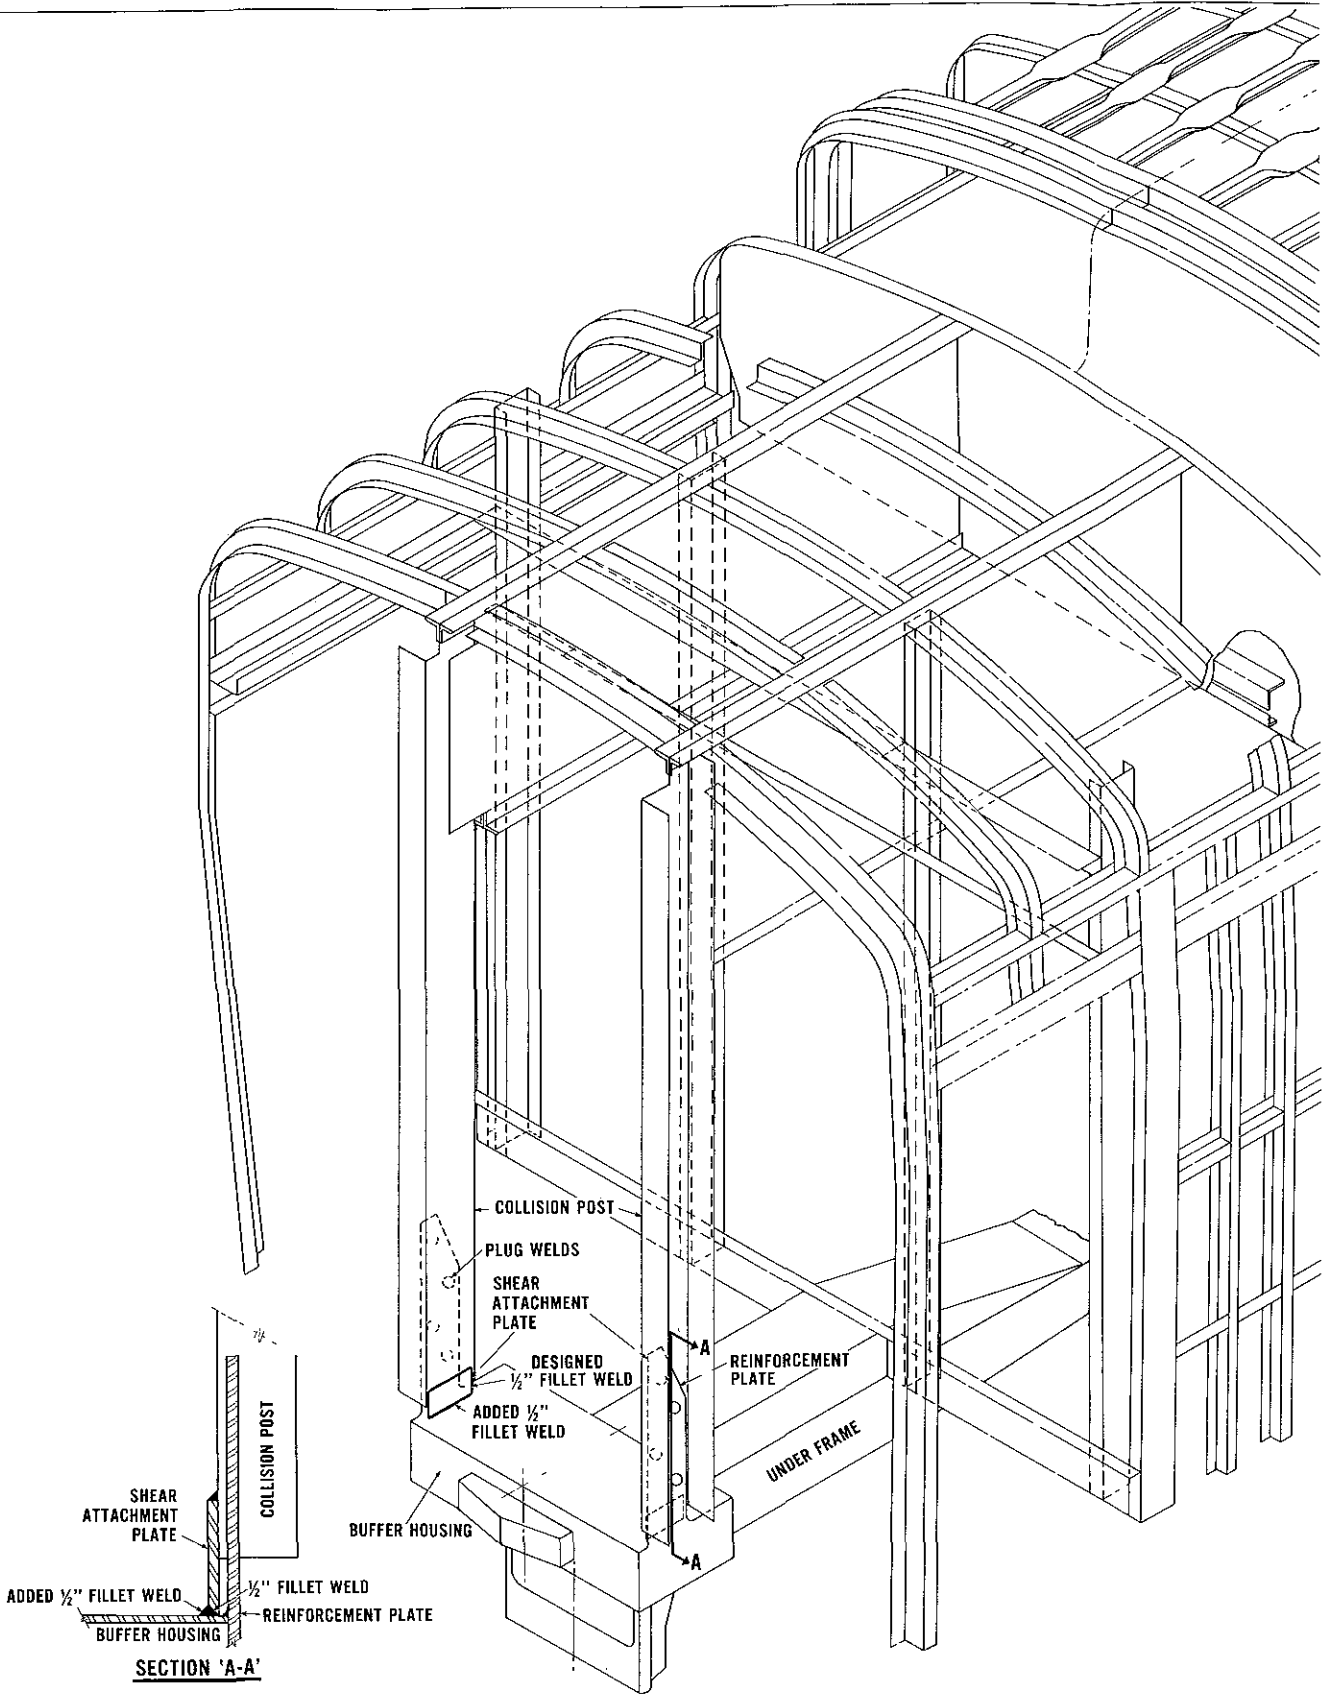
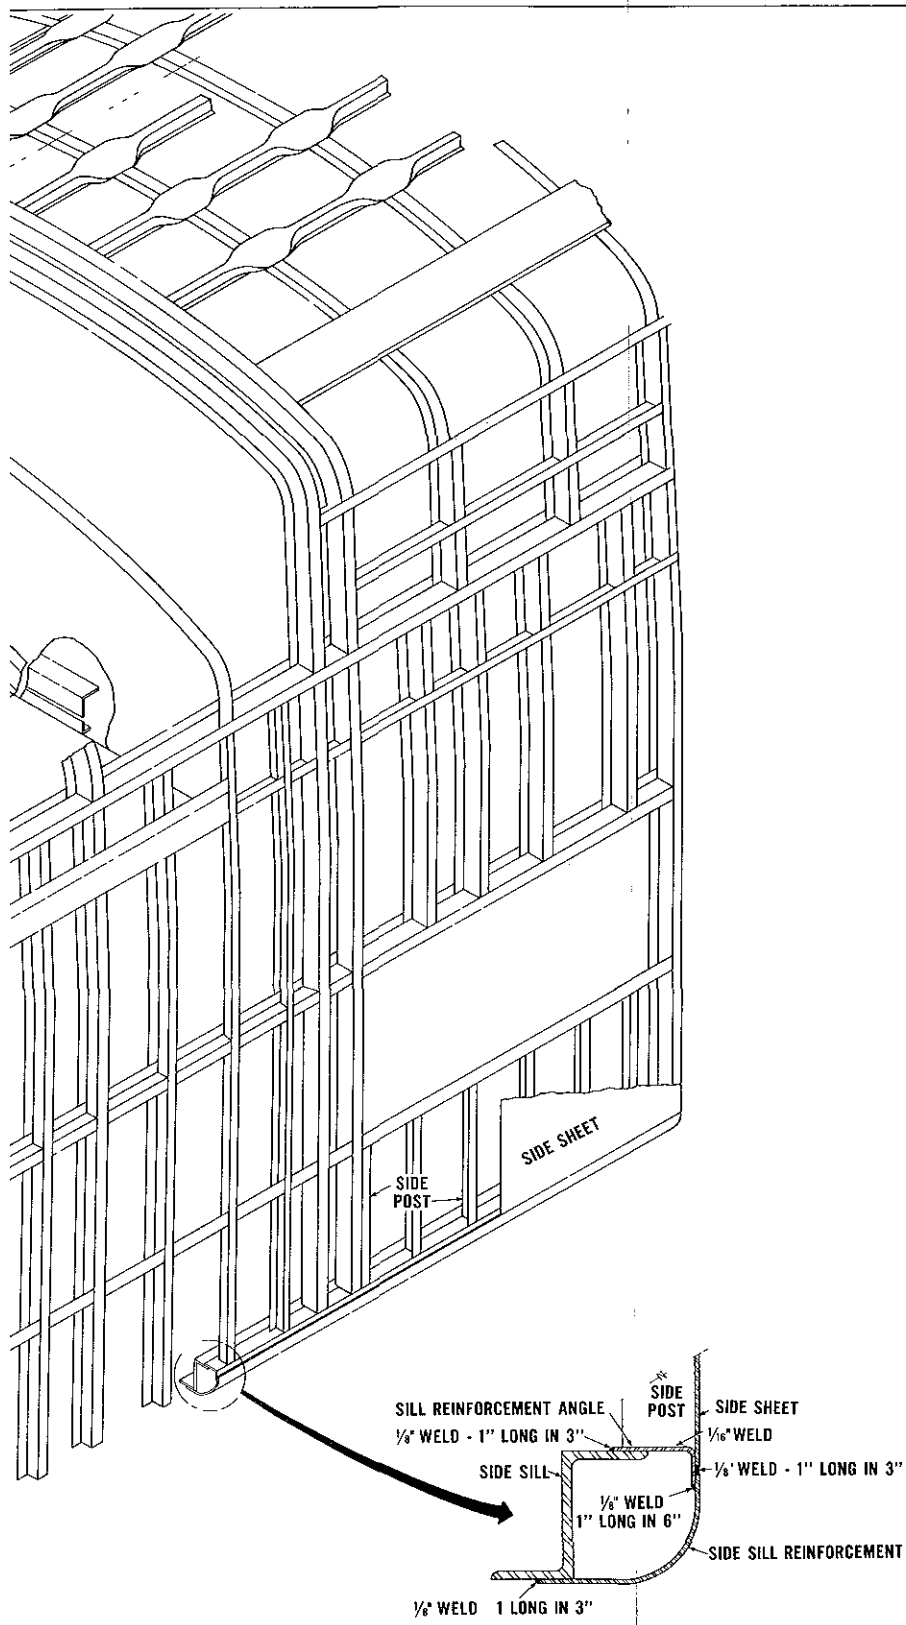
FIGURE 5

Train equipment. The collision posts of the Highliner car struck by 720 failed in the weld which attached the shear attachment plate to the underframe. Tests disclosed incomplete fusion between the plate and about 75 percent of the weld. The bottom edge of the plate was bevelled to permit the weld to penetrate through the plate to the underframe from one side. However, the bevel of the shear attachment plate extended only five-sixteenths of an inch into the plate, instead of the full one-half inch as designed. An additional 1/2-inch fillet weld which had been applied adjacent to the original weld failed in the parent materials of the underframe and shear plate. The plug welds which attached the reinforcing plate to the collision posts were fused incompletely. Further description of the design and failures of the collision posts can be found in Appendix G, which contains an interim recommendation made by the Safety Board to the FRA on April 25, 1973.

Some of the side posts on the rear car were sheared off through the welds which attached the posts to the sill reinforcing angle. Other posts were sheared off above the welds and were bent outward, which contributed to the failure of the sill reinforcing angle. Many of the intermittent welds which attached the sill reinforcing angle to the side sill broke in the welds and thus permitted the sill reinforcing angle to be torn from the side sill for about one-half of the damaged area. The intermittent welds which attached the bottom of the side sheets to the sill reinforcing angle broke and allowed the side sheets to separate. (See Figure 5.)

28. Because of the improper welds, the collision posts of the Highliner car did not meet the shear requirements of the Federal regulations.
