A CASE HISTORY OF A MUD AND ROCK SLIDE ON AN EXPERIMENTAL WATERSHED

R. L. Fredriksen

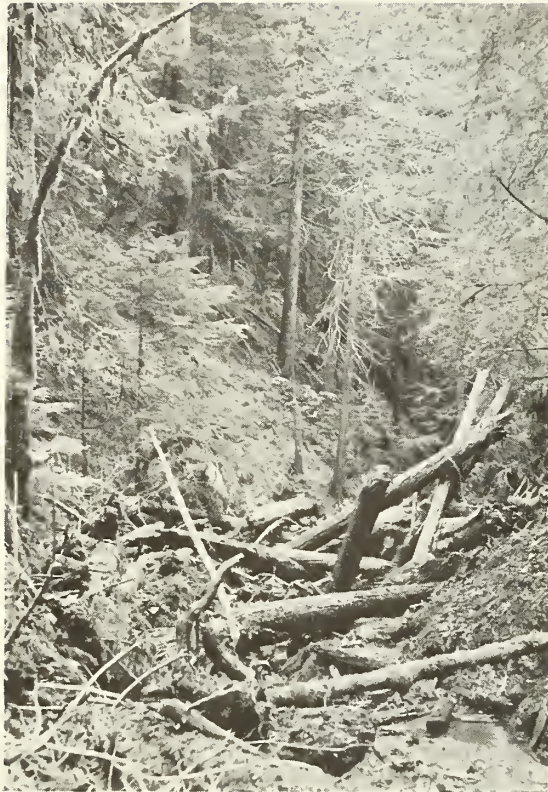
Figure 1.--Debris dam left in the stream channel by the slide.

created a short-lived dam which, when breached, triggered a massive flow of mud, rock, and logs. More debris was picked up as the flow moved down the channel, plucking whole down trees from the side slopes of the drainage. For almost 3,000 feet, the channel was scoured to bedrock leaving behind isolated gravel deposits, small log jams, and two large debris dams (figs. 1 and 2). About 1 acre of mineral soil was exposed along the margin of the stream channel.

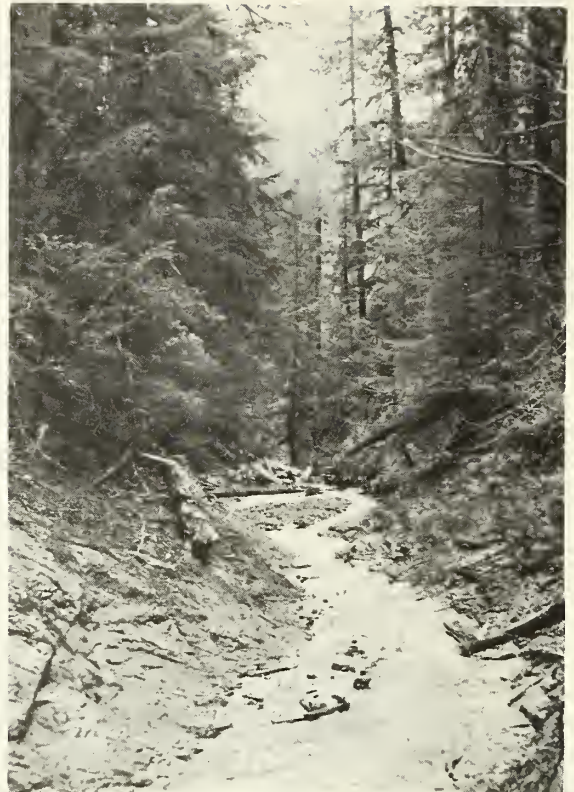
Figure 2.--Stream channel scoured to bedrock by the slide (looking downstream).

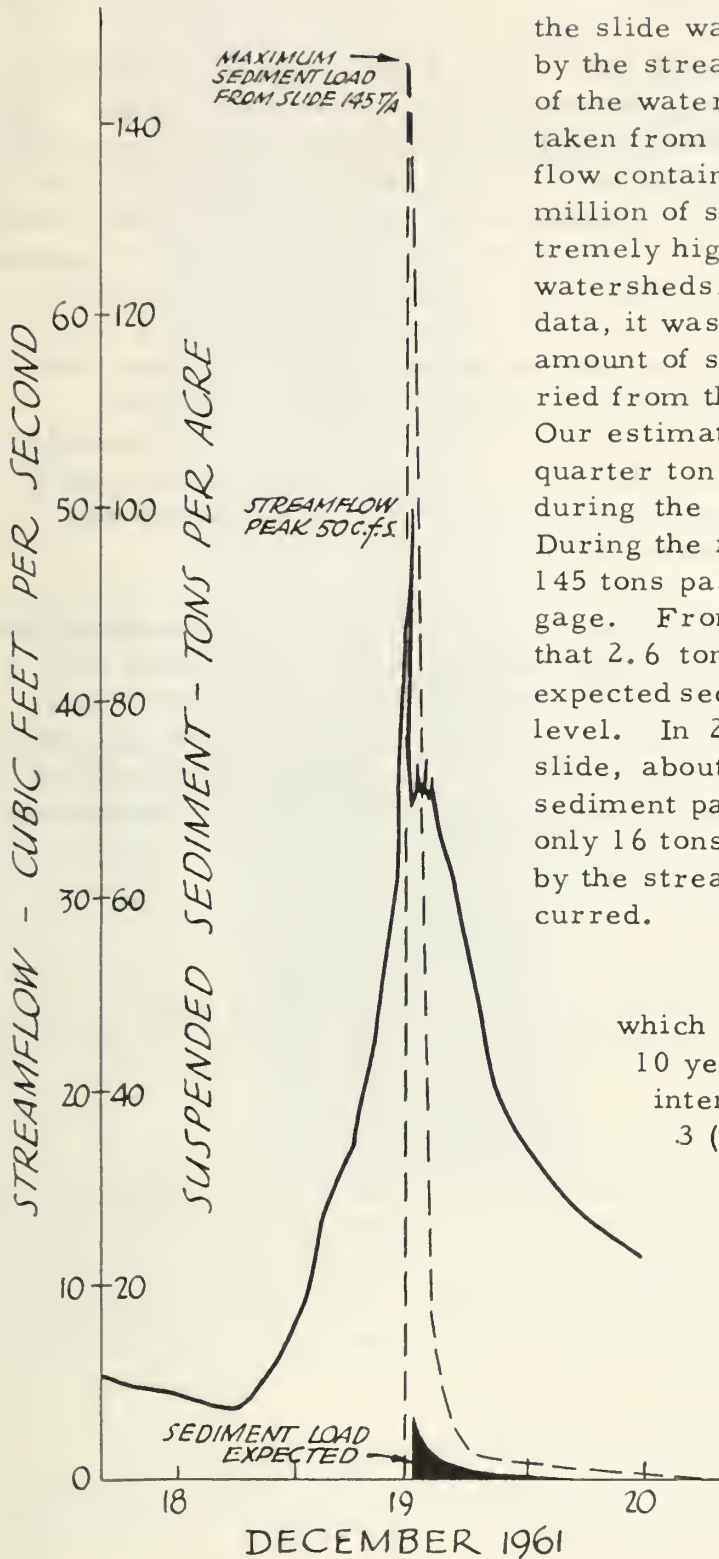
The accompanying chart traces some of the events occurring during the storm. As a result of rain on snow, streamflow rose rapidly to about 37 cubic feet per second (c.f.s.). At this stage, a surge of water, carrying silt, sand, and gravel, passed through the gage where streamflow is measured. The stream reached a peak discharge of over 50 c.f.s. and then settled down to some minor fluctuations, probably associated with the shifting and settling of the debris dams.
