RAILROAD ACCIDENT REPORT

**HEAD-END COLLISION OF
AMTRAK TRAIN NO. 392 AND
ICG TRAIN NO. 51
HARVEY, ILLINOIS
OCTOBER 12, 1979**

NTSB-RAR-80-3

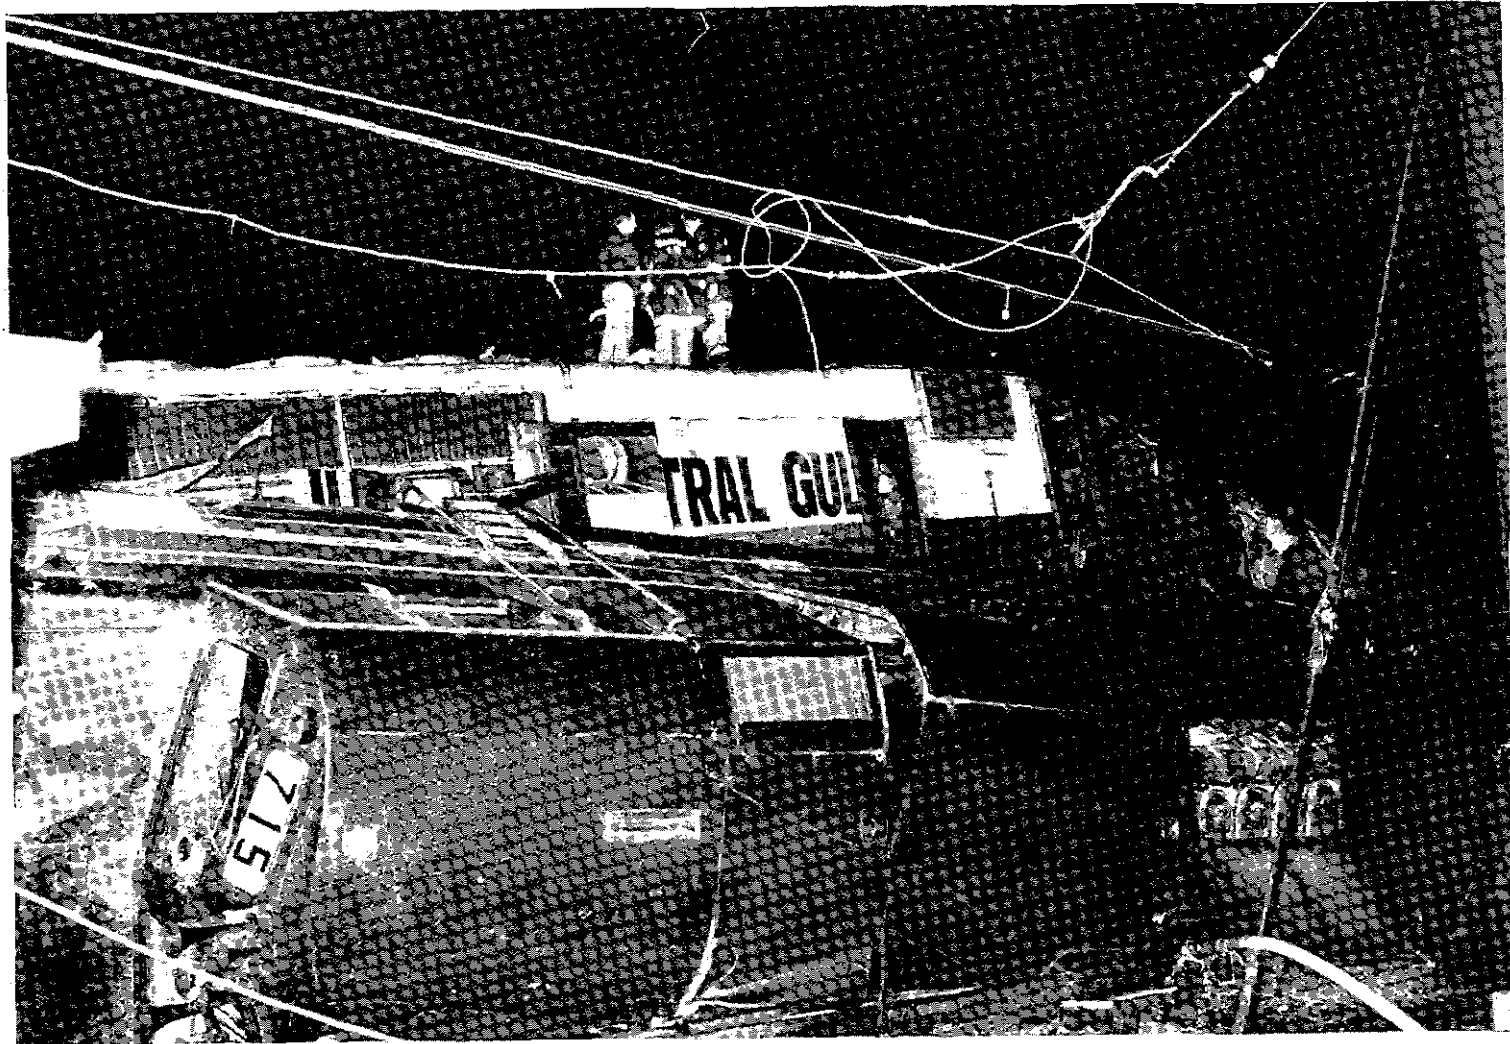
On impact, the locomotive of train No. 392 pushed the lead locomotive unit of train No. 51 34 ft under the second locomotive unit, struck and overrode the front end of the second locomotive unit, and struck and tore down the overhead catenary wires. The Amtrak locomotive and first coach of train No. 392 were overturned onto their sides. The locomotive traveled 134 feet before coming to rest on its left side adjacent to and west of the second locomotive unit of train No. 51. (See figure 1.)

Figure 1.—Amtrak locomotive unit of train No. 392
and second locomotive unit of train No. 51.

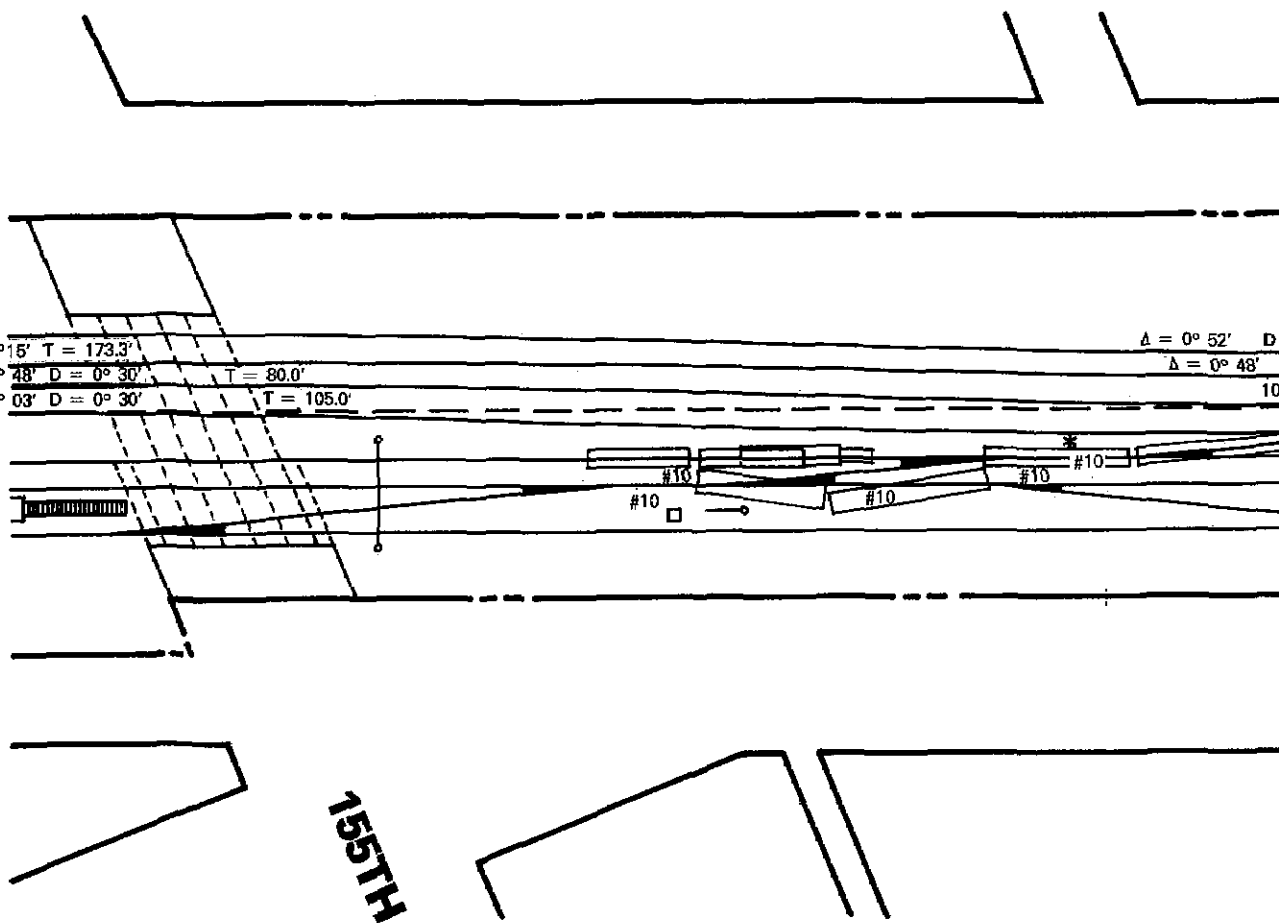
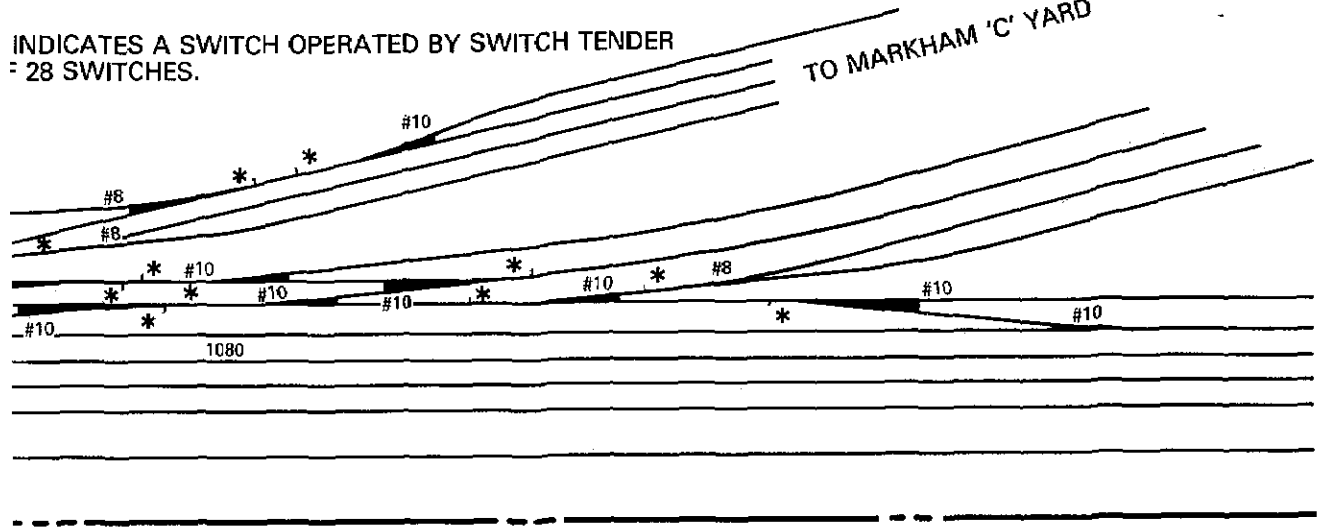
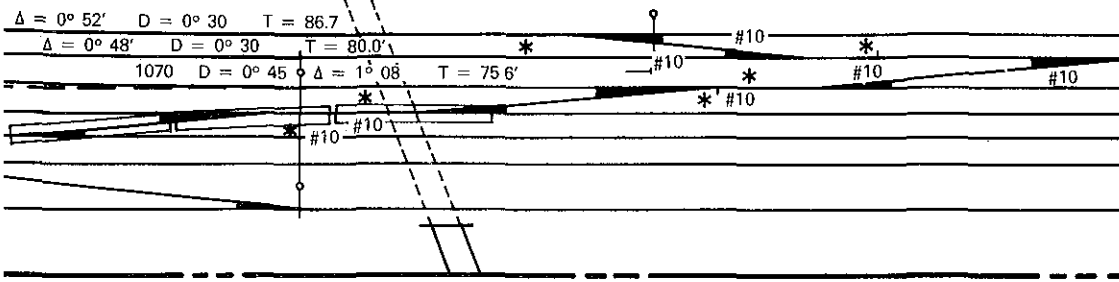
Figure 2. Plan view

Seven crossovers permitted trains to cross over from one track to another and to enter and leave Harvey yard. (See figure 2.)

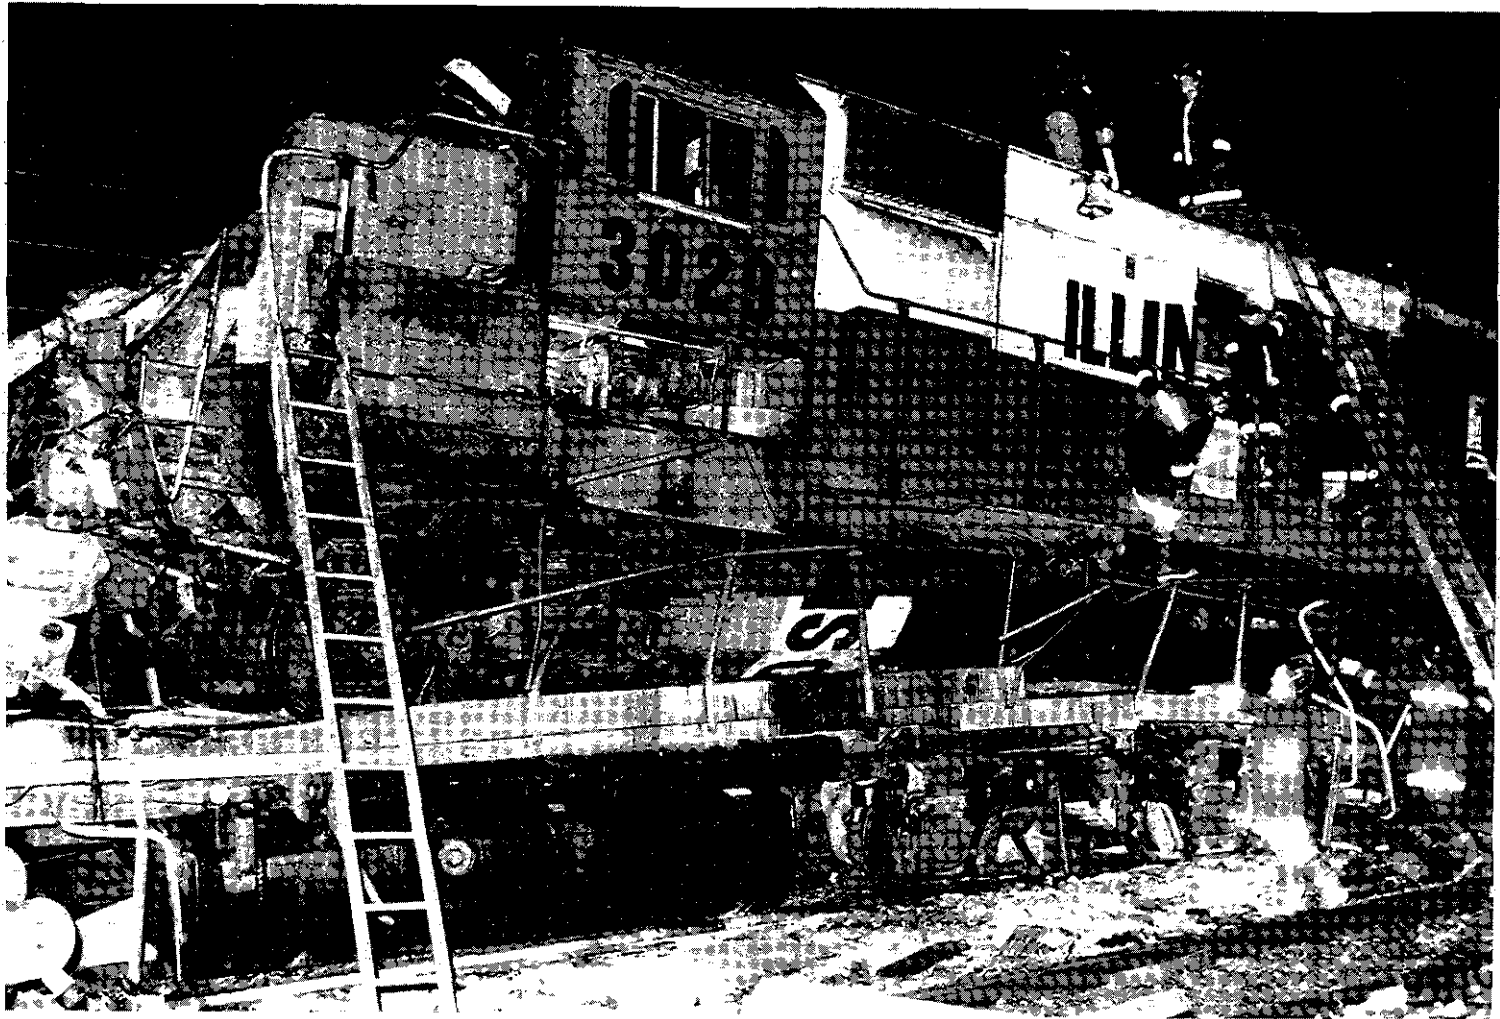
The first locomotive unit of train No. 51 was destroyed. The entire superstructure, including the cab, was sheared from the underframe. The second locomotive unit was damaged extensively. (See figure 3.) The third locomotive unit and cars were not derailed or damaged.

Figure 3.—Second locomotive unit of train No. 57.
