This document is an English translation of the Preliminary Report on the fatal accident involving the Boeing 747-412F aircraft registered TC-MCL that occurred on January 16, 2017 at Manas International Airport, Bishkek, Kyrgyz Republic.

**INTERSTATE AVIATION COMMITTEE
AIR ACCIDENT INVESTIGATION COMMISSION**

PRELIMINARY REPORT

Type of occurrence	Fatal accident
Type of aircraft	Boeing 747-412F
Registration mark	TC-MCL
Owner	LCI Freighters One Limited (Ireland)
Operator	ACT Airlines
Aviation Authority	Turkish DGCA
Place of occurrence	Near Manas International Airport, Bishkek, Kyrgyz Republic, coordinates: N 43°03.248' E 074°2.271'
Date and time	16.01.2017, 07:17 local time (01:17 UTC), nighttime

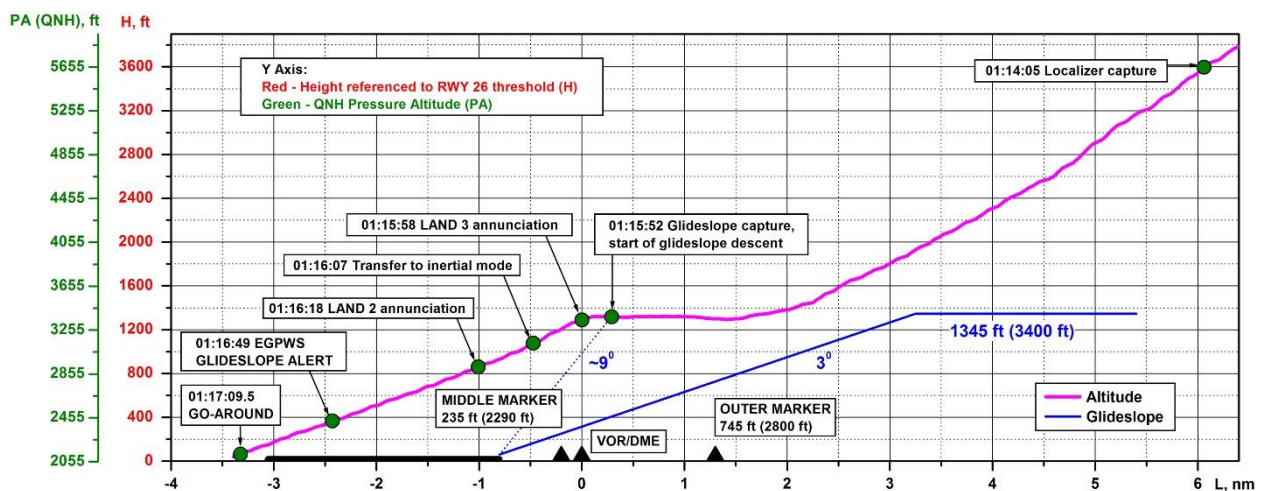
Figure 1. Vertical flight path of final approach (height is counted from RWY 26 threshold, its elevation being 2055 ft)

At 01:14:05 the DFDR recorded LOC capture (Figure 1) and start of localizer establishing maneuver. At that time the a/c was at a distance of about 6 nm in descent at an altitude of approximately 5700 ft.

Since that time the flight was performed at a constant altitude along the RWY 26 landing course. The a/c was significantly higher than the glideslope, the glideslope pointer was in full down position. The glideslope mode was armed (G/S MODE ARM), but the glideslope was not captured.

A glideslope signal was captured at 01:15:52, at that time the a/c was almost over VOR/DME MANAS at a distance of approximately 1.1 nm from RWY 26 threshold, at an angle of approximately 9° (Figure 1). However, as per the approach chart, the rated glideslope angle is 3°(Figure 4).

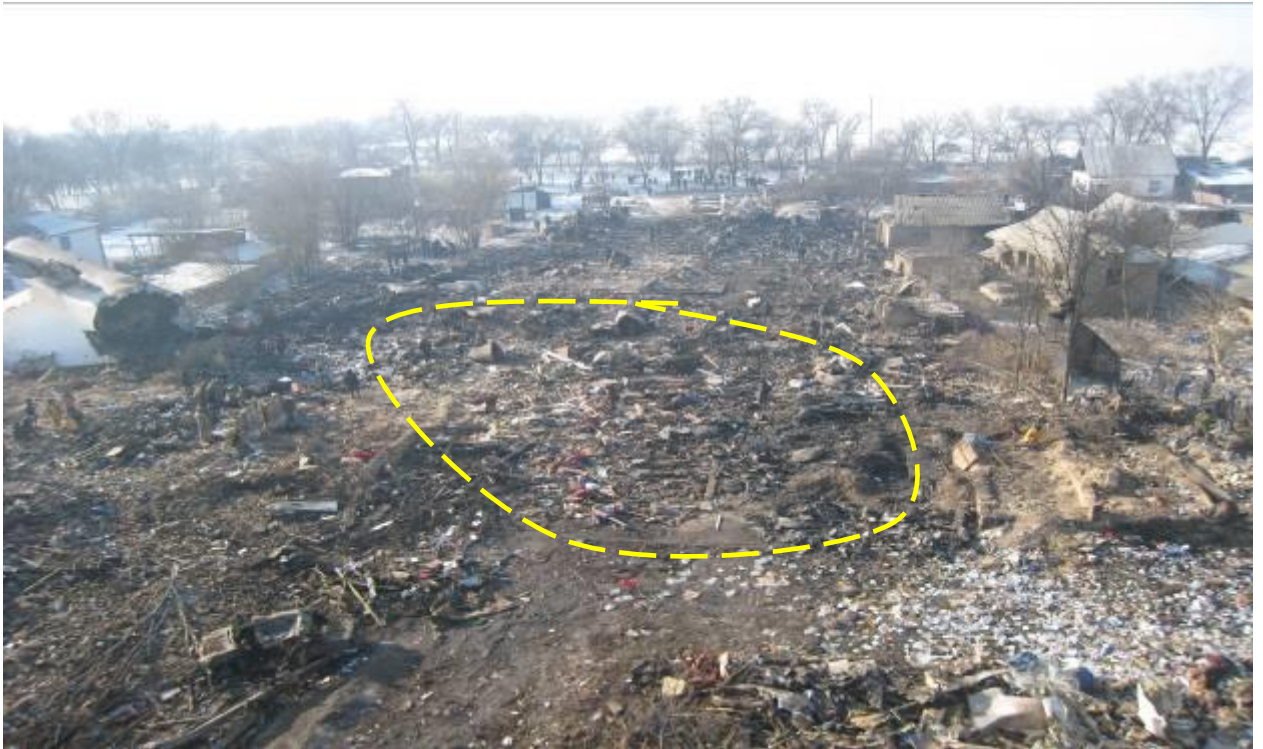
Figure 6. Main fire cell (circled by dashed yellow line)

The post-crash fire cell was located in the central fuselage area, between the separated tail and cockpit (Figure 6).

There are no signs of fire or thermal impact on the pieces of fuselage, wing and engines located before the fire cell, either on the outside or on the inside.

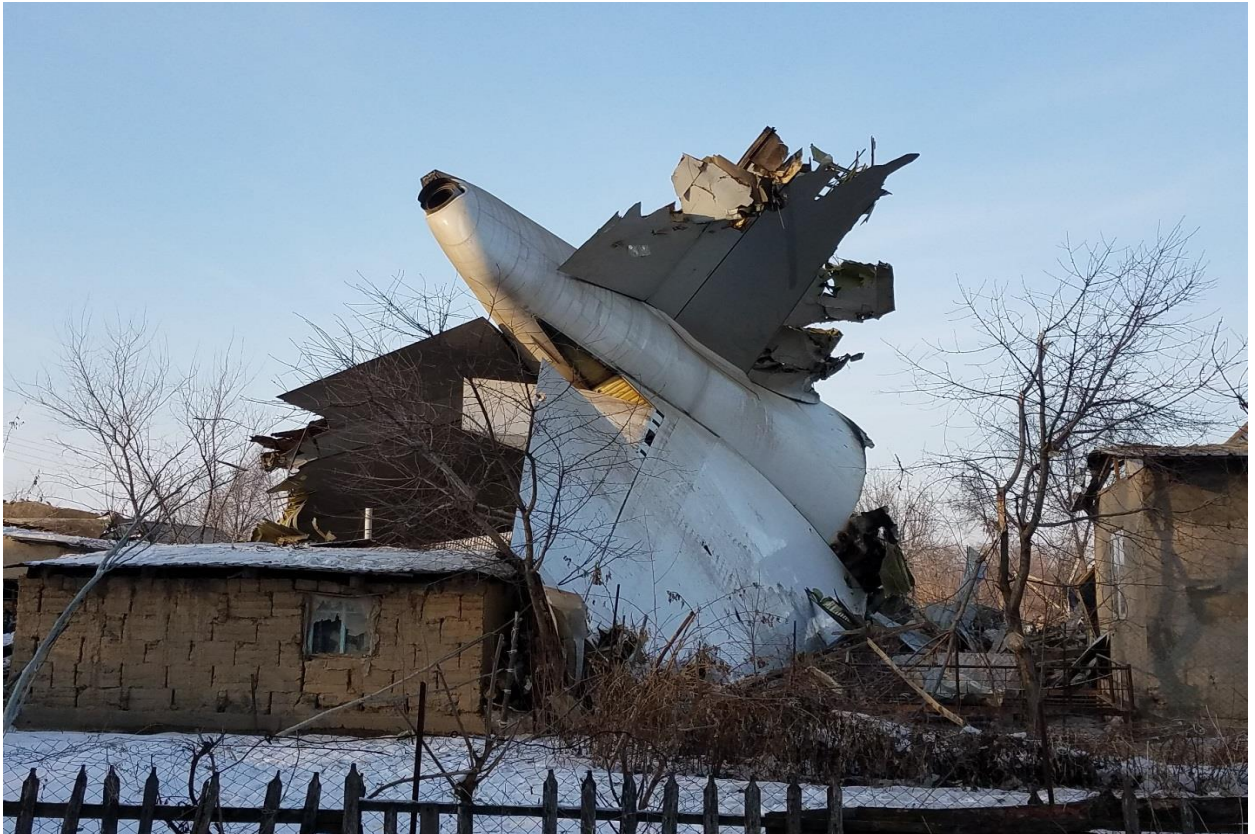
Figure 7. Empennage

The vertical fin and horizontal stabilizers (Figure 7) remained attached to the tail part of the fuselage (pressure dome to the APU exhaust). Their final position was inverted. There were no signs of fire or soot on the fin.

The horizontal stabilizer's center section, trim actuator and ballscrew showed no external damage.
