90.20 - 241 - *Nippon Vehicle Mfg. Company*

AREA NO. 90:20	TARGET I. 241	LIMITED DAMAGE INTERPRETATION NO. <u>30</u>	CONFIDENTIAL	D/P
			SHEET NO.	OF

NIPPON VEHICLE COMPANY

NIPPON VEHICLE MANUFACTURING CO.
90.20-241
Lat. 35° 07' N - Long. 136° 55' E
NAGOYA, JAPAN

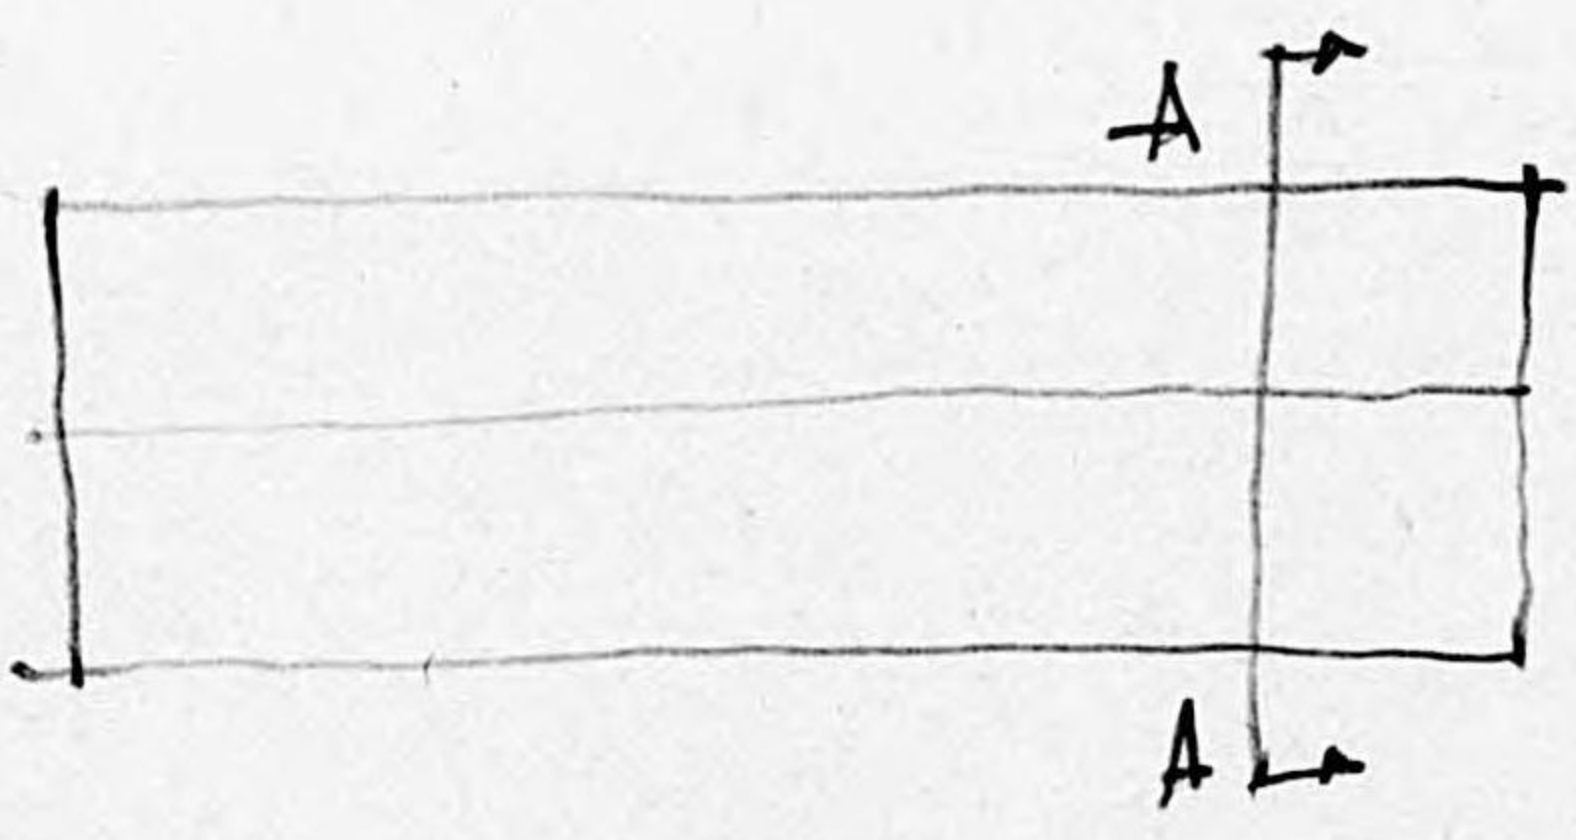
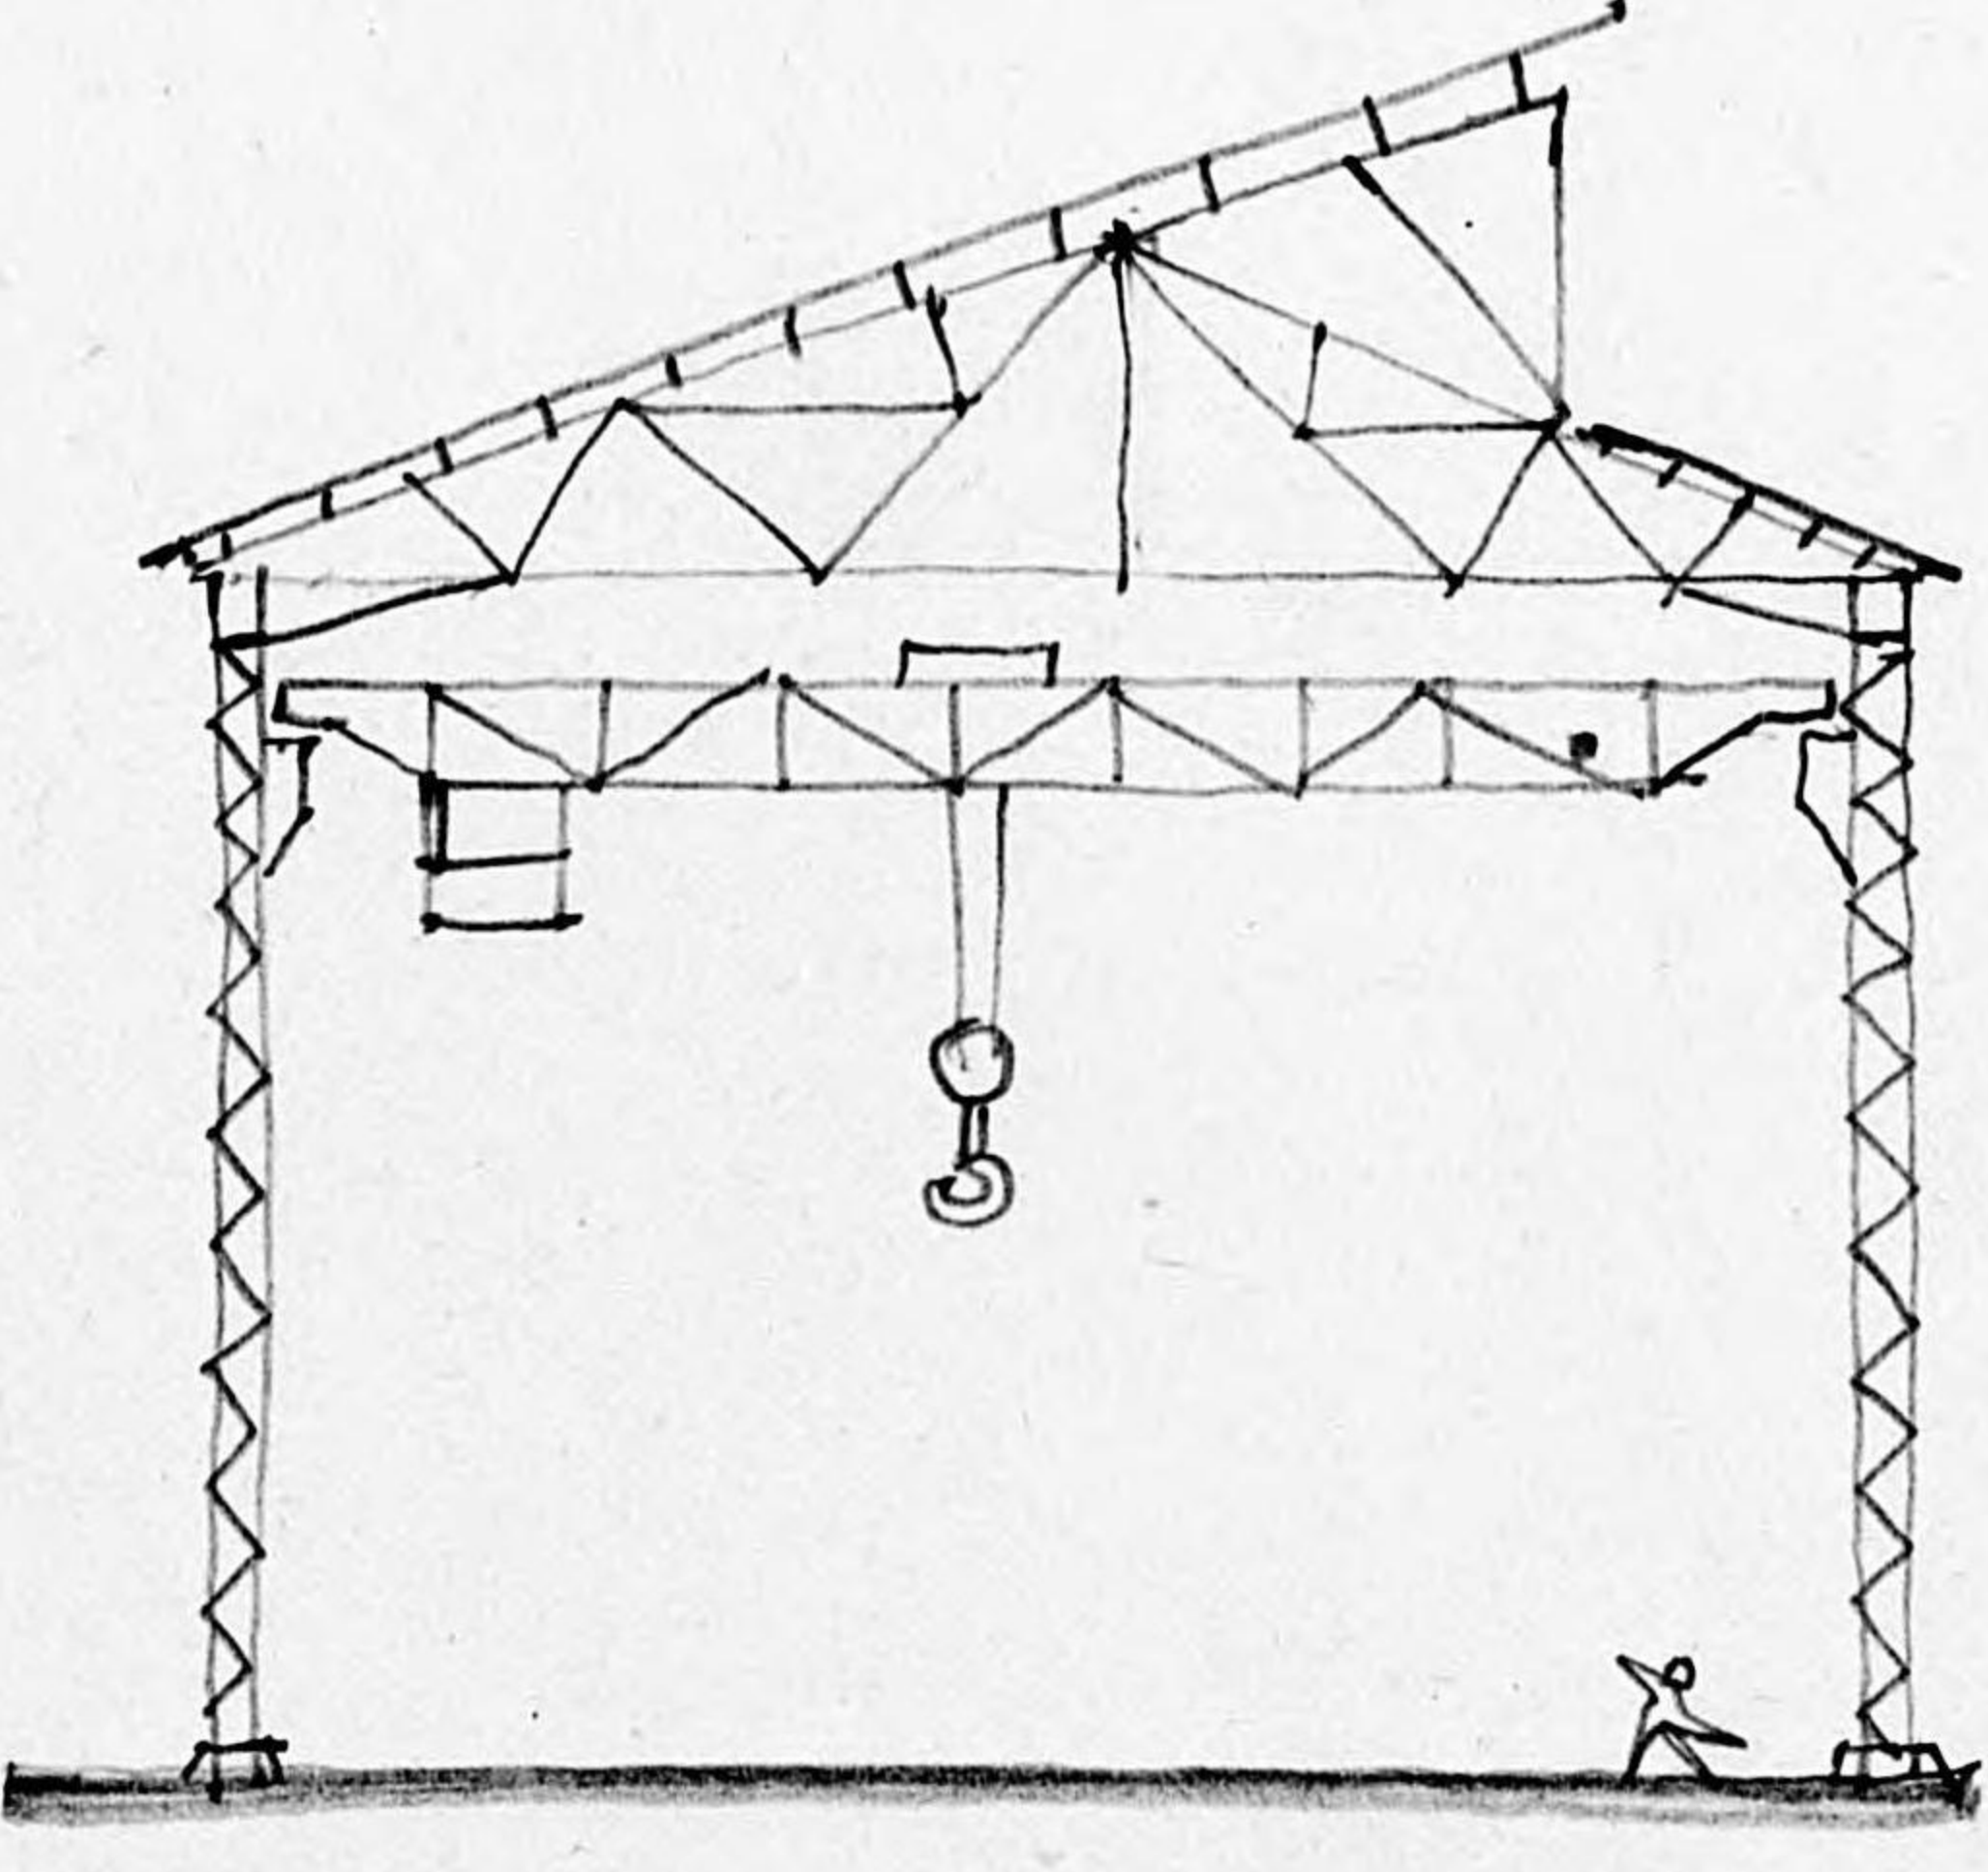
BLDG. NUMBER
8

NOTE BLDG. 7 DESTROYED

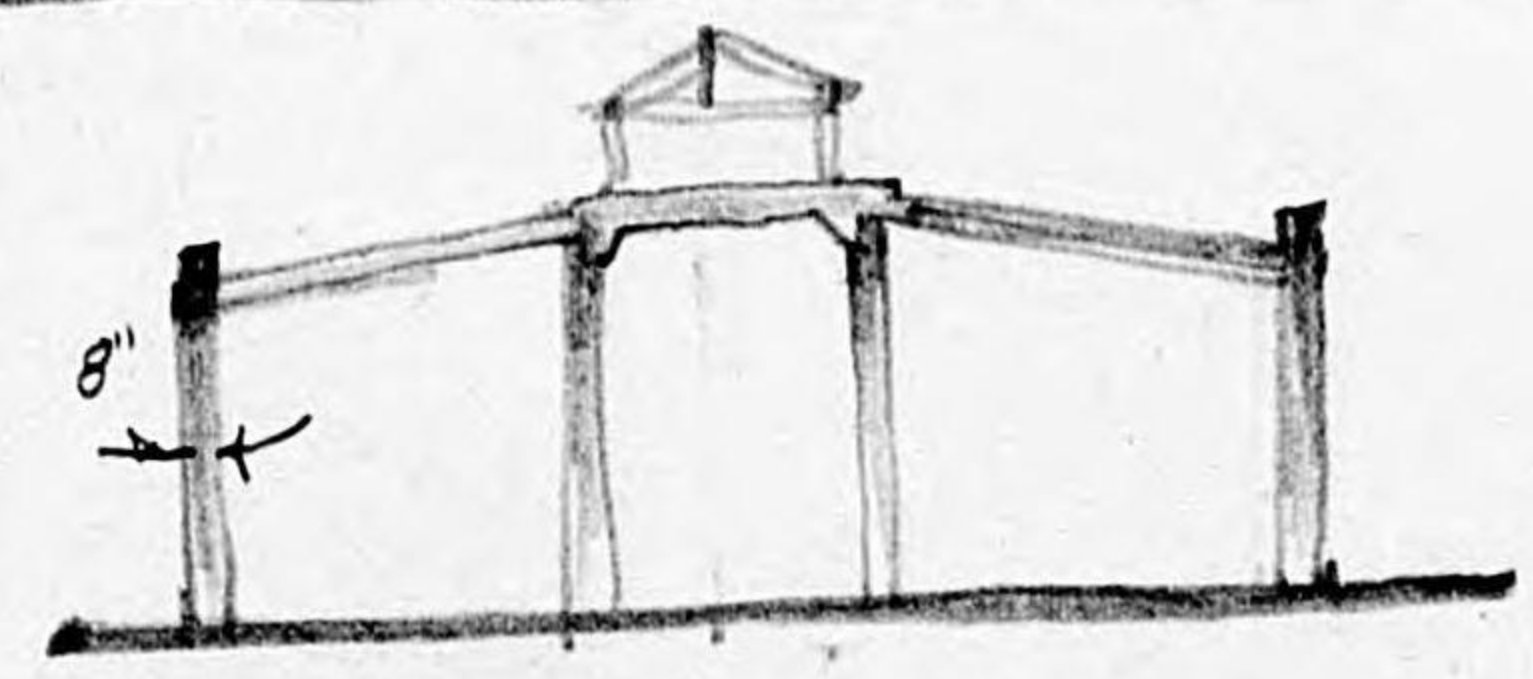
SECTION
Hollow Tile walls
Continuous wood monitor
Concrete floor.
LUMBER DRYING CELLS
BLDG. NO. 18

NOTE BLDGS. 10.
11.
DESTROYED 12.
13.
14.
15.
16.
17.

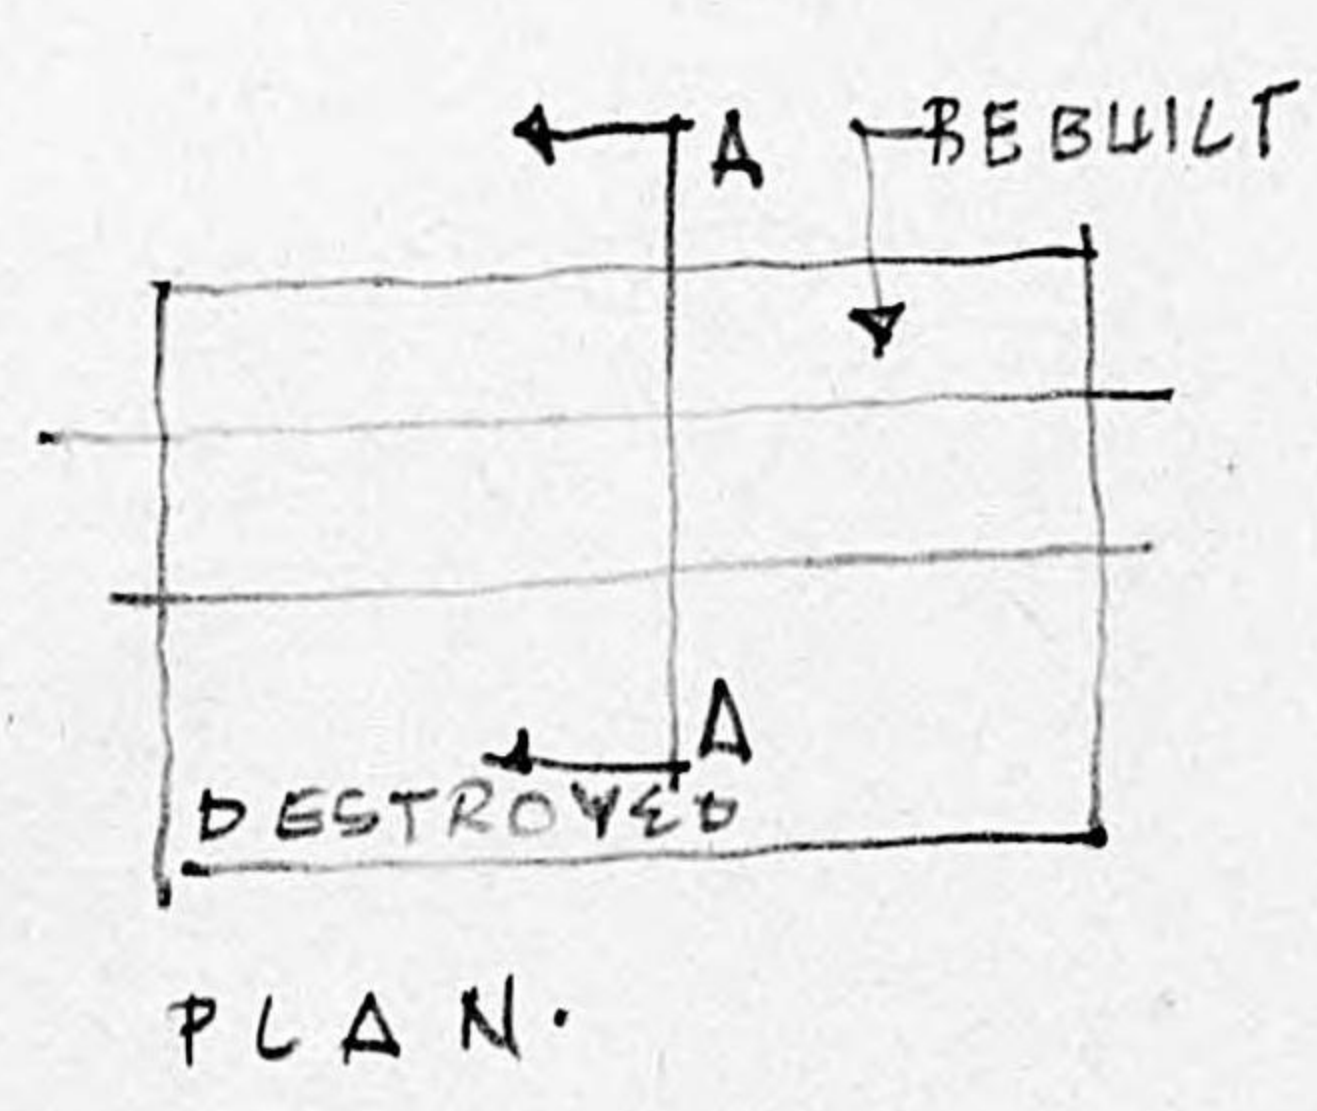
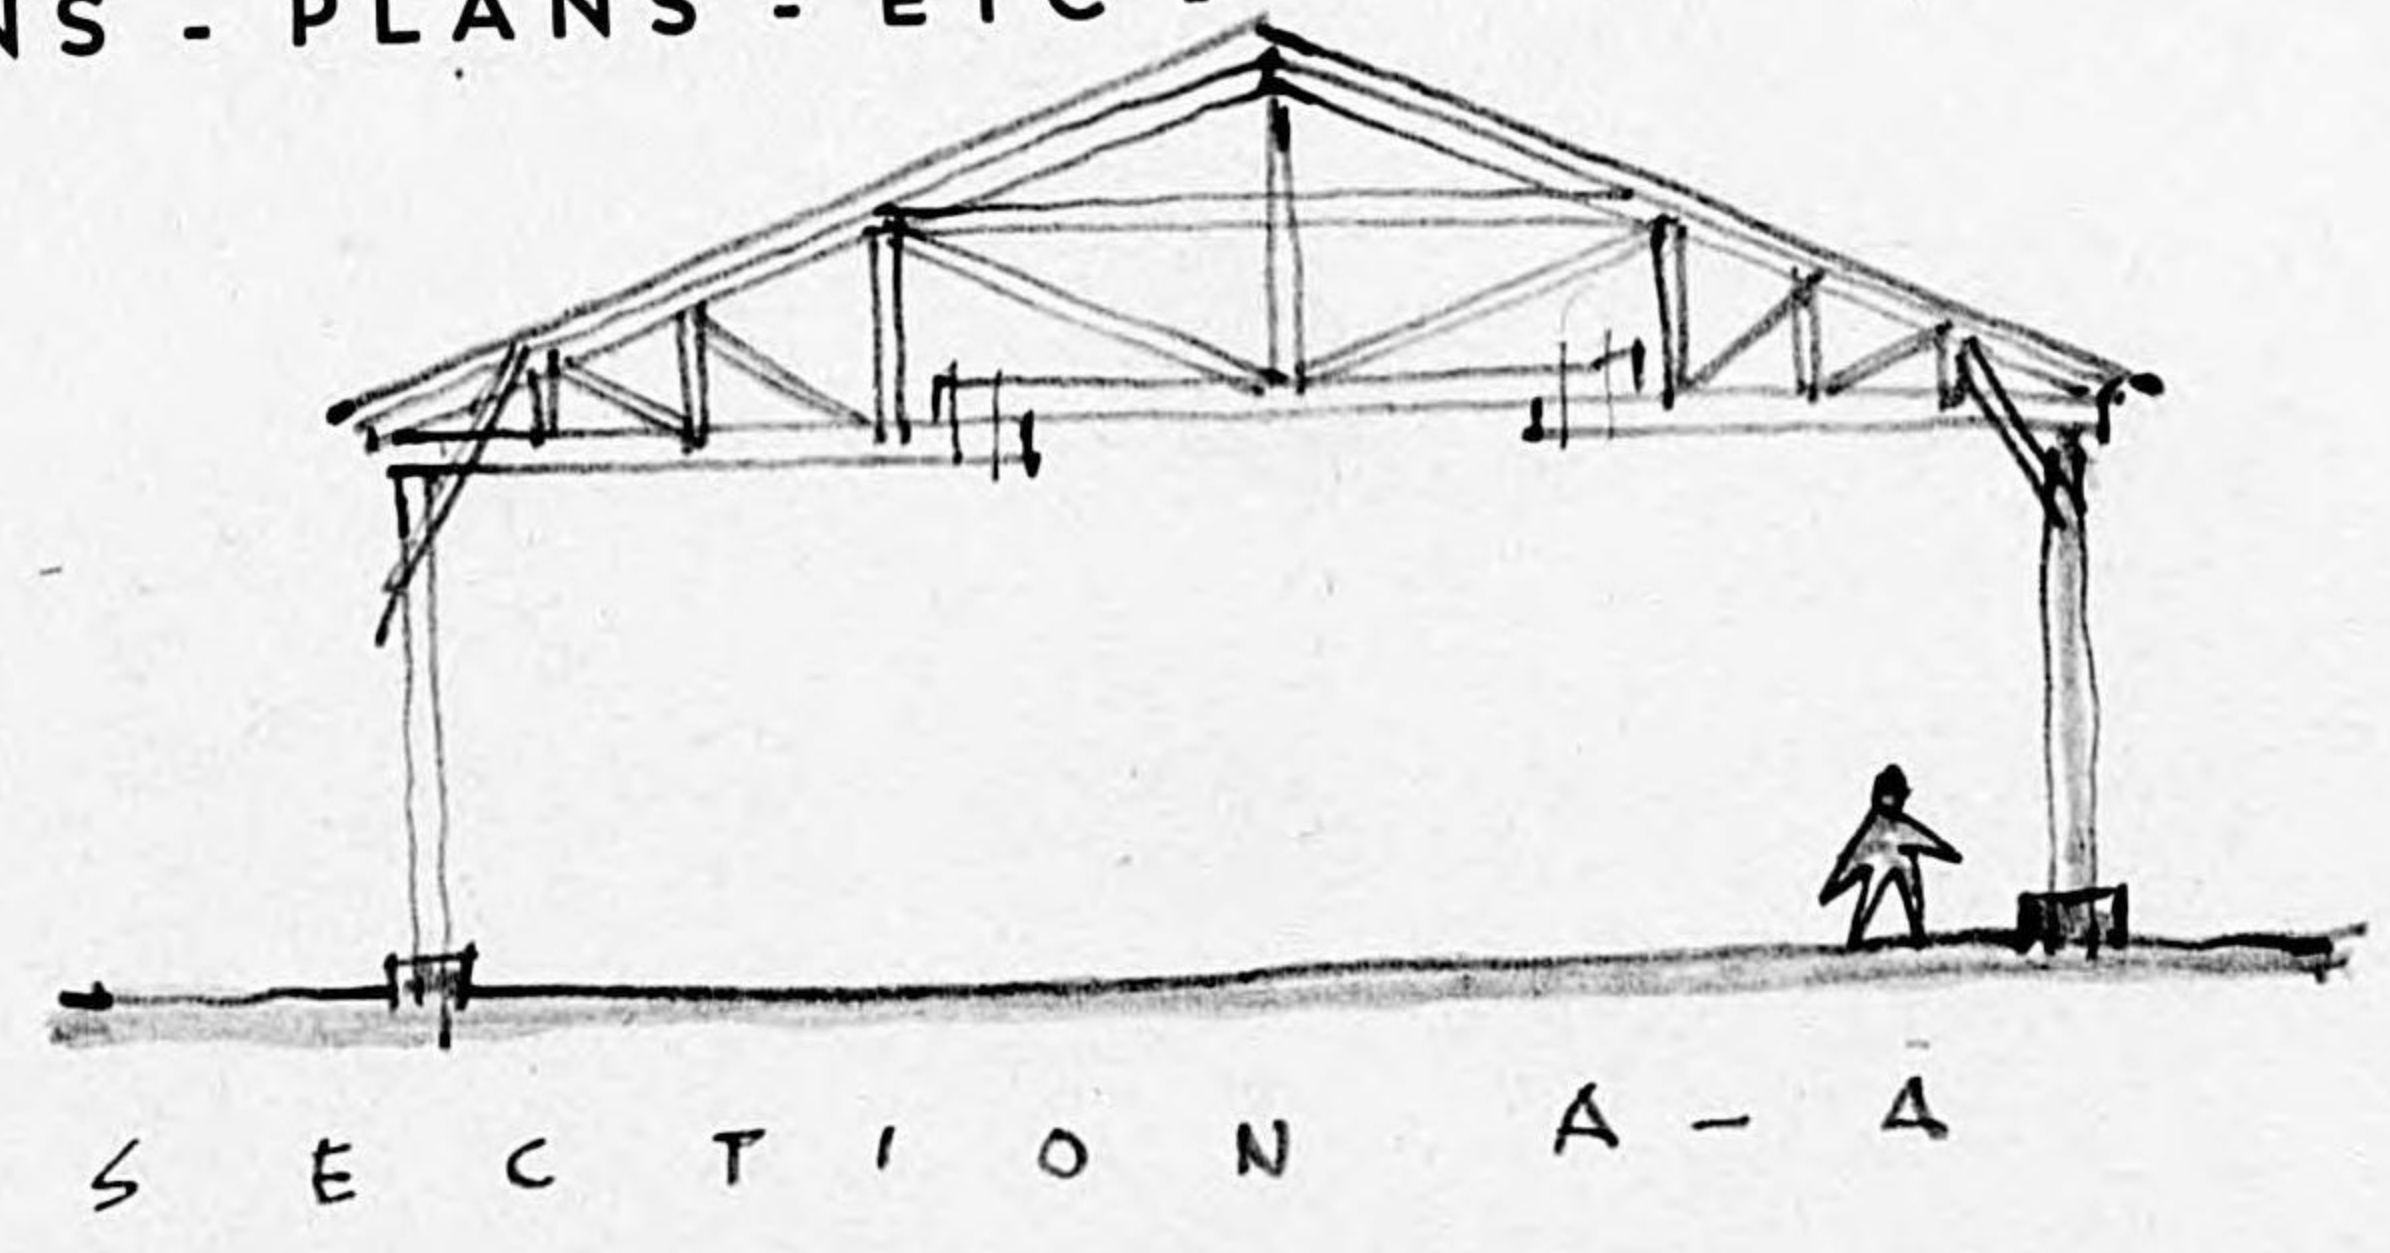
BLDG. NUMBER
22.

NOTE
BLDG 21
DESTROYED

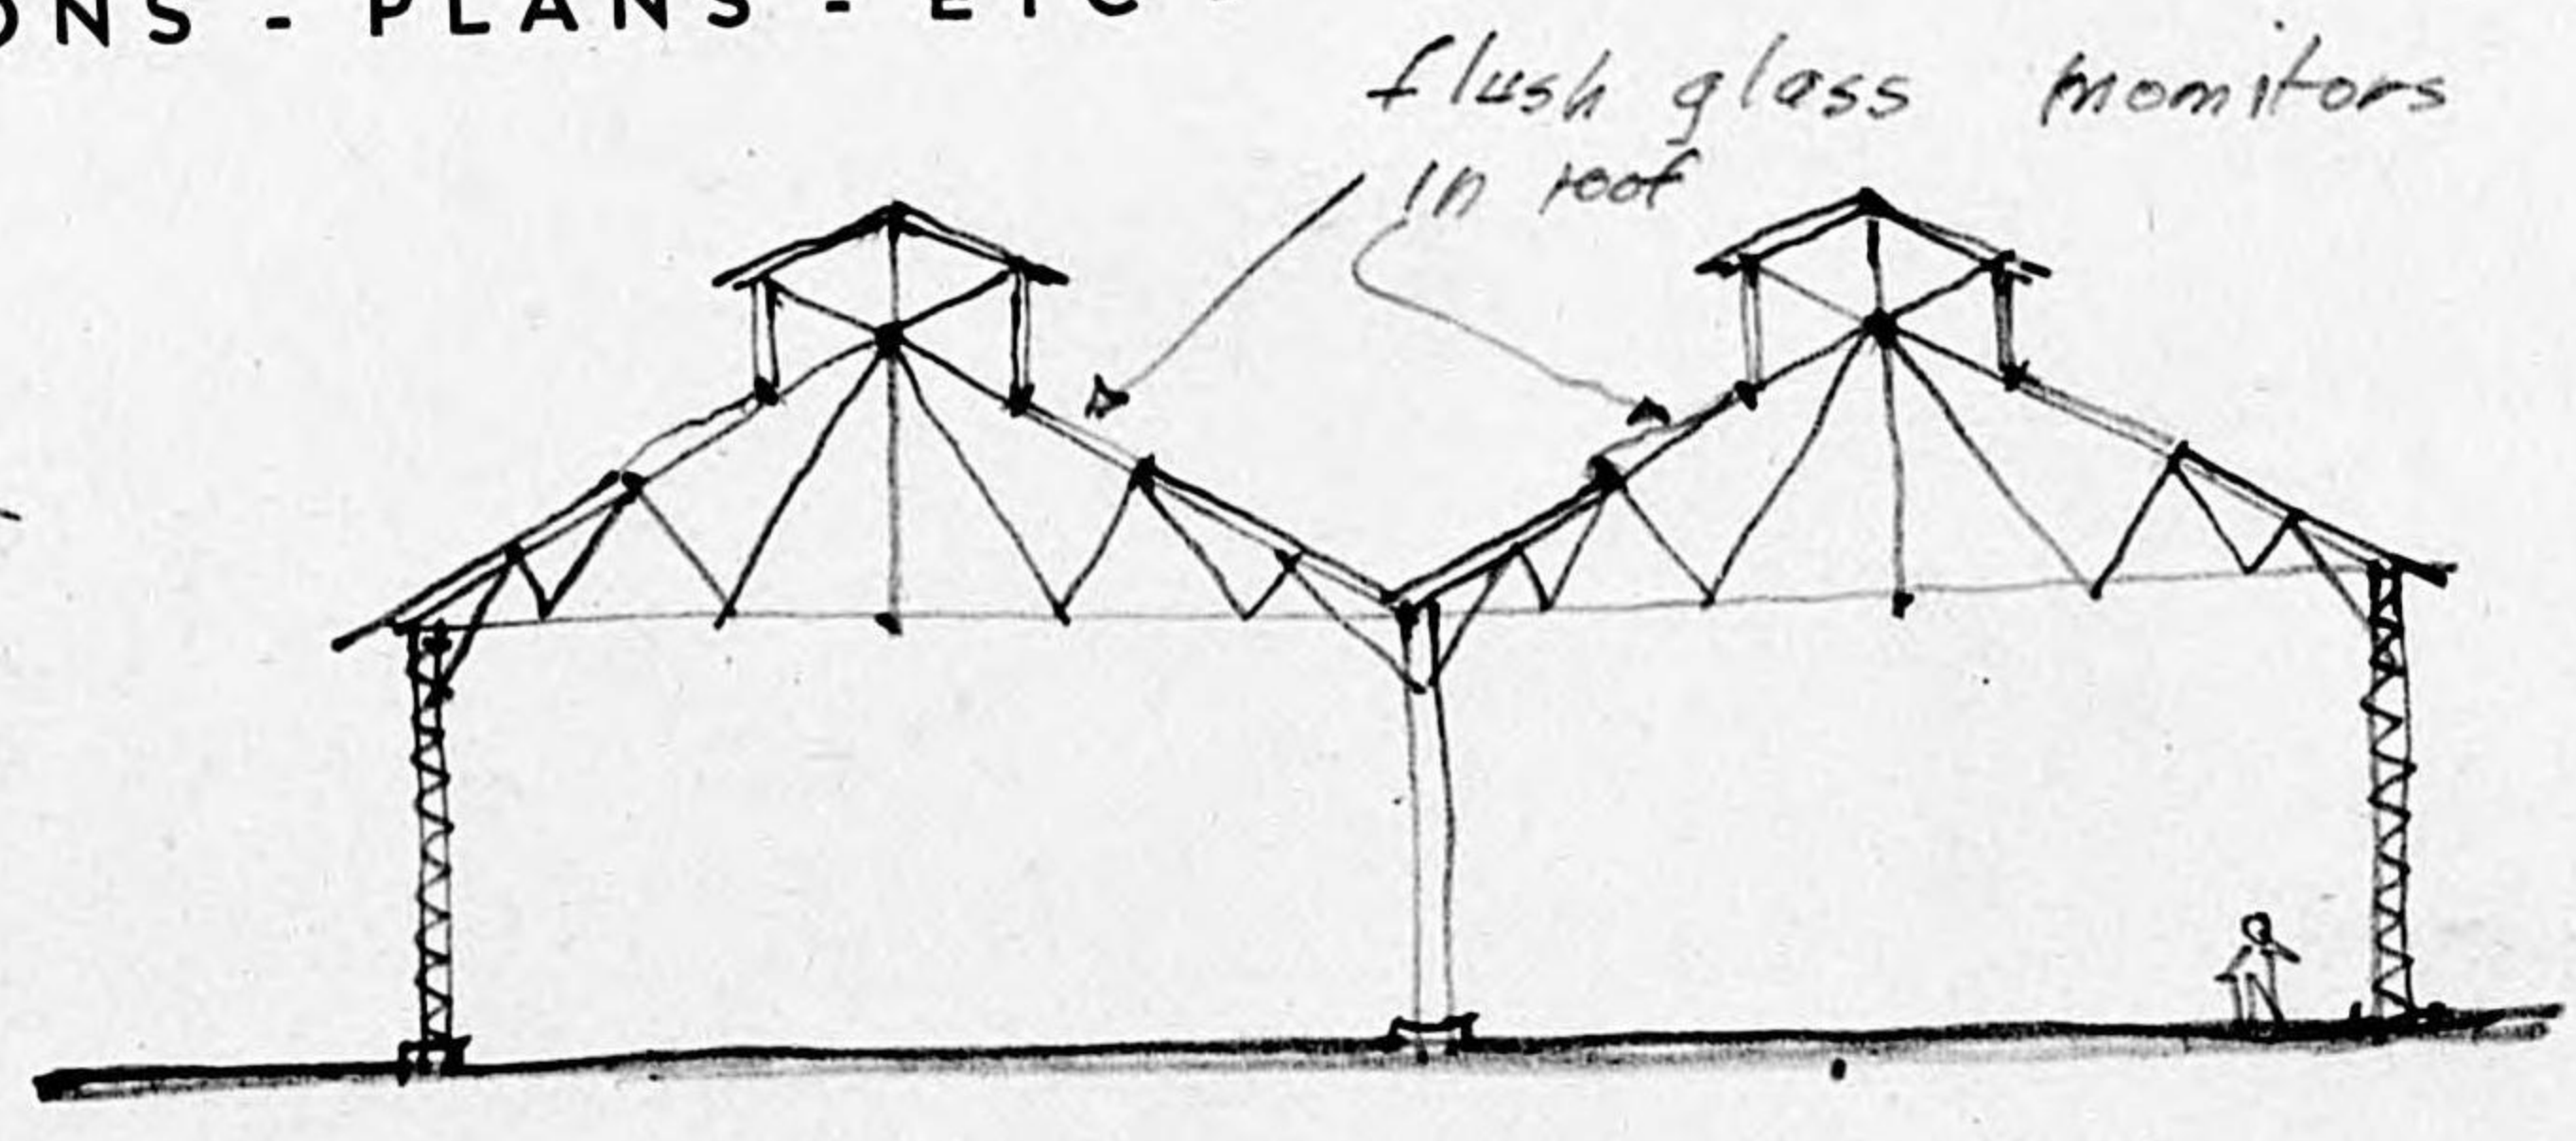
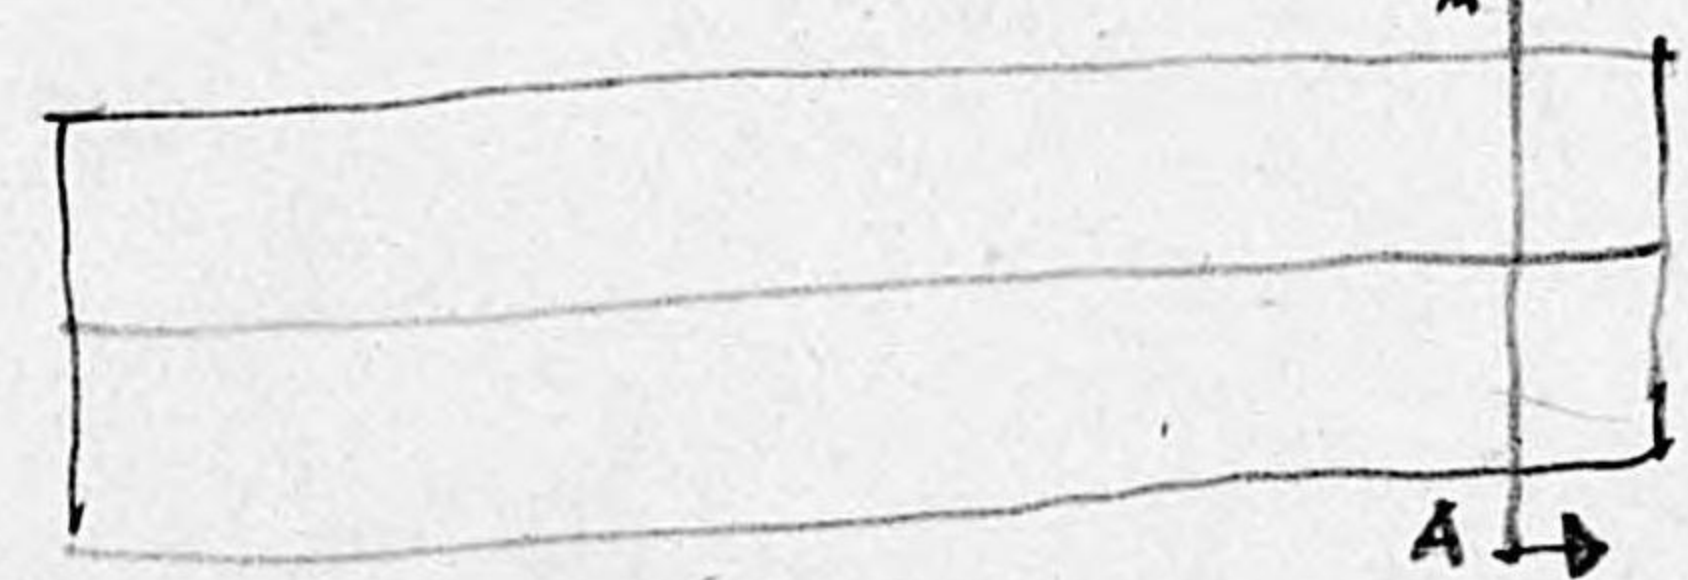
NOTE
 BLDG 23 = WOOD WORKING.
 BLDG 24 = DESTROYED
 REMOVAL OF SAND FROM
 MOLDS.

NOTE BLDG 26 } DESTROYED.
 R.R. CAR ASSEMBLY }

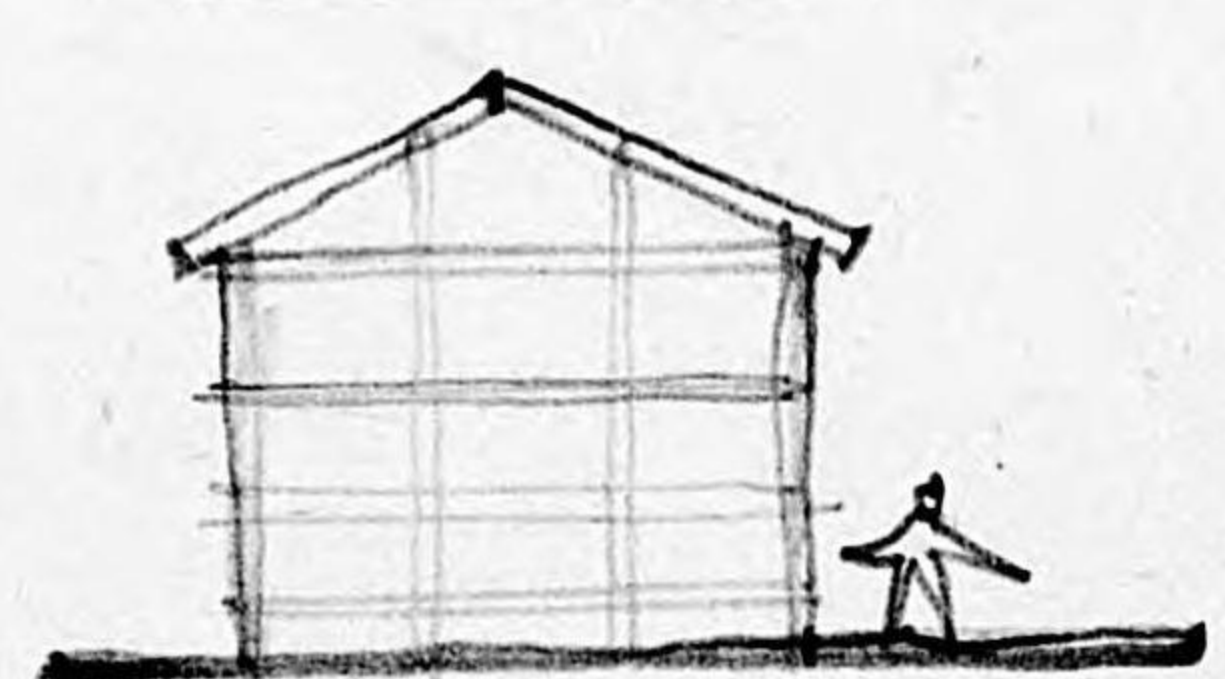
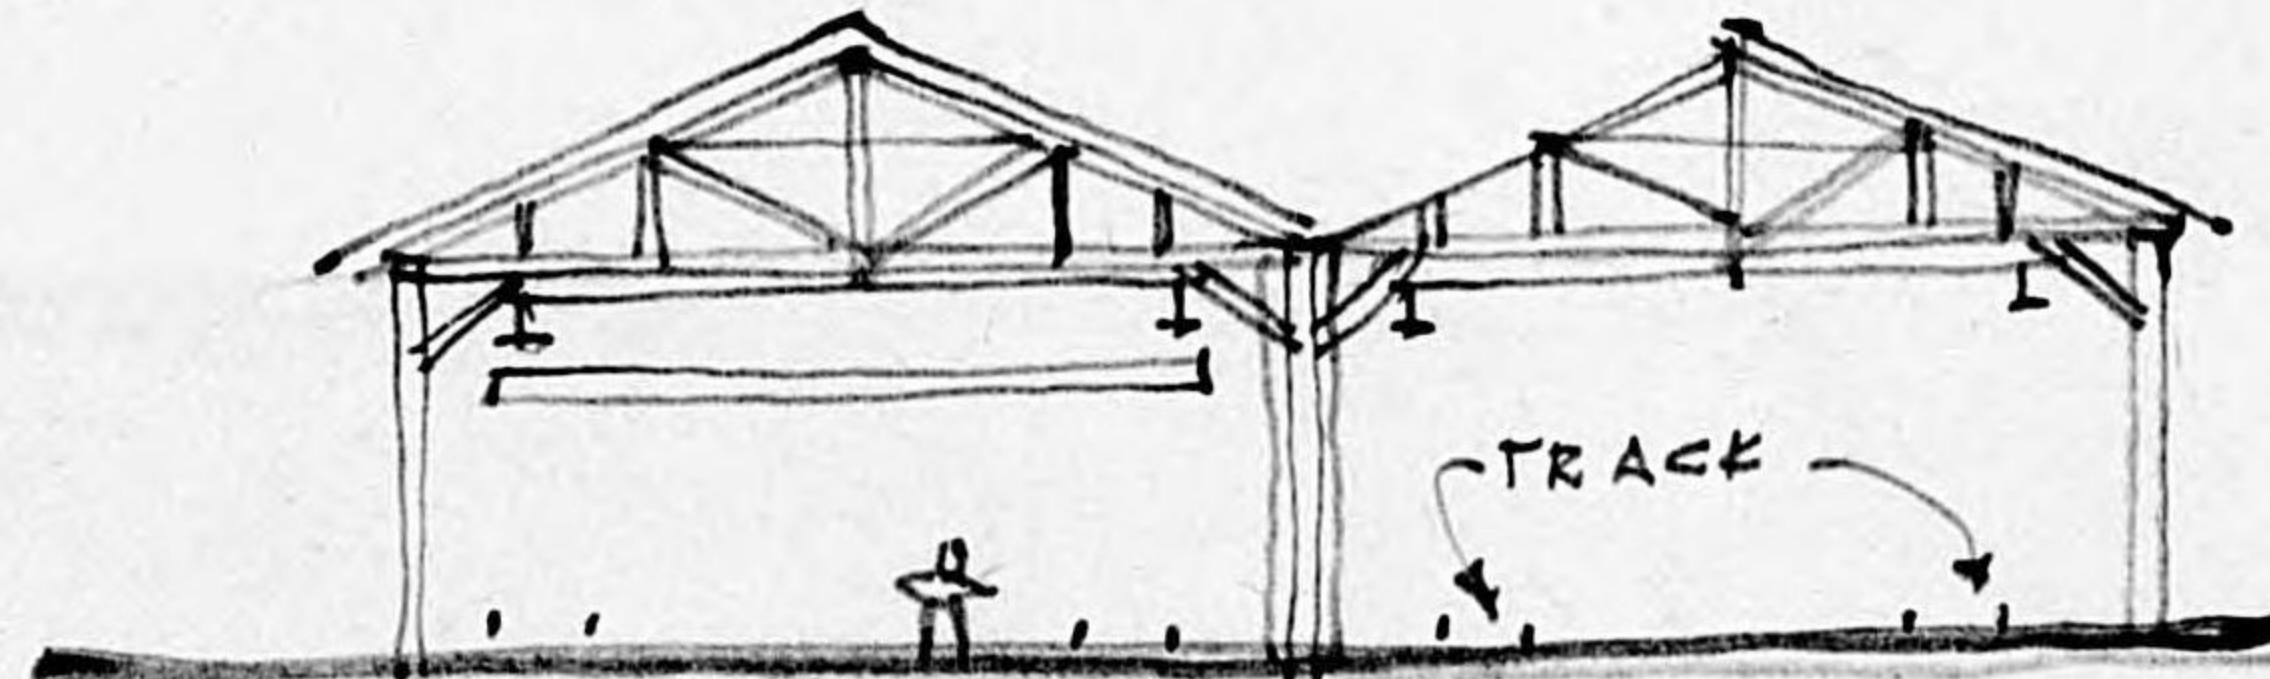
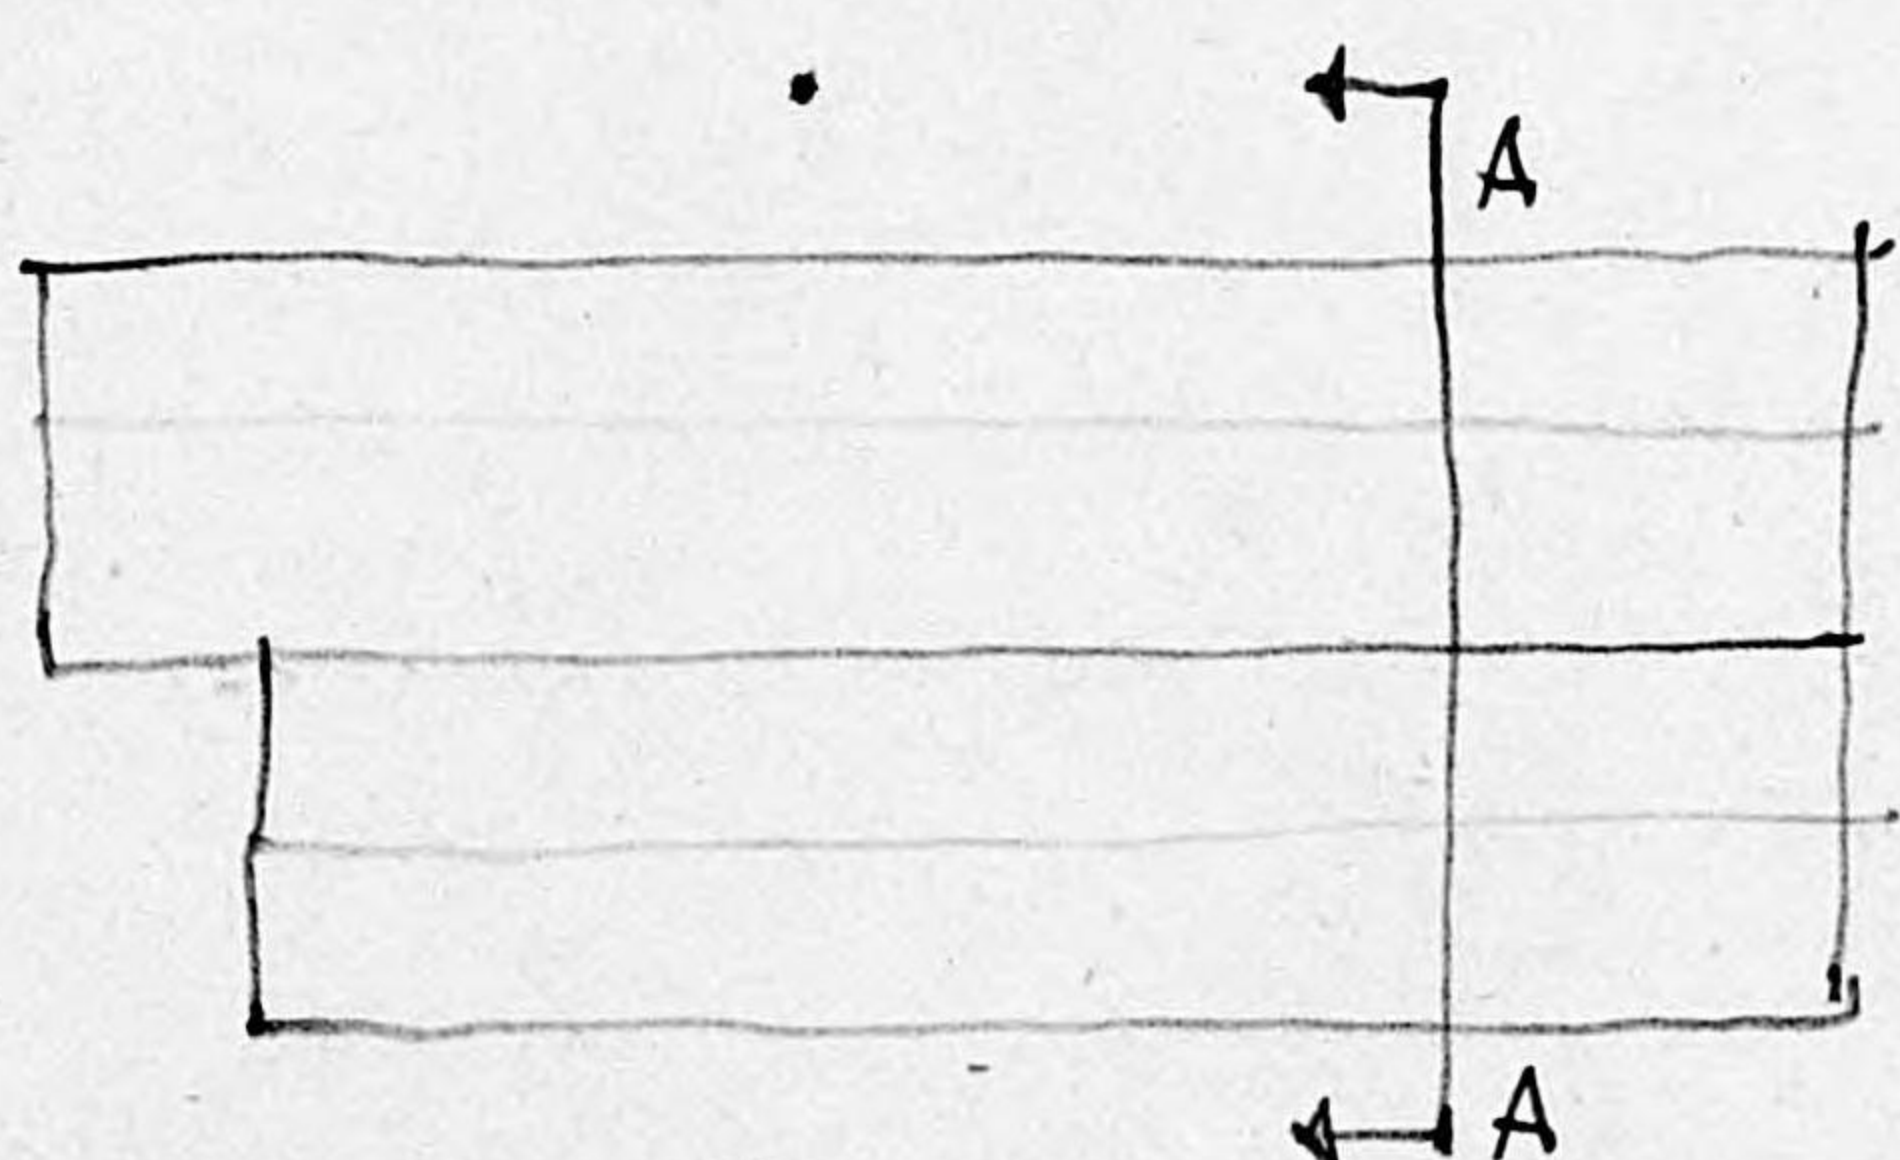
BLDG. 29.

BLDG 31.
SAME CONST.
AS 30- } DESTROYED.

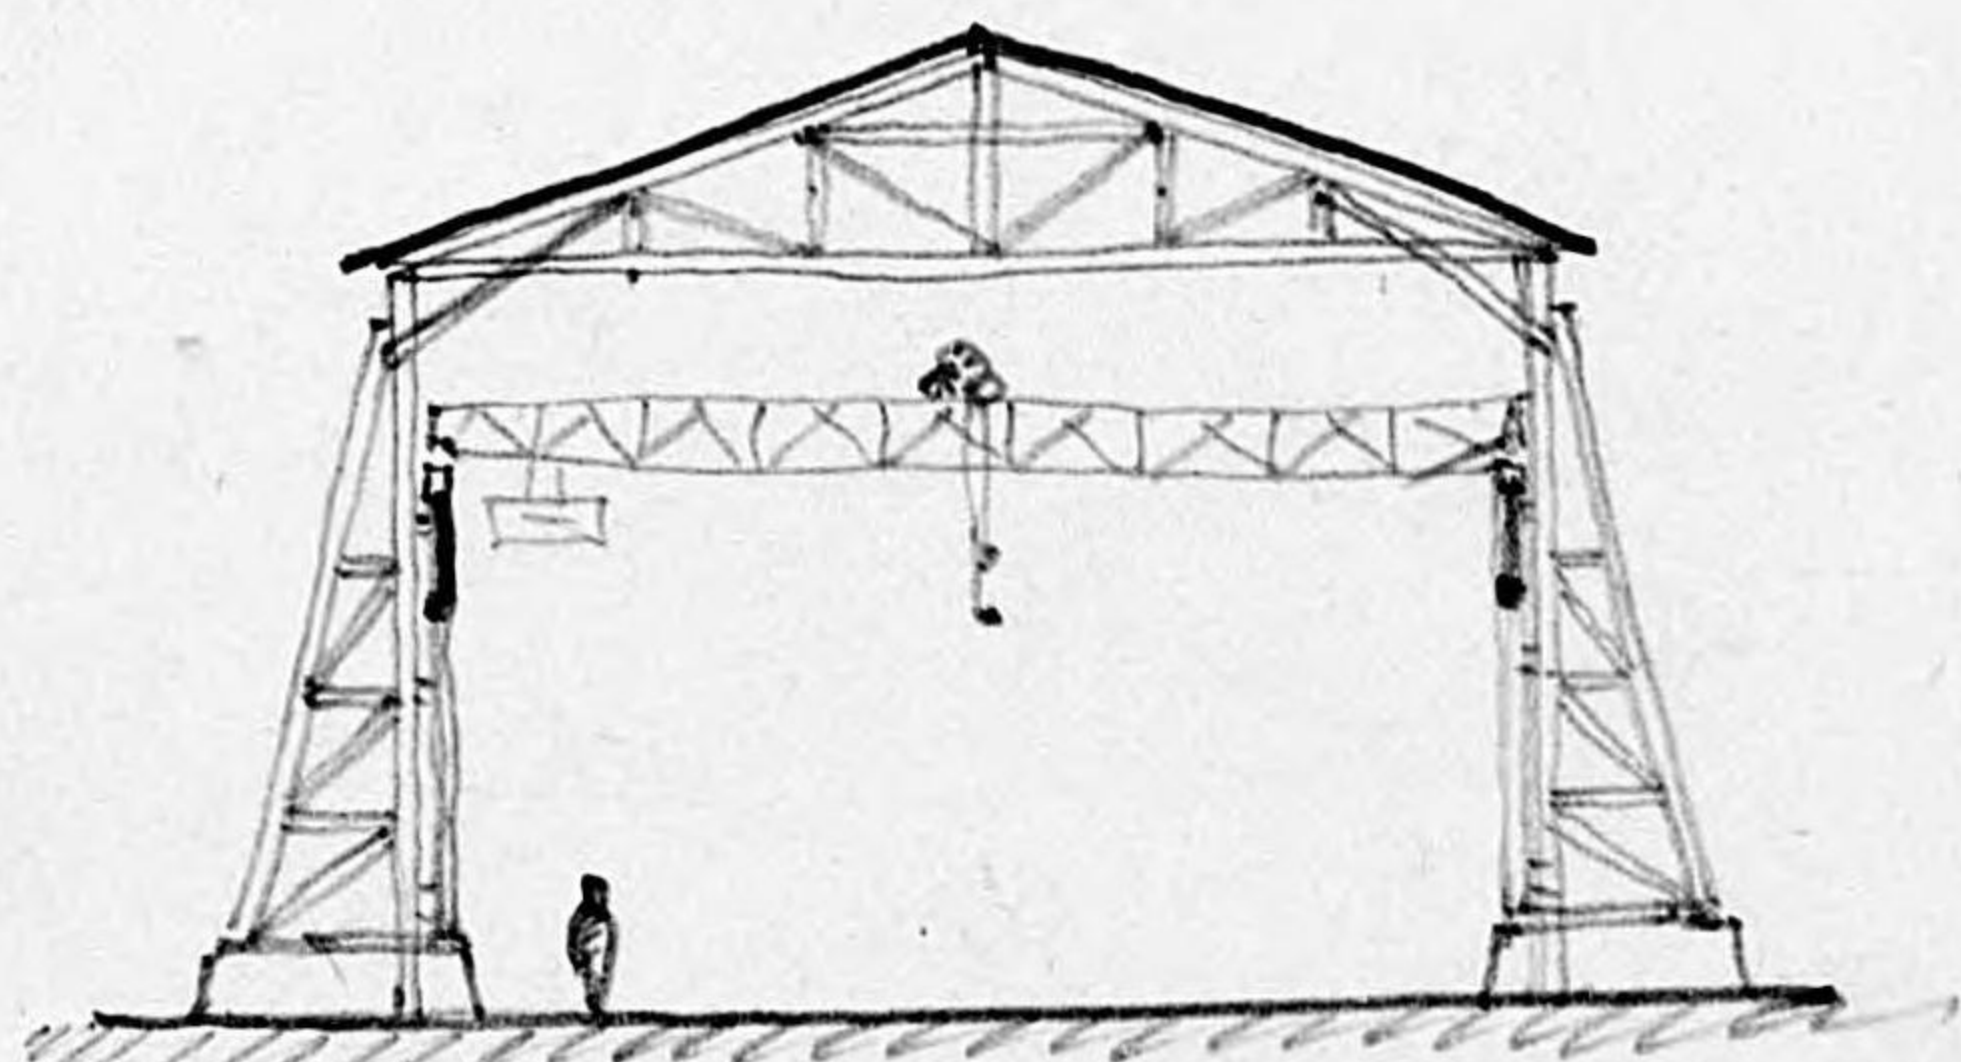
SECTION OF BLDG 42

BLDG. 43 - REMOVED OR DESTROYED.
