NIST Special Publication 901

The January 17, 1995 Hyogoken-Nanbu (Kobe) Earthquake

*Performance of Structures, Lifelines, and Fire
Protection Systems*

Riley Chung, Team Leader and Editor

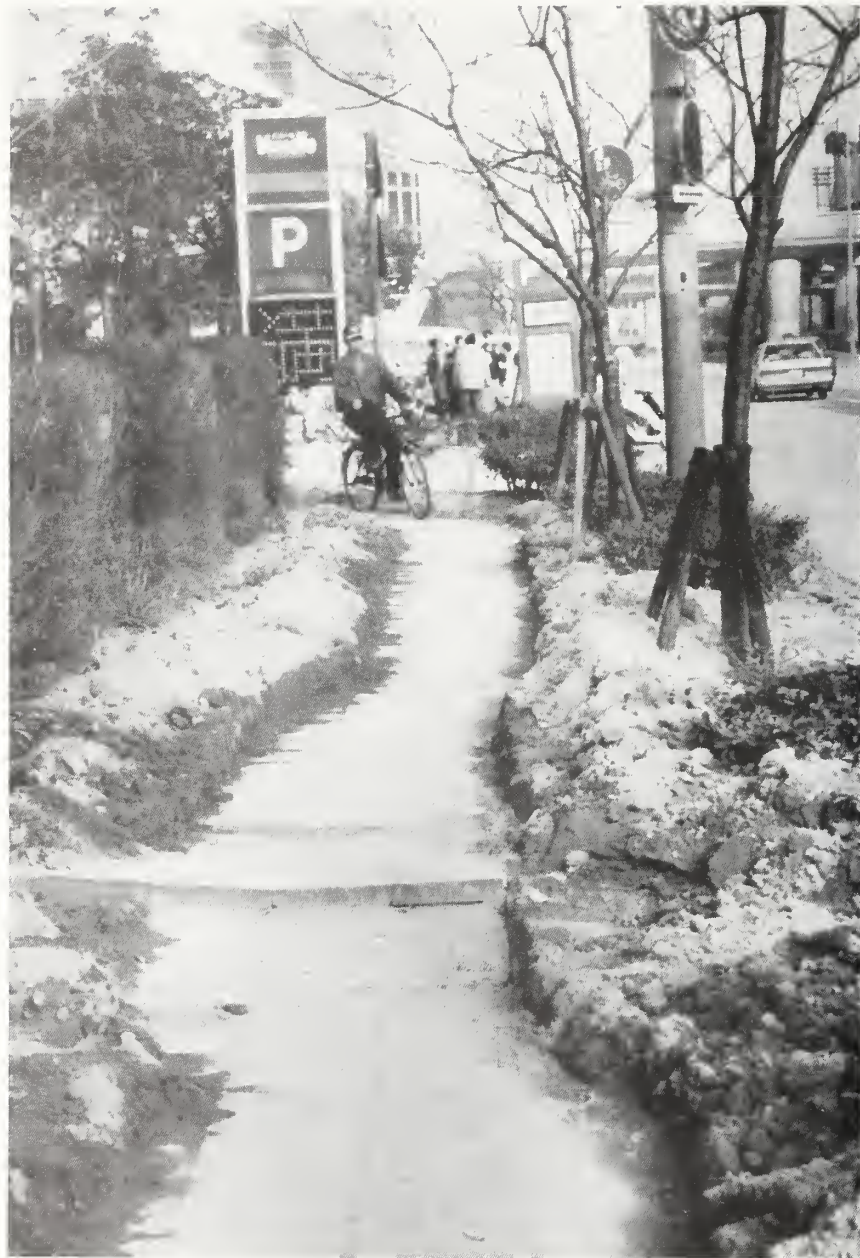
Figure 2.5.1 Path cleared through soil vented by liquefaction that covered sidewalk on Port Island (Photograph by Carol S. Prentice, USGS).

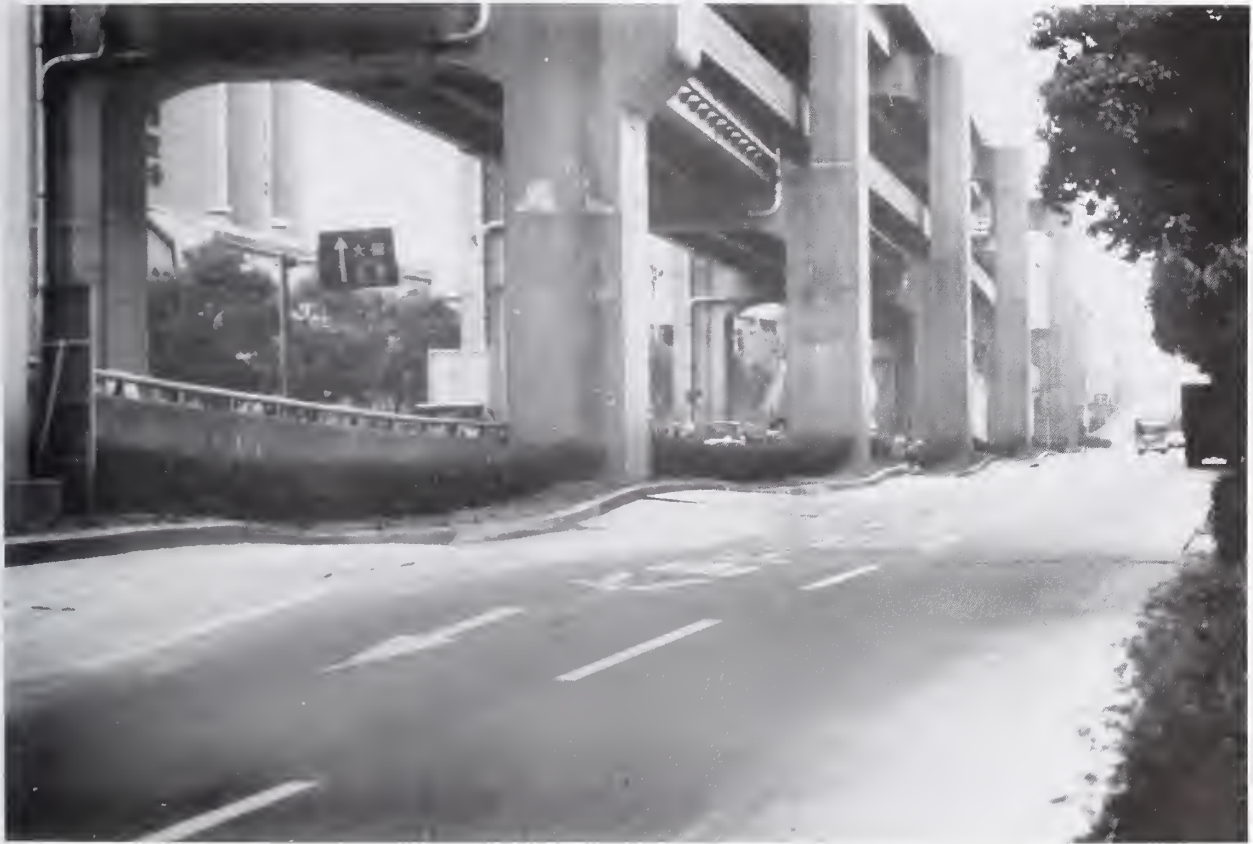
Figure 2.5.4 Differential ground settlement in artificial fill along the Harbor Freeway. Post-liquefaction consolidation cause ground to settle between bridge columns. Columns extend through the liquefied zone. (Photograph by Carol S. Prentice, USGS).

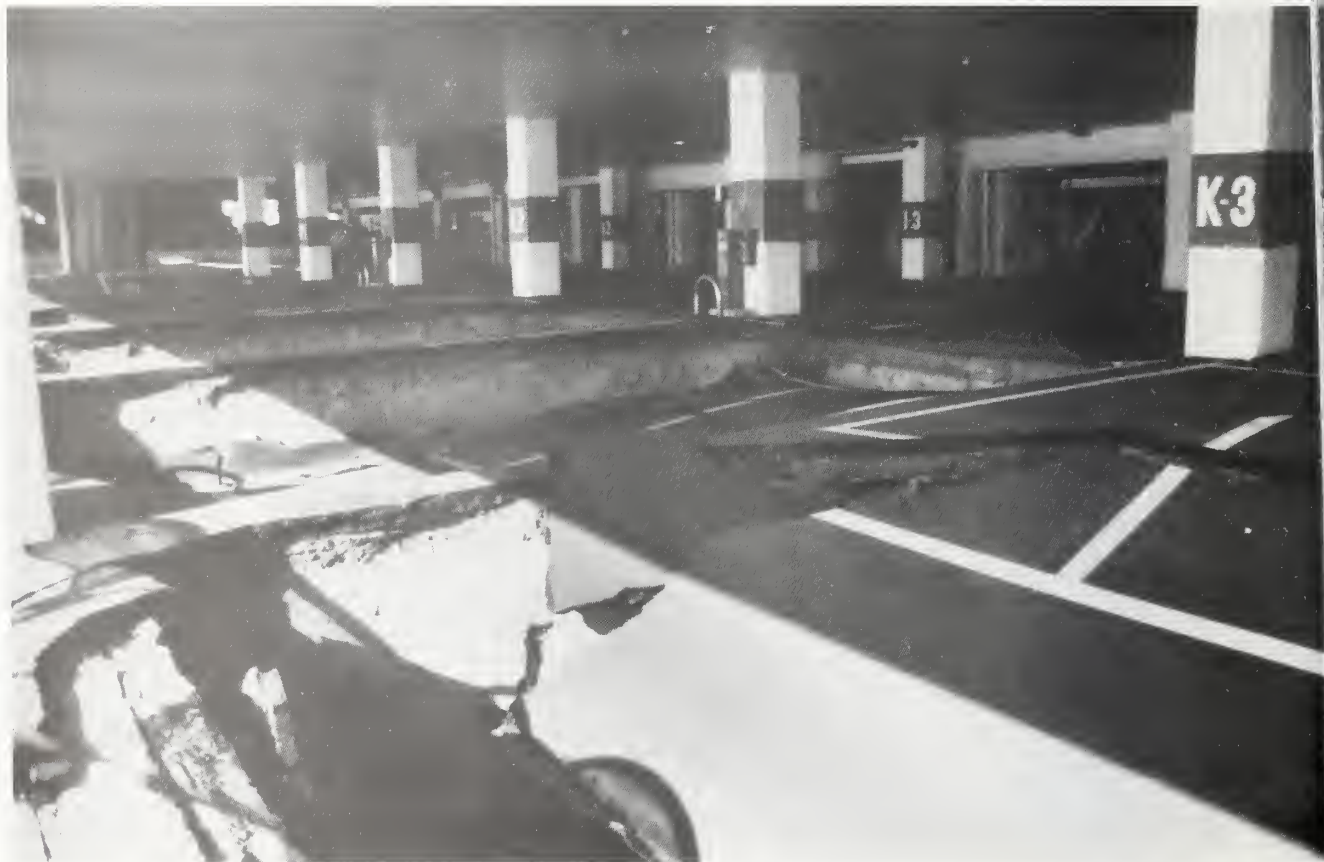
Figure 2.5.5 Differential settlement of about 1 m between columns of parking structure on reclaimed ground near the bridge to Port Island.

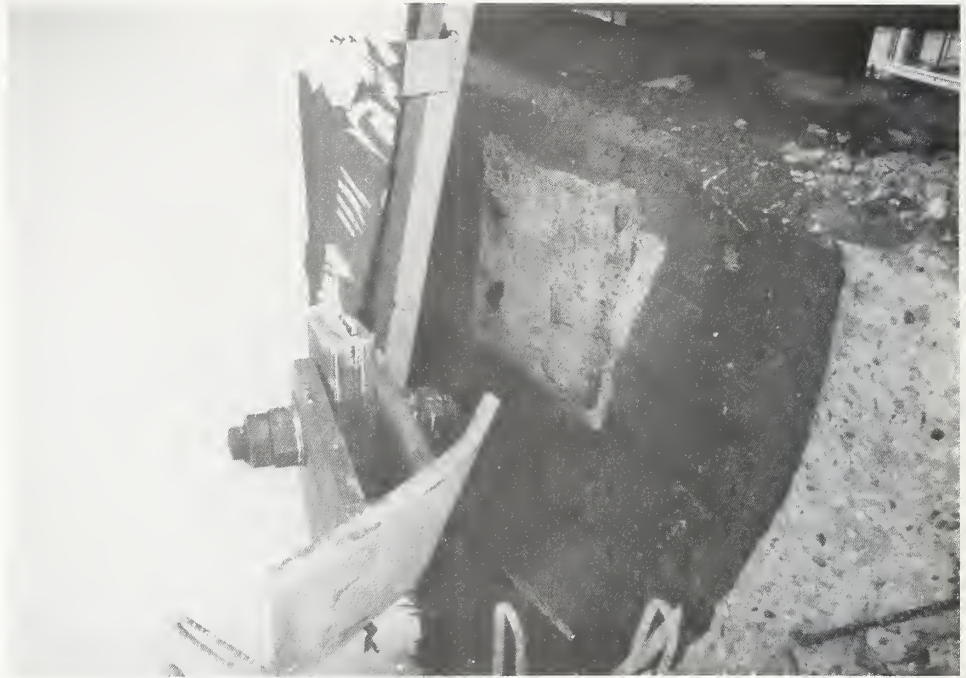
Figure 4.2.11 Damaged restrainer at Abutment A1, Mukogawa Bridge, showing failure of anchor bolts and distortion of web of main girder.

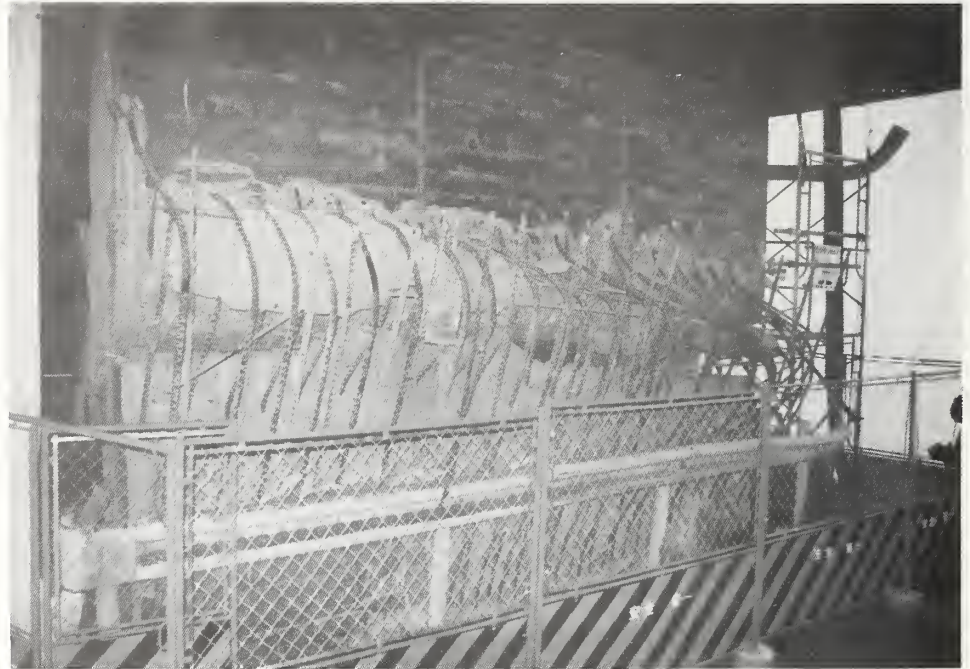
Figure 4.2.24 Shear failure in wall pier (east face), Moribe Viaduct.

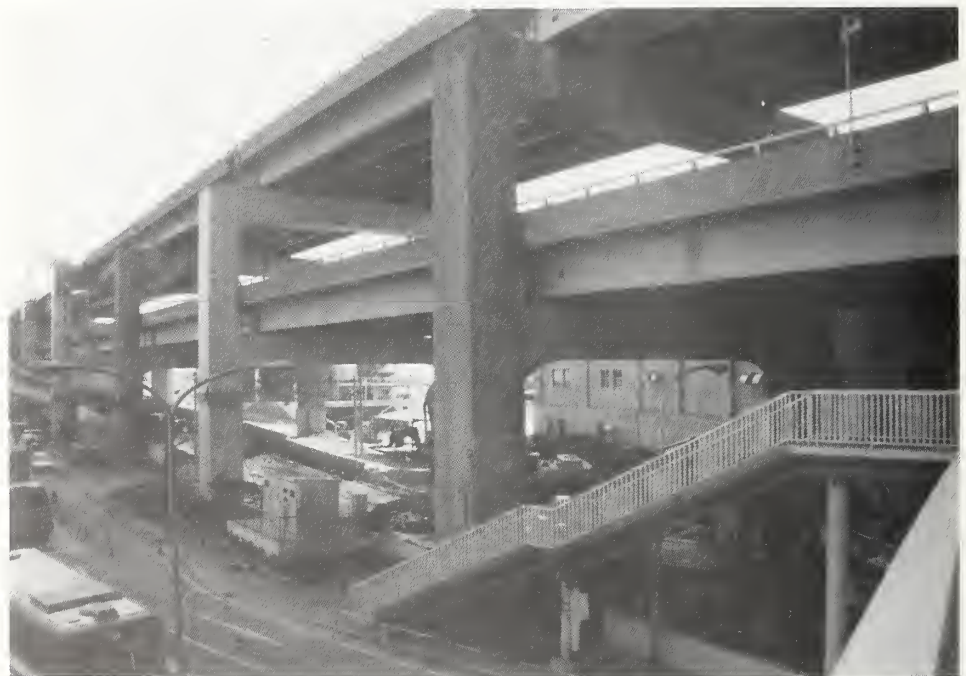
Figure 4.2.25 General view of Kobe-Ohashi Connector near Port Island showing formation of flexural hinges in lower level columns.

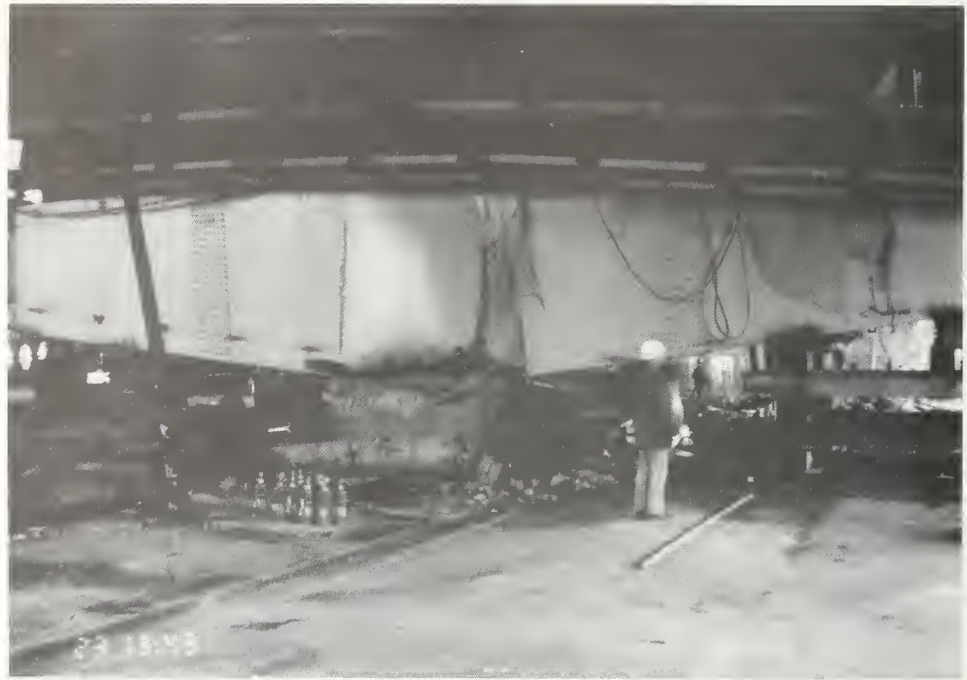
Figure 4.2.33 Pier 55, Route 3 near Tateishi.

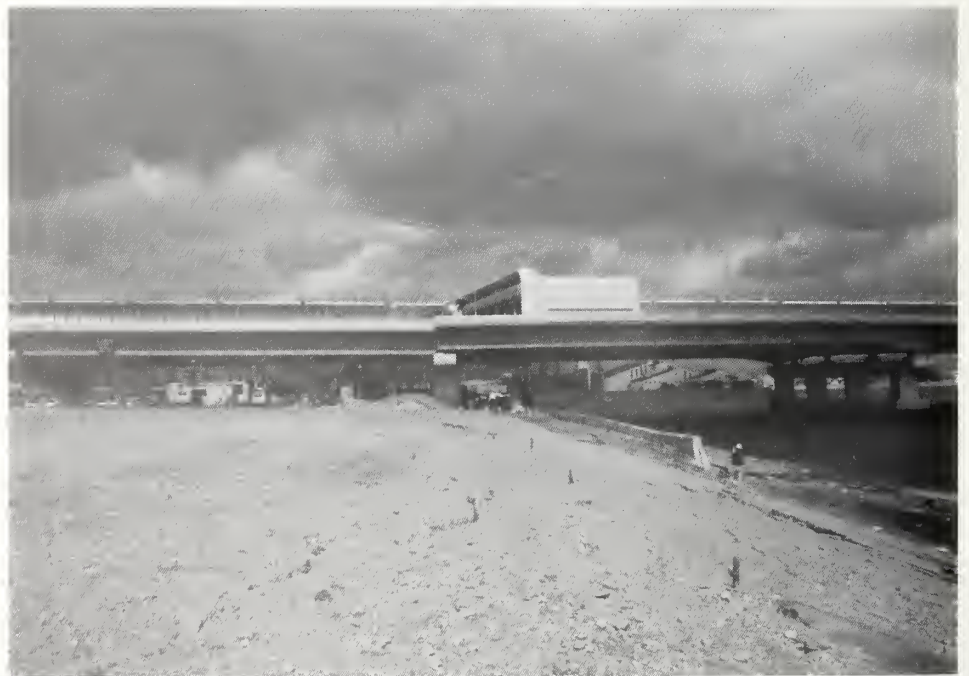
Figure 4.2.42 Distant view of the Shukugawa Bridge showing lateral deformation of the foundation soils and spreading to the right (to the center of the channel).

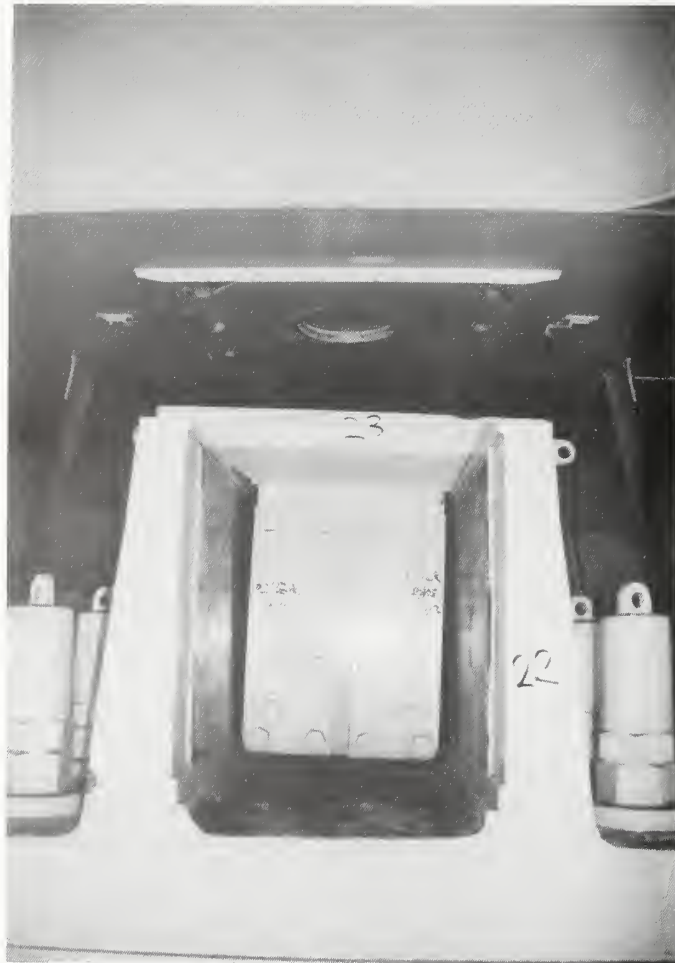
Figure 4.2.48 Failed wind shoe at Pier 187 of the Higashi-Kobe Bridge.

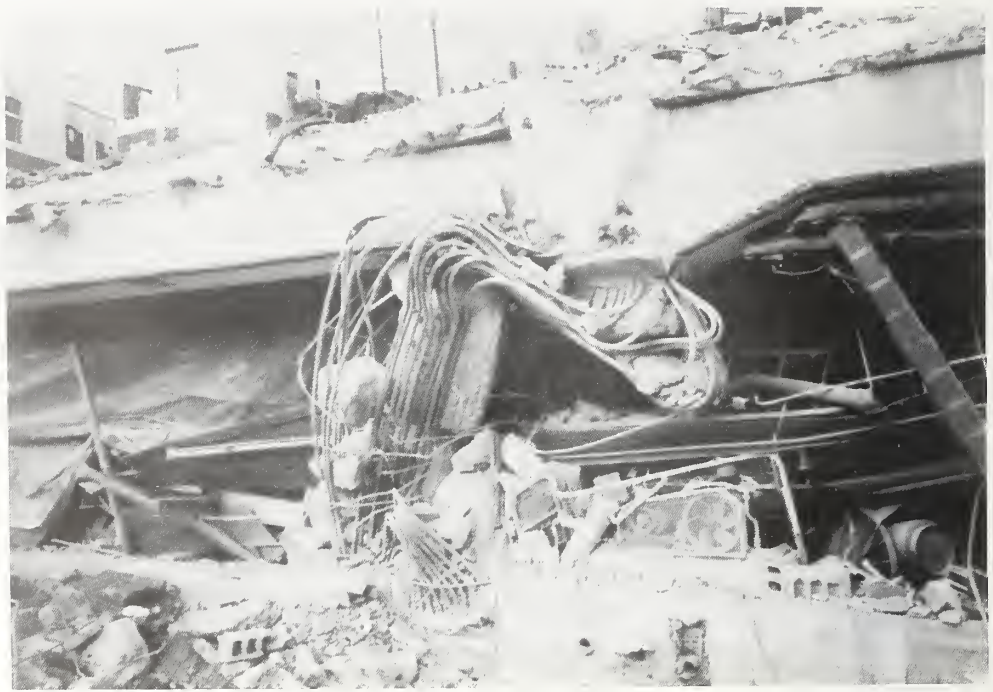
Figure 4.3.9 Failed column at Higashi - Nada - elevated rail yard.

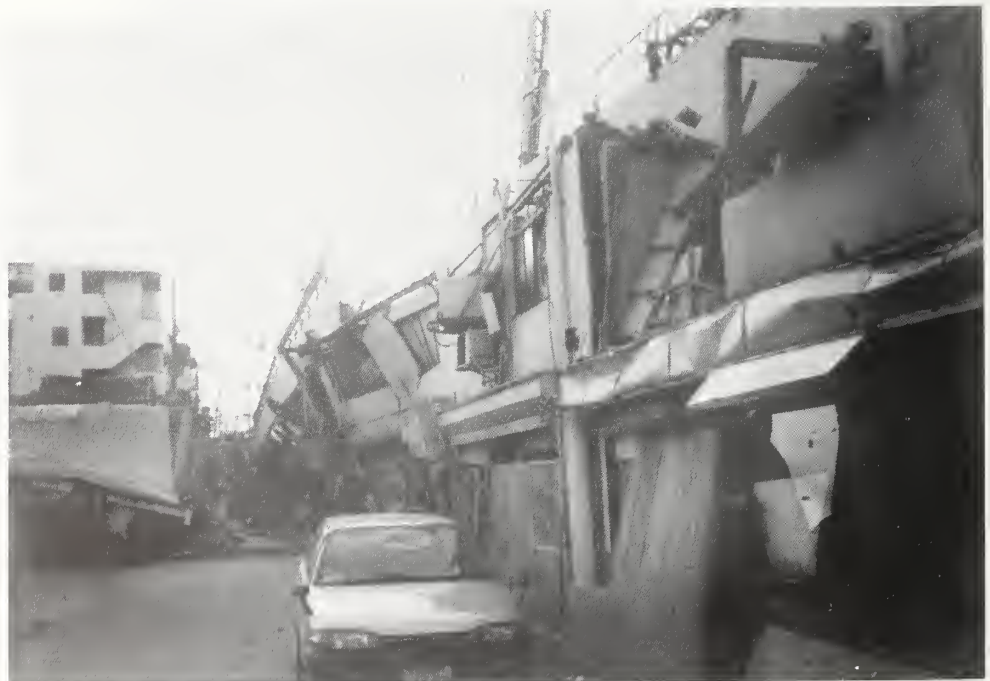
Figure 4.3.10 Collapsed rail yard at Higashi - Nada.

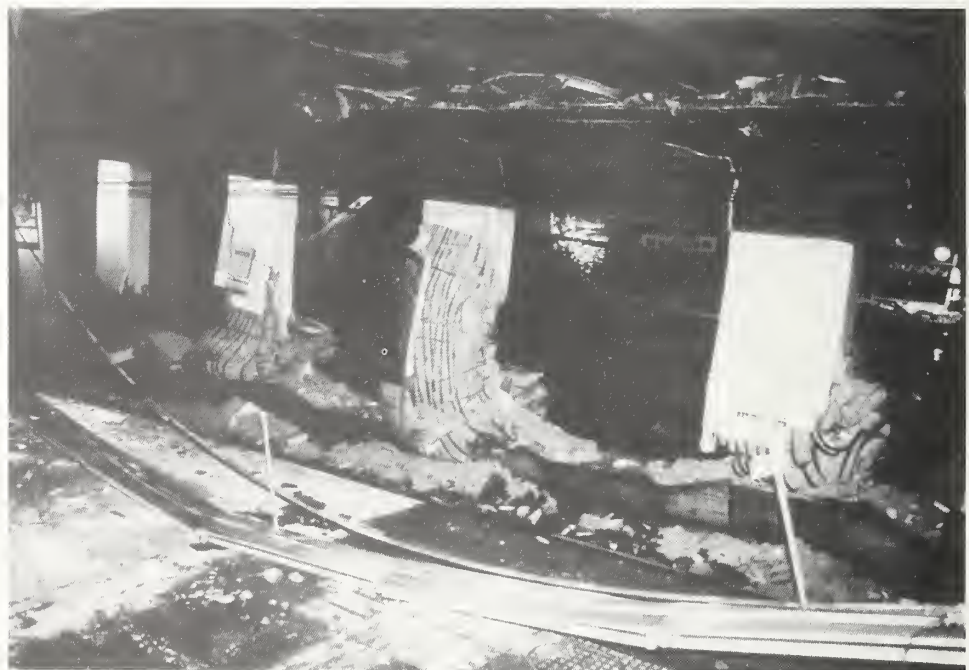
Figure 4.3.20 Compressive failure of center columns at Daikai Station.

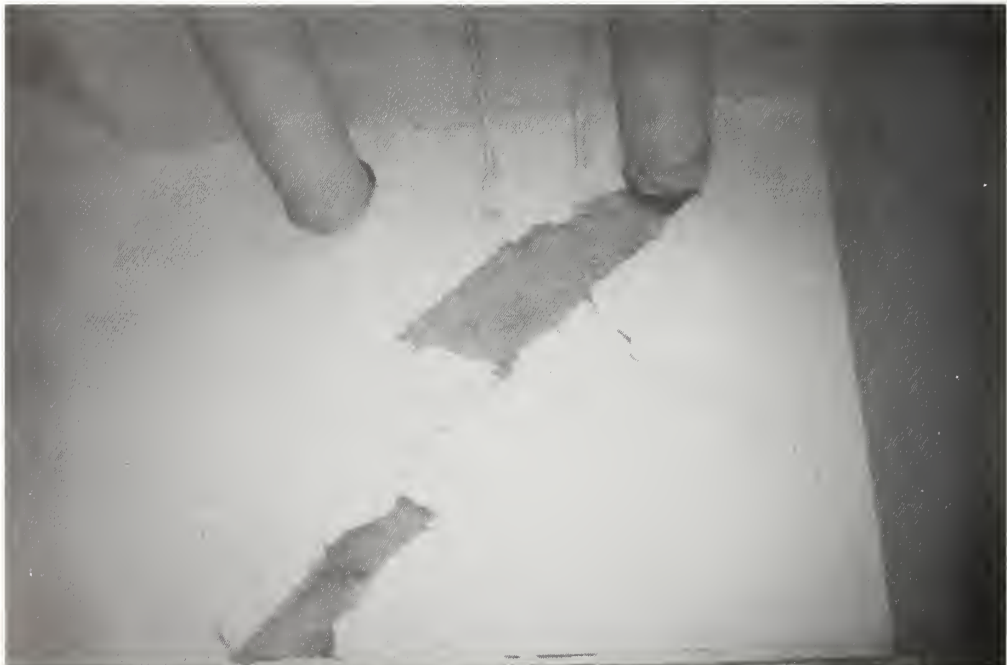
Figure 4.4.27 Cracks in the stair-well shear walls of the Osaka Airport Administration Building.

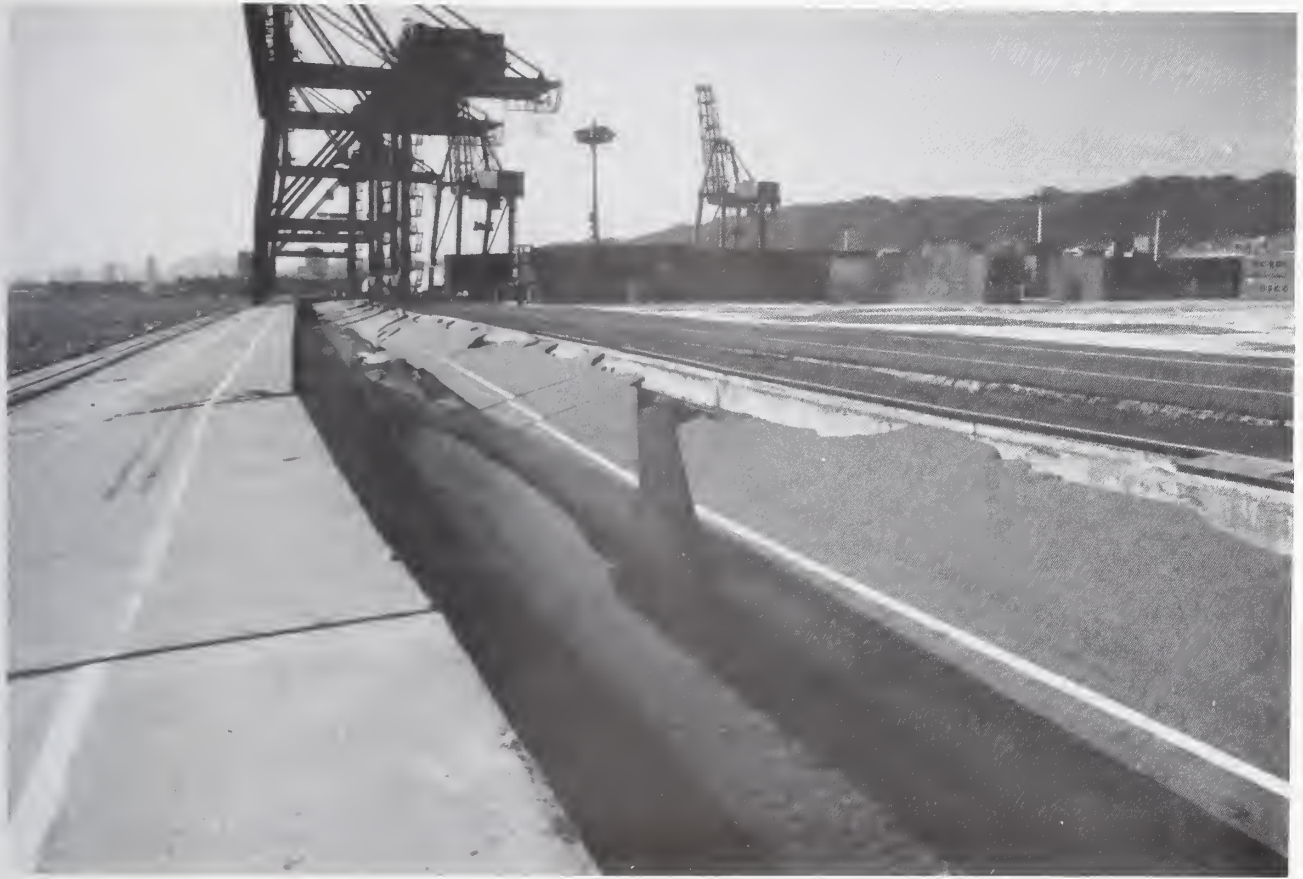
Figure 4.5.5 Damaged to Maya Wharf caused by liquefaction-induced lateral spreading. Downdropped block has formed behind quay wall where land has settled and moved outward. Landward side of block is the pile-supported rear crane rail. Photograph taken February 15, 1995.

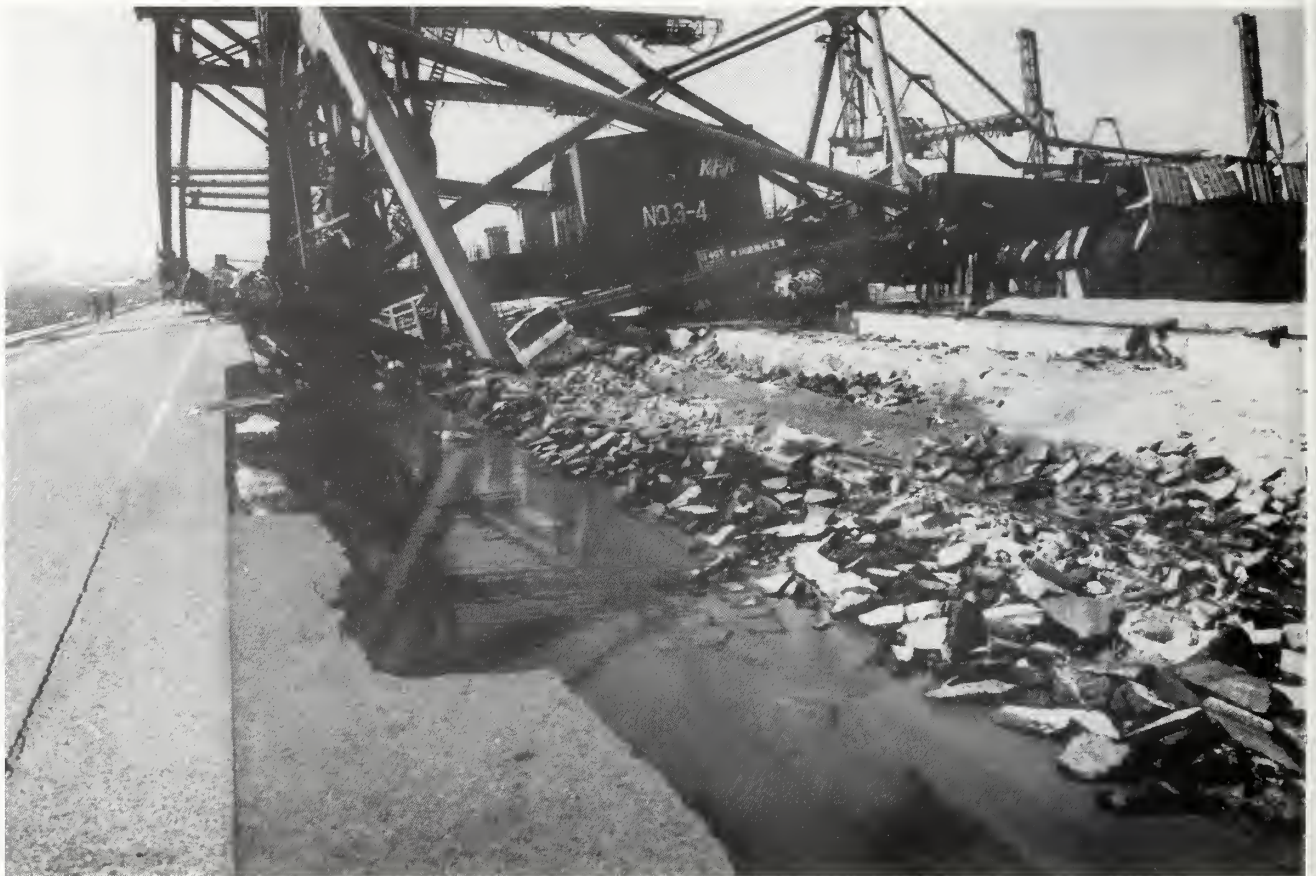
Figure 4.5.6 Collapsed crane caused by permanent differential horizontal displacement between crane rails on Rokko Island. Lateral spreading caused permanent seaward displacement of quay wall and crane rails to pull apart. This caused the legs of the crane to pull apart and crane to topple. Photograph taken February 15, 1995.

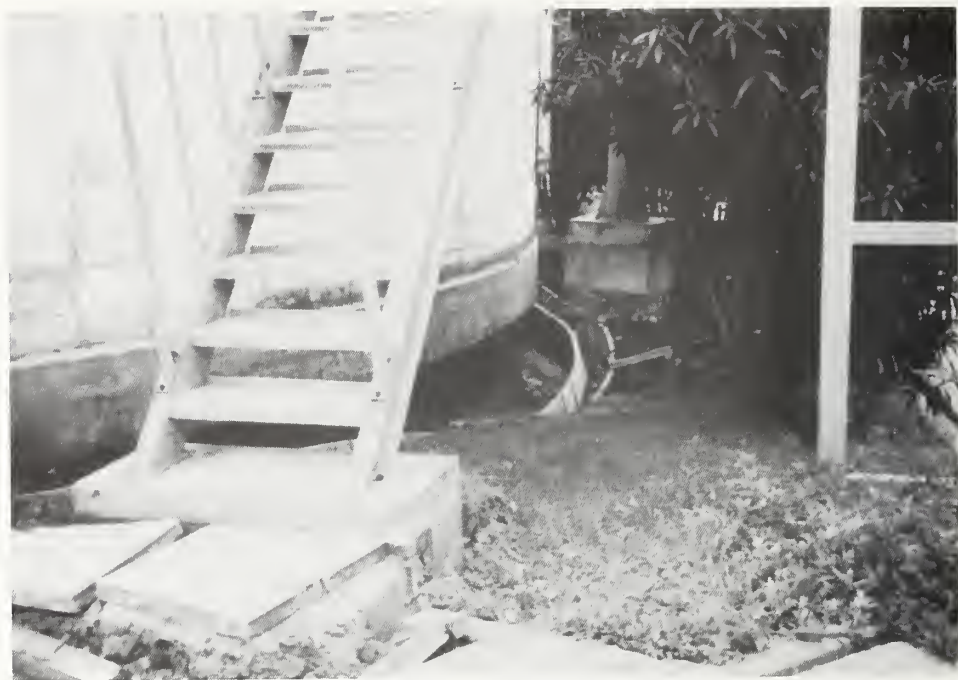
Photo 37 Differential settlement between pipe and non-pile supported structures damaged piping throughout the plant.

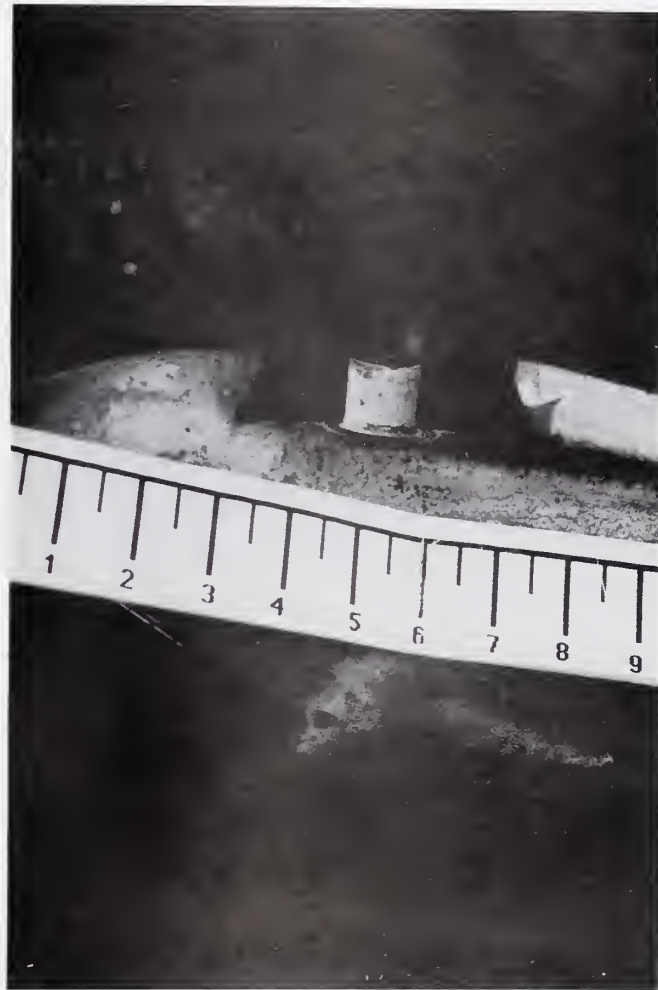
Figure 5.4.21 Failure of a current-voltage transformer base flange.

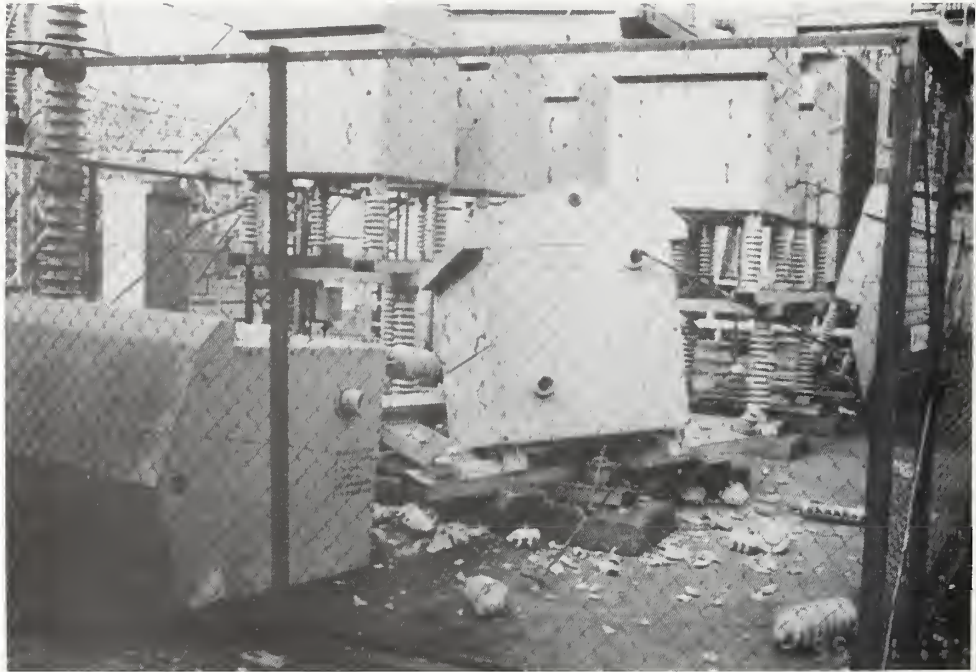
Figure 5.4.58 Neutral resistors failed, a device not used in this configuration in the U.S.

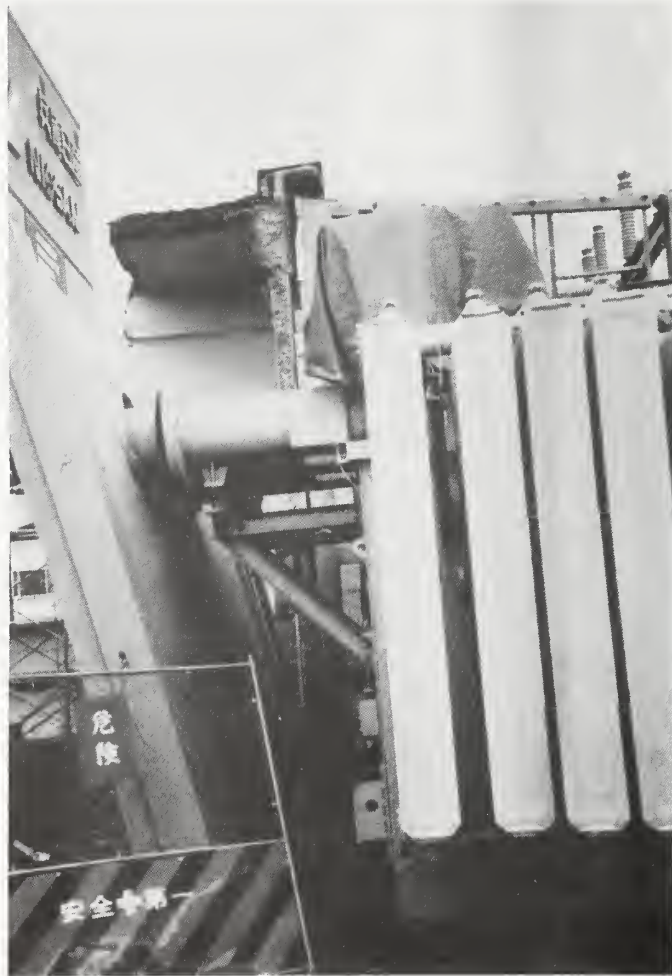
Figure 5.4.61 A transformer pushed over the fire wall after it failed its anchorage.

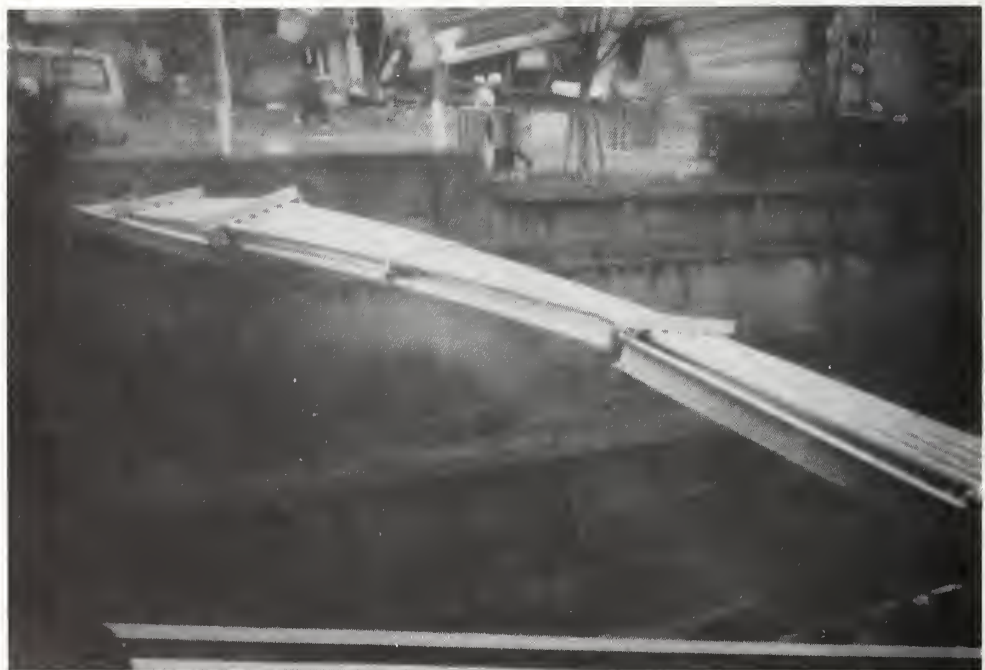
Figure 5.5.13 Walls of a canal moved causing conduit bridge and conduit to buckle.

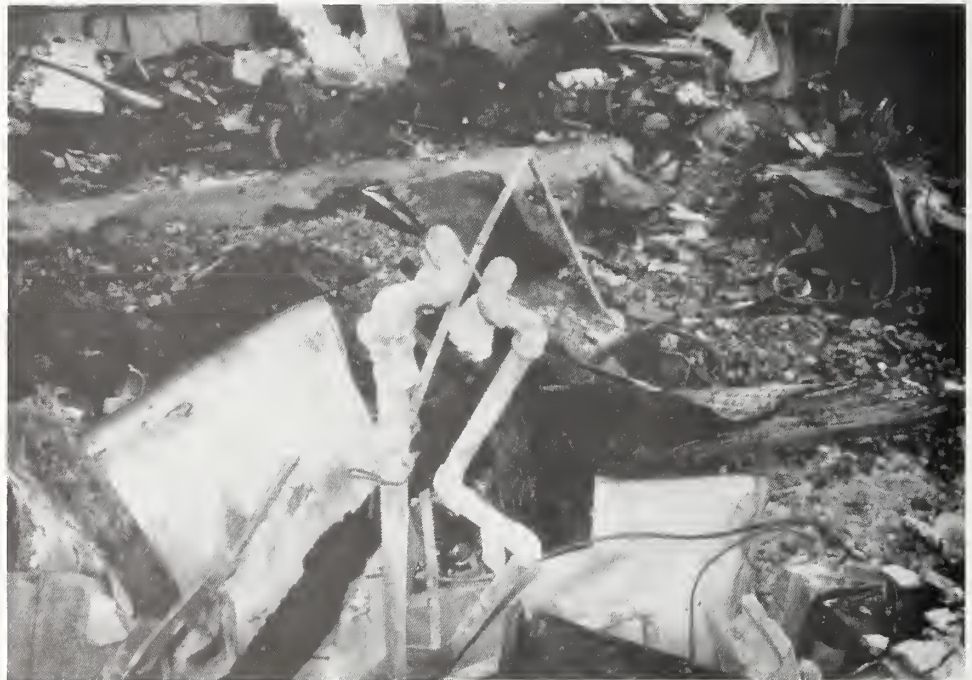
Figure 6.2.4 Broken gas meter connection.
