# AIRCRAFT ACCIDENT REPORT

AAXICO AIRLINES, INC.,  
C-46-F, N 67935, McCARRAN FIELD  
LAS VEGAS, NEVADA  
SEPTEMBER 25, 1963

## SYNOPSIS

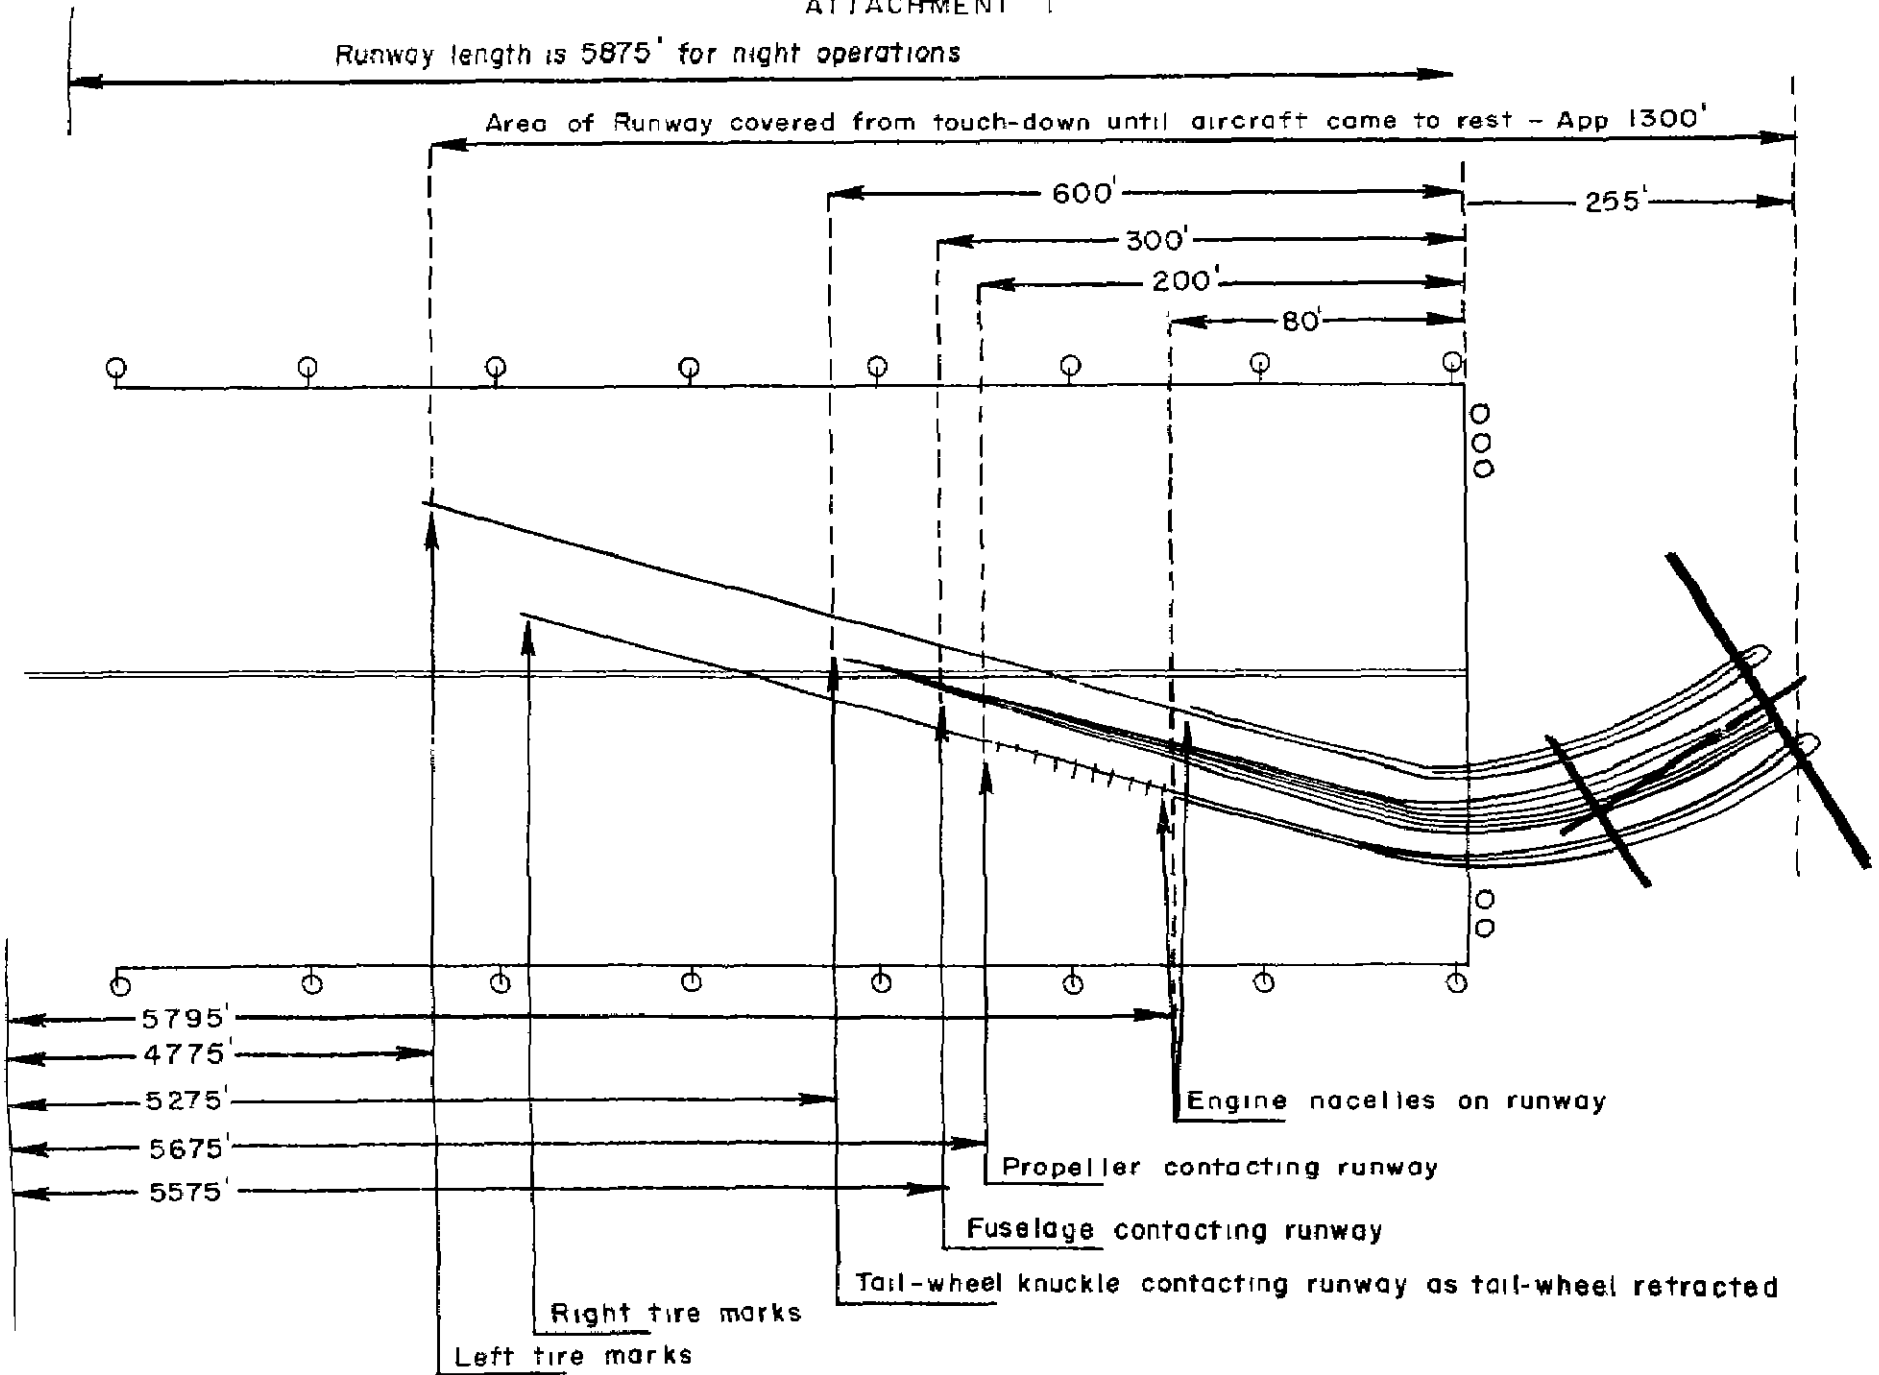
ATTACHMENT 1

Investigation revealed that heavy tire skid marks were present on the runway beginning 4,775 feet from the first runway light near the threshold and continuing for a distance of approximately 800 feet. The left tire skid mark varied from 5 to 10 inches in width. The right tire skid mark was not as dark as the left mark and remained approximately 10 inches in width along its entire length. Approximately 500 feet from the beginning of the tire skid marks (5,275 feet from the initial thresh-

old light), tail-wheel fork-knuckle skid marks appeared on the runway. Four hundred feet farther, (5,675 feet from the initial threshold light) numerous propeller slash marks appeared on the runway. The aircraft then skidded 300 feet and came to rest 180 feet beyond the departure end of the runway with the fuselage on a heading of 346 degrees magnetic (See Attachment 1)
