USDA FOREST SERVICE
RESEARCH PAPER INT-97
1971

INVESTIGATION OF SLOPE FAILURES IN THE IDAHO BATHOLITH

M. J. Gonsior and R. B. Gardner

INTERMOUNTAIN FOREST AND RANGE EXPERIMENT STATION
Ogden, Utah 84401

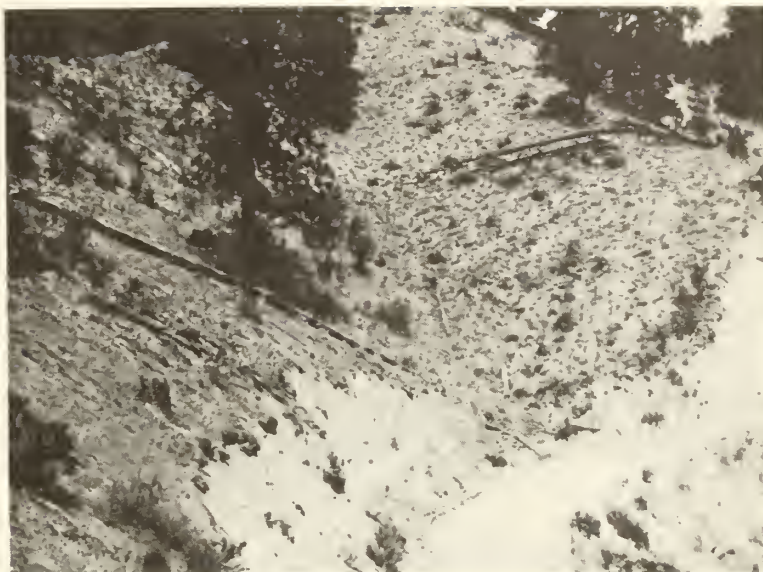
Figure 13.--This illustrates proximity of site 917-1 to ridgetop.

Site 917-1. As shown in figures 13 and 14, this site is a stable embankment crossing a small gully on Road 917 and is located approximately 1.7 miles from the junction of Road 917 and the main Secesh Road (fig. 4). A plan view and three profiles are shown in figure 15.

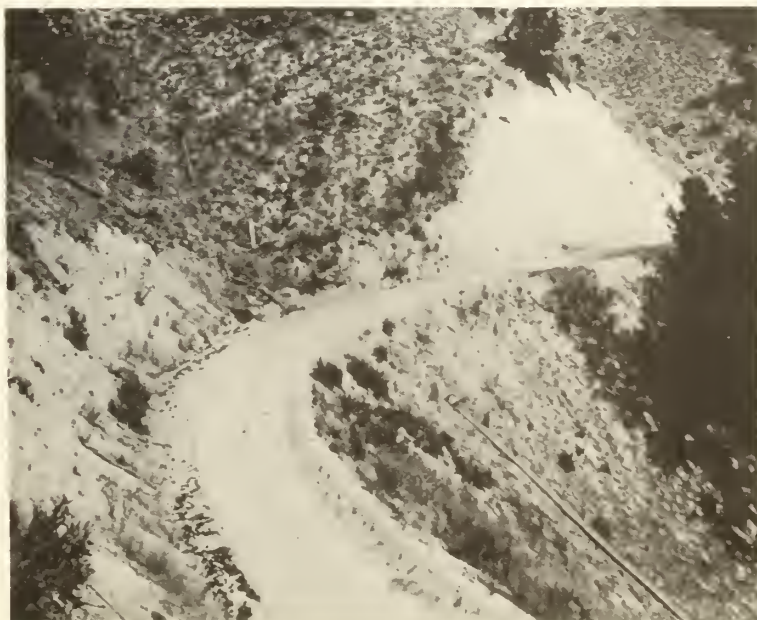
Provisions for surface drainage seem to be adequate at this site. A culvert has been properly installed in the embankment with a suitable downspout and wire mesh catchment to dissipate the hydraulic energy. The close proximity of the site to a ridgetop can be seen in figure 13, illustrating the relatively small drainage area contributing to the culvert flow. The road has a 9 percent favorable grade at this location and a similar embankment with drainage equally well provided for is located only about 100 yards up the road (east) from this site. Therefore, surface water flowing down the road does not present a drainage problem at site 917-1. A soil-cement berm, which can be seen in figure 14, prevents road-surface water from eroding the outside slope of the embankment.

Figure 14.--This illustrates berm and culvert downspouts for proper handling of water at site 917-1.

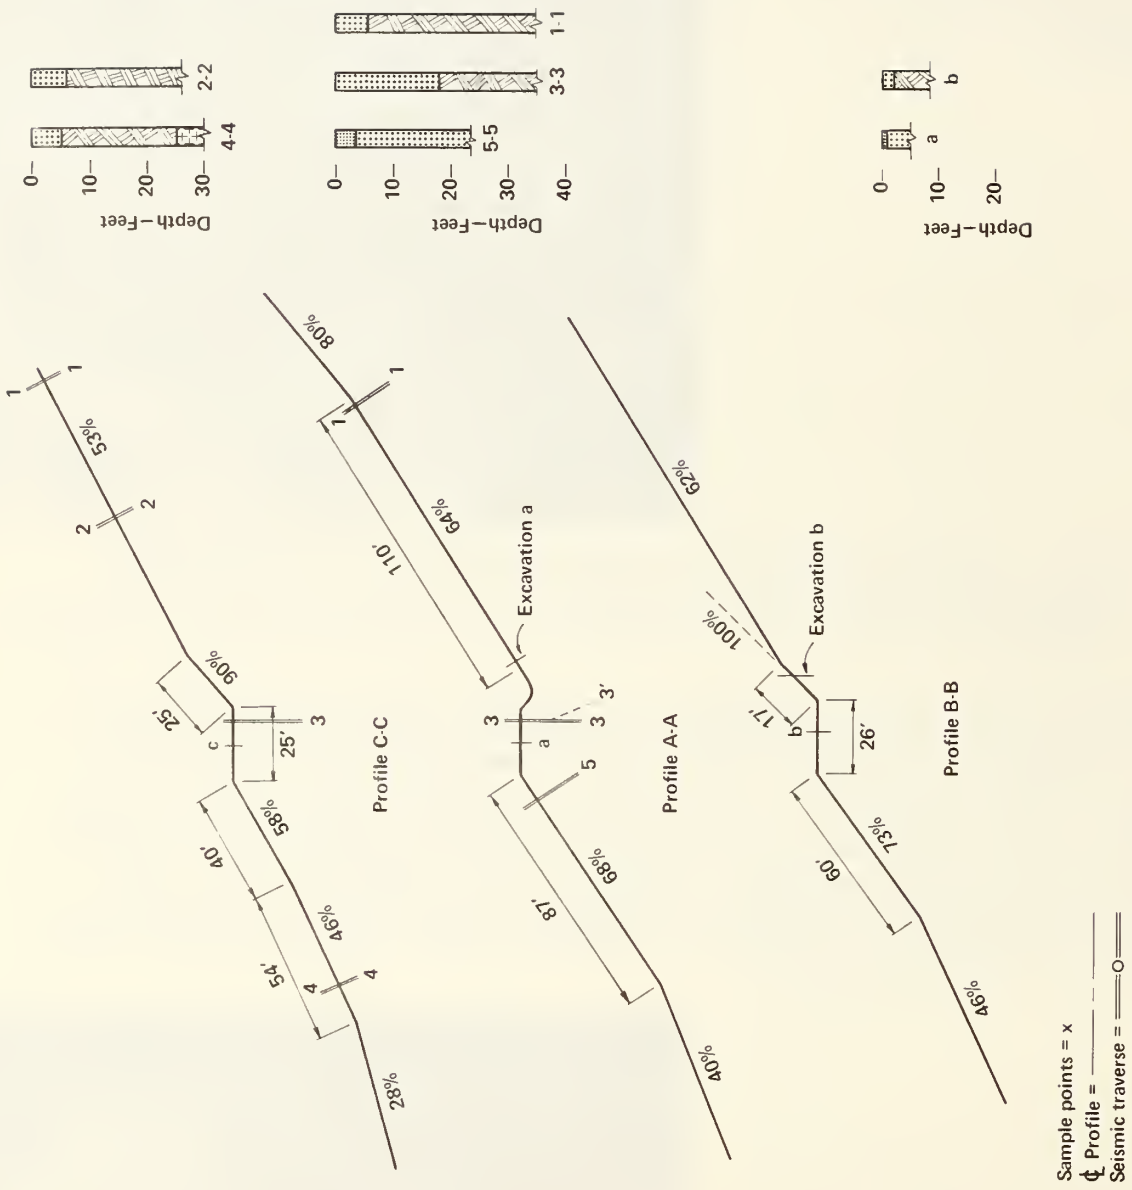
Figure 15.--Description of test site 917-1.

Five seismic traverses were run at site 917-1; the approximate locations are shown in figure 15. The small circles on the double lines represent the approximate locations at which the seismic interpretations are valid. Following are the interpretations, with the accompanying seismic velocities included:

Lines A-A, B-B, and C-C in the figure are the locations of the profiles sketched adjacent to the plan view in figure 15.

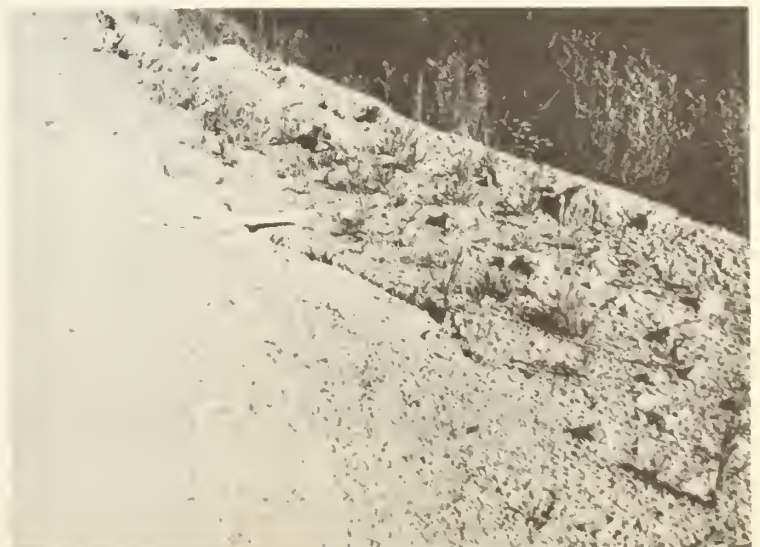
Figure 21.--Evidence of incipient failure at site 917-3, cracking and settlement of fill.

Site 917-3. This site, shown in figures 21-23, is located on Road 917 approximately 4.2 miles from the junction of Road 917 and the main Secesh Road (fig. 4). Considerable importance is placed upon the analysis of this site, primarily because failure is impending, as evidenced by cracking in the road surface and settlement of the outside portion of part of the fill (figs. 21 and 22). In addition, a narrow portion of the fill has failed, as shown in figure 23. Thus, this site offered the best opportunity for material sampling and definition of the mode and shape of failure.

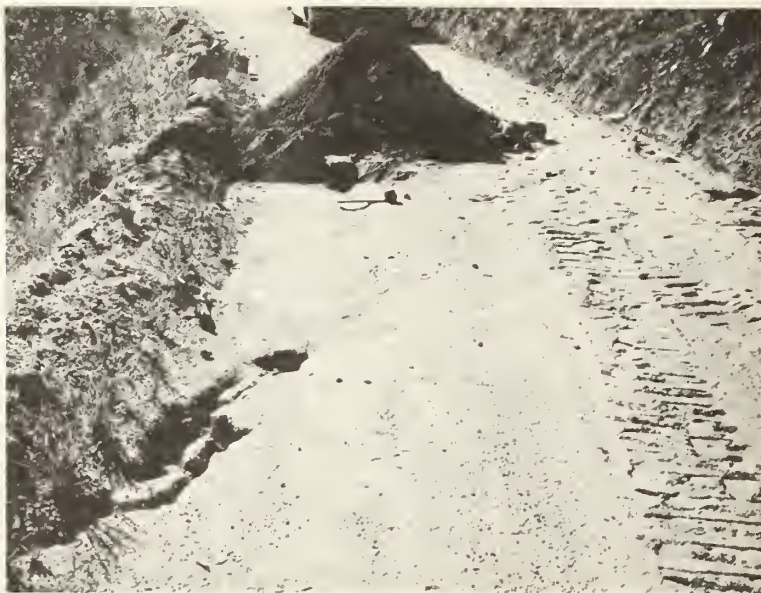
Figure 22.--Additional evidence of incipient failure, site 917-3 (test pit excavation shown in top of photo).

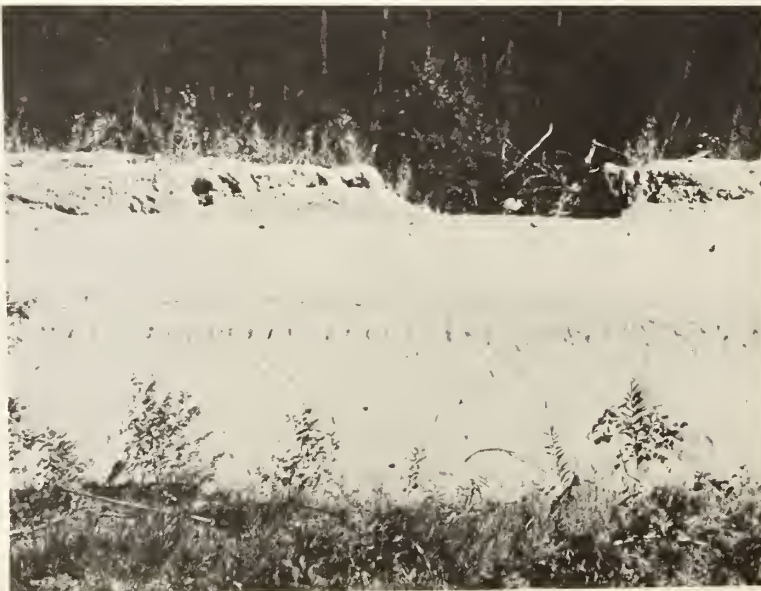
Figure 23.--Narrow failure on fill at site 917-3.

The low depth-to-length ratio of the failure at this site suggests that the infinite slope stability theory might be applied. Assuming a depth no greater than one-twentieth the length, or about 3.5 feet, developed cohesion values of only 0.18 and 0.03 p.s.i. are necessary for stability in the absence of seepage forces, for $\phi = 35^\circ$

and 38° , respectively. Under the extreme condition that would permit seepage throughout the fill, with a top flow line coincident with the fill slope, the necessary developed cohesion values would be 0.83 and 0.75 p.s.i. for $\phi = 35^\circ$ and 38° , respectively. Such an extreme seepage condition seems unlikely at this site, although it has already been noted that water collected on the road at this location. It is possible, however, that water infiltrating from the road surface combined with the ground water, resulting in emergence of the water at some location above and near the toe of the fill slope. A subsequent "blow out," or quick condition might have occurred locally, and the resultant loss of support at the toe would have allowed the upslope material to slide.

In any case, the analyses of this site and of site 917-1 seem to indicate that a more realistic value for the friction angle in this material might be about 38° .

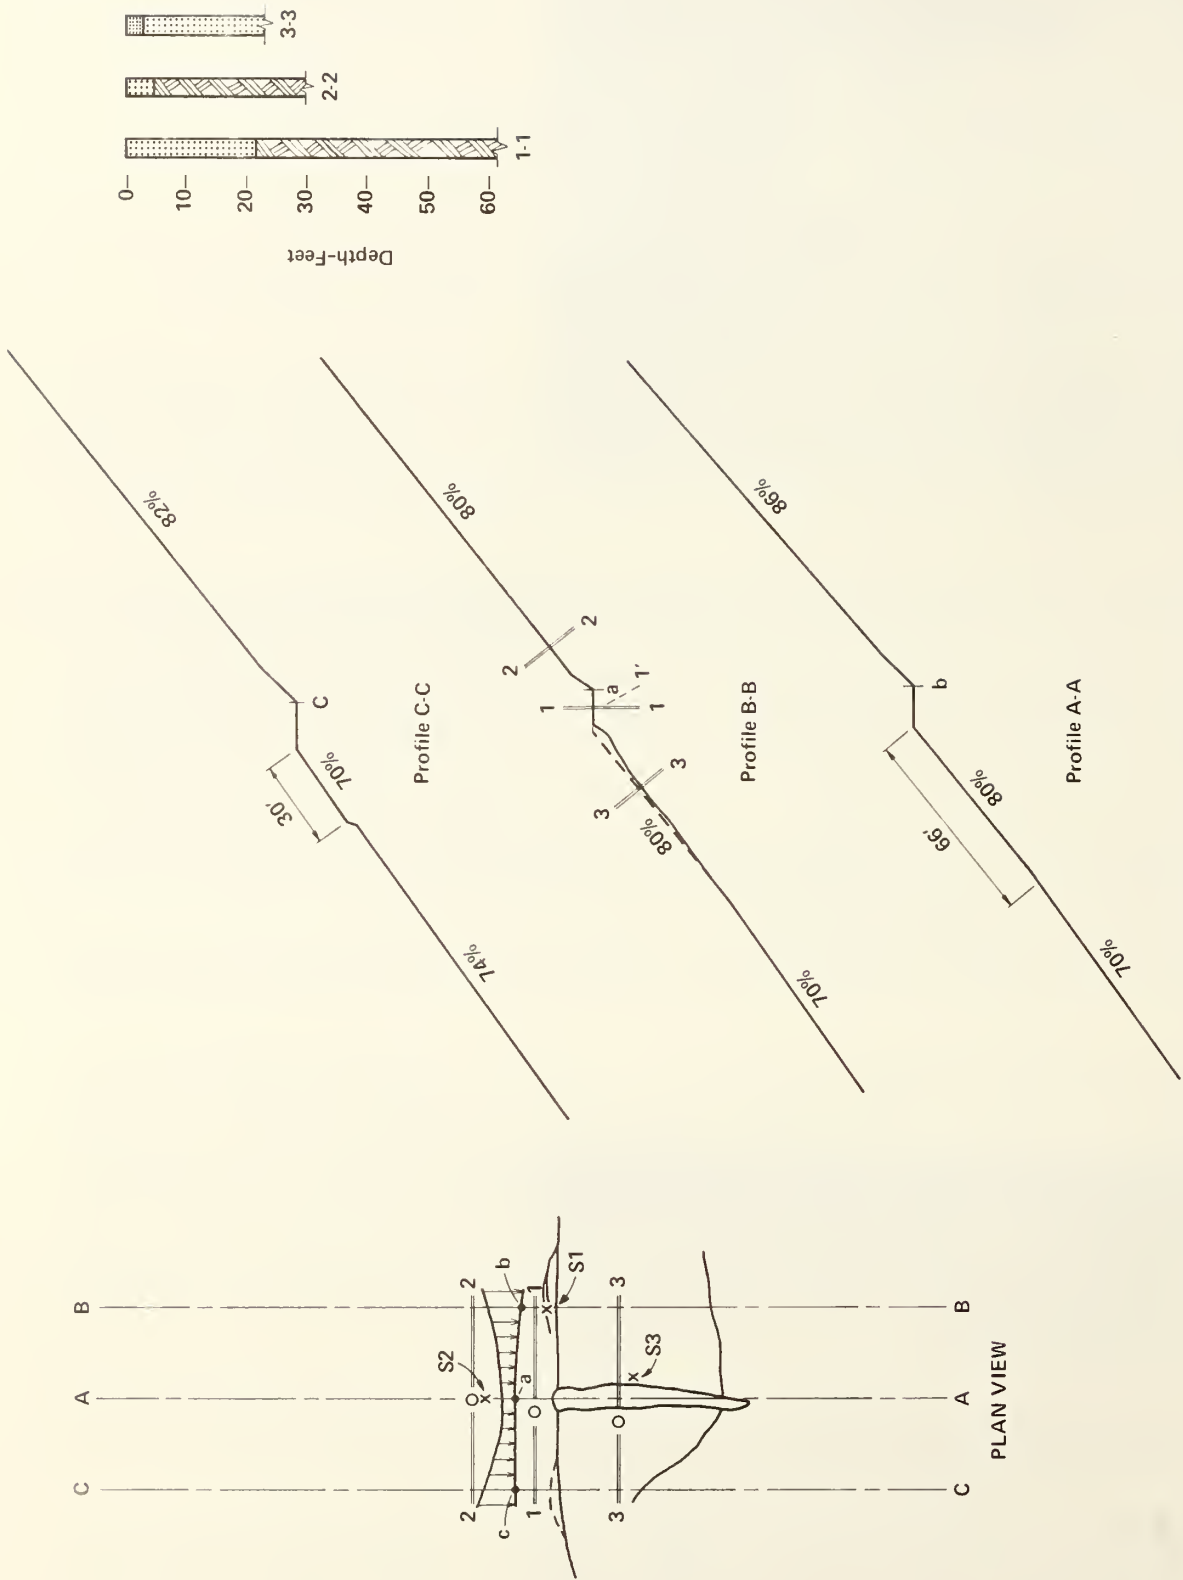
Figure 24. --Description of test site 917-3.

Plan view and profile sketches appear in figure 24, along with pertinent seismic profile and test pit information.

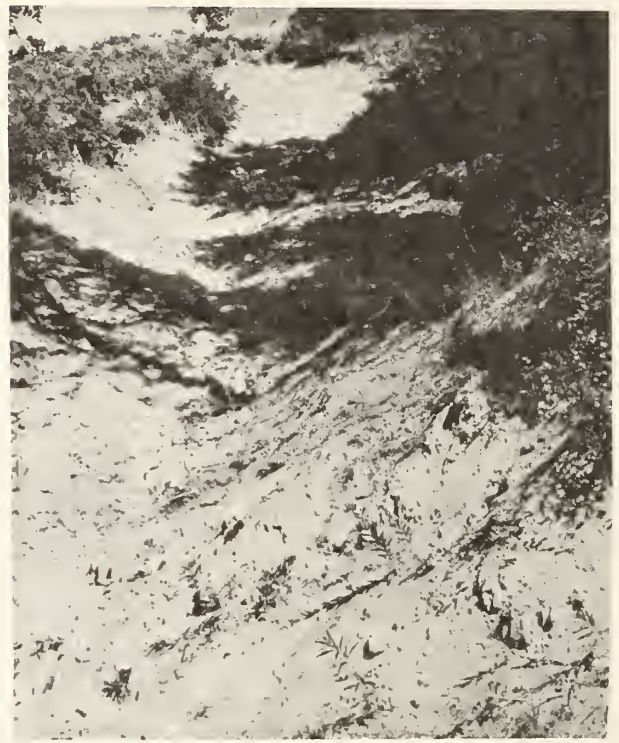
Site 917H-3. This site is a relatively long, narrow failure of material lying in a swale above Road 917H at a location within 100 yards of site 917H-2. It is pictured in figures 26 and 27, as viewed from the bottom and top of the failure, respectively.

Figure 26.--View from below site 917H-3, illustrating its long, narrow, and shallow characteristics.

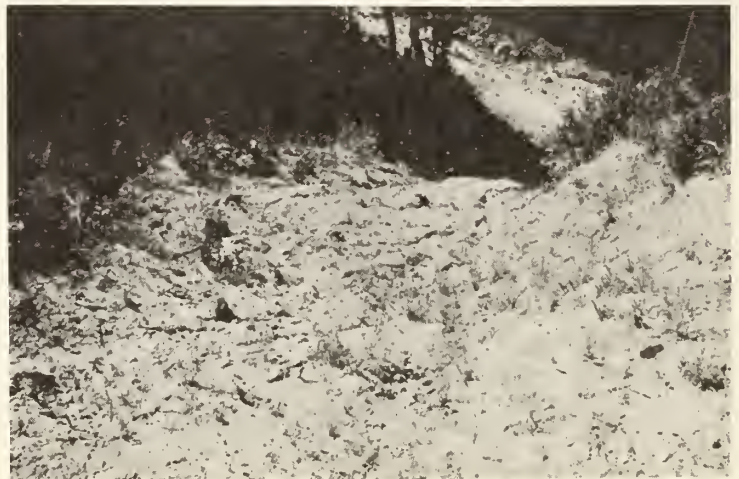
Although the road cut intersected the bottom of the swale, it is difficult to state with certainty that this resulted in sufficient loss of support to cause failure. By using appropriate techniques for the analysis of stability of a cohesive, infinite slope, it is apparent that the natural slope might have failed in the absence of road construction. Such an analysis follows:

Figure 27.--View from above site 917H-3, illustrating road at bottom.

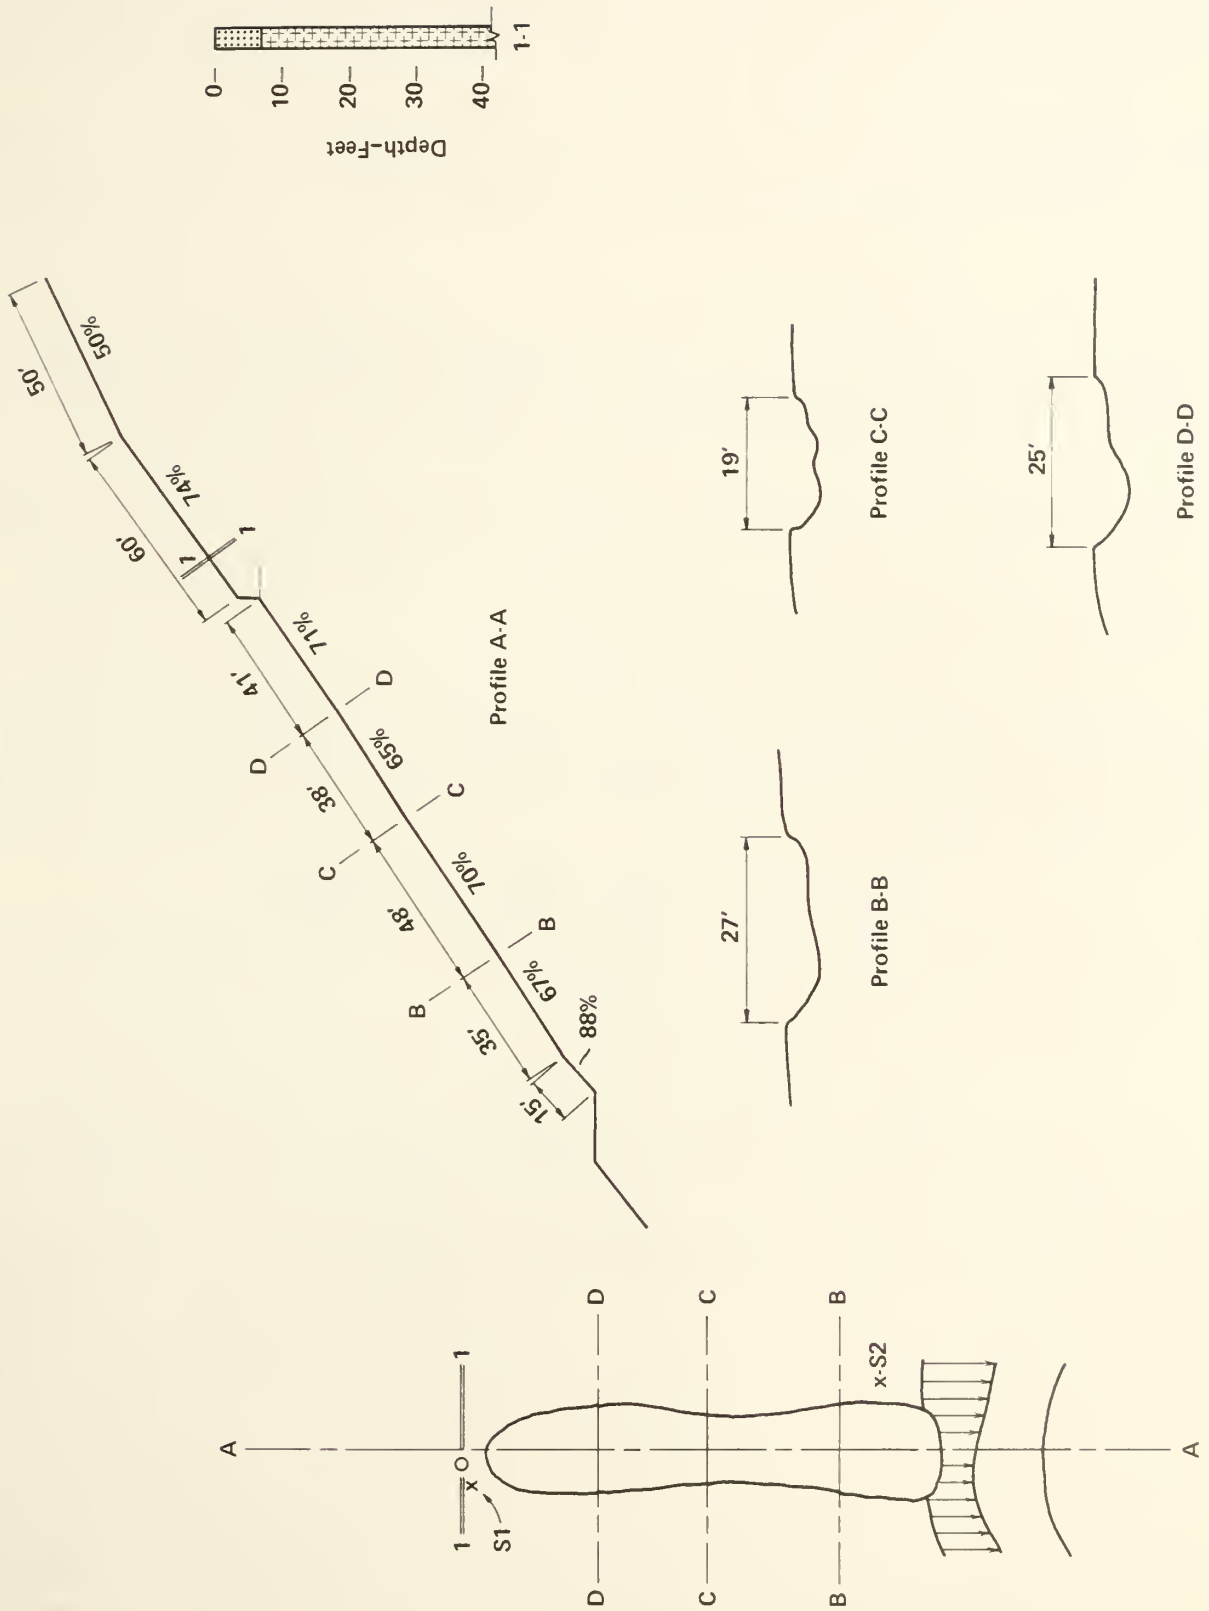
Figure 28.--Description of test site 917H-3.

Plan view and profile sketches of the site are presented in figure 28. The seismic interpretation at traverse 1 is: 6.7 feet of loose material (1,140 f.p.s.) overlying at least 35 feet of solid rock (10,000 f.p.s.).
