13. Code No. 38-15: Sakuyama Plant, Dai-Nippon Koku K.K.
(Japan Aircraft Manufacturing Plant)

8. Code No. 38-17, Pine Sewing Machine Mfg. Co.,
950, Shimo-Hiraide, Hiraishi-mura, Kawachi-gun, Tochigi-ken

12. Code No. 38-19: Kanto Industrial Co., 608, Suzumenomiya,
Suzumenomiya-mura, Kawachi-gun, Tochigi-ken

11. Code No. 38-20: Kanuma No. 2 Plant, Nippon Zoki K.K.,
393, Shimofudokoro, Kanuma-shi, Tochigi-ken

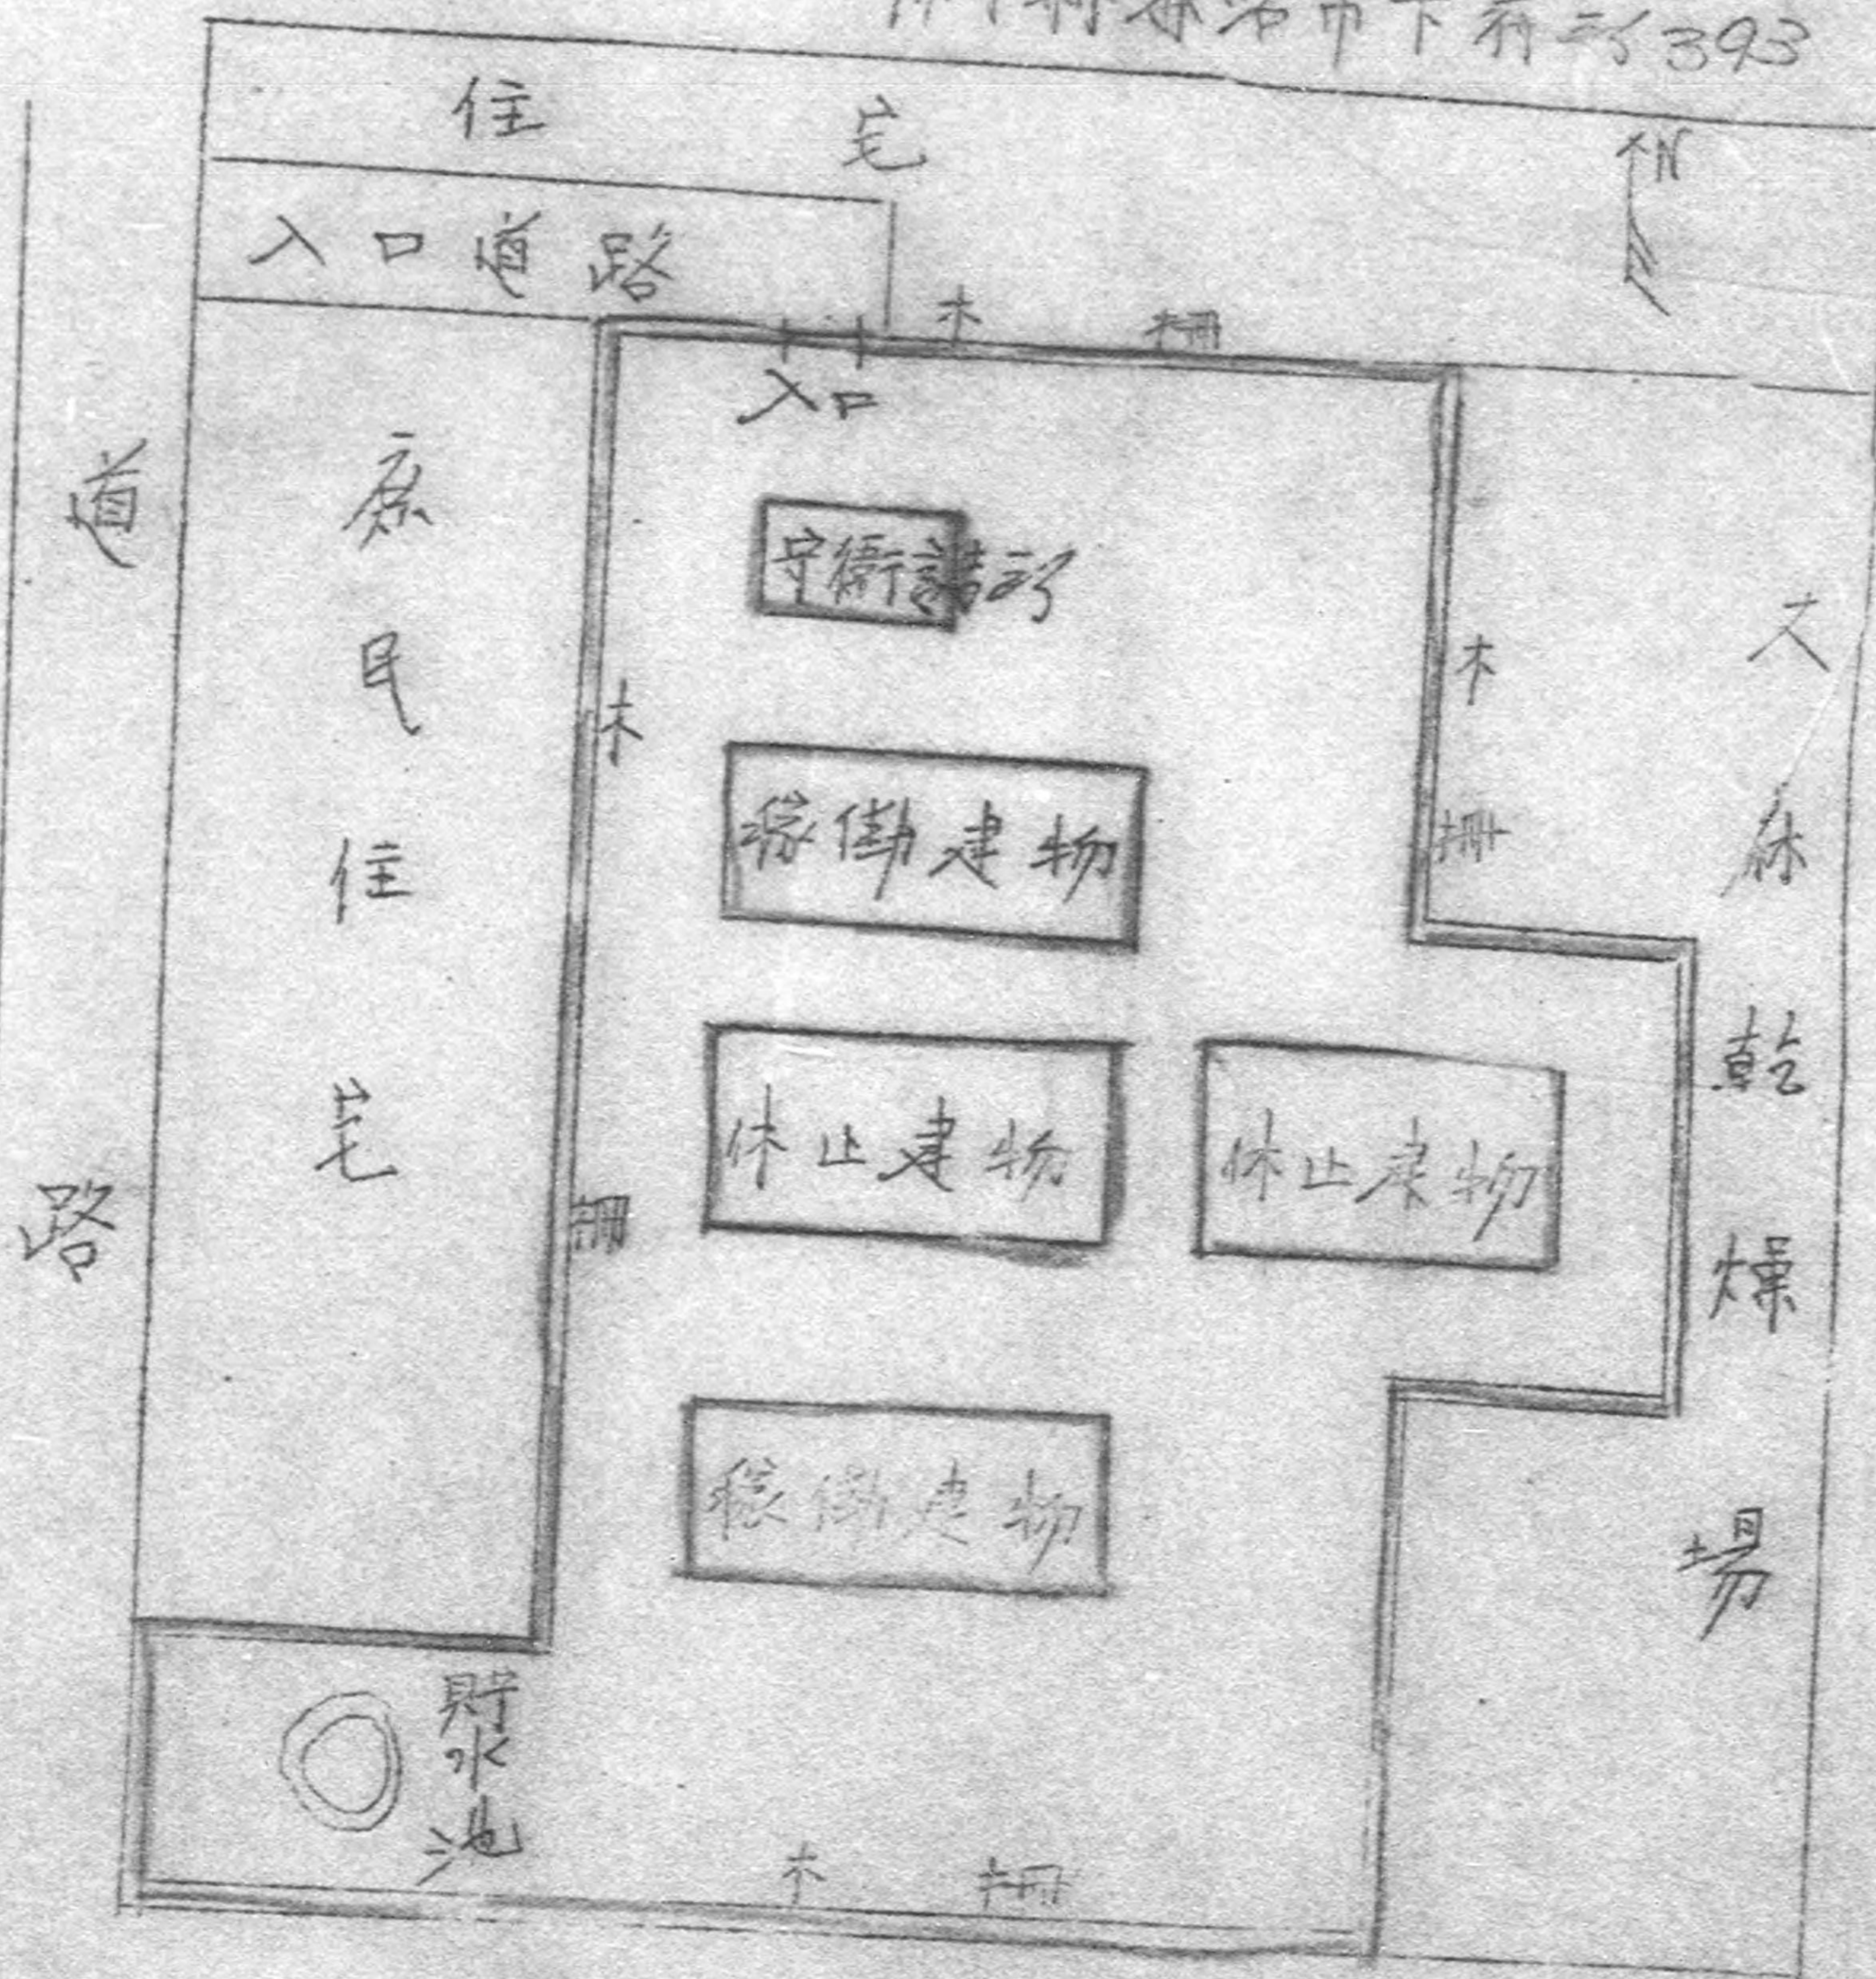
日本造機株式會社
 38-20. 第二工場
 篠木縣沼市下町393

Majority of the machines were used during the war time and there are much wears and tears on them. Few of them are adequate enough for operation.

Protection. Log fence of 7 feet in height surrounds the plant.
