RAILROAD ACCIDENT REPORT

HEAD-END COLLISION OF
AMTRAK PASSENGER TRAIN NO. 74
AND CONRAIL TRAIN OPSE-7
DOBBS FERRY, NEW YORK
NOVEMBER 7, 1980

NTSB-RAR-81-4

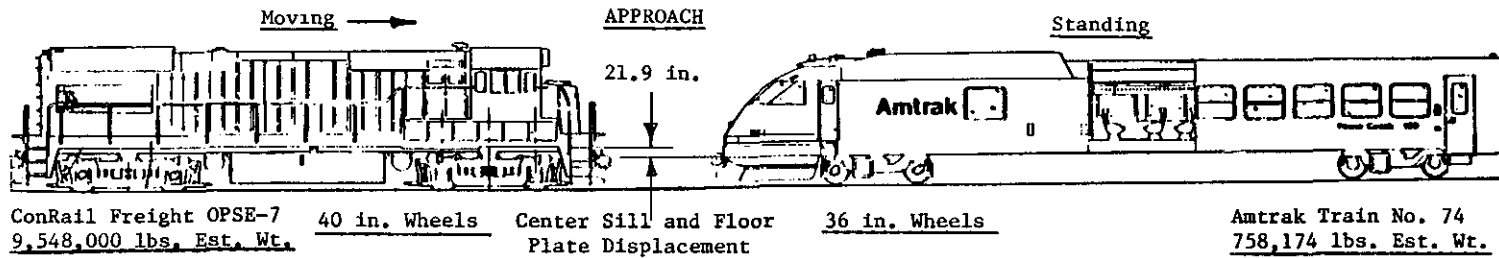
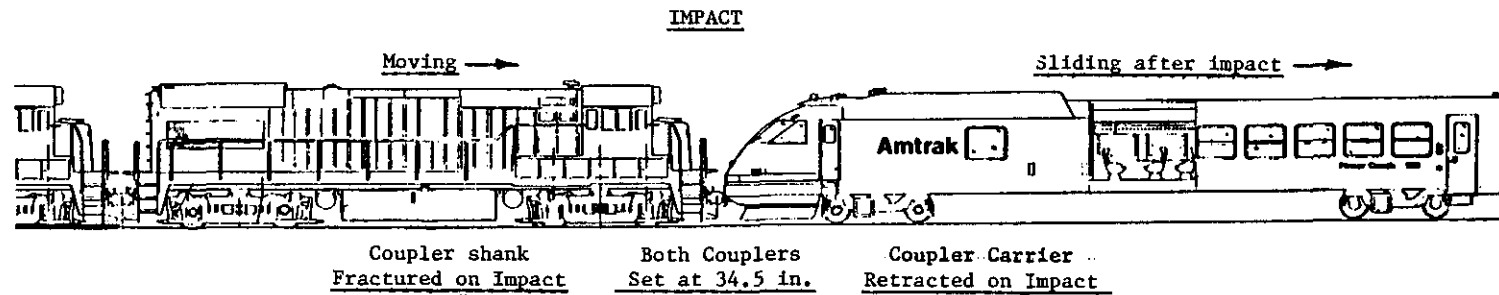
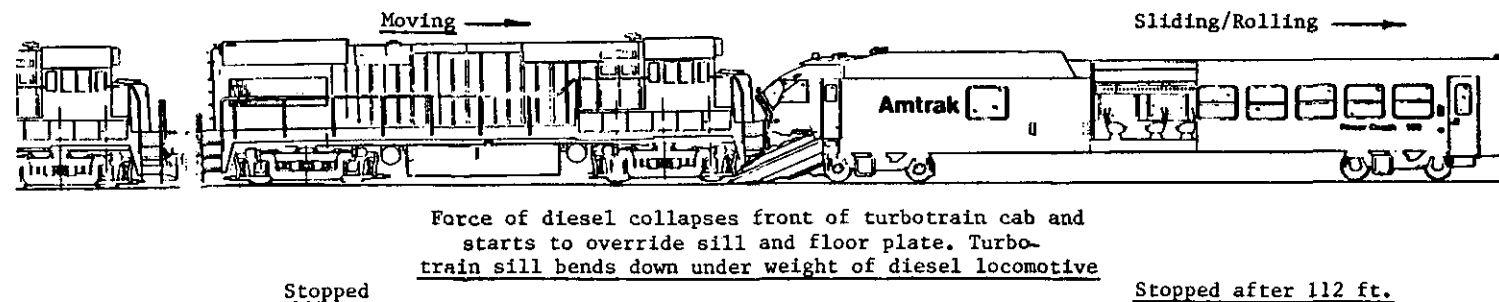
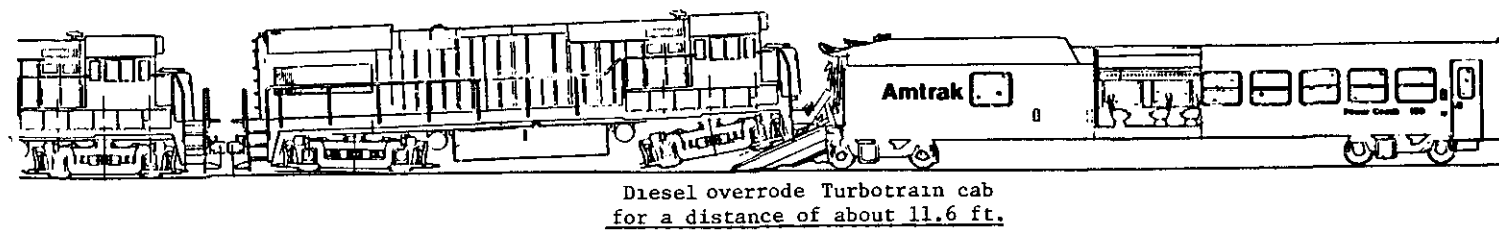
Figure 2.—Diagram of impact of OPSE-7 and No. 74.

Damage to OPSE-7 was limited to the derailed lead locomotive unit. The front end coupler was broken and the front deck, handrails, and side steps were bent, torn, and twisted. The short hood was forward and it was crushed inward.

The operating cab of the power club car of train No. 74 was destroyed because of the 10-mph impact. All floor or deck mounted equipment was torn or sheared off. The other cars in the train sustained minor structural damage.

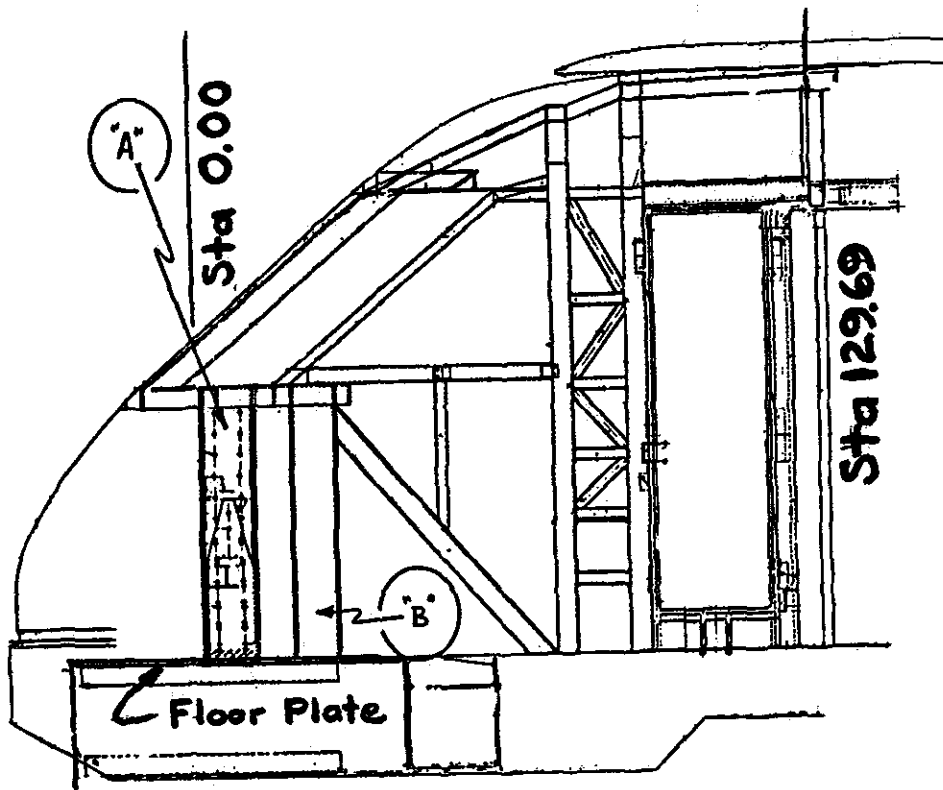
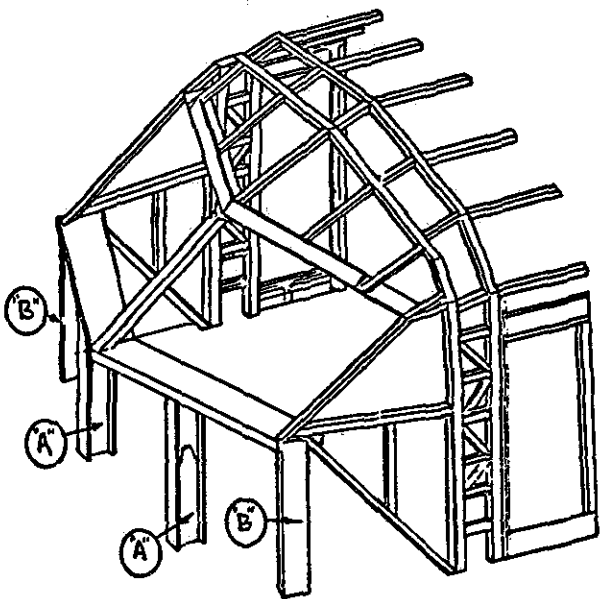
The operating cab of the power car had two 10-inch I-beam forward posts, identified by Amtrak as collision posts, (see figure 4 item "A"), welded to the floor. One end of the angled supports (item "B") was welded to the I-beams and the other end was welded to the floor. The forward posts (item "A") were tested in a mock-up configuration to meet the AAR specifications Nos. C-75 through -84, revised 1967. (See appendix H.) The height of the sill and floor plate on the power club car was 45.67 inches above the top of the rail.

Train No. 74 had traveled approximately 4 miles east of OW when it stopped. Two vertical I-beams were located at the forward end of the power car at Body STA. 0:00. (See figure 4.) These I-beams, identified as collision posts, had failed at the base welds and were pushed rearward about 7 feet. Outboard angled supports which were tied laterally to the vertical I-beams by welded steel structural members had failed at the floor attachment and had torn the floor material. The attaching welds had not failed. These posts were also pushed rearward about 75 inches. The car frame was bent downward until the forward section of the frame contacted the rail. The front AAR type E-coupler, mounted in a retractable coupler box, was found in the retracted position. The two pin-type locks which secured the coupler carrier in the extended position were found undamaged but pushed rearward to an angle of about 60° on both sides. The structural metal of the coupler carrier and the lock pin guides were bent and deformed. The lock pin retracting mechanism was severely bent and damaged. All exterior metal and fiberglass skin panels were destroyed to about 112 inches from the front. All four of the third-rail contact shoes were severely damaged.

Although the I-beam forward posts of the power car were intended to be collision posts, they failed to provide any protection since they were torn loose and pushed rearward even in a relatively low speed collision. In the test mockup that was performed on the collision posts before they were installed in the power car, the collision posts were welded to an I-beam before the test loading was applied. (See appendix H.) The actual installation of these collision posts differed from the testing because they were welded only to the much thinner floor plate. In this accident, the collision posts tore loose from the floor plate, or tore the floor plate metal. It is evident that modern passenger equipment, such as that used on train No. 74, will always sustain extensive damage in a collision with conventional locomotives because of the incompatibility of the rigid frames; its frame being approximately 21 inches lower than standard railroad equipment. Apparently, this matchup was not considered when the turboliner equipment was adopted for use on American railroads.

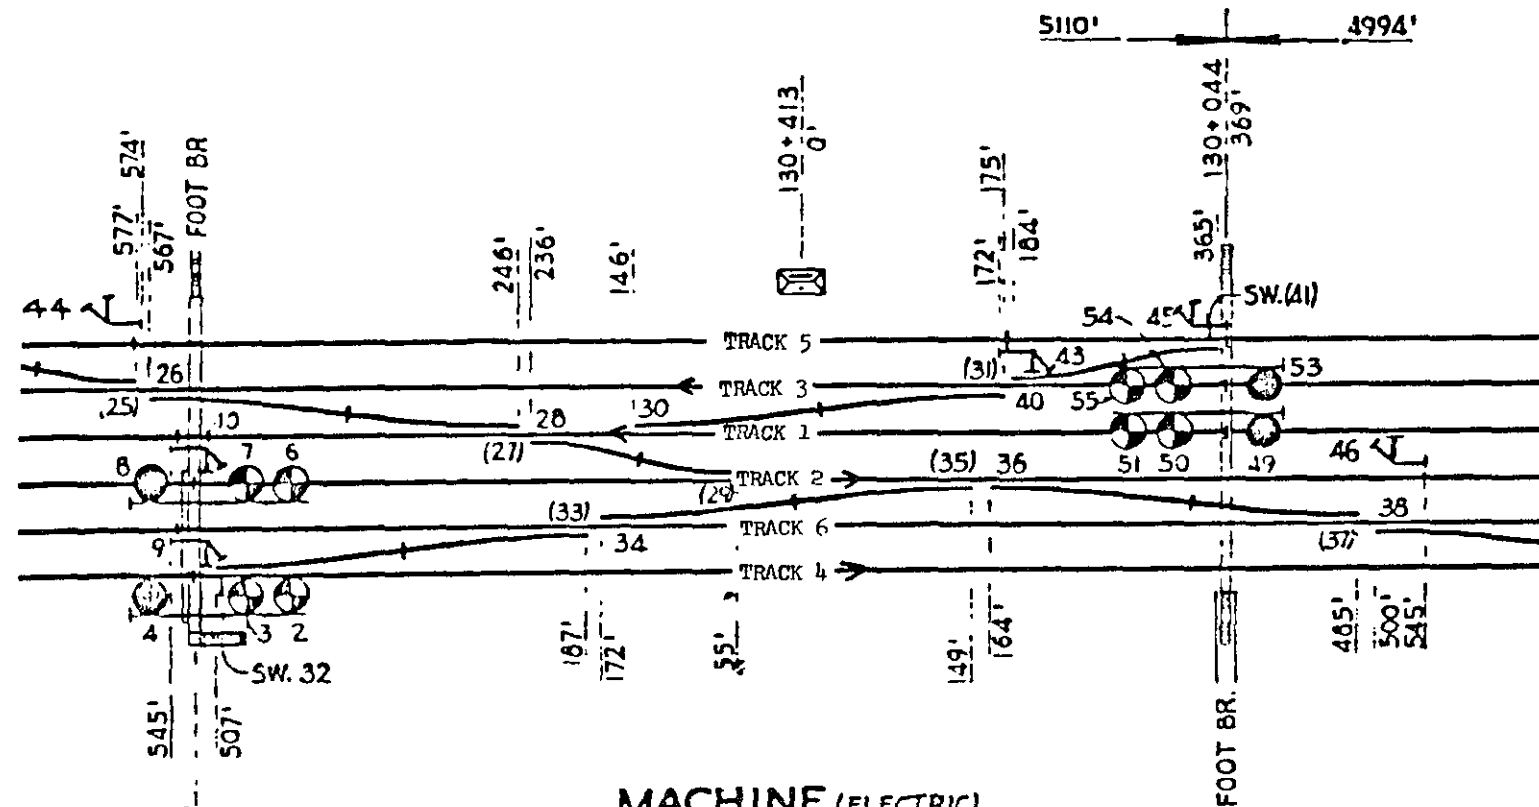
Figure 5.-- OW interlocking.

On the eastward signal mast for track No. 2 at OW interlocking, there was a fixture for a flashing letter "O", a train order signal; however, the signal had been electrically disconnected. A bracket for attaching a yellow flag or light, also a train order signal, to the tower building at OW was not accessible to the operator because the storm windows were nailed shut.
