PHYSICAL PROTECTION WORKBOOK

SHEPHARD SITE-PHASE III

(AR-NM-01-829) ALBUQUERQUE DISTRICT

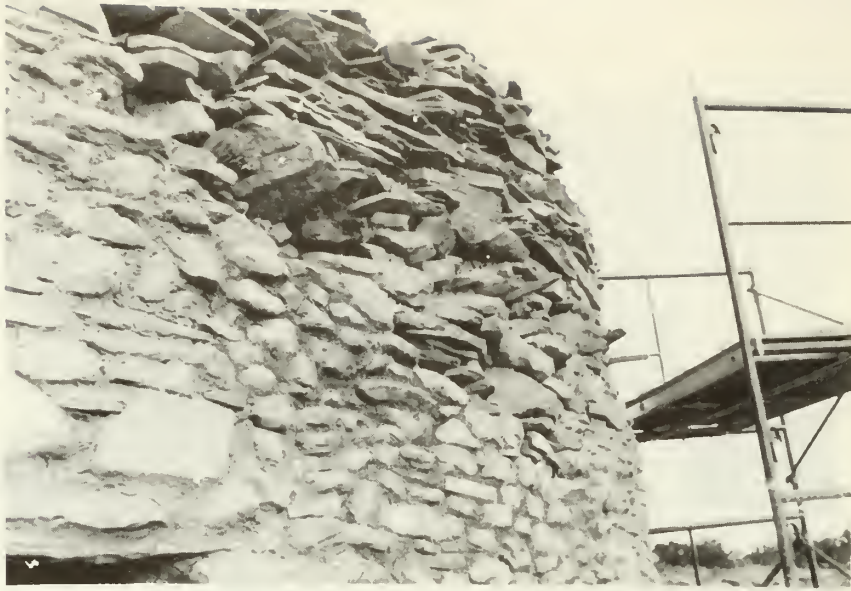
Grouting the exterior east wall of room 1, showing the contrast between the grouted and original wall surface. Note the ends of the roof beams protruding from the wall.
(looking northwest)

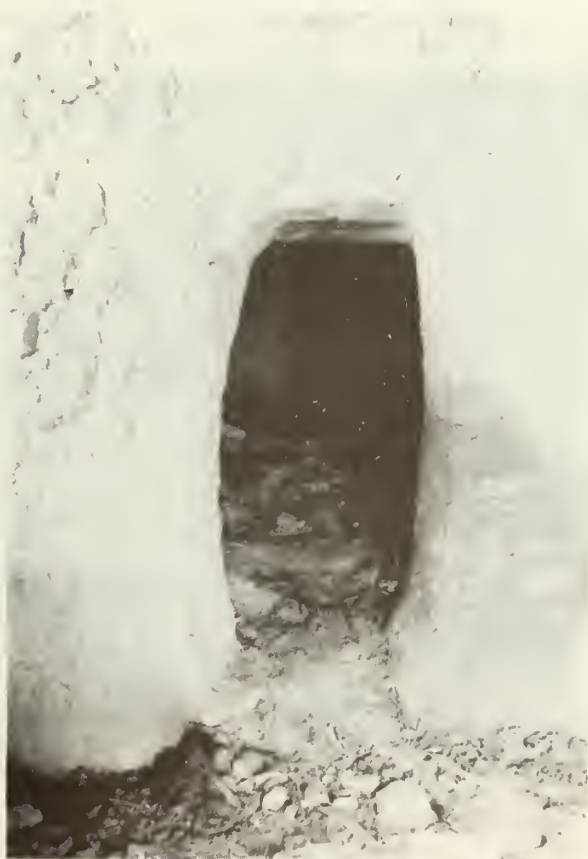
"Before" shot of the doorway
connecting rooms 1 and 2. Note how the
side of the door is eroding out.
(looking east from room 2)

"After" stabilization; the eroded area
has been patched.
(looking west from room 1)

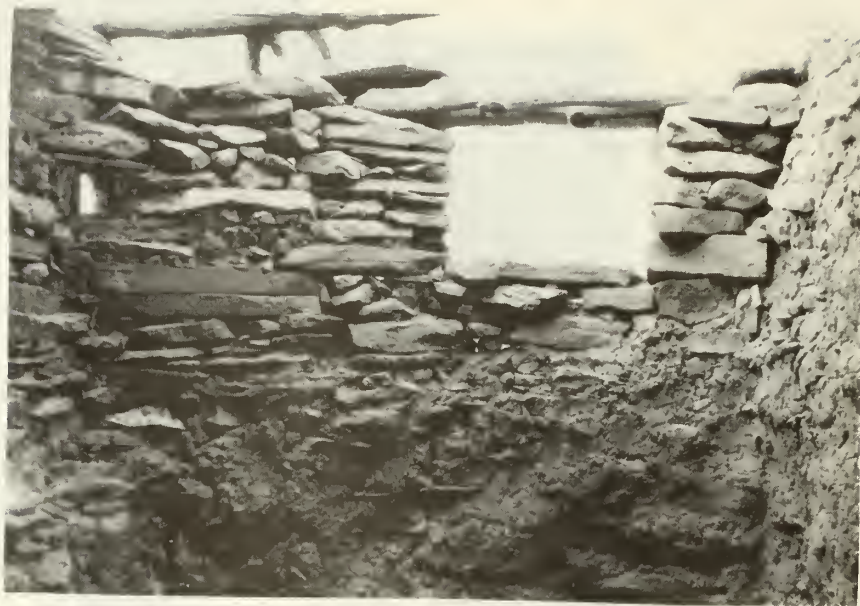
"Before" shot of the interior south wall of room 1. Note the missing section of roof and lack of mortar on the stones around the window.
(looking south)

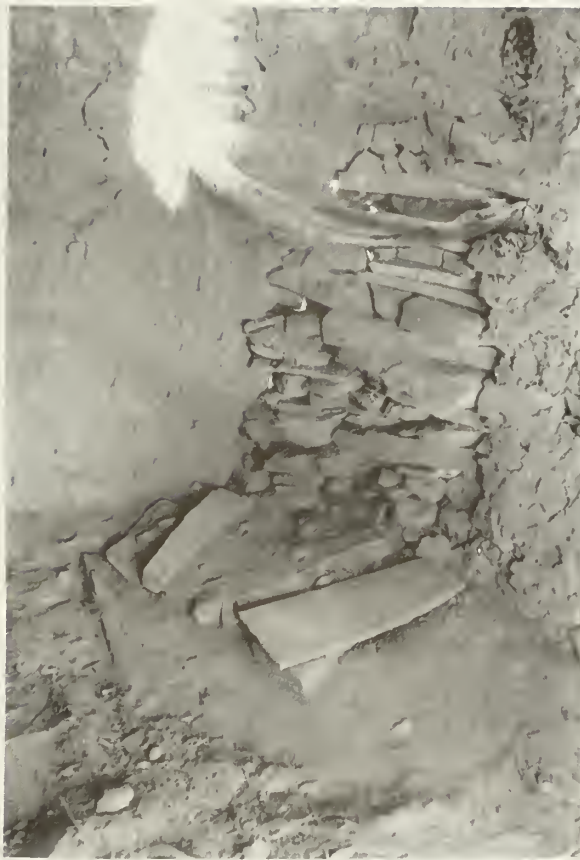
"Before" shot of "hooded" fireplace
in northeast corner of room 1. The
juniper bough was the base of the
"hood". Water coming through chimney
has caused wall deterioration.
(looking north)

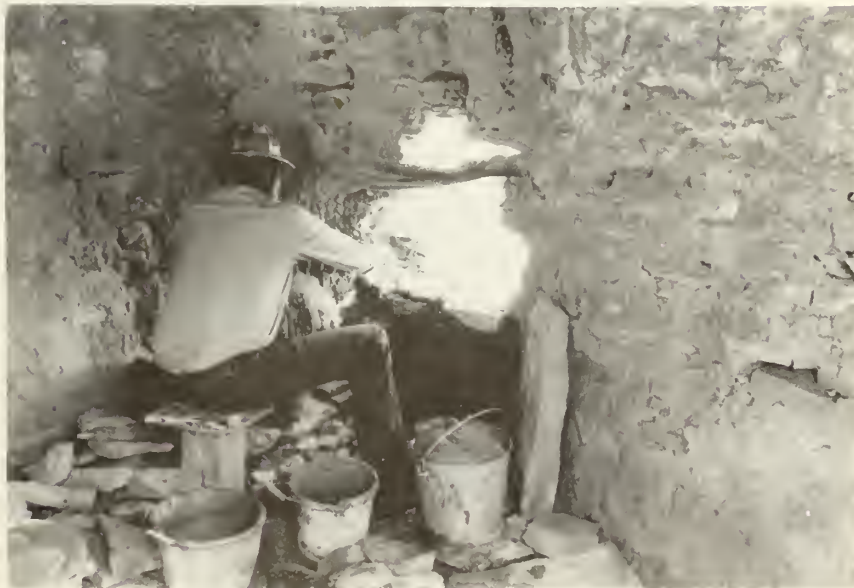
Raymond Torrivio rebuilding wall in
area of the hooded fireplace. Removal
of the stone caused the wall to settle
causing a large crack to form in the
east wall of the room. (looking north)

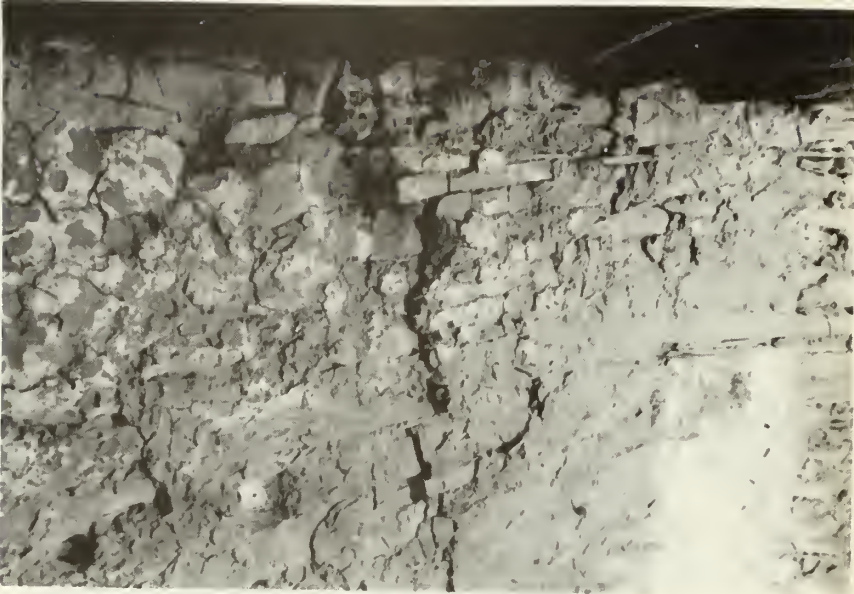
"Before" shot of a large crack which formed in the east wall of room 1 upon the removal of the stone in the hearth area during the stabilization. (locking cast)

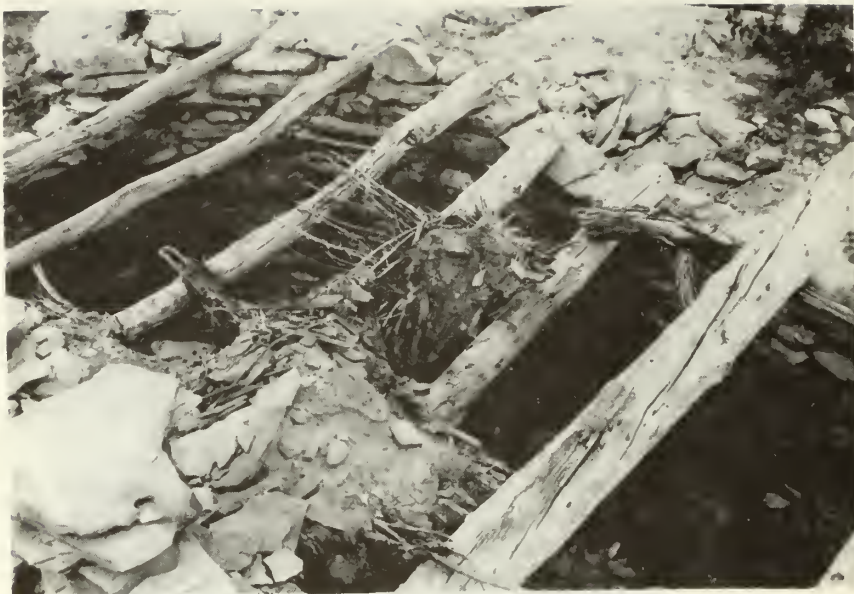
"Before" photo showing the original
appearance of the roof on room 2.
(looking south-west)

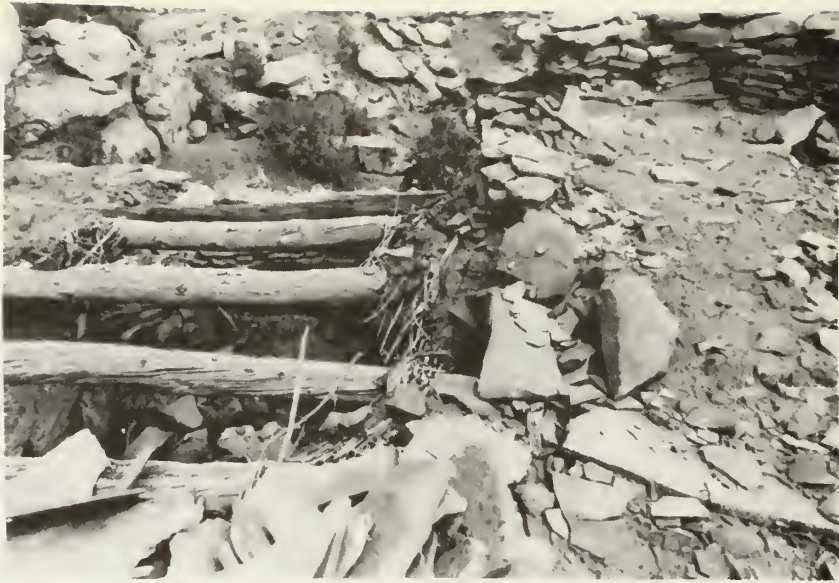
"Before" photo showing the collapsed
parapet wall on room 1 and the
deteriorated roof of room 2.
(looking north)

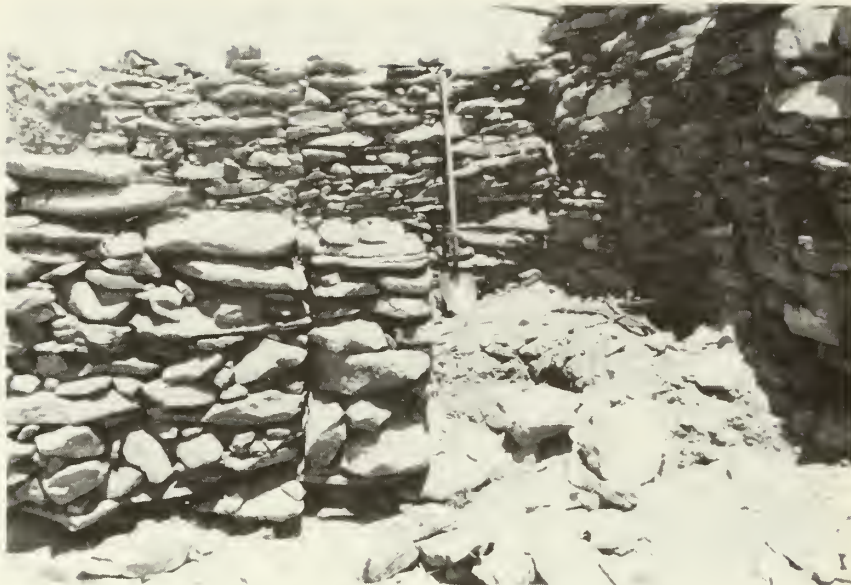
"Before" shot of room 3. Note the plugged doorway, collapsed section of wall, test pit, and remains of roof. The straight sides and absence of wall base suggest stone alignments may not be a plugged doorway, or perhaps a side entrance abandoned for a window like entrance.

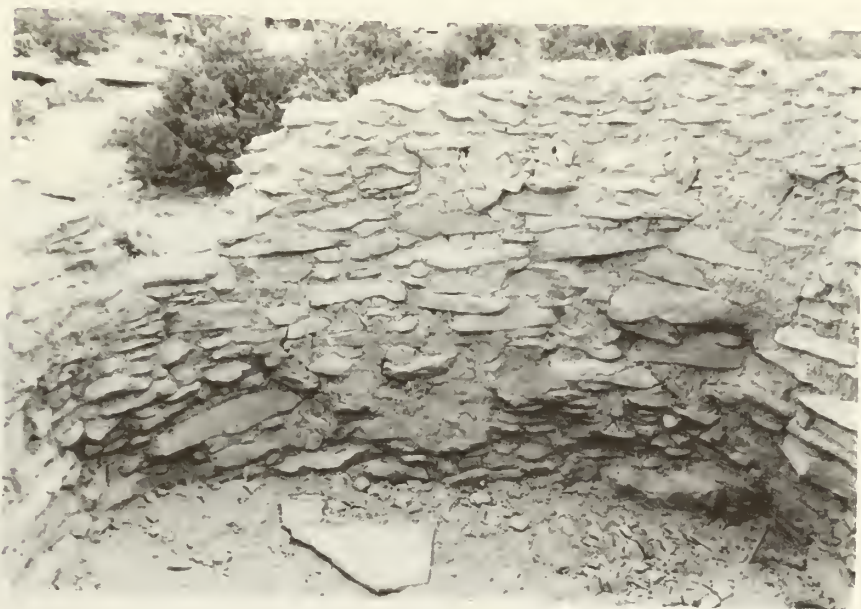
"After" stabilization. Note the
eroded window in the left of the
photograph. This window may have been
the original entrance. (looking west)

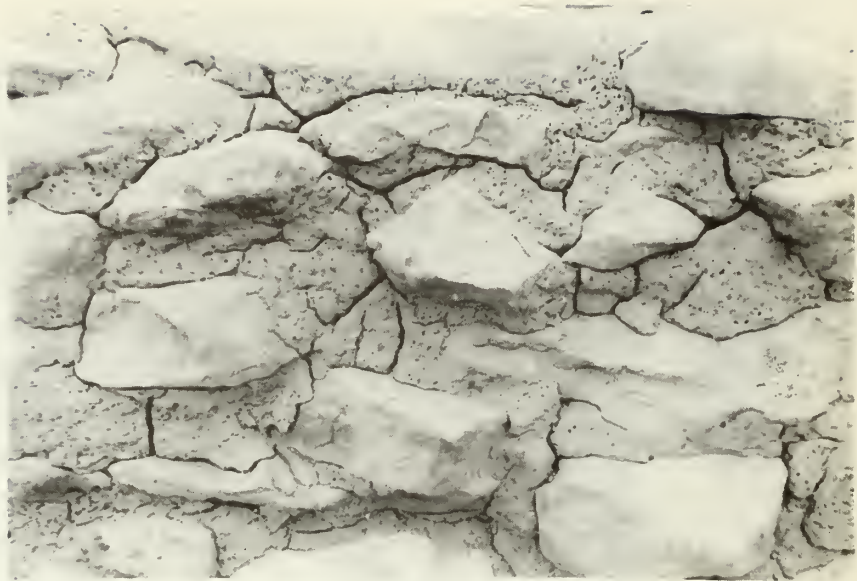
"After" stabilization; close-up of grouted south wall of room 3. The cracks in the mortar show a need for more sand in the mortar mixture. The small holes in the mortar are from striking the wet mortar with a whisk broom, a technique called "texturing" which aids in preventing cracking as the mortar dries. The mortar will now be sprayed with water and rubbed down with sticks to return a look of antiquity to the walls. (looking north)

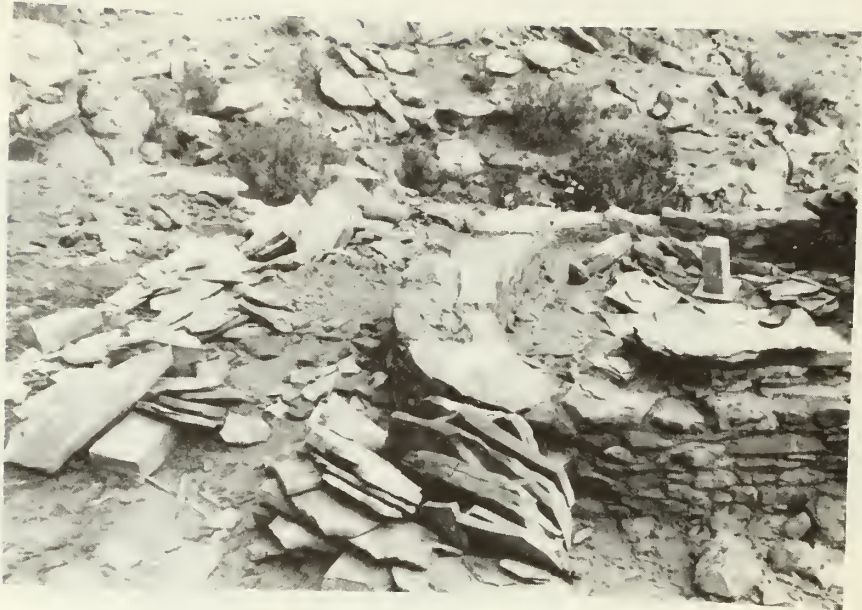
Stabilizing the walls of room 4. The south and west walls were taken down in order to correct their outward leaning. Note the cement core used in the base of these walls.
(looking north)

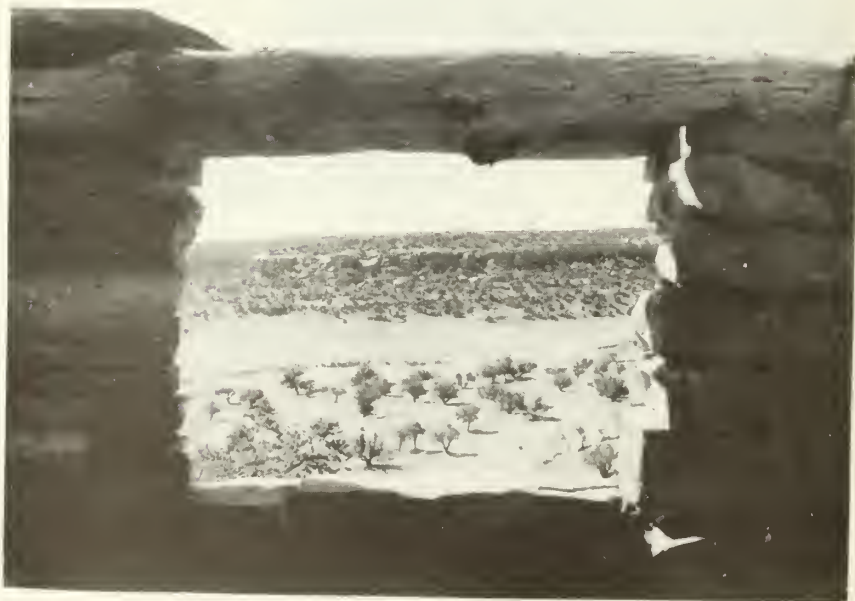
"Before" shot of the large window in the south wall of room 1. The window is the product of a recent repair job as indicated by size (too large), kind of lintels (juniper vigas) and color of clay (gray).
(looking south)

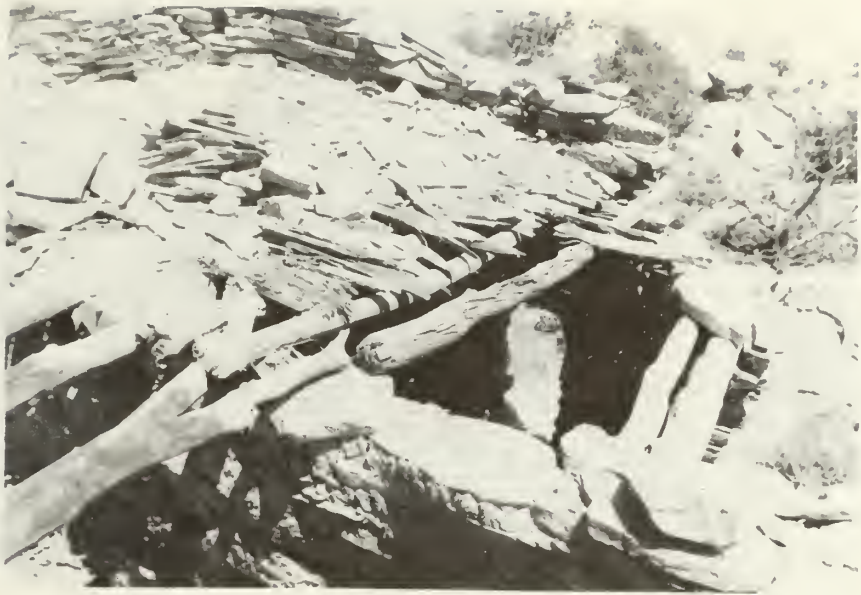
"Before" shot of the missing section
of roof on room 1. (looking east)

Two new vigas were added to fill the missing gap, so that the first 2 vigas to the south are new and the remaining 10 are original. The roof was then cleared of about 8 inches of dirt and rock down to the juniper bark covering. Stones that were once part of a chimney around the smoke hole were grouted. Split wood slats were made from dead wood in the site vicinity and layed over the vigas on the missing patch of roof. A layer of juniper bark was added next and then a sheet of .006 inch black polyethylene plastic to seal the roof. A 4 inch layer of mix 2 was placed over the plastic. Flat slabs of sandstone were set into the mud to match the original roof style. The roof was sloped to drain to the east out the drain provided in the parapet wall. The chimney hole was plugged to protect the walls below. This roof will adequately protect all interior features so that spraying with stabilizing spray, F-325, was not necessary.

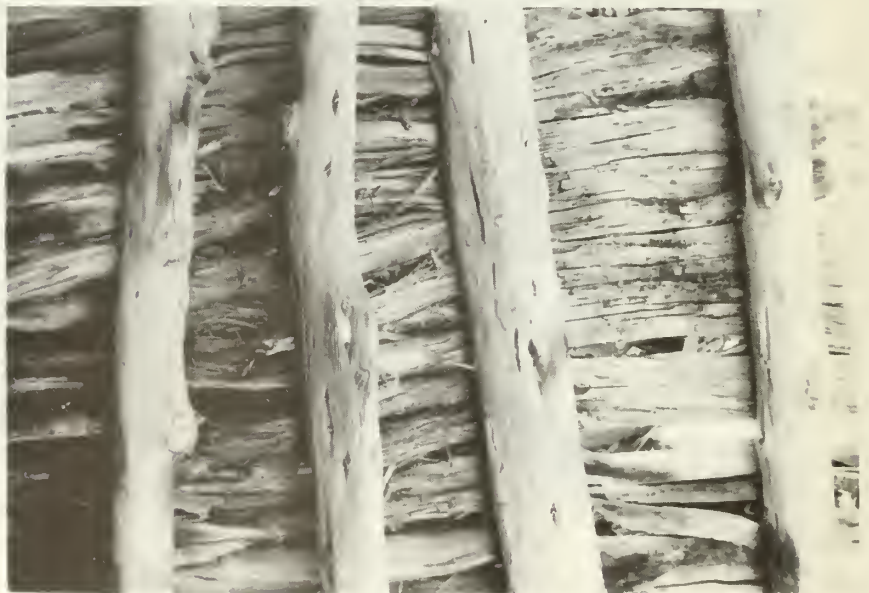
A section of roof on room 1 which shows a former repair job. The repaired section lacks smoke stain and contains branches mixed with the split wood latillas. Vigas are of juniper, Douglas fir, and pinyon.
