## CIVIL AERONAUTICS BOARD

## AIRCRAFT ACCIDENT REPORT

SOUTH CENTRAL AIRLINES, INC.  
BEECH D18S, N2999  
GAINESVILLE MUNICIPAL AIRPORT  
GAINESVILLE, FLORIDA  
FEBRUARY 3, 1964

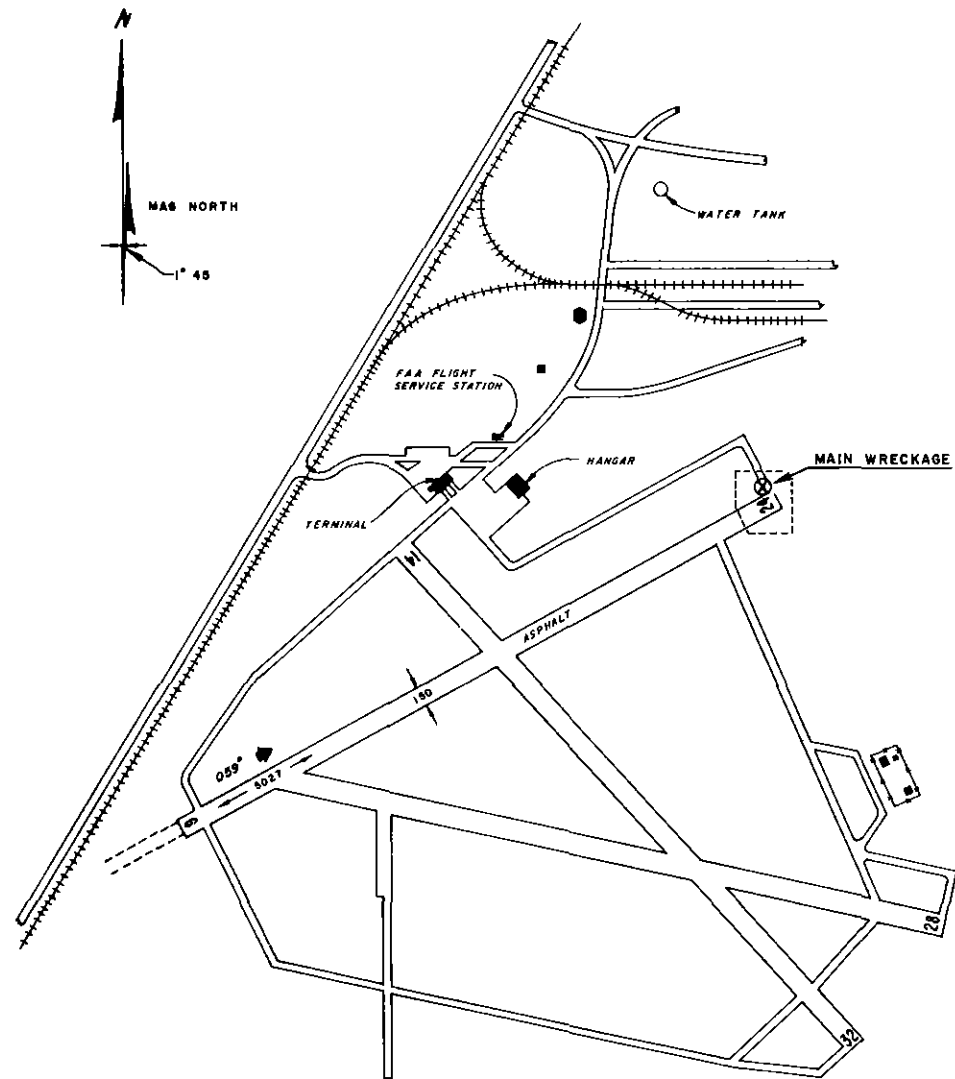
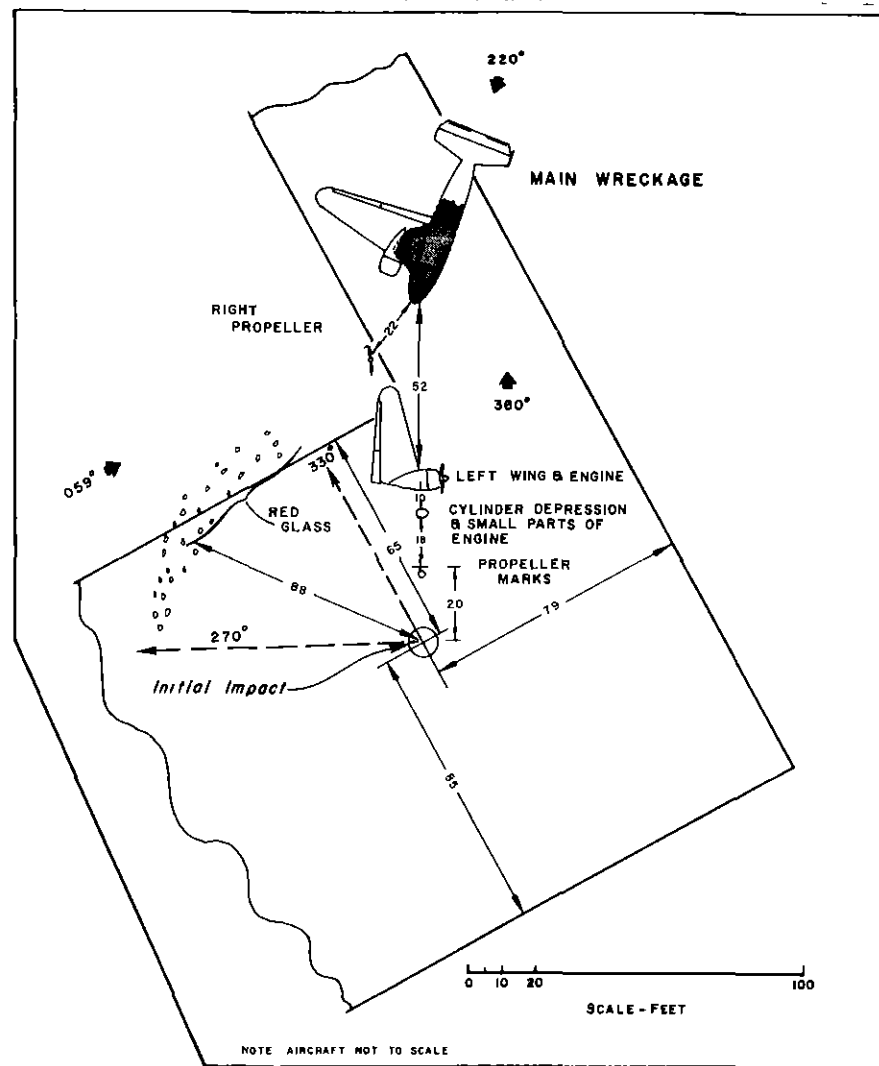
RUNWAY LAYOUT and WRECKAGE DISTRIBUTION CHART  
SOUTH CENTRAL AIRLINES — BEECHCRAFT D18S N2999  
GAINESVILLE, FLORIDA — FEBRUARY 3, 1964

Initial impact was 79 feet from the departure end of runway 6 and ten feet to the left of the runway centerline. Runway 6 is an asphalt runway which is 150 feet wide and 5,027 feet in length. Fire followed impact. The left wing and engine separated from the aircraft at impact and the fuselage, right wing, right engine, and tail assembly bounced and slid approximately 100 feet and came to rest on fire with the nose on a magnetic heading of 220 degrees.
