RAILROAD/HIGHWAY ACCIDENT REPORT

COLLISION OF A
CROWN-TRYGG CONSTRUCTION
COMPANY TRUCK WITH
AN AMTRAK PASSENGER TRAIN

ELWOOD, ILLINOIS

NOVEMBER 19, 1975

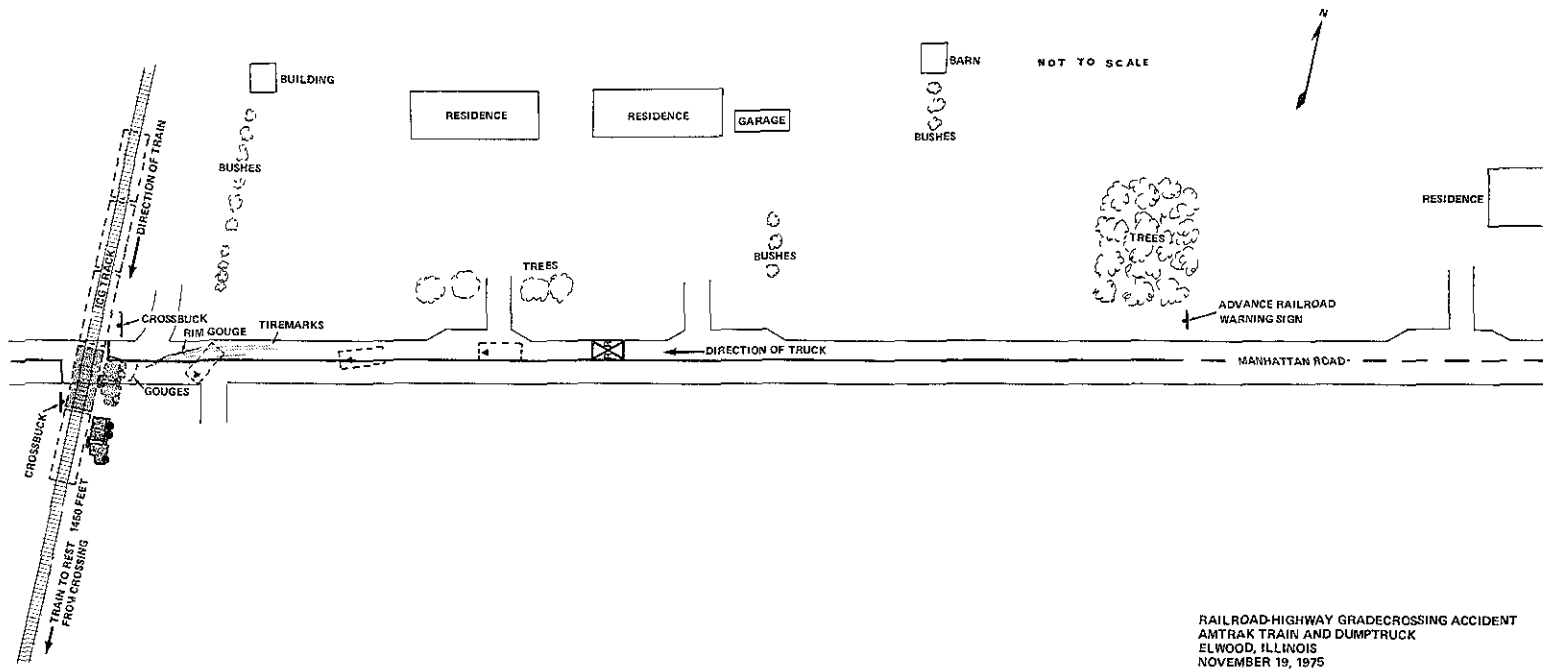
Figure 1. Accident site and crash sequence diagram.

Three arc-shaped tiremarks were found along the path followed by the truck after it began to swerve. The marks were identified as side scuff marks caused by the tires on the right side of the truck as it moved toward the southwest in a counterclockwise rotation. The longest mark, which was caused by the right rear outside tires, measured 108 feet 8 inches.

A gouge, caused by the rim of the outside rear right wheel, was found parallel to the tiremark made by that wheel as it moved across the centerline of the roadway. The gouge had a radius of 121.875 feet.

Several other gouges, caused by the overturned truck as it slid toward the track, also were found on the road. (See Figure 1.)

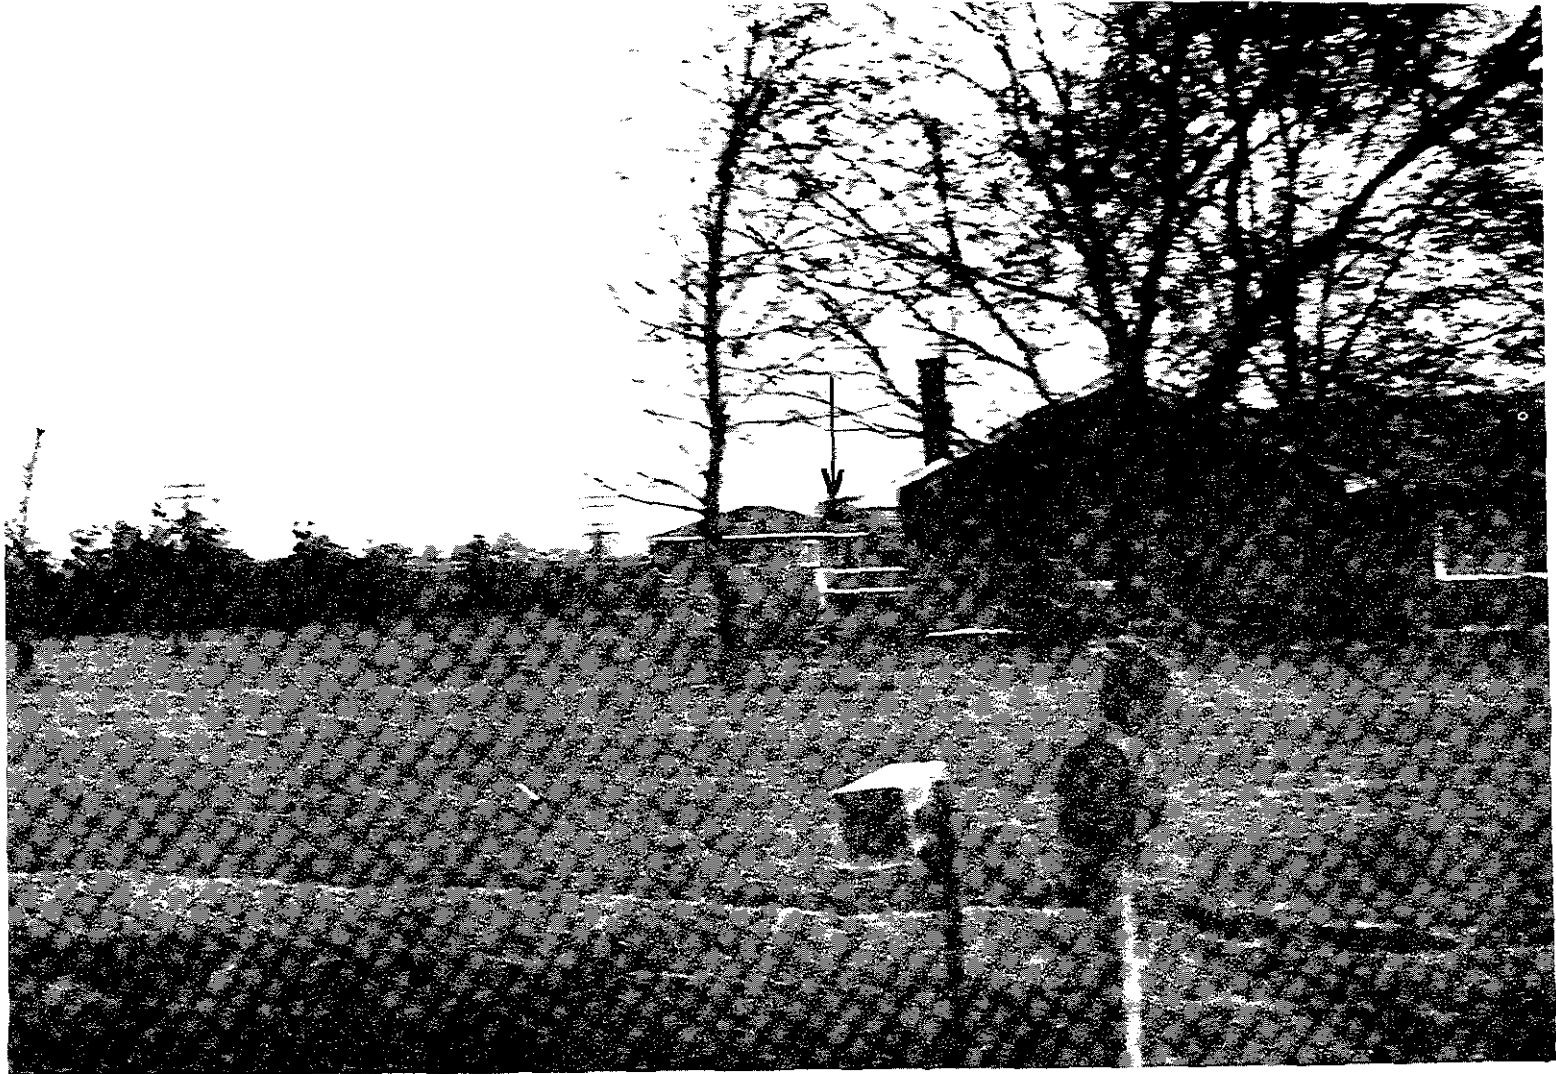
Figure 2. Looking north along the track from Manhattan Road, 200 feet from the east rail. Note (arrow) lead power car of southbound passenger train.

Two private residences, which are located on the north side of the westbound approach to the track, limit the visibility between the road and track until 200 feet before the grade crossing. From that point to the grade crossing, visibility is obstructed slightly by a fence, trees, and a freestanding building which are located on private property adjacent to the railroad right-of-way.

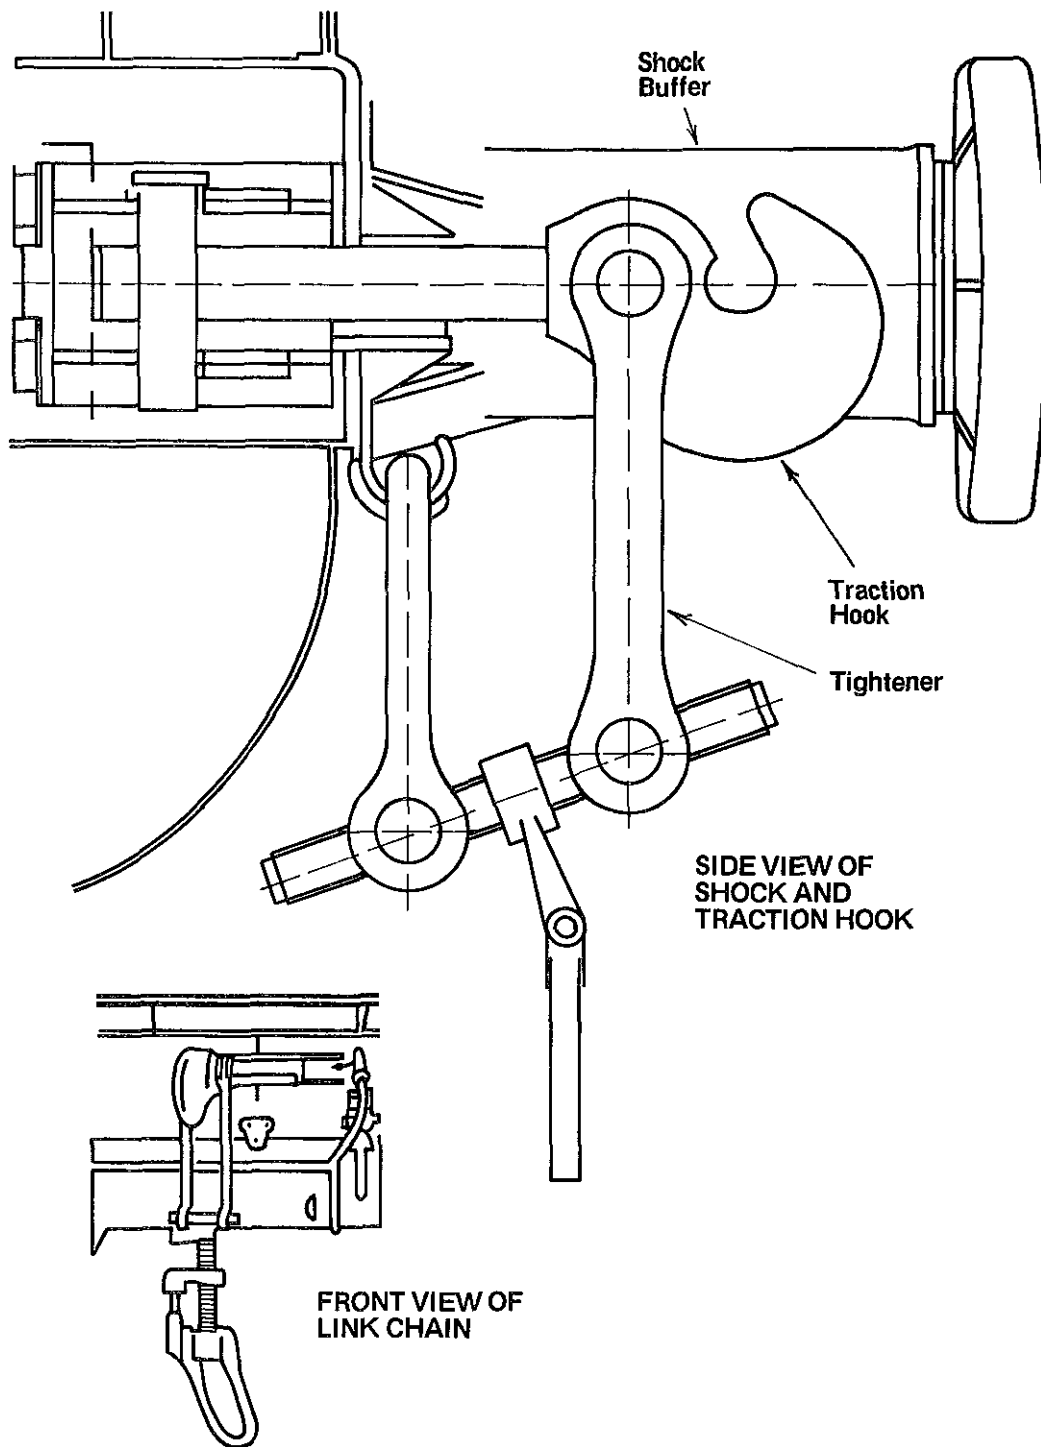
The coupler on the turbotrain was the standard type used on European and British railroad cars. (See Figure 3.) In the United States, this type of coupler is found only on the French turbotrains. The Federal Railroad Administration (FRA) had issued an exemption to Amtrak to allow the use of these couplers. Turbotrains currently under manufacture for use in the United States will be equipped with conventional H-type couplers.

Figure 3. European-type coupler assembly.

The forces generated during the crash dynamics caused the buffers which connected the end of the second car to the front of the third car to misalign and to bypass. Once the buffers were separated, the tension on the link coupler relaxed and the link was able to bounce off the hook. This permitted the cars to separate and contributed to the derailment of the third, fourth, and fifth cars.

The ease with which the European-type coupler can uncouple increases the potential for each car to react independently in an accident situation. When cars are not attached to other equipment, they are more likely to derail and to roll over; this increases the risks of loss and injury. Practical methods exist to improve this type of coupler assembly in order to insure its integrity under crash conditions.

"Require improvements to the coupler assembly on the French-manufactured turbo trains currently in service to minimize the possibility of uncoupling under crash conditions." (R-76-23)

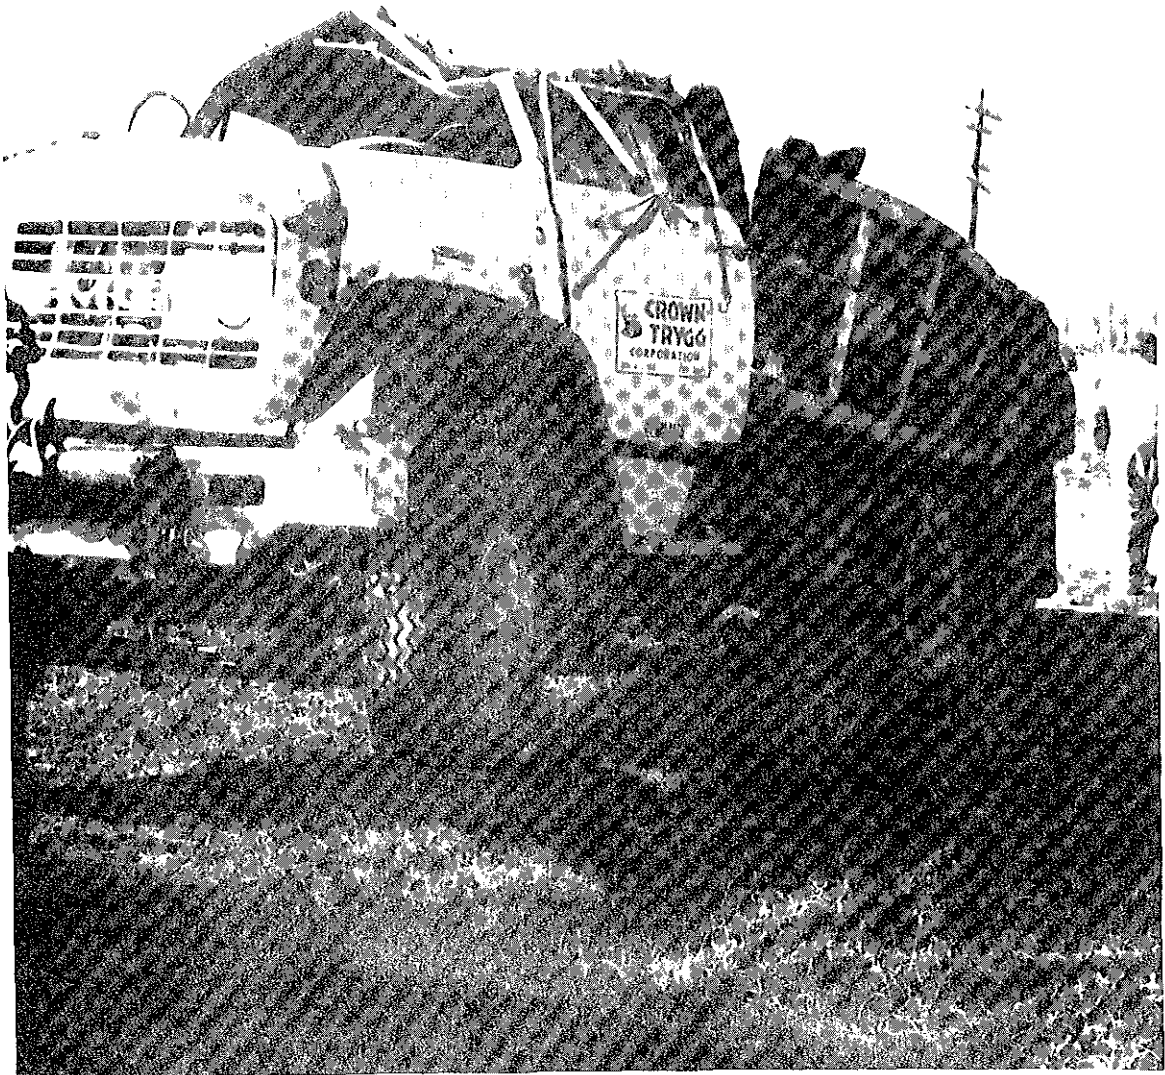
The primary damage incurred by the truck included deformation of the left side of the cab roof, deformation of the left side of the dump body, deformation of the right front fender and bumper, and displacement of the windshield. (See Figure 4.)

Figure 4. Accident truck being removed from the track area.

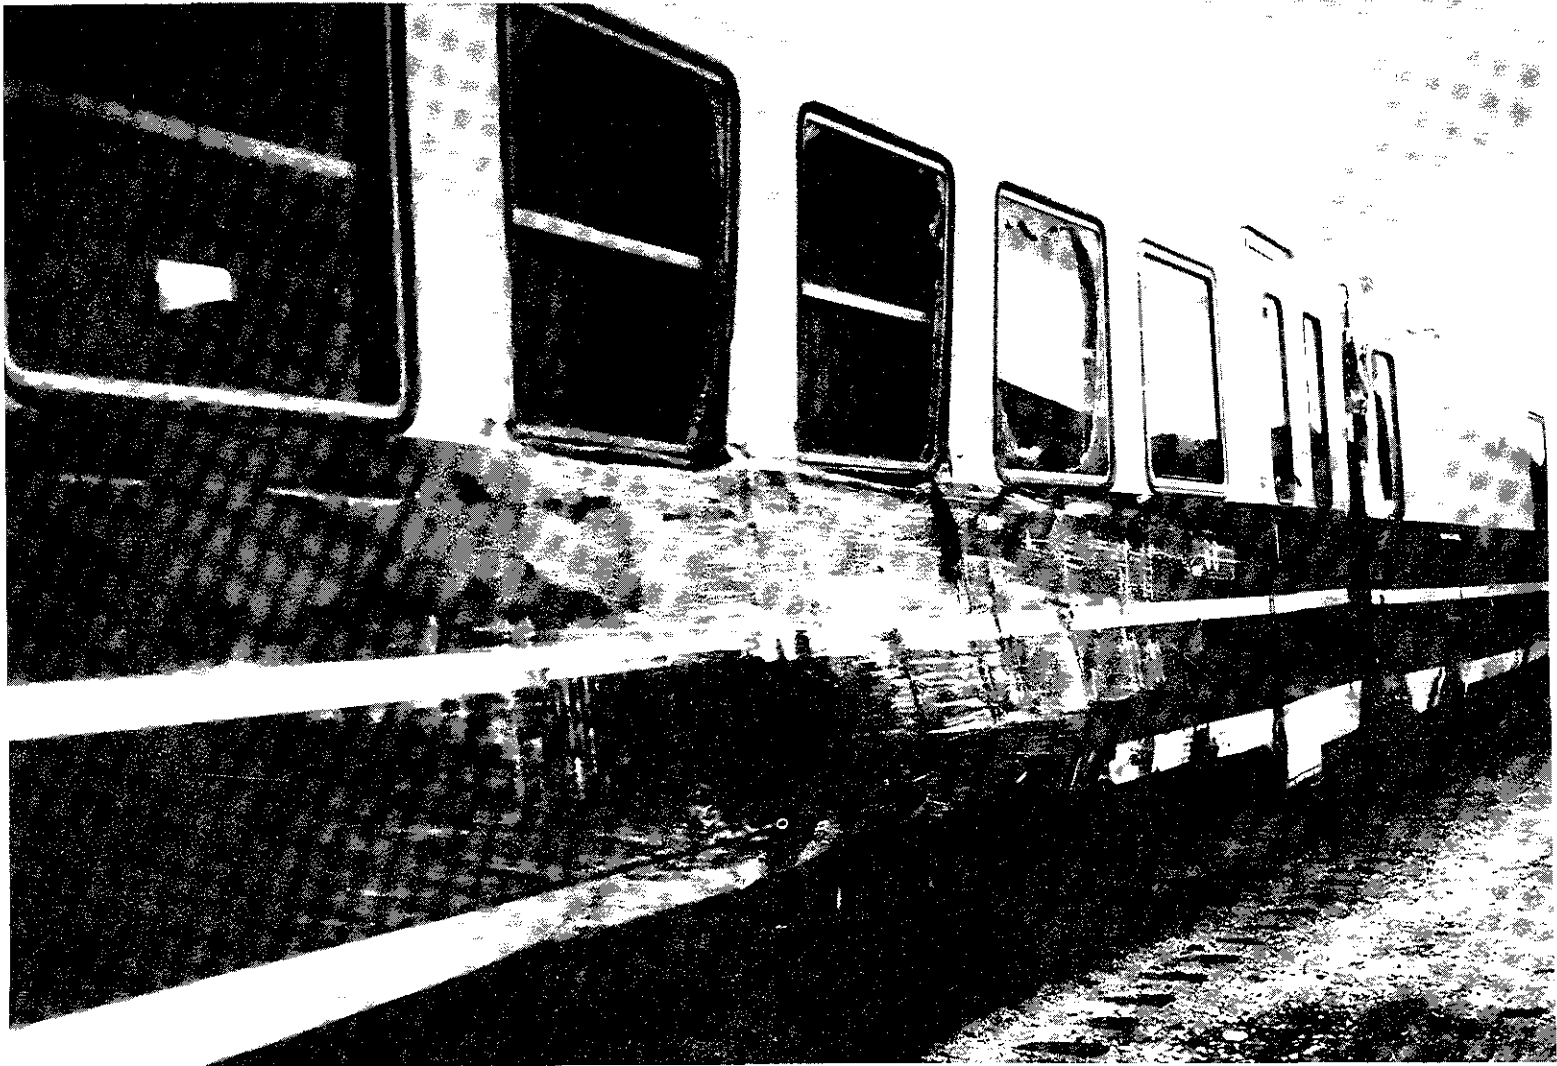
Turbotrain -- The leading power car was not damaged. Impact damage to the second car was restricted to the left rear side of the car. (See Figure 5.) The damaged area was 24 feet 6 inches long, about 6 feet high, and about 8 inches deep at its deepest point. Two double-pane windows were shattered completely and a third had only its outer pane shattered. In the area of impact, the floor was deformed slightly, a pair of seats had rotated partially, and a folding tray was deformed to the right. The floor and seats were littered with broken window glass. There were no signs of side or roof panel buckling or deformation of the overhead baggage racks.

The third car was damaged at its left front corner. At that point, the lower-outside paneling had been crinkled and had been marked with horizontal striations, and the window was broken. The left front corner of the car was crushed beginning about 8 feet above the top of rail and extending upward for 21 feet. Some additional deformation occurred just above that crushed area.

Both the second car and third were covered with asphalt in the areas which were struck by the truck. Air and electric lines which connected the second and third cars were broken.

Figure 5. Crash damage to the second and third cars of the turboliner.
