File No. 1755-42

Docket No. SA-72

REPORT OF THE CIVIL AERONAUTICS BOARD

On the investigation of an accident involving aircraft of United States registry NC 21711, which occurred on the Bismarck Municipal Airport, Bismarck, North Dakota, on August 29, 1942.

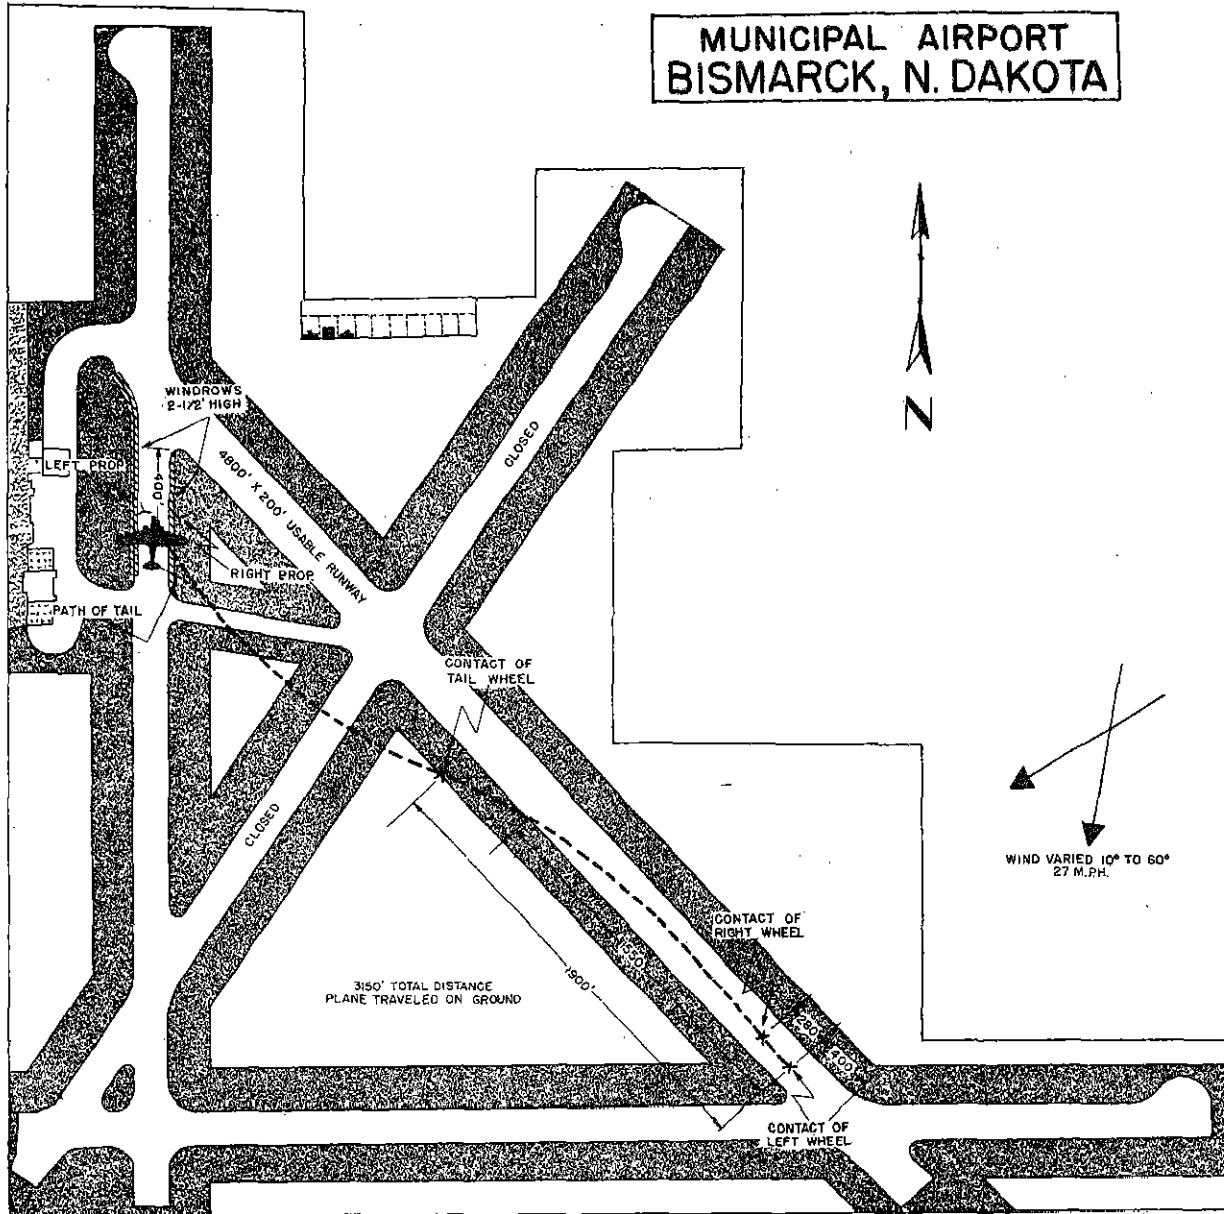
# MUNICIPAL AIRPORT BISMARCK, N. DAKOTA

The Bismarck Municipal Airport is located on a plateau 1650 feet above sea level. It is an L-shaped field of approximately 300 usable acres, with one 200 x 4800-foot surfaced runway in use. (See map opposite page.) At

the time of the accident construction work was in progress, necessitating the closing of the field except for the northwest-southeast runway. The day preceding the accident, the surfacing of the northeast-southwest runway had been laid and rolled. It was probably in a usable condition but had not been officially opened.
