## **RAPPORT**

*98-45/S-04*

*Naderende overtrek tijdens het intrekken van de flaps met de Evergreen International Airlines Boeing 747-212B, registratie N482EV, nabij Amsterdam Airport Schiphol op 20 juli 1998*

*Den Haag, November 2001*

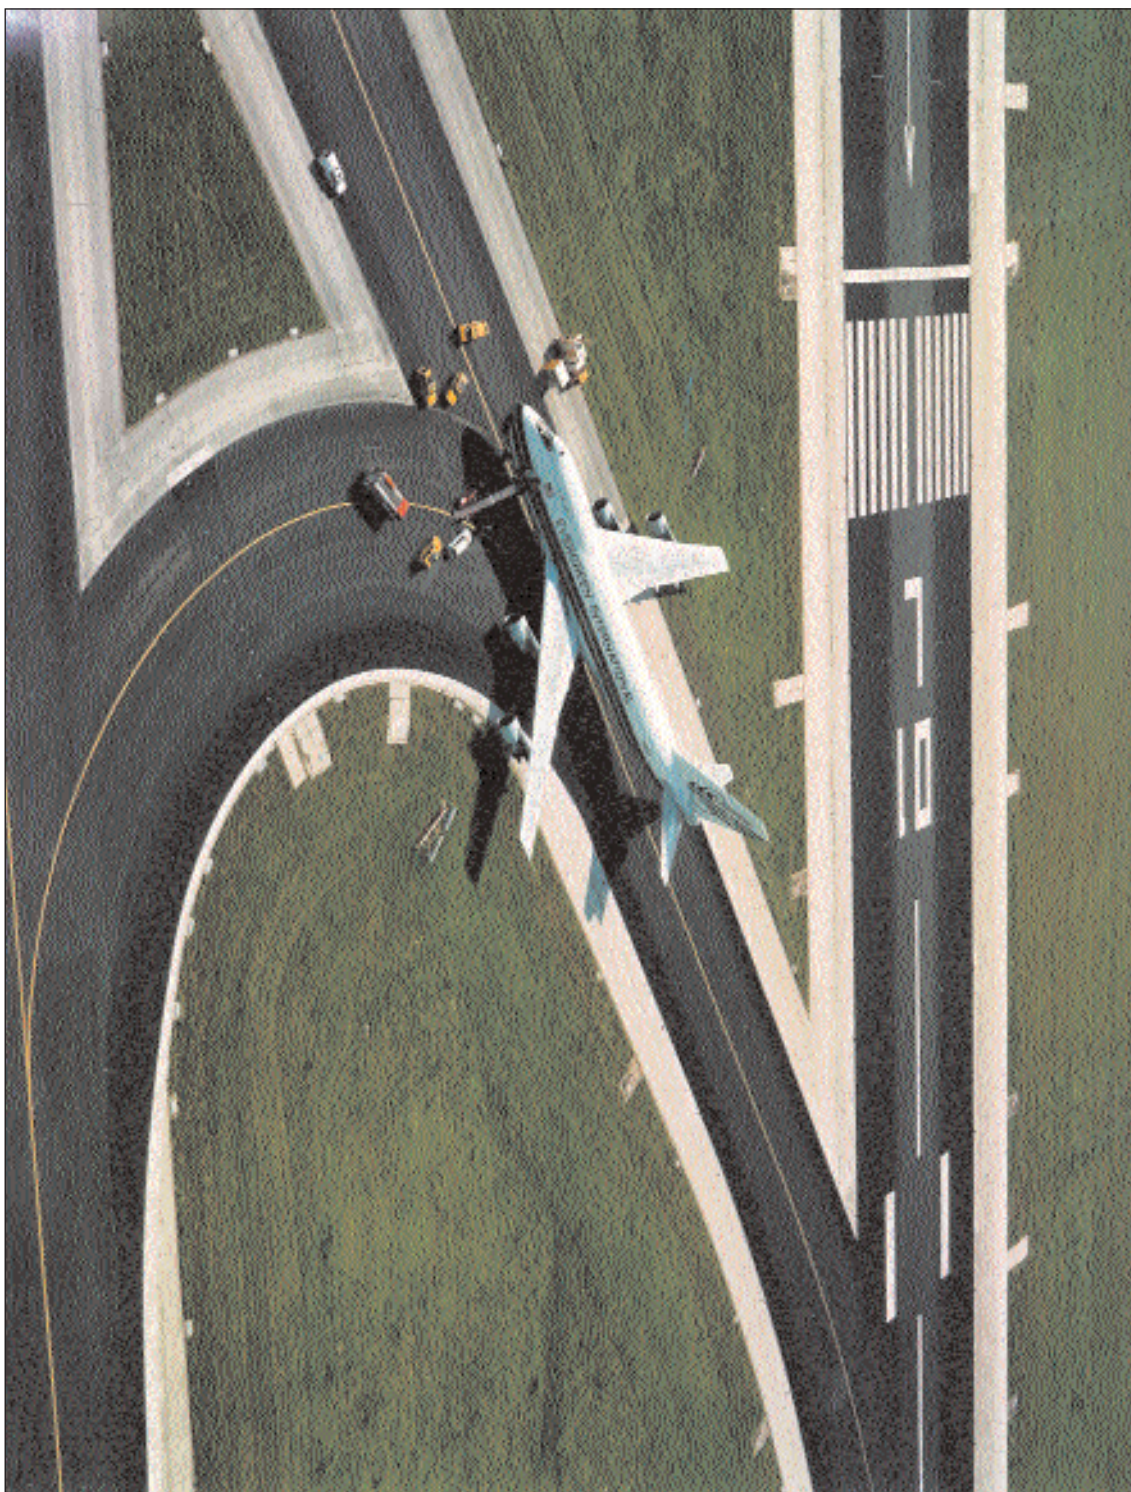
The aircraft sustained light damage to its wheels. Ten out of the 16 main landing gear tires deflated.

N482EV na het incident (Bron: KLPD)

N482EV after the incident (Source: KLPD)
