# ACCELERATED WEATHERING TESTS OF SOLDERED AND TINNED SHEET COPPER

By Peter R. Kosting<sup>1</sup>

## ABSTRACT

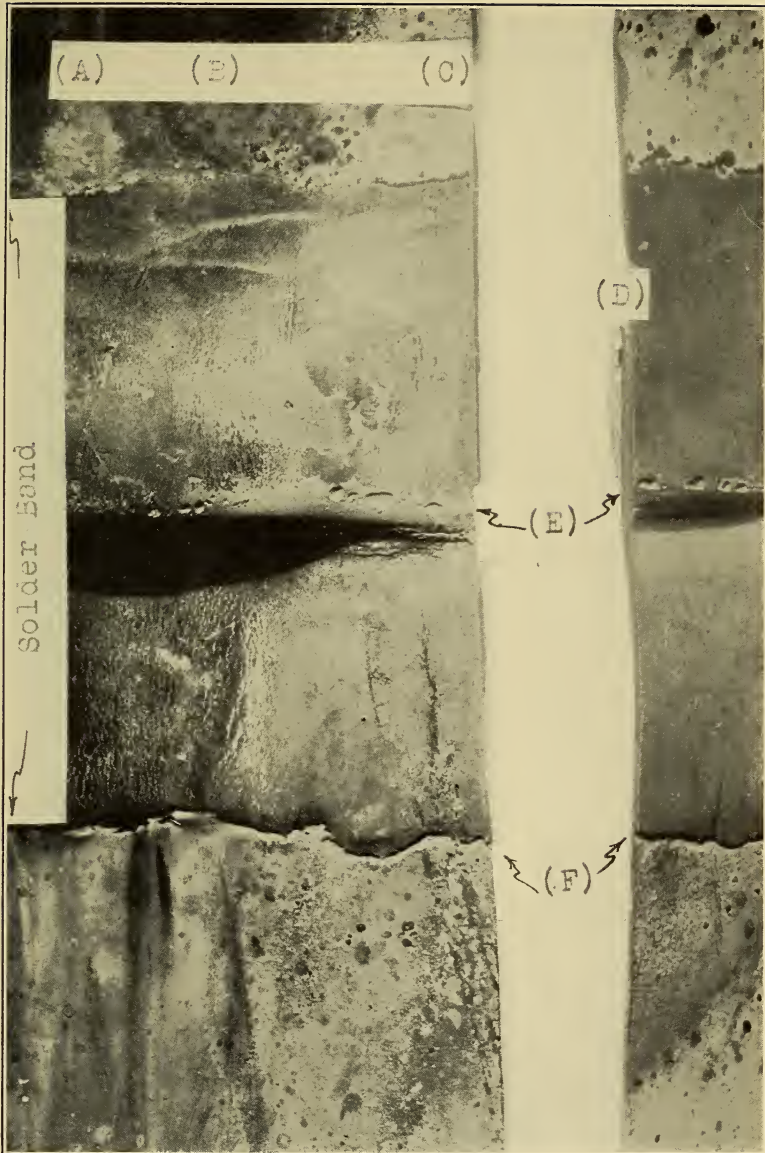
A typical case is illustrated by a sample of sheet copper which had been in service for 16 to 20 years as a valley (fig. 1) in the roof of a residence, and which was sent to the Bureau of Standards for examination. Marked furrowing was observed in the copper along the lower edge of the solder band at those portions not covered by the shingles. No localized corrosion of the copper had occurred along the upper edge, except in the areas where the flow of rain water was greatest. Pits extending through the solder into the copper had formed along the high ridge of the soldered lock seam. Evidence of included flux was obtained upon sectioning the seam. Cavity *D* was found to be filled with liquid, probably flux; likewise, the underside of the seam gave indications that flux had been left in place, although there was no evidence of any deep-seated corrosion having occurred.

FIGURE 1.—Seam corrosion on soldered copper valley.  $\times 2$

A, Etched copper where flow of rain water was greatest; B, tarnished copper; C, patina covered copper where flow of rain water was least; D, hole of seam in which flux was trapped; E, pits extending through solder at high ridge of seam; F, furrow at copper-solder junction.

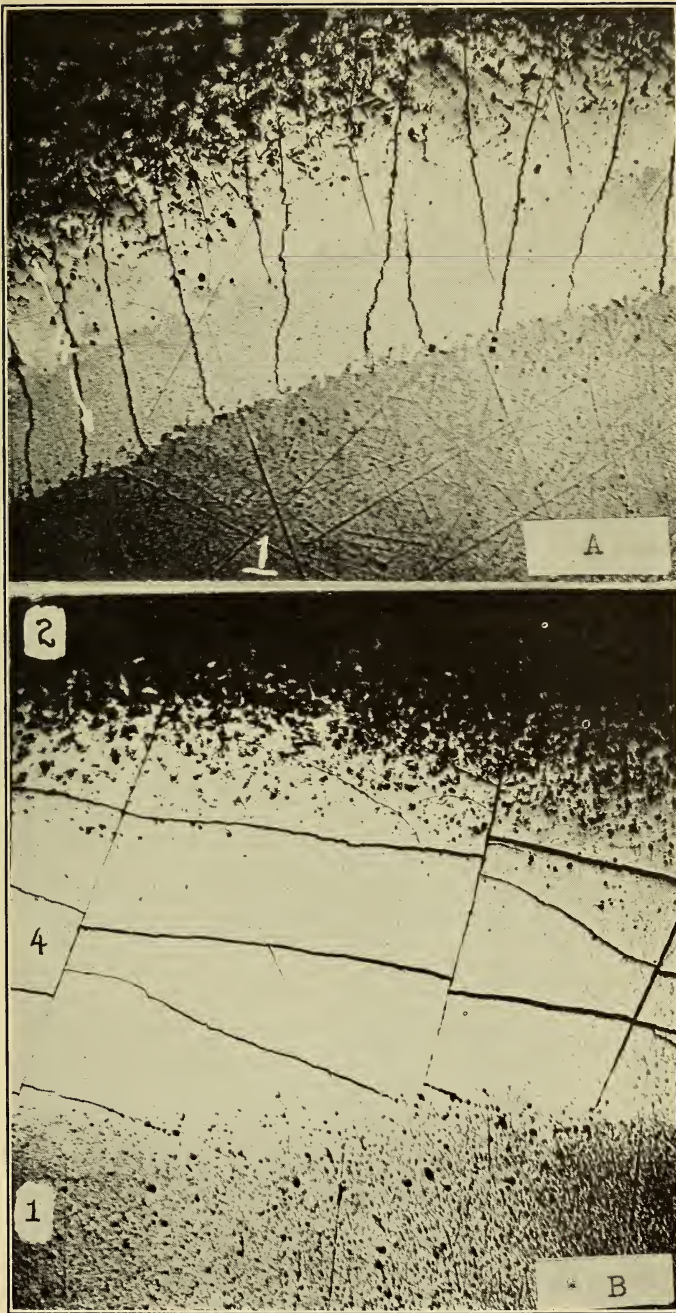
FIGURE 3.—Oblique sections of heat treated electroplated sheet copper showing cracks in coating.  $\times 100$

A, Heated to 350° C.; B, heated to 500° C. 1, Sheet copper base; 2, unchanged tin; 4, copper-tin alloys. Both unetched.

The microstructure of the coatings on heat-treated electrotinned copper was rather complex. Electrotinned copper had but one phase present in the coating—the tin. Upon heating to 350° and 500° C., the copper and tin alloyed, copper dissolving quite rapidly in the tin. The alloy layers were brittle and slight bending caused them to crack, as shown in Figure 3. Many of these cracks extended through the alloy layer only. During polishing a slight relief effect was sometimes obtained, as shown in Figure 3(a), thus revealing the complex nature of the coating.

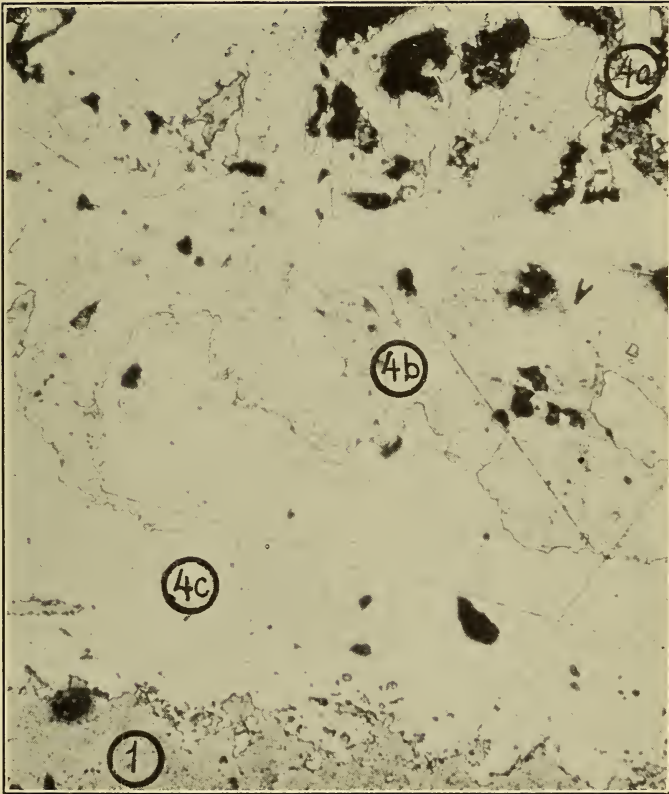
By heating to 500° C. another phase was formed which tarnished brownish on etching. This phase and the dove gray and brilliant white phases noted above are to be seen in Figure 5. In one place only, not shown, was the needlelike structure with a brilliant white fringe found to have a definitely blue color, characteristic of the  $\eta$  phase. It is assumed that the brownish phase is  $\delta$ , the brilliant white  $\epsilon'$  and the dove gray  $\eta$ .

FIGURE 5.—Oblique section of electroplated sheet copper heated to 500° C. for 3 hours.  $\times 200$

Etchant: Concentrated nitric acid. 1, Sheet copper base; 4a, brilliant white  $\epsilon'$  phase; 4b, bluish  $\eta$  phase; 4c, brownish  $\delta$  phase.

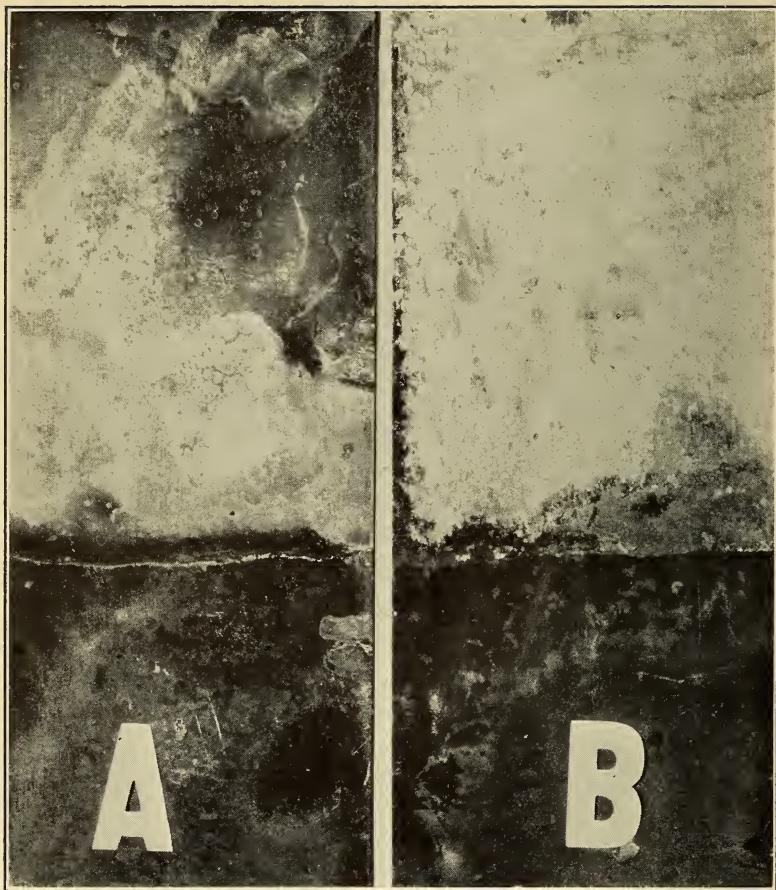
The physical appearance of the specimens after corrosion is shown in Figures 7 to 10. Figure 9 is a magnified view of the furrowing which is especially in evidence in the A specimen; the B specimen shows, on the other hand, very slight attack.

FIGURE 7.—Seam corrosion after 100 hours accelerated weathering at  $50^{\circ}$  C.  $\times 0.7$

The surface has been scrubbed with bristle brush and water. A, Soldered at  $270^{\circ}$  C. and heated to  $500^{\circ}$  C.; B, soldered at  $270^{\circ}$  C. Lower half is copper, upper half is solder covered

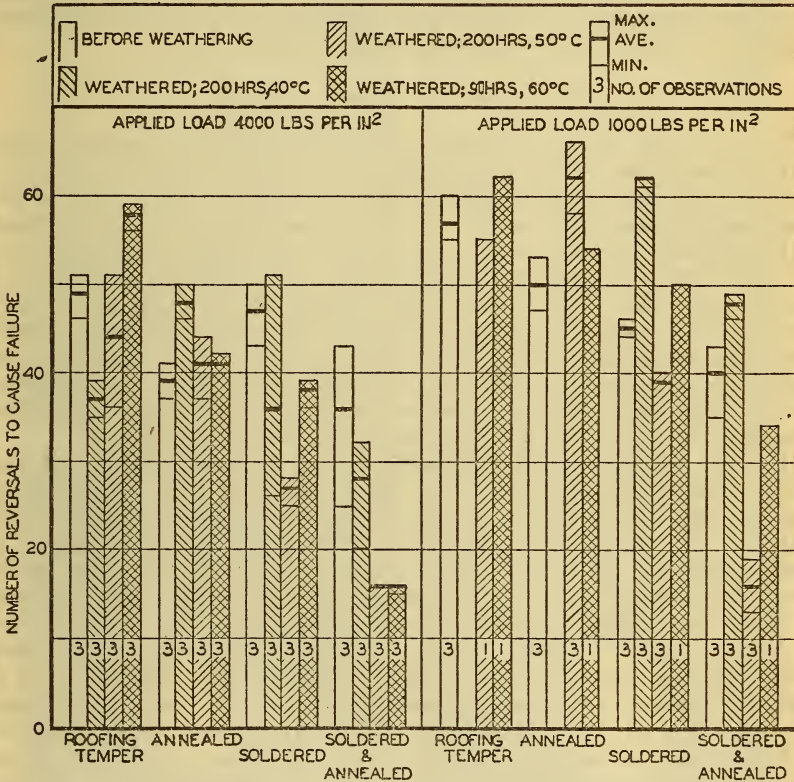
In Tables 4 and 5 and in Figure 6 are given the results of accelerated weathering of soldered copper. At the end of the first 100-hour period many of the specimens were found, after scrubbing, drying, and weighing, to have increased in weight, and after 200 hours very slight losses were noticeable. However, after removing the corrosion film by pickling considerable loss in weight was observed. The reported corrosion rates for soldered copper were calculated on the assumption that all the loss was from the bare copper portion whose area was very nearly 50 per cent of the total area exposed. These figures indicate that the corrosion rate of soldered copper increased with increase in annealing temperature to which the solder was subjected.

FIGURE 6.—Results of bend tests of plain and soldered sheet copper

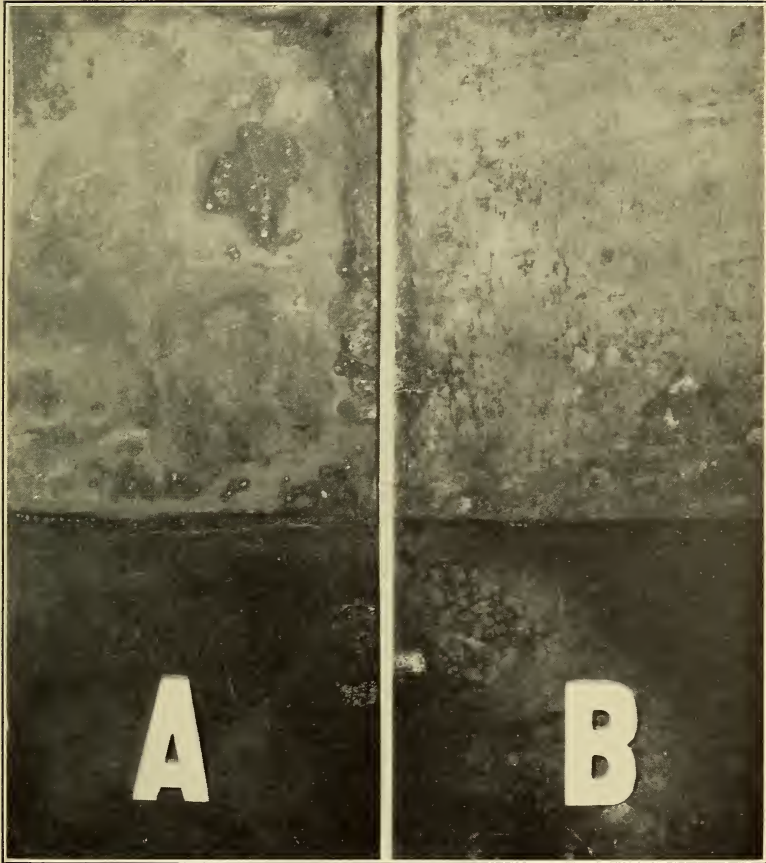
FIGURE 8.—Same as *Figure 7*, but after 200 hours accelerated weathering at 50° C.  $\times 0.7$

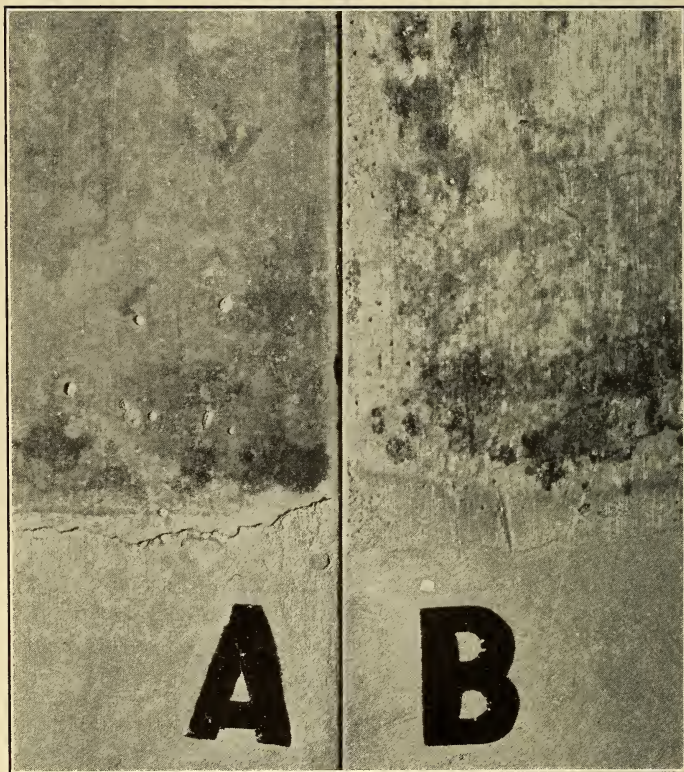
FIGURE 9.—Same as Figure 8, but after pickling.  $\times 3.7$

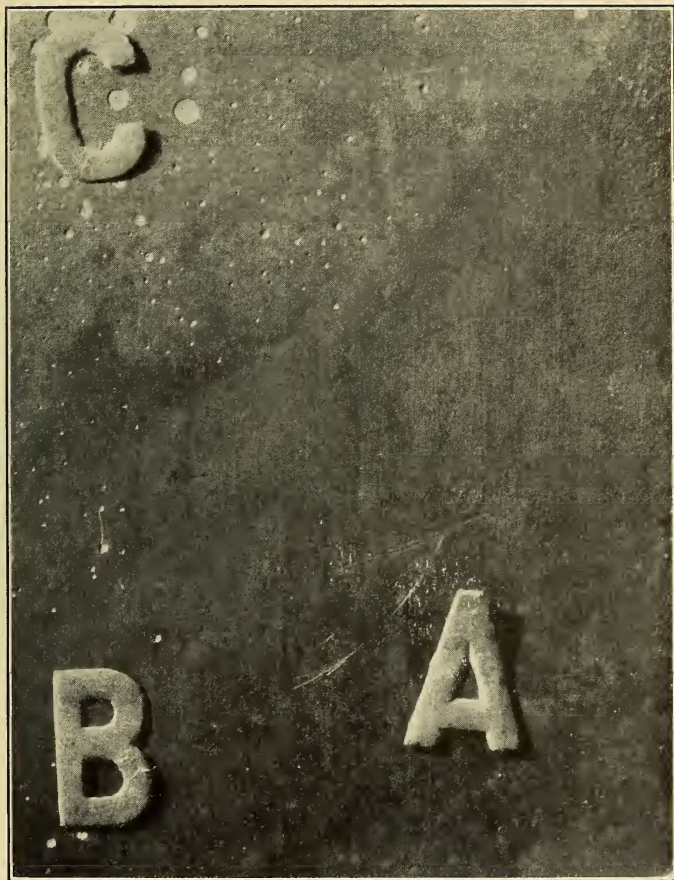
FIGURE 10.—*Phases on acceleratedly weathered soldered copper*  
A, Dull gray with no pits; B, blue gray with a few pits; C, white gray with many pits.

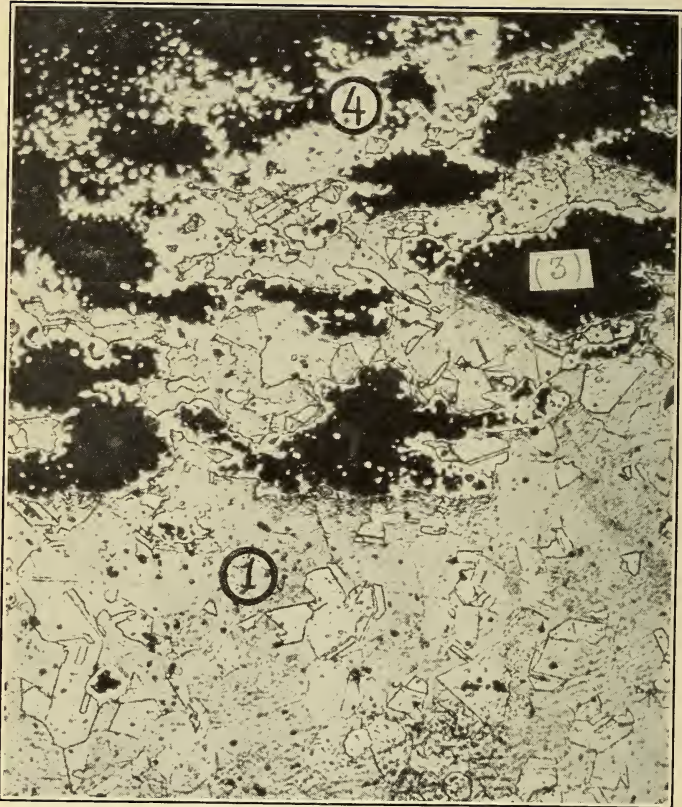
FIGURE 11.—*Oblique section of sheet copper soldered at 270° C.*  
× 500

Etchant:  $\text{NH}_4\text{OH} + \text{H}_2\text{O}_2$ . 1, Sheet copper base; 3, unchanged solder; 4,  $\epsilon'$  phase.

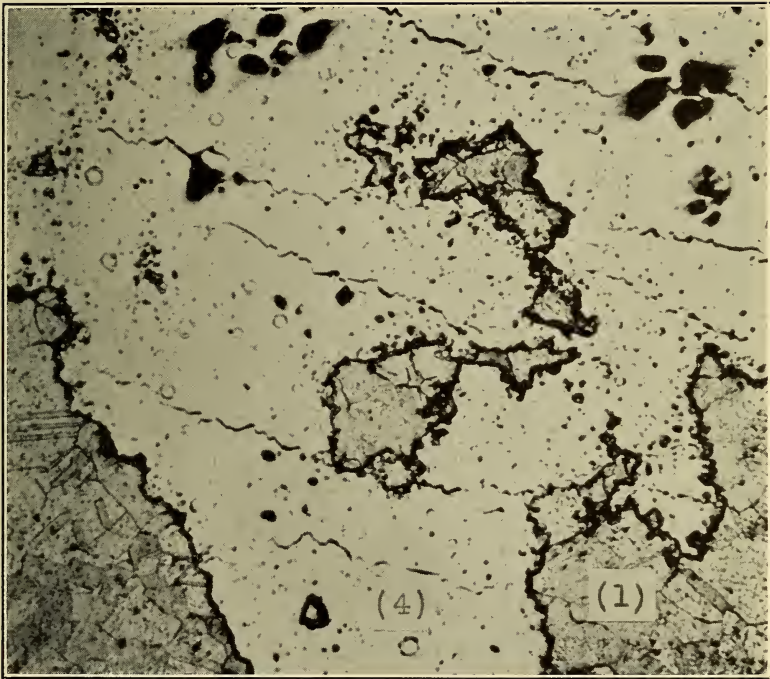
The characteristic microstructures of the soldered specimens are shown in Figures 11 to 13. Figure 12 shows the cracks in the very thick coating of copper-tin alloys on soldered and annealed copper. The black line between the copper and the alloys resulted from the deep etching of the copper, which is anodic to the coating in ammonium hydroxide.

FIGURE 12.—*Oblique section of sheet copper soldered at 270° C. and heated to 500° C. for 3 hours. × 500*

Etchant:  $\text{NH}_4\text{OH} + \text{H}_2\text{O}_2$ . 1, Sheet copper base; 4, copper-tin alloys.

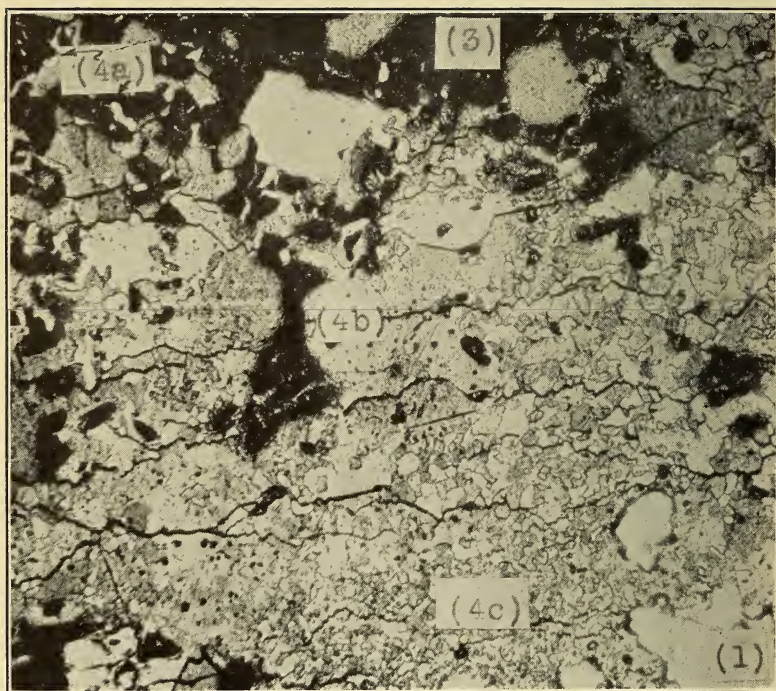
FIGURE 13.—Same as Figure 12, but after prolonged etching with  $Fe_2Cl_2.HCl$  and nitric acid dip.  $\times 200$

1, Sheet copper base; 3, unchanged solder; 4a, bright areas of  $\epsilon'$  phase; 4b,  $\eta$  phase; 4c,  $\delta$  phase.
