*NIST Special Publication 778*

# *Performance of Structures During the Loma Prieta Earthquake of October 17, 1989*

*H. S. Lew, Editor*

January 1990

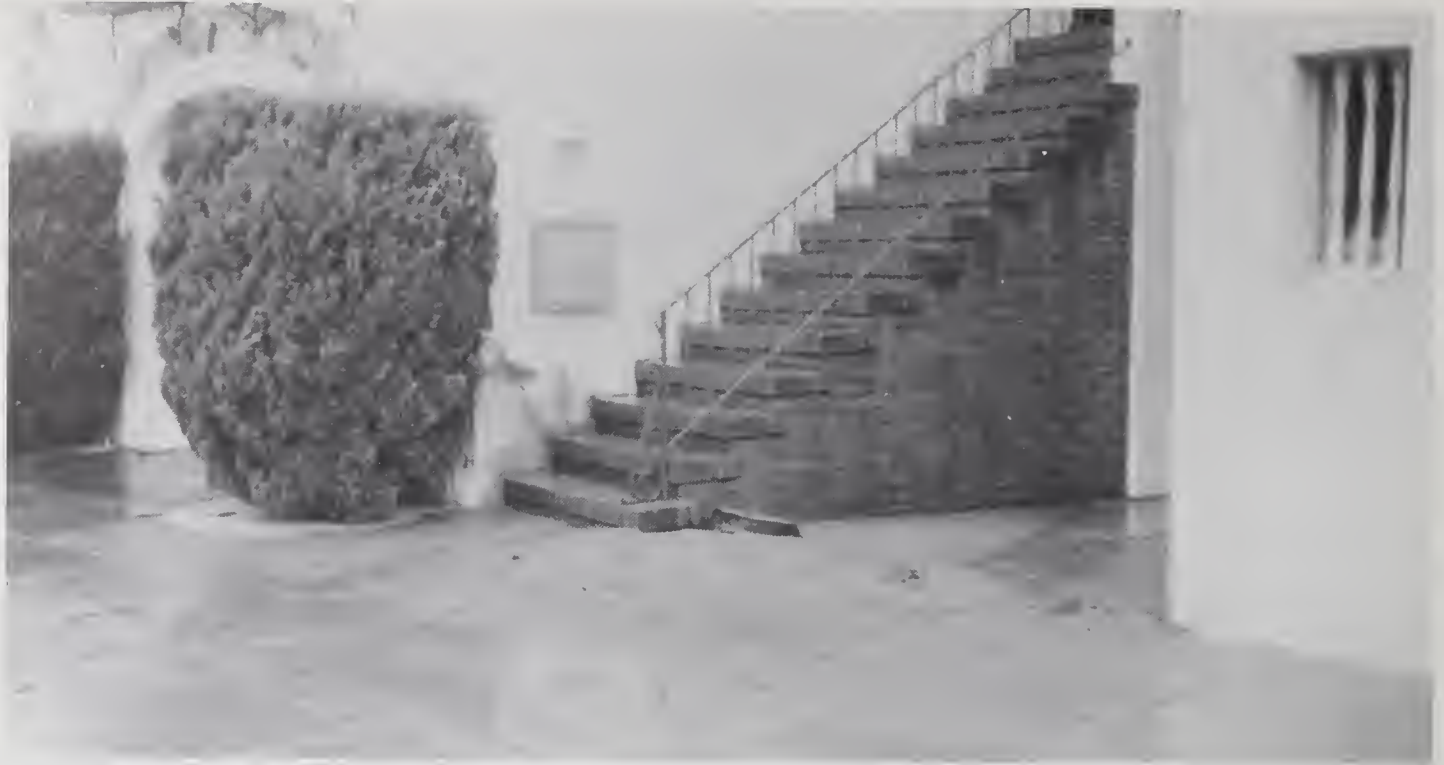
Figure 3.3.3 Sand boil in the Marina District of San Francisco.

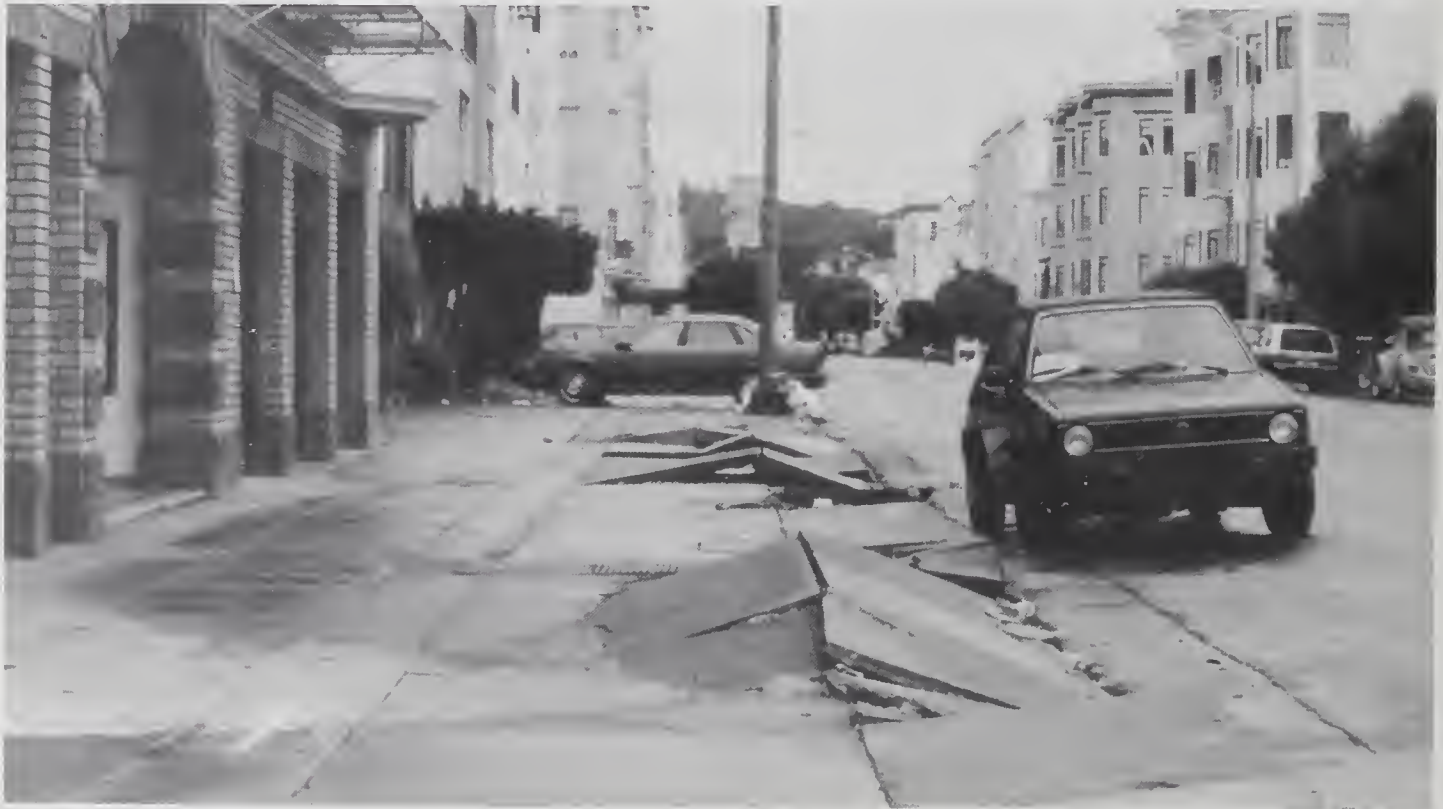
Figure 3.3.4 Typical liquefaction damage in the Marina District of San Francisco.

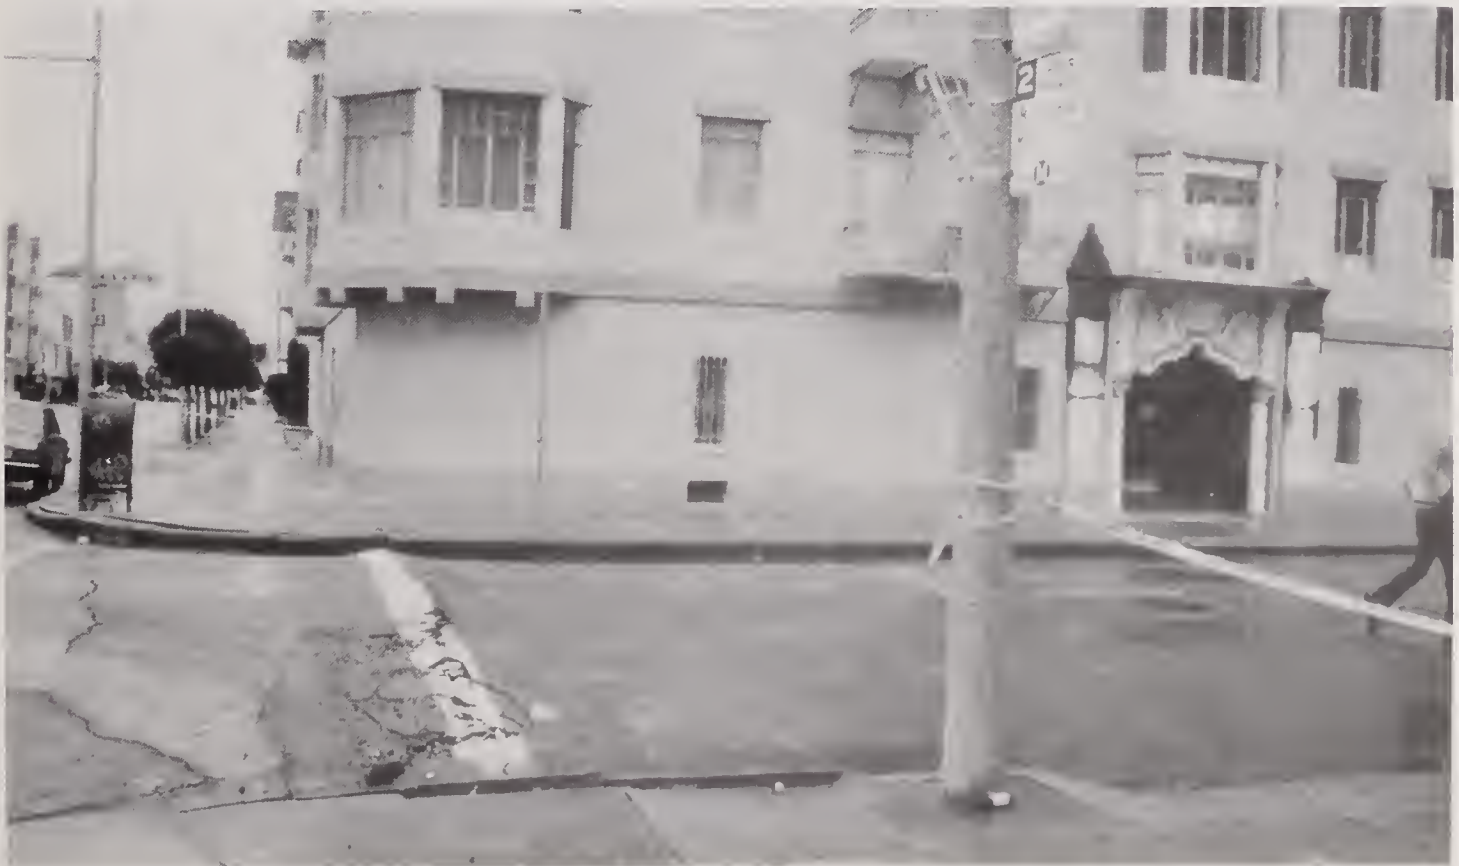
Figure 3.3.6 Pavement heave over utility pipe.

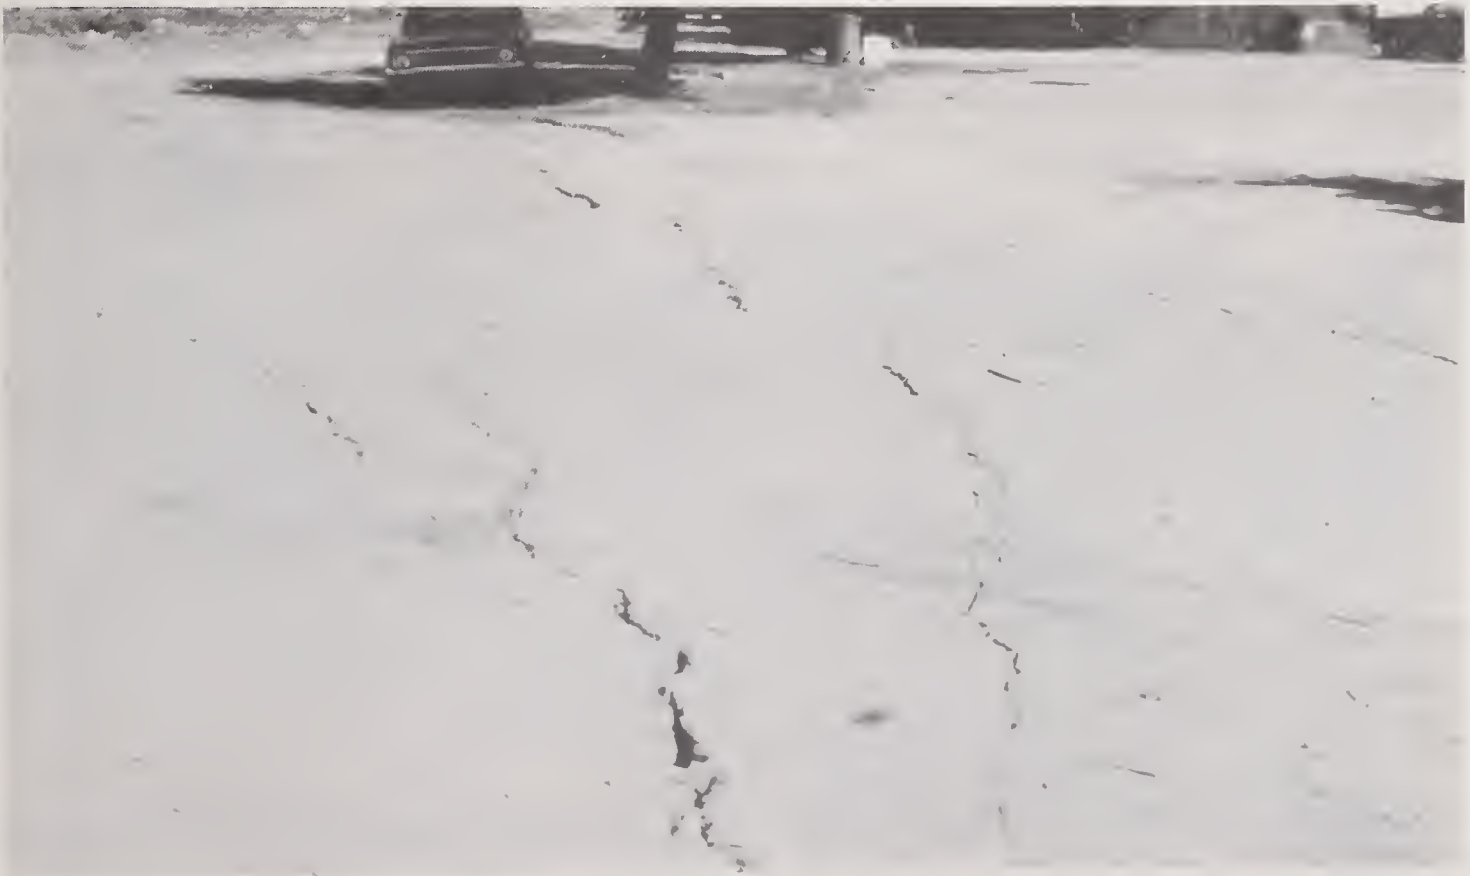
Figure 3.3.9 Tension cracks behind Pajaro River levee.

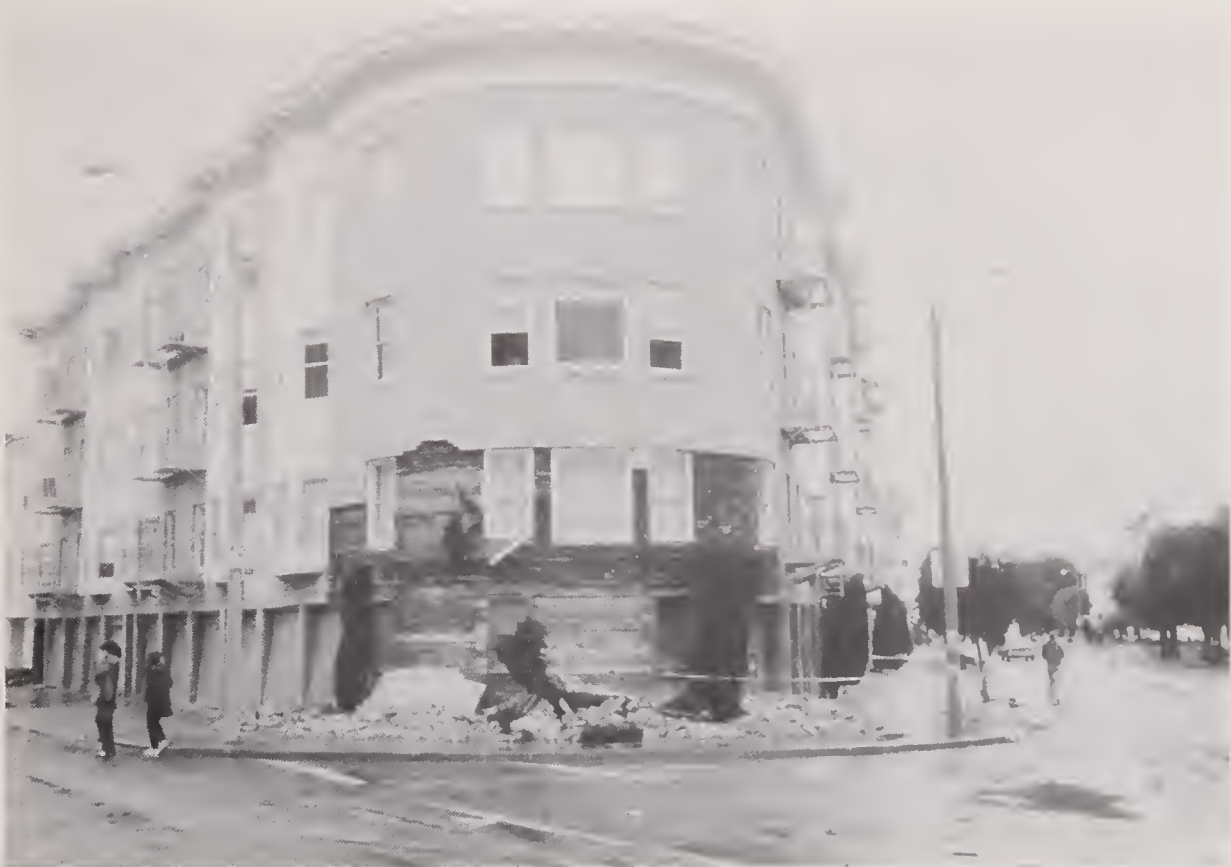
Figure 4.2.17 Example of building with failure of brick masonry facade (location #2).

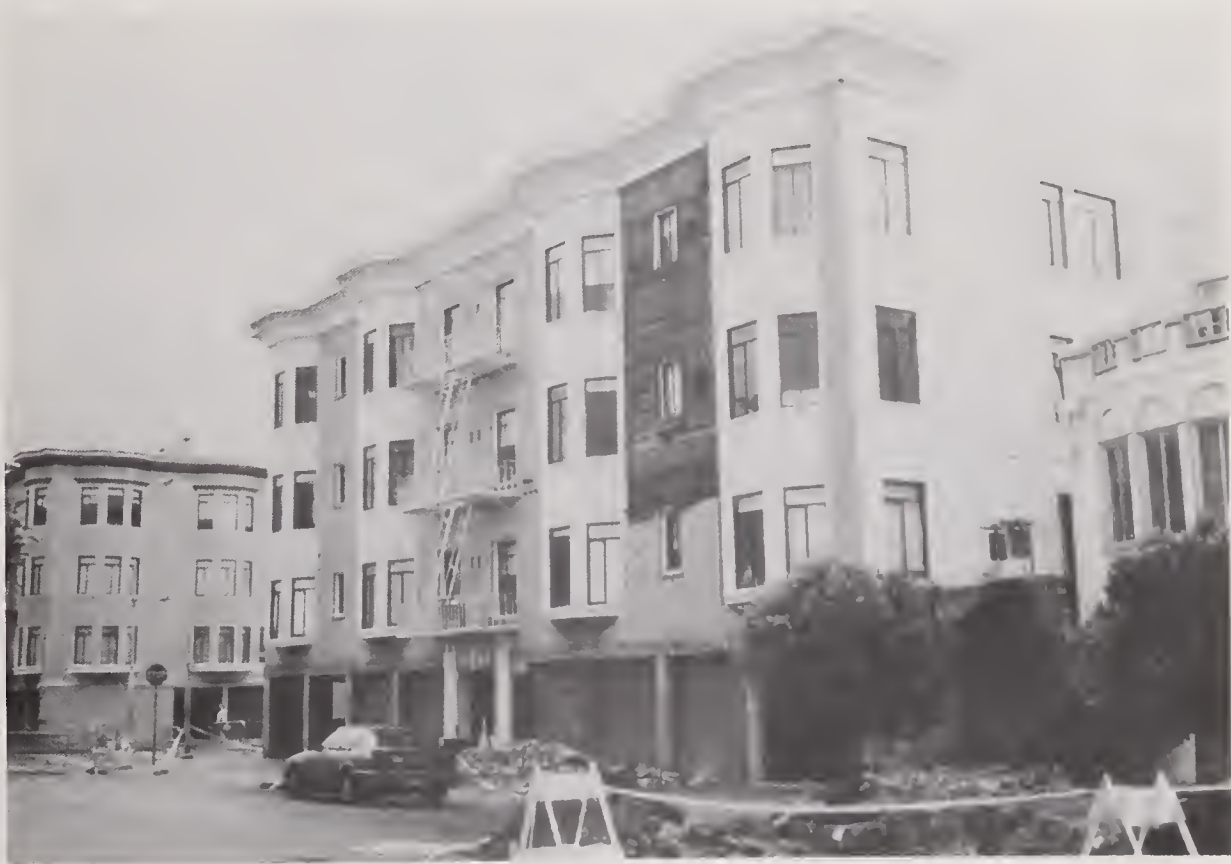
Figure 4.2.18 Example of building with failure of brick masonry facade (location #10).

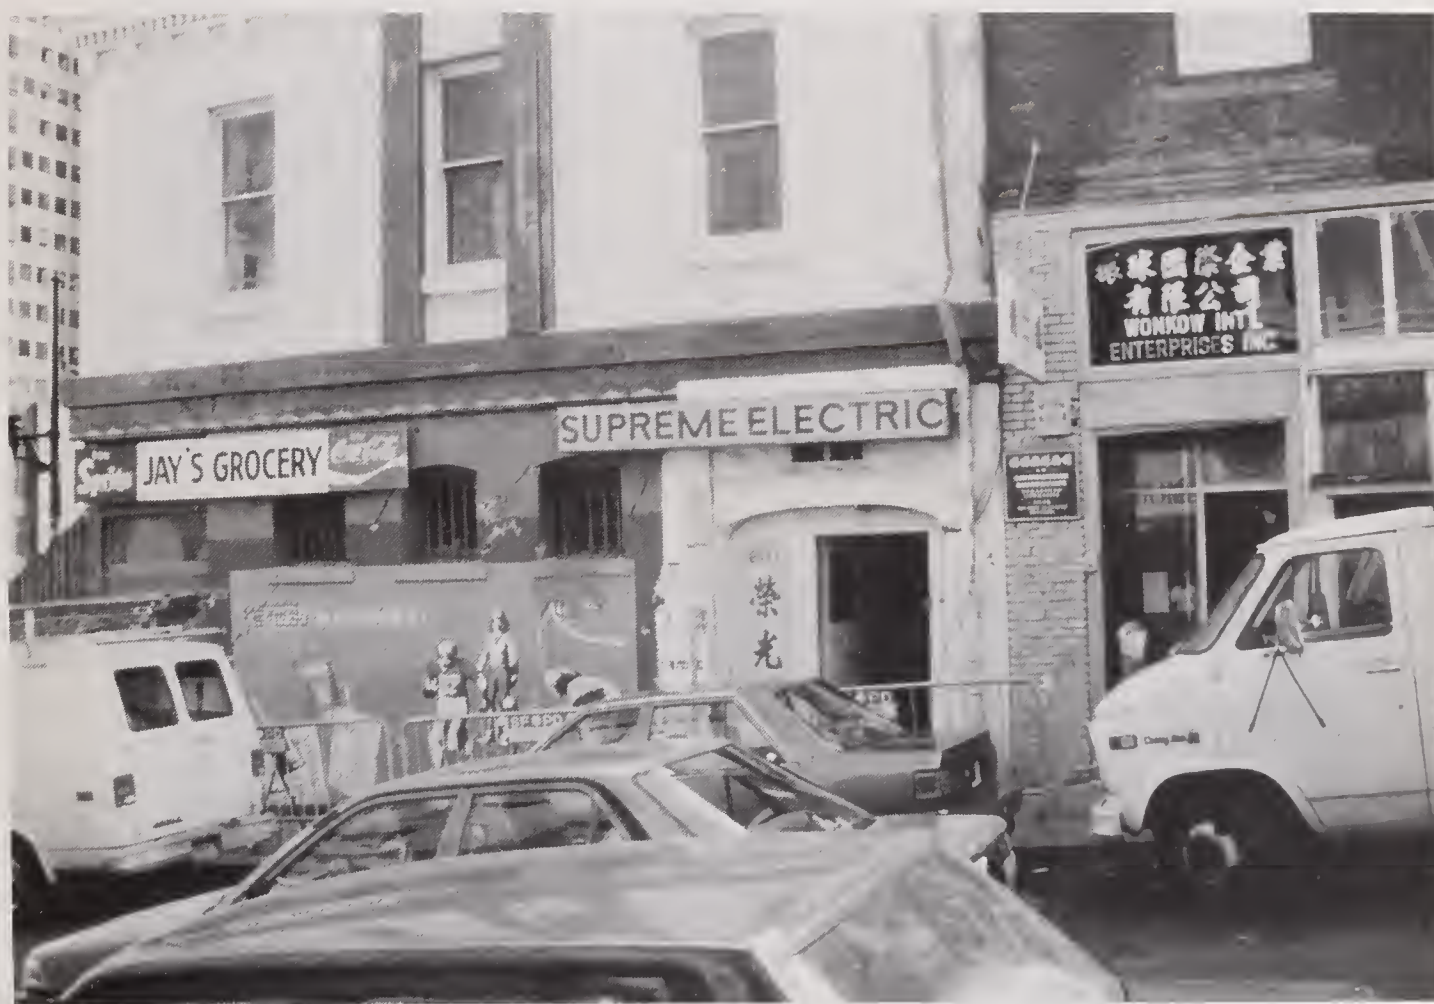
Figure 4.2.25 Example of damage to unreinforced masonry building in the Chinatown area (location #1).

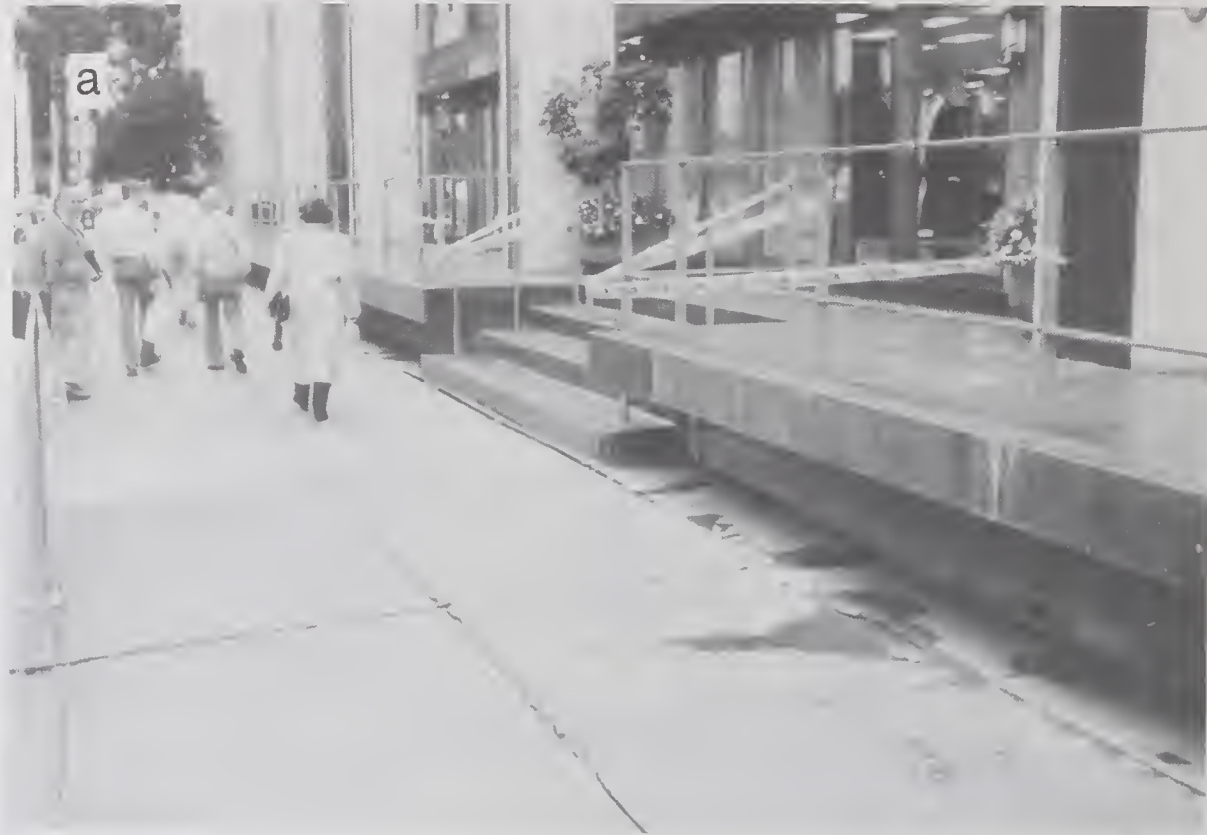
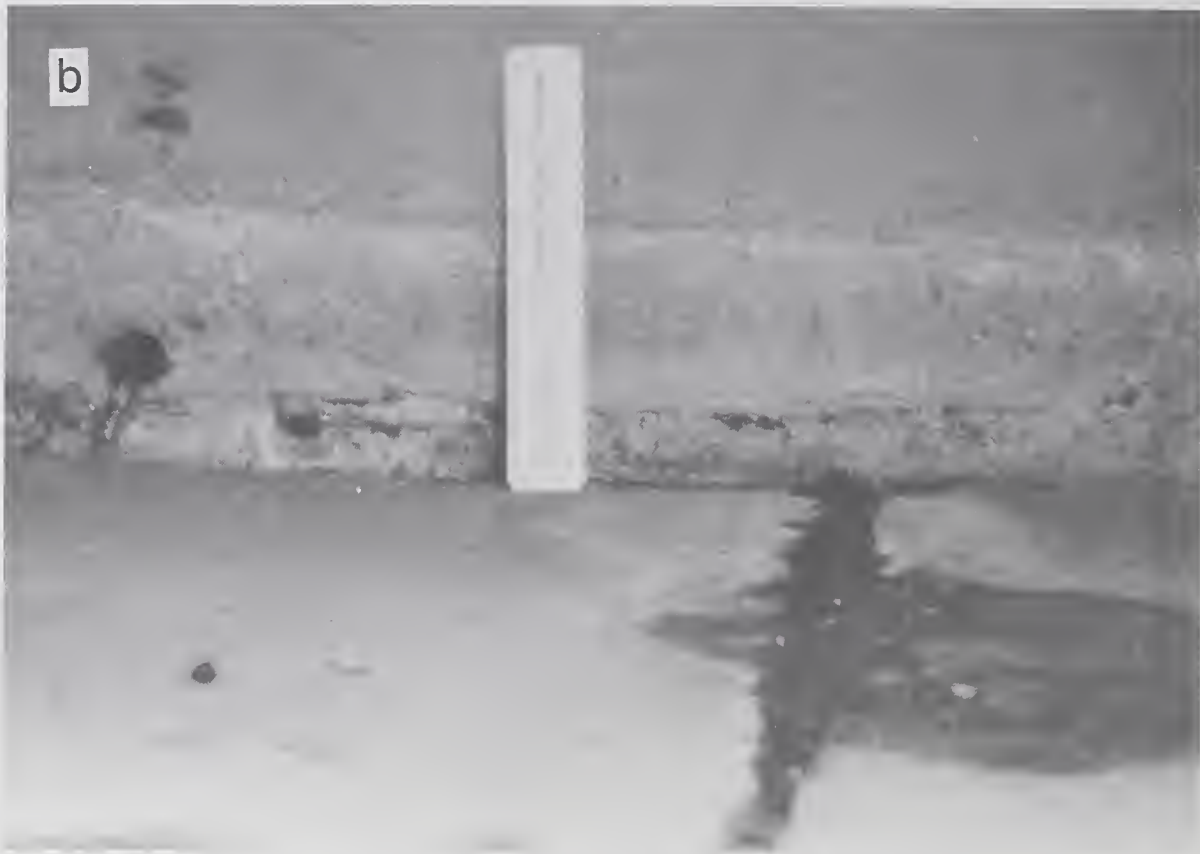
Figure 4.2.26 (a) Sidewalk showing distortions due to differential settlements, and (b) close-up view of intersection of sidewalk with retaining wall showing magnitude of differential movement.

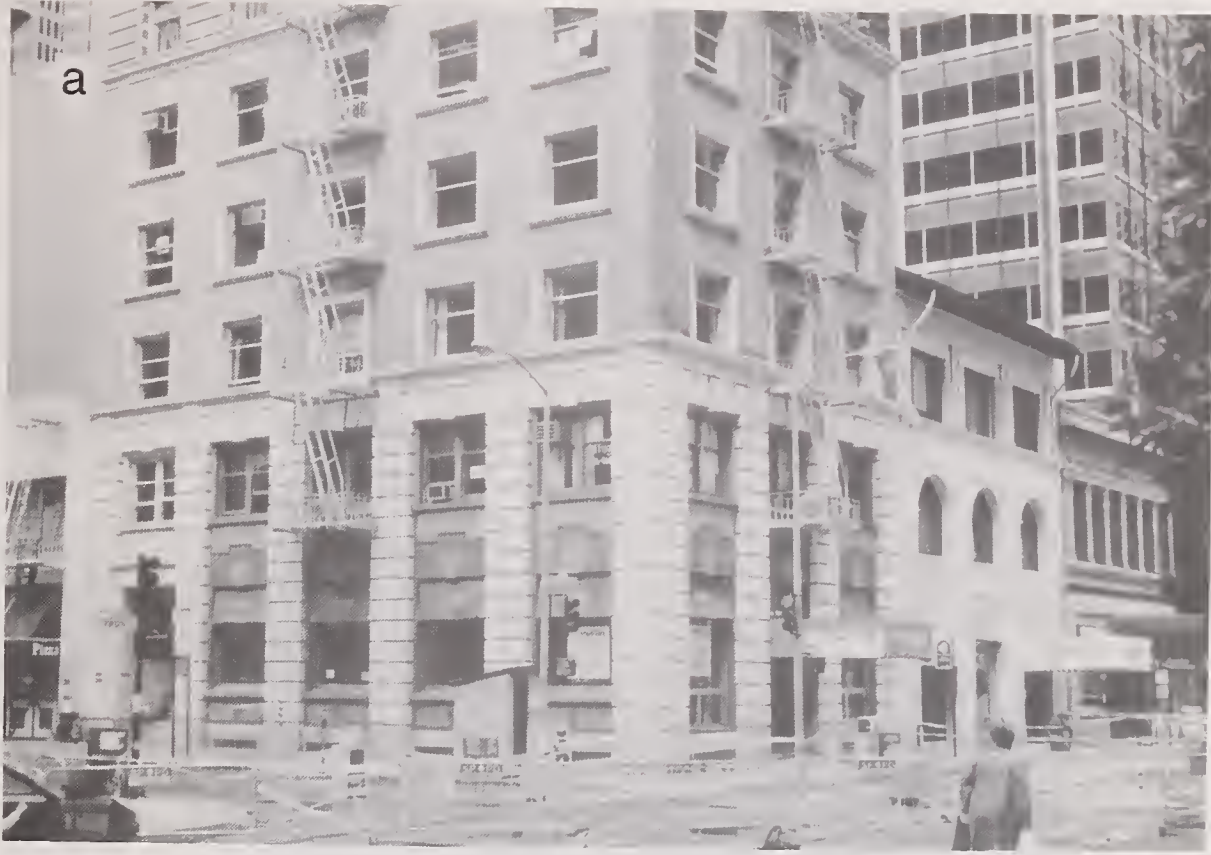
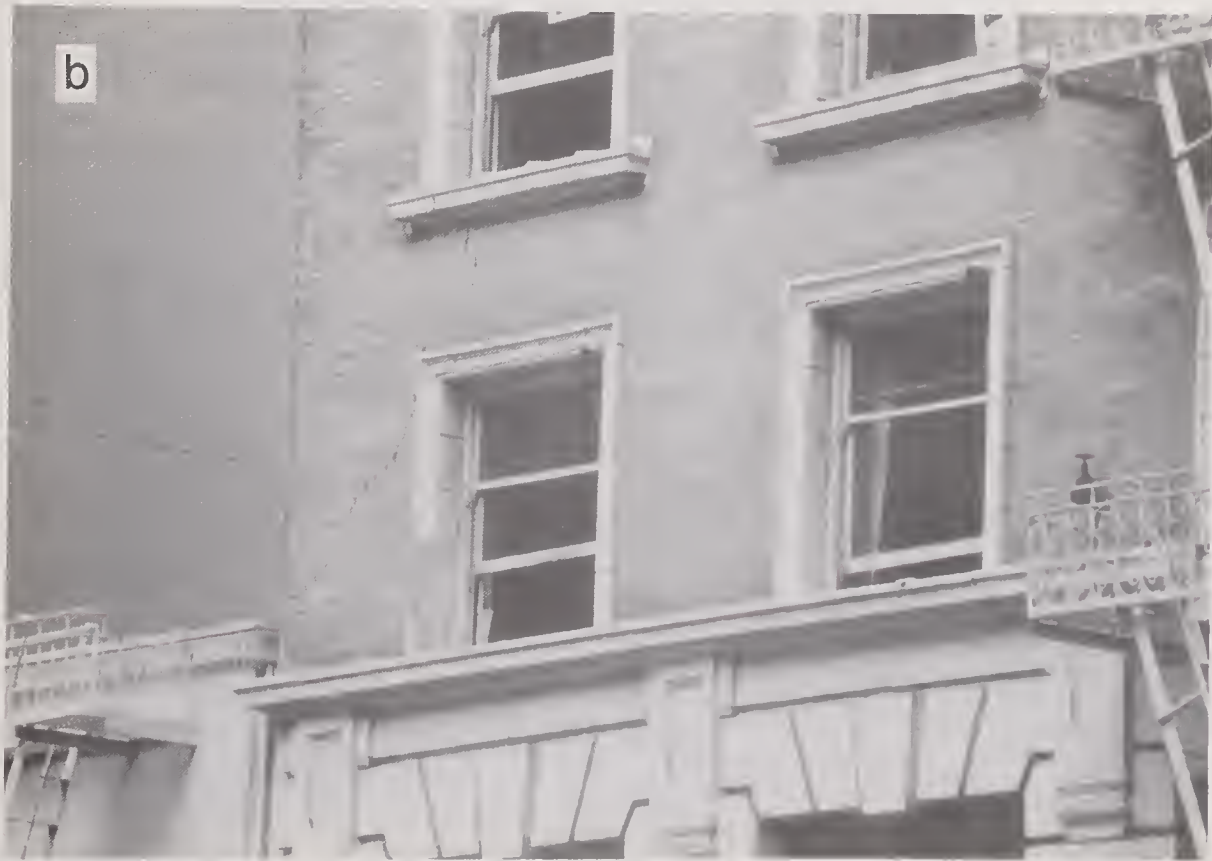
Figure 4.2.27 (a) Severely damaged Marine Building at corner of Front St. and California St.; (b) Close-up view of the northwest corner showing severity of cracking.

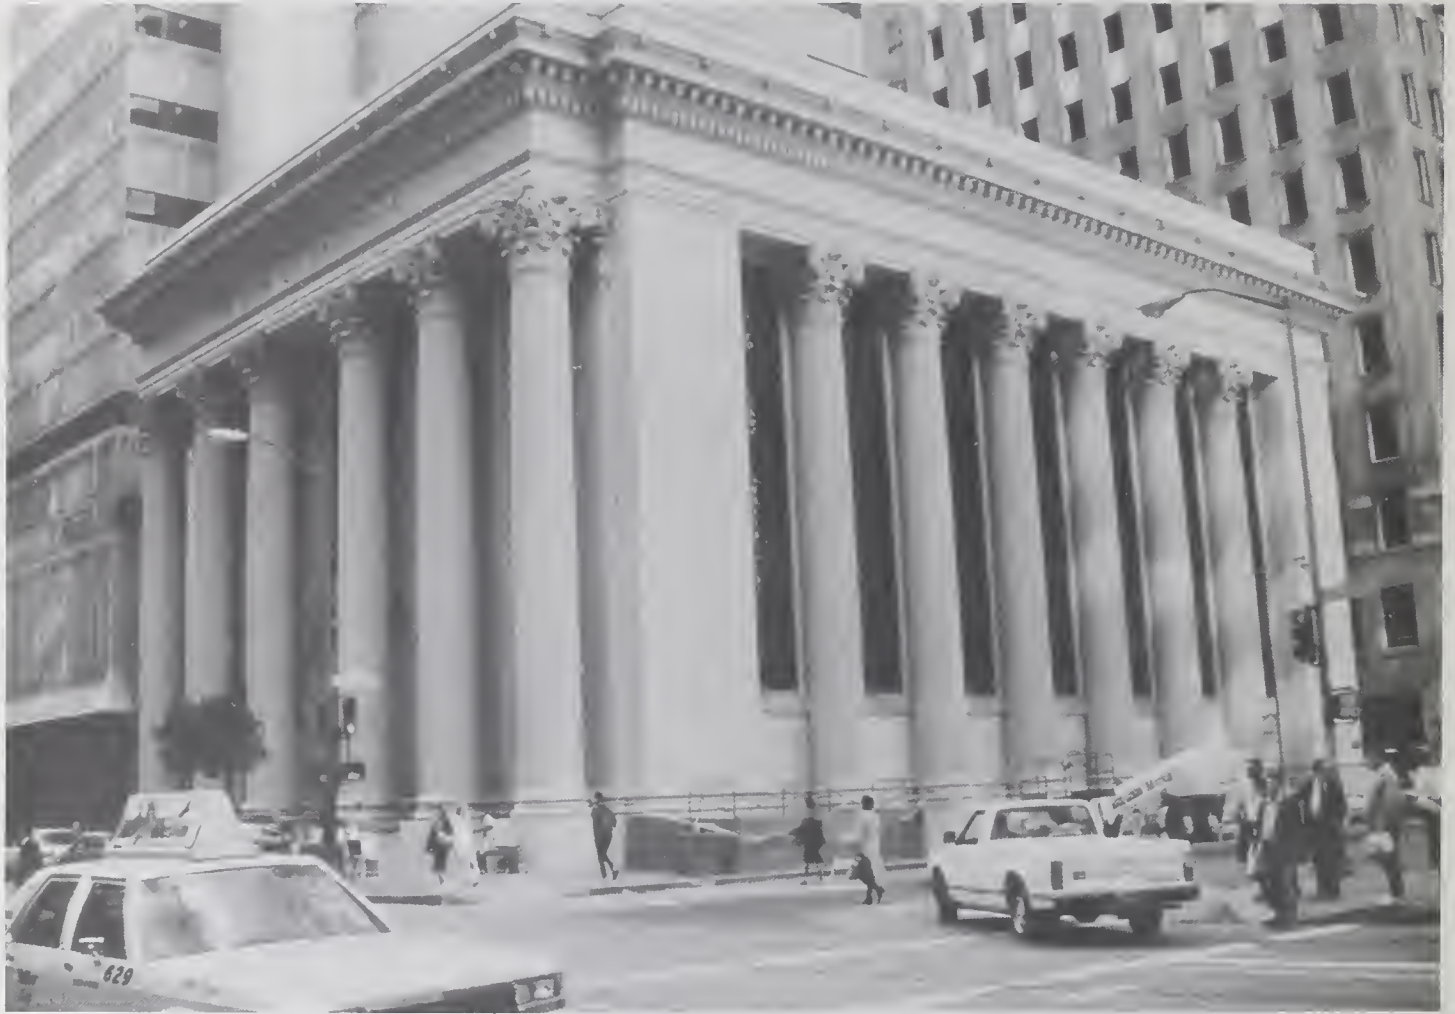
Figure 4.2.30 Damage to the stone facing of the Bank of California building.

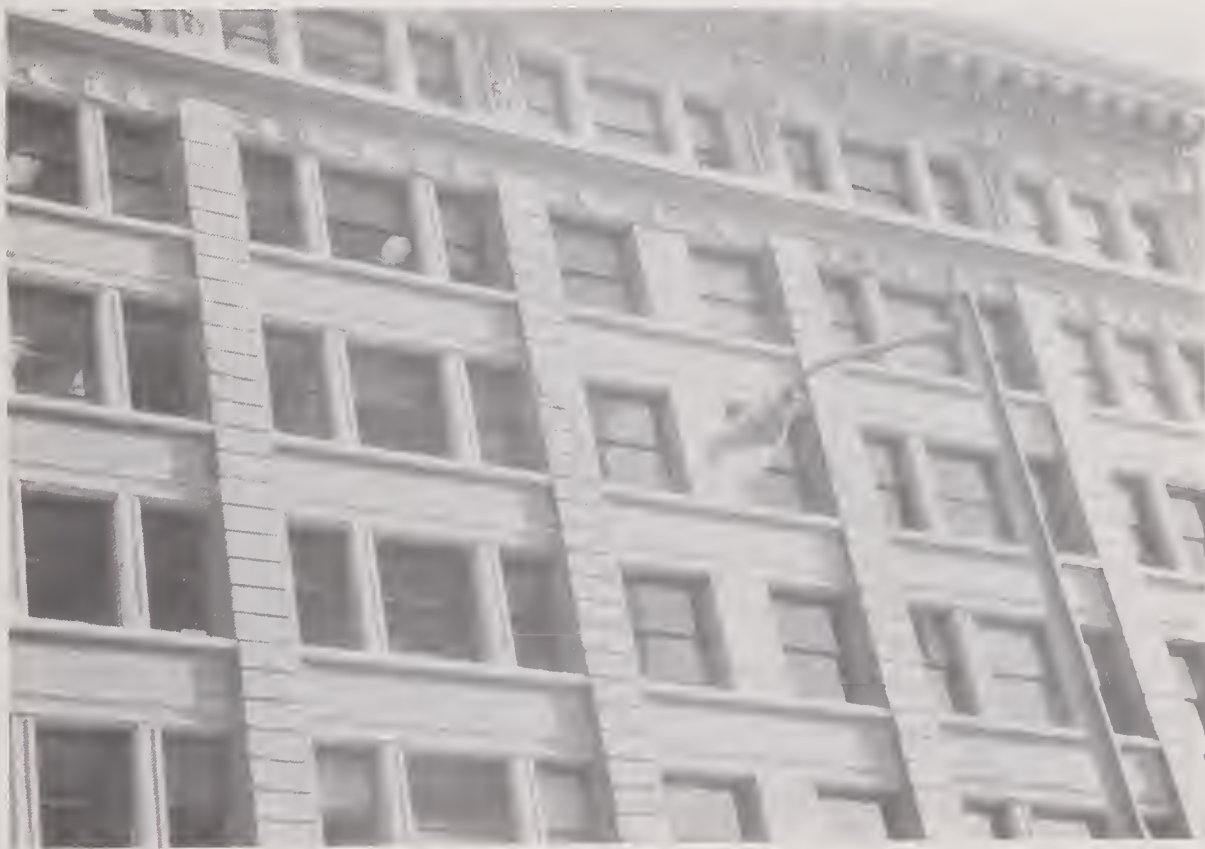
Figure 4.2.32 Example of damage to masonry cladding of Wells Fargo Bank building (location #7).

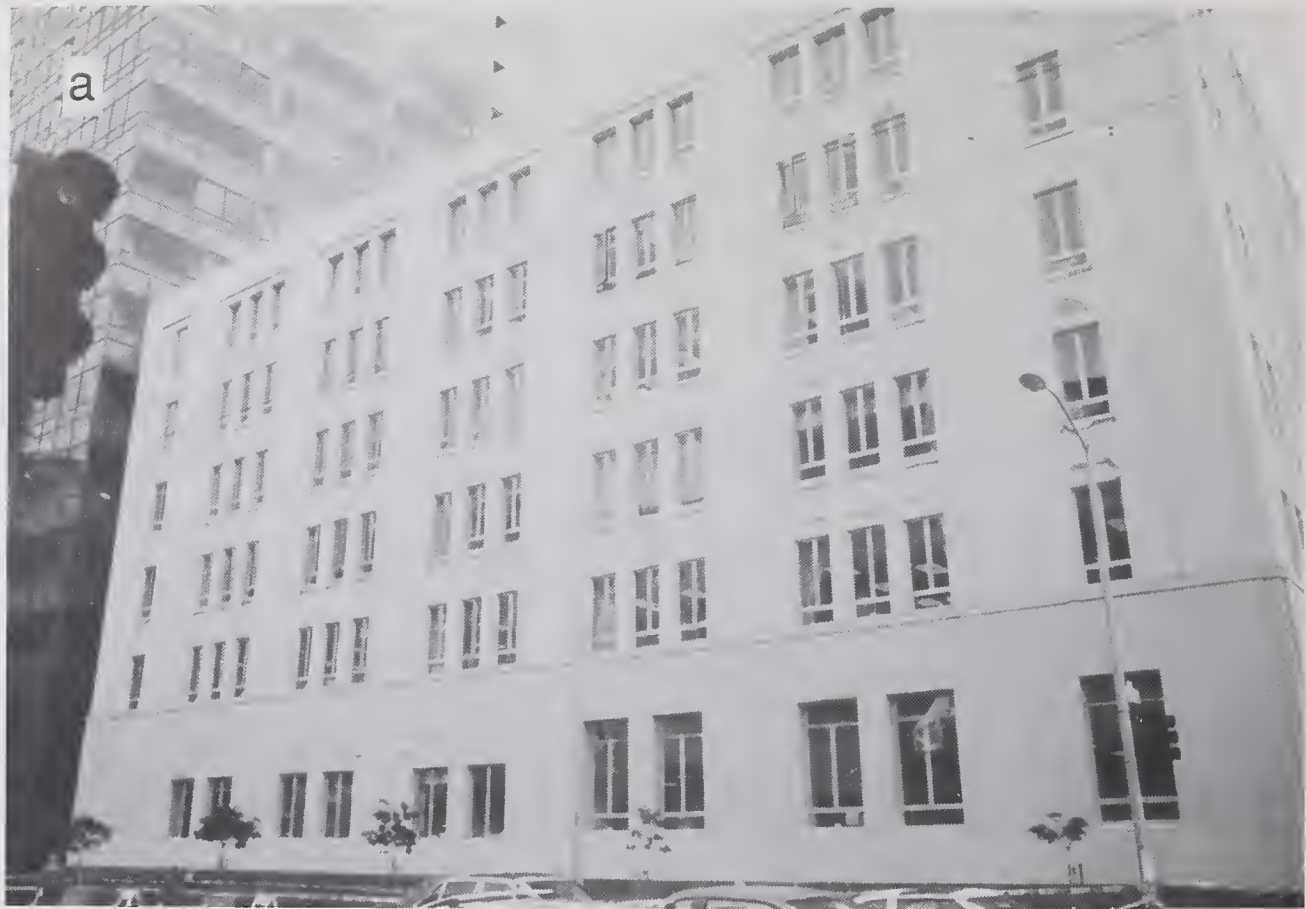
Figure 4.2.33 (a) Reinforced concrete, flat-slab building which sustained severe damage to the exterior walls (location #6); (b) close-up view of damage to spandrels.

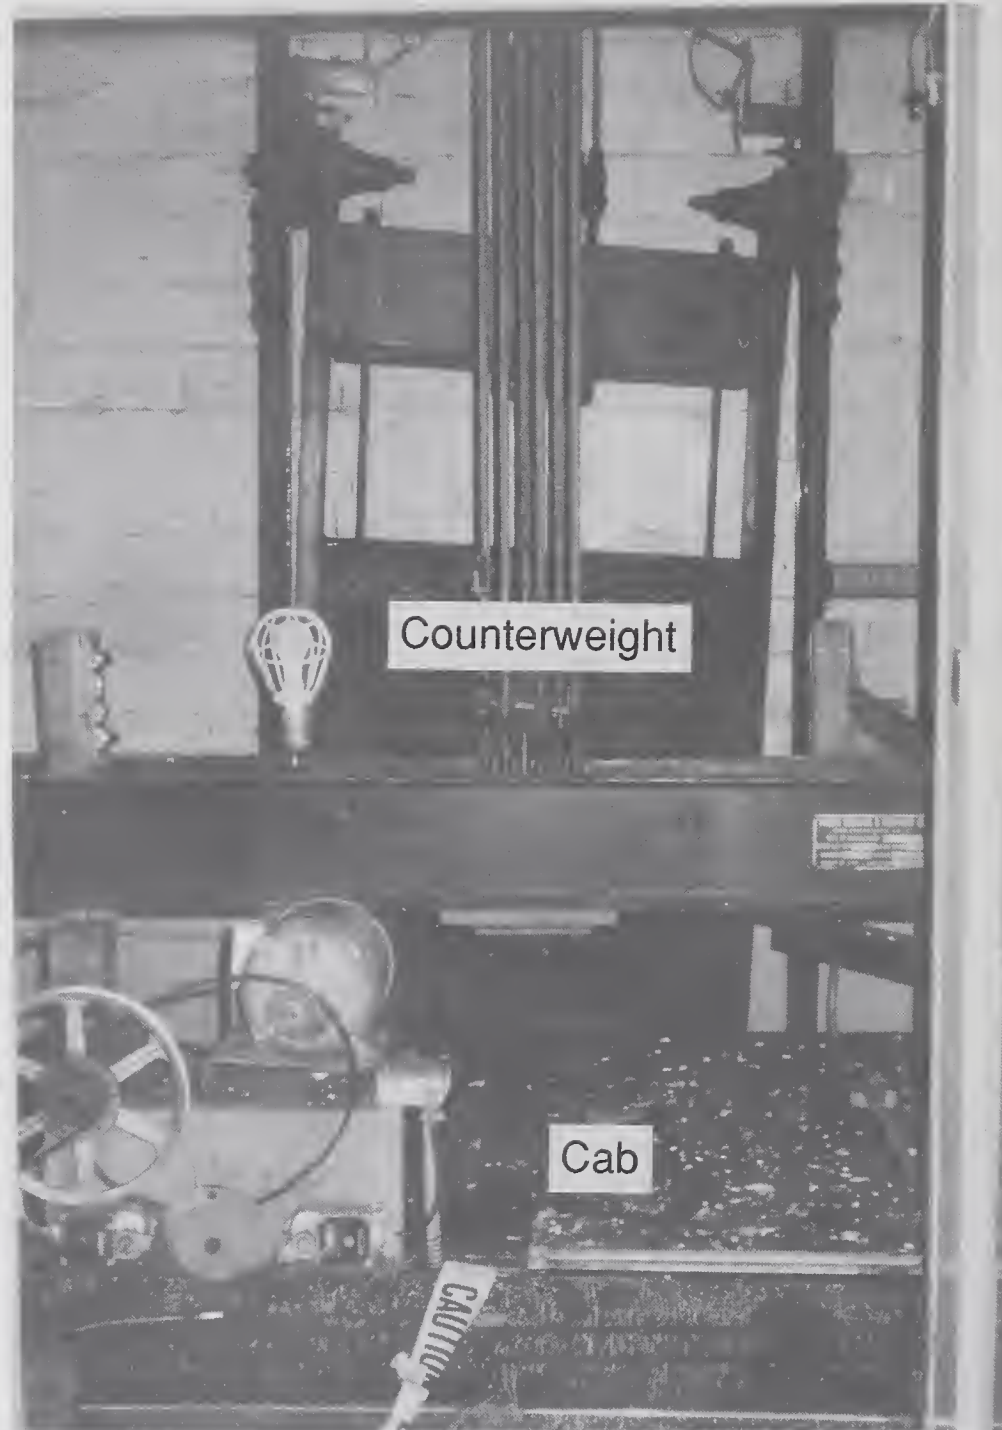
Figure 4.2.35 Elevator counterweight jumped out of its track and collided with the cab in the Old Federal Building (location #9).

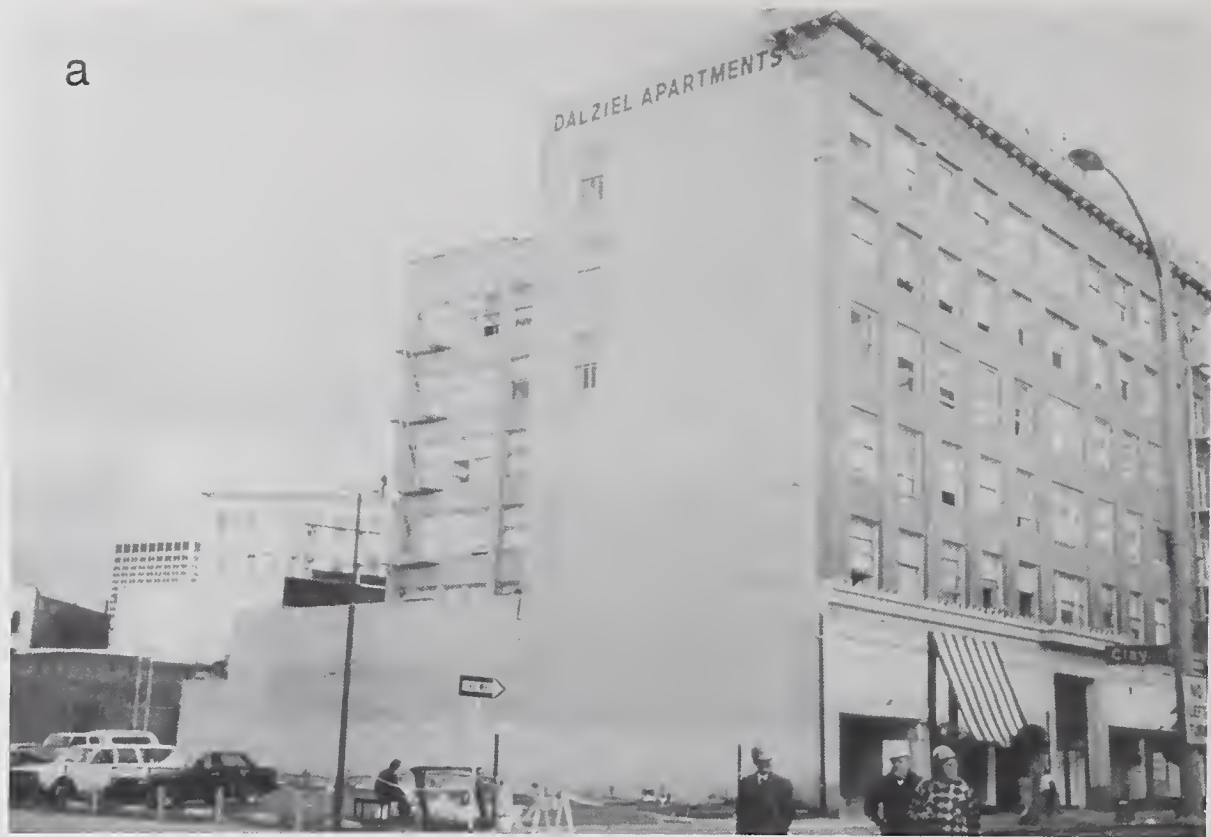
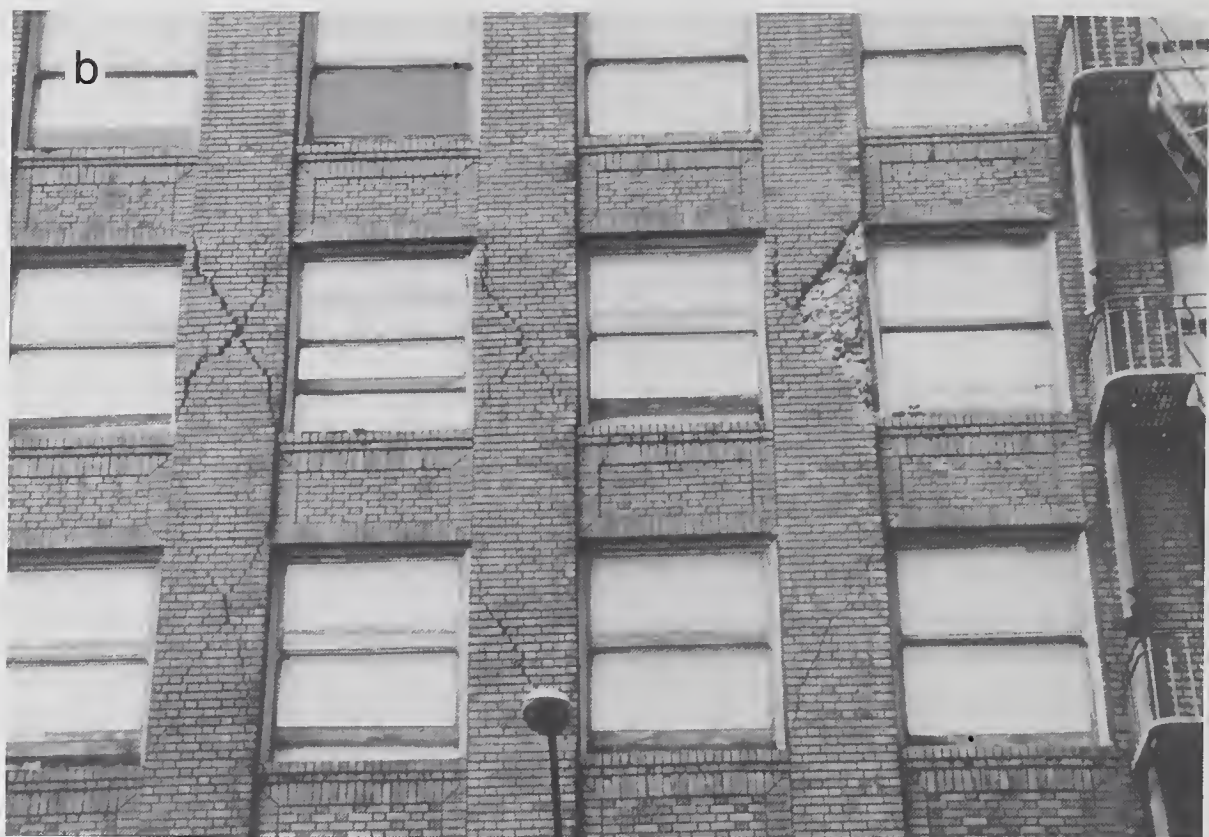
Figure 4.3.2 Dalziel apartment building: (a) overall appearance and (b) close-up view of cracking in masonry piers (location #1).

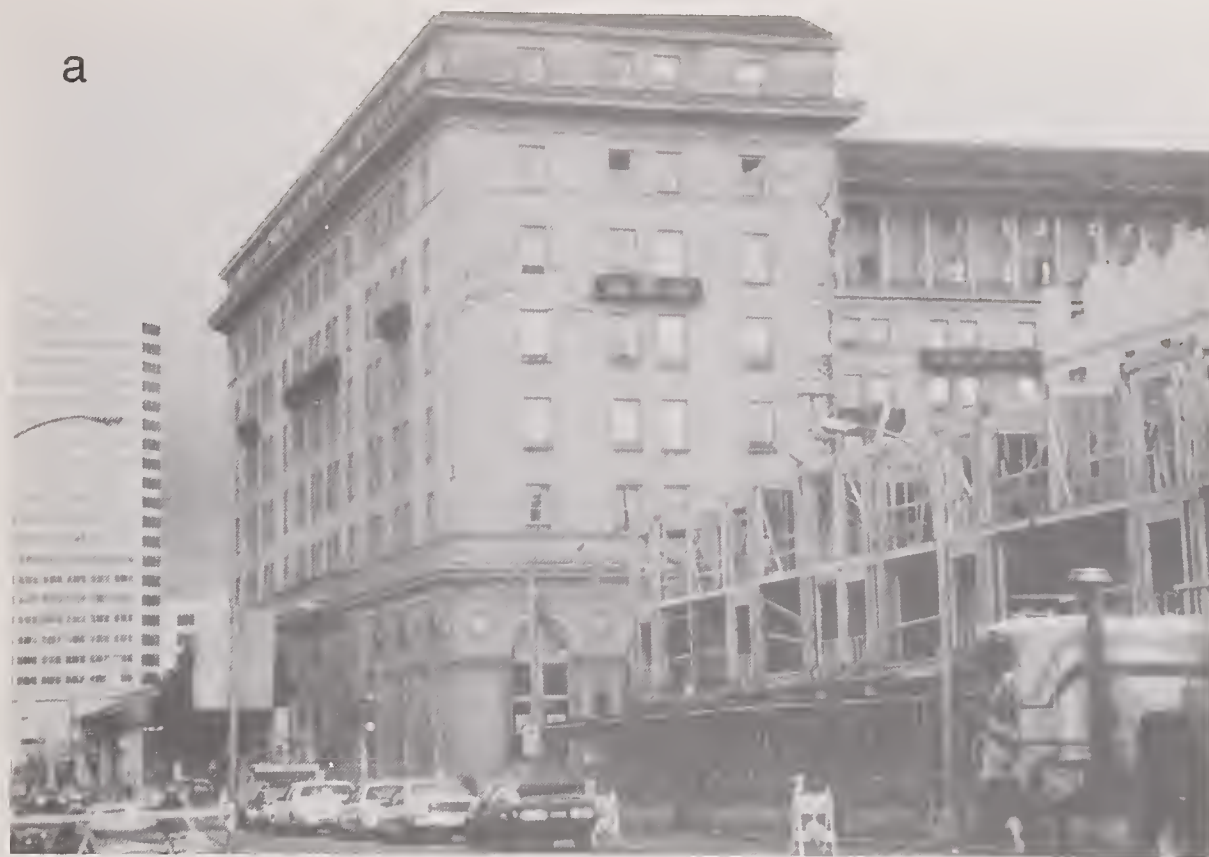
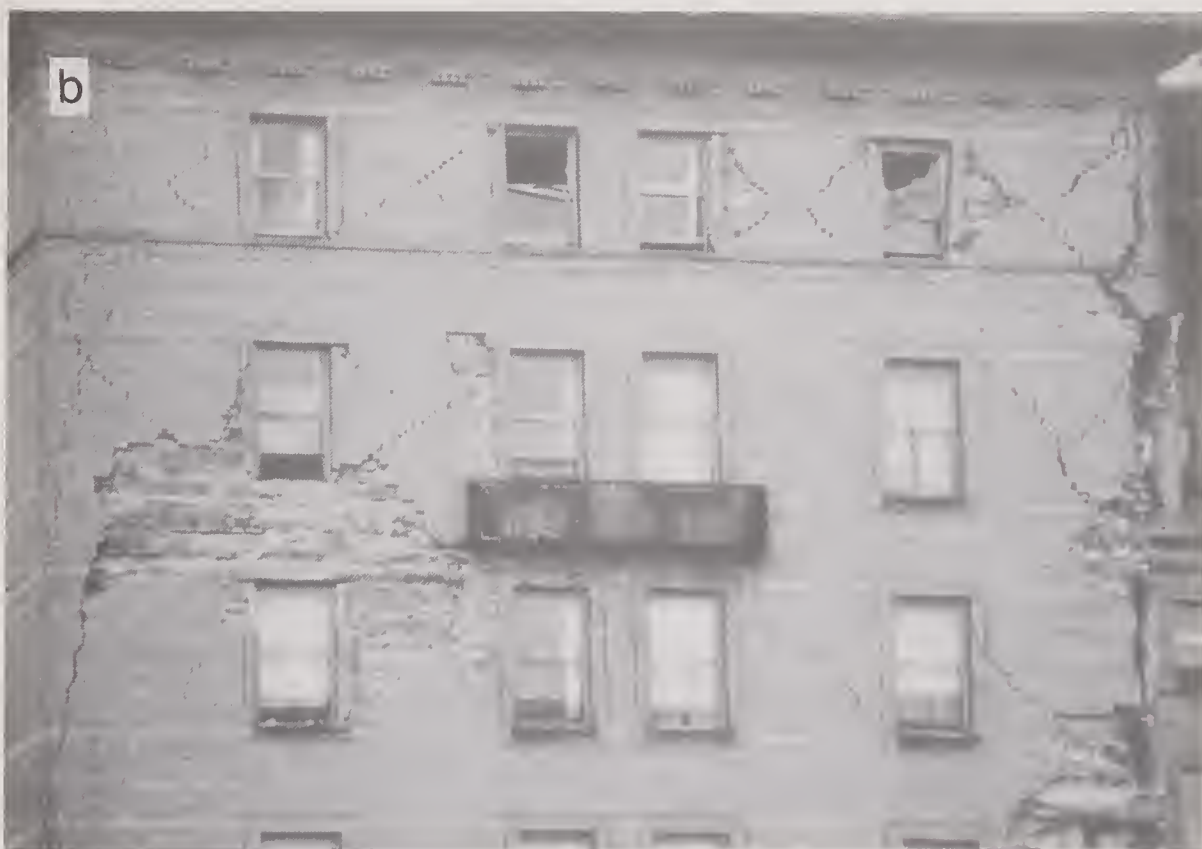
Figure 4.3.3 Oakland Hotel: (a) View of west wing and (b) close-up view of damaged masonry infill (location #6).
