*NIST Special Publication 778*

# *Performance of Structures During the Loma Prieta Earthquake of October 17, 1989*

*H. S. Lew, Editor*

January 1990

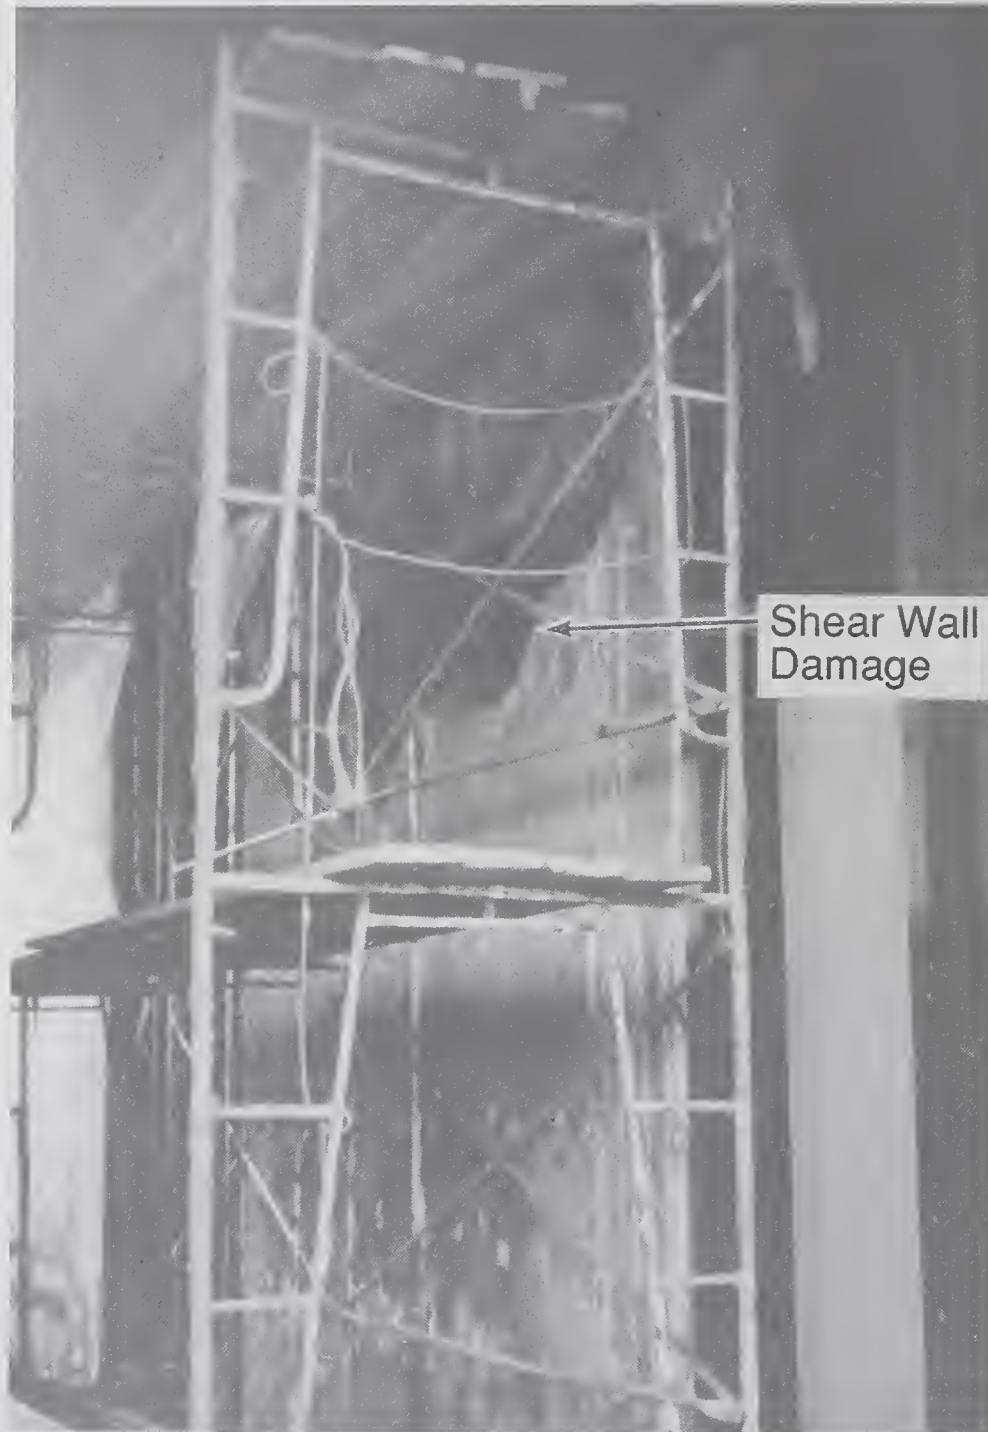
Figure 4.3.8 Damage occurred to the shear walls of a 16-story telecommunications building (location #7).

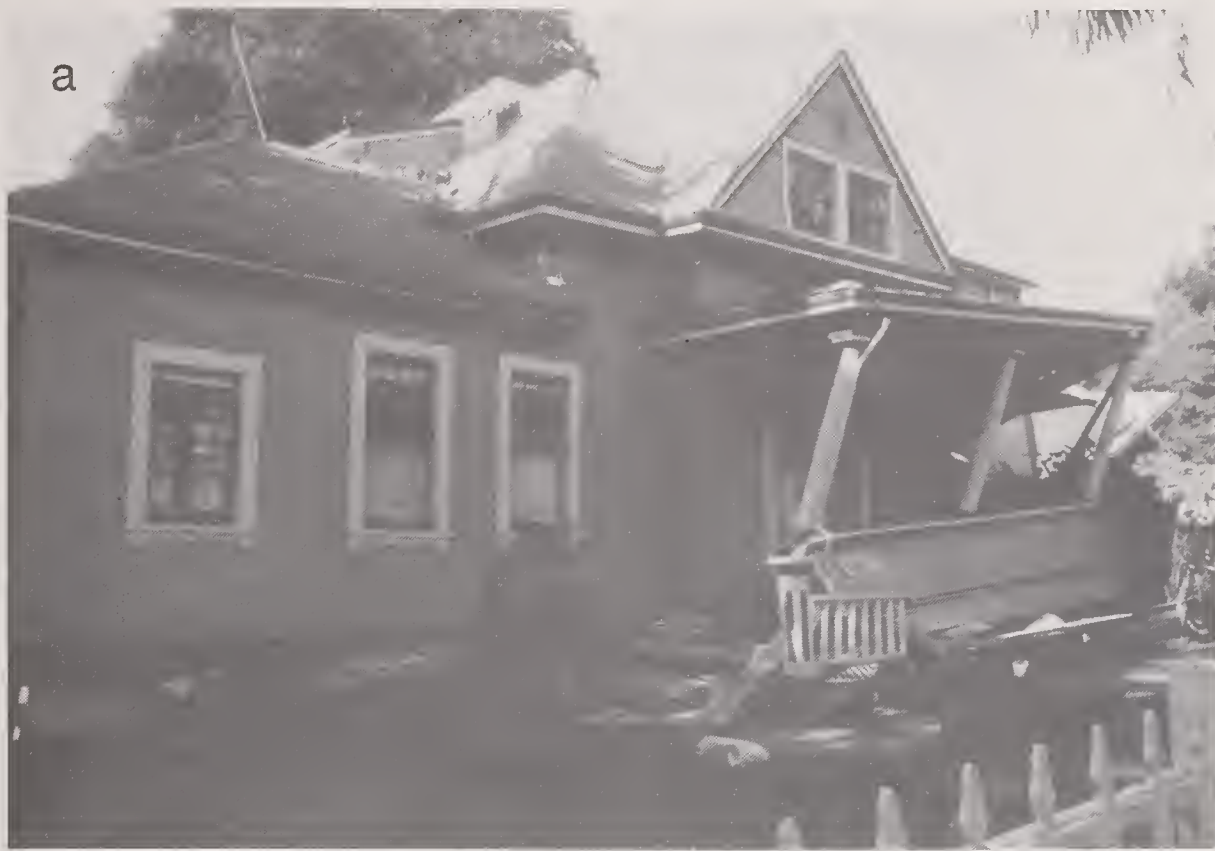
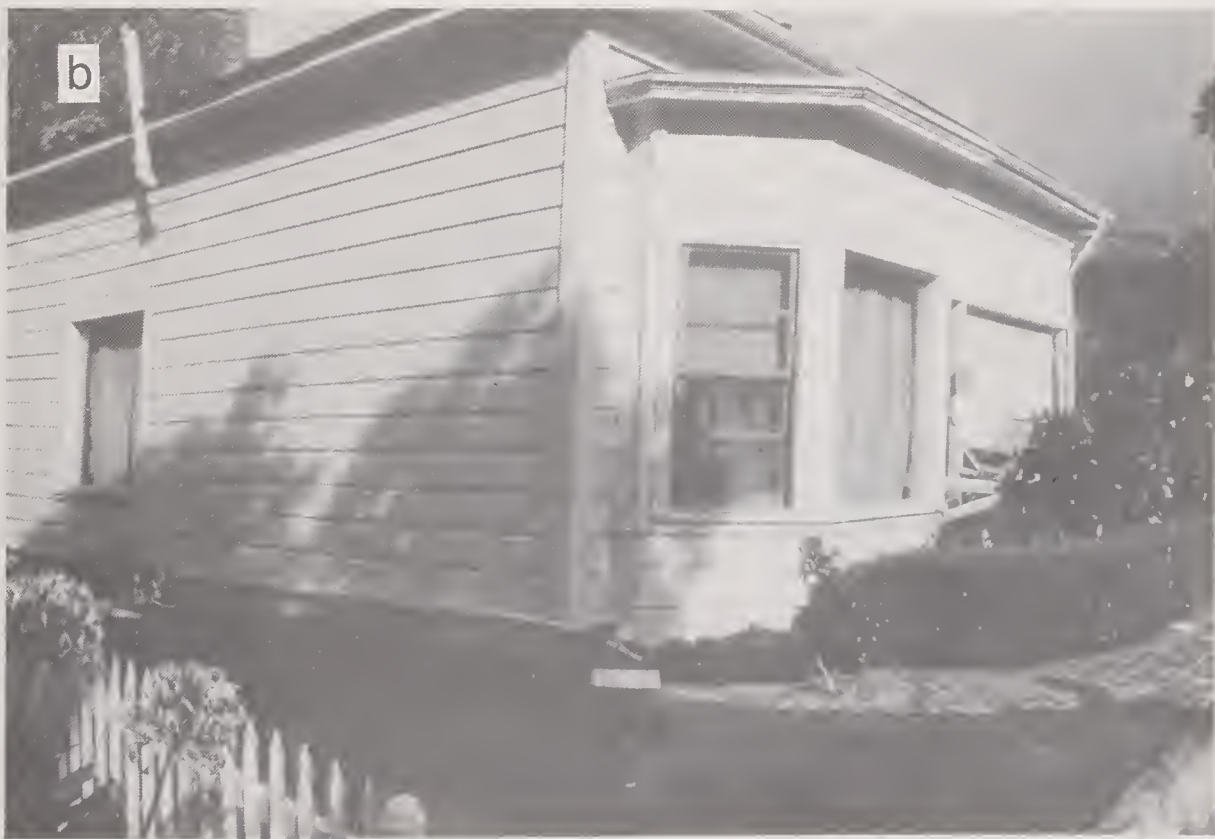
Figure 4.4.2 Examples of failures of houses in Los Gatos: (a) large house suffered large distortion and (b) a small house was rocked off of its foundation.

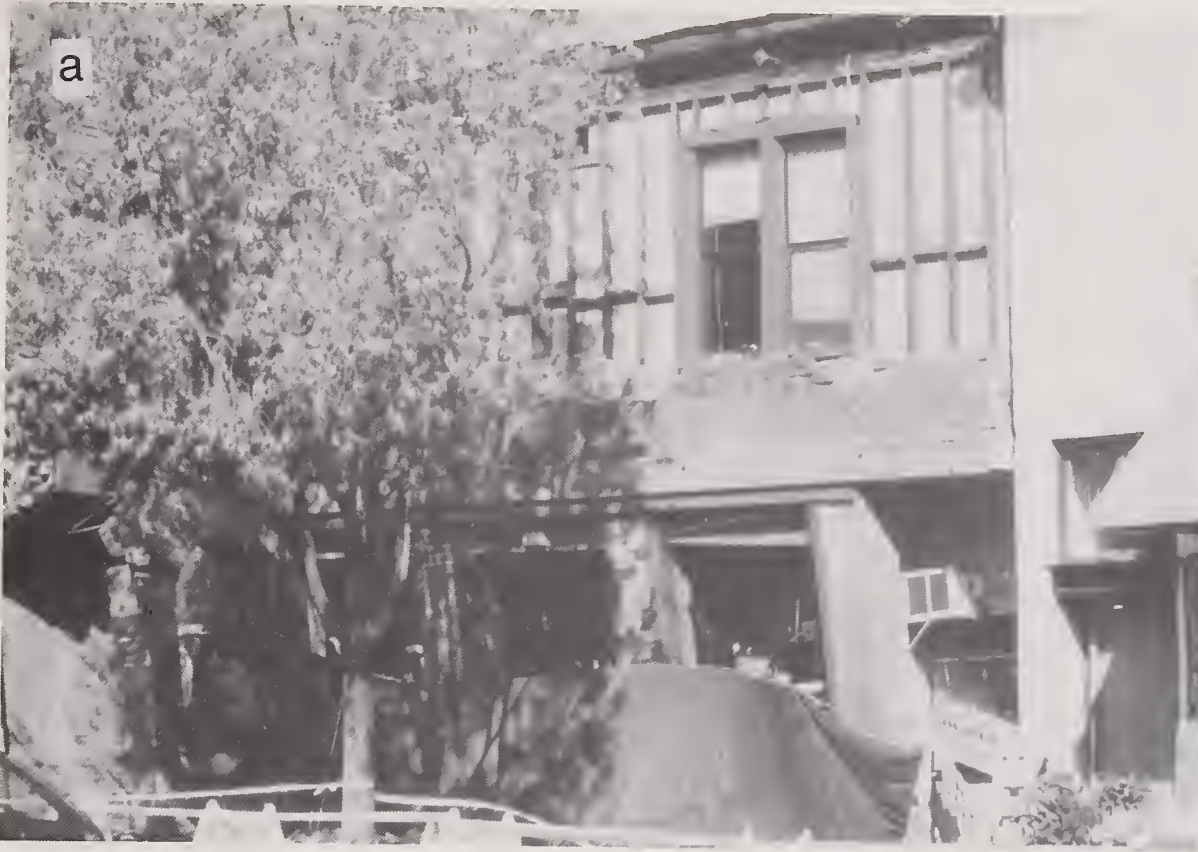
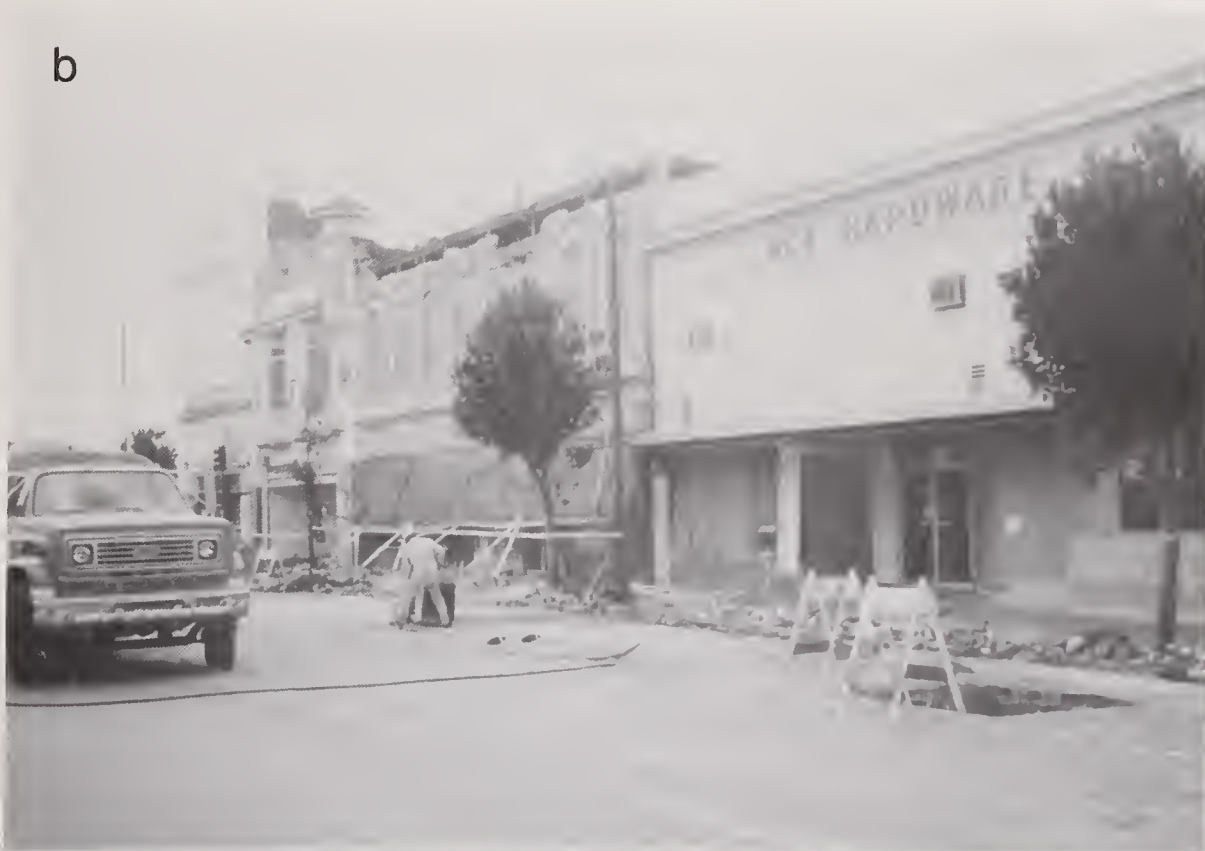
Figure 4.4.4 (a) Failure of wood-framed building with masonry walls and multiple opening in first story (Los Gatos); (b) typical damage to parapets and storefront windows (Watsonville).

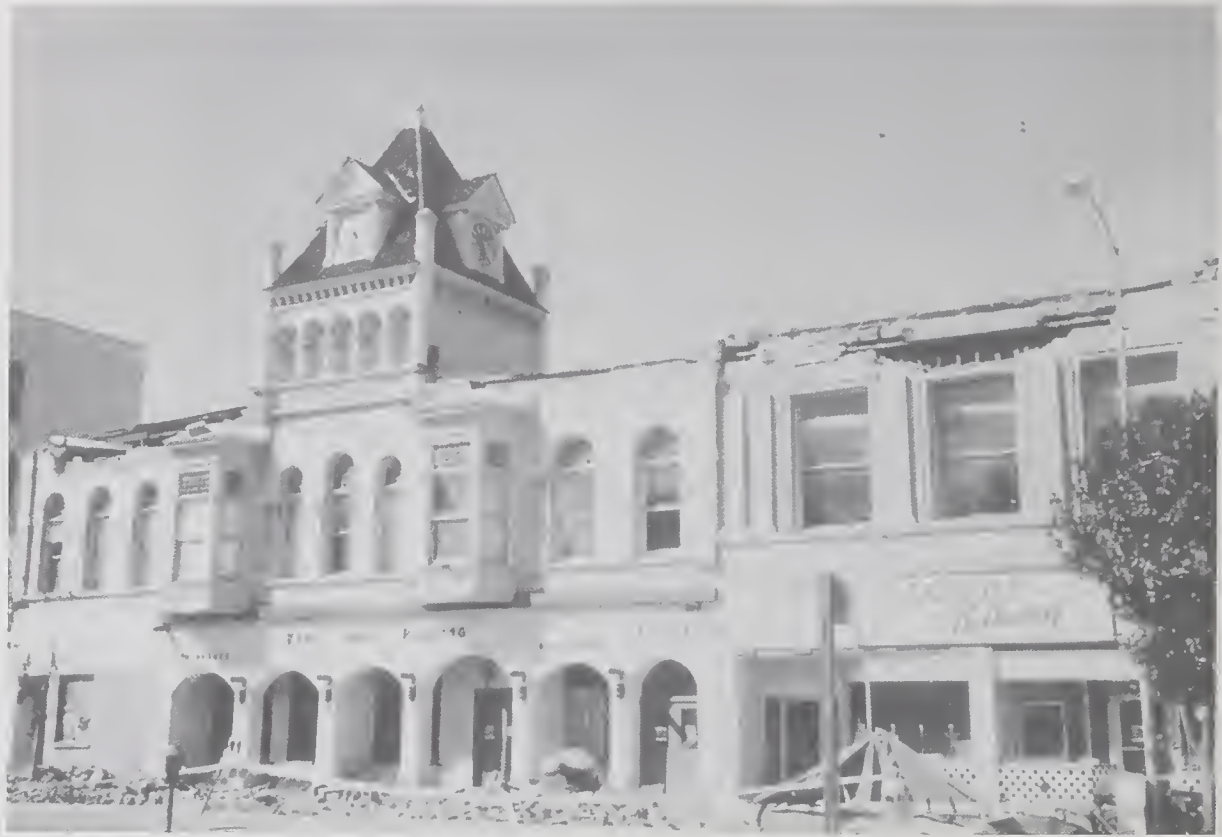
Figure 4.4.5 Falling brick from this old masonry building in Watsonville caused one death.

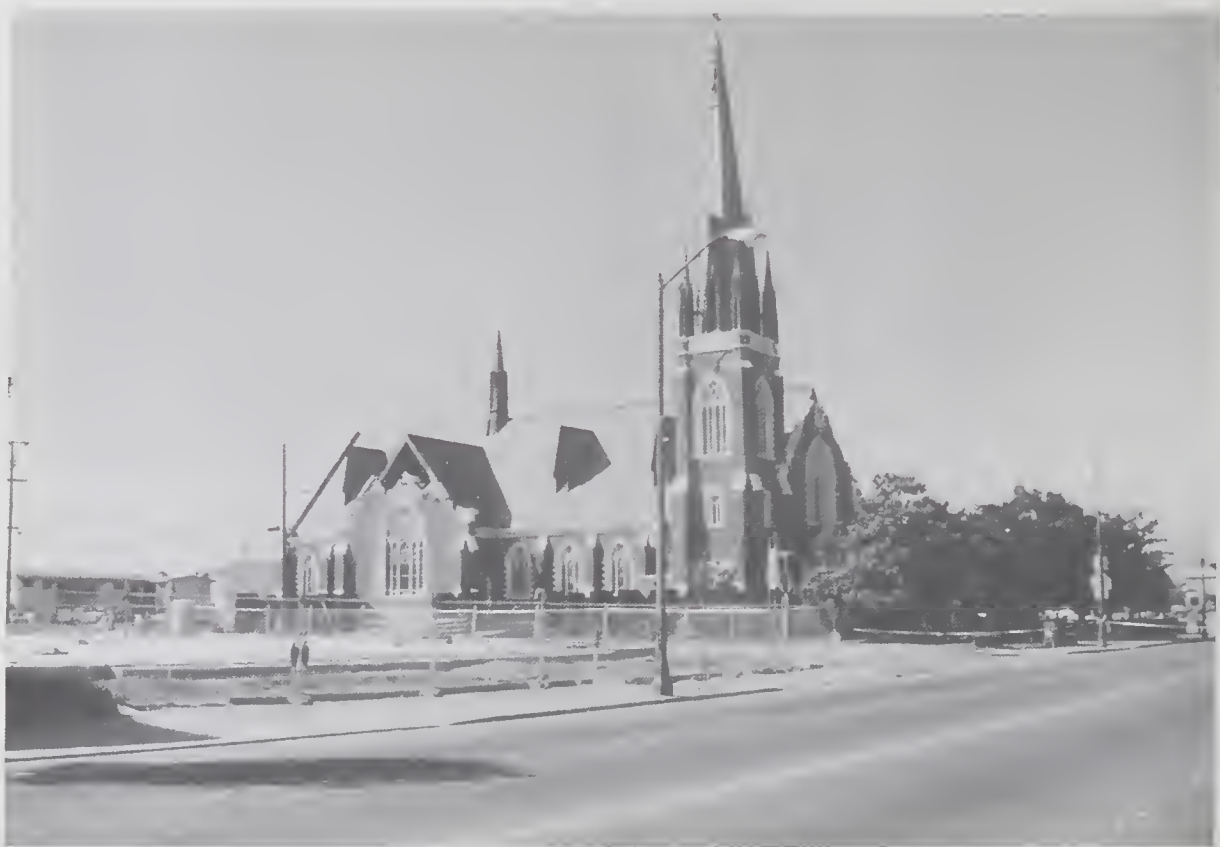
Figure 4.4.6 St. Patrick's Church in Watsonville was severely damaged.

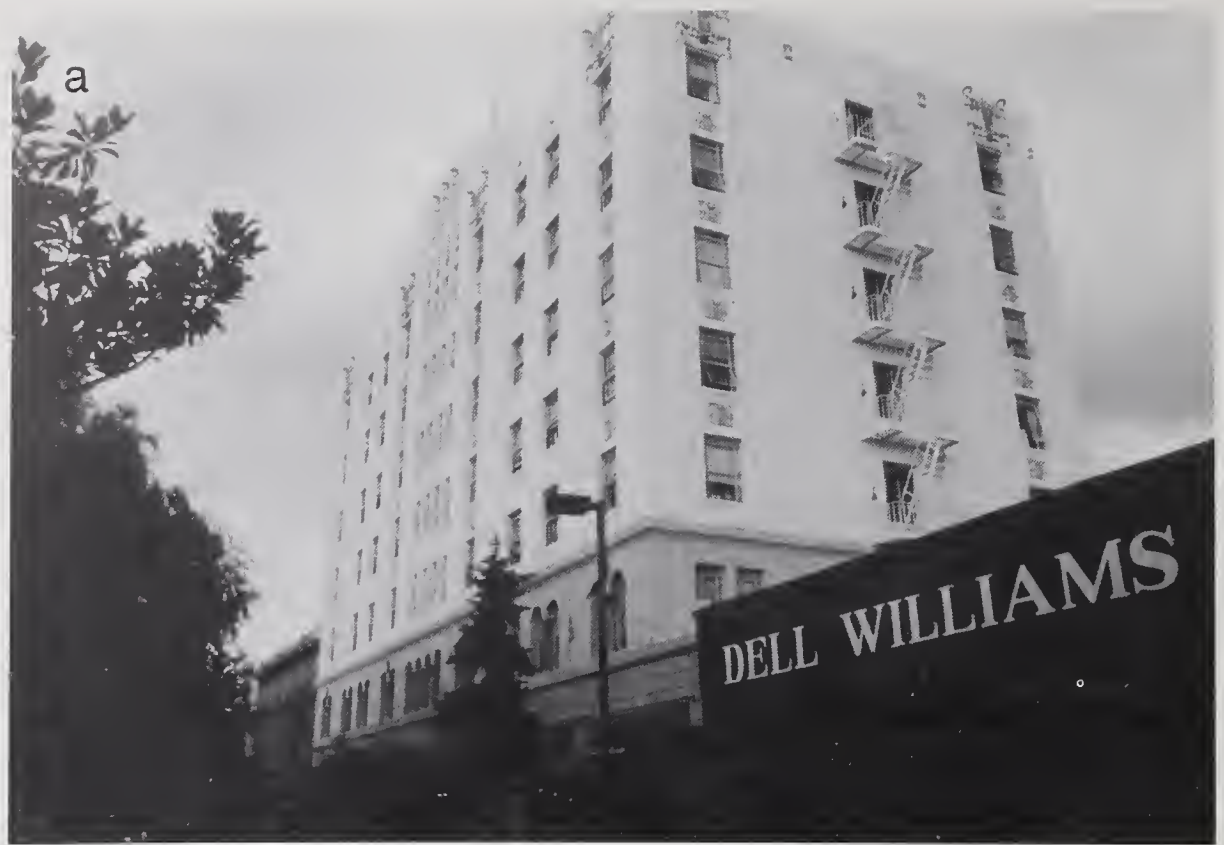
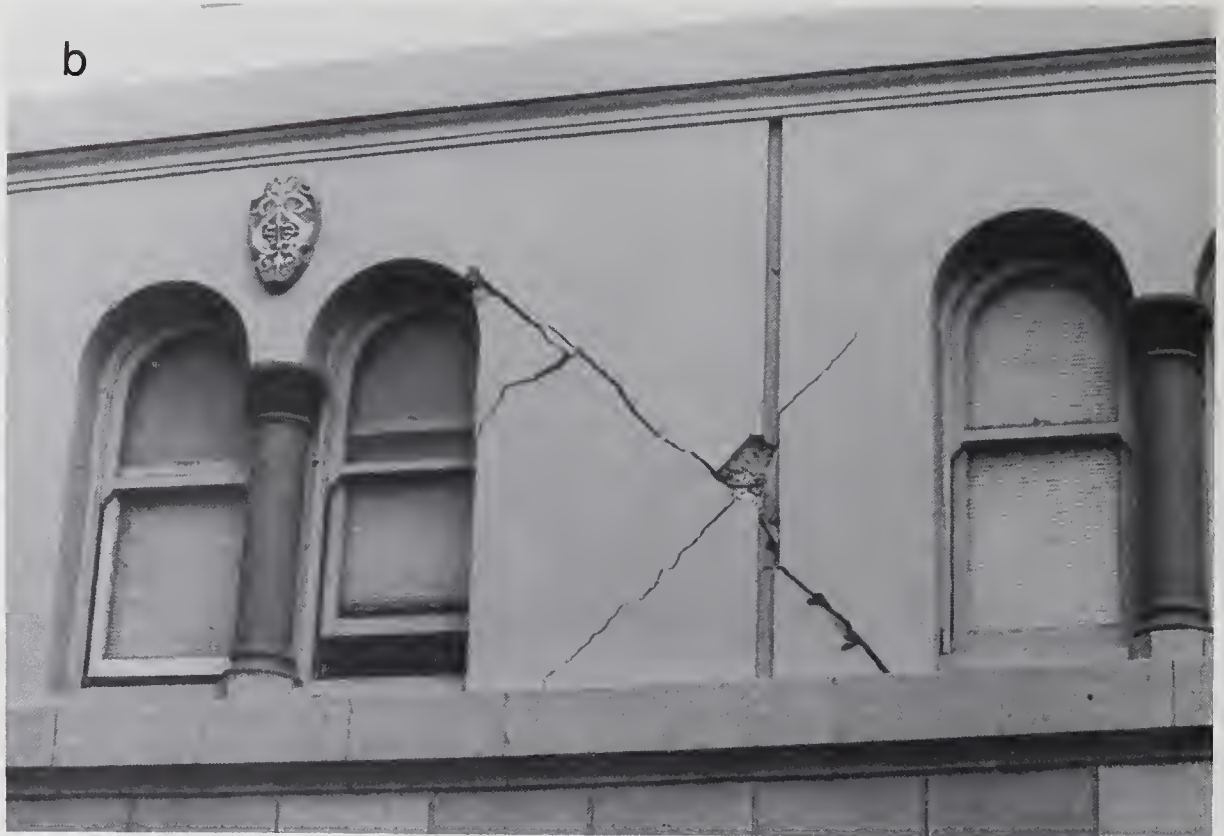
Figure 4.4.11 (a) Seven-story, reinforced concrete building suffered severe cracking; (b) Close-up view of damage to second-story walls.

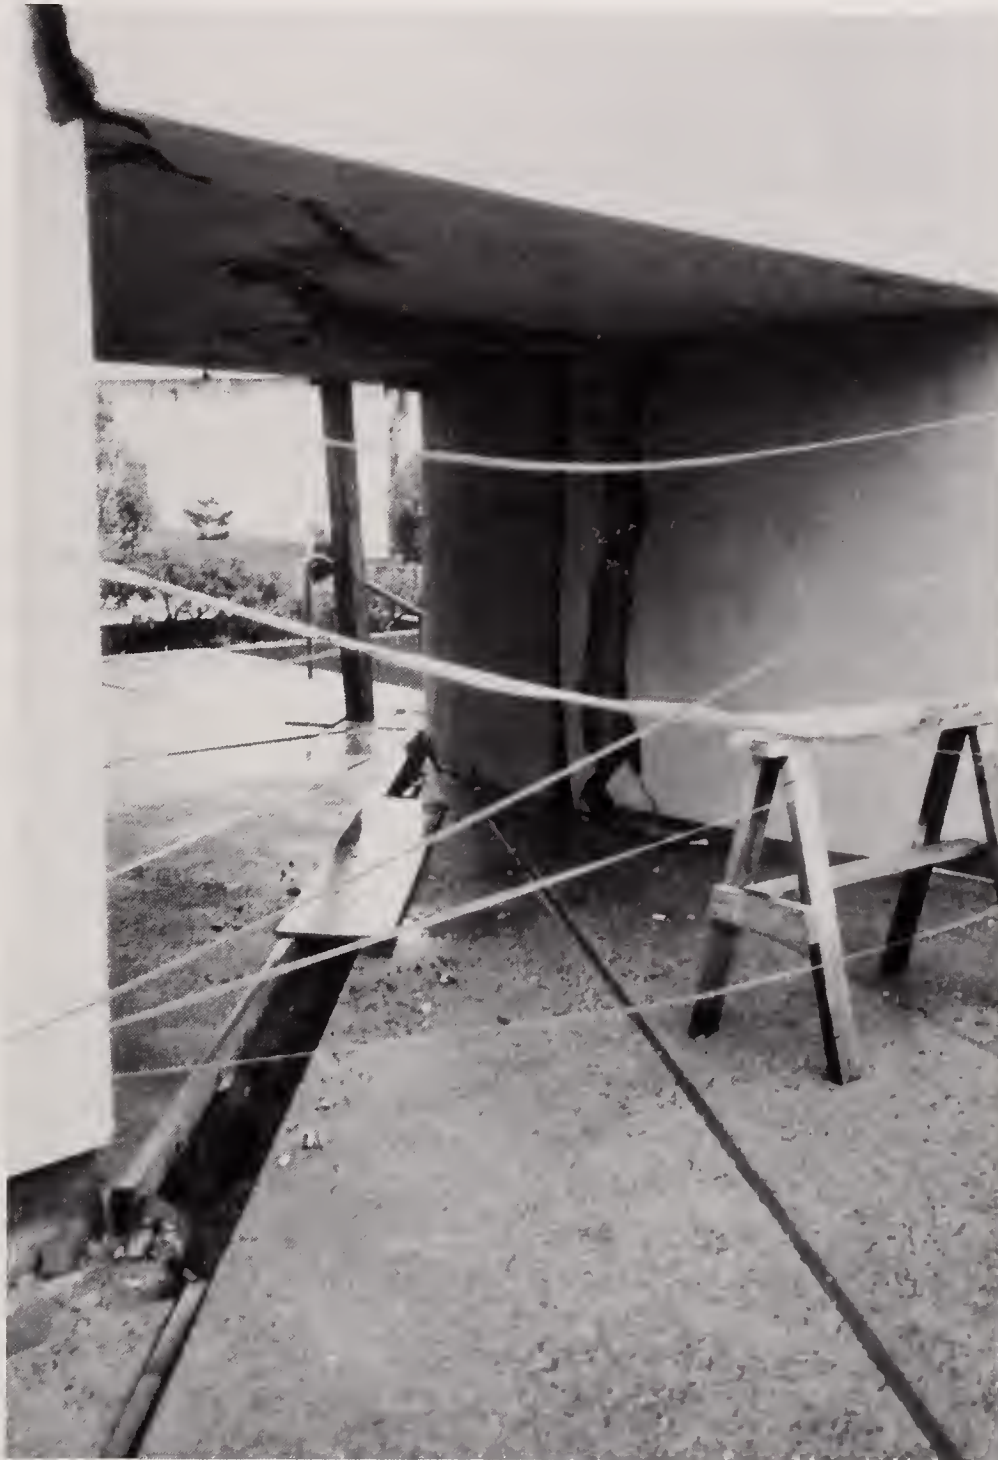
Figure 4.4.12 Damage to Marine Laboratory in Moss Landing as a result of soil liquefaction.

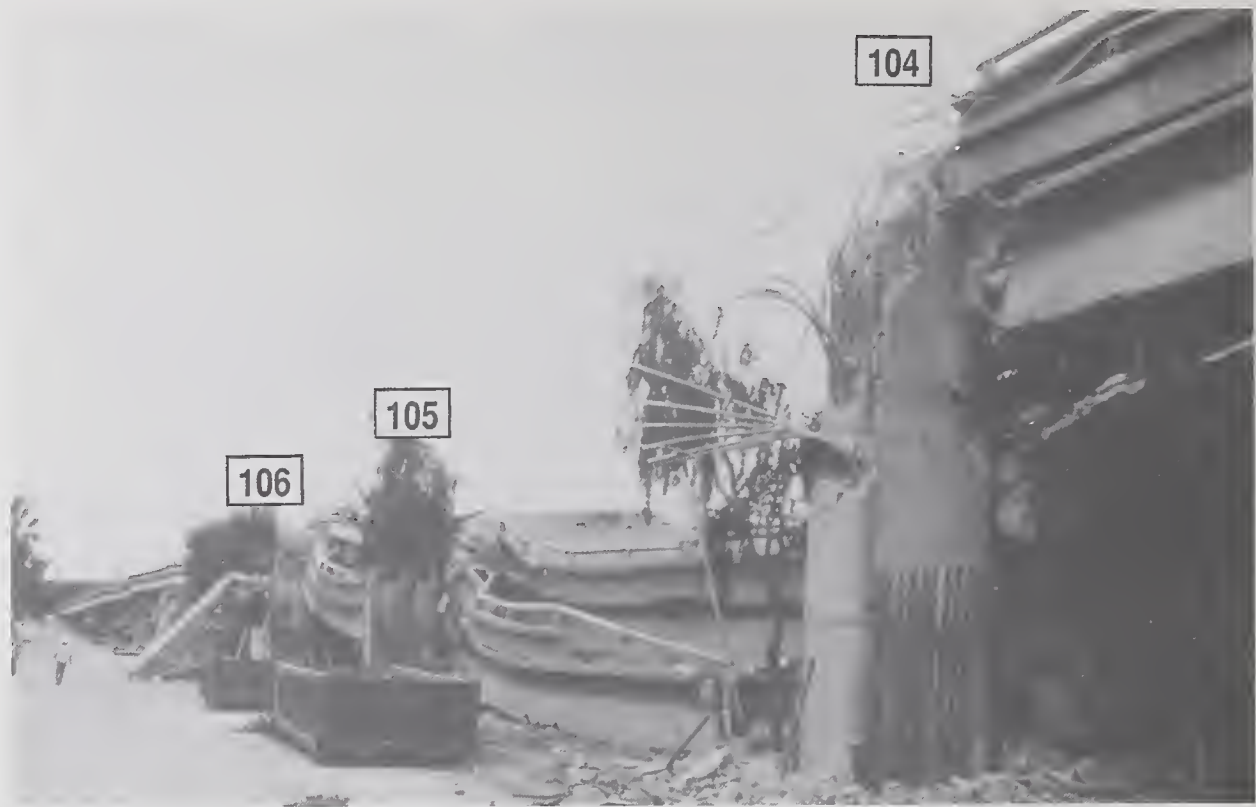
Figure 5.6.38 The section of Cypress Structure between Bents 104 and 106 was the only location in which both upper and lower bent frames failed.

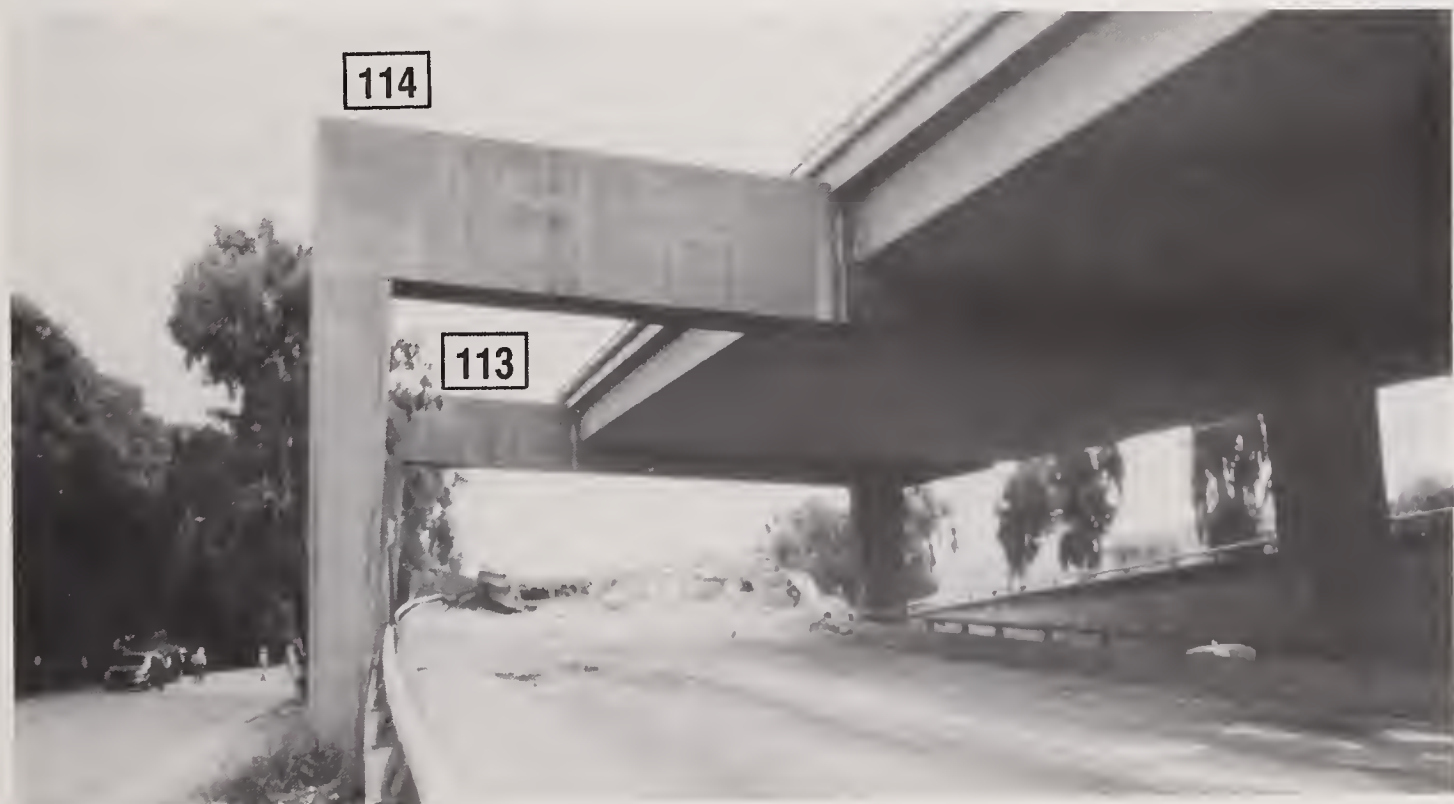
Figure 5.6.41 View looking south along the east side of Cypress Structure from Bent 115. The northern limit of the collapse extended to within six feet of Bent 113.

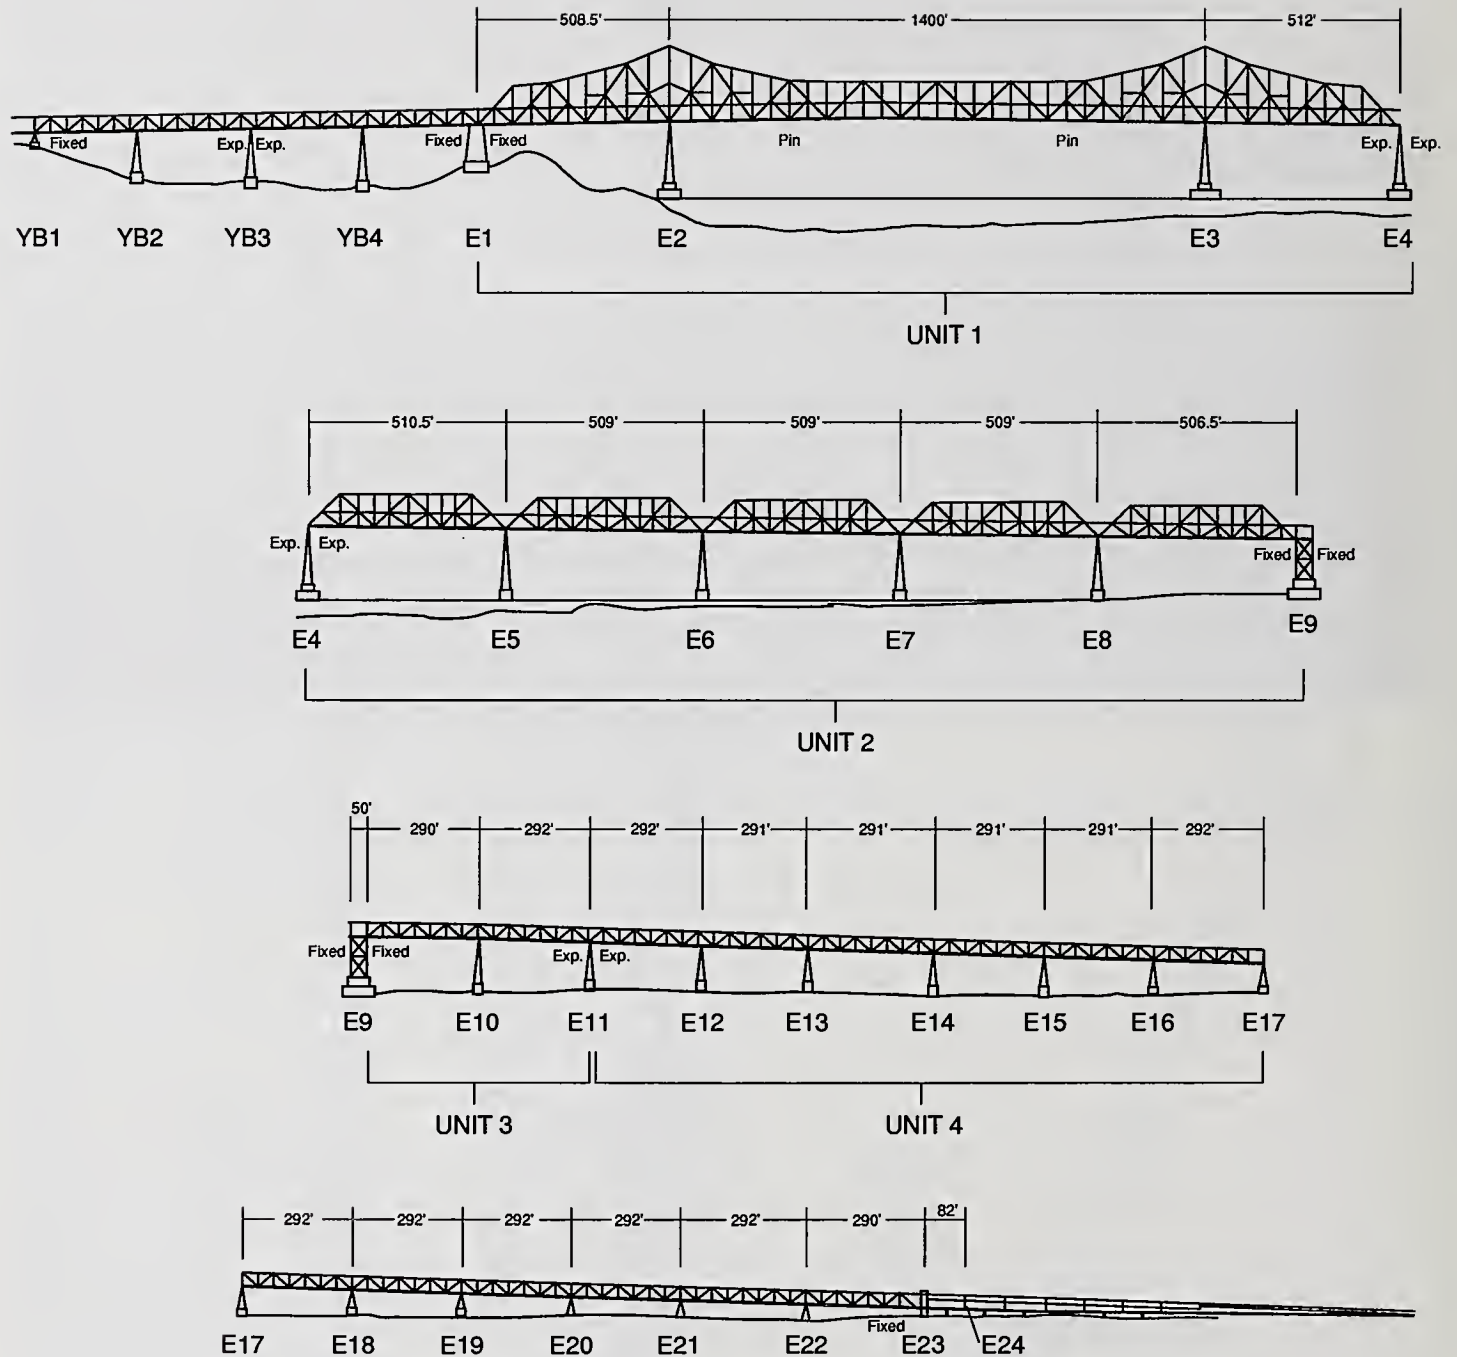
Figure 5.7.3 Detail of the east bay truss spans. Unit 3 was determined to have moved eastward as much as 10 inches, causing the collapse of the two deck segments at Pier E-9. Additional damage, generally involving the failure of retainer bolts, occurred between Piers E-17 and E-24.

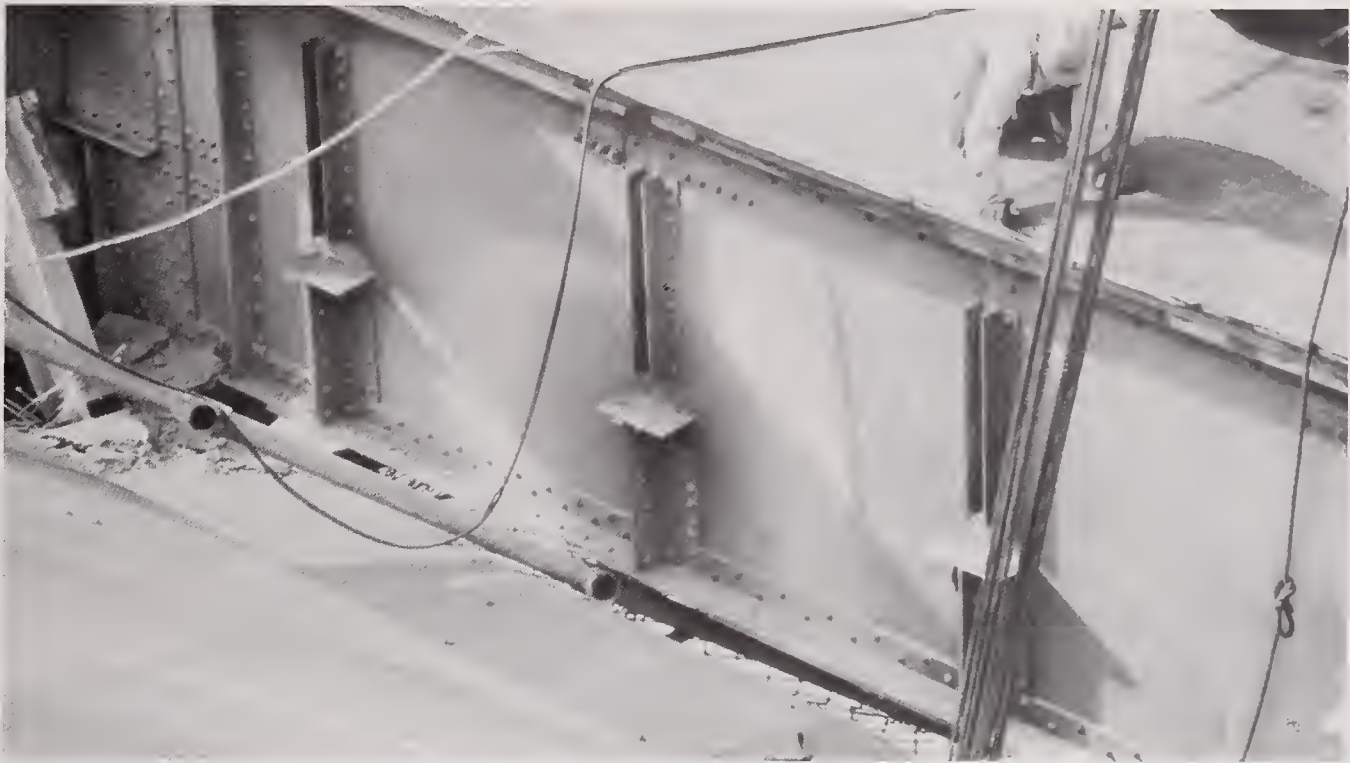
Figure 5.7.7 Close-up of the western girder seats for the lower road deck at Pier E-9. Lack of significant damage to these seats, and to those supporting the upper road deck, indicates that both upper and lower segments moved eastward by an amount sufficient to permit both to slide off the western seats and drop simultaneously.

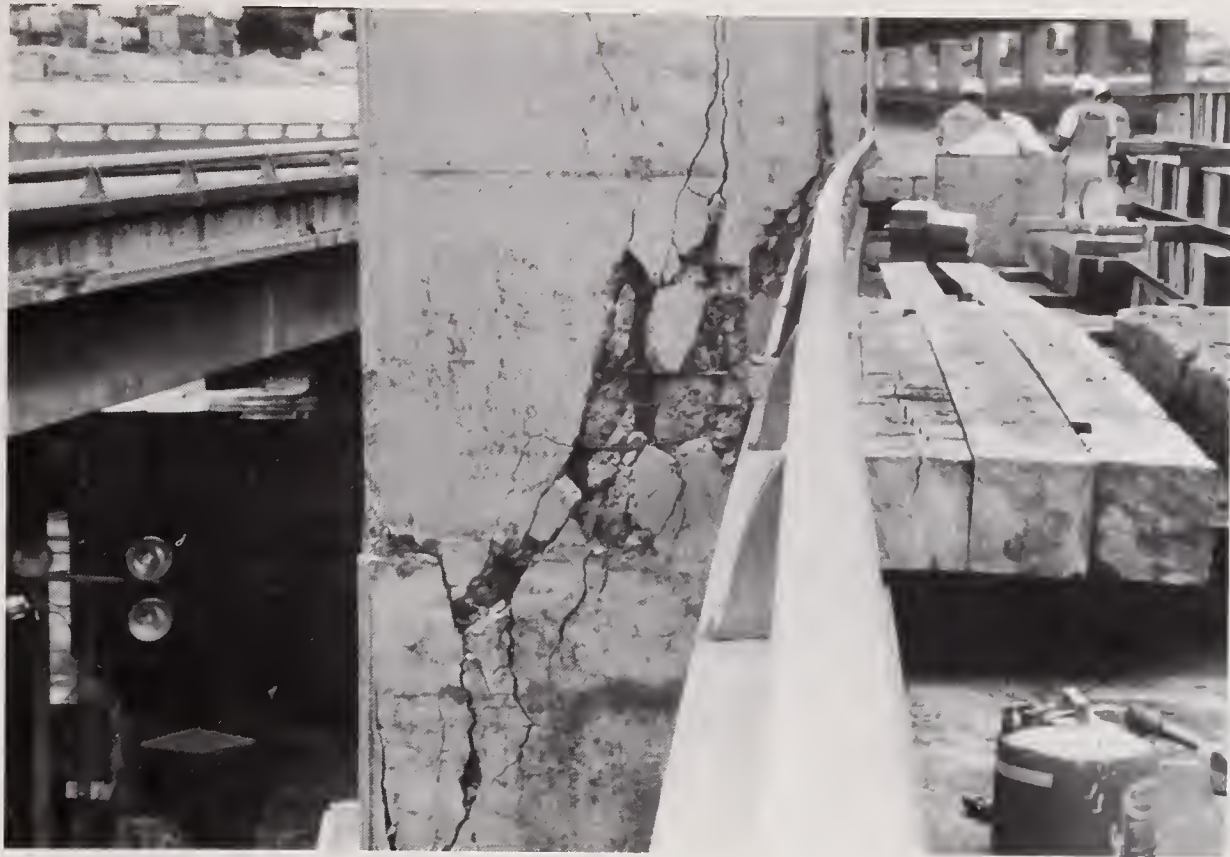
Figure 5.9.7 Diagonal cracking of the east-side column of Bent 52 (north face).

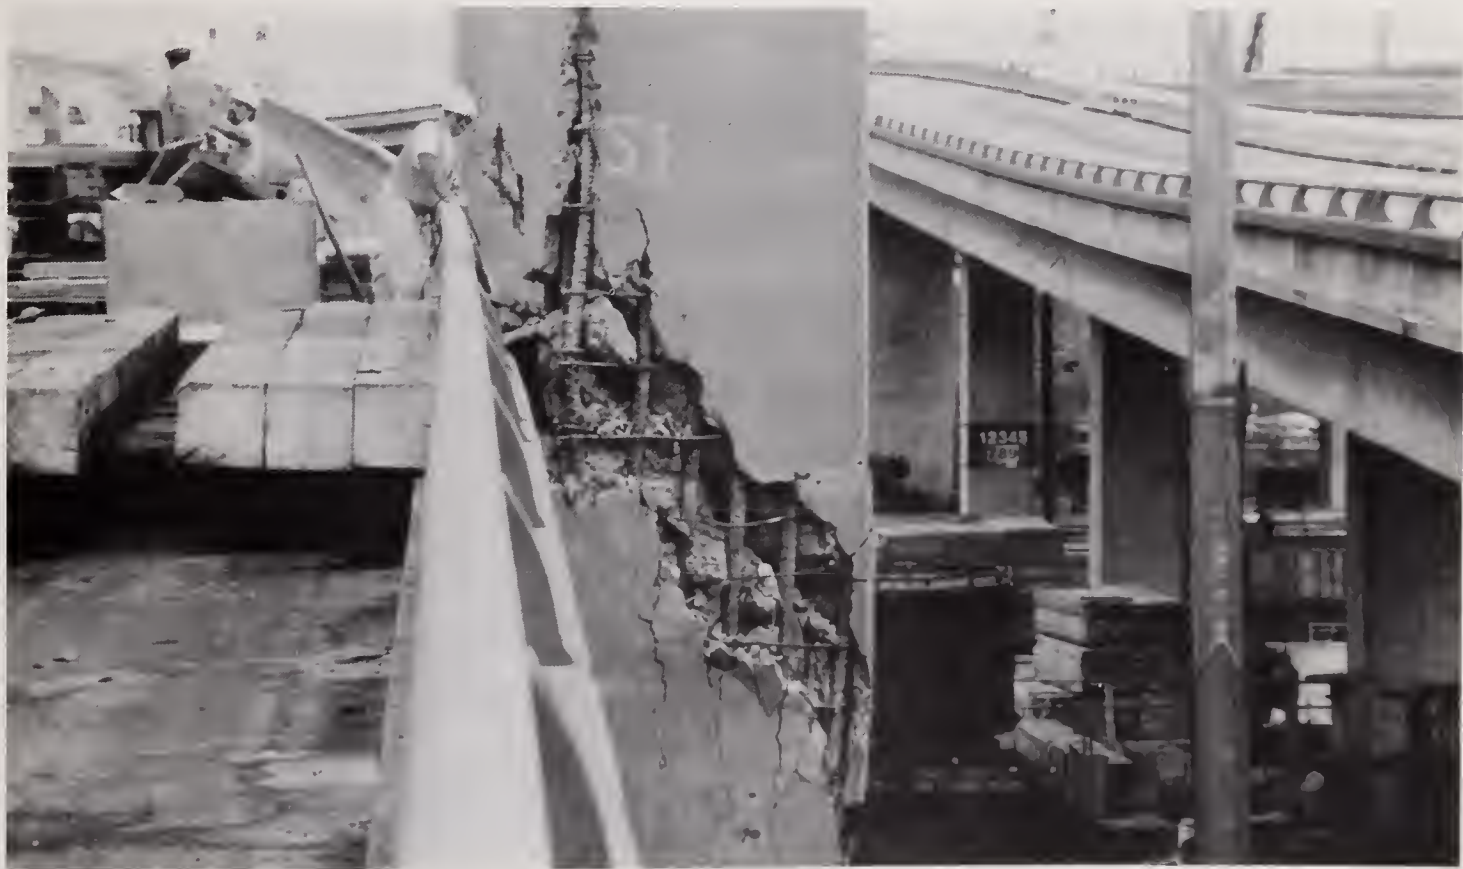
Figure 5.9.8 Diagonal cracking of the east-side column of Bent 51 (south face).

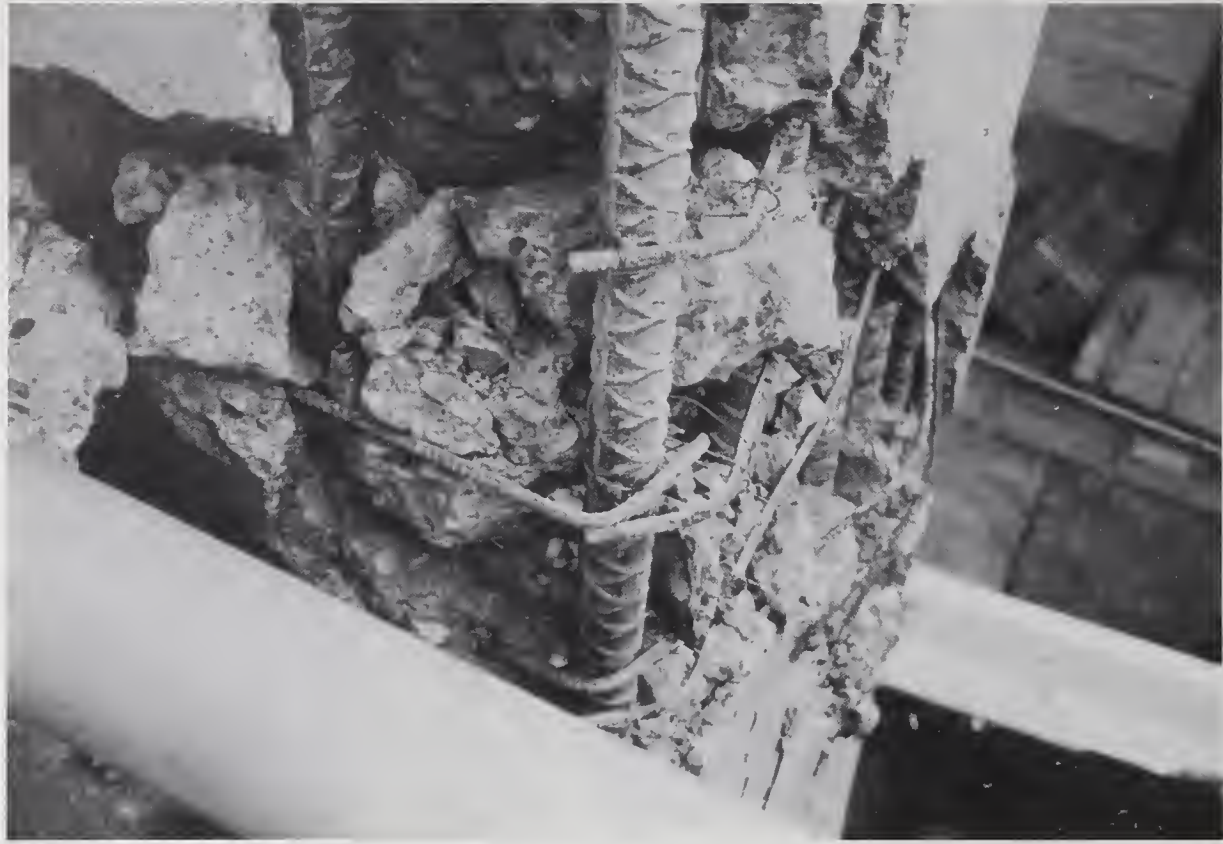
Figure 5.9.9 Close-up view of the failure zone of Bent 51, showing anchorage failure of ties.

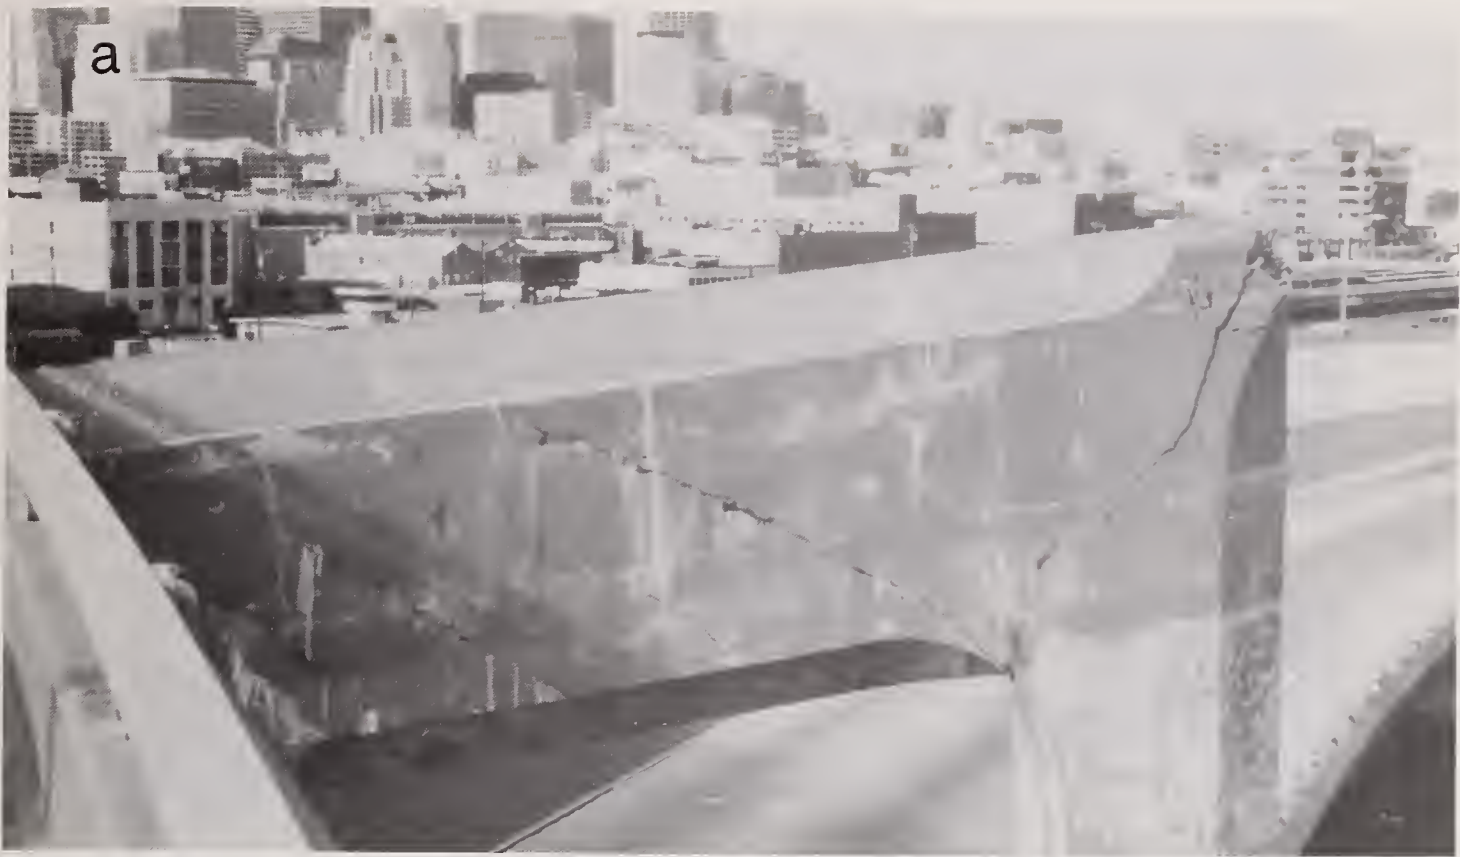
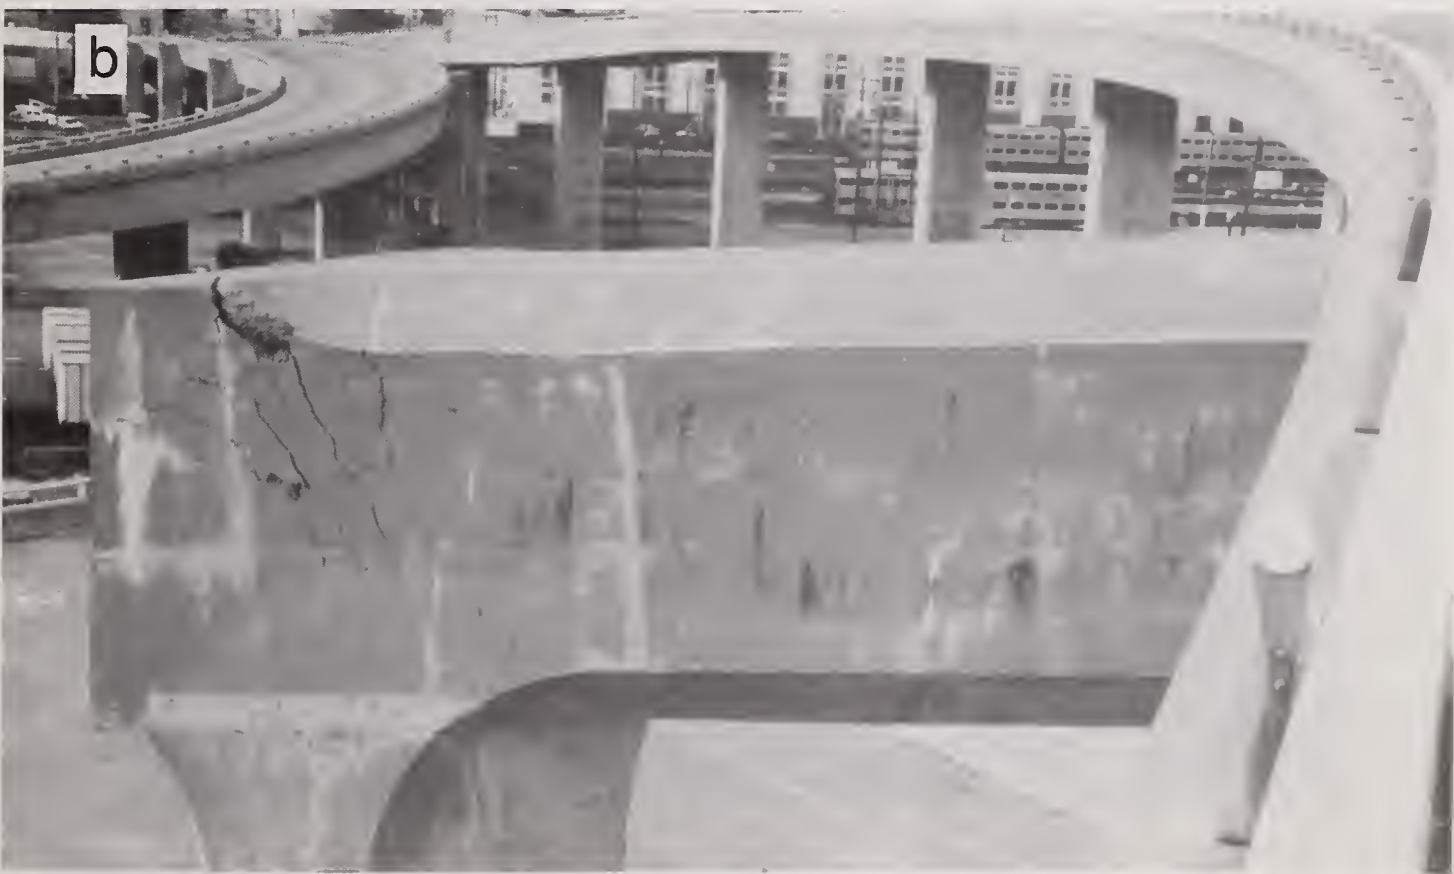
Figure 5.9.14 Damage to girder supporting exit ramp: (a) eastern portion and (b) western portion.
