*NIST Special Publication 778*

# *Performance of Structures During the Loma Prieta Earthquake of October 17, 1989*

*H. S. Lew, Editor*

January 1990

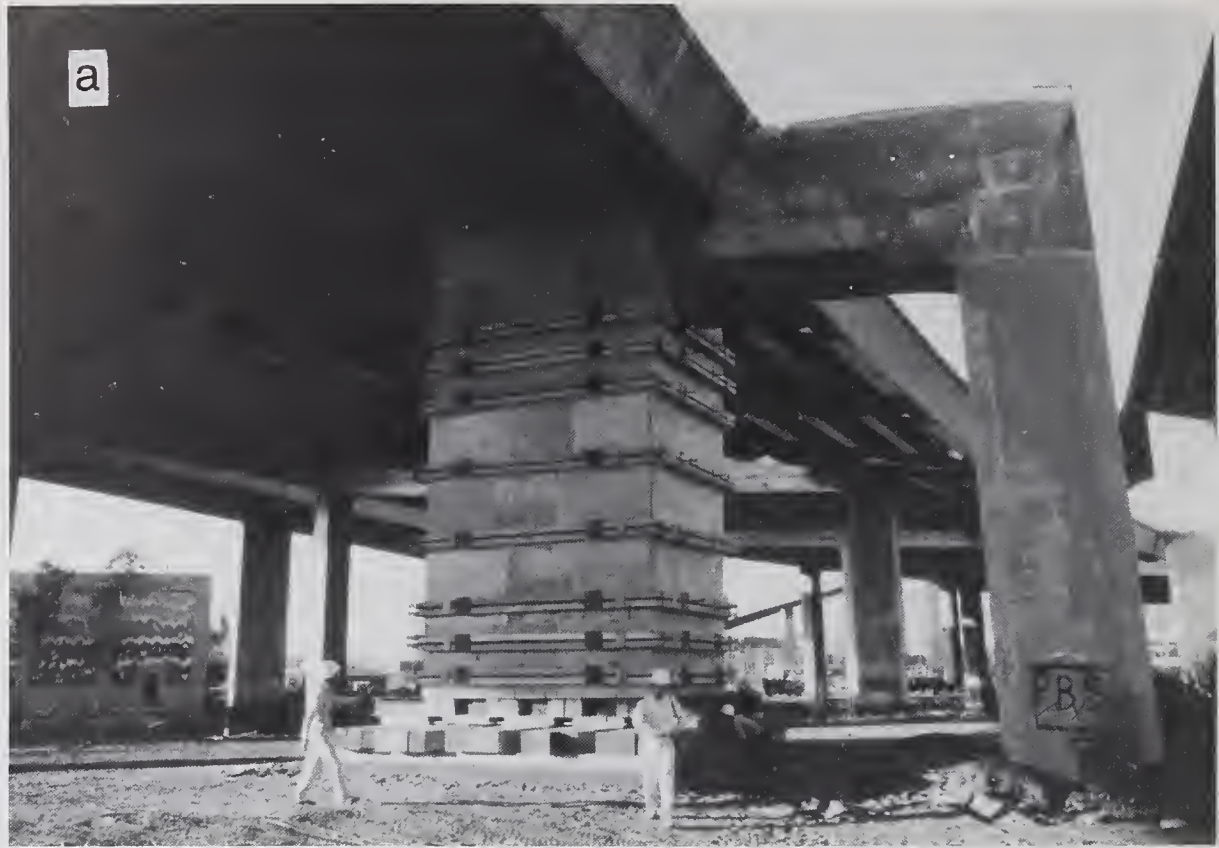
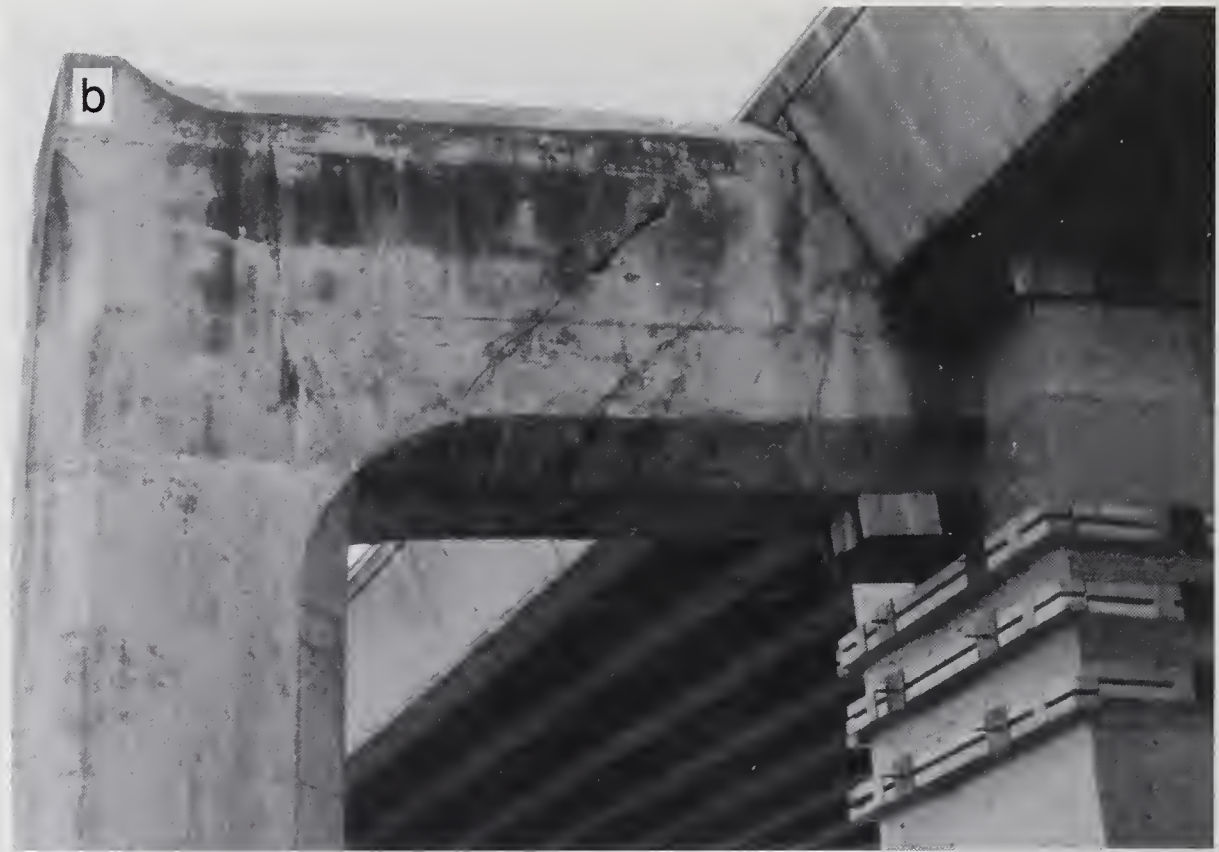
Figure 5.9.15 (a) Bent 32 supporting I-280 at Sixth St. exit ramp and (b) close-up of girder showing diagonal cracking.

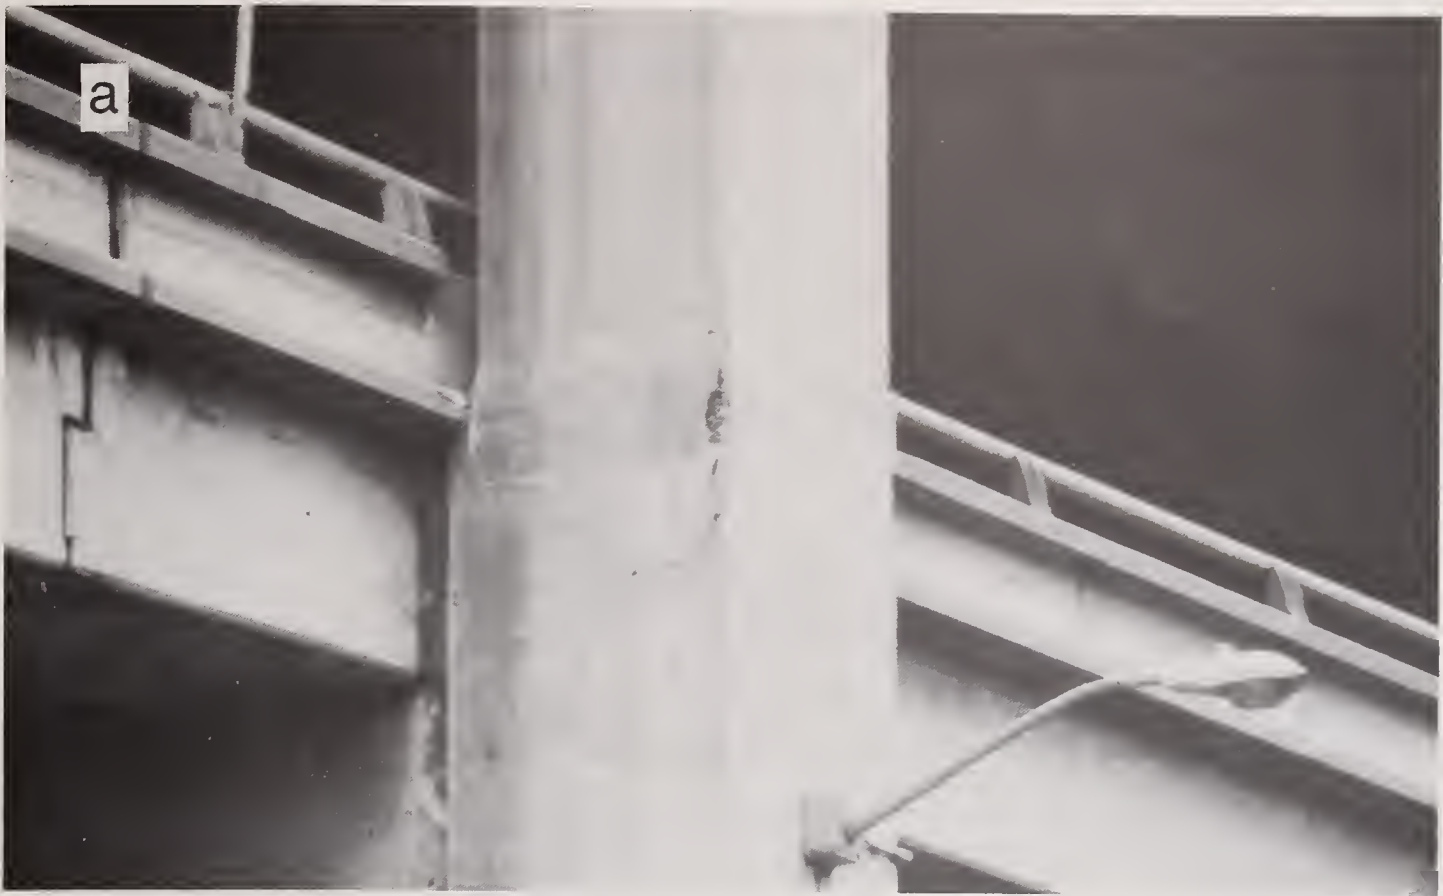
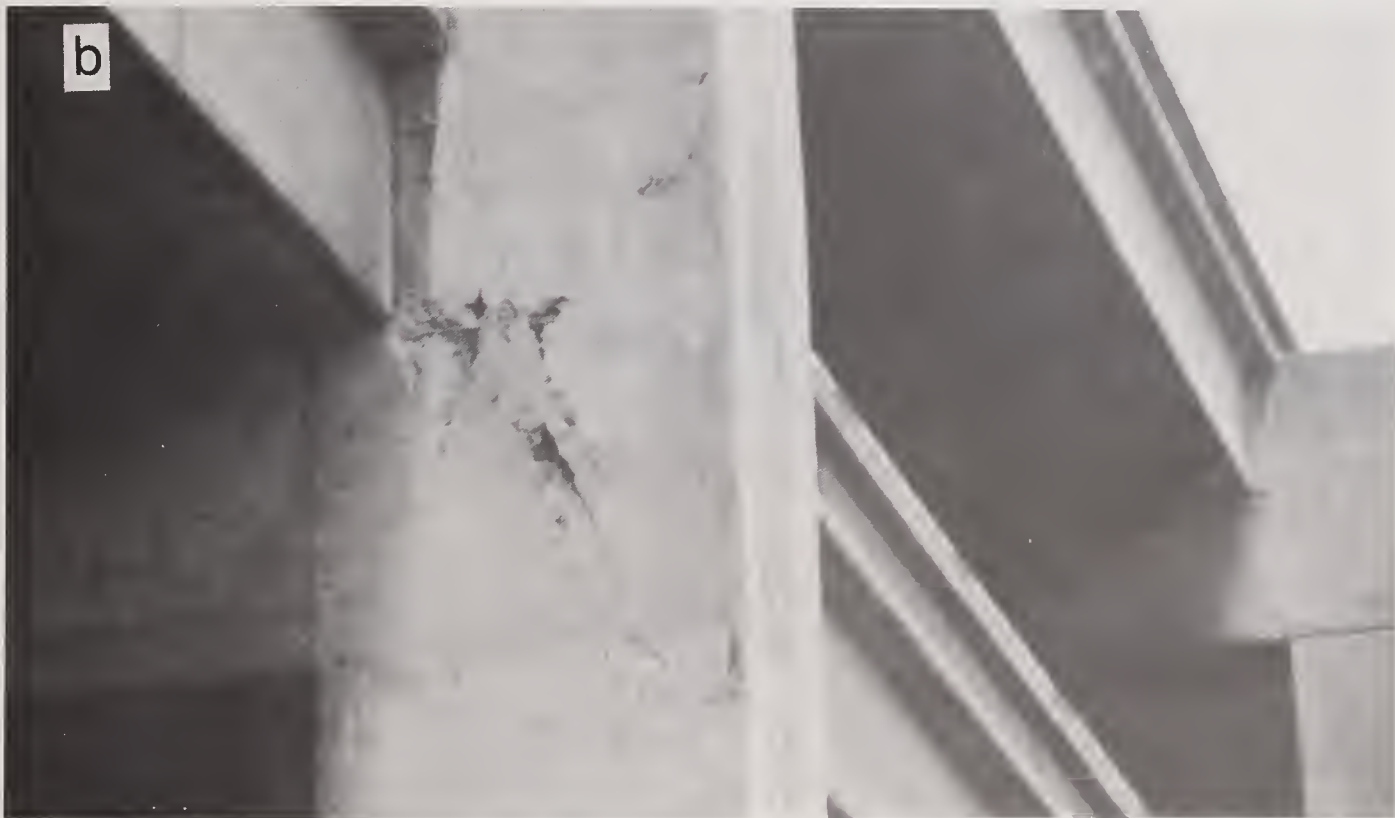
Figure 5.10.5 (a) Close-up view of west side of Bent 78 showing diagonal cracking in joint and vertical cracking at girder-column boundary; (b) close-up view of east side of Bent 79 showing diagonal cracking in joint.

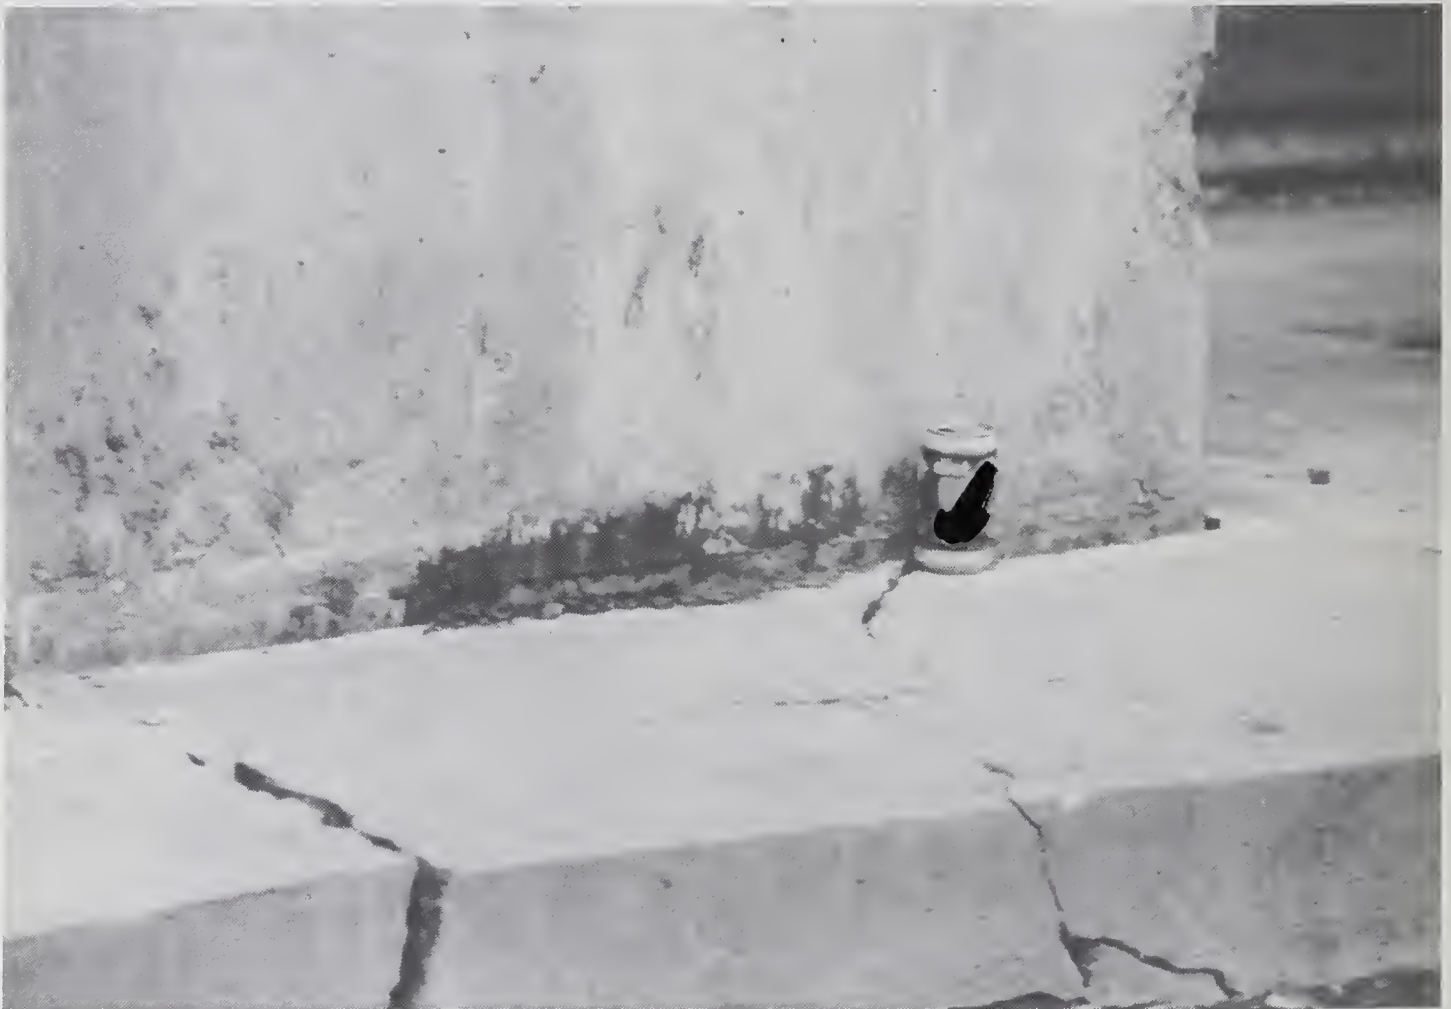
Figure 5.10.6 Evidence of large ground movement at east side base of Bent 77.

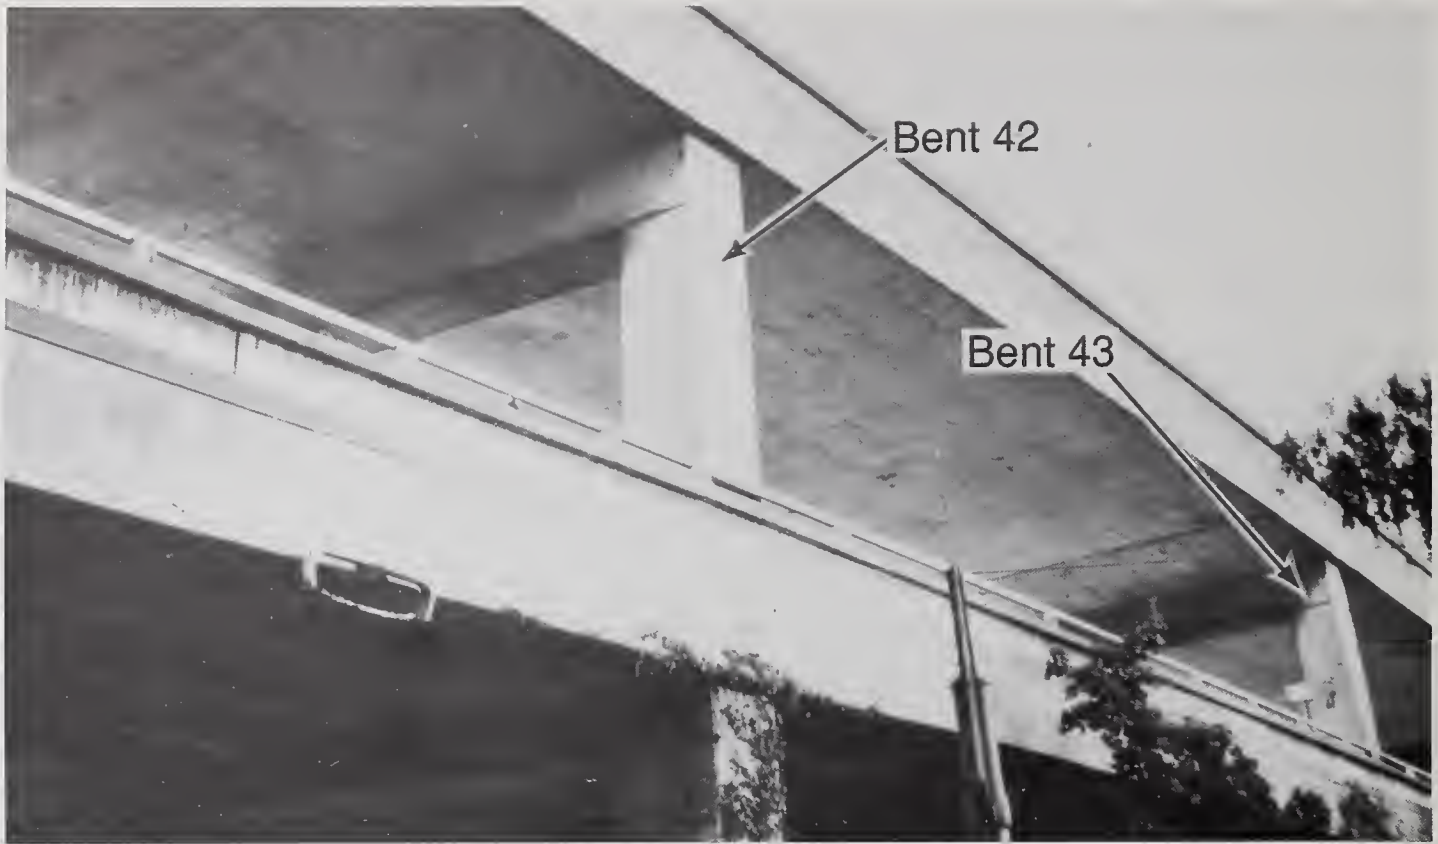
Figure 5.11.1 View of east side U.S. 101 north of Hayes St. showing damaged Bents 42 and 43.

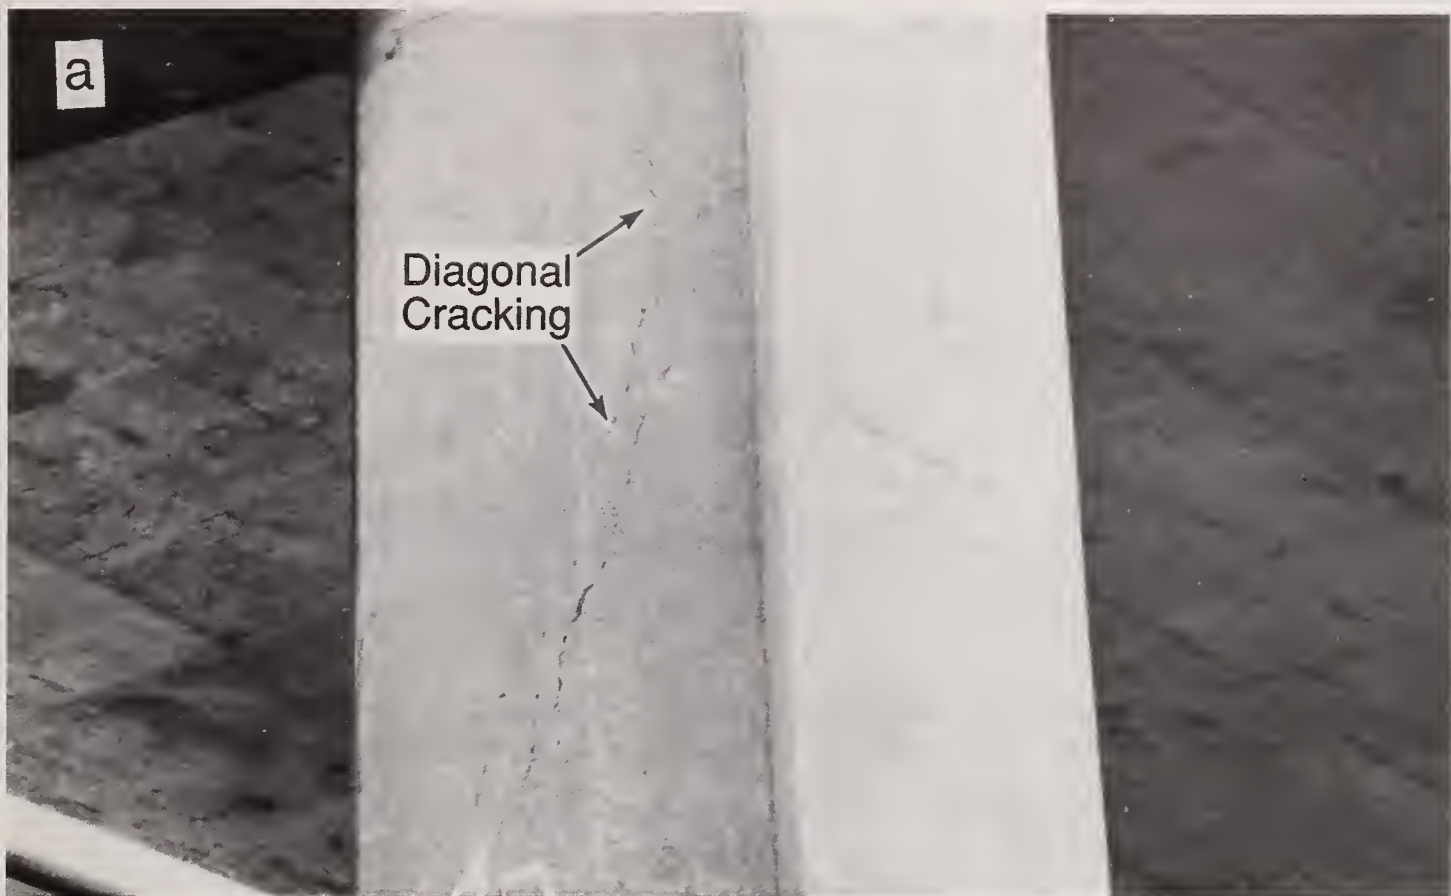
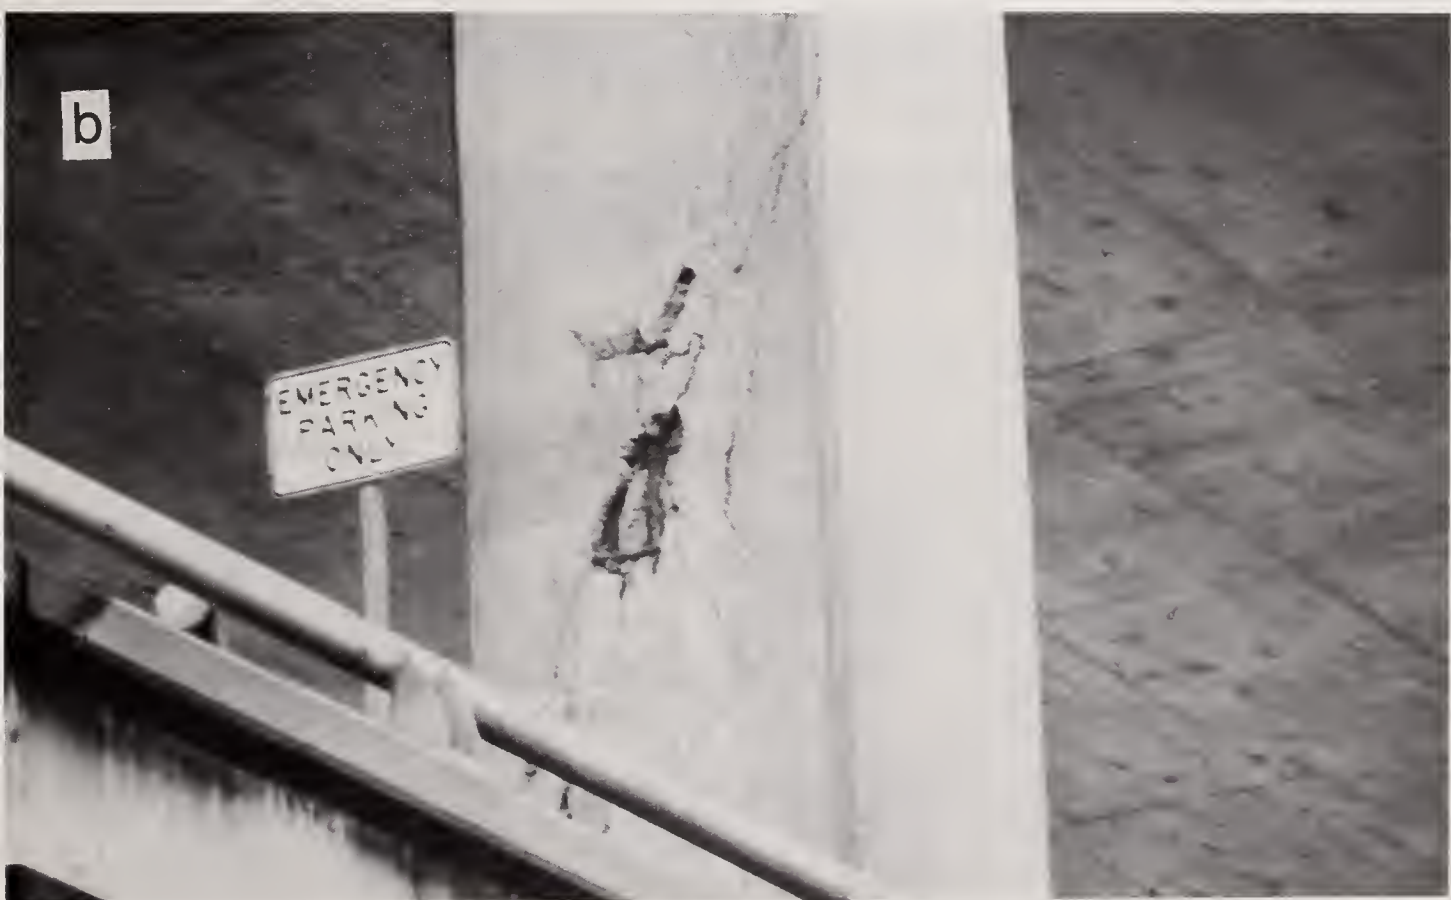
Figure 5.11.3 Close-up views of east side columns of (a) Bent 42 and (b) Bent 43.
