ASCH BUILDING FIRE NEW YORK

March 25th, 1911

By F. J. T. STEWART

*Superintendent, Bureau of Surveys, New York Board
of Fire Underwriters*

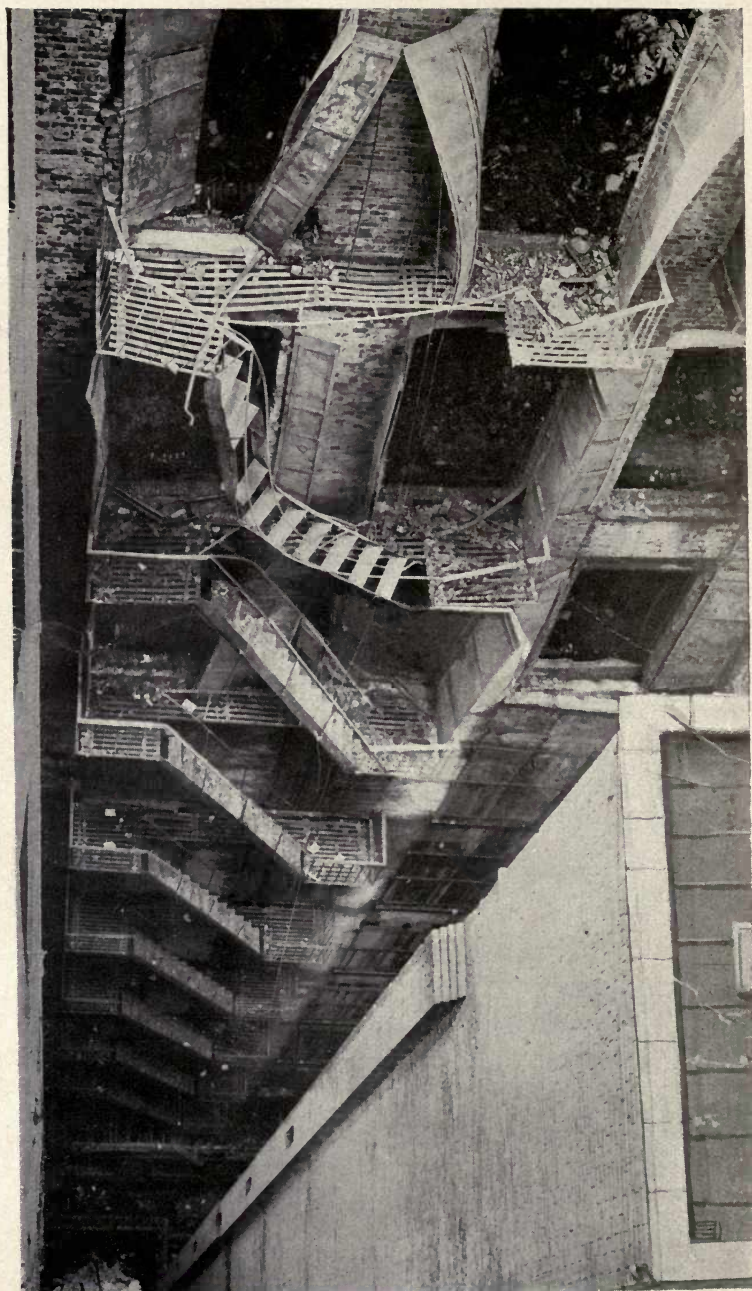
THE ASCH BUILDING, NEW YORK, U.S.A.
View of Fire Escape, looking down from adjoining roof

the steps being 17½ in. (0.444m.) wide. The platform between steps and wall is 18 in. (0.457m.) wide. The fire escape did not extend to the bottom of the court and the latter had no exit to the street. Page 4 shows a view of the fire escape, looking down after the fire. The wrecking of the top flight of the fire escape was probably due to the heat.

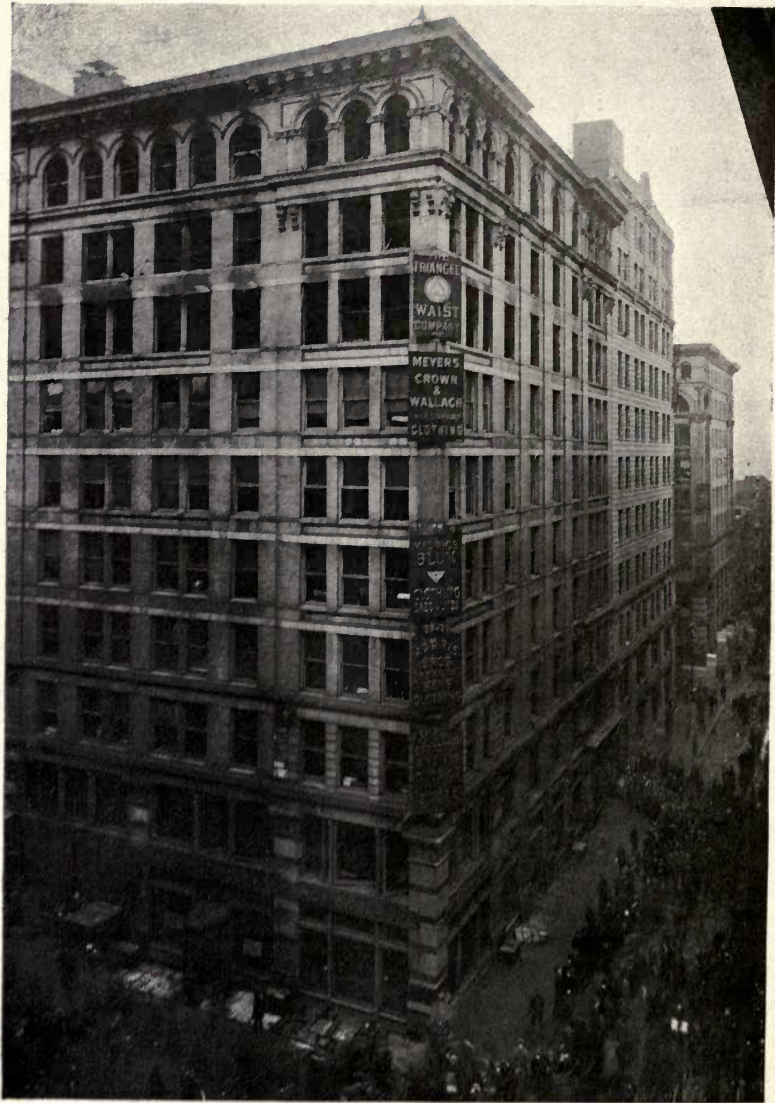
THE ASCH BUILDING, NEW YORK, U.S.A.
View after the Fire

Fig. 1 shows an exterior view of the building after the fire.

Damage to Building.—The upper three floors, *i.e.*, 7th, 8th, and 9th floors, were completely burned over and practically all trim and finish destroyed. The damage to the structural part of the building on these floors was relatively small. The lower face of about one-fifth of the tile roof arches was broken off and the covering on one column supporting the roof was slightly broken. The parapet wall at the north court is out of plumb from 4 to 5 in. (0.102m. to 0.127m.) at top owing to the sagging, under heat, of the unprotected channel iron window lintels which support it. The floor arches and column covering in the 7th and 8th stories was very little damaged. The lower flange of the girder supporting the curtain wall at the north side on the upper three floors was exposed. It was fireproofed by two inches of cement above the wooden window frames. The wired glass panels in the passenger elevator shafts on the upper floors had softened and rolled out of the framing in most cases, demonstrating again the unreliability of wired glass for inside stair and elevator protection. There was also some small damage to trim and finish by fire on the ground floor. The water seemed to find its way through the fireproof floor arches with comparative freedom, and the finish on practically all floors was water soaked.

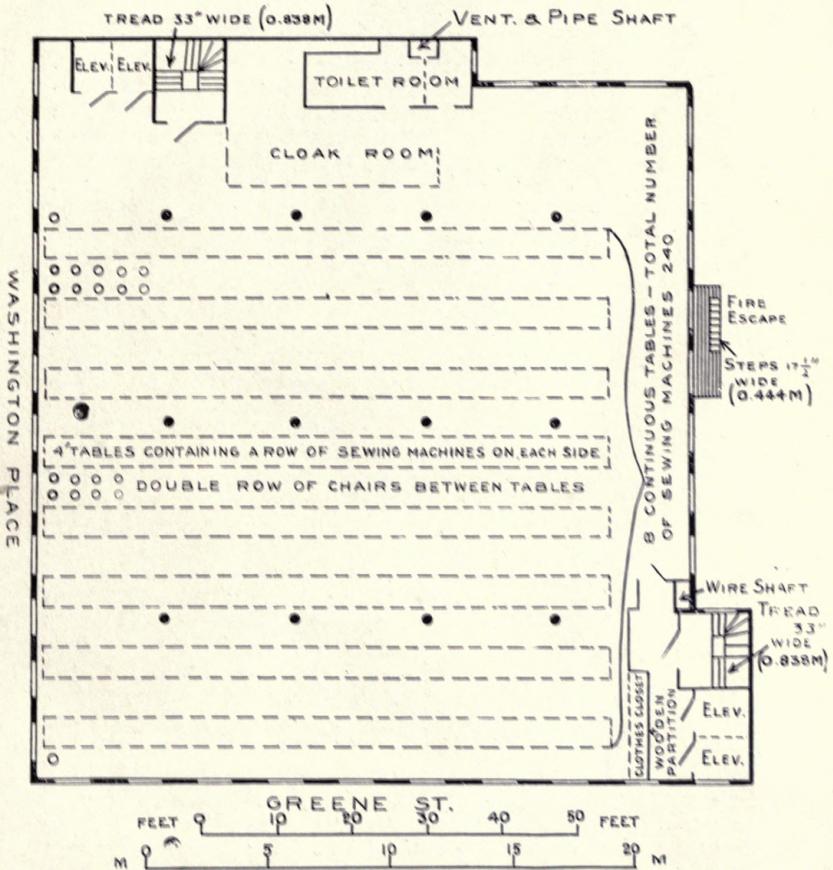
PLAN OF 8TH FLOOR

On the 8th floor there were eight unbroken rows of 4ft. (5.486m.) tables each containing double rows of sewing machines and shirt waists in process of manufacture. These tables extended from the Washington Place front (south wall) to within 10ft. (3.048m.) of the north side of the building. (See plan, Page 9.) This latter space at the north side was partially filled with stock, and also contained a gangway extending east and west along the north side. Approximately 300 operators were on this floor.

There were no gangways running east and west at the south side of the 7th and 8th floors, the sewing machine tables extending close up to the wall. The space between the tables was approximately four feet wide and contained two rows of chairs back to back for the operators. This space also contained baskets and other receptacles for the goods in process of manufacture. The only convenient way for the operators next to the south wall to reach the stairs and elevators at the south-west corner, was to walk the entire length of the crowded space between the tables to the north side and then use the gangways which extended along the north and west sides of the building.

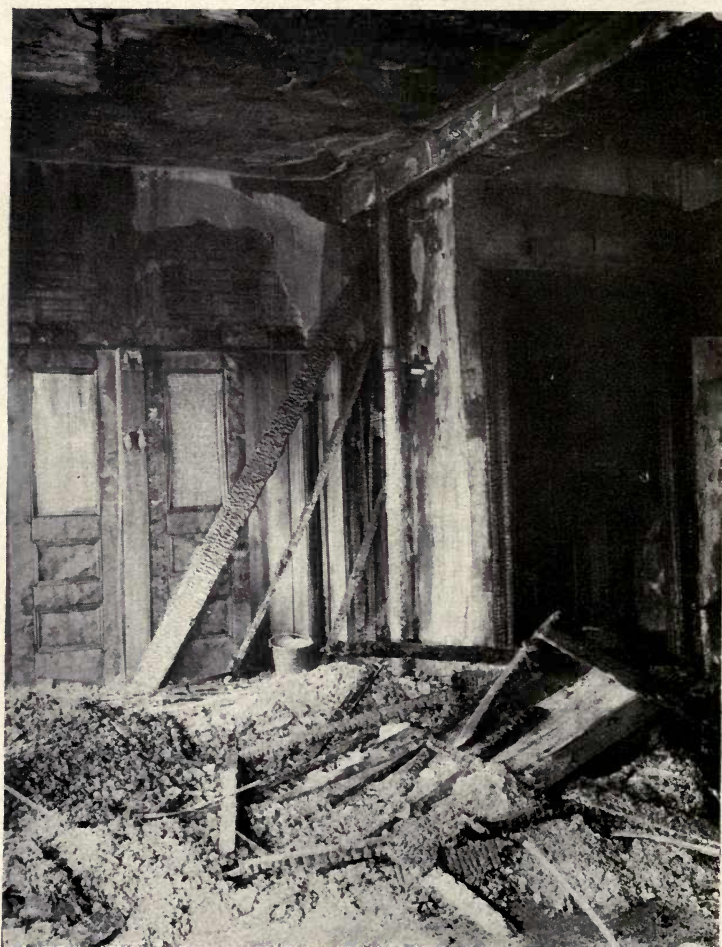
According to the information obtainable the operators, crowded among the machines, chairs and goods on the 7th and 8th floors, were badly panic stricken immediately after the start of the fire, and as a consequence made slow progress towards the exits. Considerable delay is said to have been experienced in opening the doors leading to the stairs at the south-west corner of the building as they opened *inwardly* and the women became jammed against them. Practically all the employés on the 7th floor eventually escaped by way of the stairways and elevators. The comparatively small number of employés on the 9th floor escaped chiefly by way of the stairway at the north-east corner to the roof, and thence to the roofs of adjoining buildings. Some also escaped by way of the elevators from the 9th floor to the street. Practically the entire loss of life was confined to those employed on the 8th floor. More than half of the number said to have been on this floor escaped. It seems apparent, however, that by the time this number had got out, the elevators had stopped running and the flames around the two inside stairways and outside fire escape, both on this floor and those adjoining, would not permit any further egress in these directions. The result was that all who remained on the floor until this condition prevailed were overcome by the smoke and fire or jumped out of the windows. It is said that a few—probably 20—from the upper floors descended by way of the outside fire escape. These re-entered one of the lower stories and passed down the stairways.

ASCH BUILDING, NEW YORK, U.S.A.
An Interior View after Fire
