REPORT OF THE CIVIL AERONAUTICS BOARD

Of the investigation of an accident involving civil aircraft of the United States NC 25678 which occurred near Chicago, Illinois, on December 4, 1940.

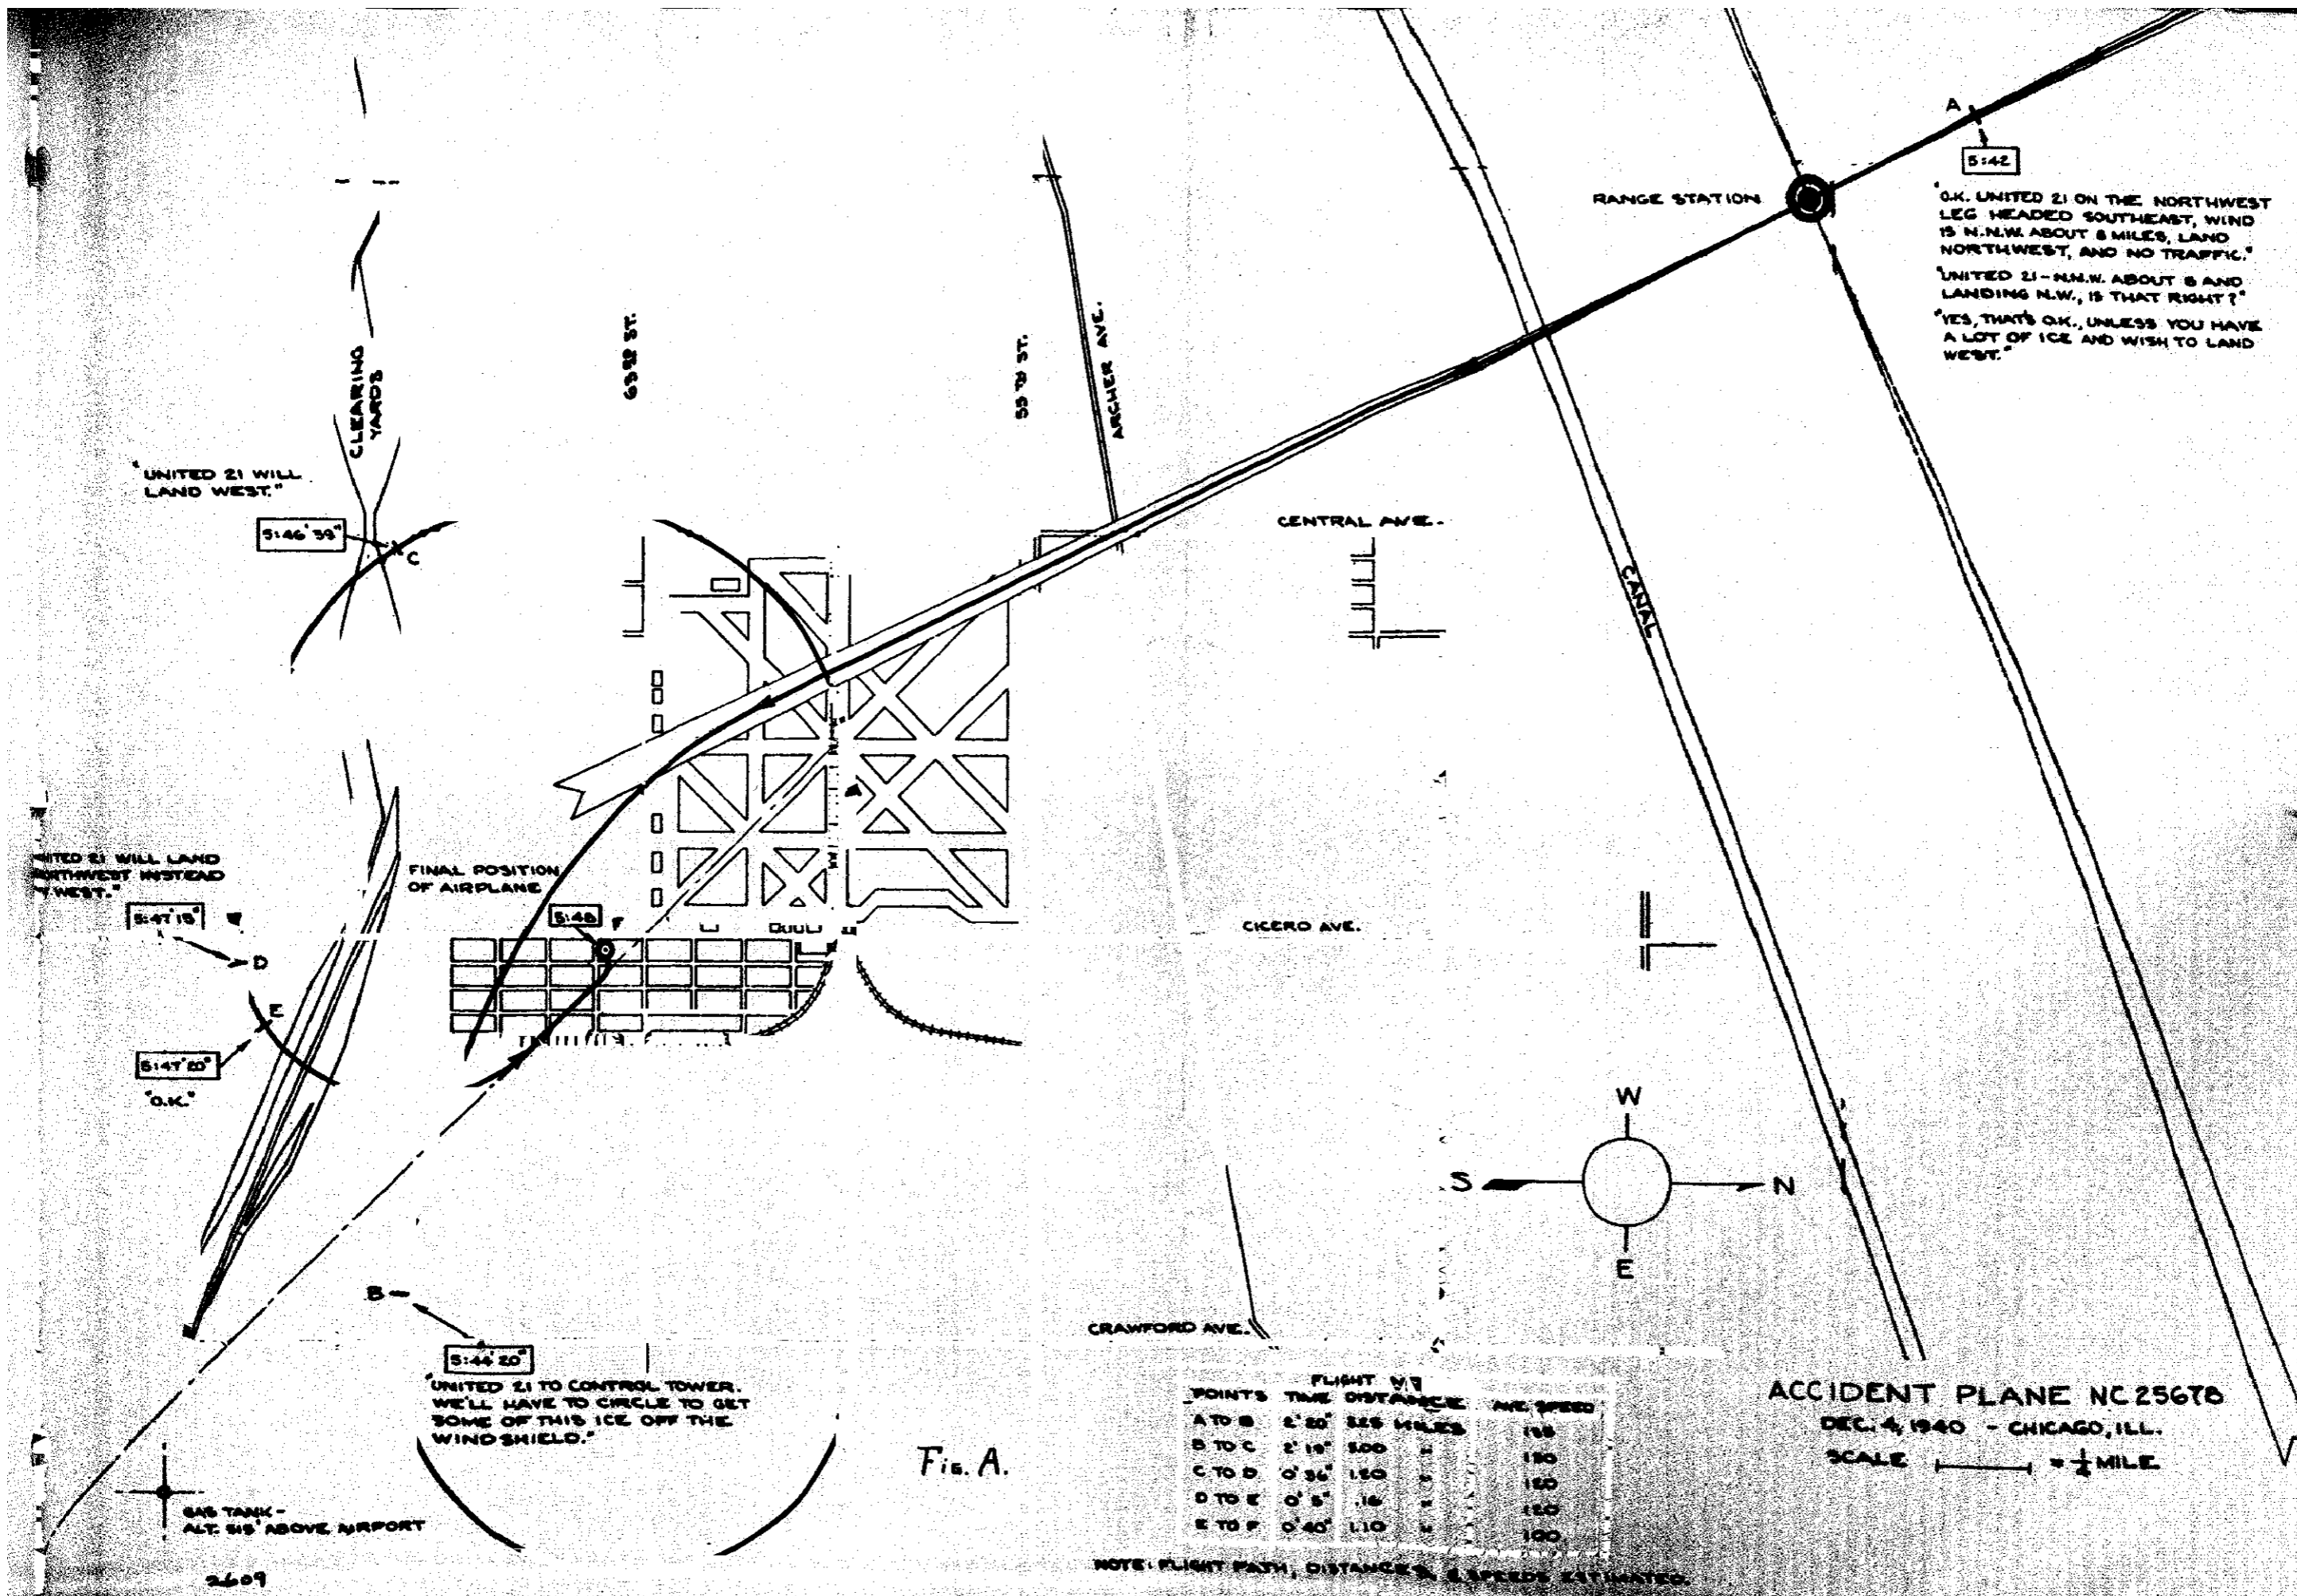
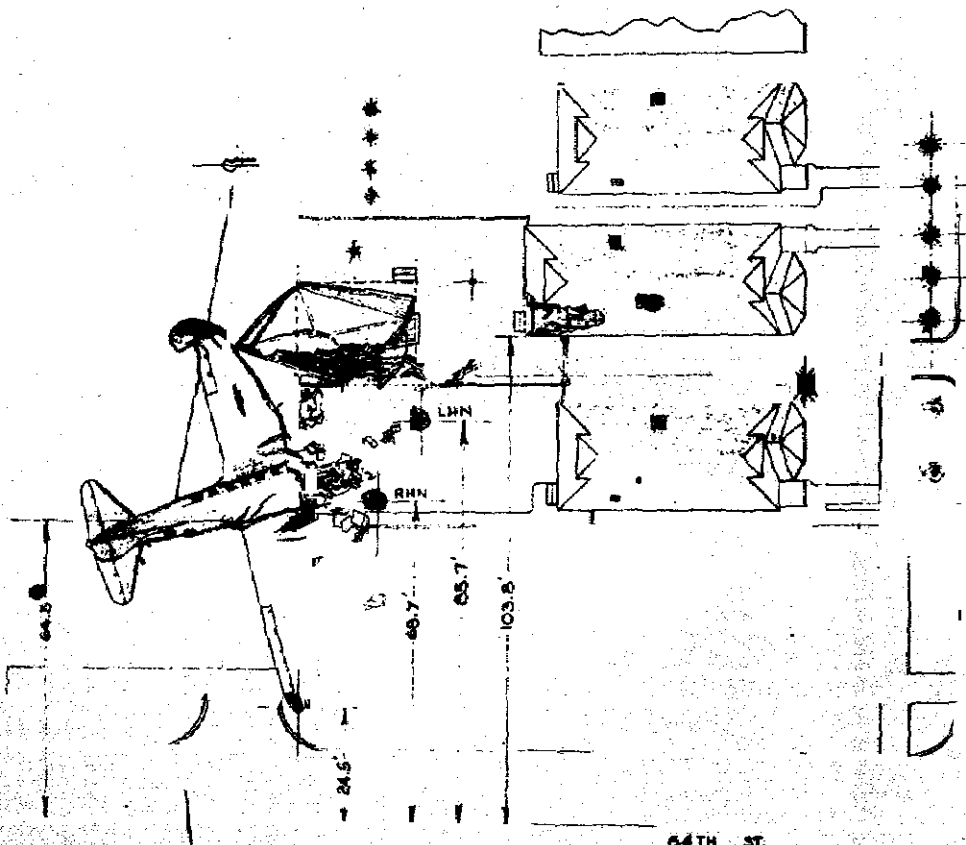
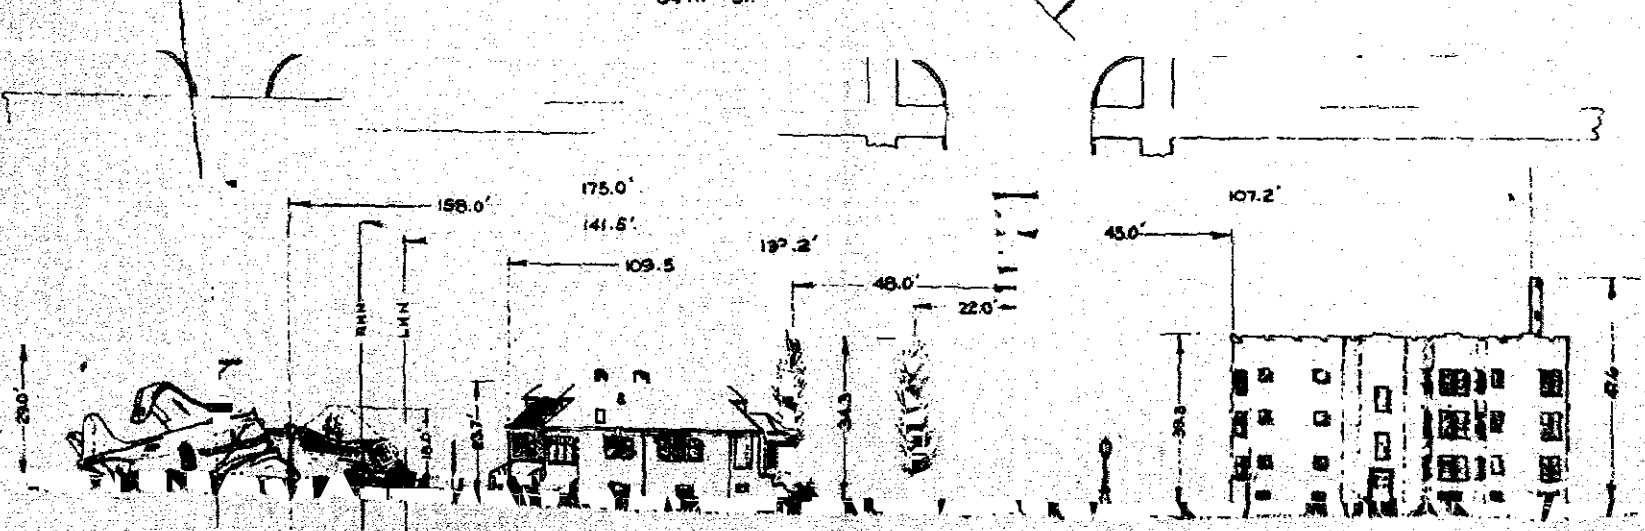
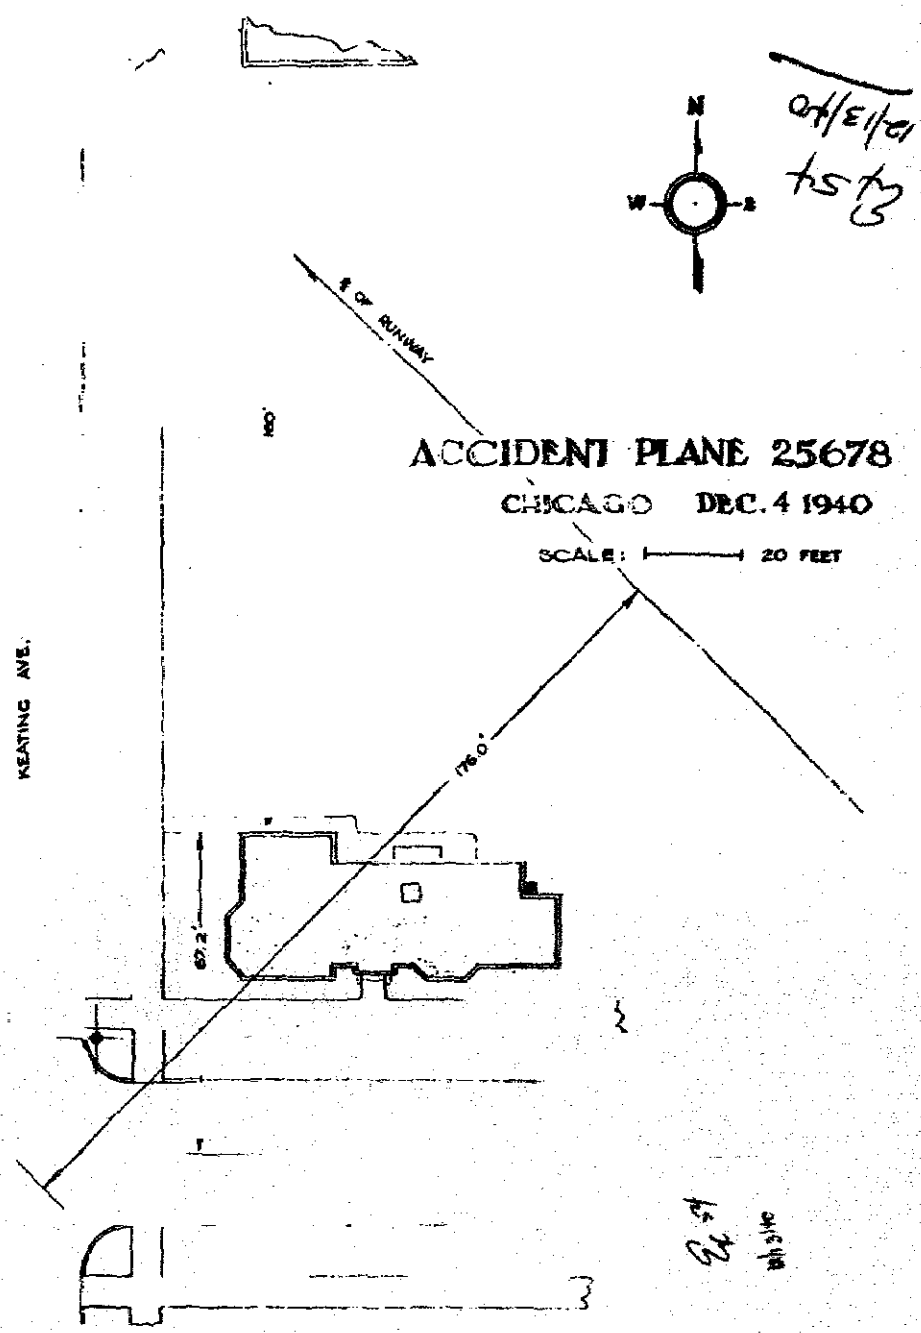
ACCIDENT PLANE NC 25678
 DEC. 4, 1940 - CHICAGO, ILL.
 SCALE $\frac{1}{4}$ MILE

At this point a 180-degree turn was made to the left and the plane headed due west across the airport directly over the railroad tracks which border the present field on the north. Just west of the center of the field a 90-degree turn was made to the left, the airplane proceeding south to a point about one mile south of the southwest corner of the field where a further turn was made and the flight proceeded east to a point about one mile south of the southeast corner. At this point, the airplane made a final left turn which aligned it with the northwest runway at a point approximately one-half mile southeast of the end of the runway.

During these maneuvers the airplane probably descended from the 900-foot level (above the ground) at which contact was first established to about 300 feet as it completed the left turn toward the landing

area, and continued to lose altitude slowly until it reached a point about 700 feet southeast of the southeast corner of the airport at an altitude estimated between 150 and 200 feet. At this point the airplane whipped off violently to the left and plunged to the ground.
