Report IN-005/2014

Incident involving a BOEING MD-11 aircraft, registration PH-MCU, operated by MARTINAIR CARGO, at the Tenerife South/Reina Sofía airport (Santa Cruz de Tenerife, Spain) on 9 March 2014

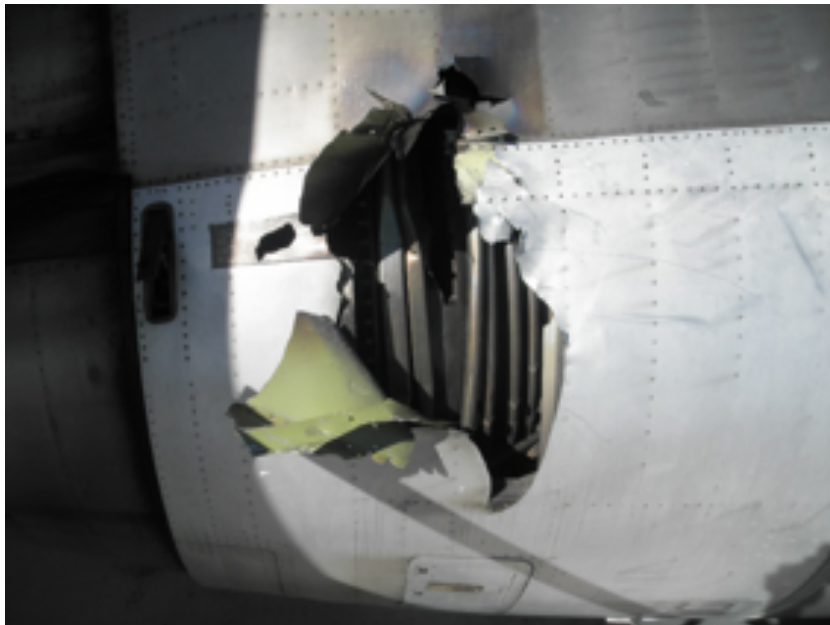
Figure 1. Photograph of the larger hole in the reverser cowling of the no. 3 engine

The larger of the two measured 78.7 x 35.5 cm. There were no burn marks or signs of melting on the fracture surfaces, the edges of which were bent outwards. In the area adjacent to the top part of the hole there were two blue-purple colored areas, consistent with heat coloring.

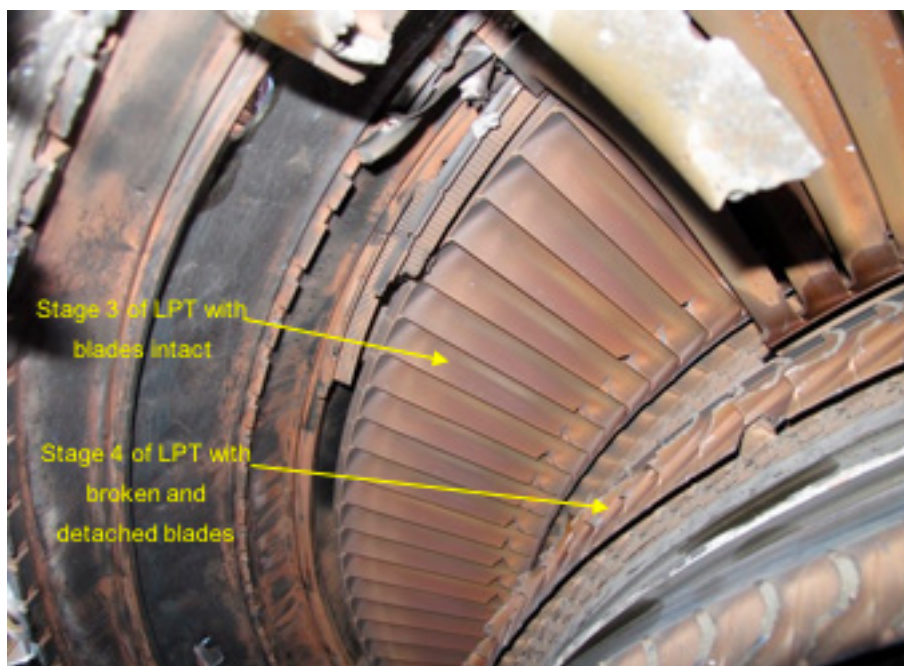
Figure 2. Low-pressure turbine (LPT)

There were multiple impact notches along the entire surface on the inside of the exhaust nozzle.

The inspection of the engine revealed that there had been an uncontained failure of the LPT, specifically in the plane of the 5th stage, which affected stages 3 through 6⁴, as detailed below:

- Blades in stage 3 rotor: damaged, in proper position
- Vanes in stage 4 stator: severely damaged, some missing
- Blades in stage 4 rotor: all airfoils missing
- Vanes in stage 5 stator: severely damaged some missing.
- Blades in stage 5 rotor: all airfoils missing
- Vanes in stage 6 stator: numerous missing
- Blades in stage 6 rotor: all airfoils missing
- LPT case: penetrated from the inside outward.

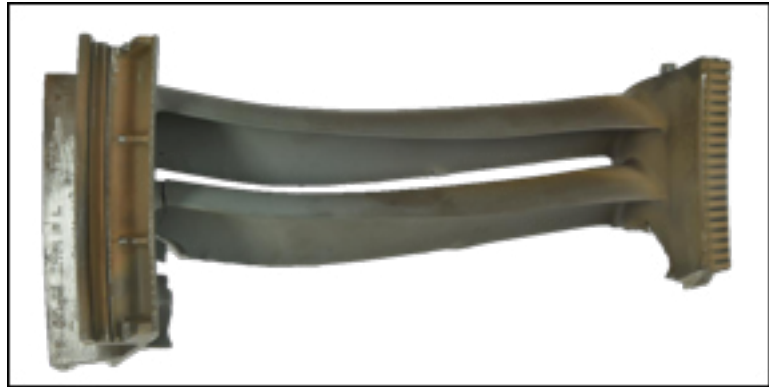
The investigation has determined that the failure of the no. 3 engine was caused by an airfoil that detached from vane no. 22 cluster in the 4th stage of the low-pressure turbine (LPT).

The root cause of the fracture was probably the pressure pulses (HPT 2E excitation) generated by the 2nd stage of the high-pressure turbine (HPT), which led to high vibrations in the stator of the 4th stage of the LPT, resulting in the formation of fatigue cracks in the vanes.

The remaining clusters remained in place, though they exhibited impact damage and loss of material. They were all complete except for no. 22, which had lost one of the three vanes in the cluster (see Figure 3). Most of the fracture surface was flat and dark. Vane clusters 15, 27 and 30 to 33 exhibited signs of internal corrosion. Of these, only groups 30 and 31 had sustained a loss of material.

Figure 3. No. 22 vane cluster in the stator of stage 4 in the LPT

A visual inspection revealed that cluster 22 had fractured and the lower vane had detached. Each cluster consists of three vanes called the lower, middle and upper vanes.
