**JOINT PCG-MARINA MARINE SAFETY INVESTIGATION**  
**ON THE INCIDENT INVOLVING “FBca GEM-VER”**

Re: Incident involving “FBca GEM-VER”  
and a fishing vessel on  
09 2350H June 2019 at vicinity waters  
of Recto Bank (Reed Bank), WPS  
X-----x

**MARINE SAFETY INVESTIGATION REPORT OF AN**  
**INCIDENT INVOLVING “FBca GEM-VER”**

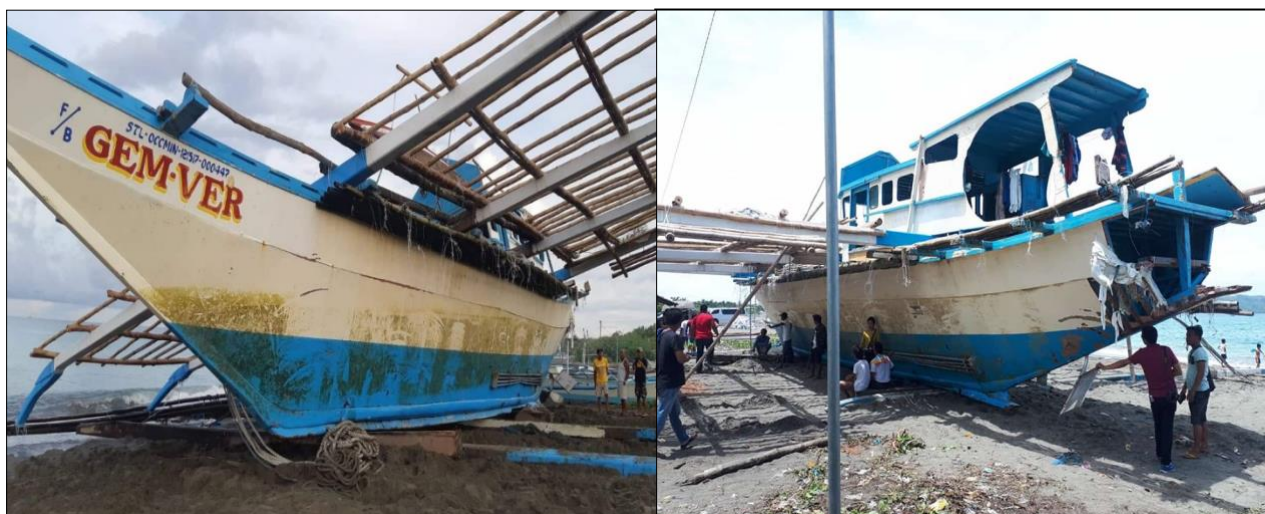
FIGURE 2  
Forward Portion

16. Post Structural Assessment conducted on FBca "GEM-VER" yielded to the following results:
  - a) Aft side hull on the port side was destroyed with tear left on the hull making the side longitudinal frames visible.

- b) The stern post of the vessel was destroyed, leaving the keel which initially caused the flooding on the vessel.
  - c) The bulkhead at the stern was destroyed due to the incident which compromised the engine compartment and eventually caused flooding thereat.

- e) Both port and starboard side hull on the stern contain tear.
  - f) Deck planking was mostly intact except on the stern part.
  - g) The fish (cargo) hold including the bulkheads, frames, and stiffener on midship are intact.

17. Images of FBca “GEM-VER” after the incident

42. Post Structural Assessment. Based on the post structural assessment conducted, FBca “GEM-VER” is considered a total loss.
