Technical Note

T/N: OR-1

Date: May 1981

Use of Juniper Trees to Stabilize Eroding Streambanks on the South Fork John Day River

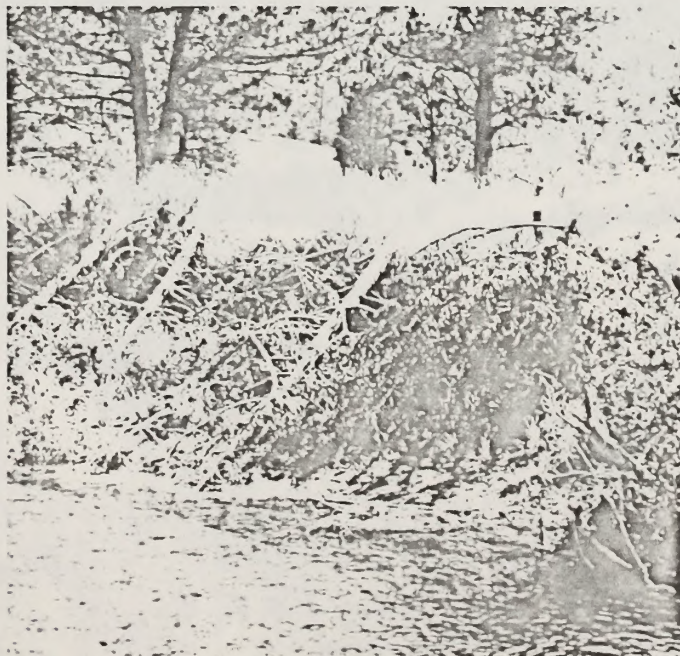
Many sites had tree tips buried under 2 feet of silt the first year after placement (Figures 5 and 6). This formed a slope below the vertical bank. Native plant

Figure 6 After. Junipers were placed on the bare, eroded bank during the summer of 1977. This photo was taken during the fall of 1978. Banks have sloped due to silt deposition and the establishment of riparian vegetation.

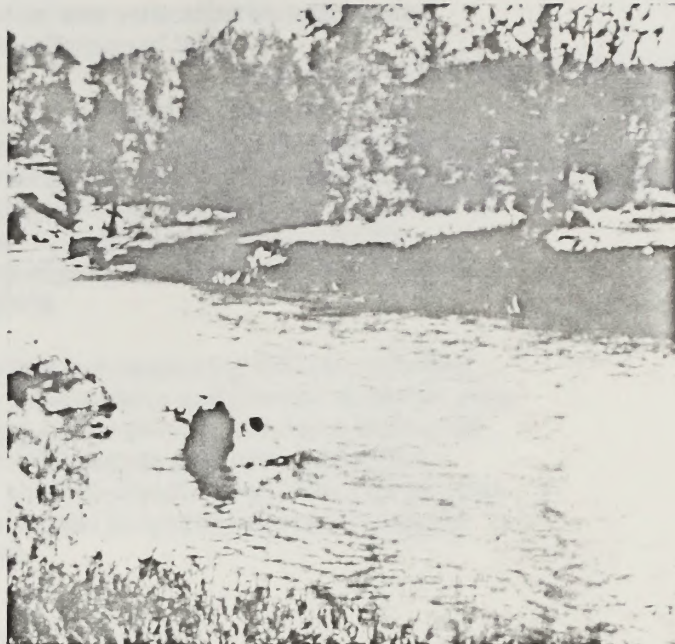
Figure 5 Before. Vertical cutbanks were present on far bank in 1976.

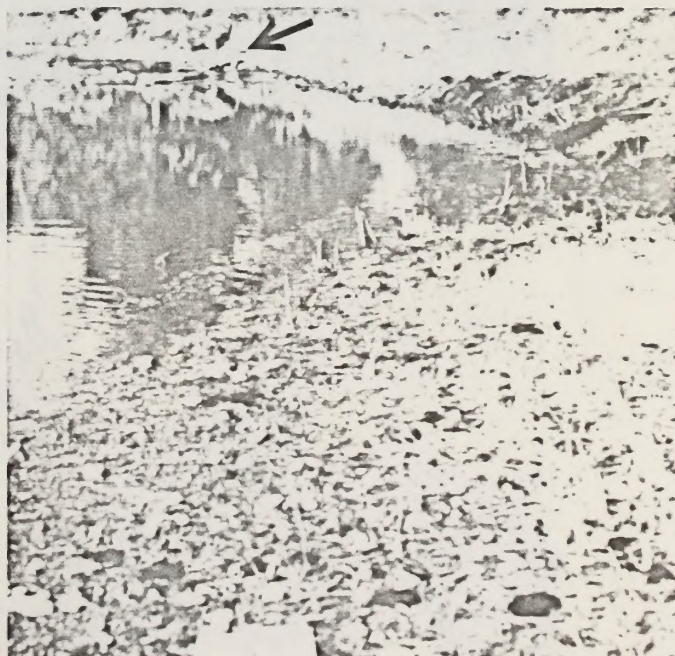
Figure 7 This area was devoid of riparian vegetation in 1973. Cutbank occurred behind the cow (see arrow).

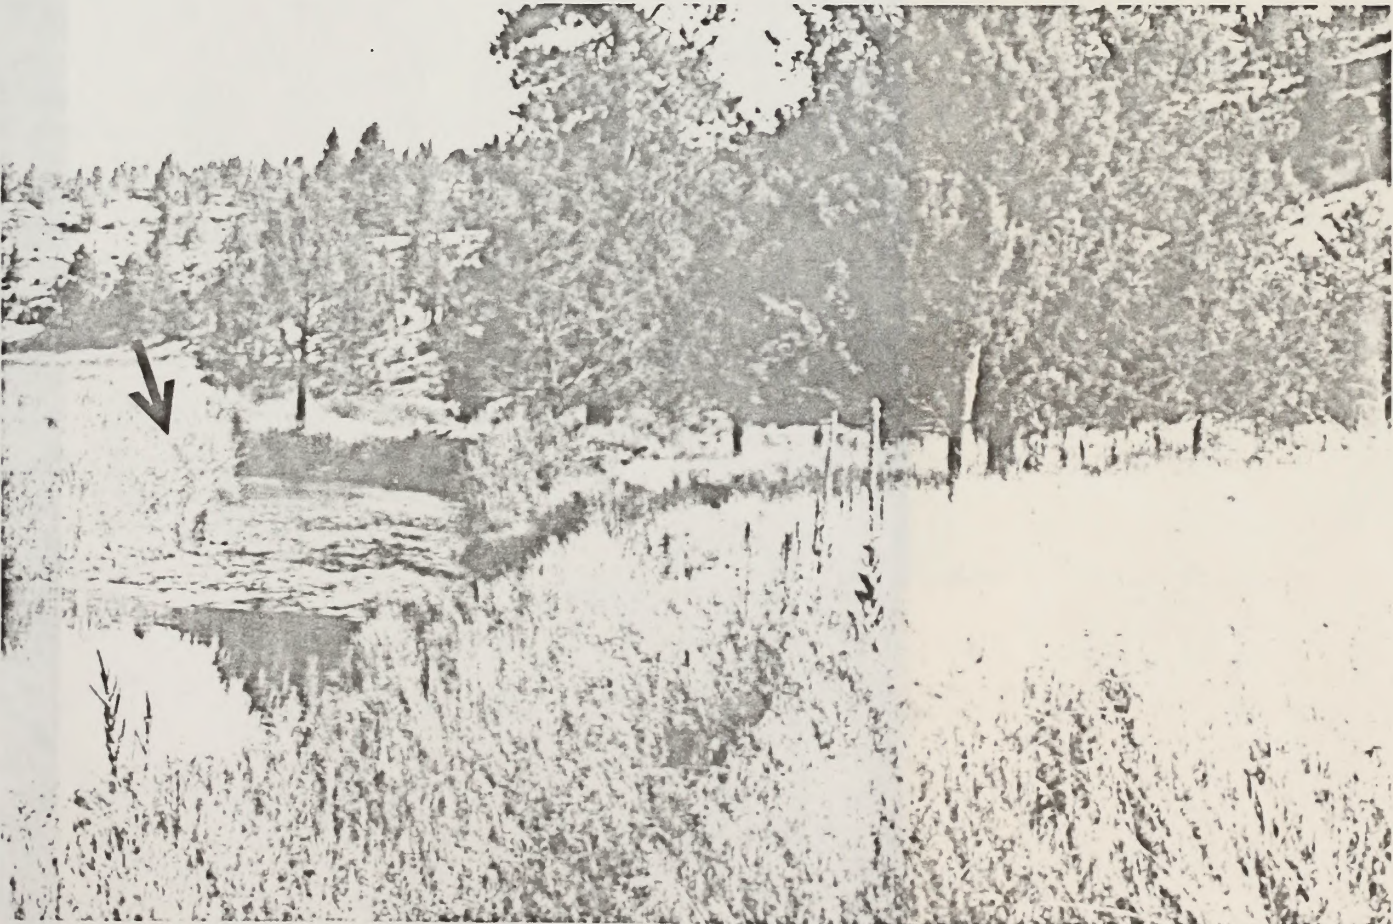
succession occupied such sites during the first growing season. Willow cuttings, planted prior to juniper placement, often were successful. The annual deposition of sediment collected in tree limbs and plant cover was occupied by emerging native plants by early summer. Proper grazing management plus bank stabilization allowed an encroachment of riparian vegetation on some stream channels (Figures 7, 8, and 9). This caused a deepening of the channel, improving salmonoid habitat.

Figure 9 Photo taken during the summer of 1978. The same site as figure 7. This site was lightly grazed annually during the fall. Junipers were placed on the cutbank in 1977. Note encroachment of willows on left bank point bar (arrow). Point bar was bare of willows in figure 7.
