ULTRASONIC DETECTION OF
OVERBUFFING IN RETREADED TIRES

S. N. Bobo
A. J. Scapicchio

AUGUST 1977
INTERIM REPORT

1. Report No. HS-802-539		2. Government Accession No.		3. Recipient's Catalog No.	
4. Title and Subtitle ULTRASONIC DETECTION OF OVERBUFFING IN RETREADED TIRES				5. Report Date August 1977

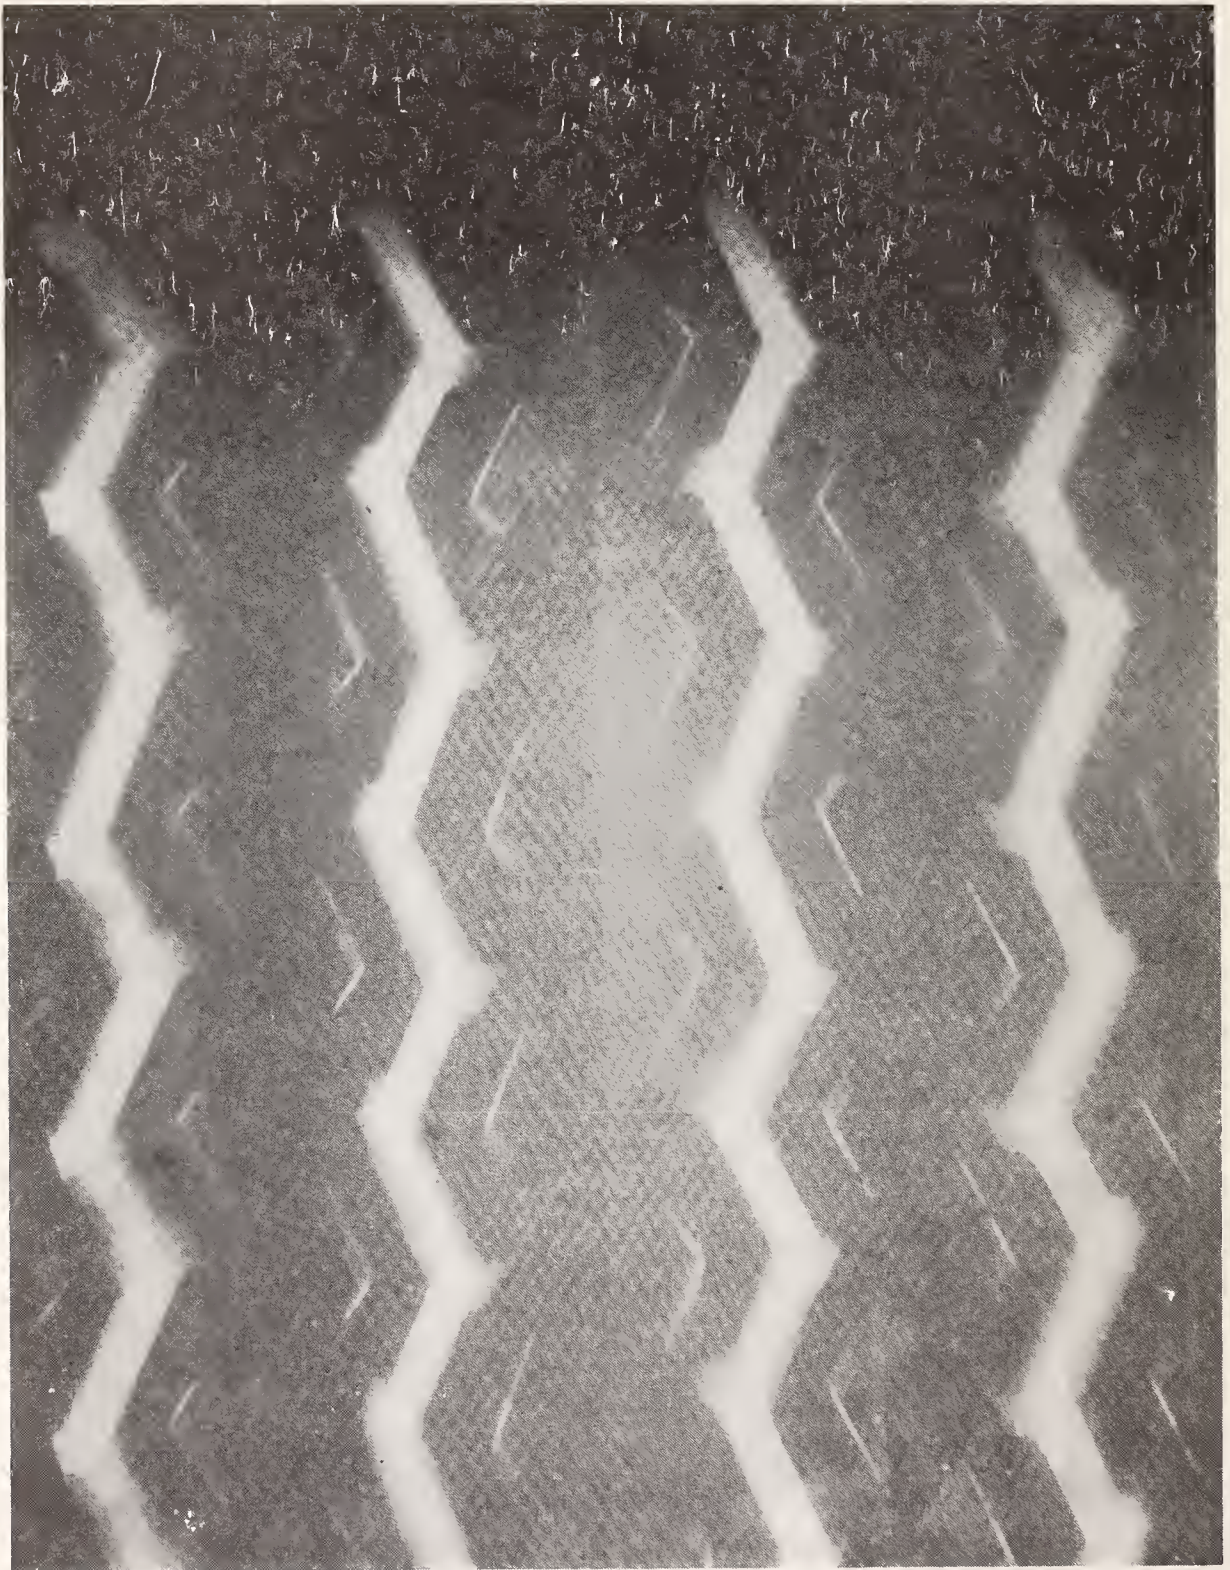
Prior to ultrasonic inspection, the tires were inspected using the Picker X-ray system at TSC. As may be observed in the typical x-ray photograph (Figure 1 below), no pertinent information is readily available. Only a gradual dimming of the weave pattern in the fabric within the tire is dimly visible. All tires in this experiment were x-rayed but no cord overbuffing could be identified from x-ray display or from photographs, therefore photographs were not included. Next, ultrasonic inspection was performed. Figures 5 and 6 are ultrasonic images of the two

FIGURE 1. X-RAY OF TIRE SHOWING CORD STRUCTURE

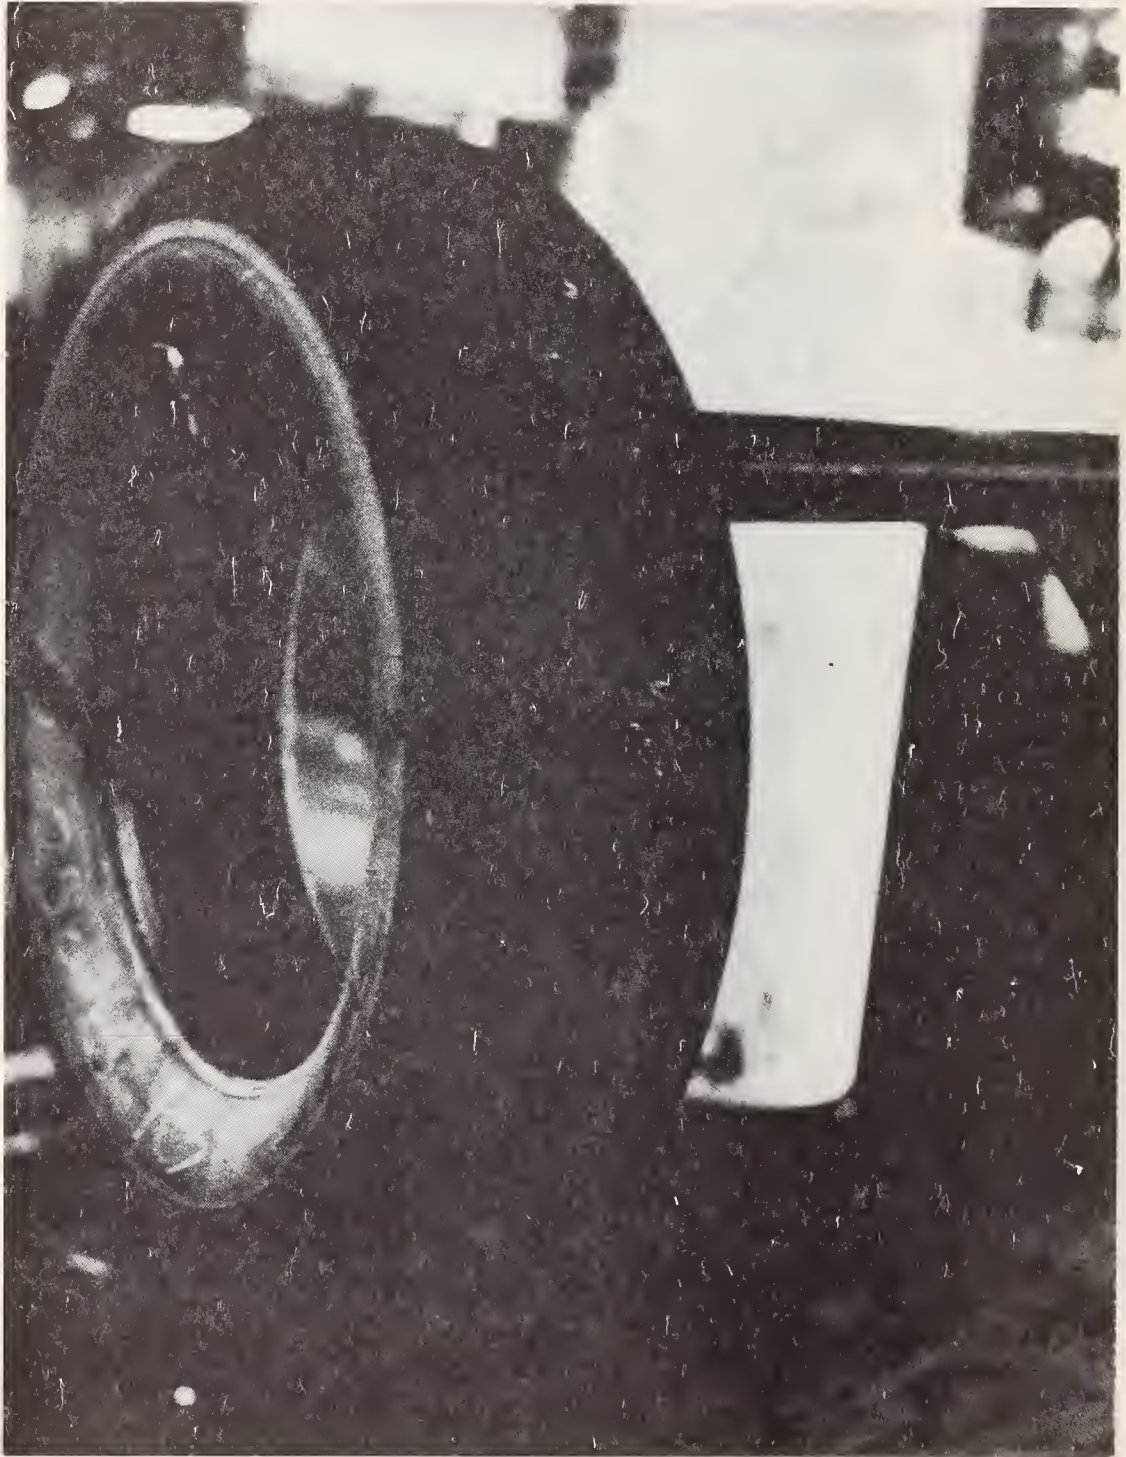
Figures 3 and 4 are photographs of tires 2312 and 2313 respectively. Tire 2312 was buffed with a rasp whose plane of rotation was parallel to the plane of the tire. Tire 2313 was buffed with a rasp whose plane of rotation was parallel to the tire axis with the rasp starting its cut on the left and leaving the tire on the right.

FIGURE 3. LONGITUDINALLY BUFFED CASING SHOWING BUFFING DAMAGE

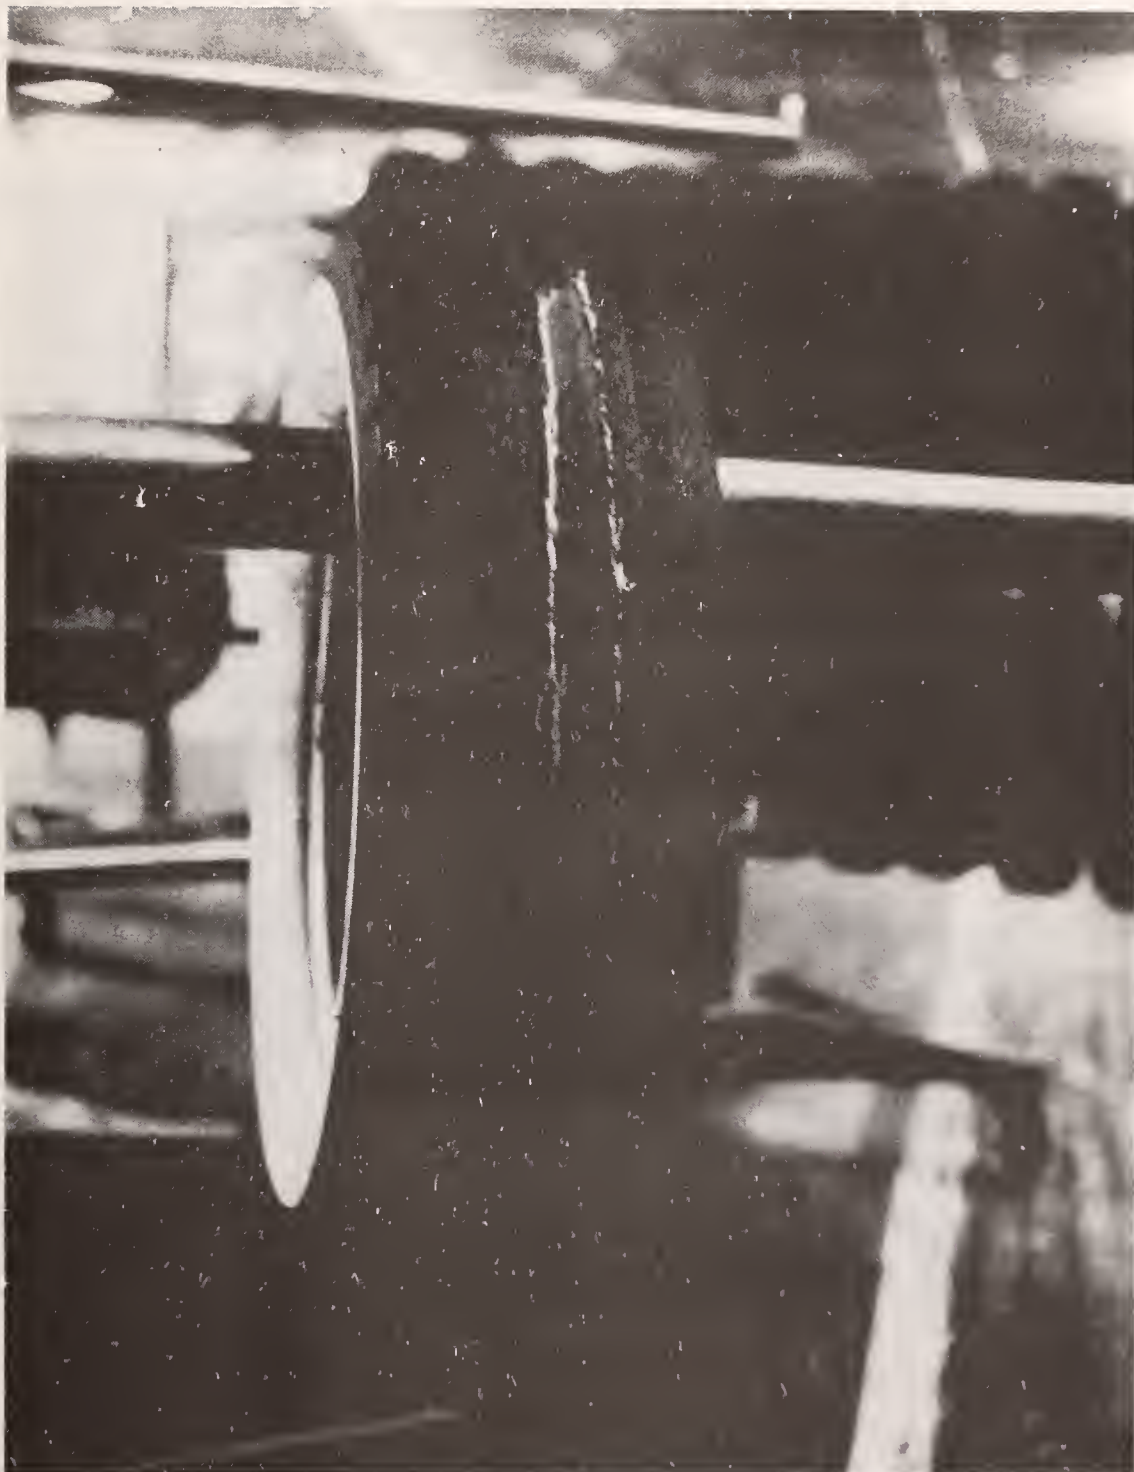
FIGURE 4. AXIALLY BUFFED CASING SHOWING BUFFING DAMAGE

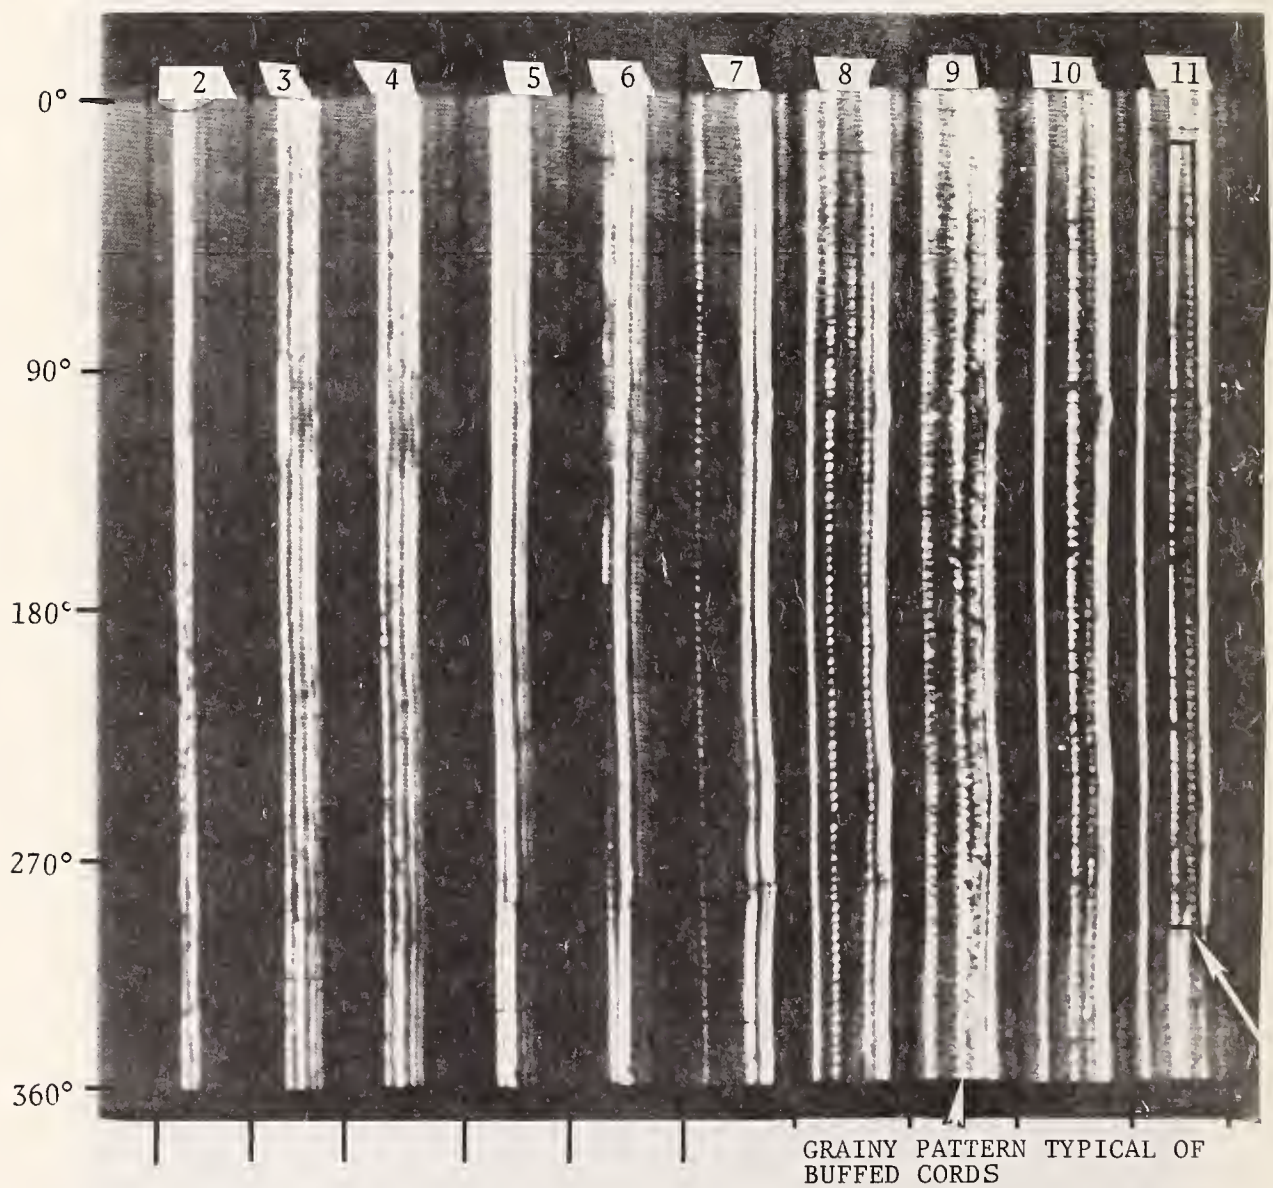
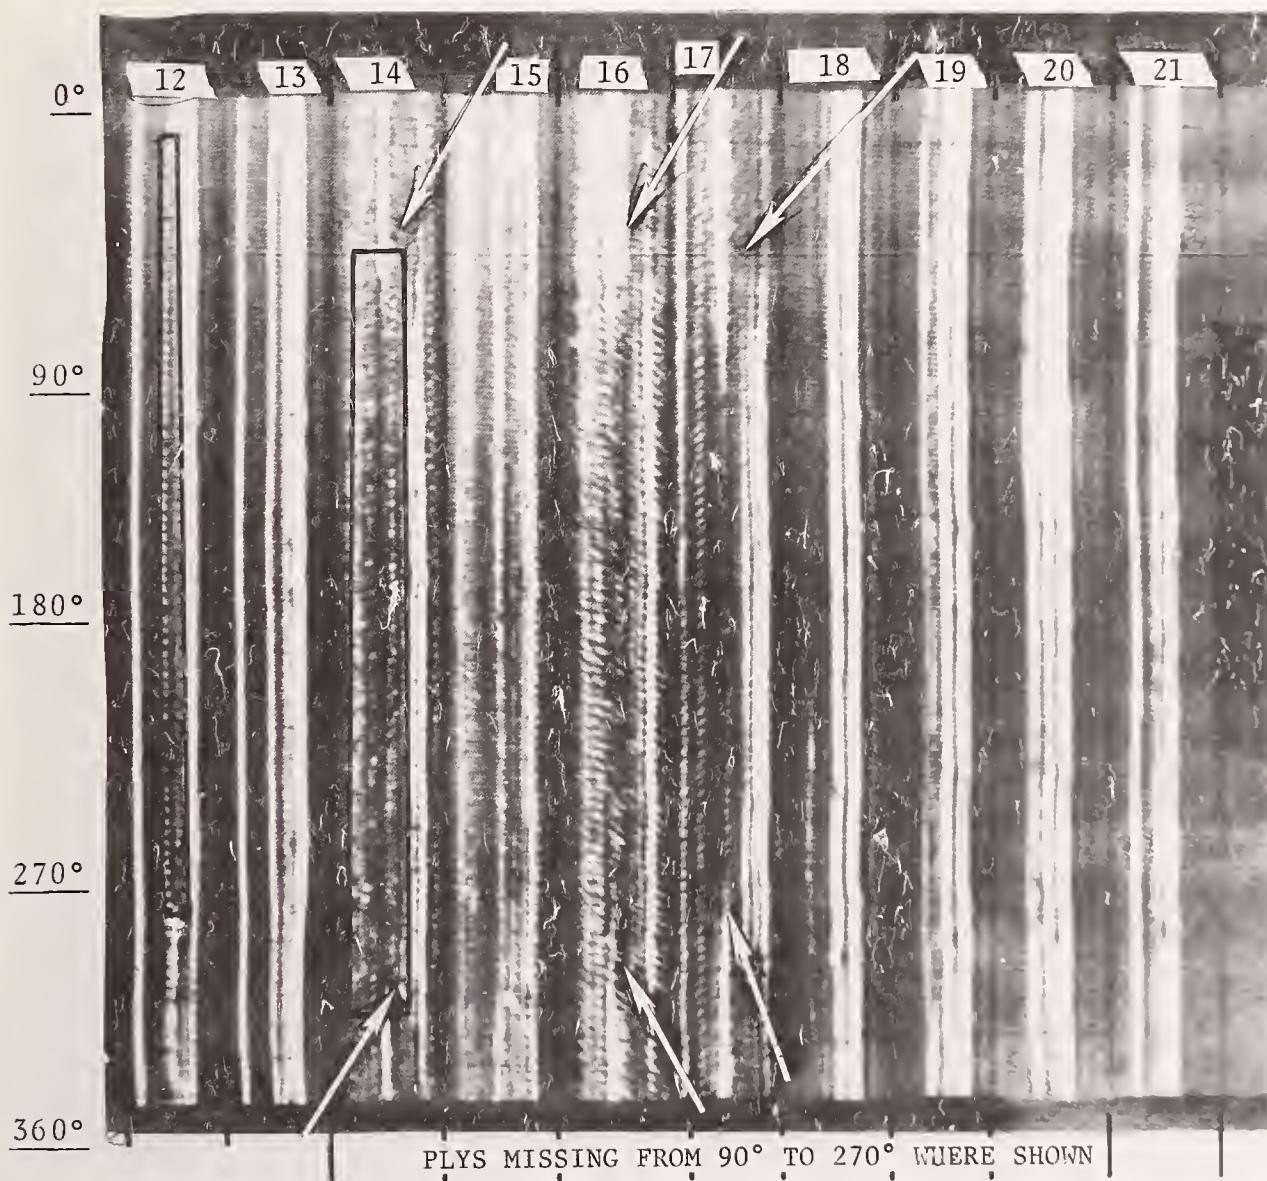
biased-ply tires in question. Carefully observed, these images can show the extent and severity of the buffing damage. In Figure 5 (tire 2312), channel 11 shows an irregular pattern of damage starting at a rotation point of about 300 degrees and going to 30 degrees. Channel 12 shows a similar condition. Channel 13 was not aimed at the site of the damage and shows no flaw information. Channels 14, 15, and 16 show reflection systems of increasing severity and extent with severely reduced reflections from underlayers, always a clear signal that severe damage has occurred within the tire. In Figure 6 (Tire 2313), the damage is apparent in channels 14, 15, 16, and 17, with extensive reflections at the outer ply surface running from 170 to 290 degrees in rotational direction, with secondary disturbances in channel 16 completely around the tire. The disappearance of the reflected signal is even more apparent in this tire.

FIGURE 5. HARDCOPY DISPLAY OF RADIALLY BUFFED TIRE CASING

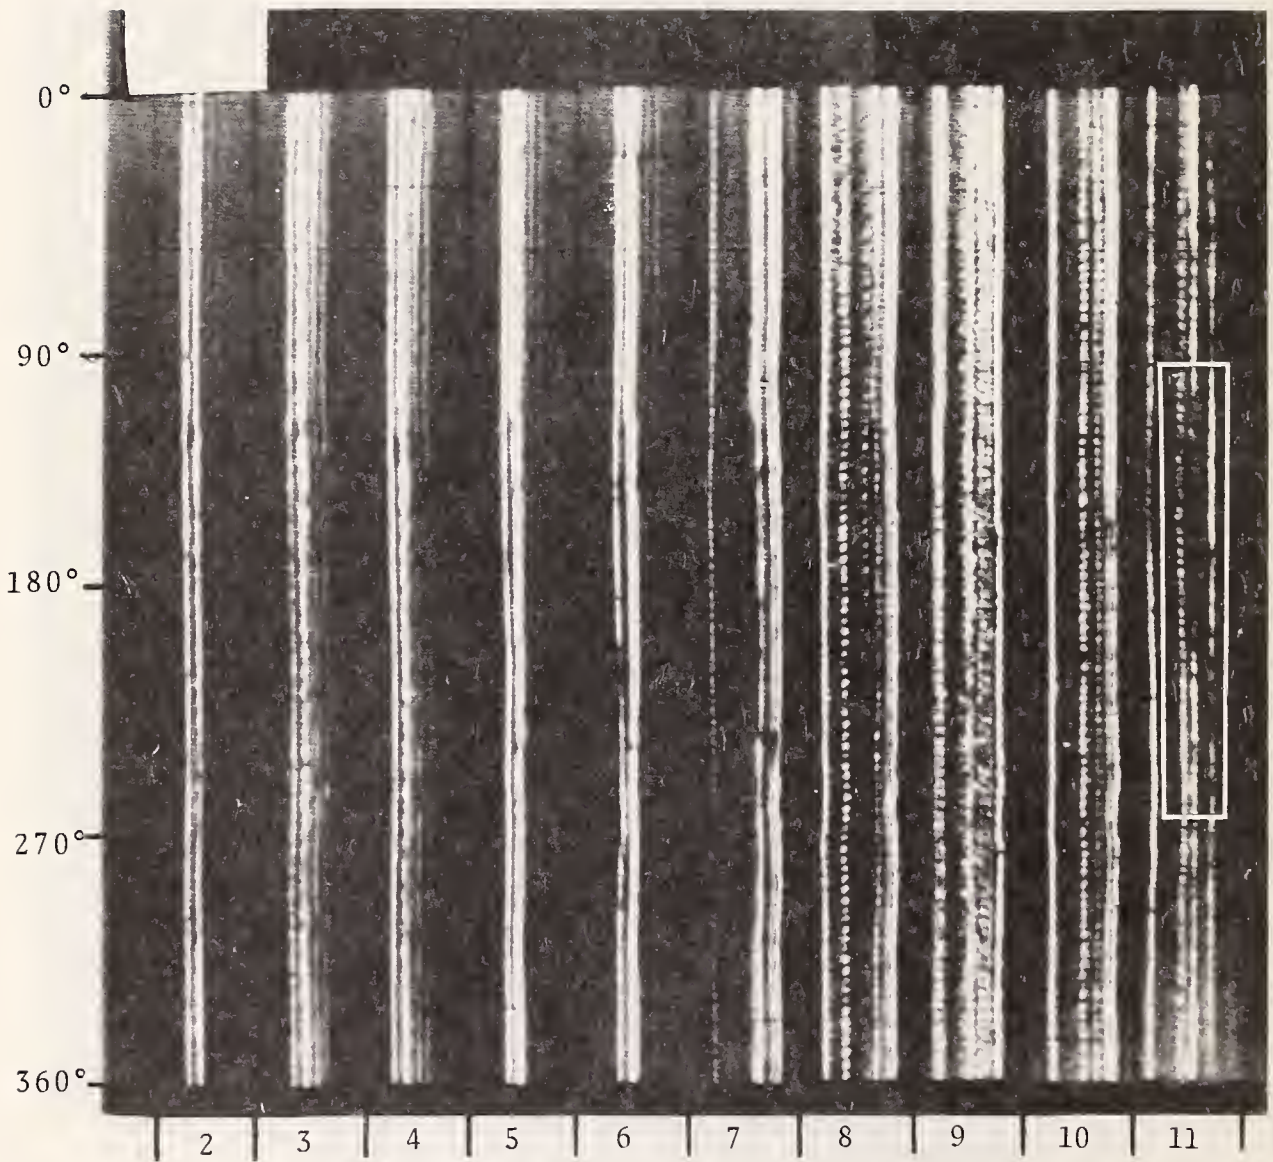
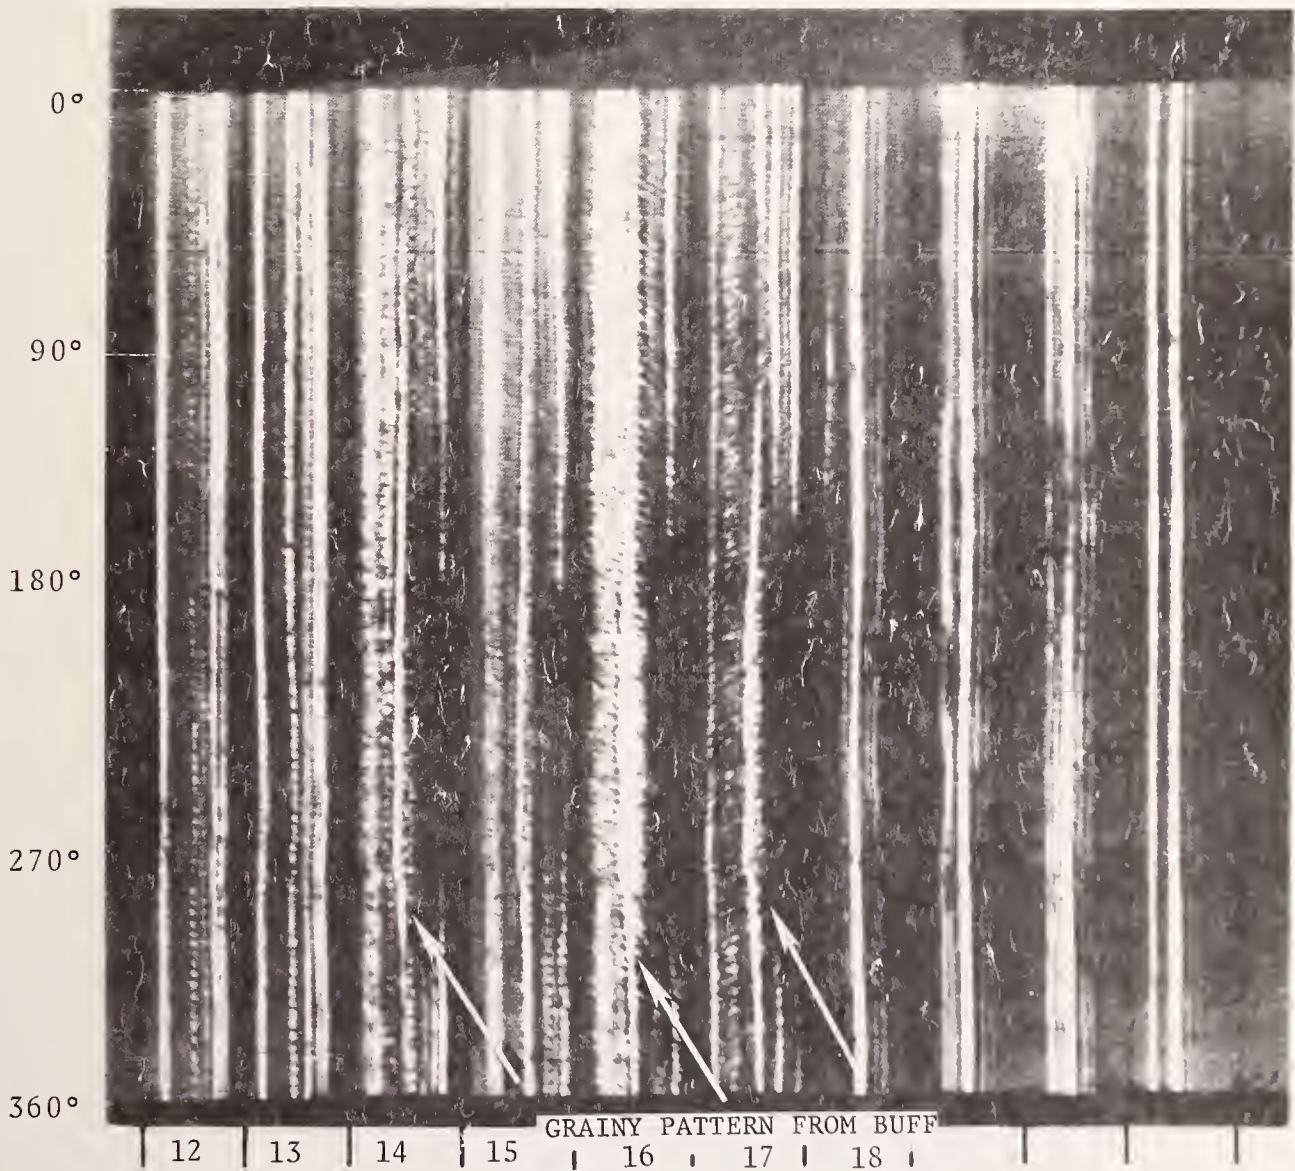
FIGURE 6. HARDCOPY DISPLAY OF AXIALLY BUFFED CASING

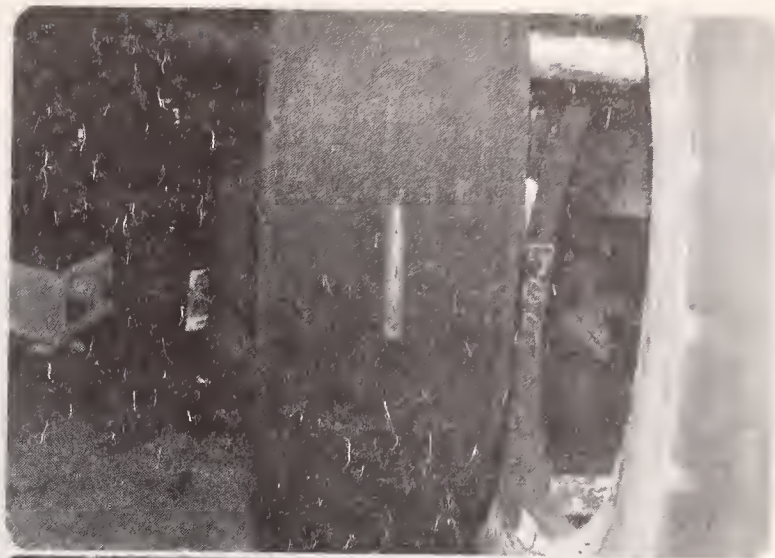
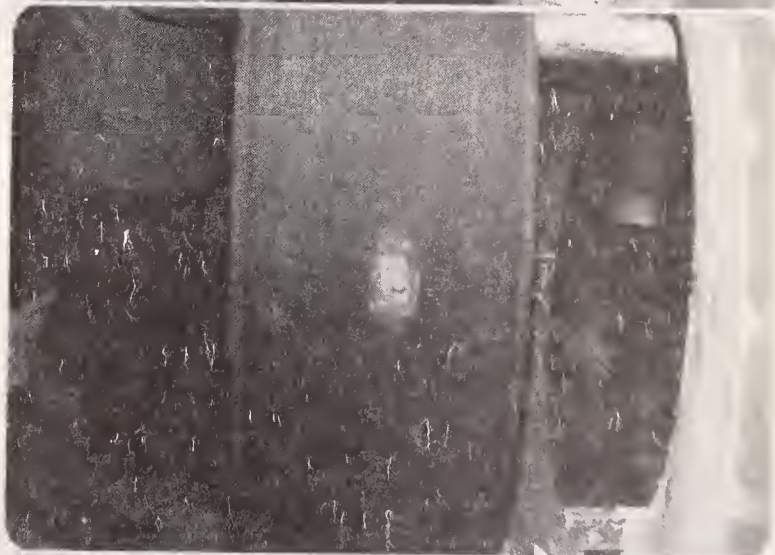
FIGURE 7. TIRE NO. 1 BUFF AT 0, 90 AND 180 DEGREES

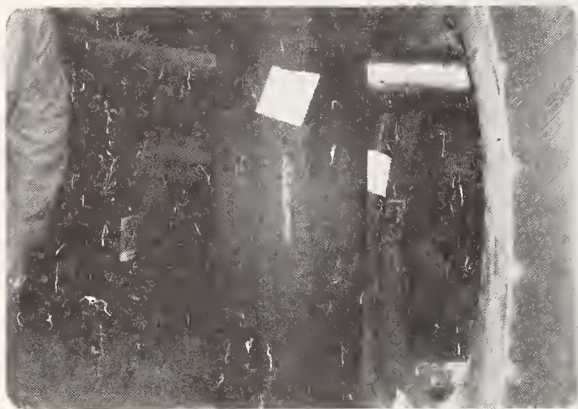
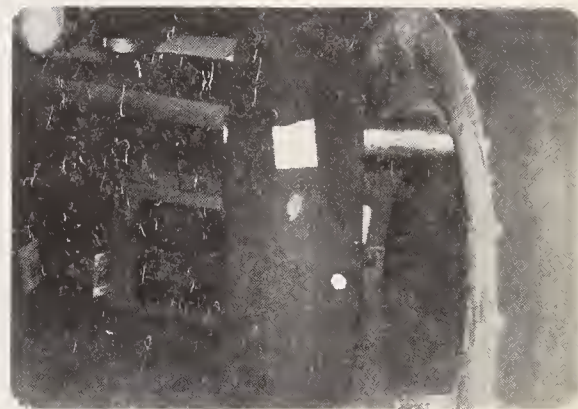
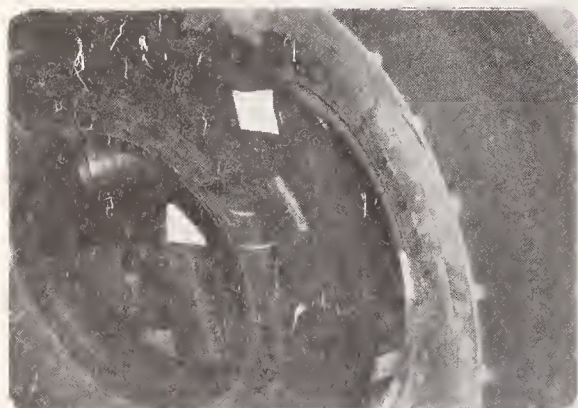
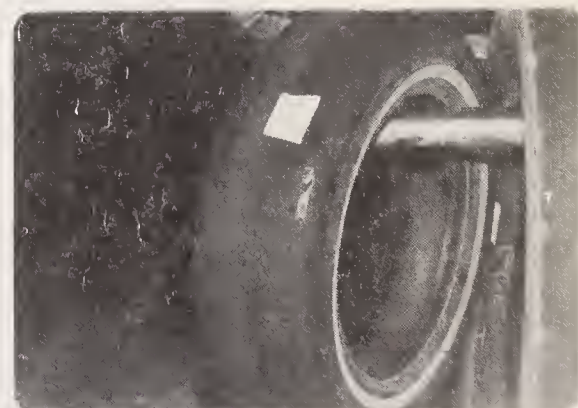
FIGURE 8. TIRE NO. 2 BUFF AT 0, 90, 180 AND 270 DEGREES

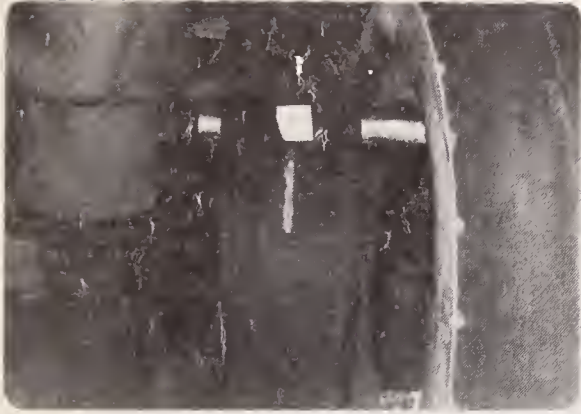
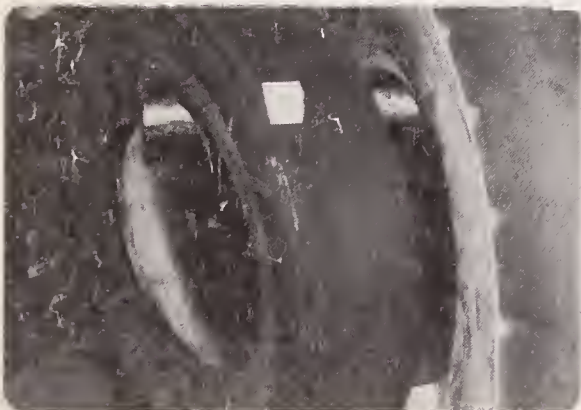
FIGURE 9. TIRE NOS. 3 AND 4 BUFFS AS NOTED

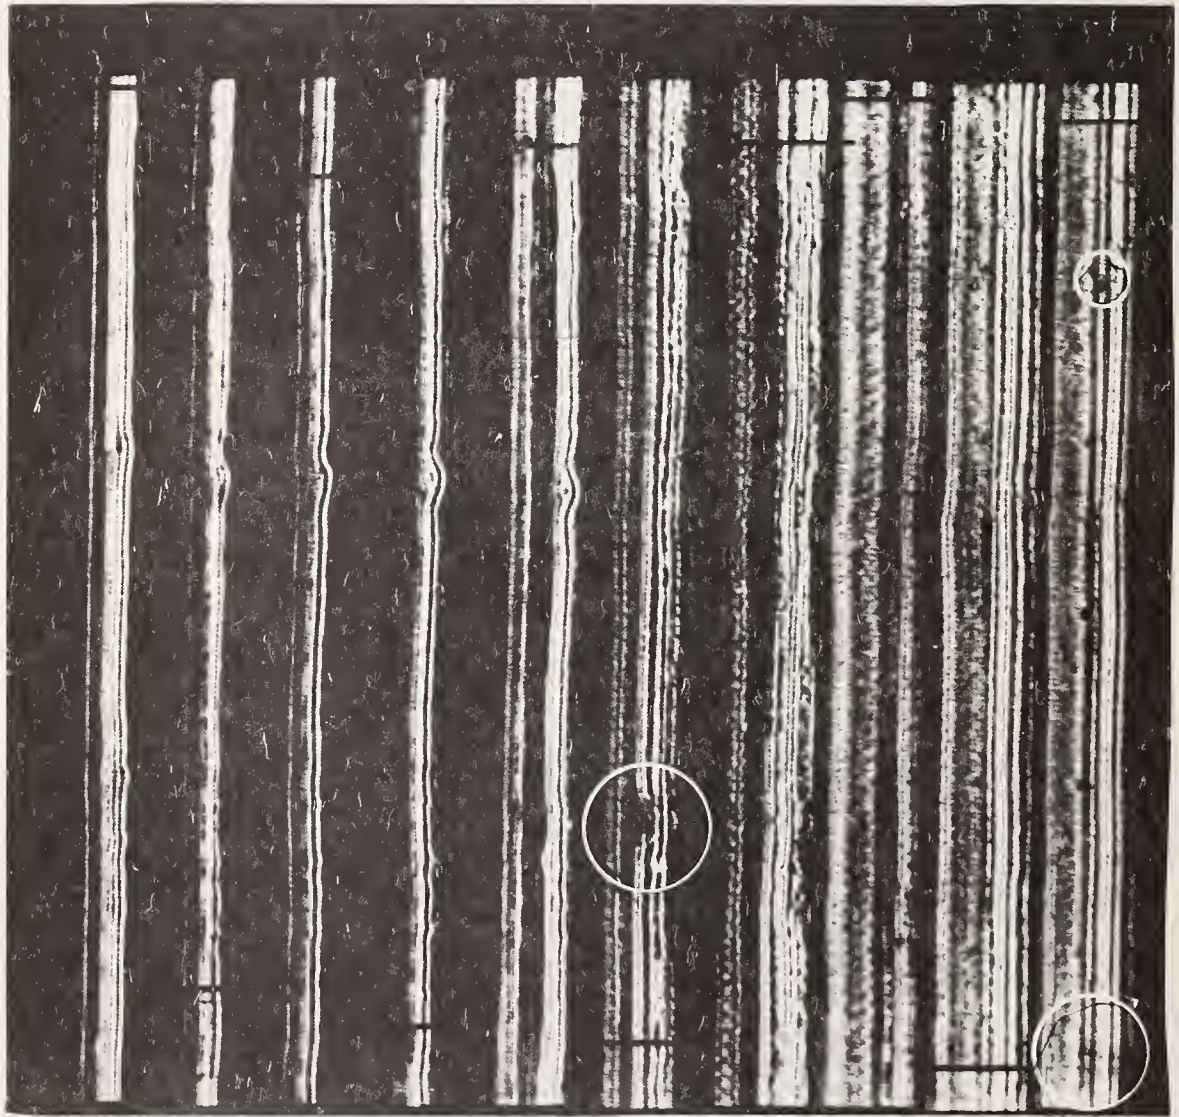
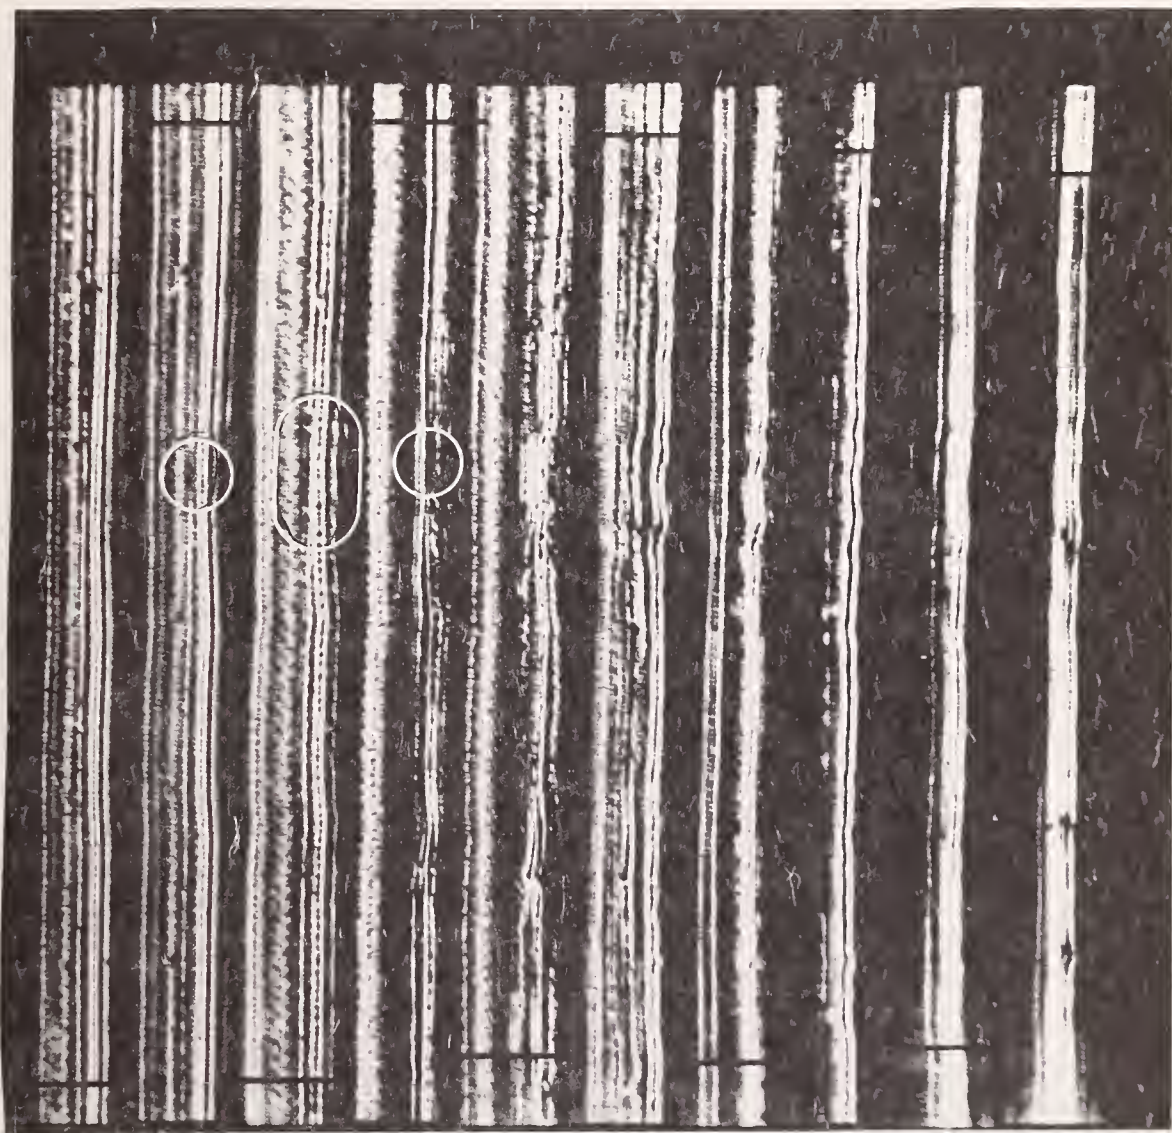
FIGURE 10. HARDCOPY DISPLAY OF TIRE NO. 1, STEEL BELTED RADIAL

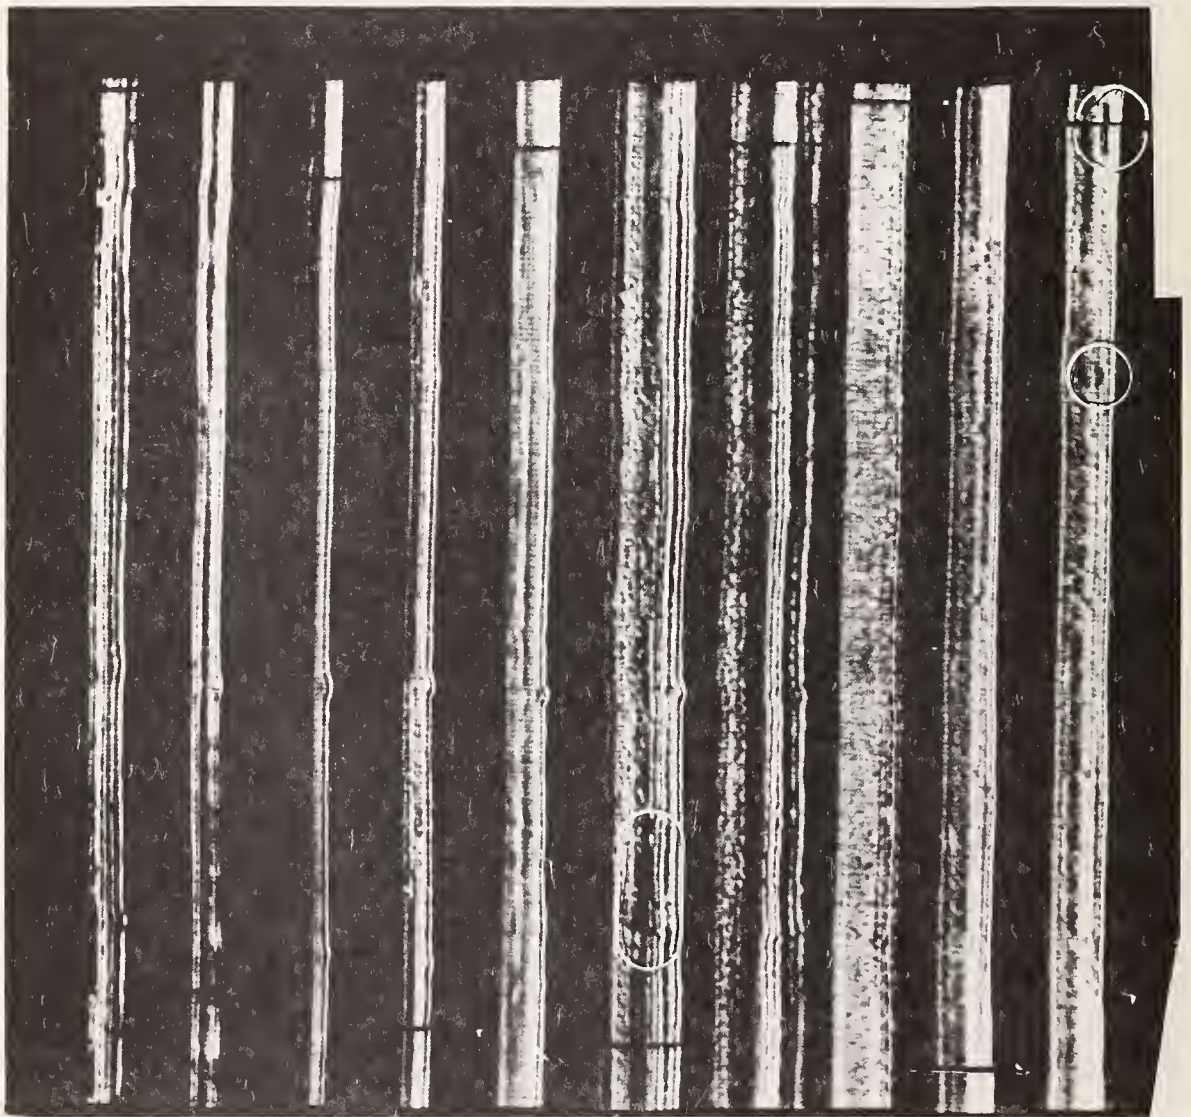
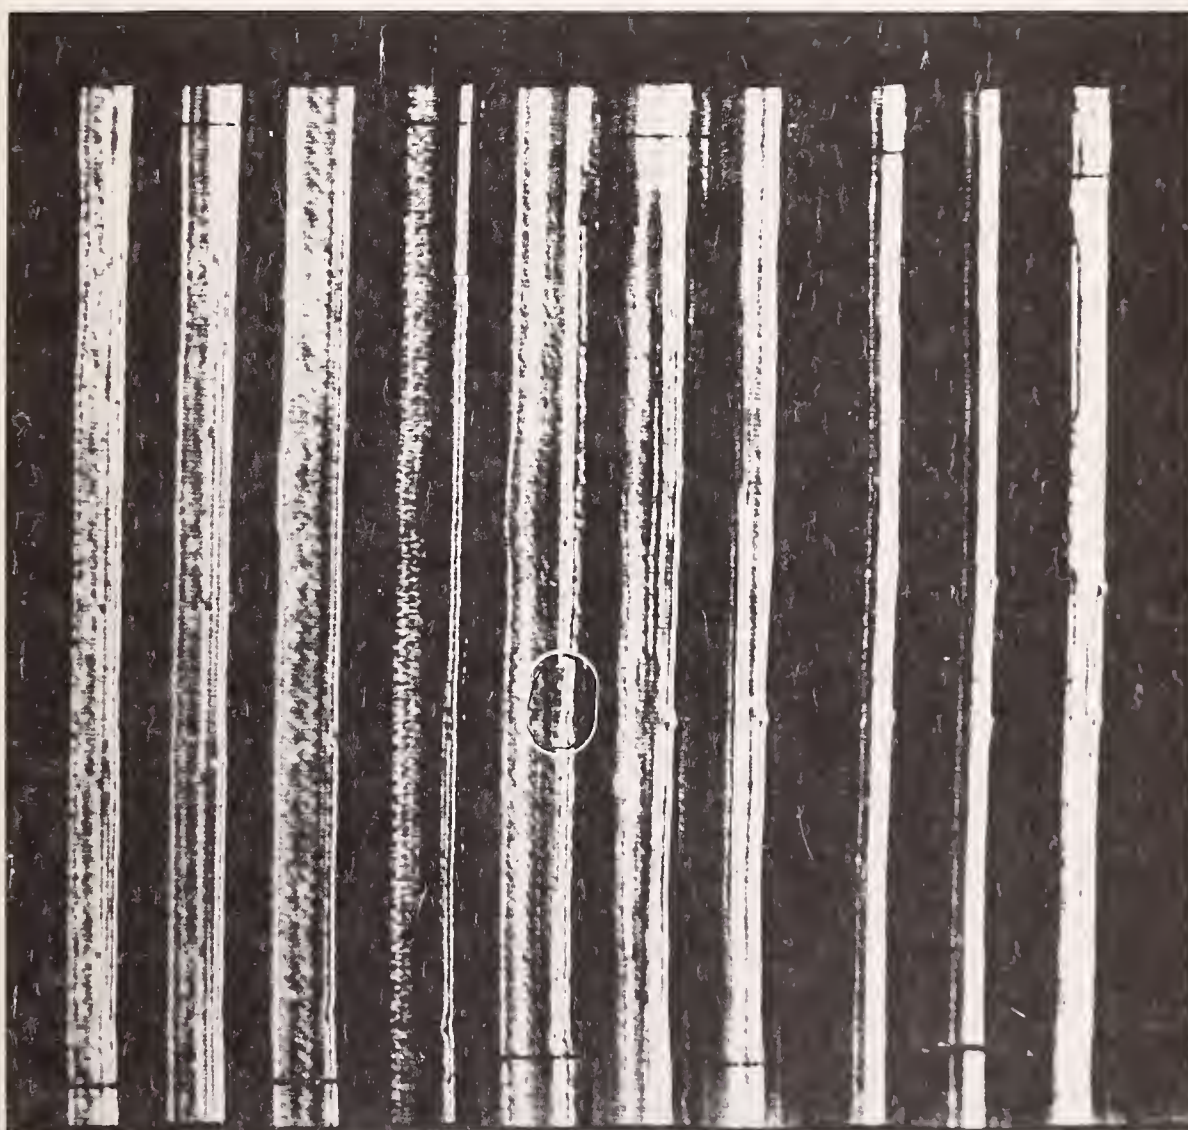
FIGURE 11. HARDCOPY DISPLAY OF TIRE NO. 2, GLASS BELTED BIAS

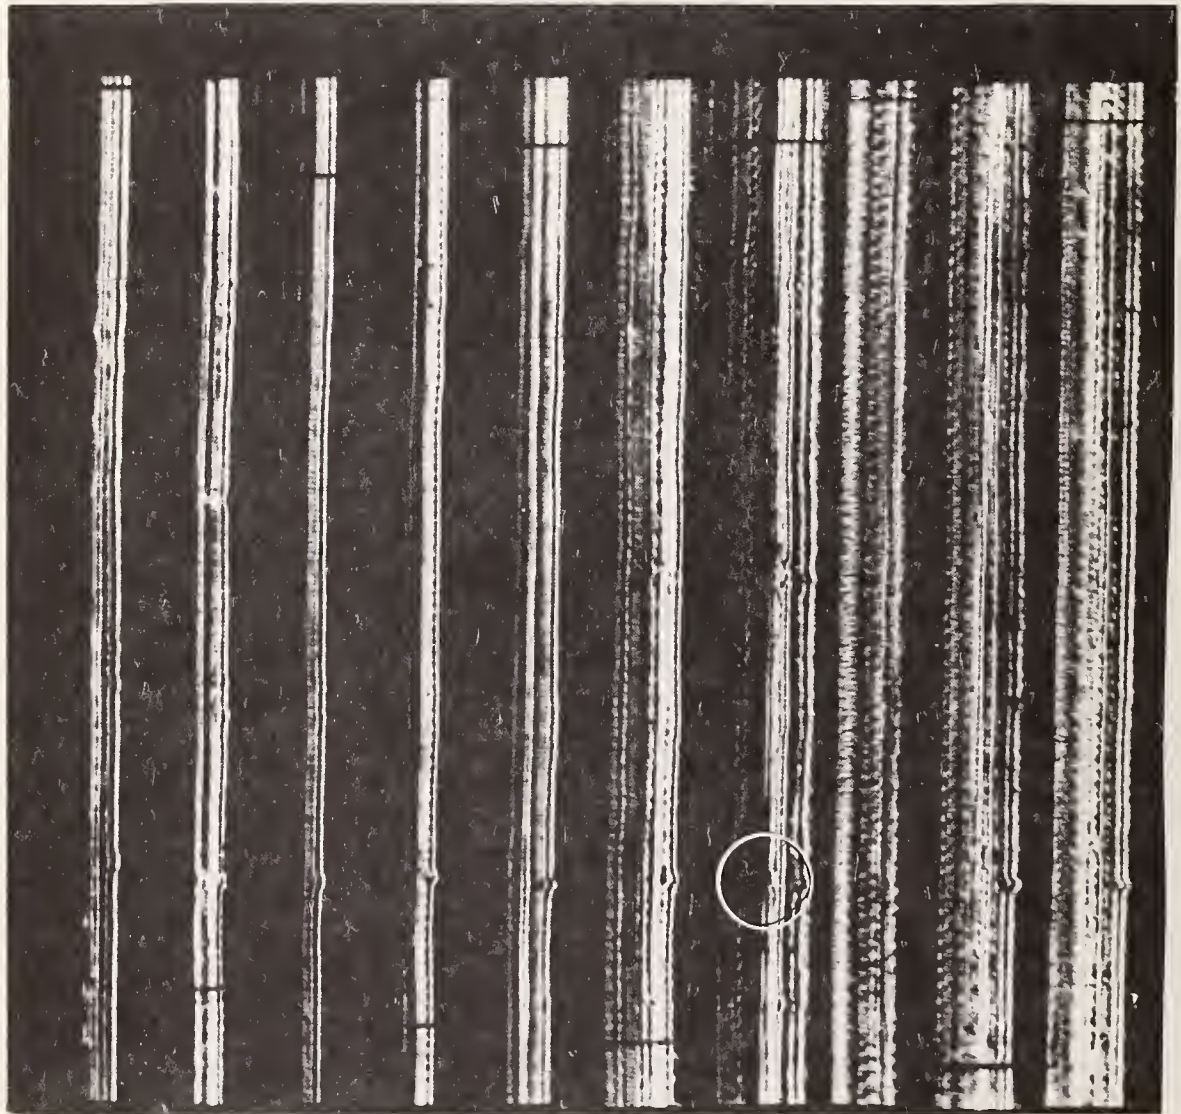
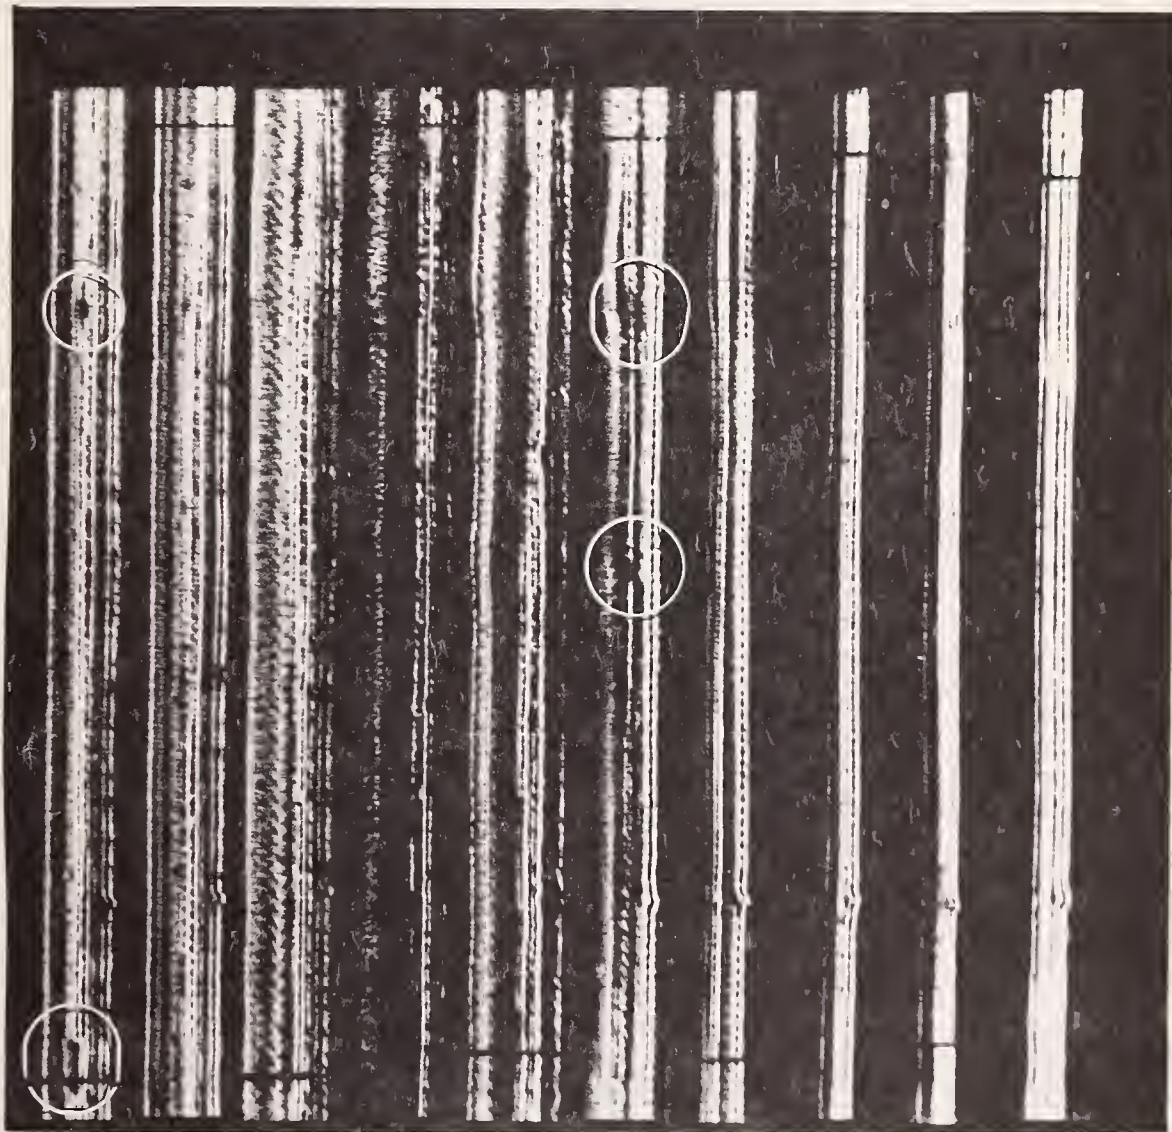
FIGURE 12. HARDCOPY DISPLAY OF TIRE NO. 3, BIAS BELTED
