ULTRASONIC DETECTION OF
OVERBUFFING IN RETREADED TIRES

S. N. Bobo
A. J. Scapicchio

AUGUST 1977
INTERIM REPORT

1. Report No. HS-802-539		2. Government Accession No.		3. Recipient's Catalog No.	
4. Title and Subtitle ULTRASONIC DETECTION OF OVERBUFFING IN RETREADED TIRES				5. Report Date August 1977

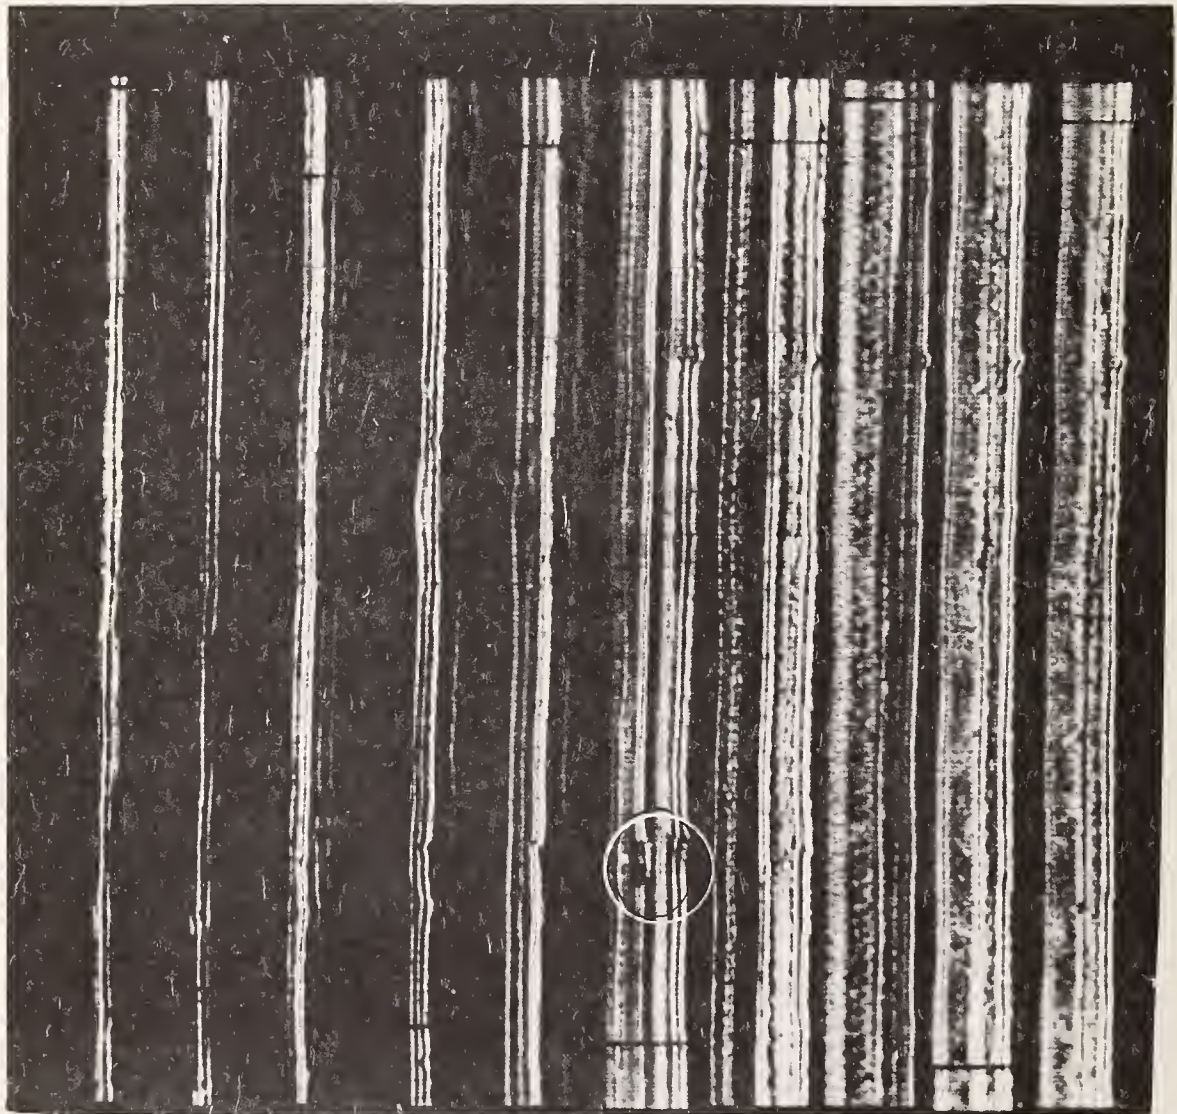
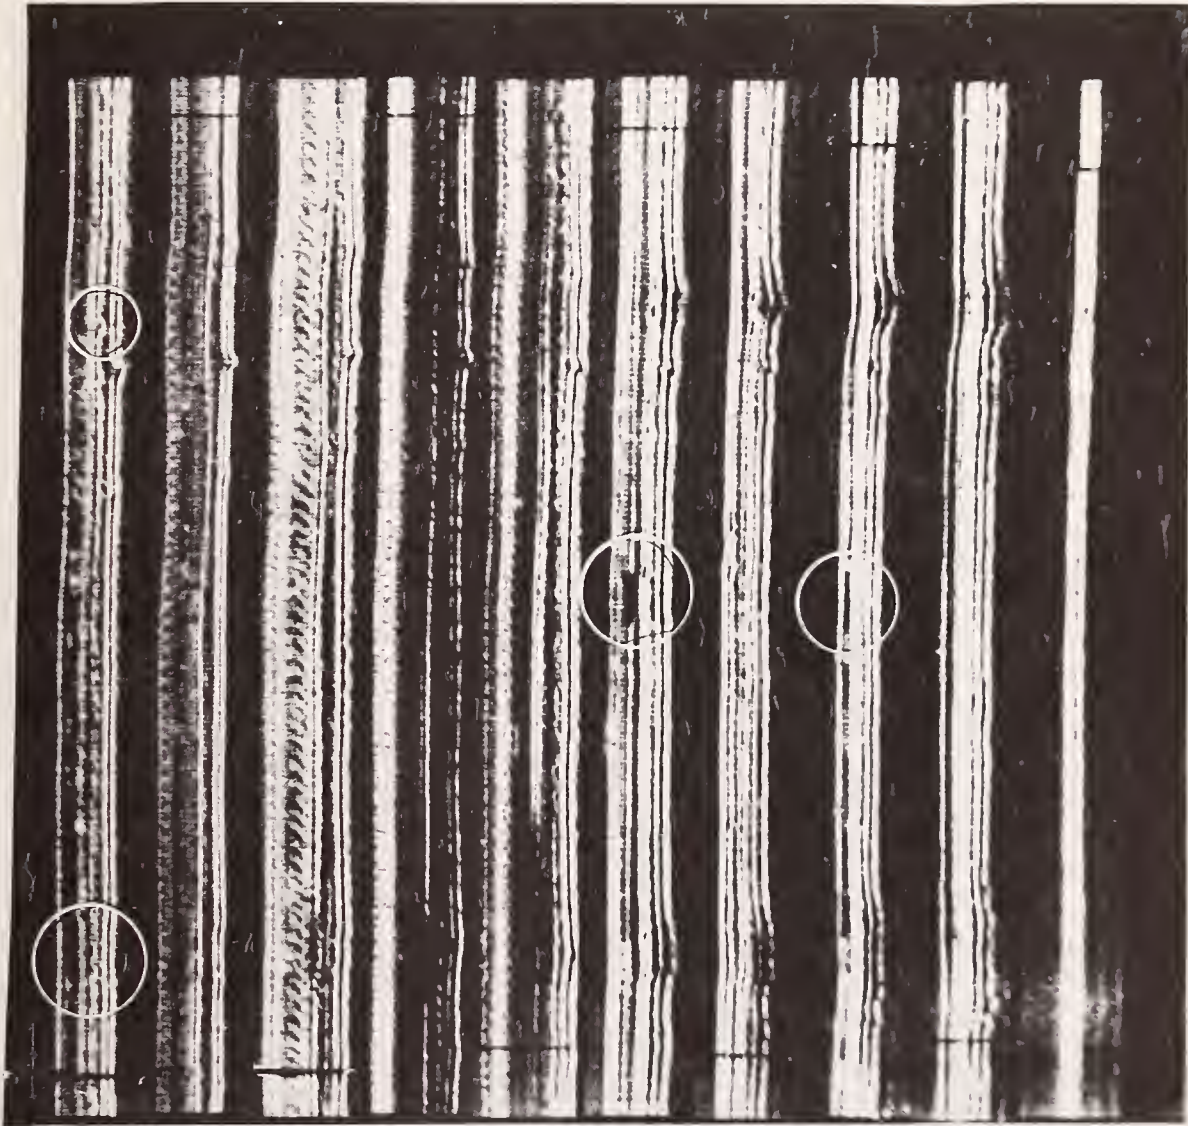
FIGURE 13. HARDCOPY DISPLAY OF TIRE NO. 4, BIAS BELTED

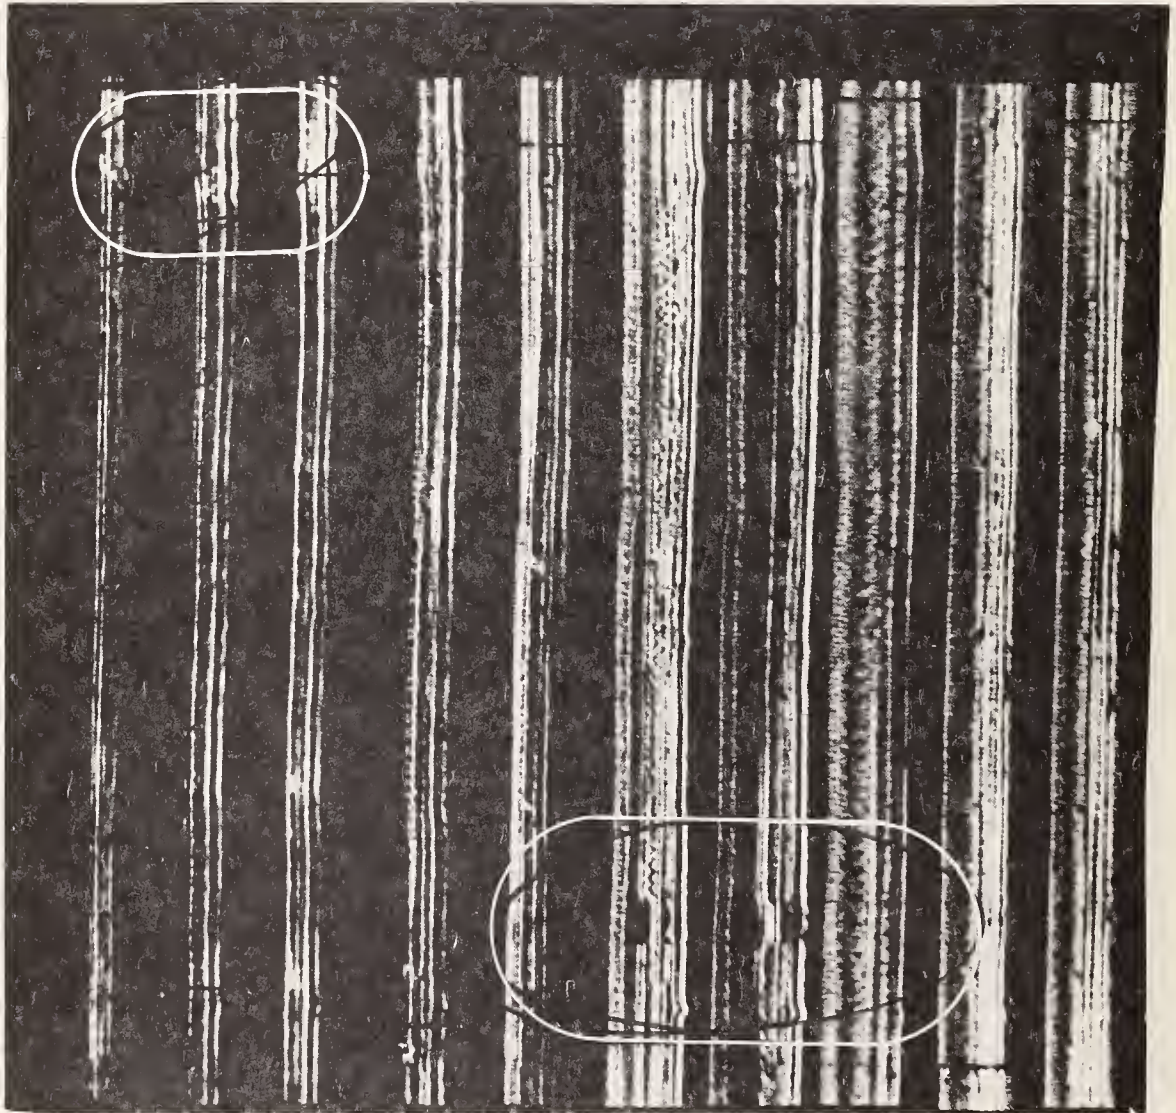
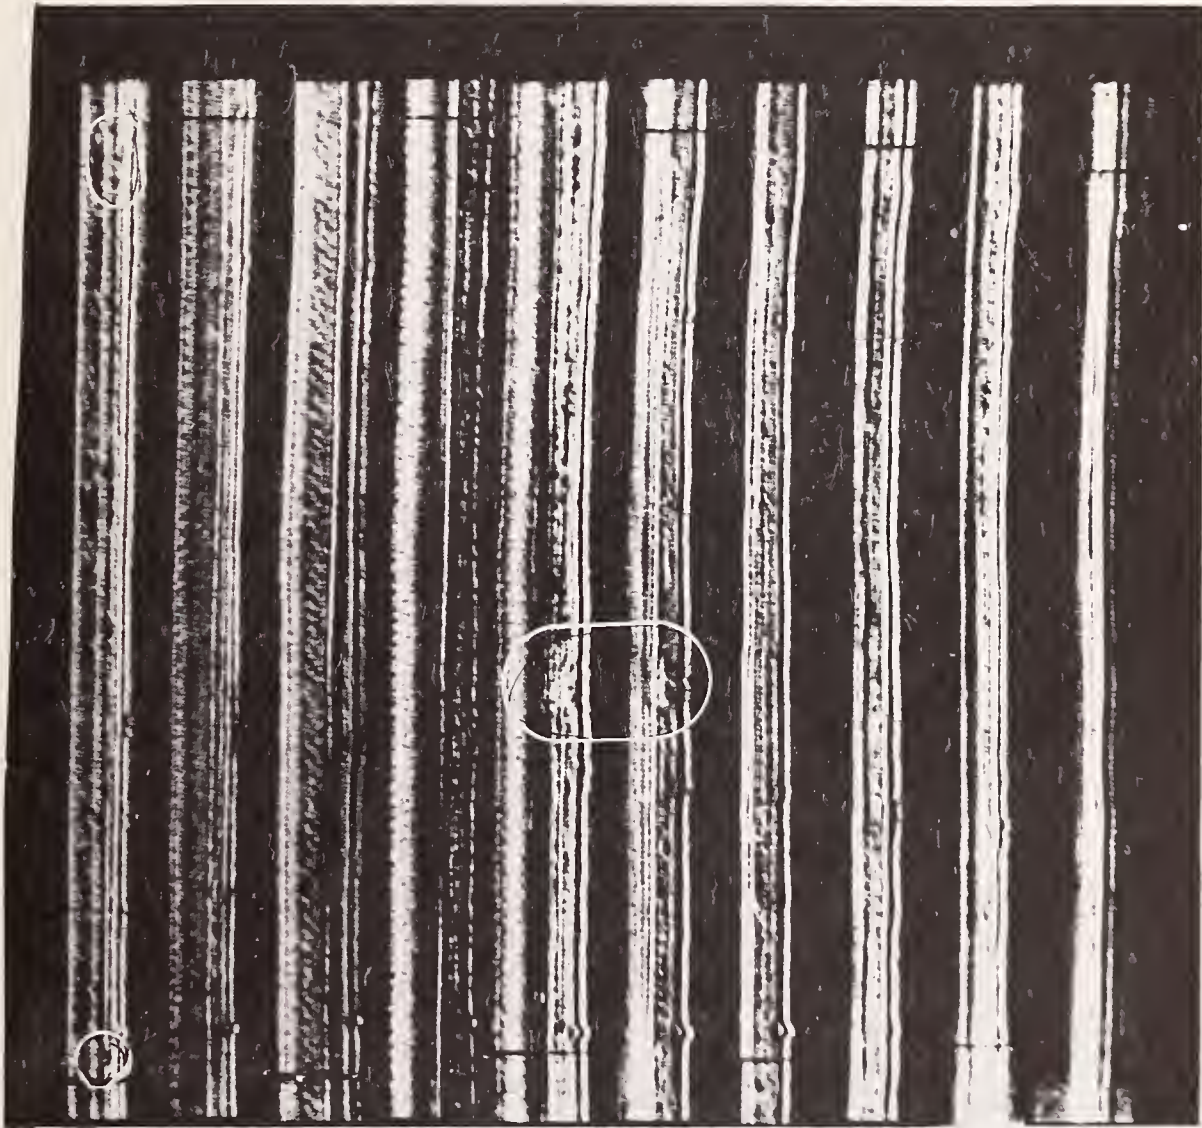
FIGURE 14. HARDCOPY DISPLAY OF TIRE NO. 5, 4-PLY POLYESTER

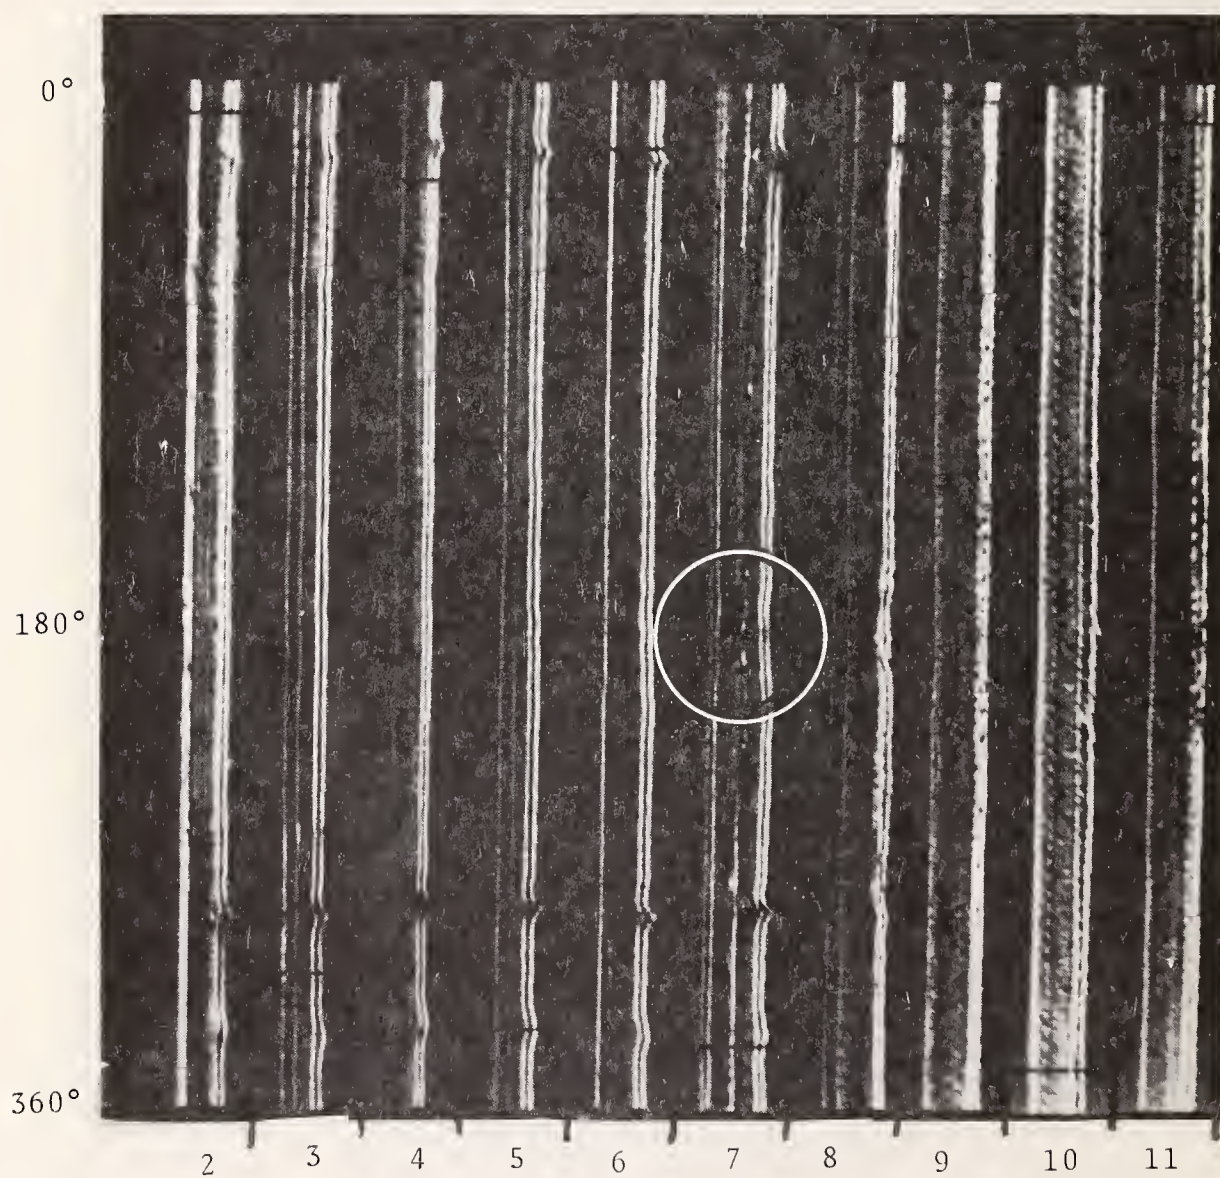
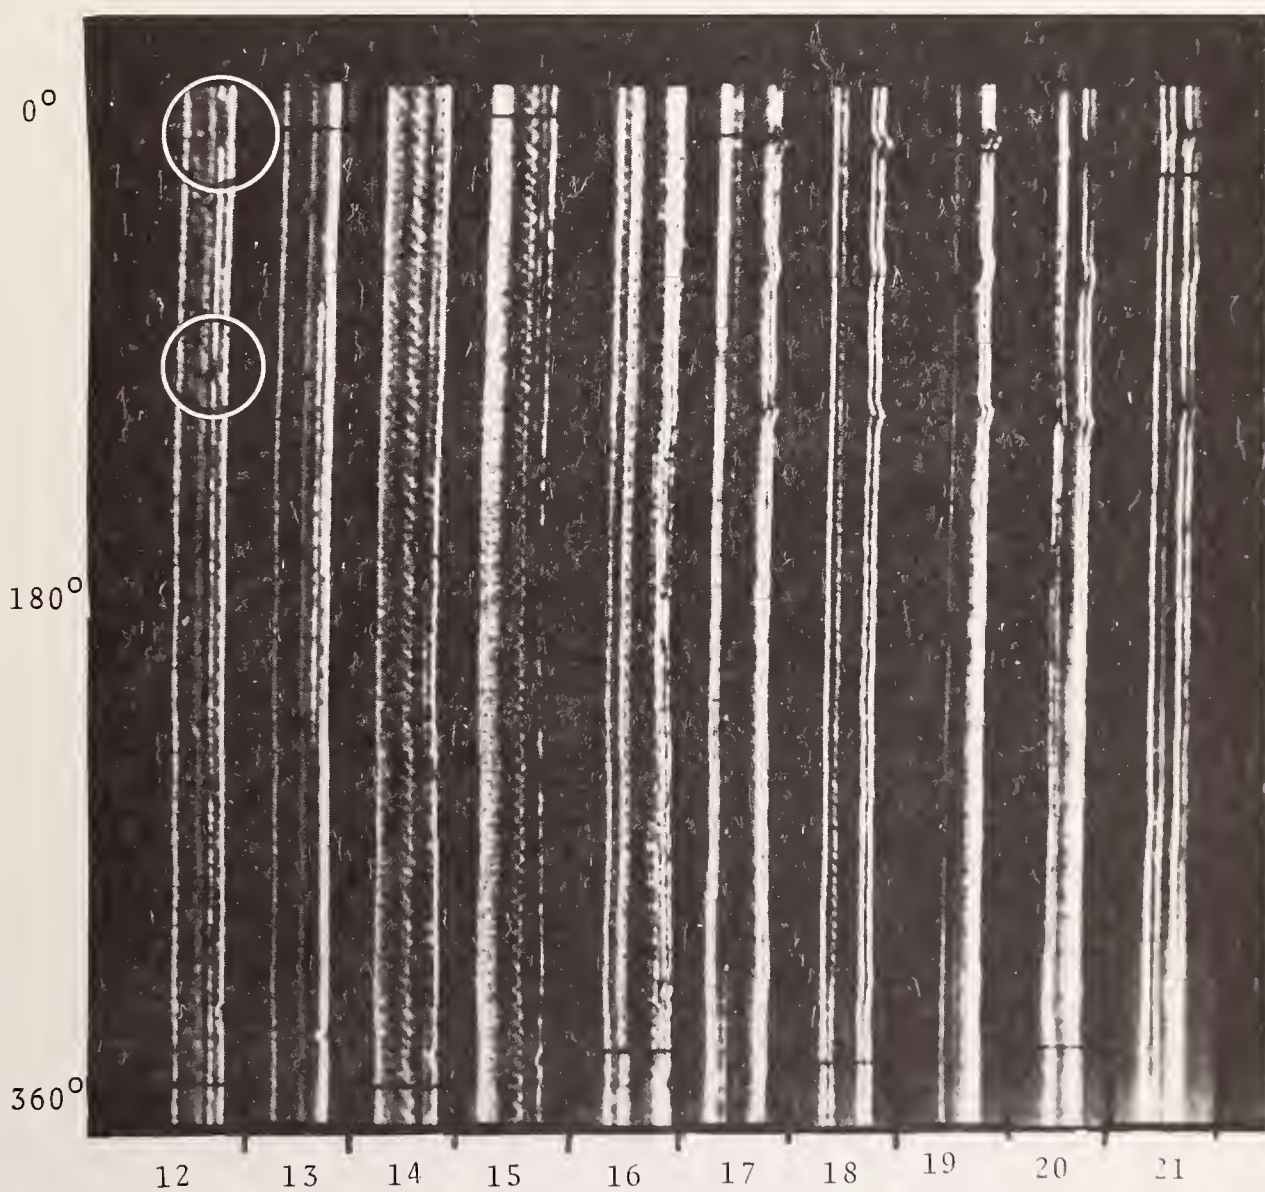
FIGURE 15. HARDCOPY DISPLAY OF TIRE NO. 6 , 4-PLY POLYESTER
