# Ballistic damage of graphite-epoxy plates

BALLISTIC DAMAGE OF GRAPHITE-EPOXY PLATES

MASTER OF SCIENCE IN AERONAUTICAL ENGINEERING

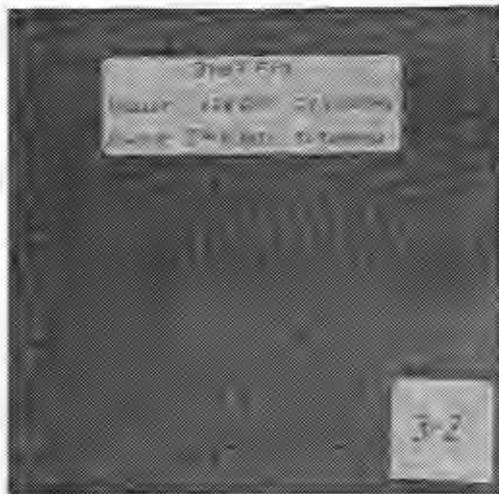
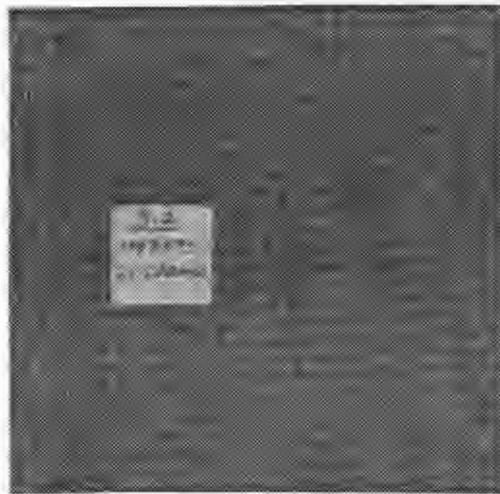
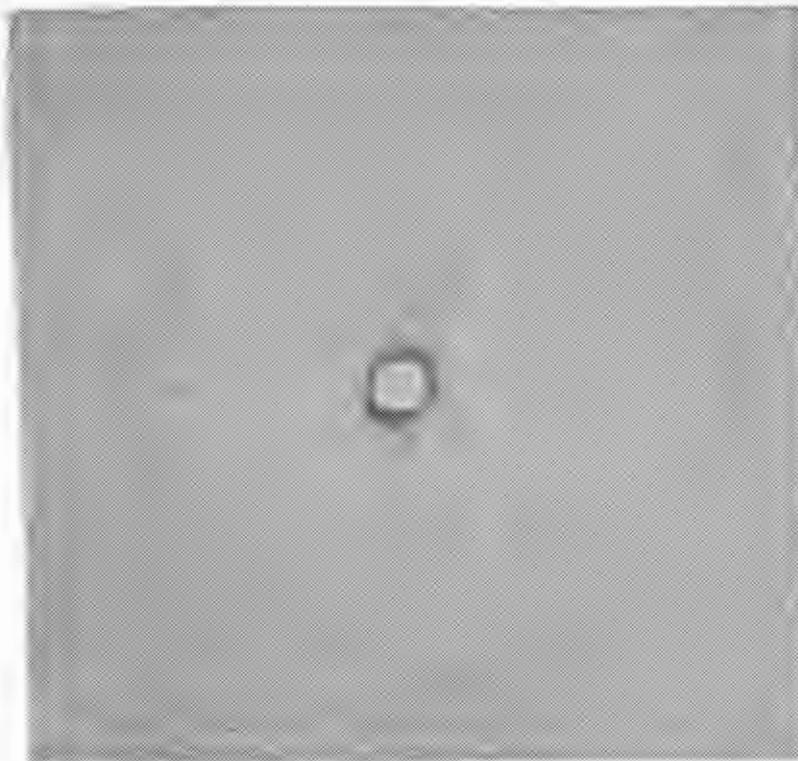
Figure 12 - COMPARISON OF X-RAY AND PHOTOGRAPH OF SPECIMEN DAMAGED AT 3407 FPS

The effect of mass variation did not appear to be a major factor in damage area or extent of fiber separation due to ballistic impact. The damage done to the specimens was nearly uniform for the three masses investigated. Figures 12, 13, and 14 depict the variable-mass specimens and the damage experienced.

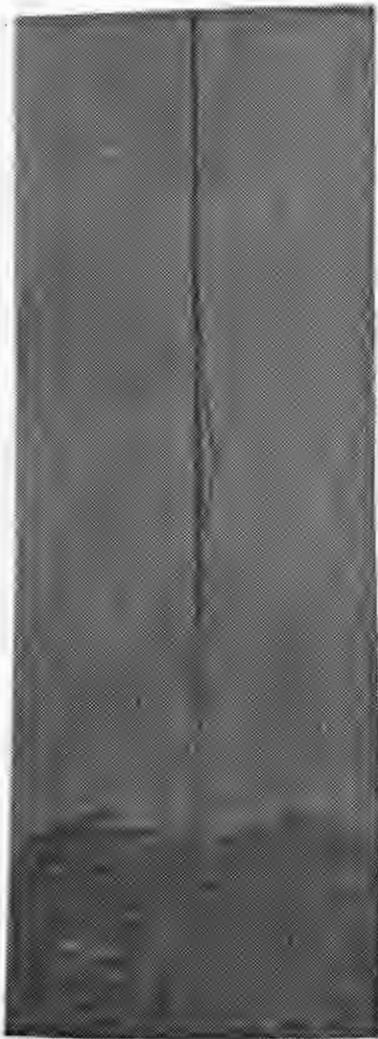
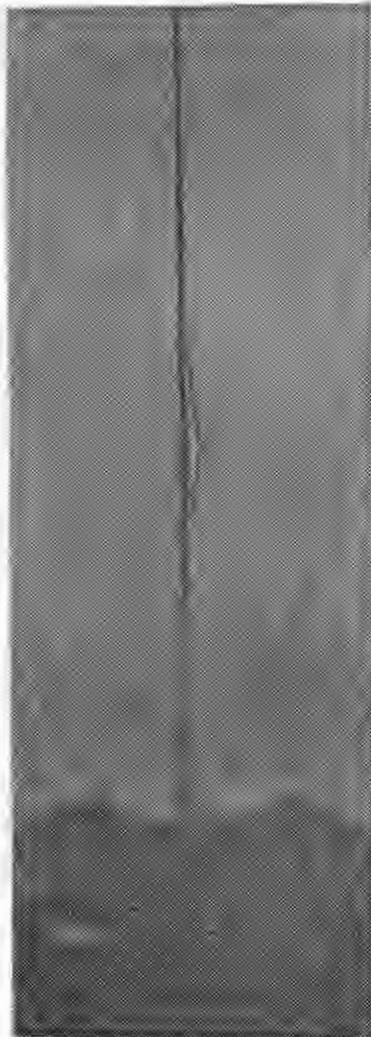
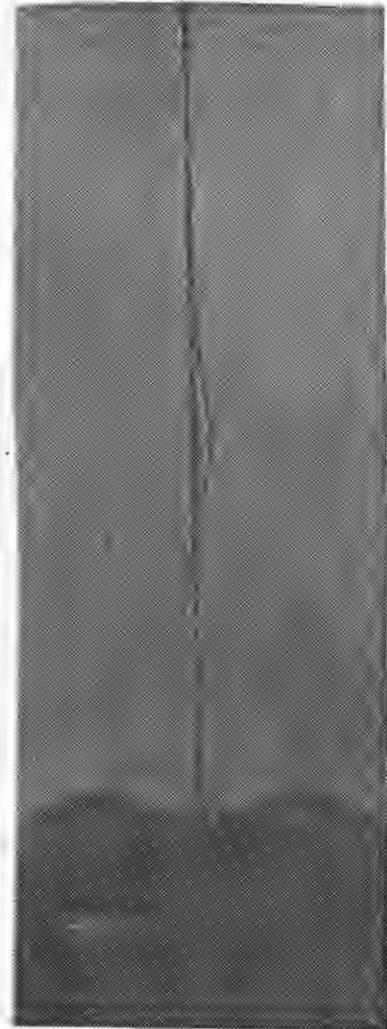
Figure 20 - TENSILE TEST LOADING-TO-FAILURE SEQUENCE

The maximum loading at failure was recorded. Figures 20, 21, and 22 illustrate the sequence of events leading to and including failure of a specimen. The outer laminae of the composite specimens ( $0^\circ$  direction) were the only laminae that experienced this separation and protruding. The second ply ( $45^\circ$  direction) appeared to remain intact until final failure. The three mechanically drilled control specimens also experienced this separating and protruding above and below the hole, even though they did not have any prior delamination caused by ballistic damage. As loading was applied to these specimens they reacted the same way as the ballistically damaged specimens behaved up to and including failure. The undamaged control specimens showed no sign of physical change while being loaded until they broke.

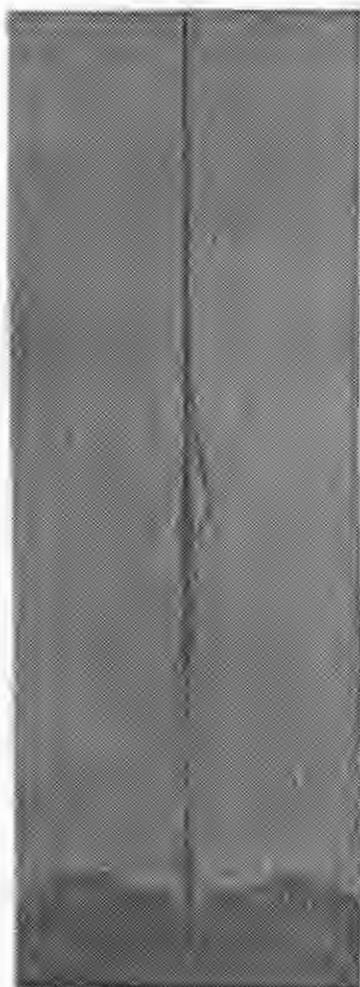
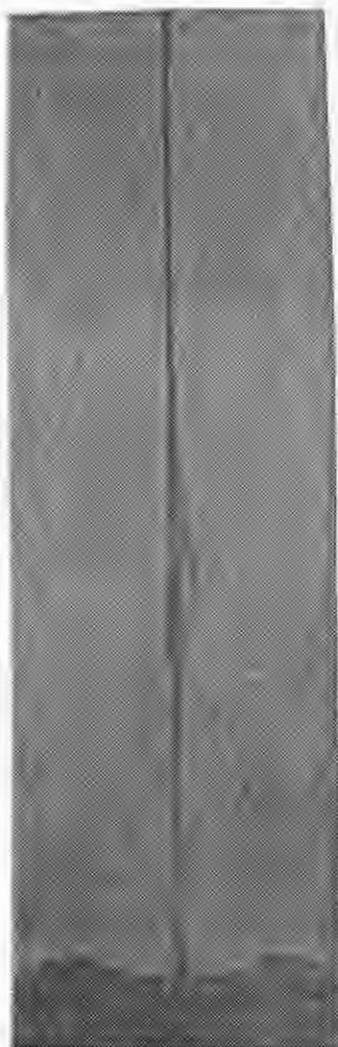
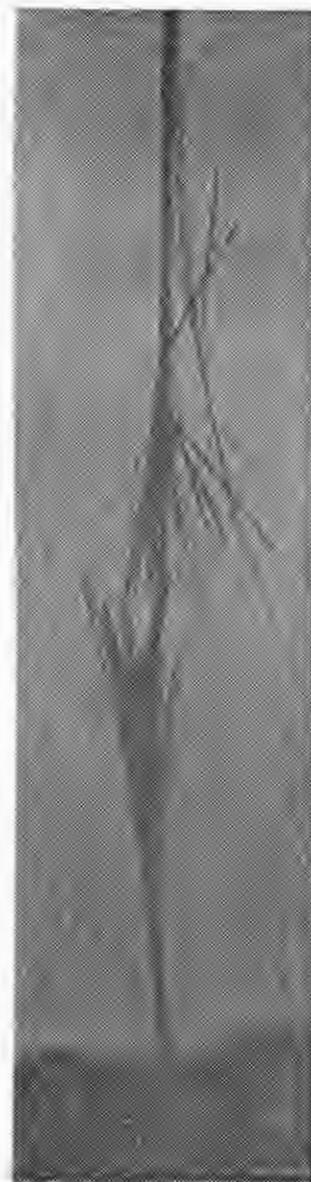
Figure 22 - TENSILE TEST LOADING-TO-FAILURE SEQUENCE

In the specimens tested that contained holes, which included damaged and drilled holes, the fracture line was at the hole or within the influence area of the hole. By passing a  $+45^\circ$  line and a  $-45^\circ$  line through the center of the hole and noting where these lines intersected the edge of the specimens, the influence area of the hole could be described. All the lines of failure passed within this 1.5 inch-by-1.5 inch area.

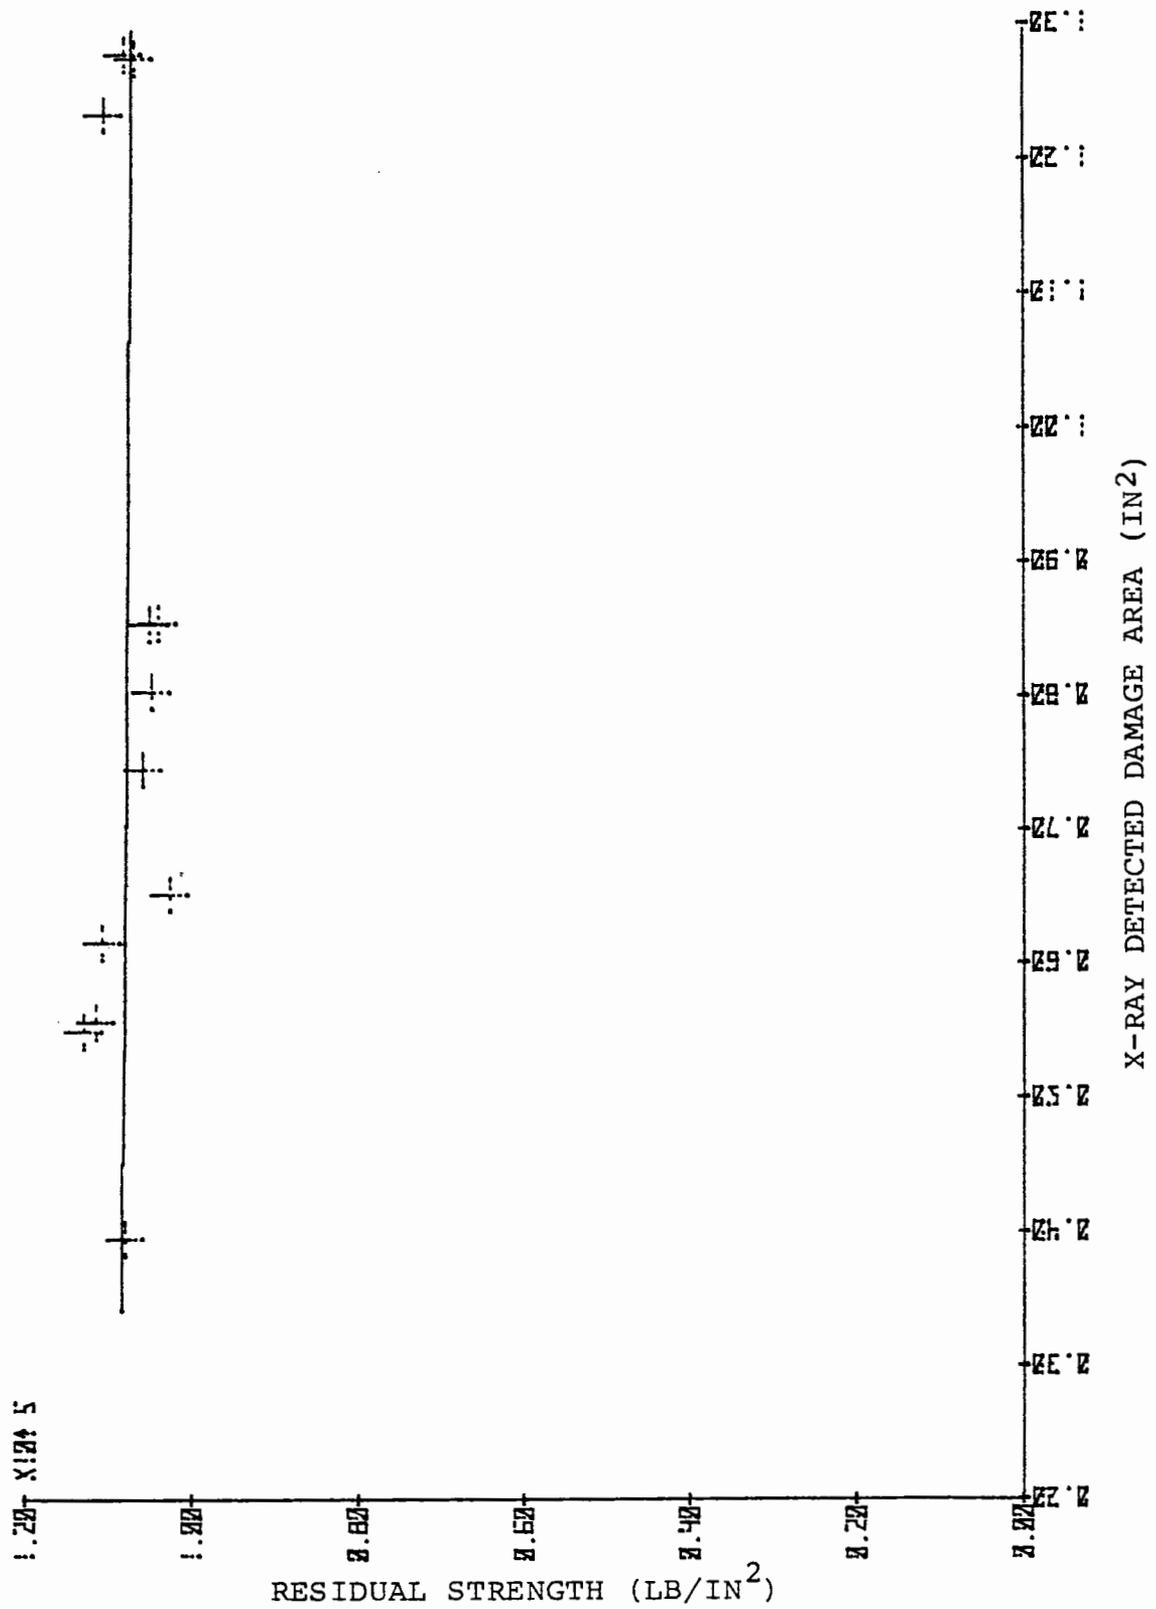
Figure 26 - X-RAY DETECTED DAMAGE AREA VS. RESIDUAL STRENGTH

Figure 26 shows the variation of residual strength with x-ray detected damage area. Again the ultimate average stress is essentially constant, but in this case the residual strength is greater than that of the undamaged control specimens. Obviously, this finding cannot be correct: the explanation is that fibers which have been delaminated but not broken around the hole are included in the damaged area shown on the x-ray picture. These fibers actually do carry load,

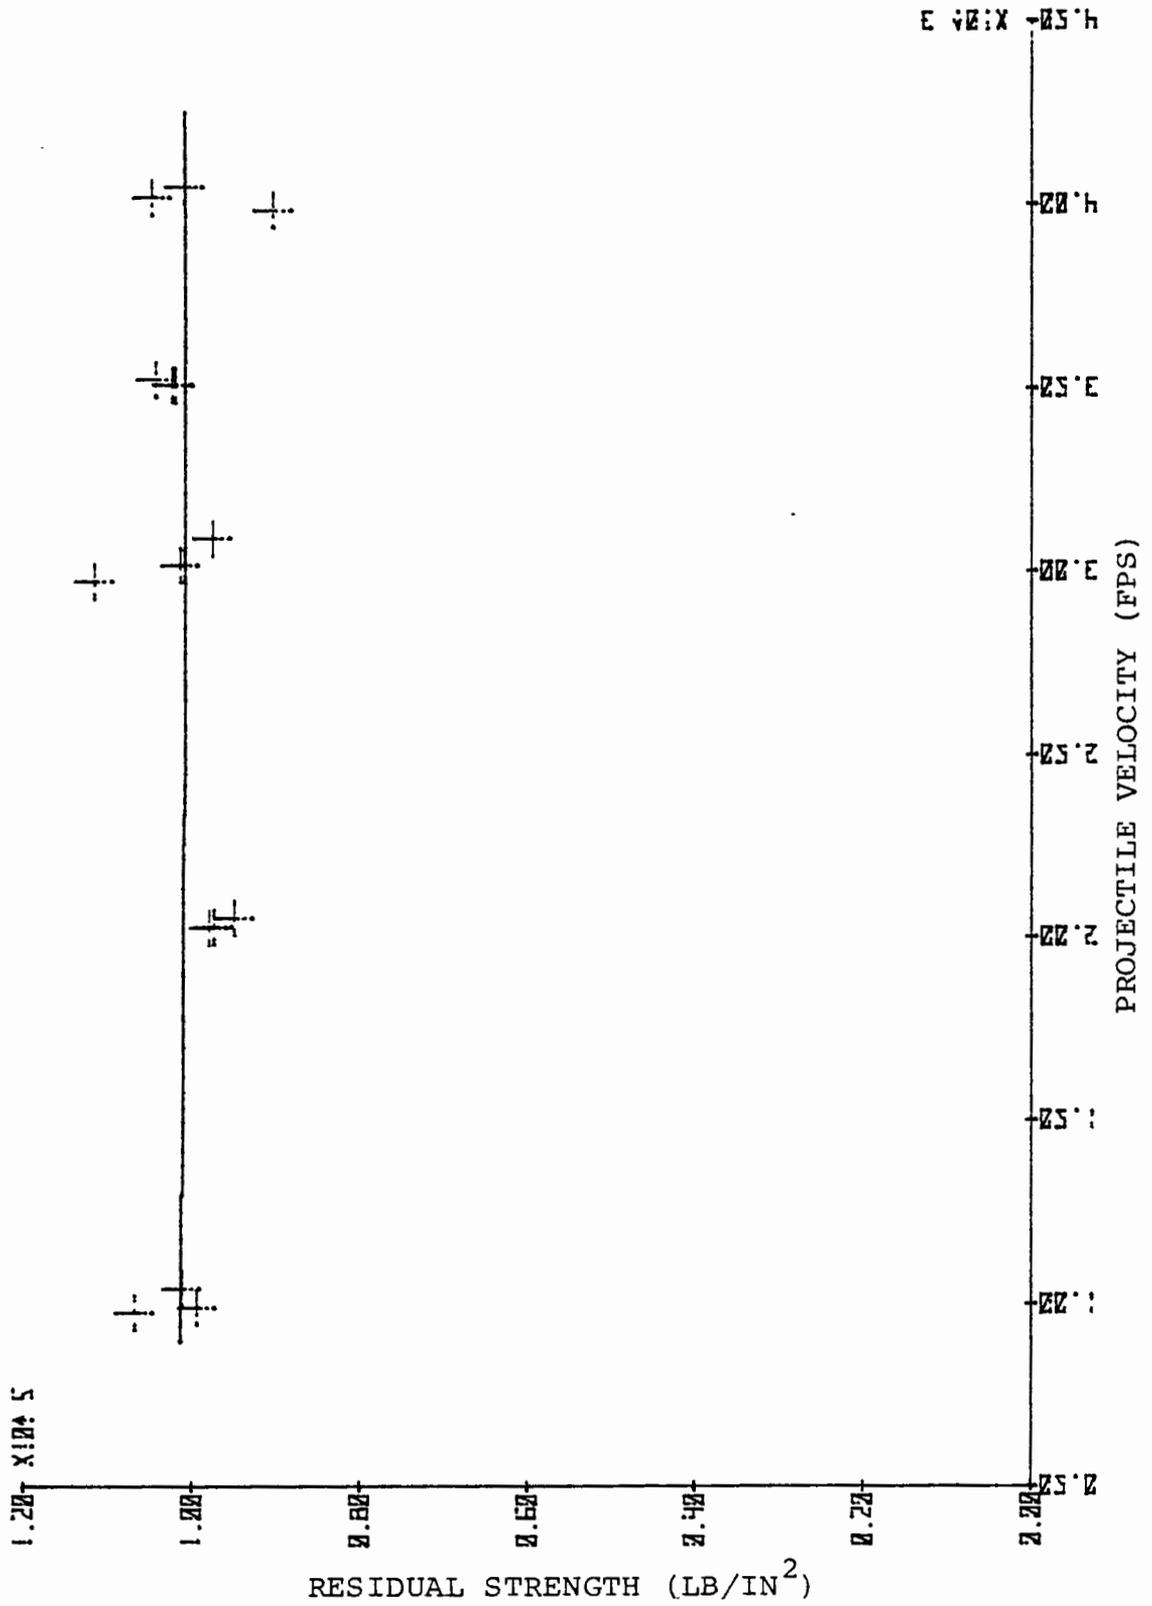
Figure 27 - RESIDUAL STRENGTH VS. PROJECTILE VELOCITY

Figure 27 plots residual strength vs. projectile velocity and shows that the residual strength is essentially independent of the velocity of the impacting projectile. Figure 28 shows the variation in visible damage width as a function of projectile velocity, while Figure 29 shows the variation in visible damage length as a function of projectile velocity. Consideration of these figures leads to the conclusion that for the specimens tested and the loading scheme (i.e., uniaxial tension) used in this test series, damage length has little or no effect on residual strength. Since projectile diameter was not varied, and velocity changes had little effect on damage width, the effect of damage width on residual strength was not determined. Changes in projectile velocity did cause changes in damage length, but as can be inferred from Figure 27, these changes in damage length did not result in changes in residual strength.
