## ACCIDENT INVESTIGATION REPORT

EASTERN AIR LINES - FLORENCE, SOUTH CAROLINA - SEPTEMBER 7, 1945The Accident

EASTERN AIRLINES DC3, NC33631

ACCIDENT, FLORENCE, S.C., SEPT. 7, 1945

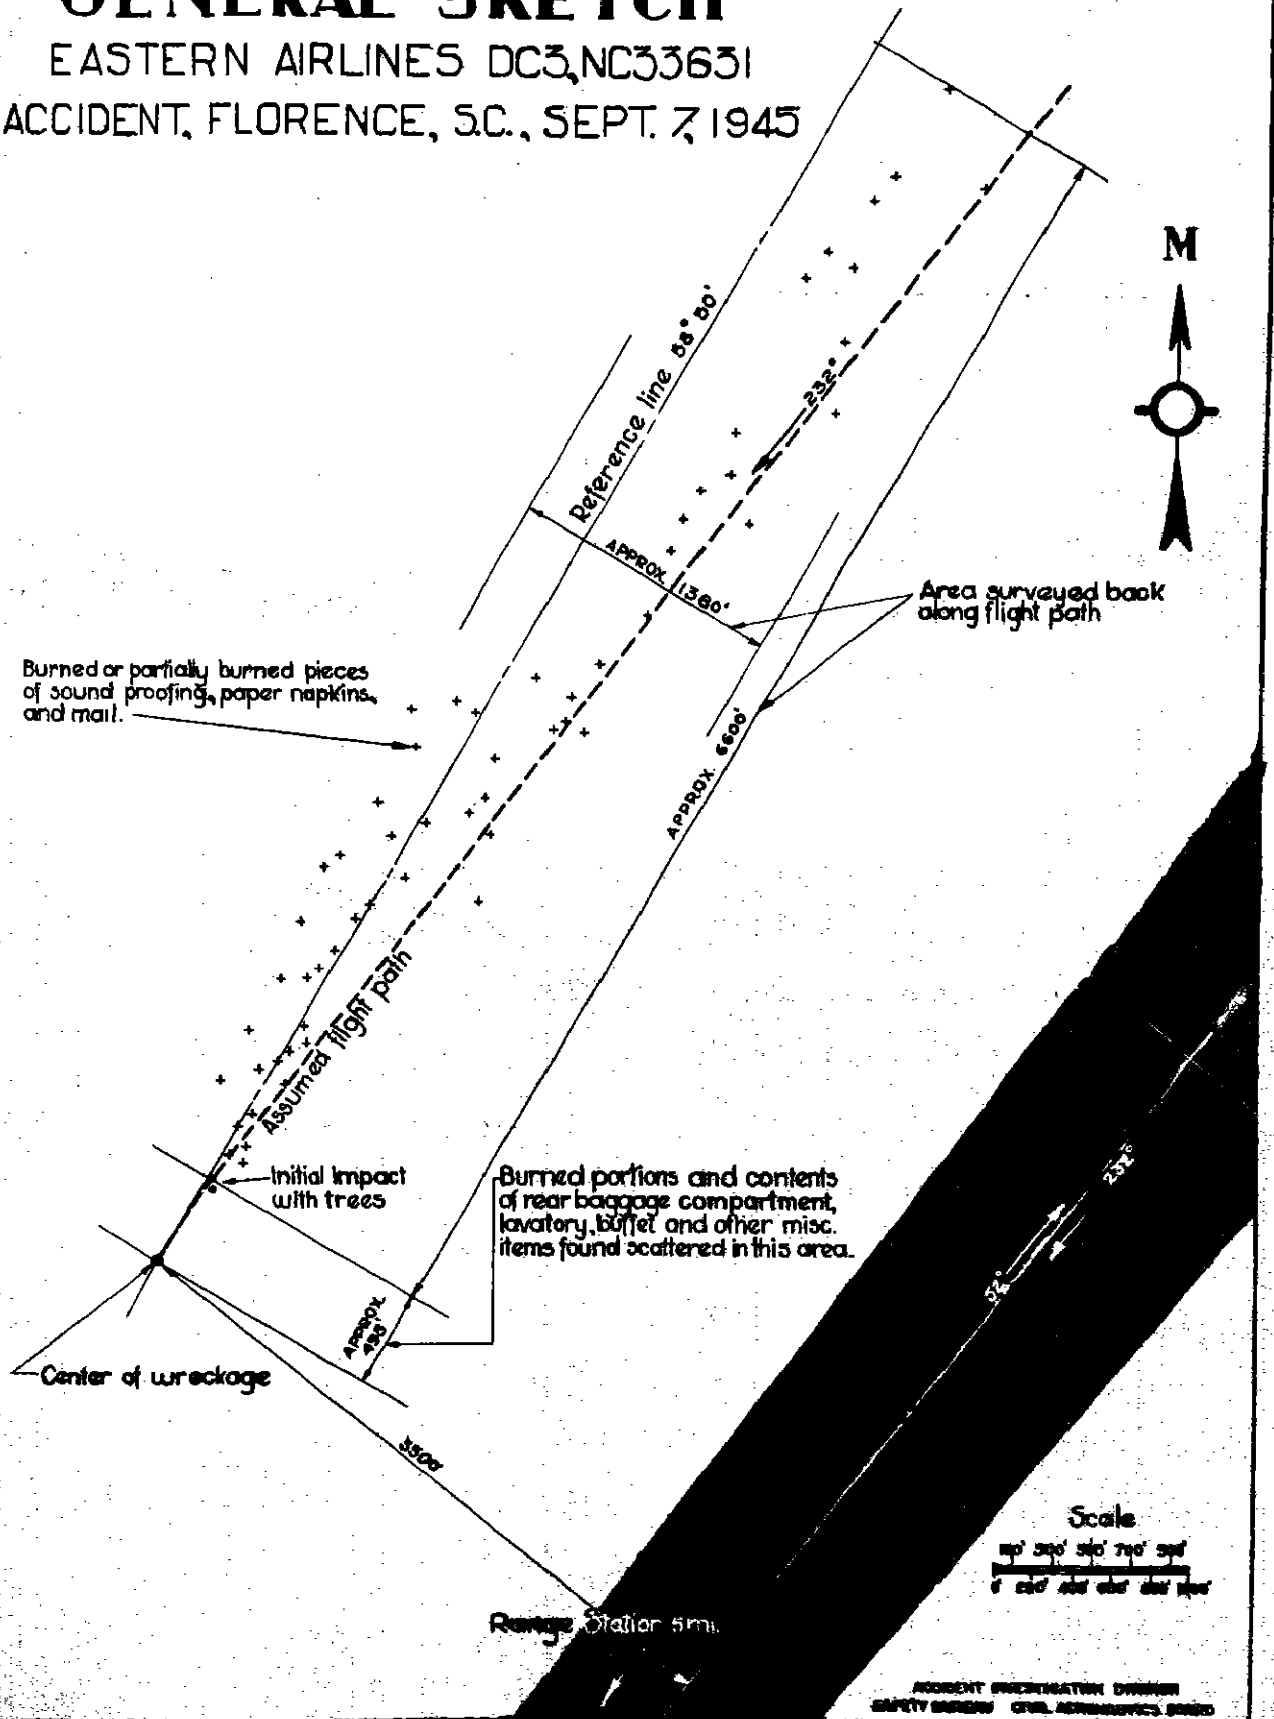
# GENERAL SKETCH

Examination of objects which fell from the aircraft between the points of first and final contacts (495 feet apart) indicated that most of them were from the general region of the lavatory, buffet and rear baggage compartment. All of the objects from this part of the airplane were either severely burned or showed signs of fire. Along the probable flight path back of the point of initial contact were found numerous pieces of burned soundproofing, partially burned paper napkins, a few partially burned letters and a small piece of material from personal luggage. These items were scattered over an area about 400 feet wide and at least a mile long, and are conclusive evidence that the aircraft was afire prior to the crash. (Attached sketch shows their distribution.)

A detailed study of the wreckage and of the parts which fell from the airplane prior to impact with the ground indicates definitely that the concentration of fire in flight was in the rear of the fuselage. The great number of pieces of burned paper napkins indicates the presence of fire within the buffet compartment. Burned soundproofing and various items from the lavatory compartment which were found almost completely consumed by fire prior to final impact indicate a strong possibility that the lavatory was the location of the initial fire. However the presence of burned mail and the piece of luggage suggests the possibility

of the fire originating within the rear cargo compartment. In general the origin of the fire can be fixed in the area of the right side of the rear baggage compartment, the lavatory and possibly the adjacent portion of the buffet. Apparently flames, sparks and thick smoke were being forced into the tail cone of the fuselage from where they extended into the stabilizers. Fire was so intense in the right stabilizer as to burn through the rear spar web fabric covering and ignite the right elevator in flight.
