The Locomotive

THE HARTFORD STEAM BOILER
INSPECTION AND INSURANCE CO.

INDEX TO VOL. 42—1938-1939

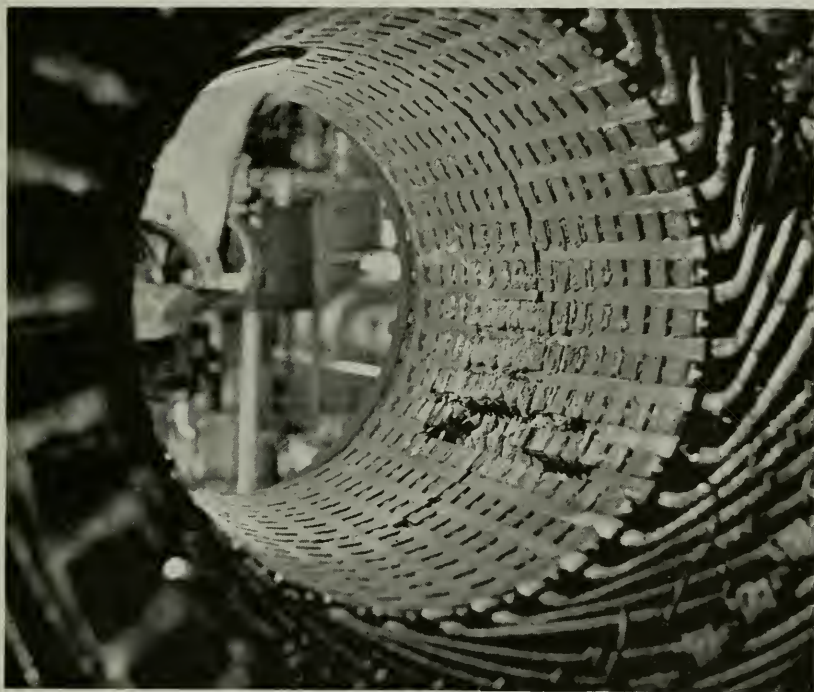
Stator burnout caused by short circuit in a cable.

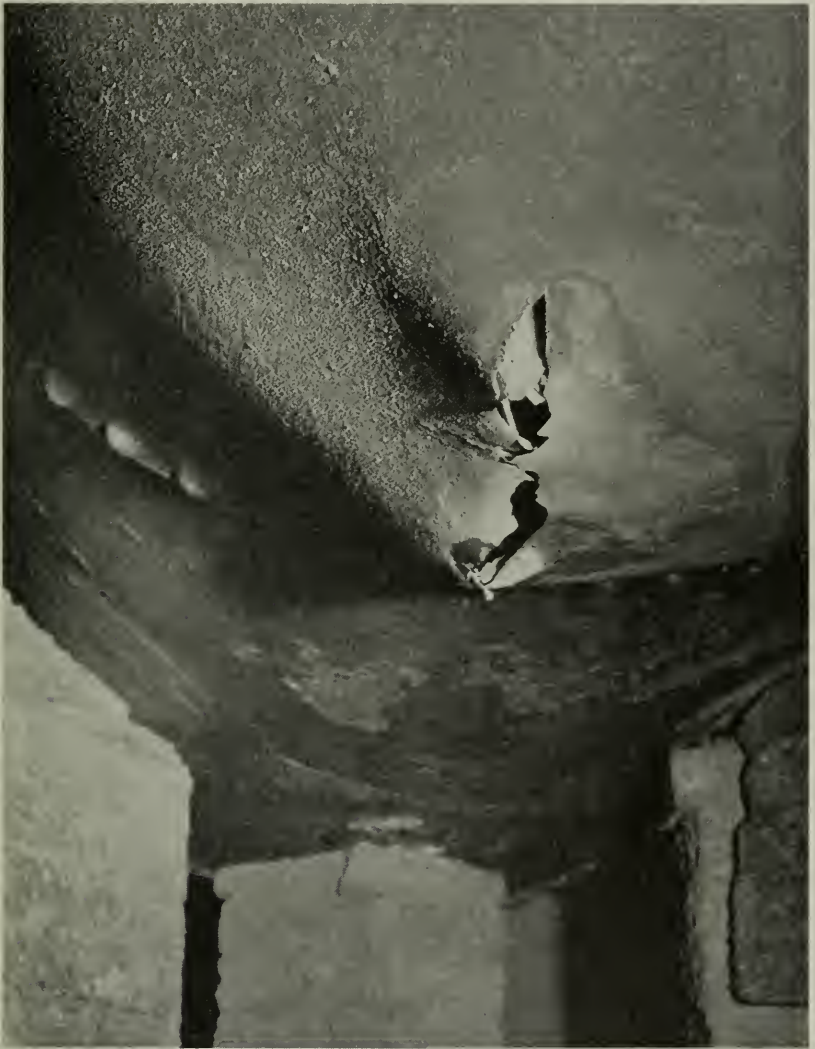
Figure 1. A serious rupture caused by over-heating.

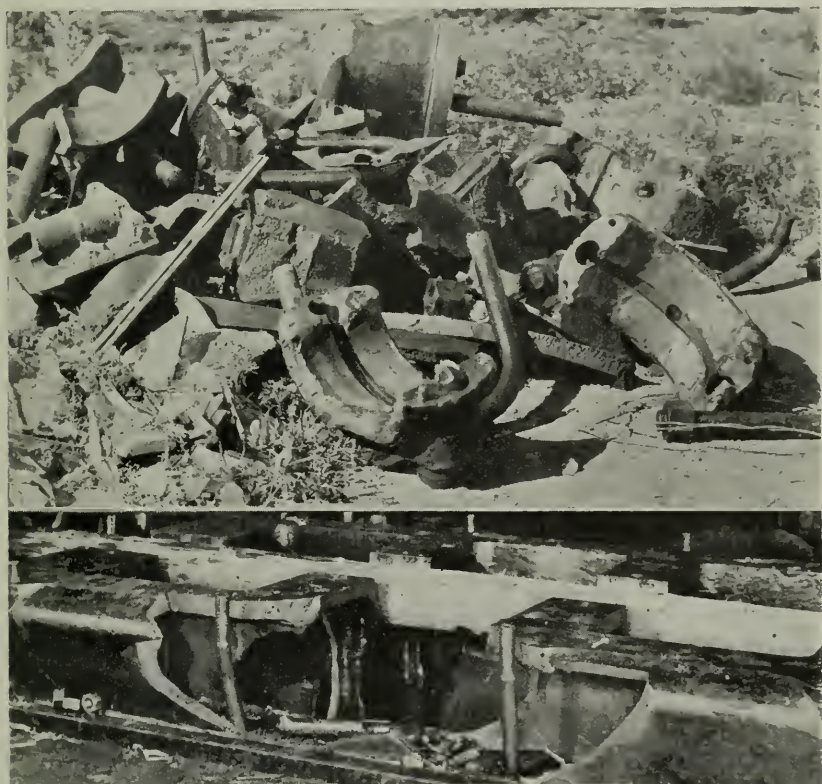
Figure 1—Above—This pile of metal contains parts of a 600 hp Diesel engine which was destroyed in a second or two when it over-speeded. Below—One side of the engine base after the broken engine parts passed through it.

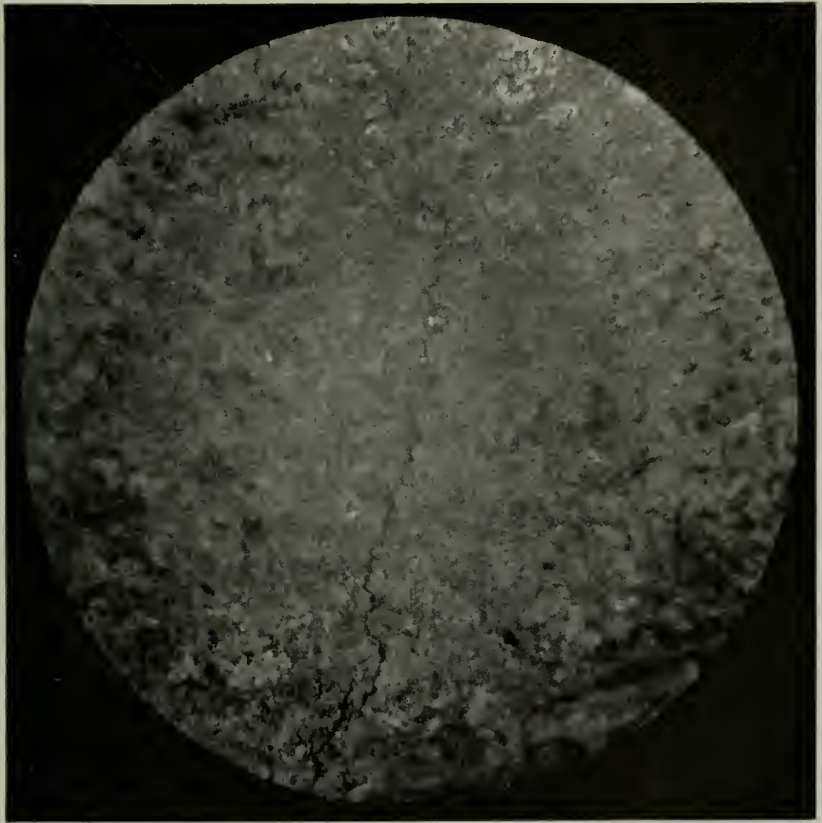
Figure 1—An embrittlement defect at about 100 magnifications. This is what the eye sees when using the regular Hartford Steam Boiler magniscope on a highly polished wall surface of a rivet hole.

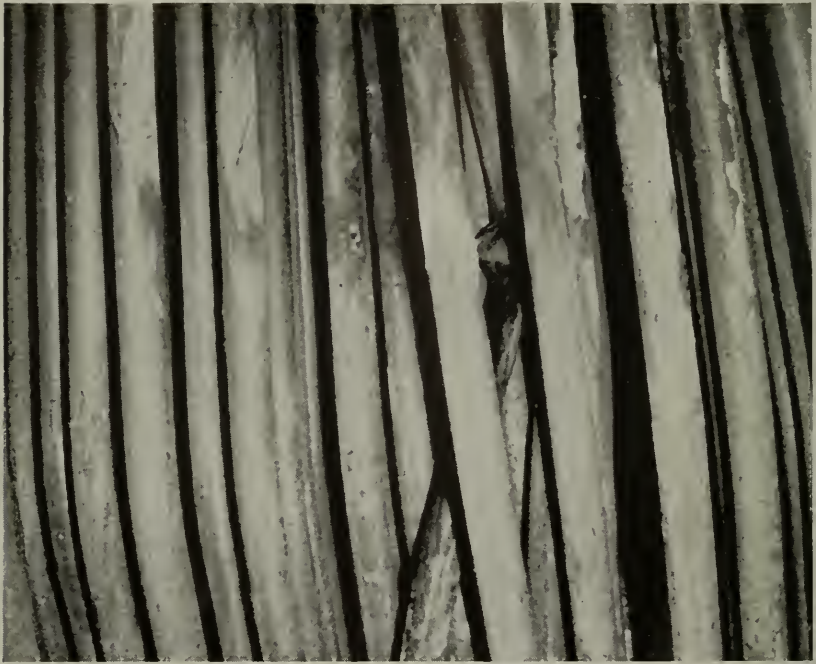
Figure 3—A bank of tubes in which magnetic oxide formed due to excessively high temperatures.

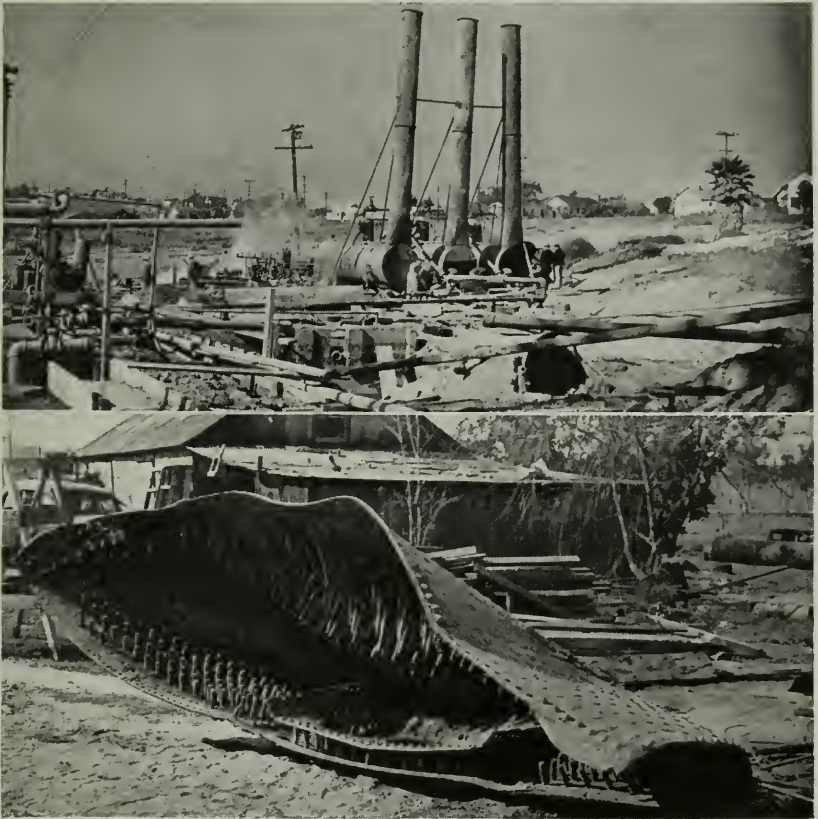
Figure 2—Above—An oil field drilling scene. Below—Outside wrapper sheet of the fourth boiler after it had traveled 900 feet.

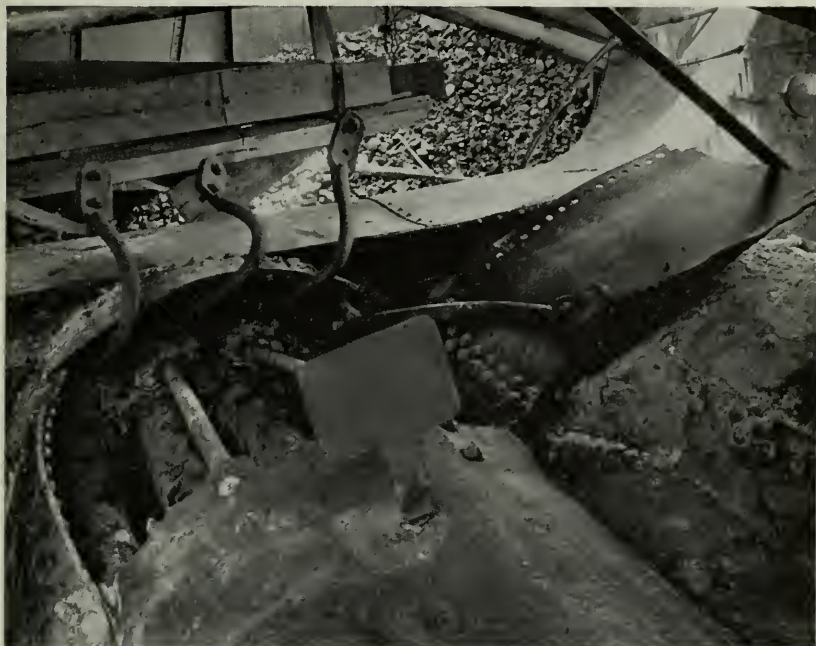
Figure 1—The failure in Boiler No. 2. The break along the rivet holes near the caulking edge of the seam at the left is clearly evident.

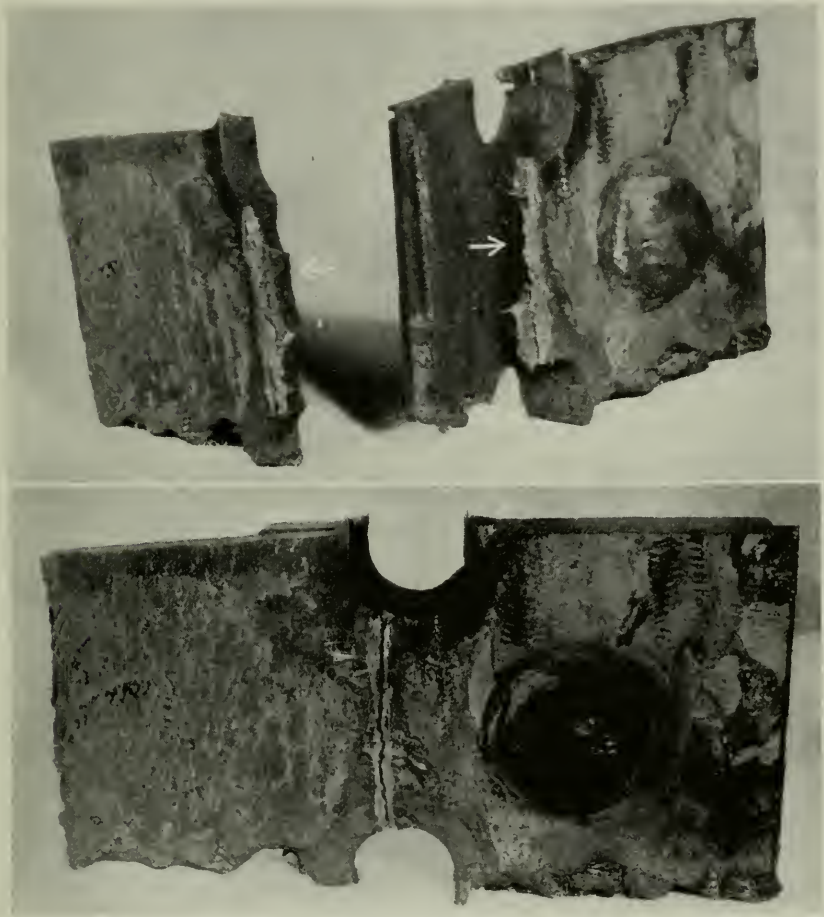
Figure 2—A fully developed embrittlement defect in metal from one of the steamer's boilers. The lower picture shows the rivet hole to rivet hole direction of the disintegration. The top picture is of the same pieces of metal as the lower, the dark areas in the break illustrating the development of the embrittlement (see arrows).

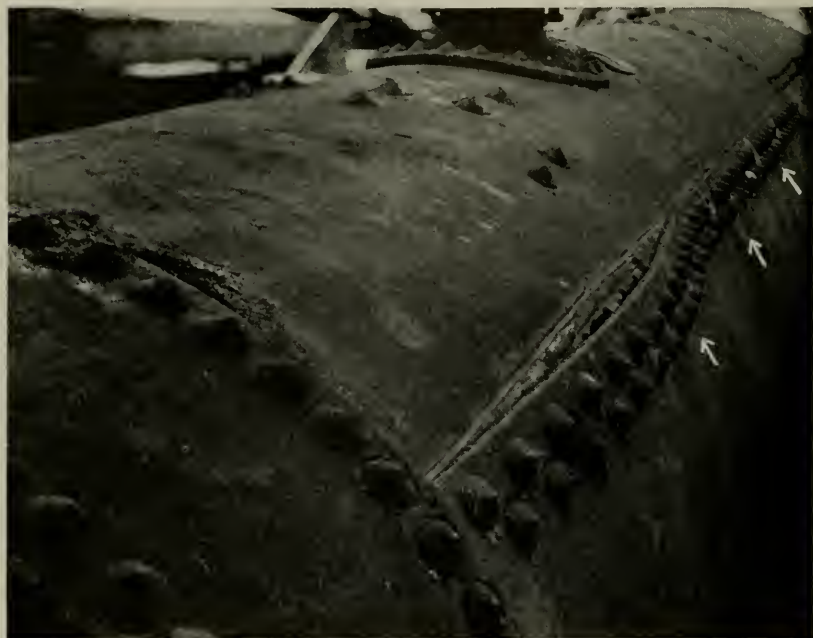
Figure 3—Failure in the longitudinal seam of No. 1 boiler during the hydrostatic test. A few of the paths of embrittlement defects are exposed and clearly show the progress from rivet hole to rivet hole. This boiler has been slotted as a means of detecting a lap seam crack. The slots are indicated by the arrows. See also Figure 4.

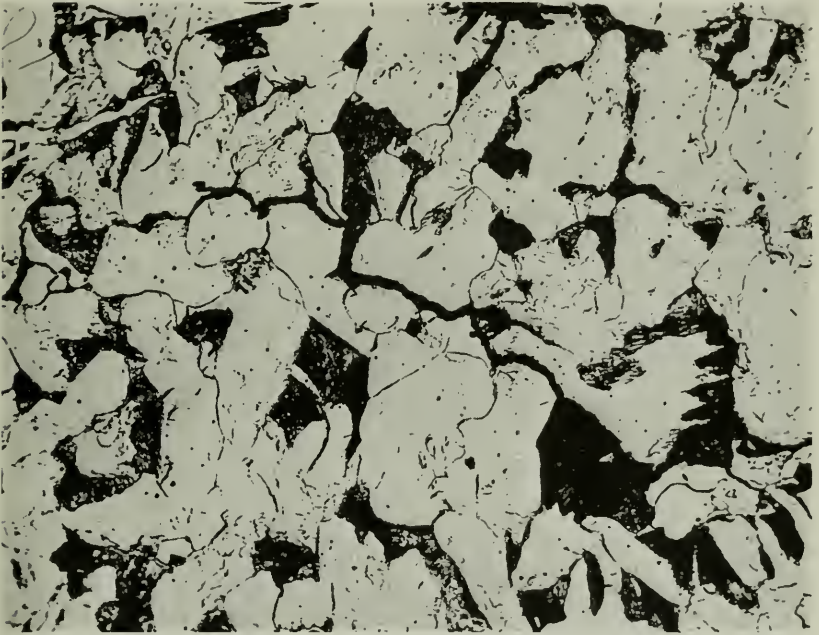
Figure 8—Embrittlement at 500 magnifications in a section of plate from Boiler No. 1.

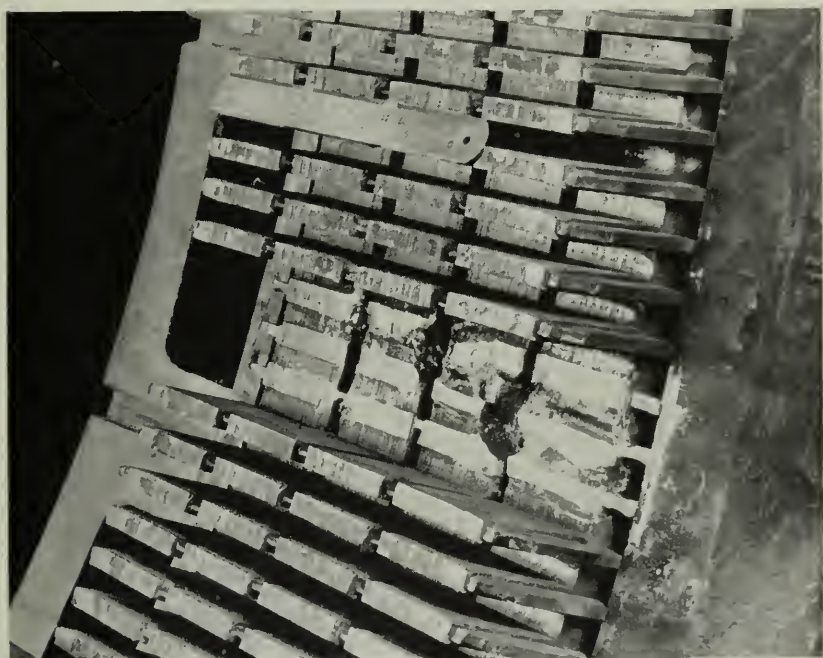
Figure 1—Failure of 450 hp hoist motor showing the iron burns after three laminated teeth had been cut away.

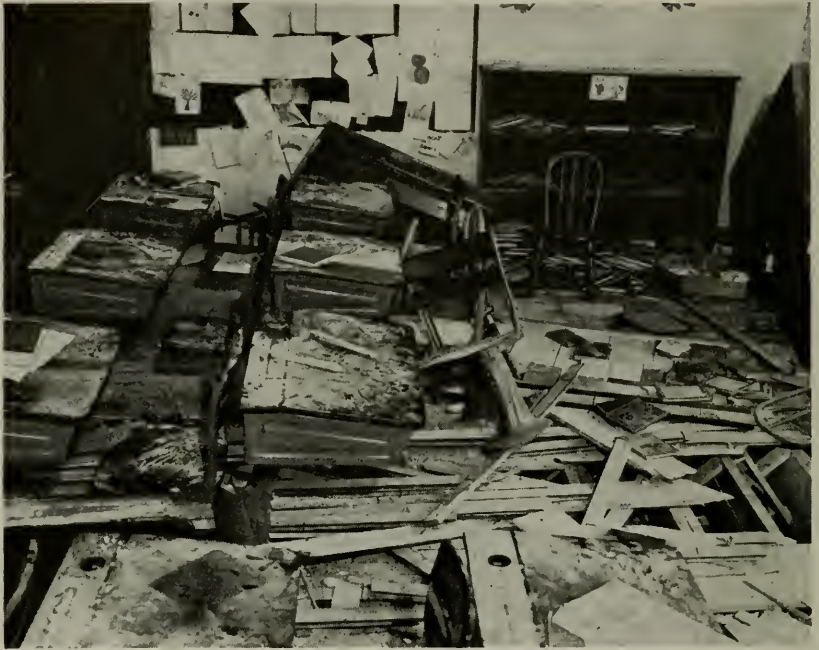
Figure 1—School room after air lift water system tank exploded.

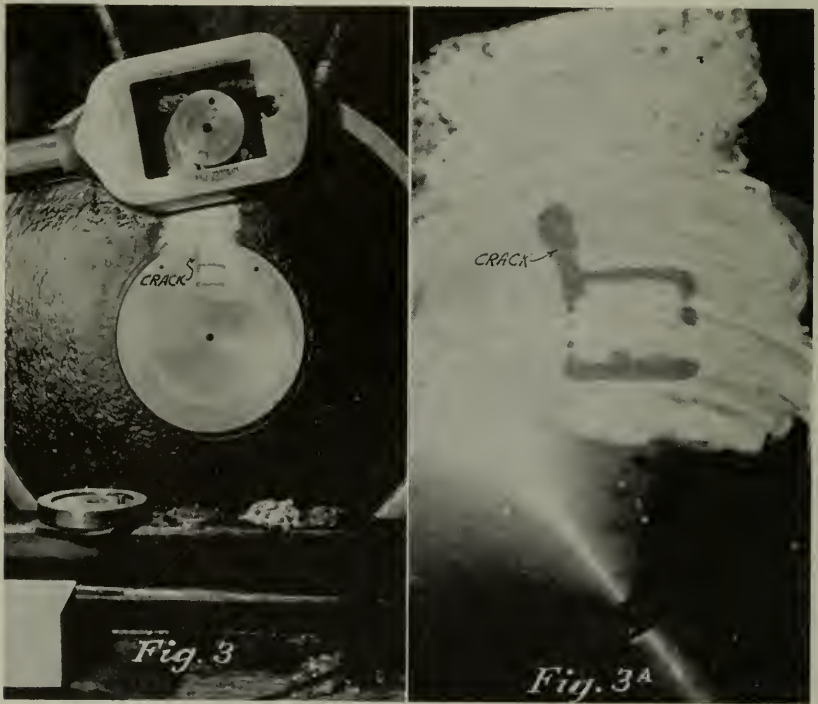
Figures 3 and 3A—A fine crack in the keyway of a steam engine crank. Figure 3A is a magnification of the defect.

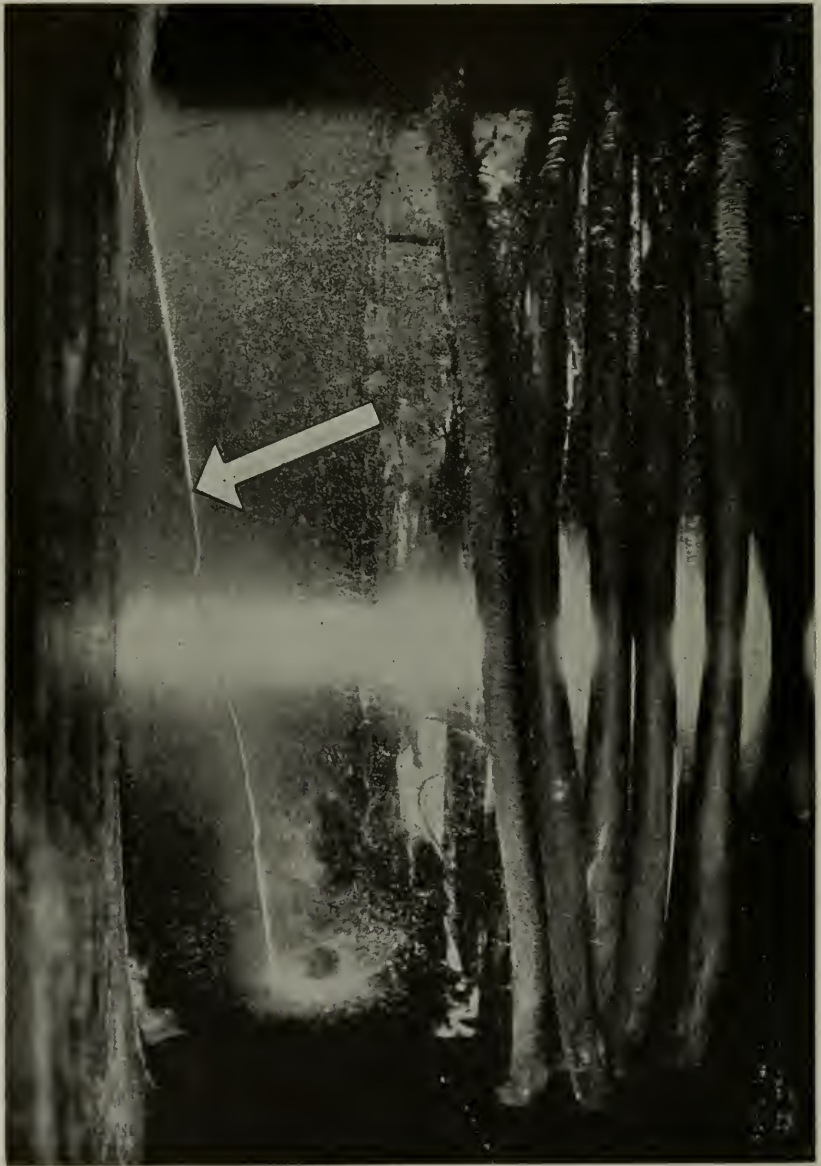
Figure 5—Magnaflux method applied to a shaft to determine the extent of a crack which had been detected by means of the unaided eye. The magnetizing coils are shown at the right.

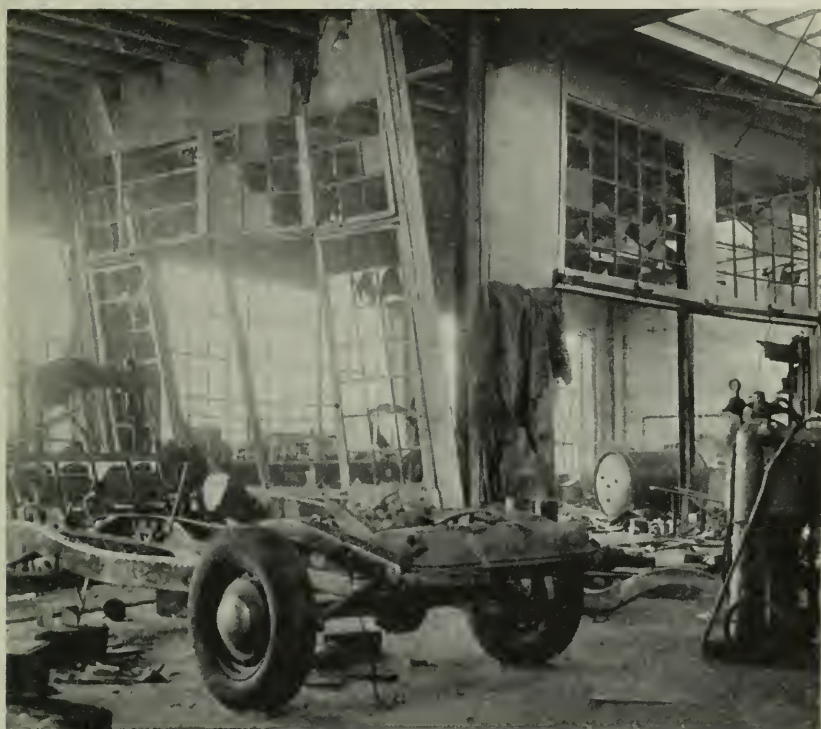
Figure 1—Typical damage as the result of an air tank explosion. This accident occurred in a paint spray room. A workman was injured.

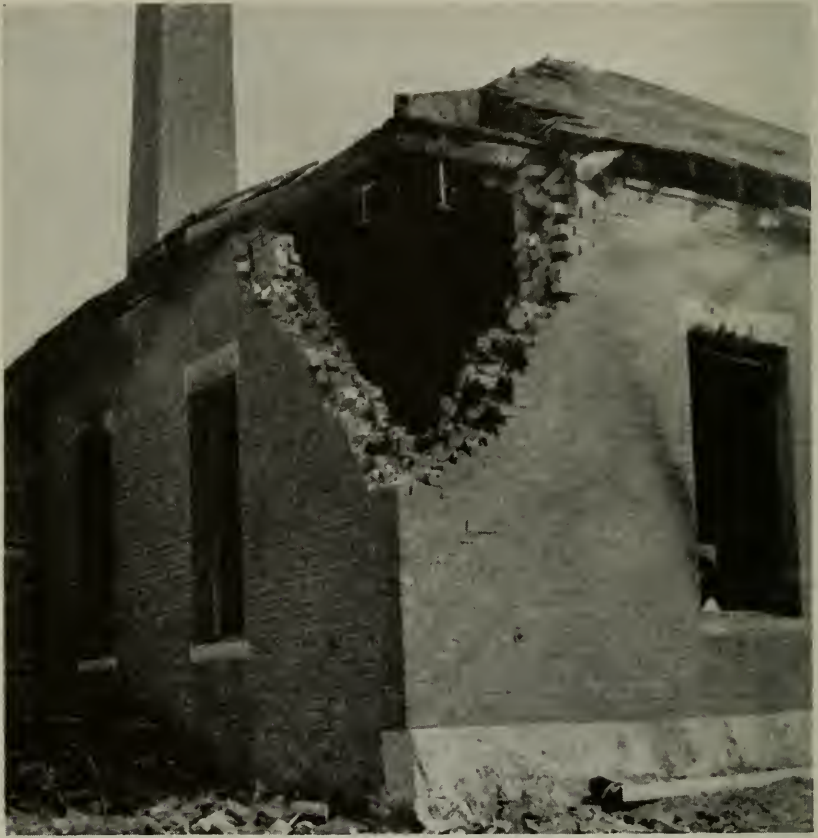
Figure 4—Where an air tank head passed after an explosion. The photograph gives an idea of the force of compressed air suddenly released.

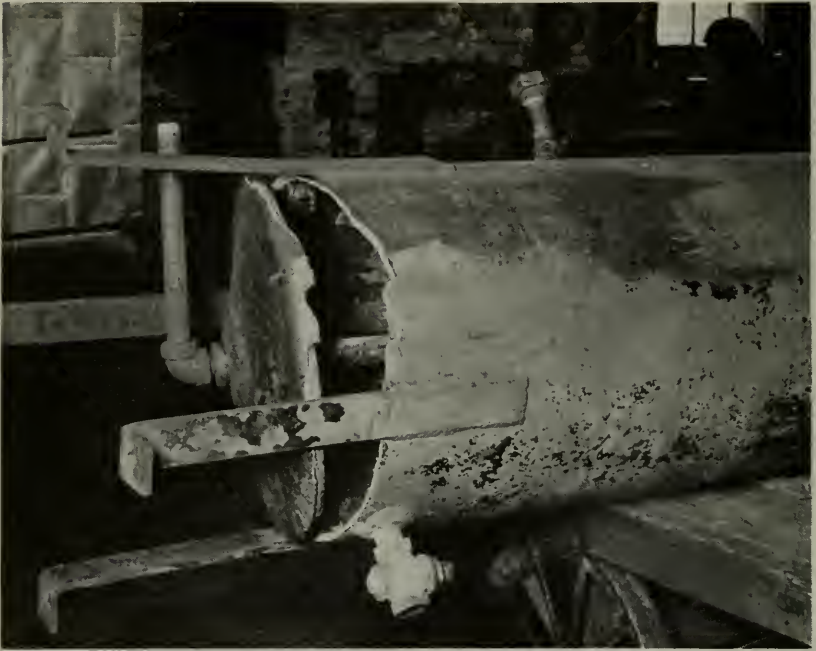
Figure 5—Broken shell of a hydro-pneumatic tank in which the shell had been crimped around the head and welded.

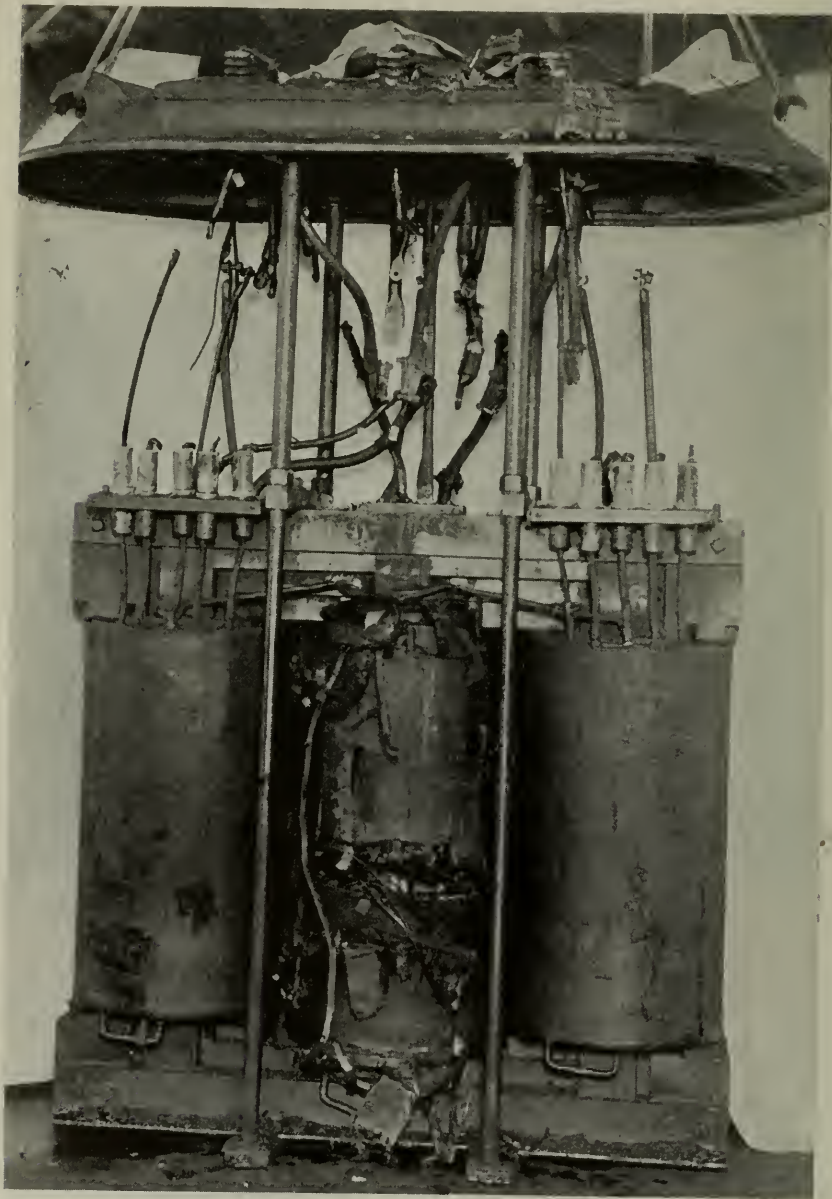
Figure 1—Coils of a 500 kva transformer after a short circuit in the primary windings. The photograph shows the high voltage terminal side of the transformer.

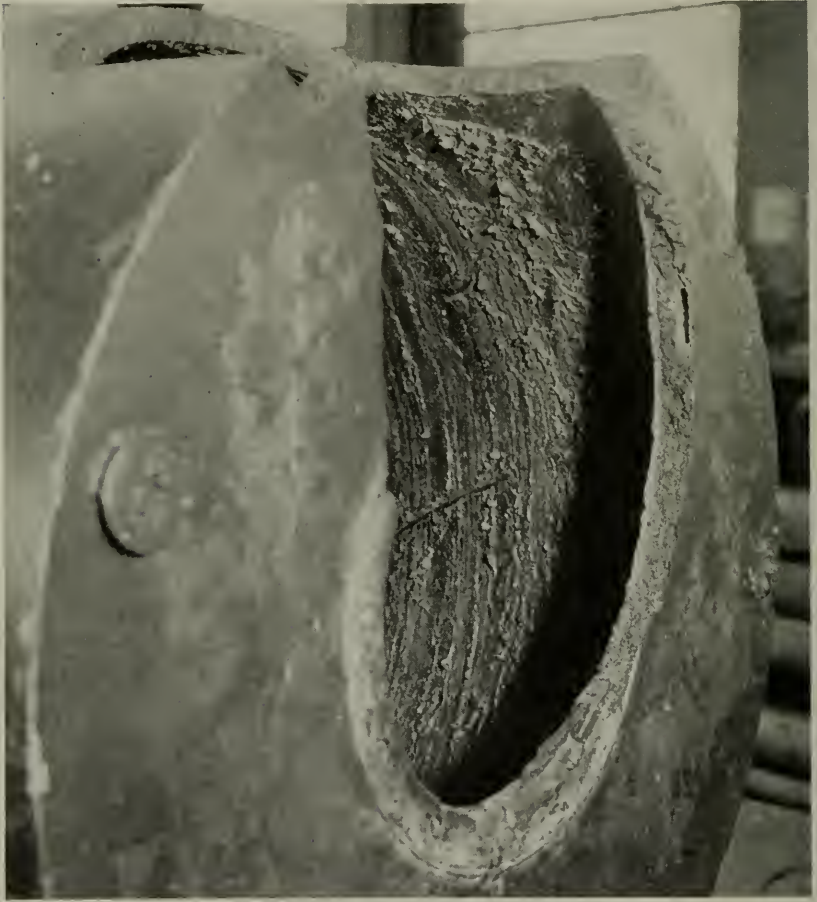
Figure 3—Lard cooler which exploded under normal use because of the failure of a defective casting.

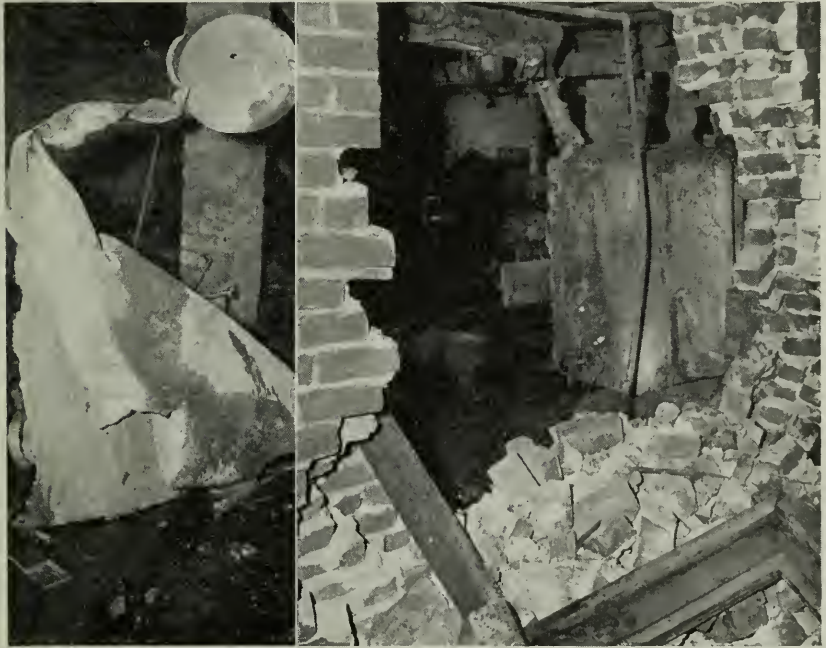
Figure 5—Left—Hot water tank after its explosion. Right—Hole in brick wall made by the exploding tank.

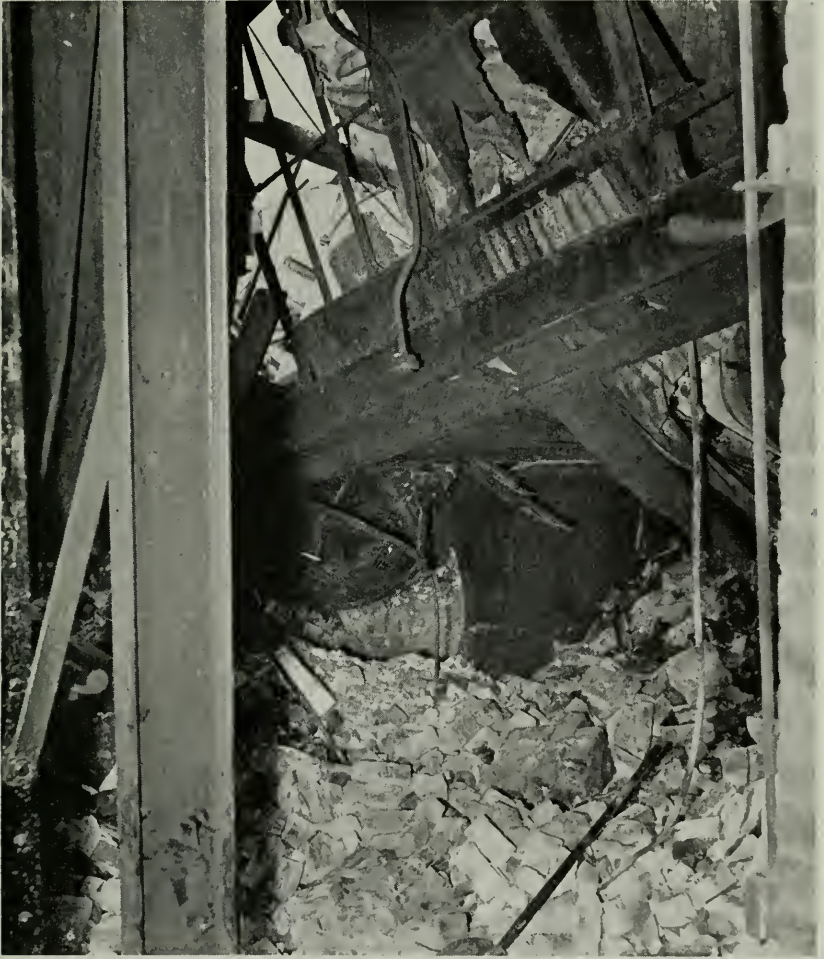
Figure 1—Top page 226—Damage after the explosions of a creosote tank and a water tube boiler at a southern plant.

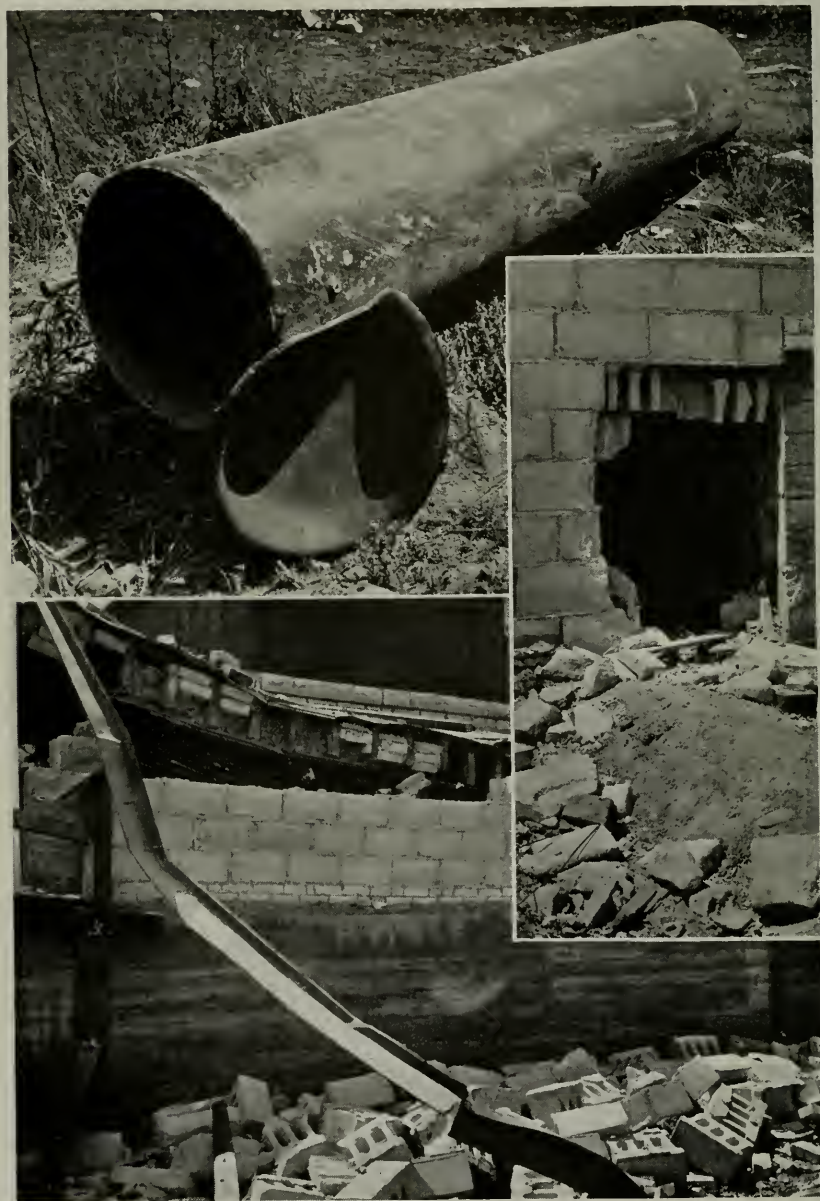
Damage following the explosion of an ammonia receiver after the city water supply was reduced and hot refrigerant gas was pumped through the condenser into the receiver. This accident occurred some months ago in Toronto. The pictures recently became available.

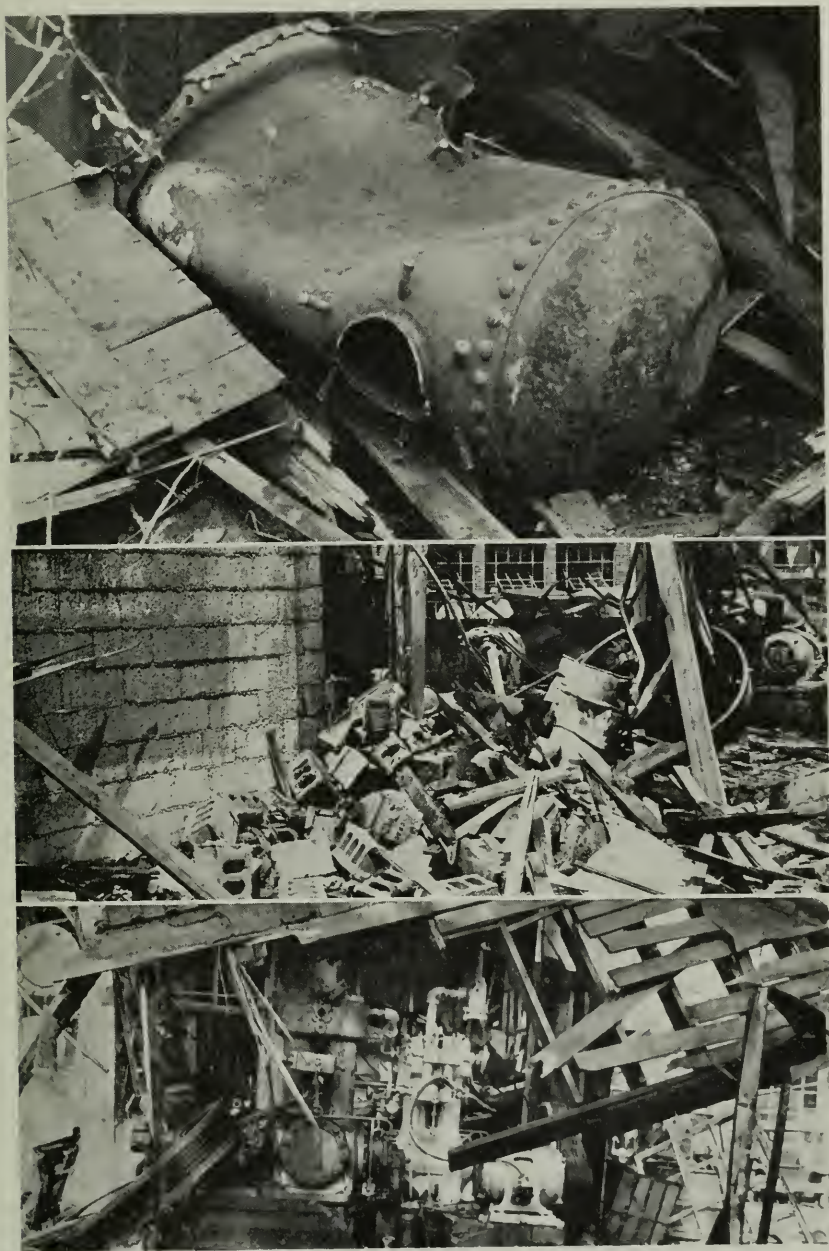
Three views of wreckage following the explosion of a 42" x 8' vertical tubular boiler at an ice cream plant on August 2.

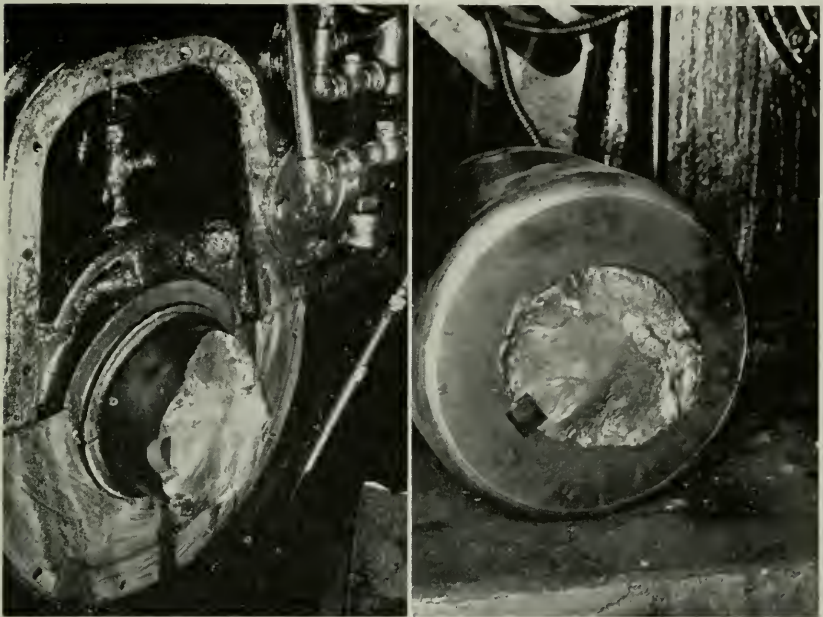
A GOOD example of a shaft break because of torsional vibration is illustrated by the two photographs on this page showing the faces of the break, which started at the keyway and progressed about 40 per cent of the way through the shaft before the final separation occurred. The picture at the left shows the engine end of the shaft and that at the right the coupling end.

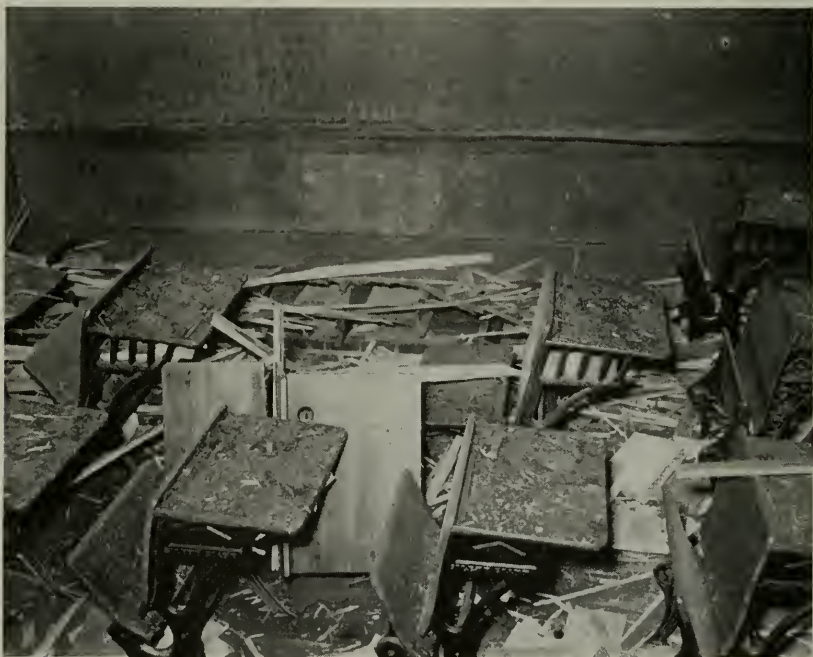
Above is a room at an Alabama school after the bursting of a hydro-pneumatic tank. Air pressure higher than the tank could withstand caused the explosion after the automatic control of the compressor failed to work. The tank went through the floor, ceiling and roof and fell to the ground outside the building. Fortunately the accident occurred at 8:00 P.M. when the room was empty. During school hours it accommodated 37 sixth grade pupils.

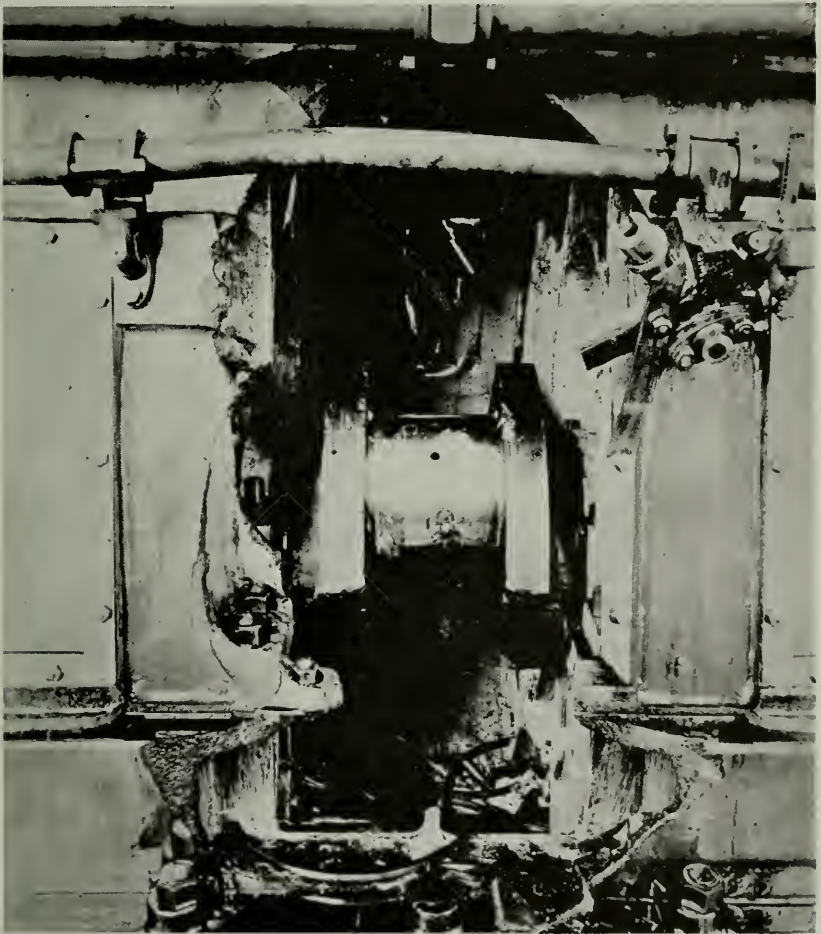
Figure 3—A wreck brought about by a crankbolt failure in a 2,000 hp engine. This accident resulted in a lost estimated at \$15,000. Vertically the picture shows about 5 feet of the engine.

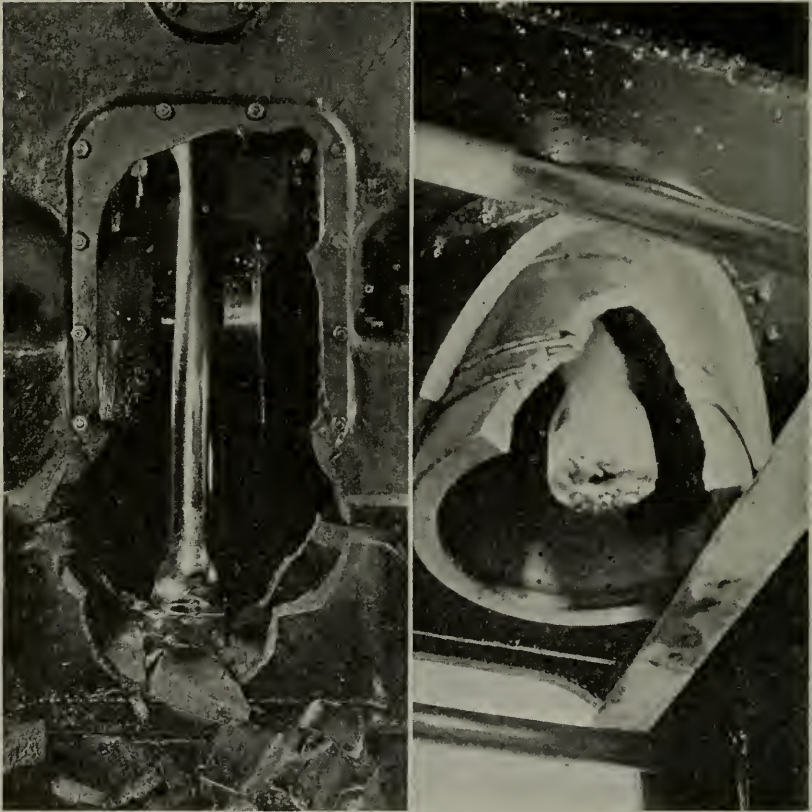
Figure 4—Left—Crankbolt breakage in a 260 hp Diesel engine. Figure 5—Right—Broken connecting rod and other damage on a 600 hp engine. This accident was caused by failure of a crankbolt, which had been in use for approximately 30,000 operating hours.

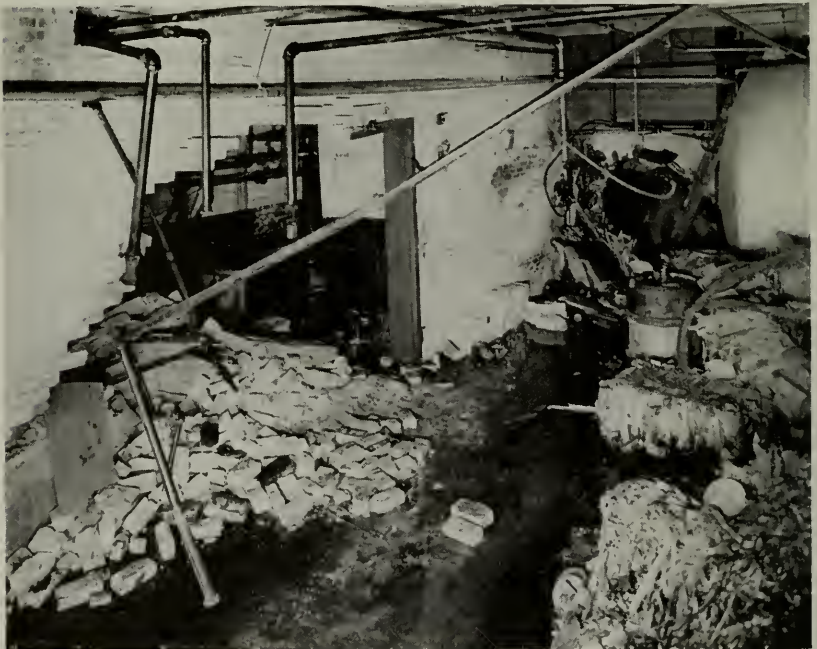
Part of the damage caused by the recent explosion of a condensate receiving tank.

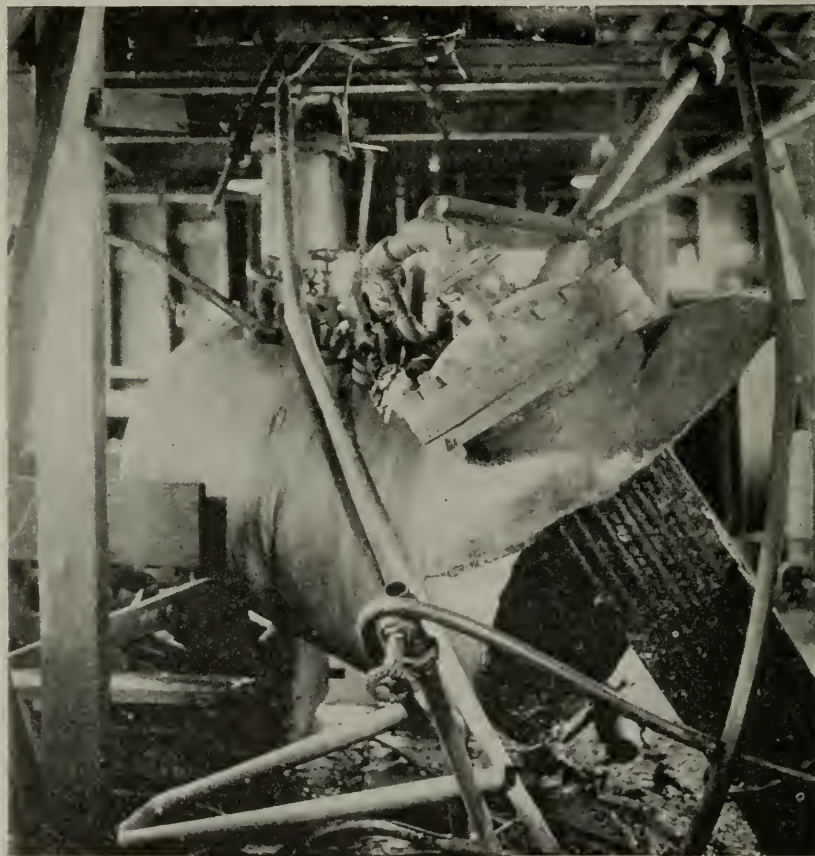
Damage after a combustion explosion in a chemical process tank.

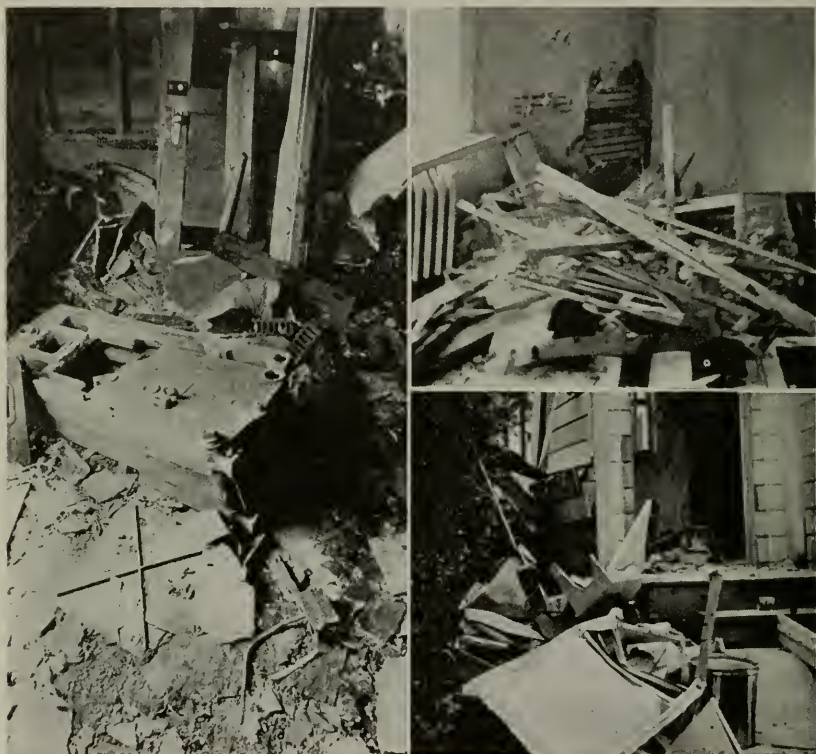
Left—Damage caused by the bursting of a hot water heating boiler from excess pressure. An investigation brought the conclusion that the system had been expected to operate with no expansion tank outlet and no relief valve. This accident occurred in Detroit.

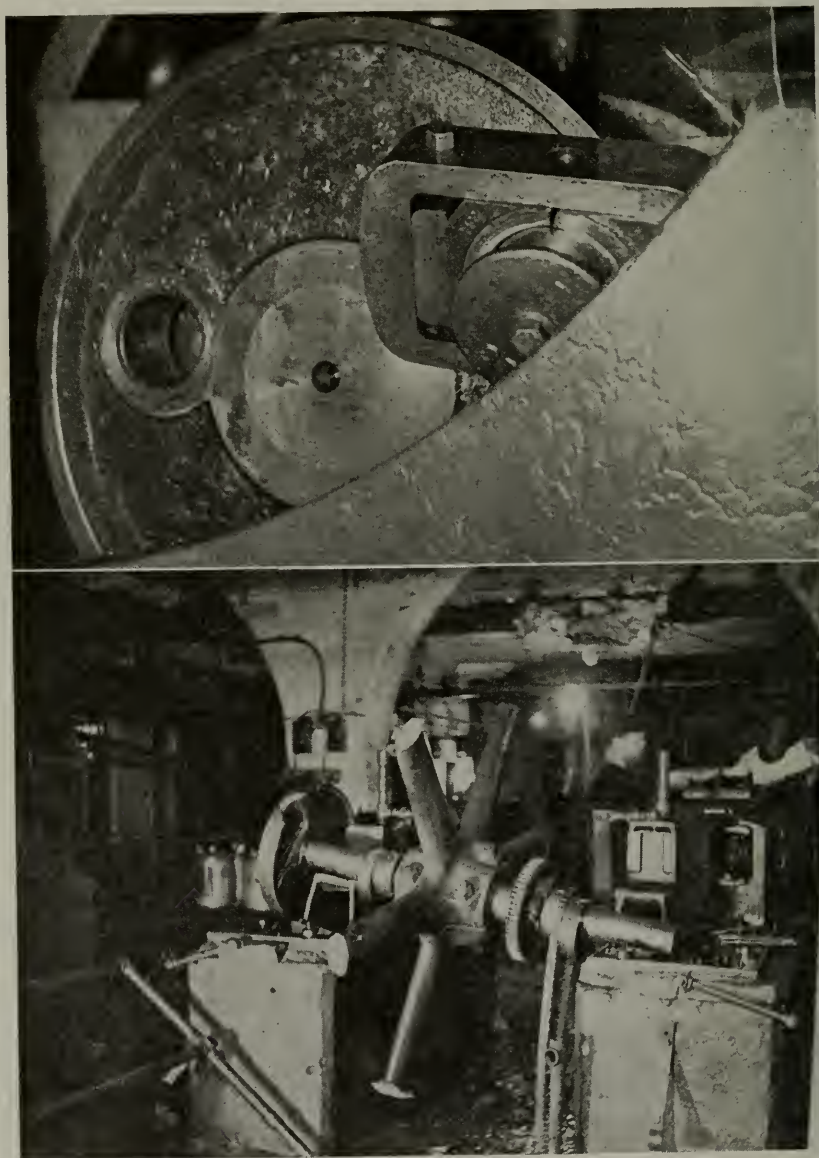
Figure 1 (above)—View of Engine No. 1 showing the loosened crank-pin and the connecting rod jammed between the disc and the frame.

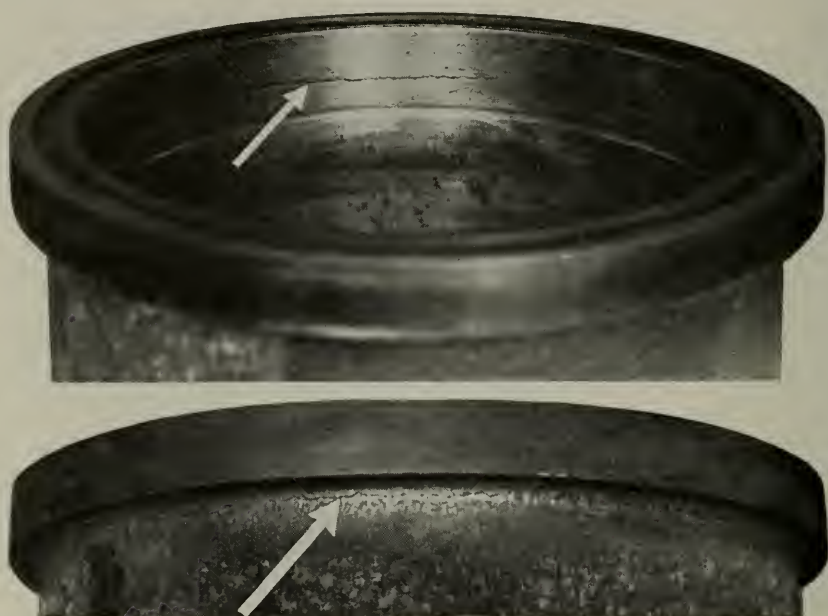
Figure 2 and 2A—Views showing a circumferential crack near the top of a 15" cylinder liner. This crack permitted leakage of water into the cylinder.
